MCA Prohibition Notice dated 2 May 2004 and Prohibition  
Notice Addendum dated 3 May 2004

The Test House Report – T40821 dated 3 June 2004. Laboratory Report  
Examination of a Fractured Bollard Mounting Plate Weld and Associated  
Material from the Thames River Craft *Star Clipper*

**LABORATORY REPORT  
EXAMINATION OF A FRACTURED  
BOLLARD MOUNTING PLATE WELD  
AND ASSOCIATED MATERIAL FROM  
THE THAMES RIVER CRAFT  
*STAR CLIPPER***

Tension Technology International Ltd – Report TTI-NOH-2004-274  
dated 4 August 2004 – “Final Report on the Examination and  
Tensile Testing of a Polypropylene Rope Strop, and Calculations  
to Establish the Likely Rope Stored Energy Involved in the Vessel  
Bollard Failure of the *Star Clipper*”

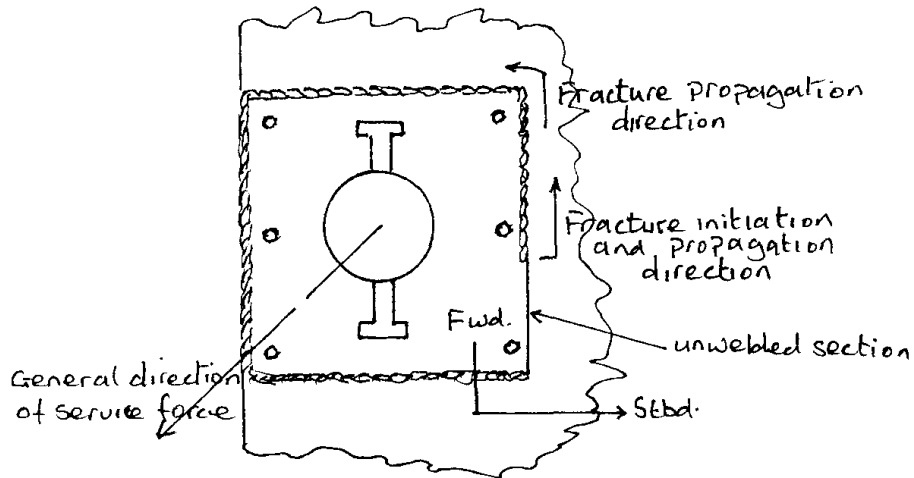
## T40821 APPENDIX 5 Sheet 2

Fractographic evidence suggested that fracture had initiated at the end of the inboard side weld and had propagated in a forward direction as shown in the following sketch.

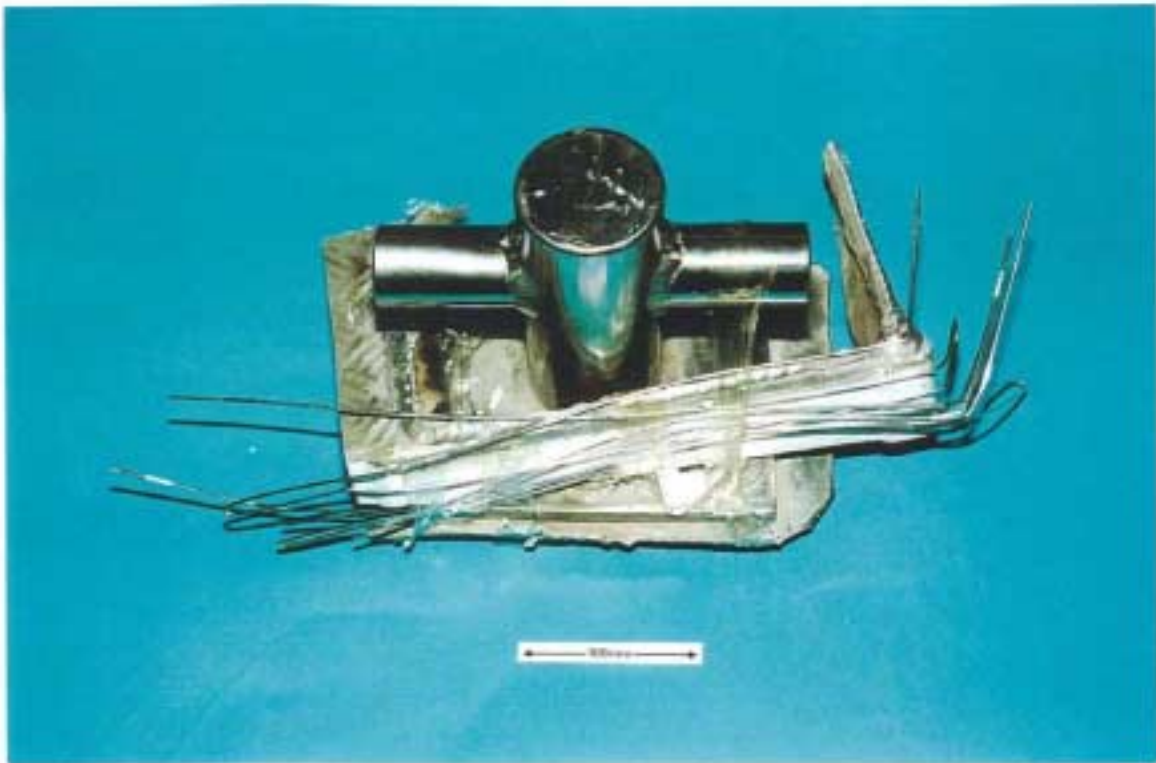
Figure 1: Forward port side bollard and associated material from STAR CLIPPER, shown as received.

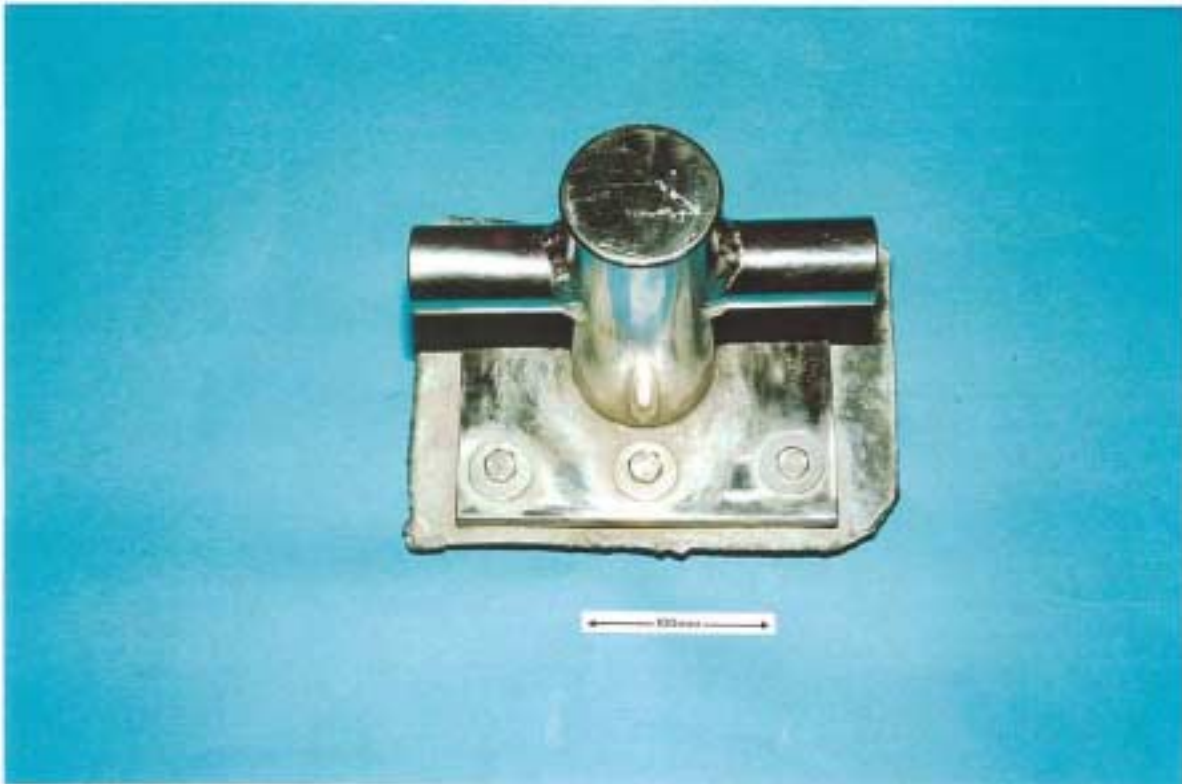
The bollard was supplied attached to the torn out walkway insert plate by six M10 stainless steel bolts, each secured with an appropriate stainless steel nut, washers and locking nut at the insert plates underside (figures 5 and 6). Though none of the six securing bolts appeared damaged, all but the aft outboard underside washer exhibited evidence of severe deformation. Although it is conceivable that some distortion of the washers could have occurred during installation of the bollard, the pattern and severity of the damage appeared more consistent with deformation of the insert plate preceding its detachment. A combined weight of 14.169kg for the bollard, mounting plate and fixings was established via a calibrated load cell prior to disassembly.

Figure 5: Bollard, shown still bolted to the walkway insert plate.

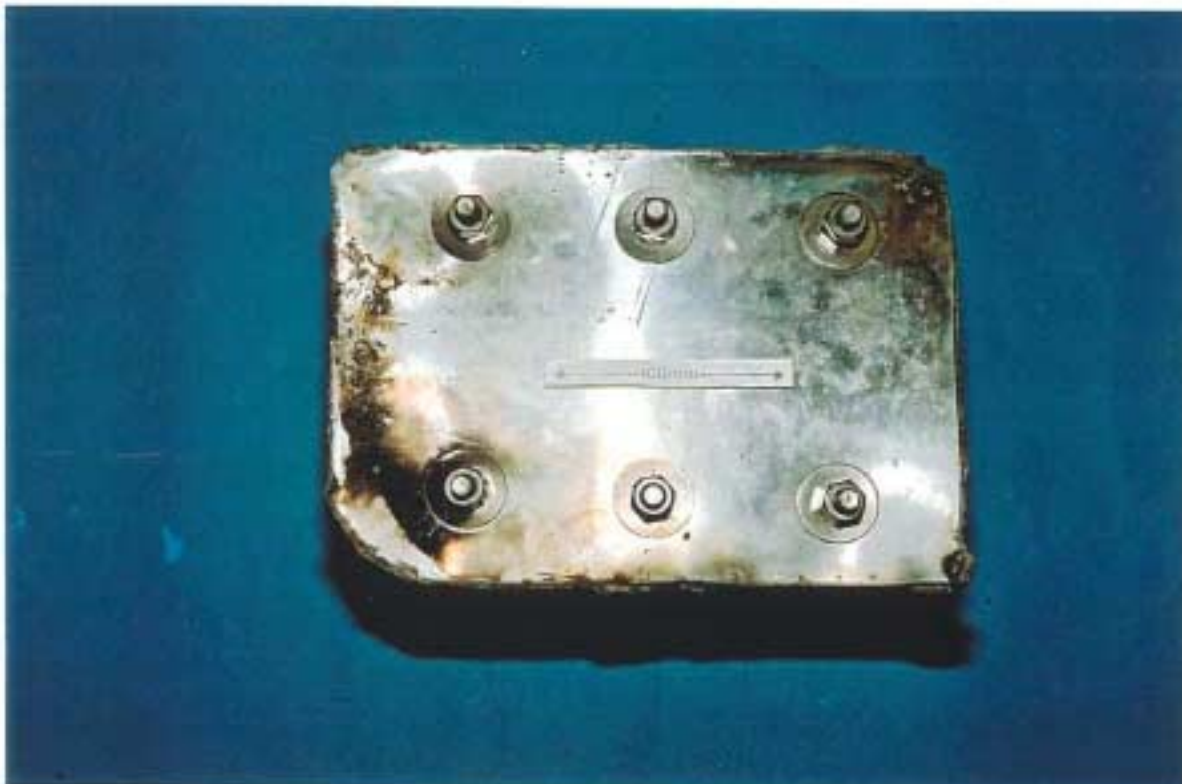
Figure 6: Underside of detached insert plate, showing nut and locking nut securing arrangement.

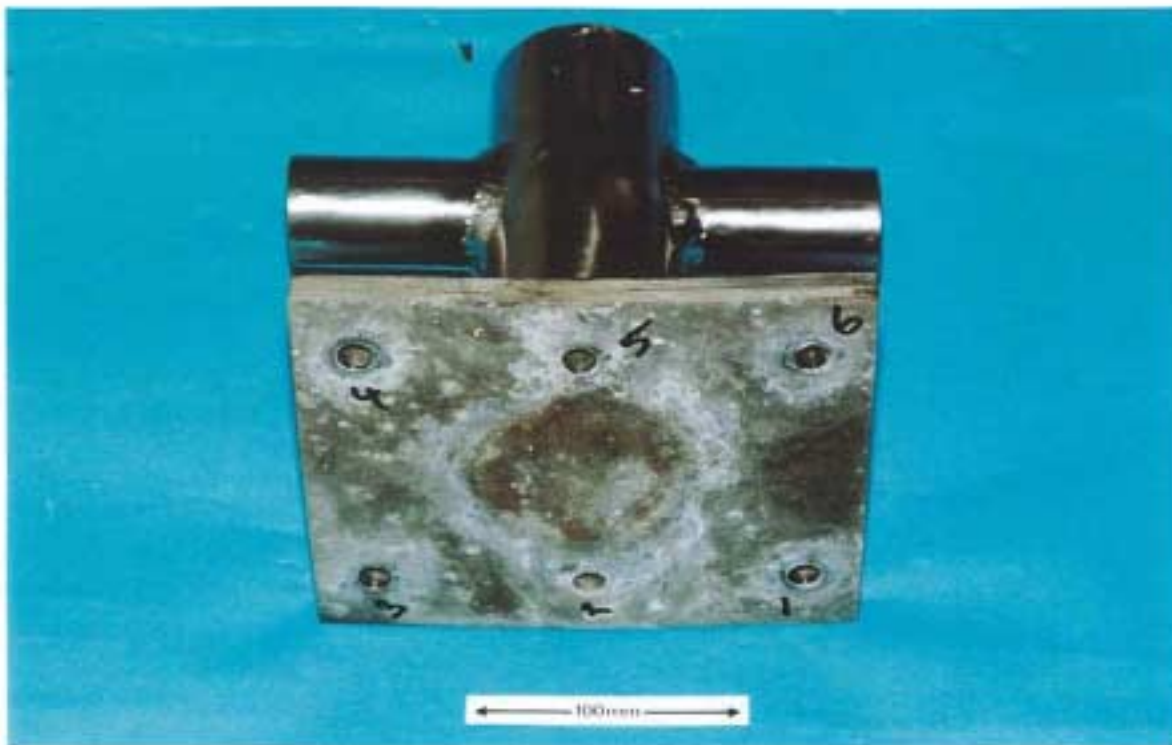
Figure 7: Underside view of bollard, showing welding related distortion of the base plate.

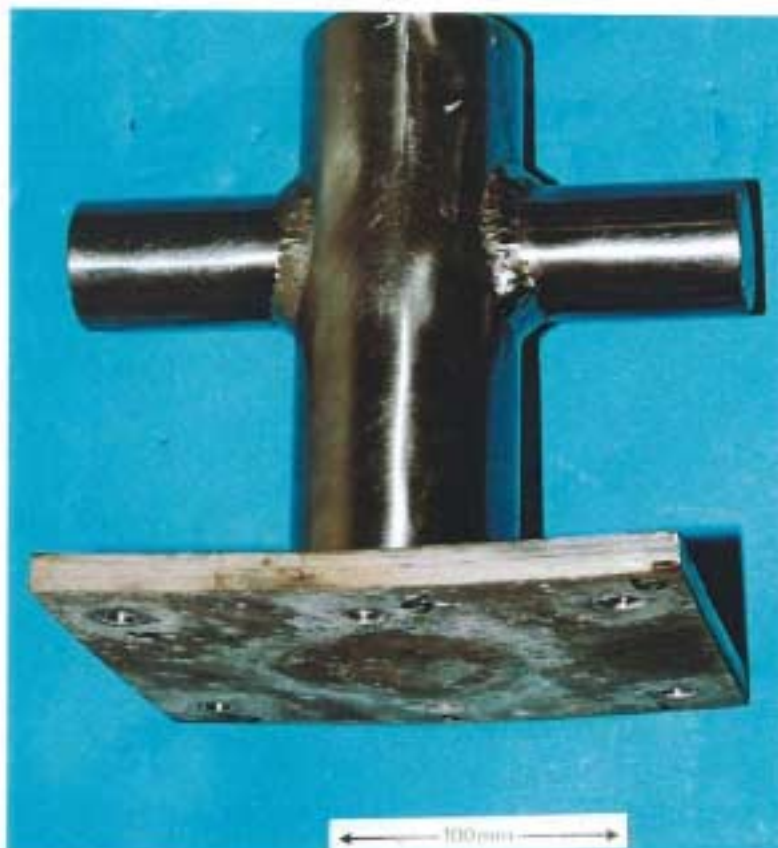
Figure 8: Side view of bollard, showing welding related base plate distortion.

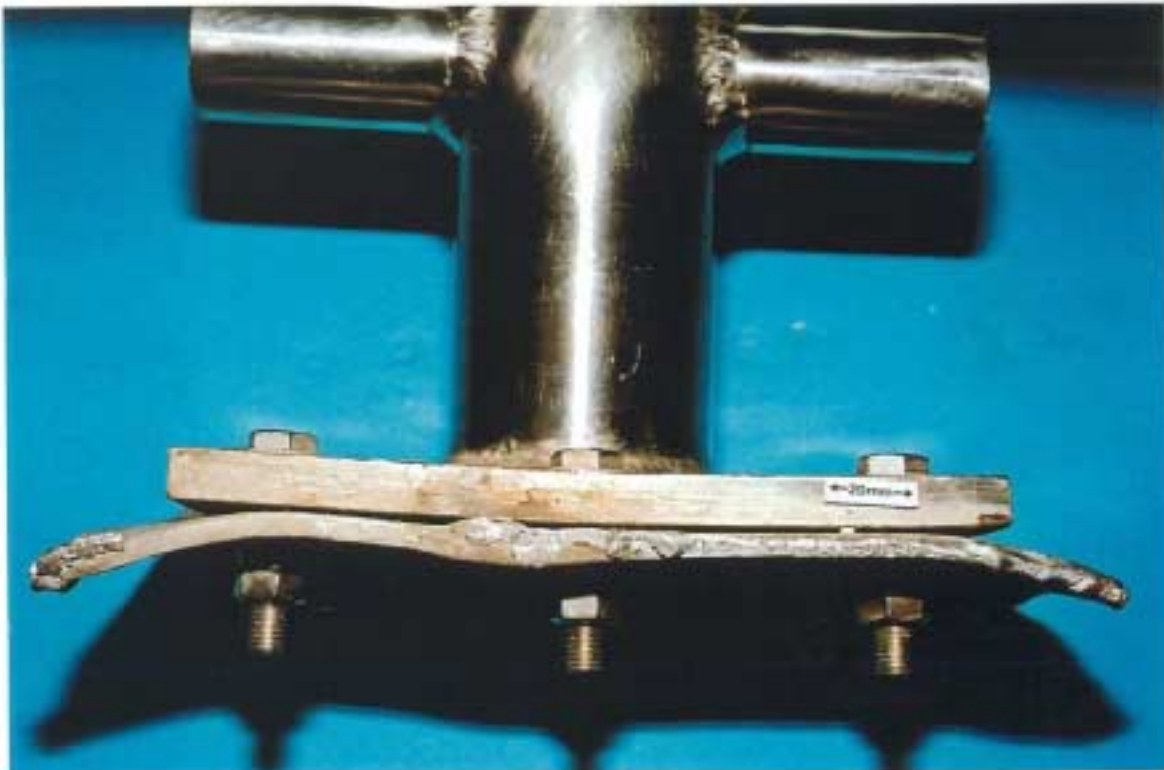
The inboard insert plate edge appeared to have only been welded at the forward end. Fracture had occurred through the throat (the shortest distance from the weld root to the weld face or cap) of the weld length present, and though the plate had been restrained at both inboard corners, significant upwards deformation was apparent (figures 9 and 10). The outboard edge was fully welded and fracture had occurred through the throat of the full weld length. In the case of this edge, fracture was accompanied by upward deformation around the forward bolt hole and severe downwards indenting of the bollard base into the insert plates aft outboard corner (figures 11, 12 and 13). The forward edge exhibited evidence of welding along its full length, and fracture had again occurred through the throat of the full weld length. The weld fracture at this plate edge was accompanied by upward deformation of the plate around both bolt holes (figures 14 and 15). The aft plate edge exhibited evidence of a weld along its full length, and fracture yet again had propagated through the throat of the full weld length. The deformation at this plate edge was upwardly directed at the inboard corner bolt hole, in contrast with the outboard corner, which exhibited downwards indenting of the bollard base into the insert plates outboard corner (figures 16 and 17).

Figure 10: Detail of above, showing fracture in weld metal that was present at the forward end only.

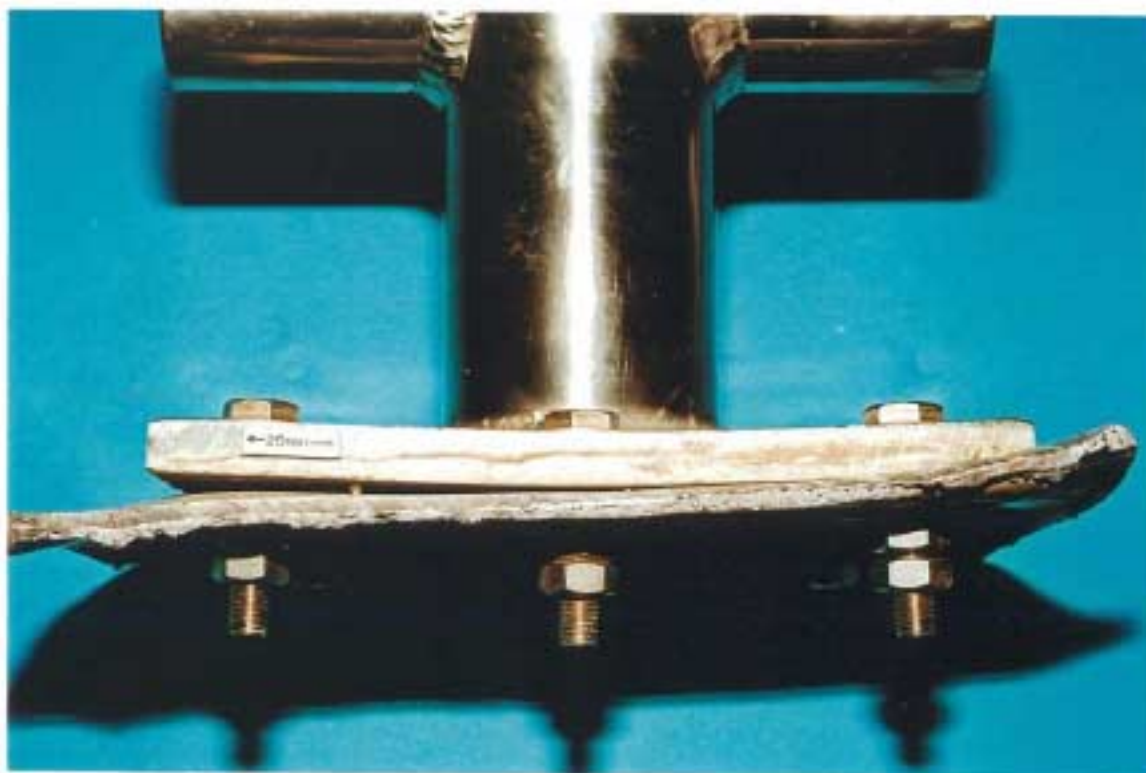
Figure 12: Detail of above, showing fractured weld metal.

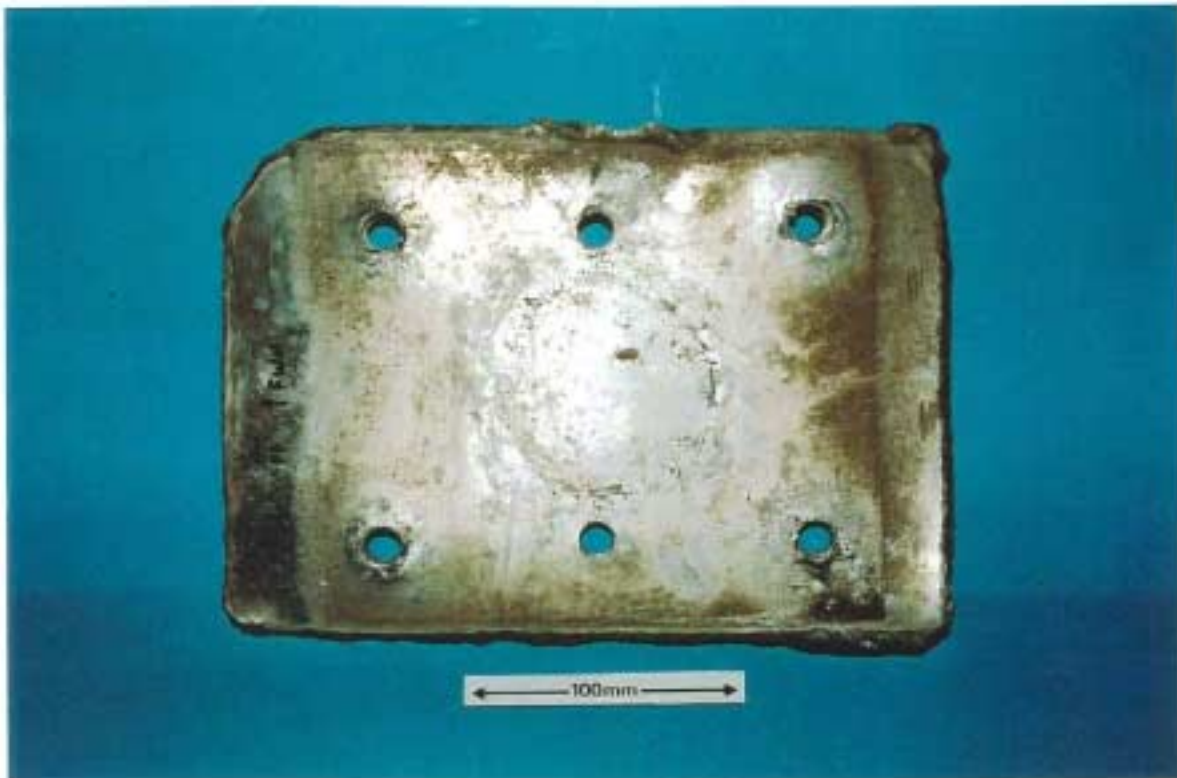
Figure 13: Insert plate, showing bollard base downwards indenting of the aft outboard corner (lower right corner of field).

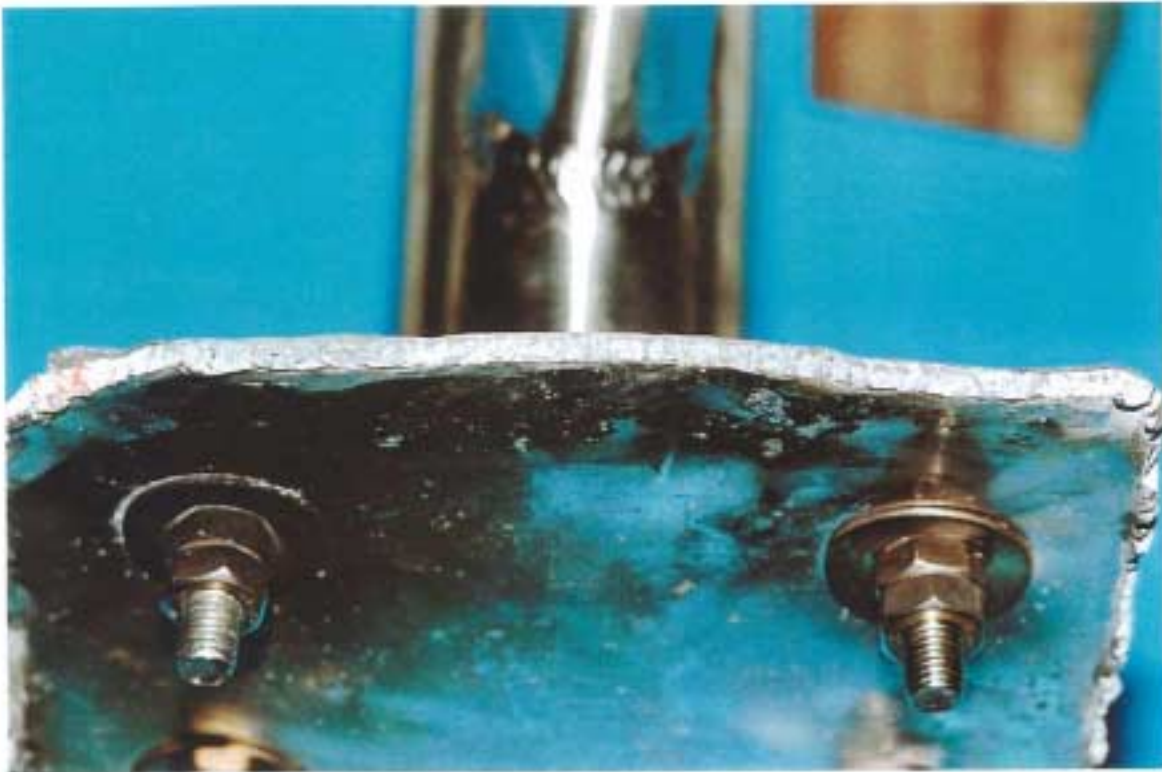
Figure 15: Detail of figure 14, showing fractured weld metal.

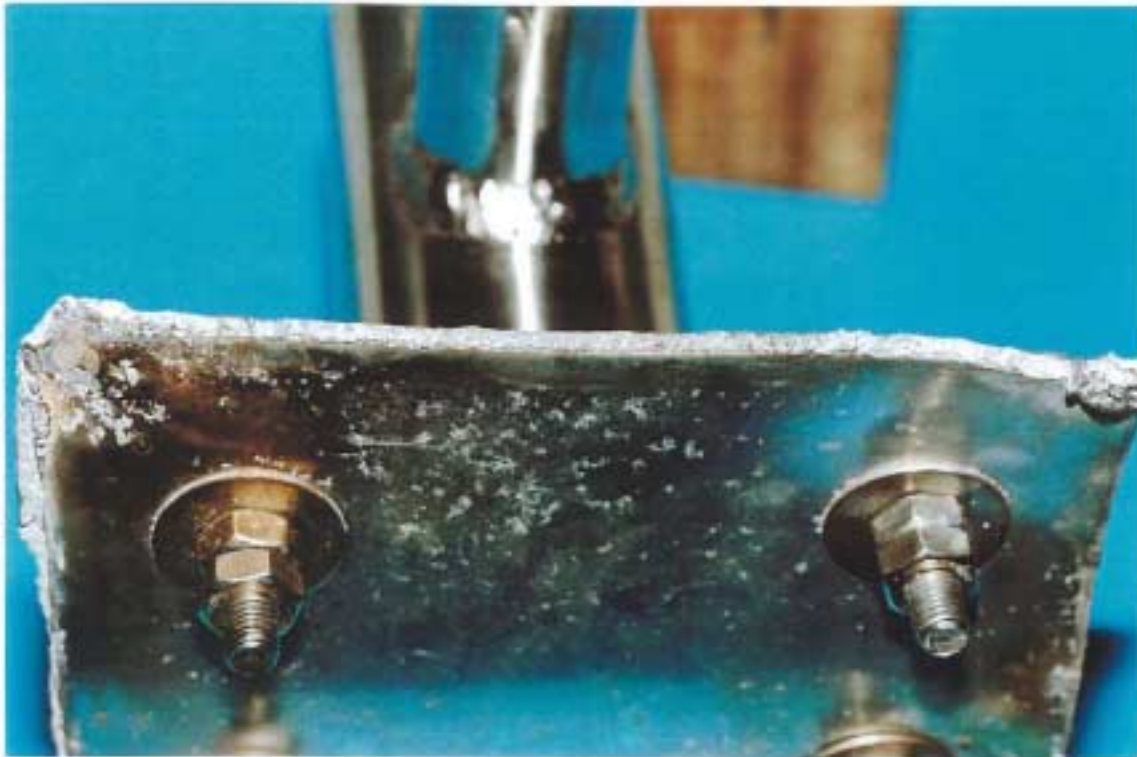
Figure 17: Detail of figure 16, showing fractured weld metal.

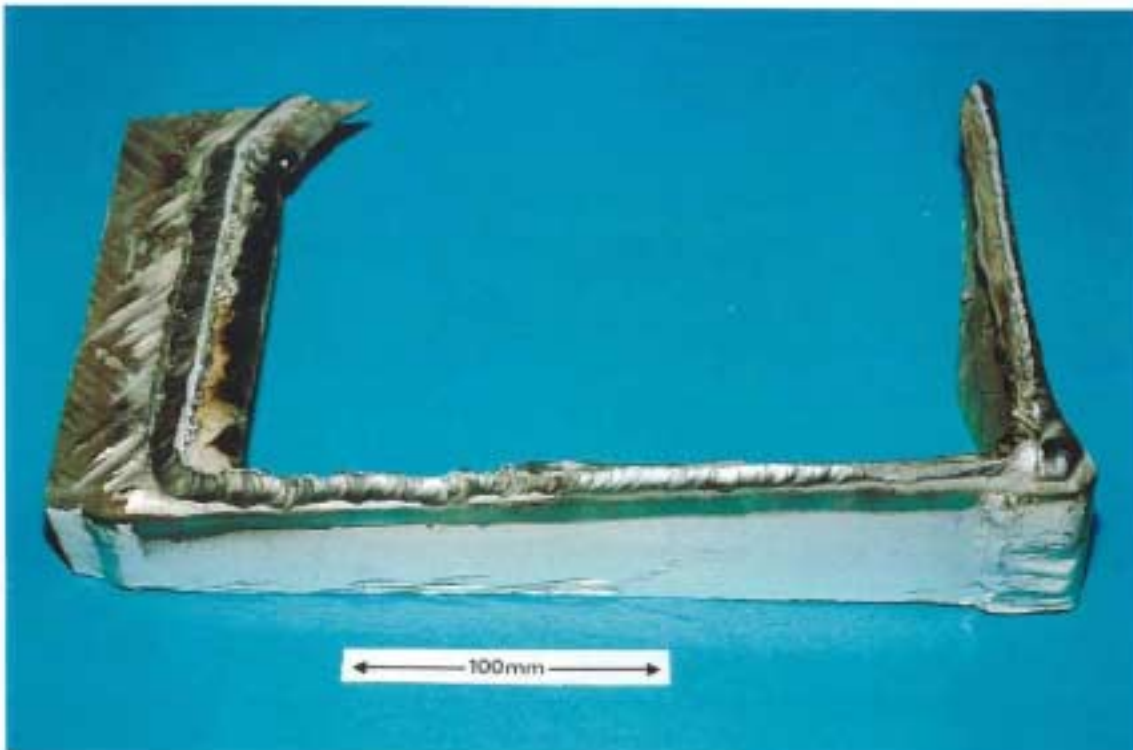
The underside fracture half comprised only the forward, outboard and aft ends, and is shown in figure 18. The piece had been close cropped from the raised passenger access way floor support structure and contained three sides of the fractured insert plate weld, the double skin outboard side plates, forward chequer plate, forward under-floor transverse member and the double skin aft end transverse plates.

Figure 18: Underside fracture half comprising the forward end, outboard side and aft ends only.

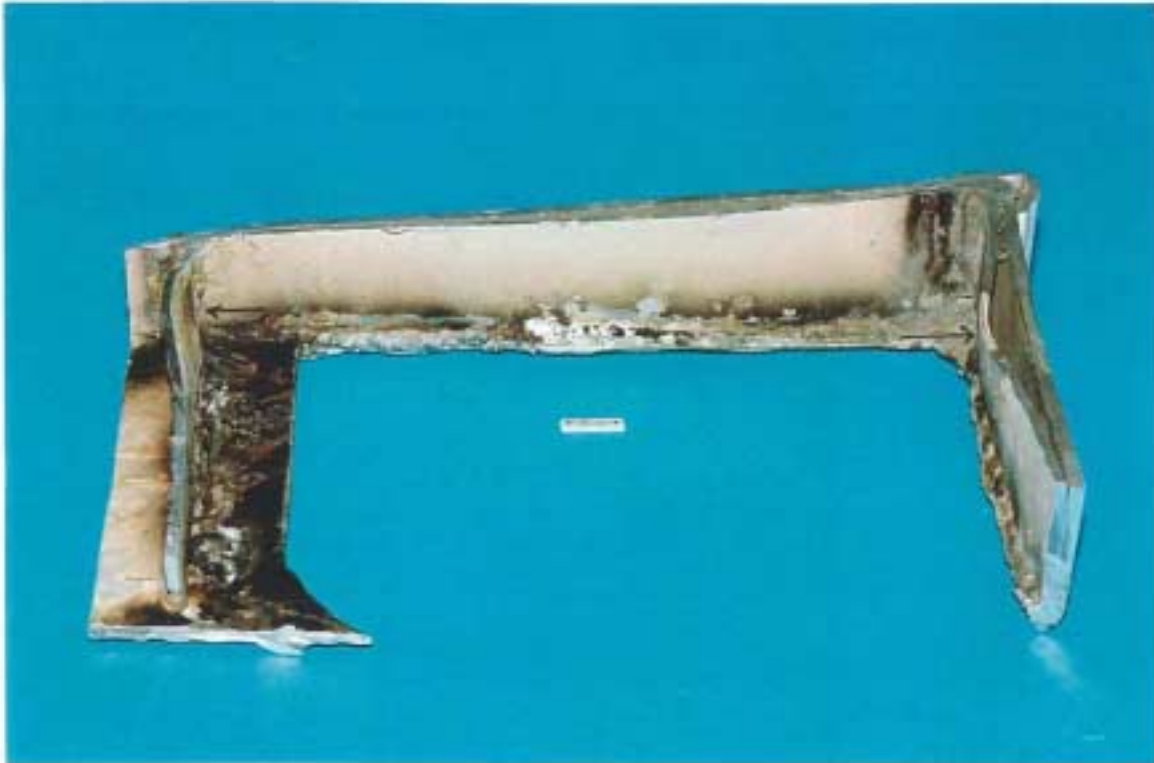
The under-floor forward transverse member and the aft transverse inner skin member both exhibited pronounced buckling damage (figure 19). Though it was possible to conclude that buckling had resulted from a force acting in the vessels transverse direction. It was not, however, possible to determine from the evidence if the damage had pre-dated fitting of the insert plate, or whether, as appears more likely, it was contemporary with the casualty incident.

Figure 19: Under-floor section, showing buckling damage to forward and aft transverse members (arrowed).

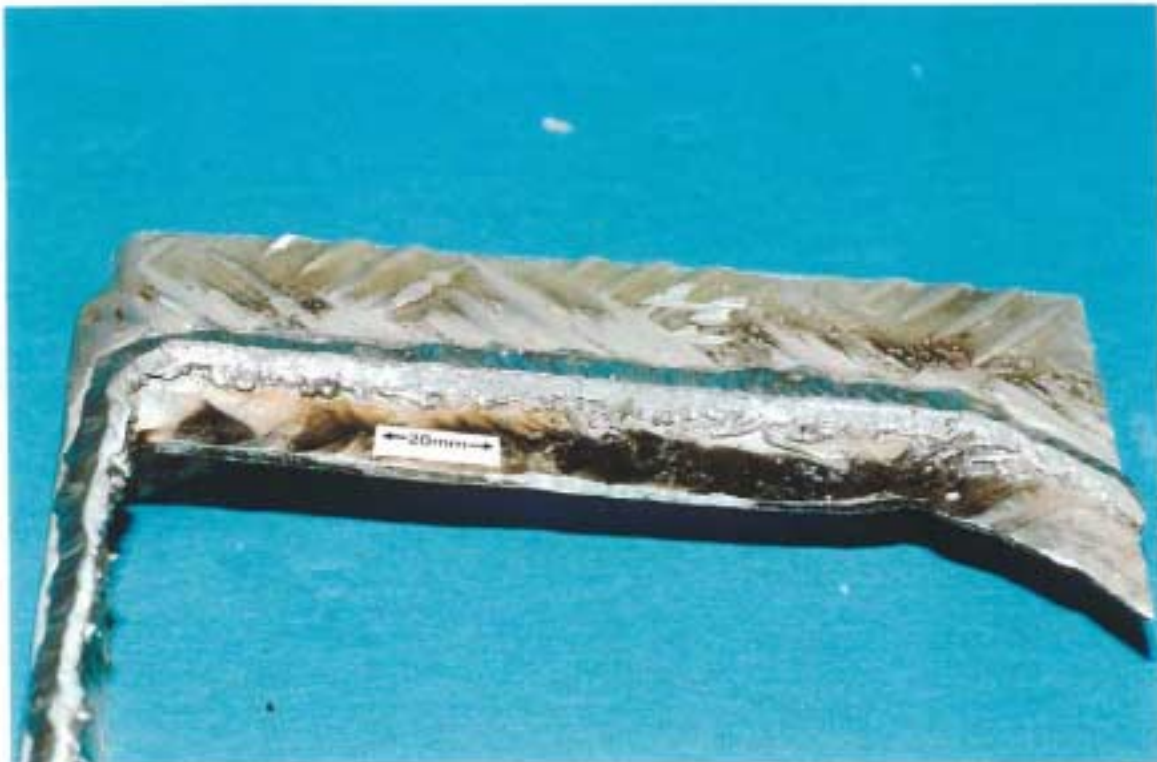
Figure 20: Under-side fractured forward weld section.

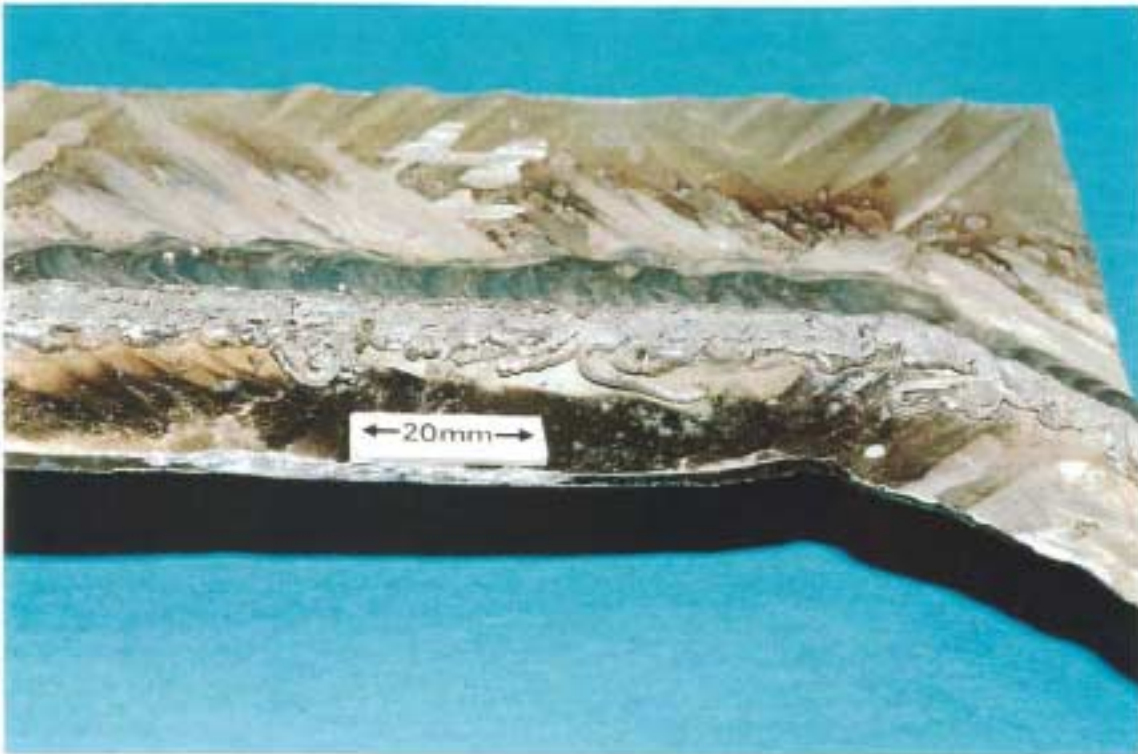
Figure 21: Detail of figure 20, showing unfused root bead roll-through and possible entrapped consumable welding wire in weld root.

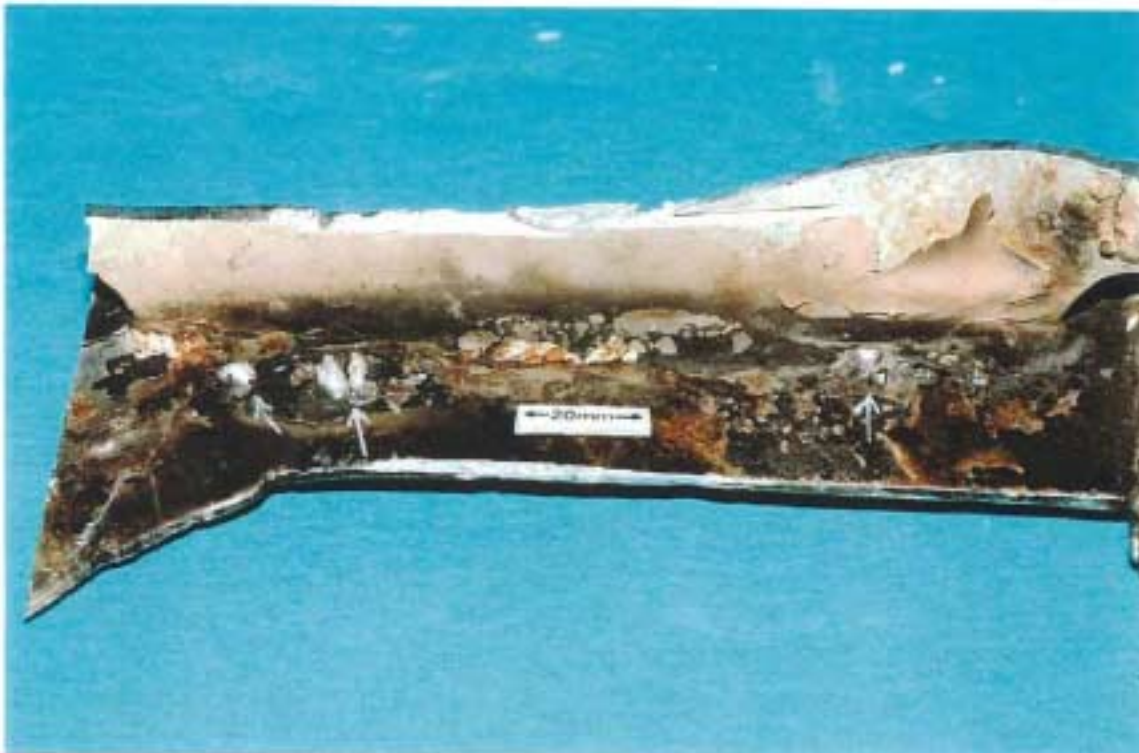
Figure 22: Under-floor forward section, showing local excess penetration or burn-through the chequer plate (arrowed) from the insert weld to the upper chequer plate surface.

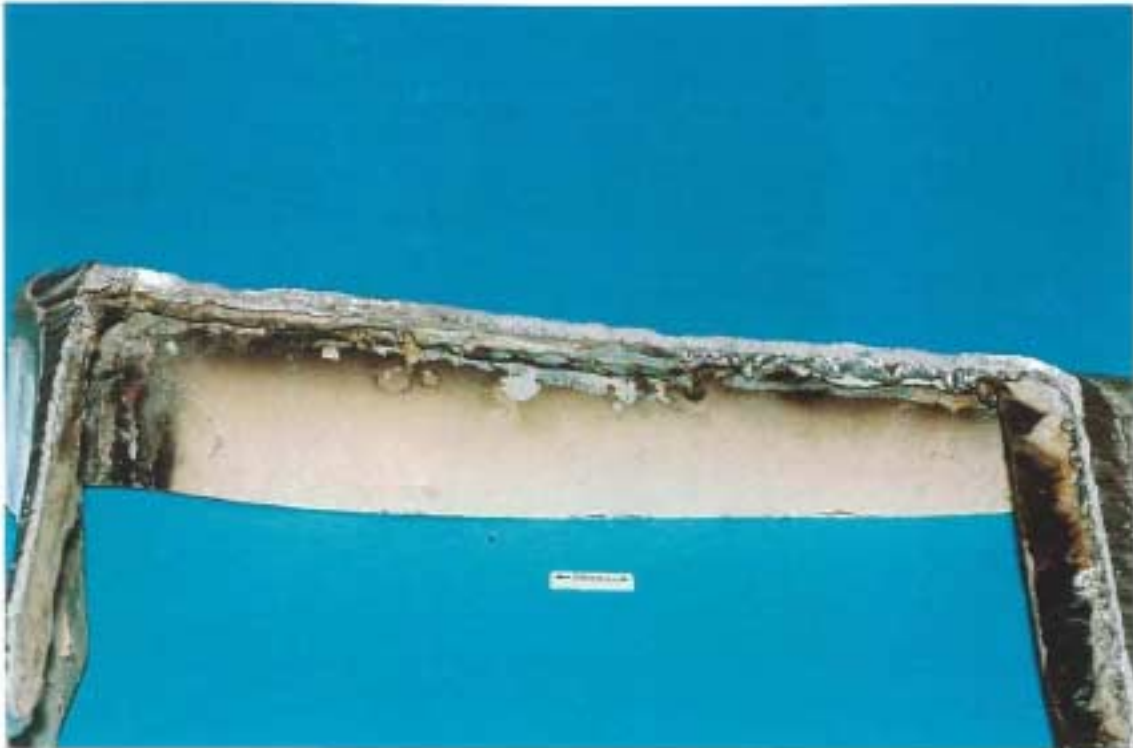
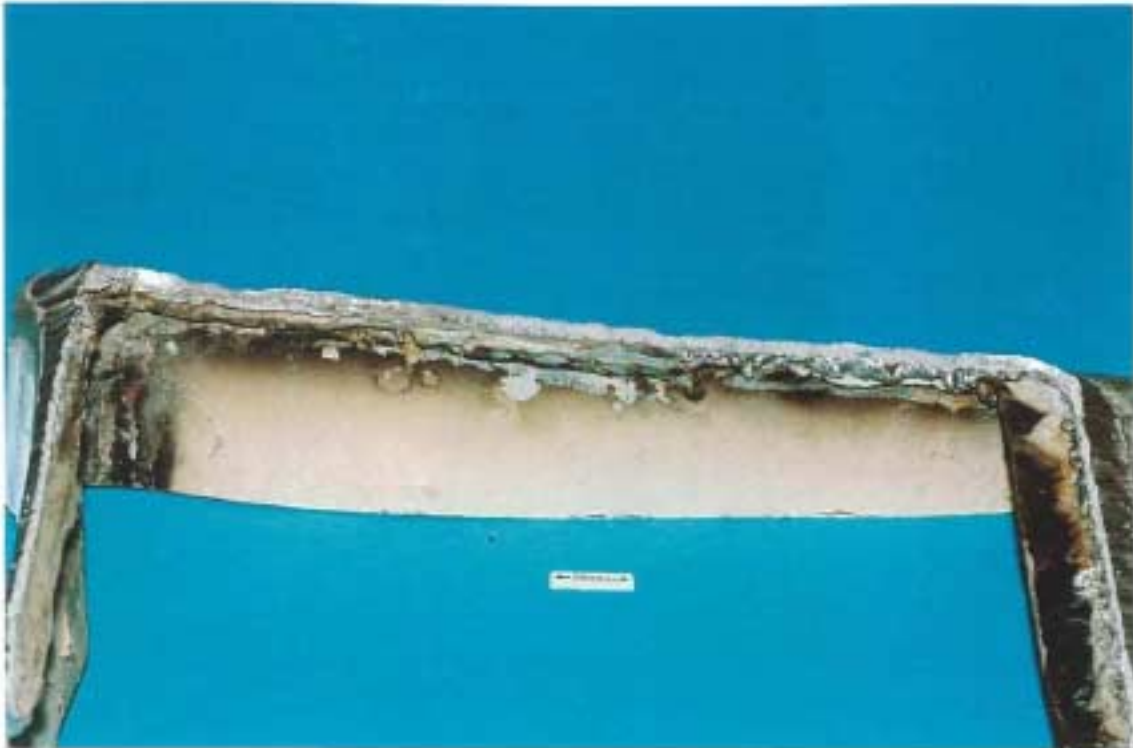
Figure 23: Under-side of fractured outboard weld section.

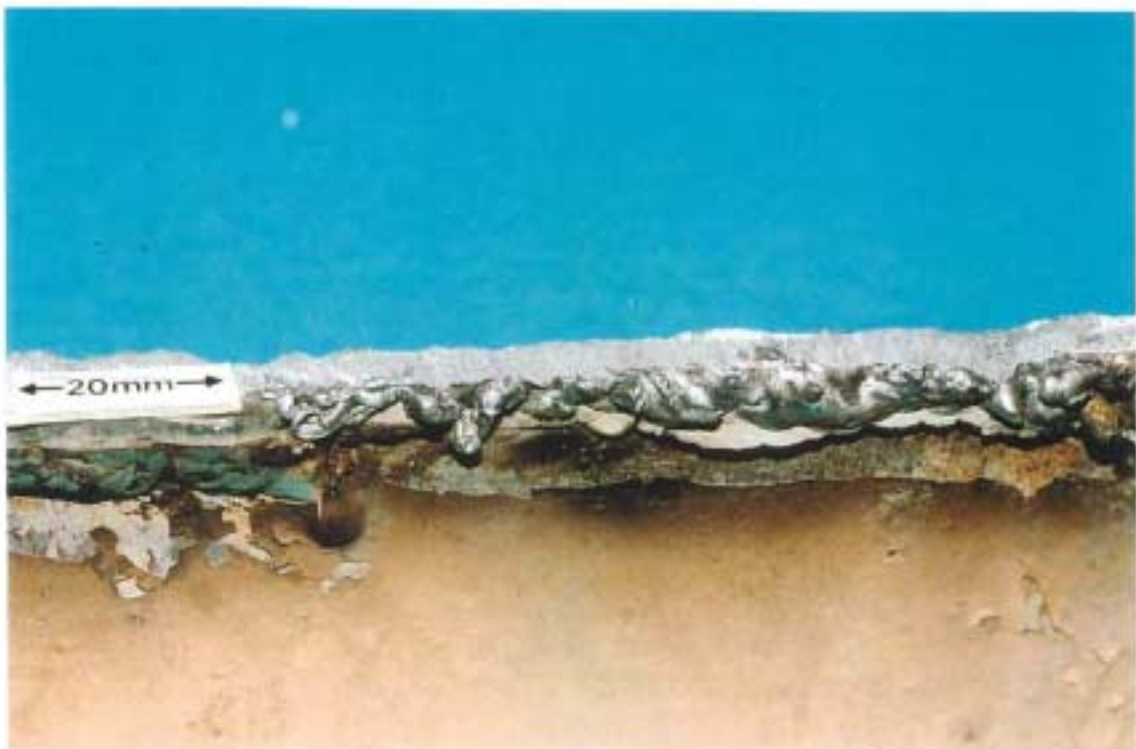
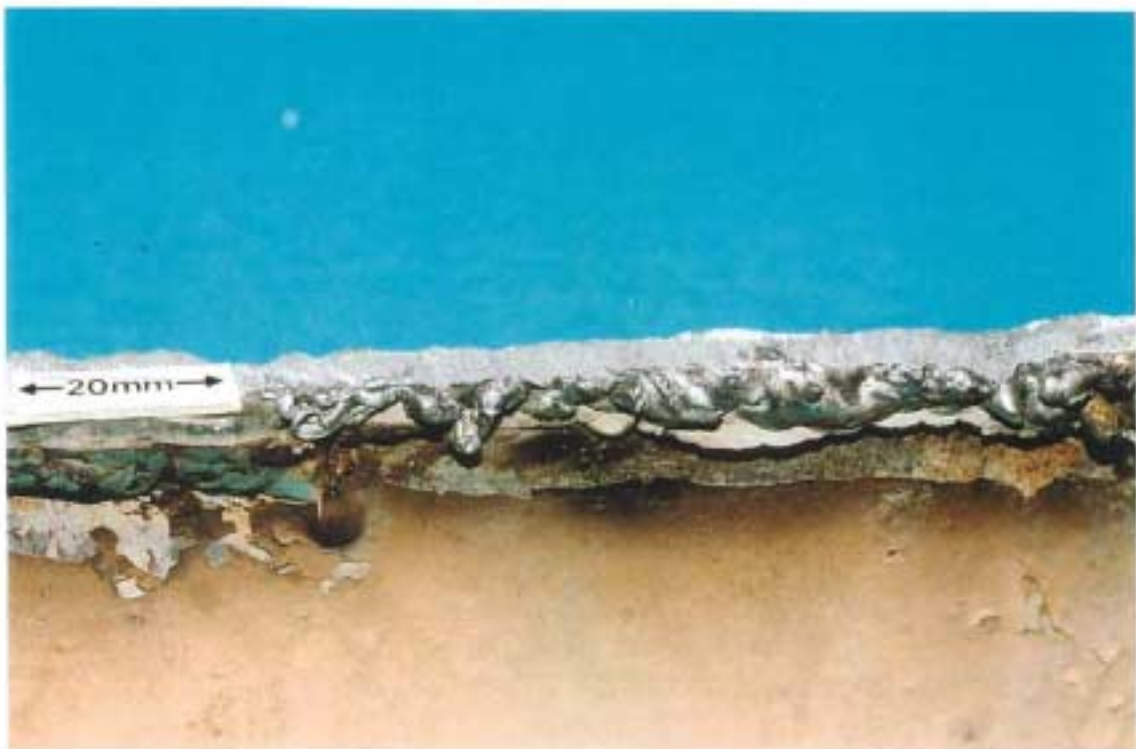
Figure 24: Detail of above, showing area of excessive root penetration.

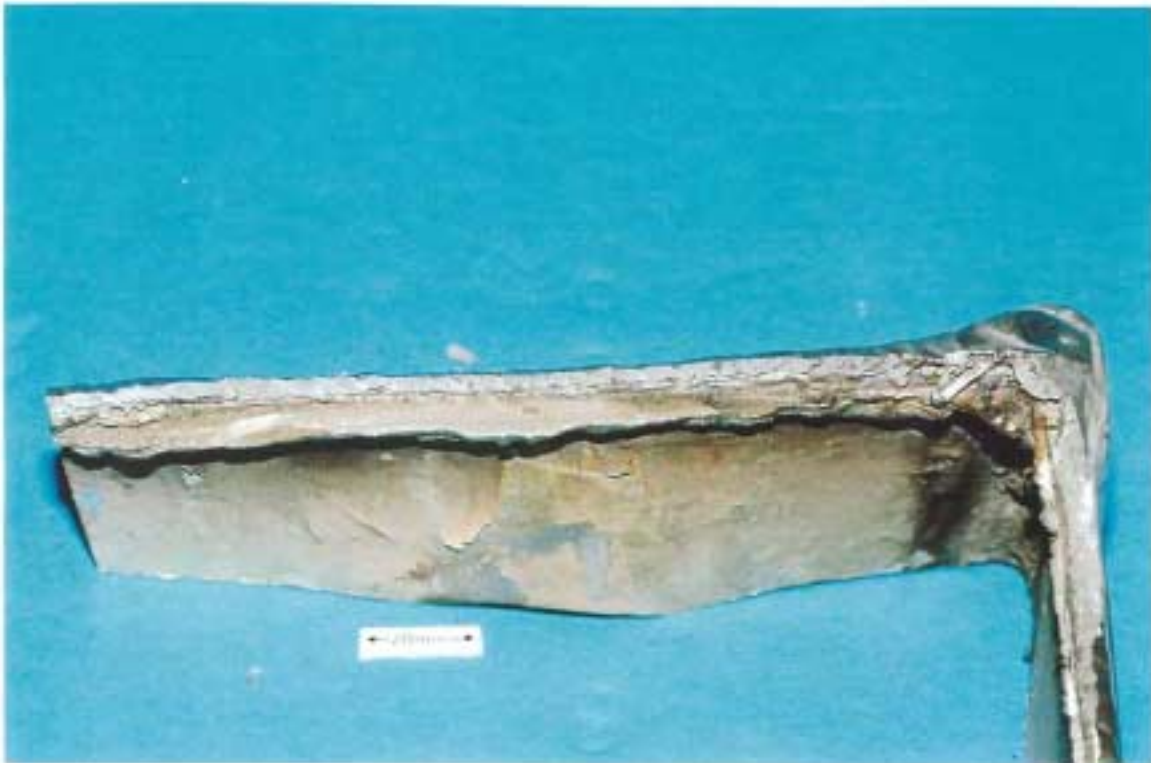
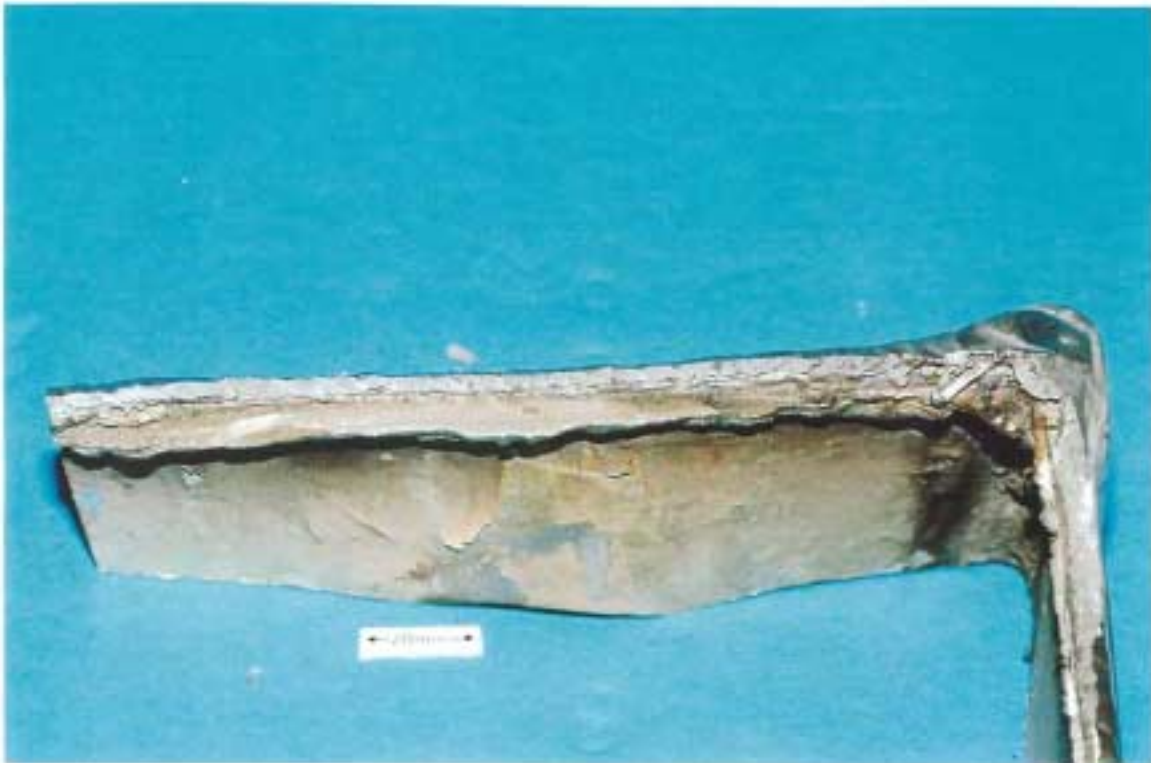
Figure 25: Under-side of fractured aft weld section.

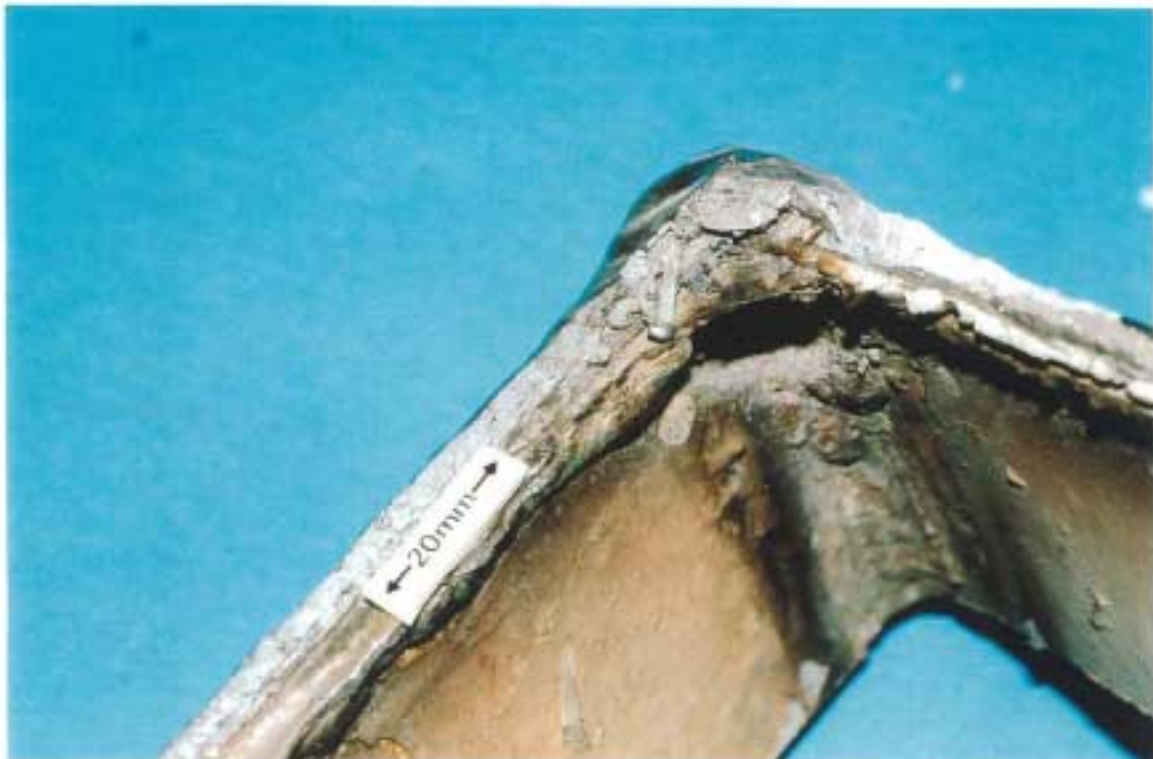
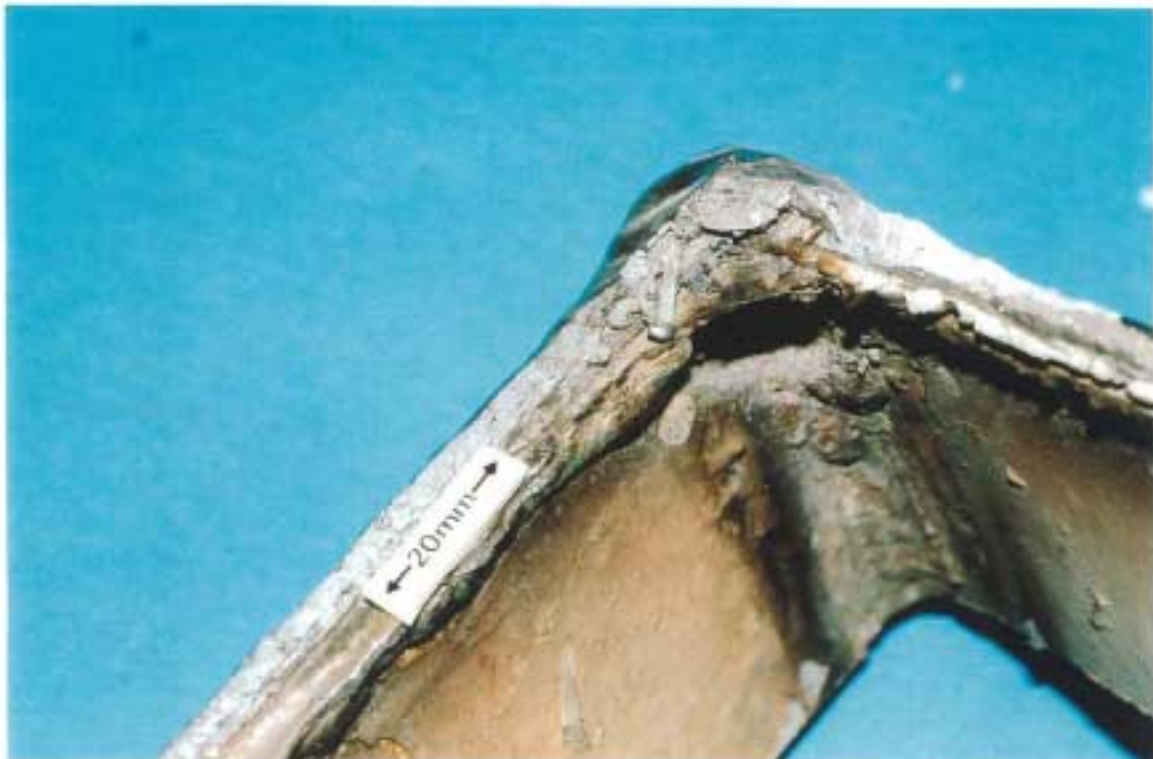
Figure 26: Detail of above, showing weld root defects in the corner transition region from the outboard weld side.

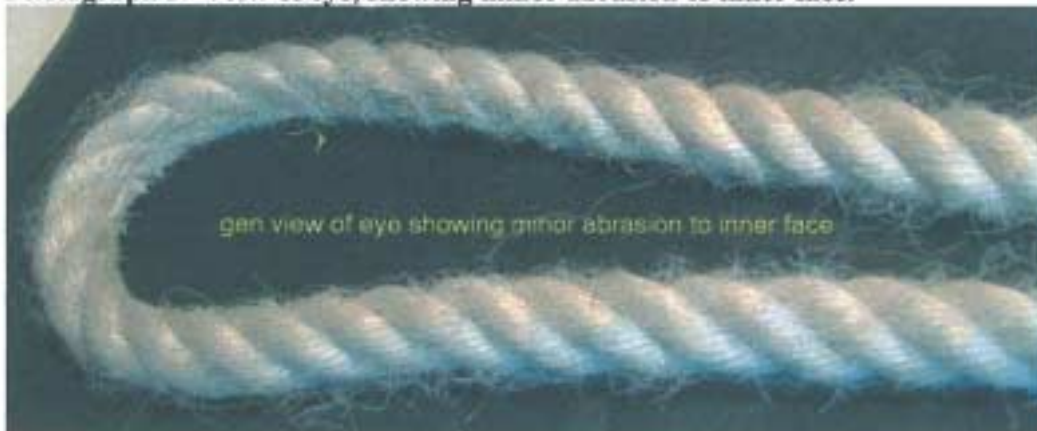
The assembly appeared in good condition, Photograph 2 showing a view of the rope used in the assembly. Photograph 3 is a view of the eye, showing minor abrasion to its inner face, where it has been in contact with bollards or other mooring devices.

**Photograph 3 View of eye, showing minor abrasion to inner face.**

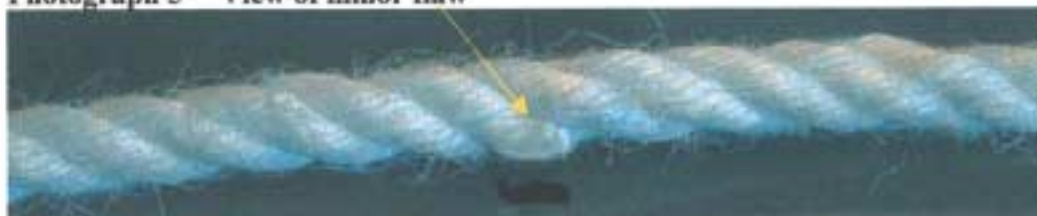
Photograph 4 shows the splice used to create the single eye, and Photograph 5 shows the one minor problem seen in the 'rope part' of the assembly, a raised loop, maybe caused by the rope catching on an object.

**Photograph 5 View of minor flaw**
