MCA Prohibition Notice dated 2 May 2004 and Prohibition  
Notice Addendum dated 3 May 2004

The Test House Report – T40821 dated 3 June 2004. Laboratory Report  
Examination of a Fractured Bollard Mounting Plate Weld and Associated  
Material from the Thames River Craft *Star Clipper*

**LABORATORY REPORT  
EXAMINATION OF A FRACTURED  
BOLLARD MOUNTING PLATE WELD  
AND ASSOCIATED MATERIAL FROM  
THE THAMES RIVER CRAFT  
*STAR CLIPPER***

Tension Technology International Ltd – Report TTI-NOH-2004-274  
dated 4 August 2004 – “Final Report on the Examination and  
Tensile Testing of a Polypropylene Rope Strop, and Calculations  
to Establish the Likely Rope Stored Energy Involved in the Vessel  
Bollard Failure of the *Star Clipper*”

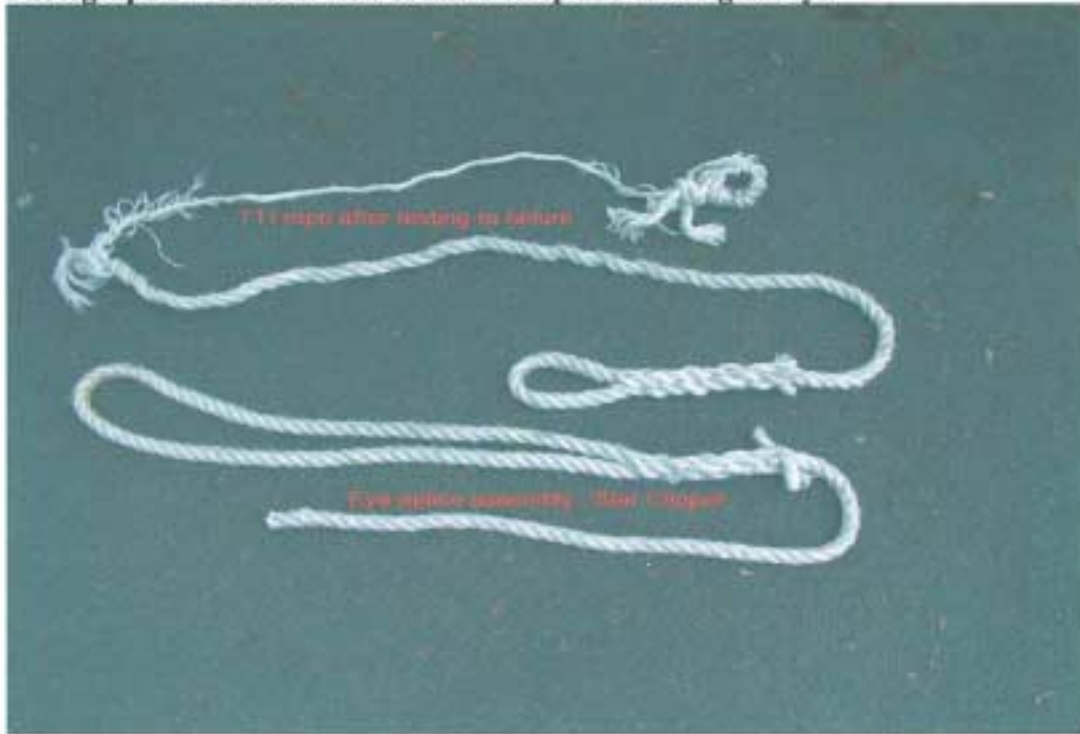
The Breaking Load was 65.04 kN, 6.63 tonnef.  
 The Breaking Extension was 508 mm, 14.97%

The failure was just below one of the splices, and Photograph 8 shows a general view of the failed strop with the original eye for comparison

**Photograph 8** General view of failed strop and the original eye

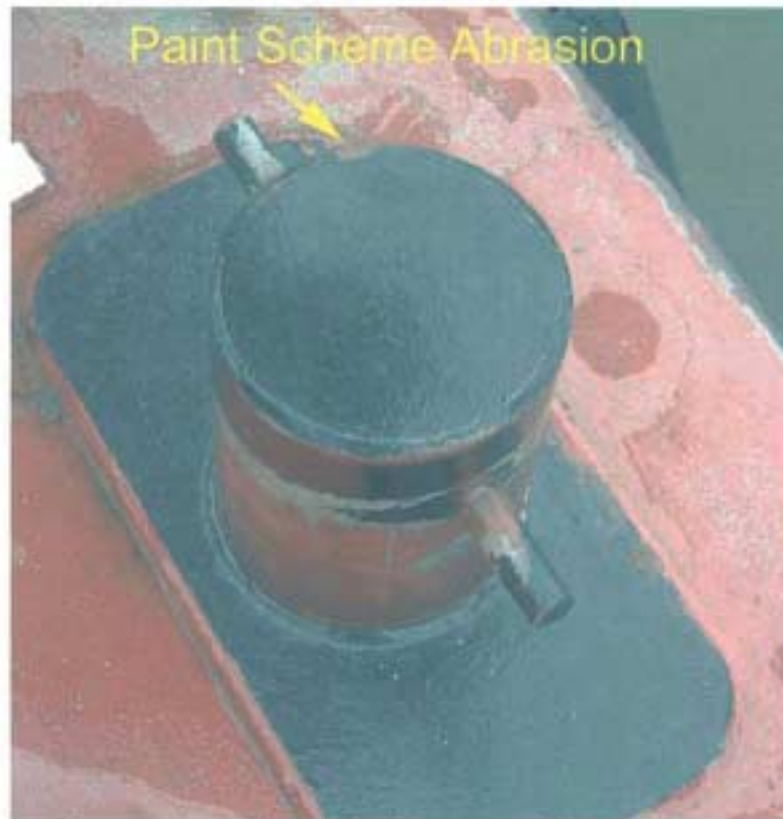
Photograph 9 – Pier Bollard [ courtesy of MAIB]

An inspection of the photograph provided, does show loss of paint at the top edge of the bollard in a place that seems to be consistent with path of the rope
