Report of the investigation

***KINGFISHER II***

5 miles east of North Uist

**Report No 15/2004  
November 2004**

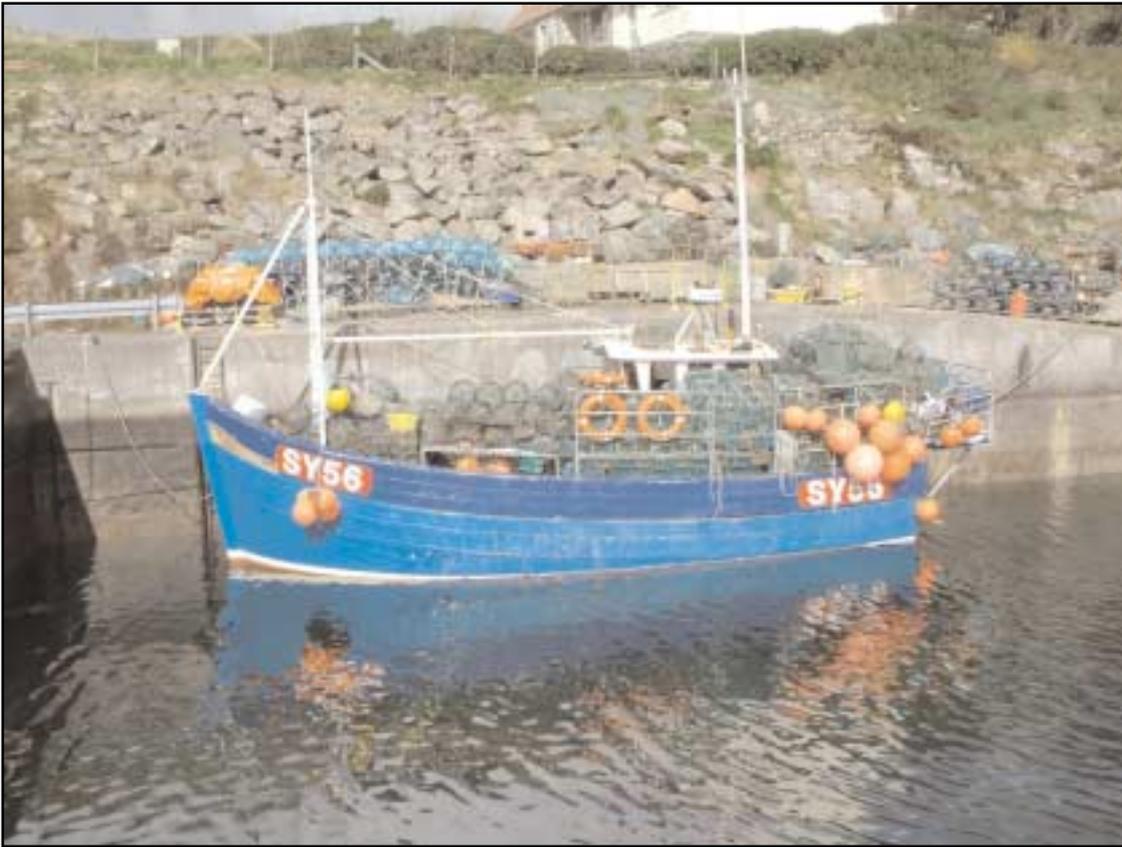
Figure 2

General view of extent of creel loading

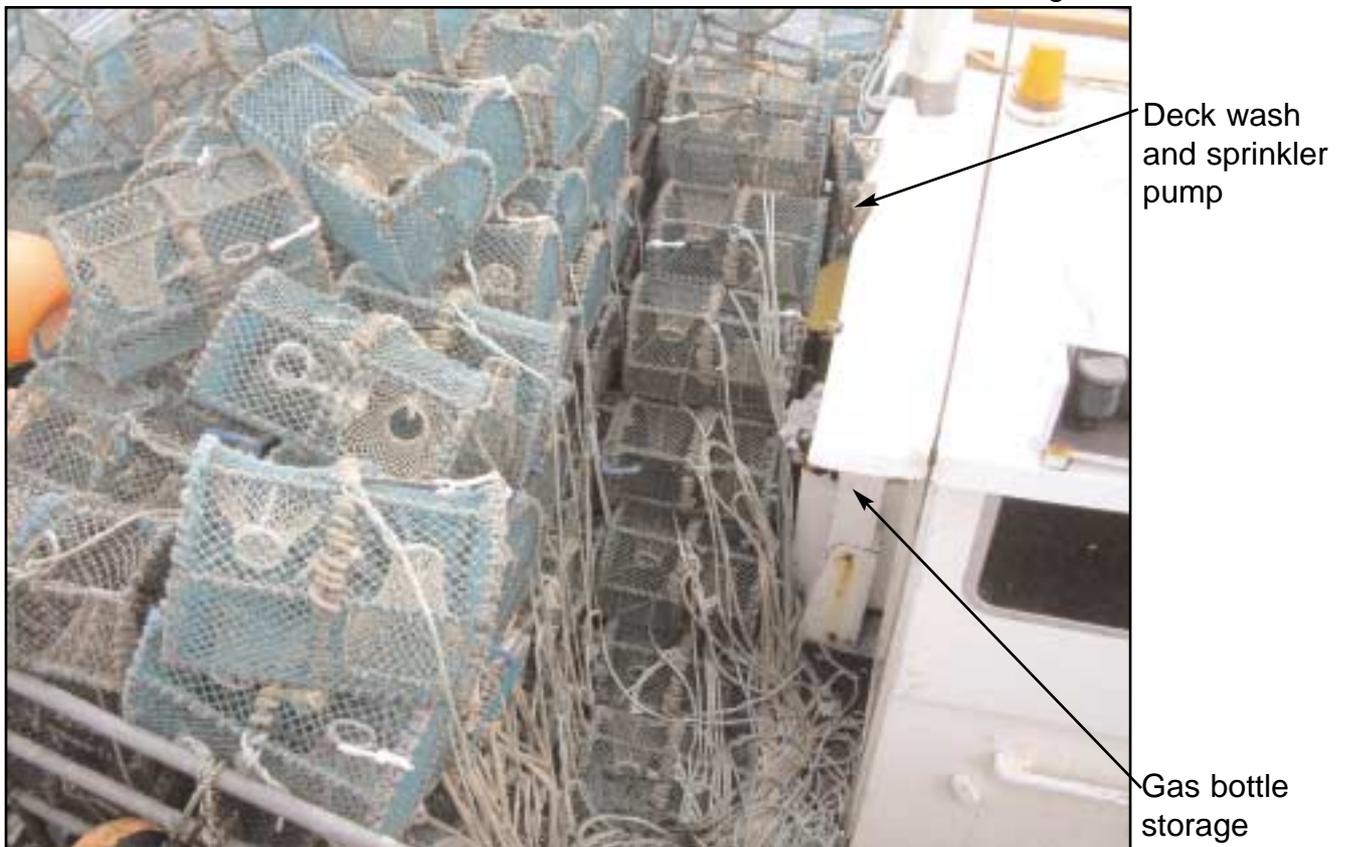
Figure 3

View of creels in the vicinity of the wheelhouse

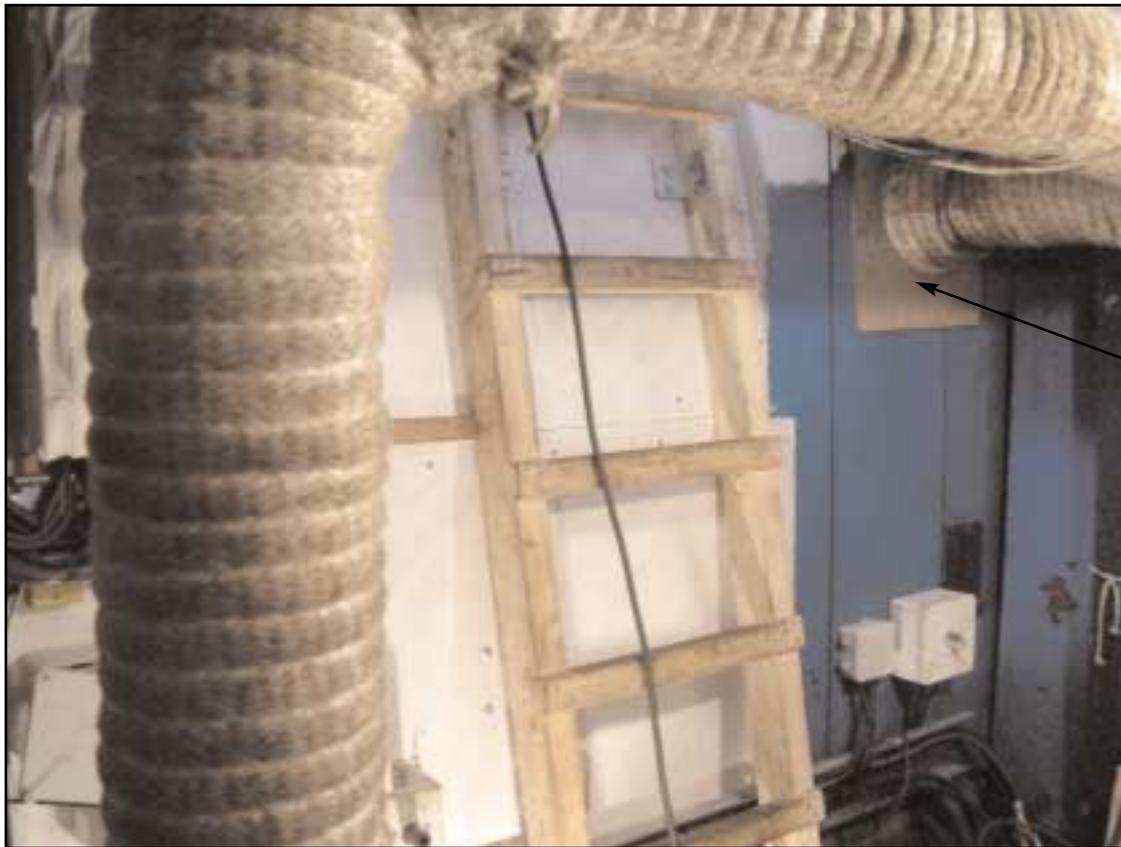
Area of bulkhead penetration. (Now shown with a post repair closure plate.)

Main engine exhaust passing through engine room/accommodation area bulkhead

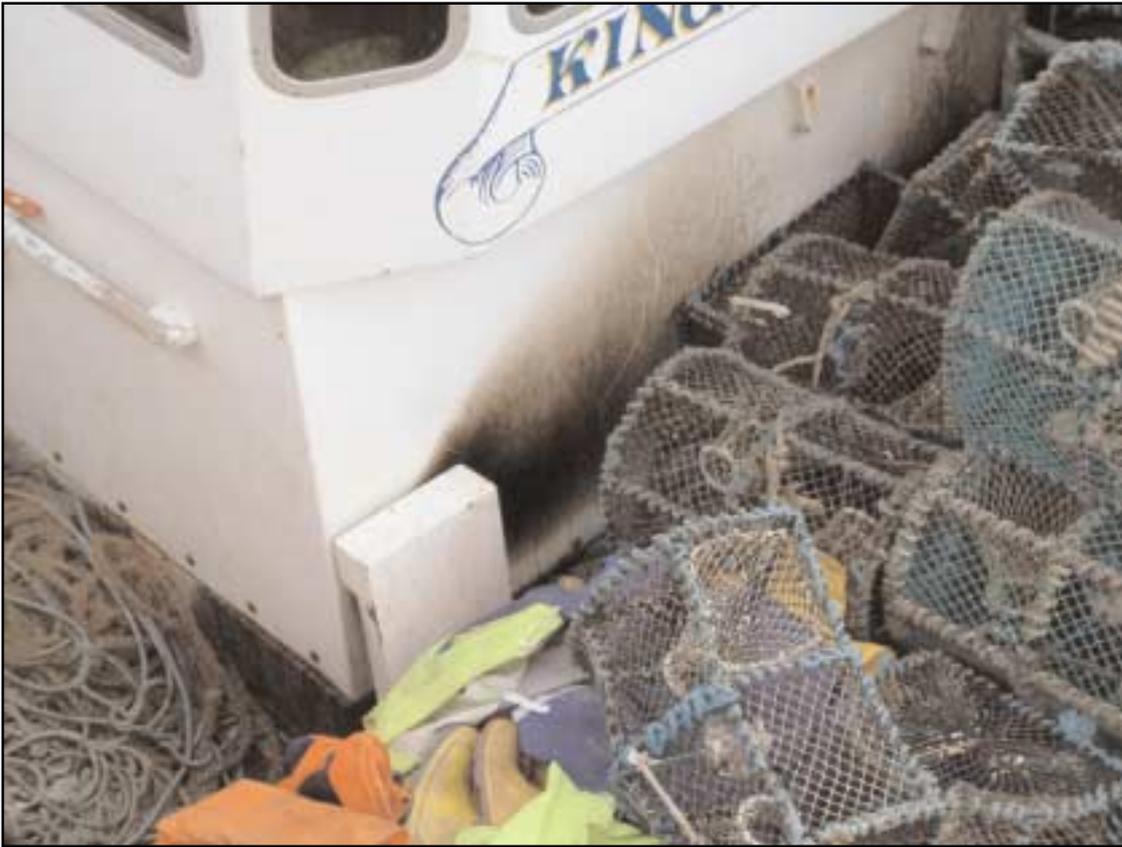
Figure 5

Creel obstruction of engine room vents

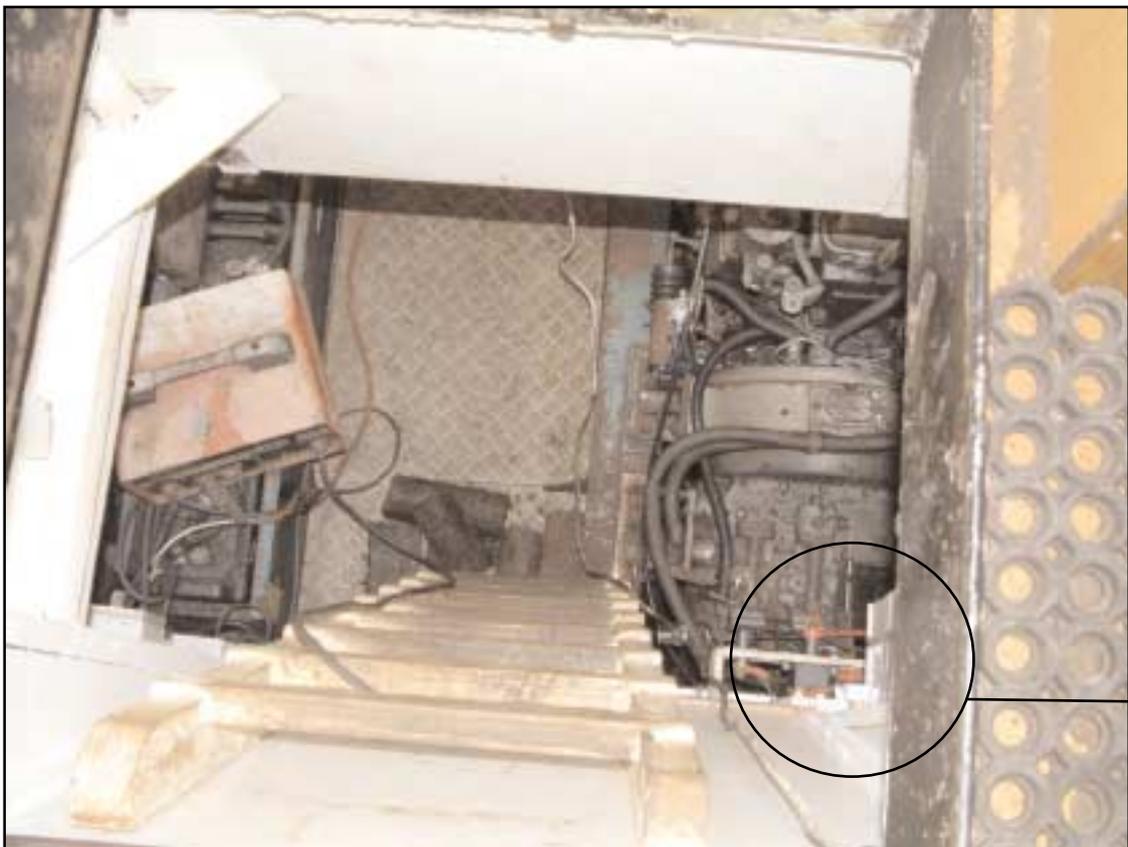
Figure 6

Seat of fire

Location of the seat of fire

It is possible that a defect in an electrical component resulted in a cable rating being exceeded, causing it to break down the cable insulation. If this cable was among the bunch situated in the vicinity of the lower part of the after bulkhead, smouldering was likely, and this would explain the deep char in this area.

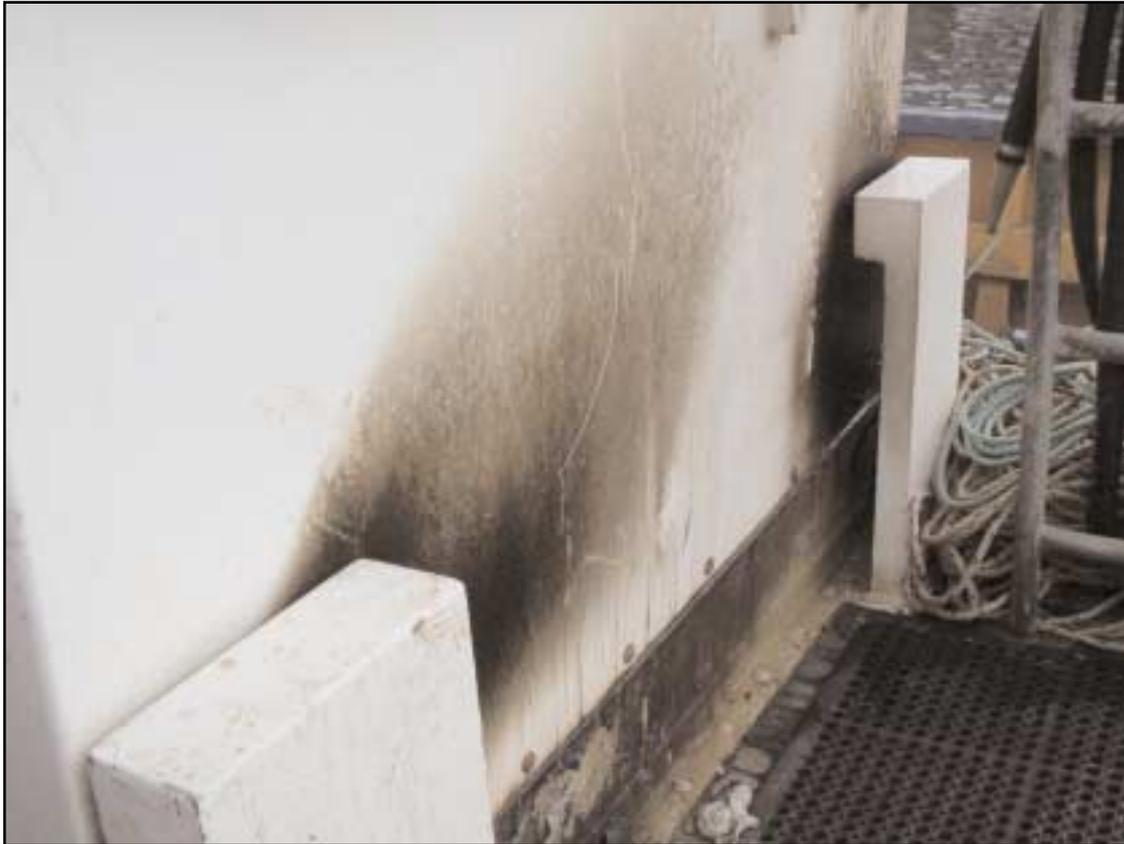
Smoke discharge marks from engine room vents

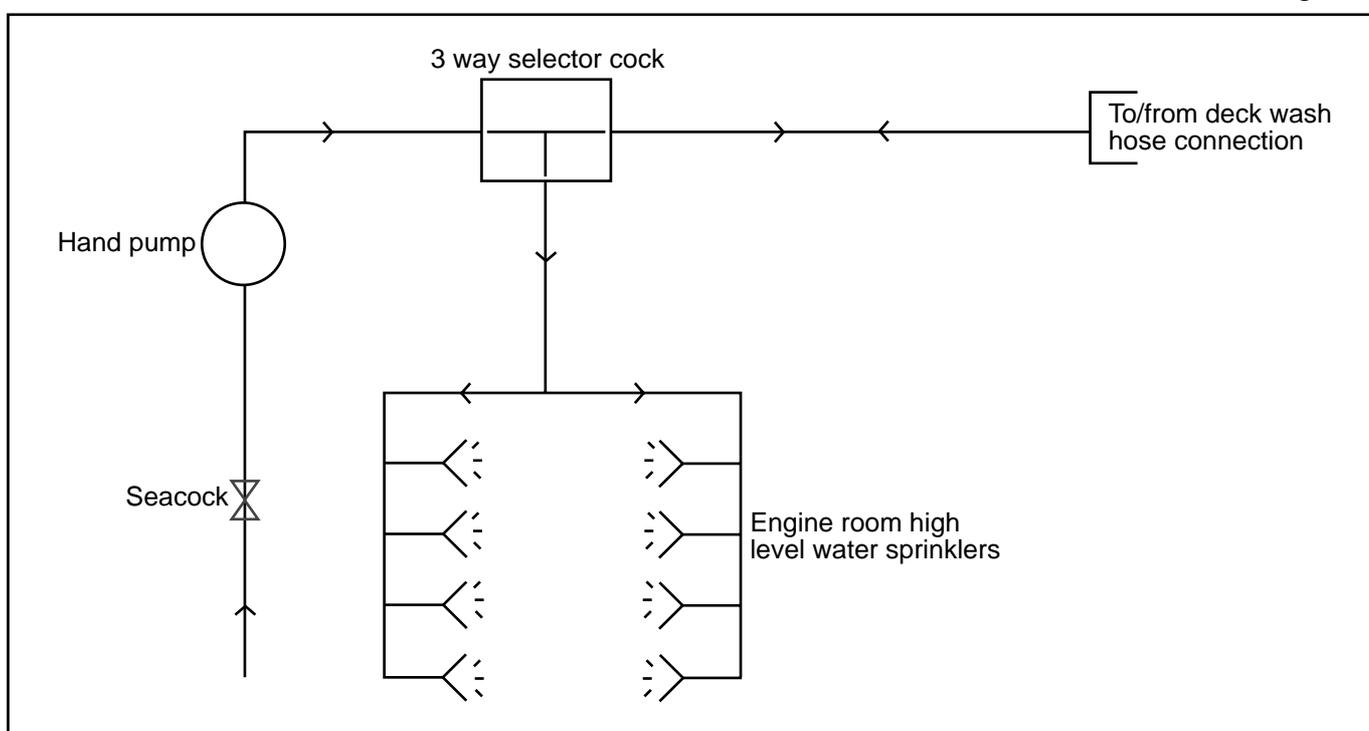
Figure 9

Deck wash and engine room high level sprinkler arrangement

The hand pump supplying the engine room sprinkler system and deck wash and the associated selector cock were situated on the port after external bulkhead of the wheelhouse. Unfortunately, access to the system was completely blocked by the large number of creels stowed in the vicinity of the wheelhouse. Even if access could have been made, the skipper and crew were unfamiliar with the operation of the system. It was also found that the selector cock was seized through lack of operation and maintenance.

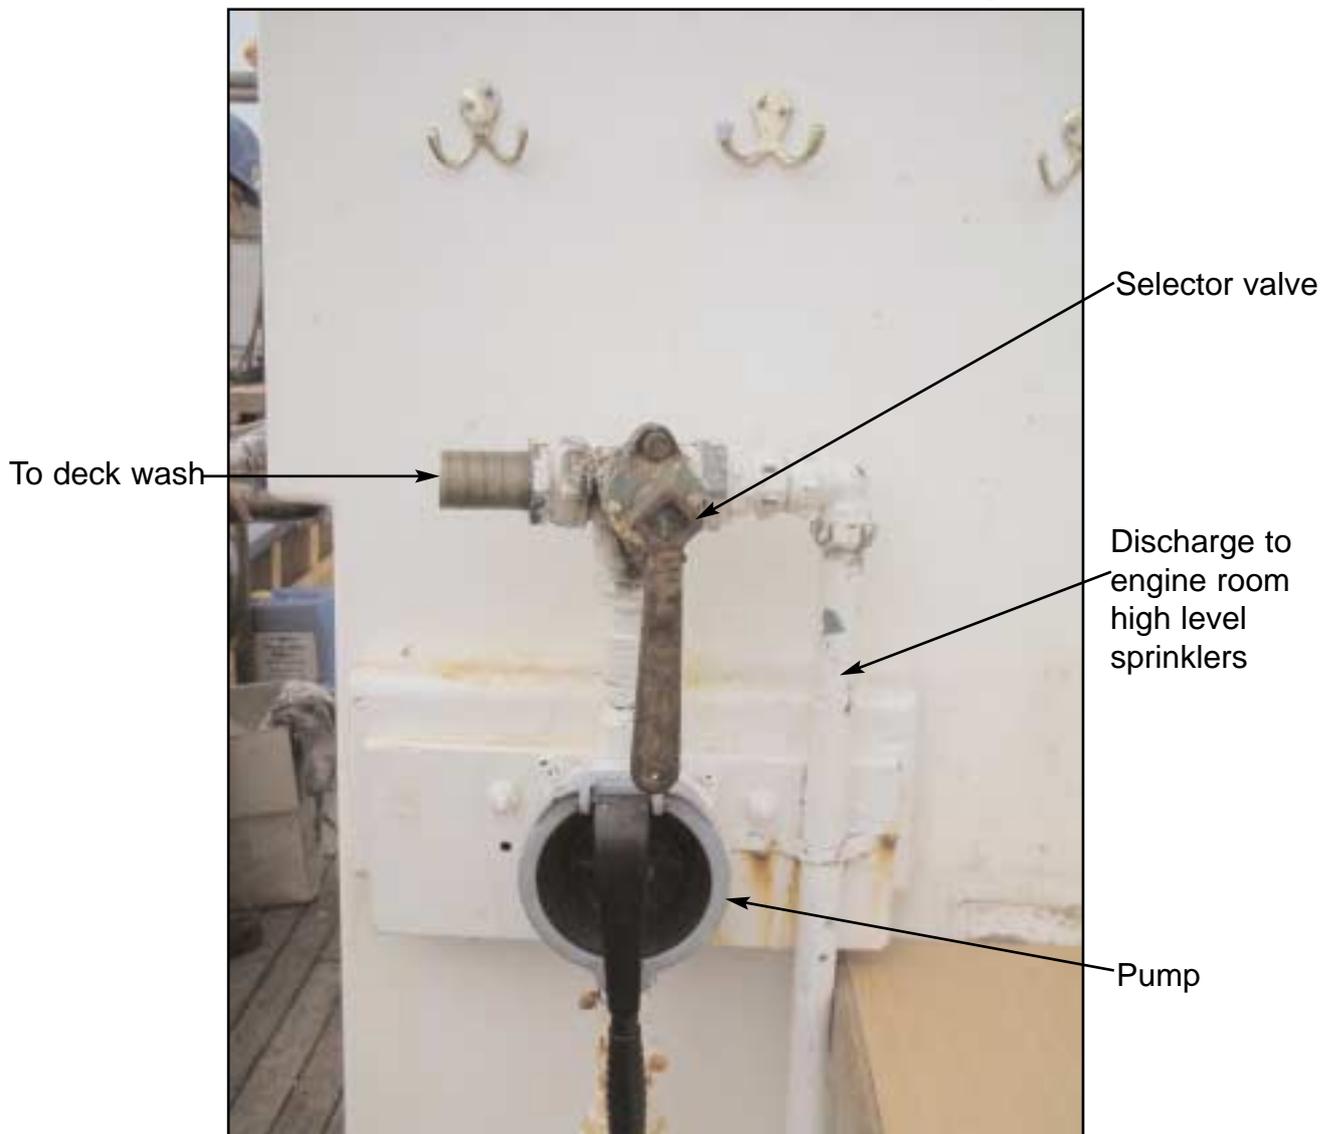
Figure 10

Deck wash pump and selector valve

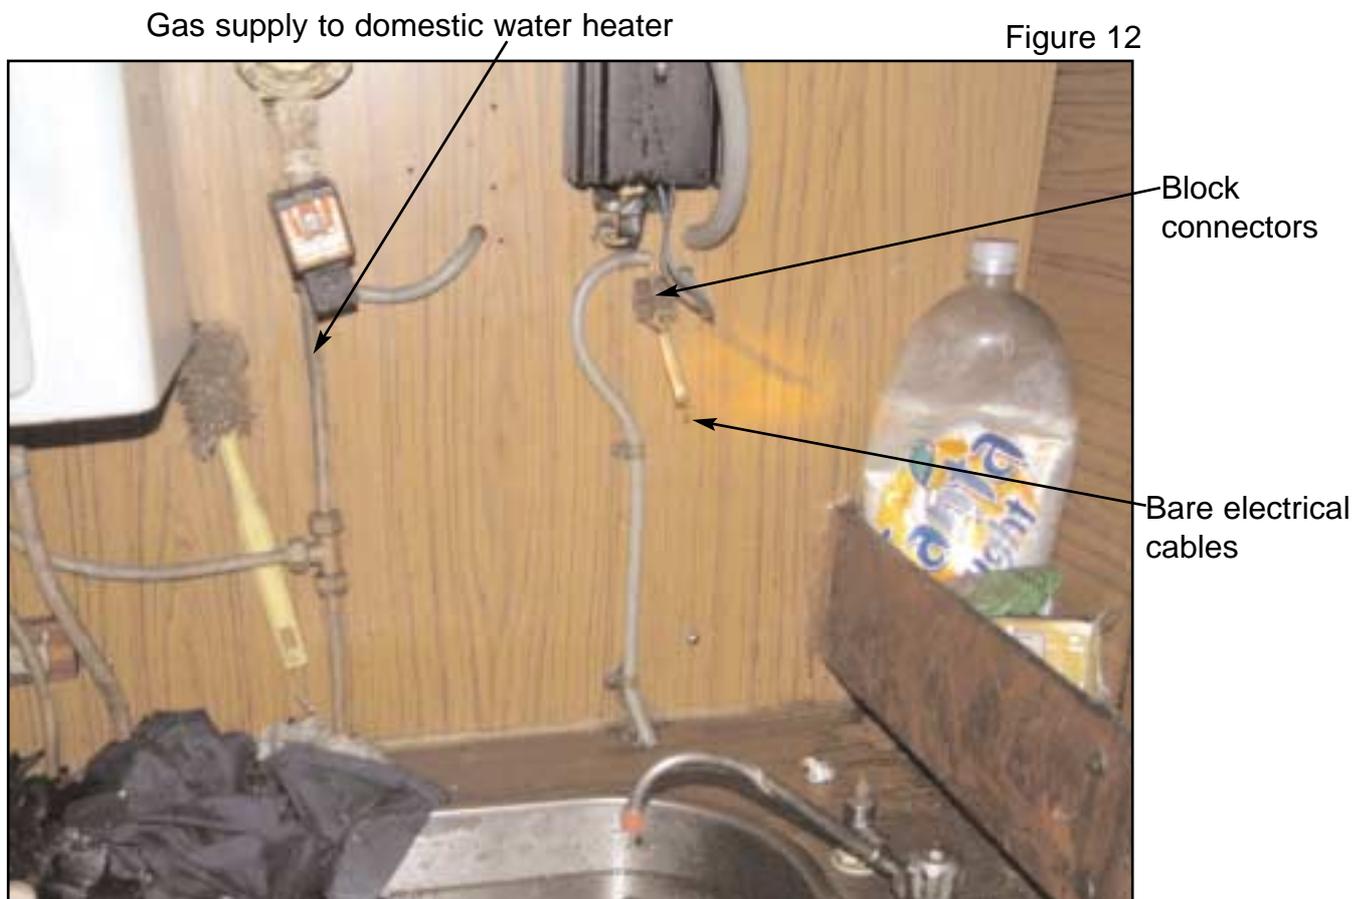
A number of nylon block connectors were fitted around the vessel. Some of these were adjacent to the domestic water heater. **Figure 12** clearly illustrates the hazard.

Example of block connector use and exposed wiring

- 2.6.1 It was evident that standards of electrical workmanship onboard *Kingfisher II* were variable. For example, there was widespread use of nylon connector blocks in the circuits. Whilst these are useful for temporary repairs, they should not be used as a permanent solution for connecting cables, especially if they are exposed. Electrical cables left bare in connectors substantially increase the risk of electrical failure and heating, particularly in the harsh engine room environment.

Various exposed wires were seen, and whilst there might have been no power to these cables, they should have been correctly insulated to prevent the risk of electrical shock through inadvertent re-connection. The earthing straps on both sets of batteries were also noted to be in poor condition.

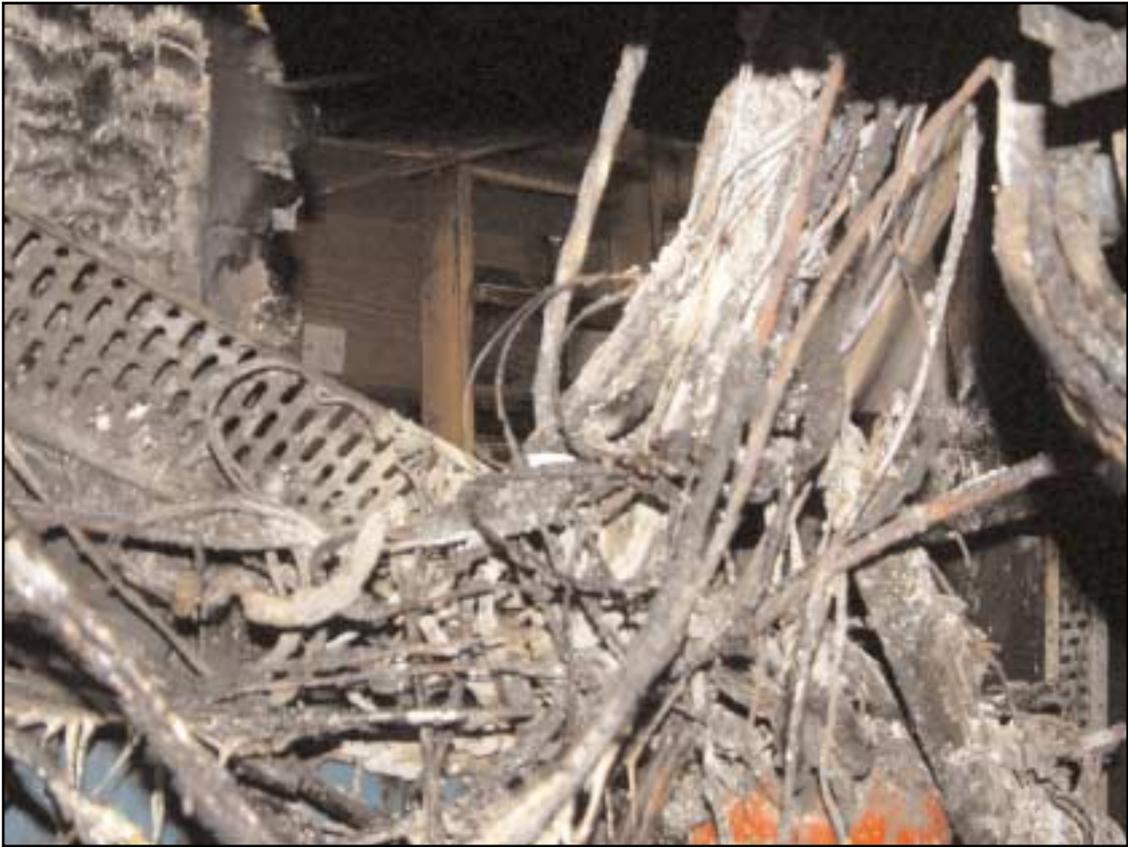
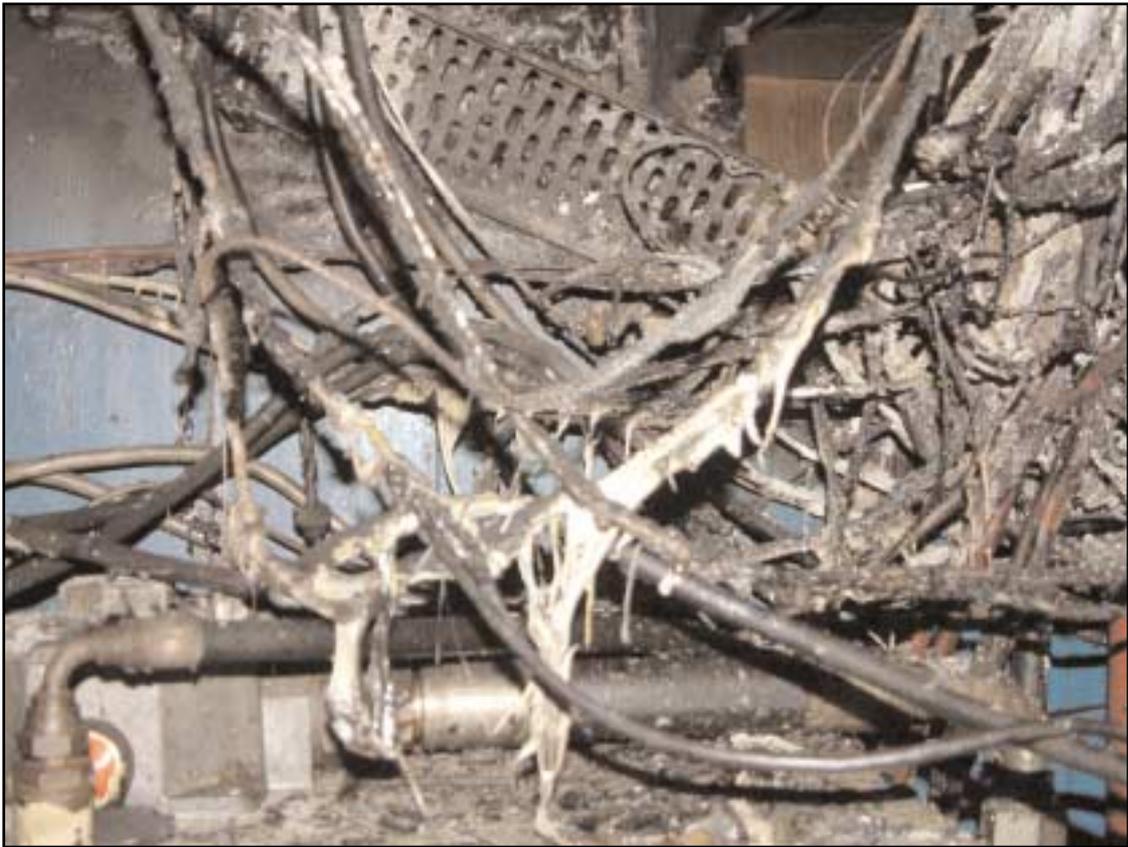
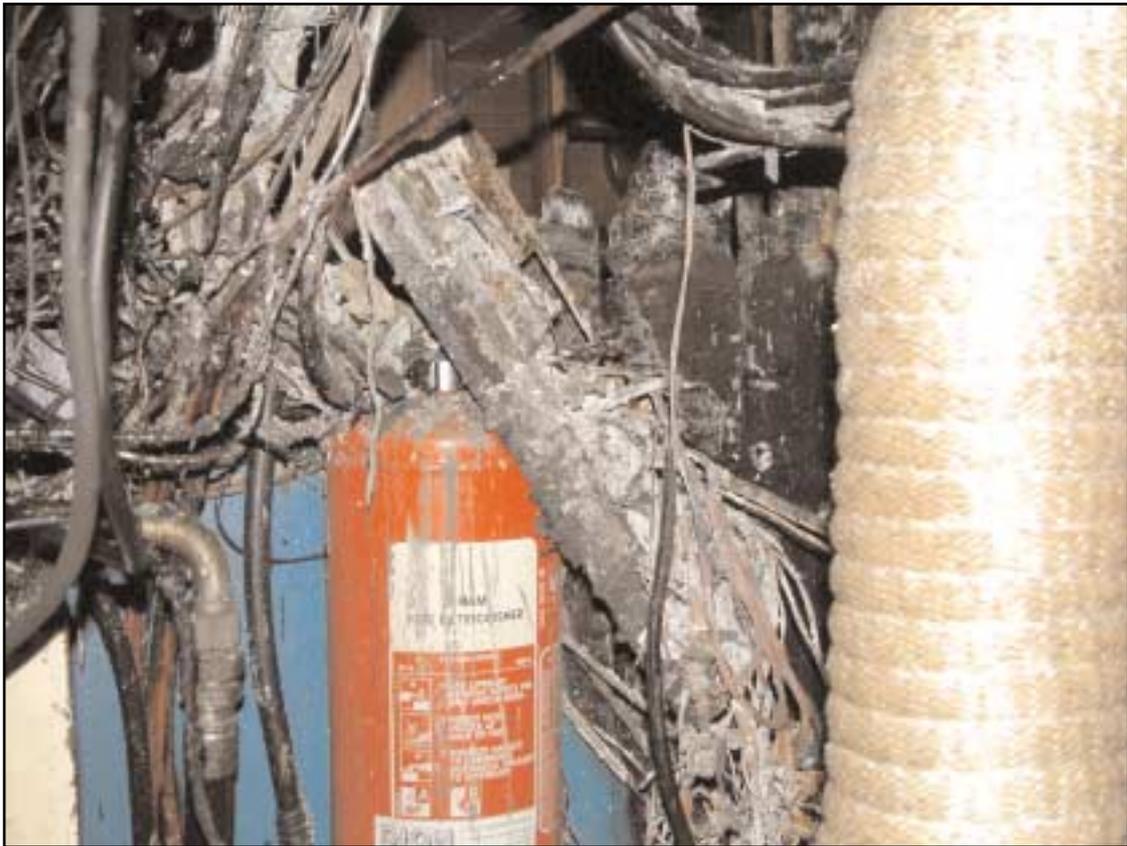
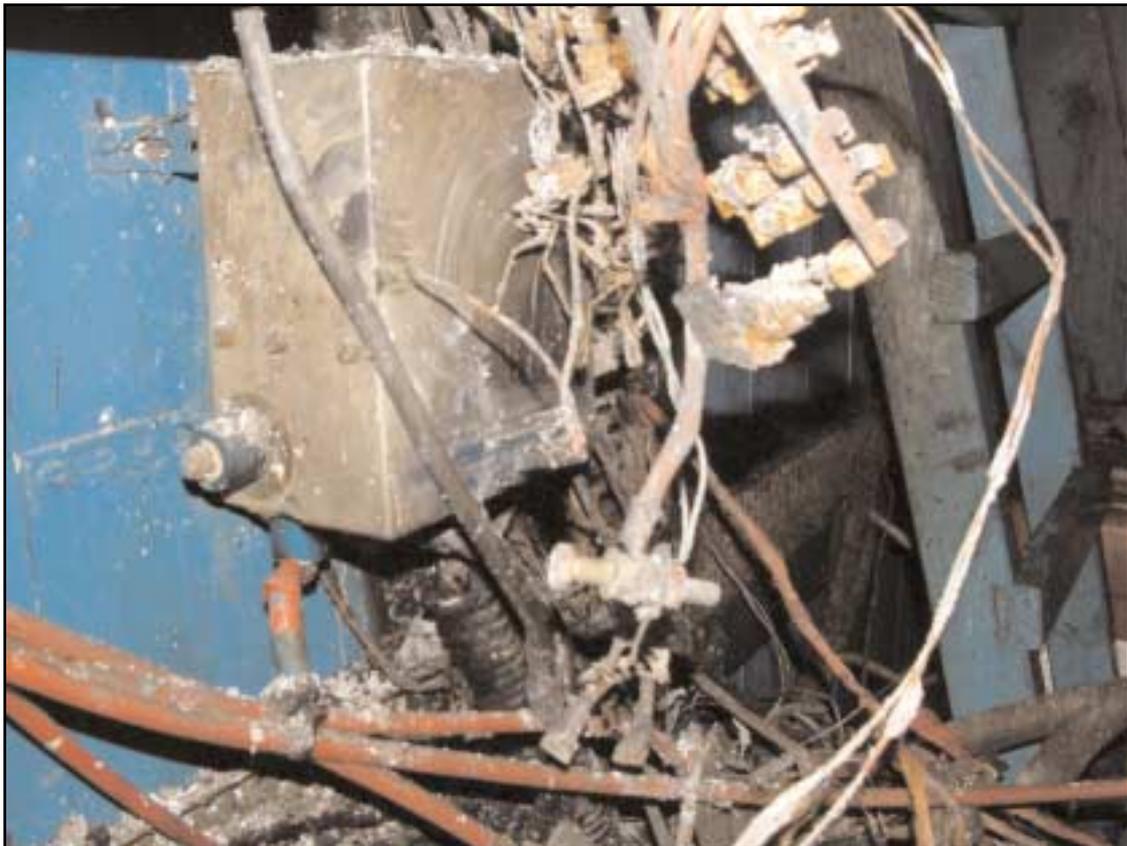
Examples of engine room electrical cable  
and distribution panel damage

The fire damage to the electrical cabling situated on the after engine room bulkhead was extensive. The insulation from all the cables was completely burnt away. The nylon ties securing the cables to the vertical and horizontal cable trays were also destroyed, causing the cables to collapse haphazardly at floor plate level.

The steel clad plastic distribution panel, situated close to the top of the after bulkhead, had been completely destroyed. Panel connectors and clamps were virtually the only recognisable distribution panel components. Examples of the engine room electrical cable and distribution panel damage are at **Annex B**.

Remnants of distribution box

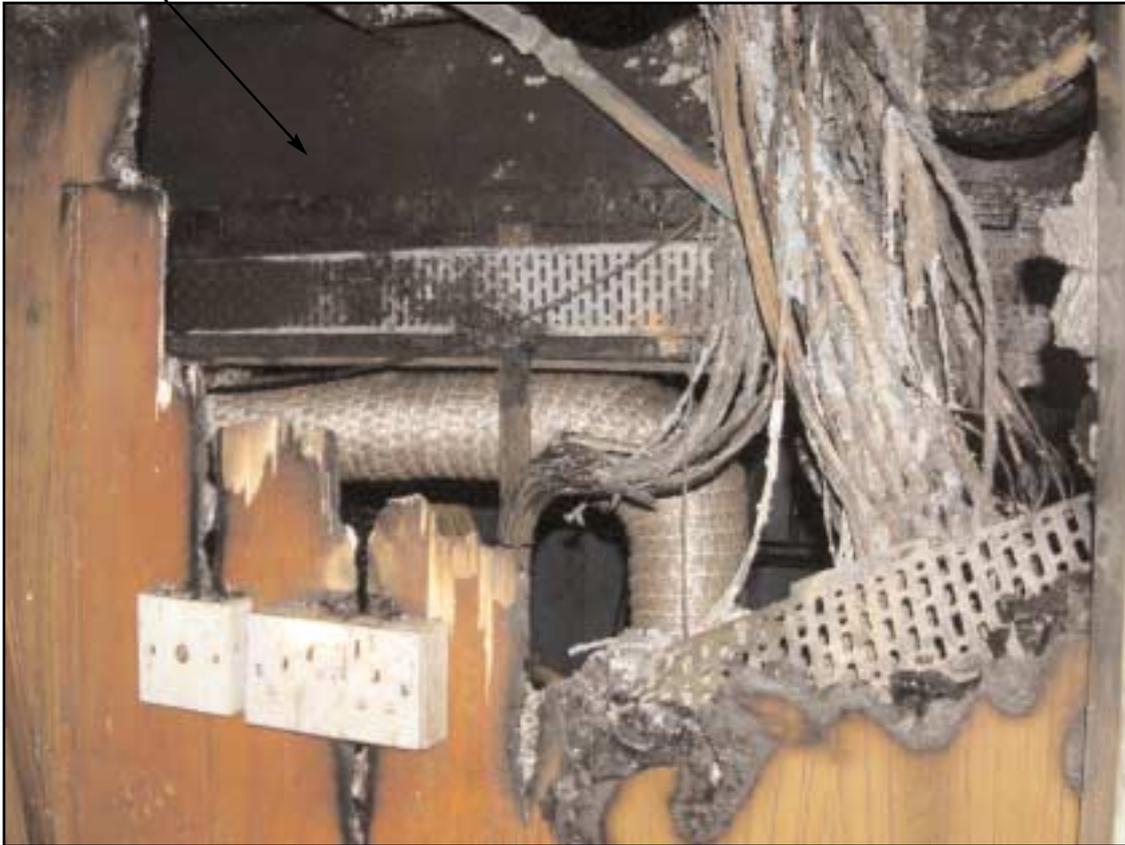
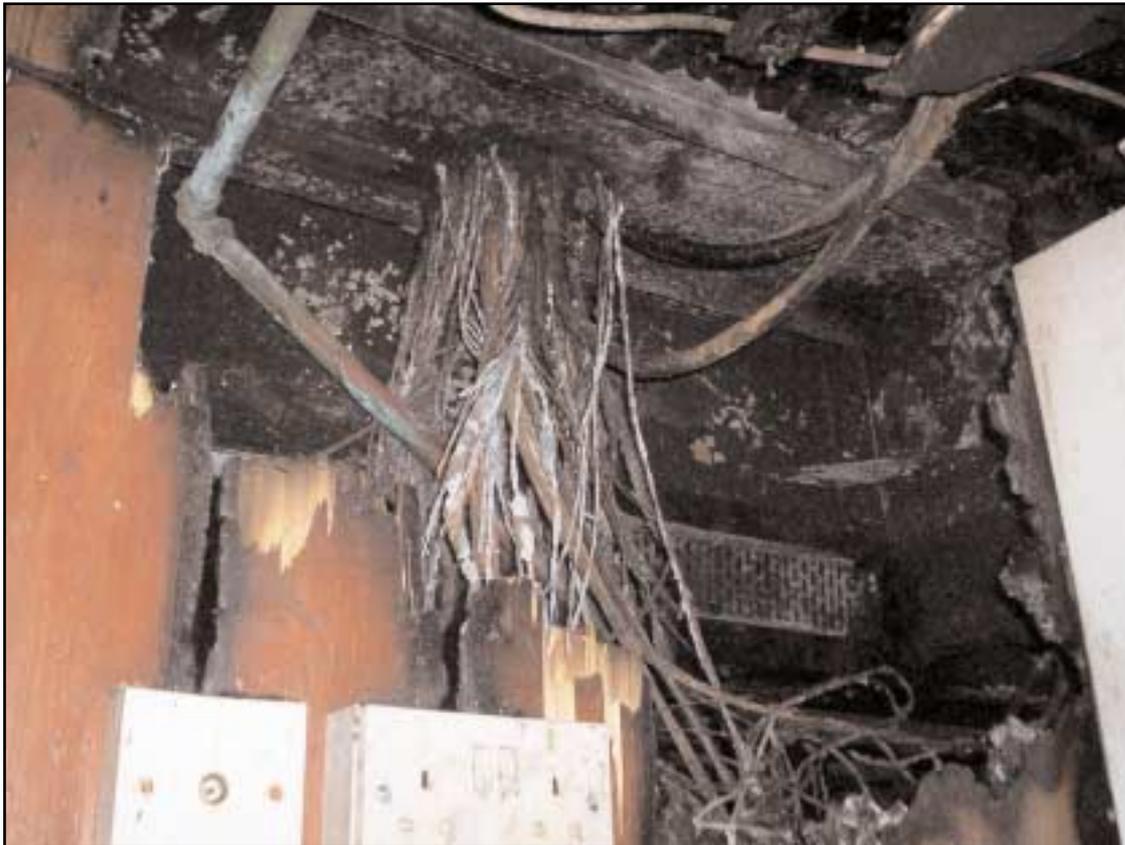
Views from accommodation area

There was extensive damage in way of the metal clad, plastic electrical distribution board. This was situated high on the bulkhead and just to starboard of the centreline. A large portion of the bulkhead (approximately 1.2m<sup>2</sup> and about the size of the distribution panel) in this area had burnt completely away, opening the bulkhead to the accommodation area.

Site of distribution box

The engine room/accommodation bulkhead has been partially renewed in way of the fire damage and cladded with material to B15 standard.

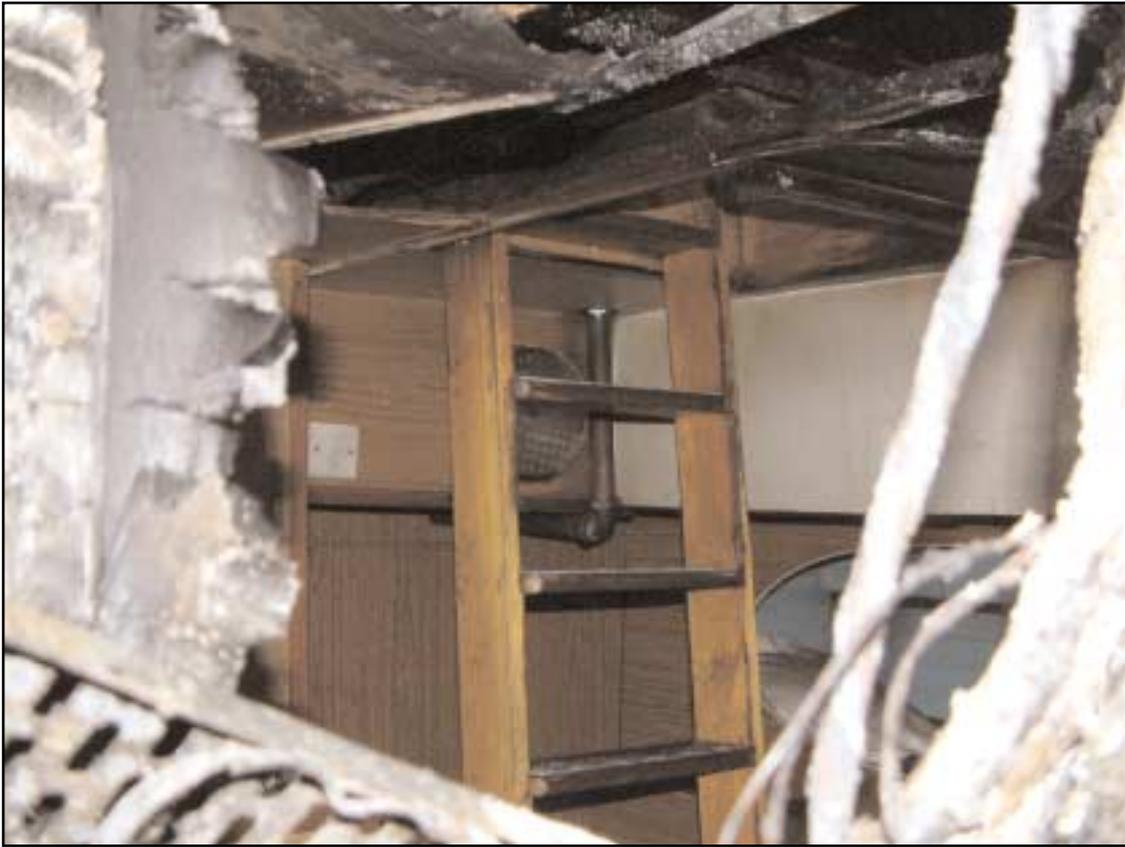
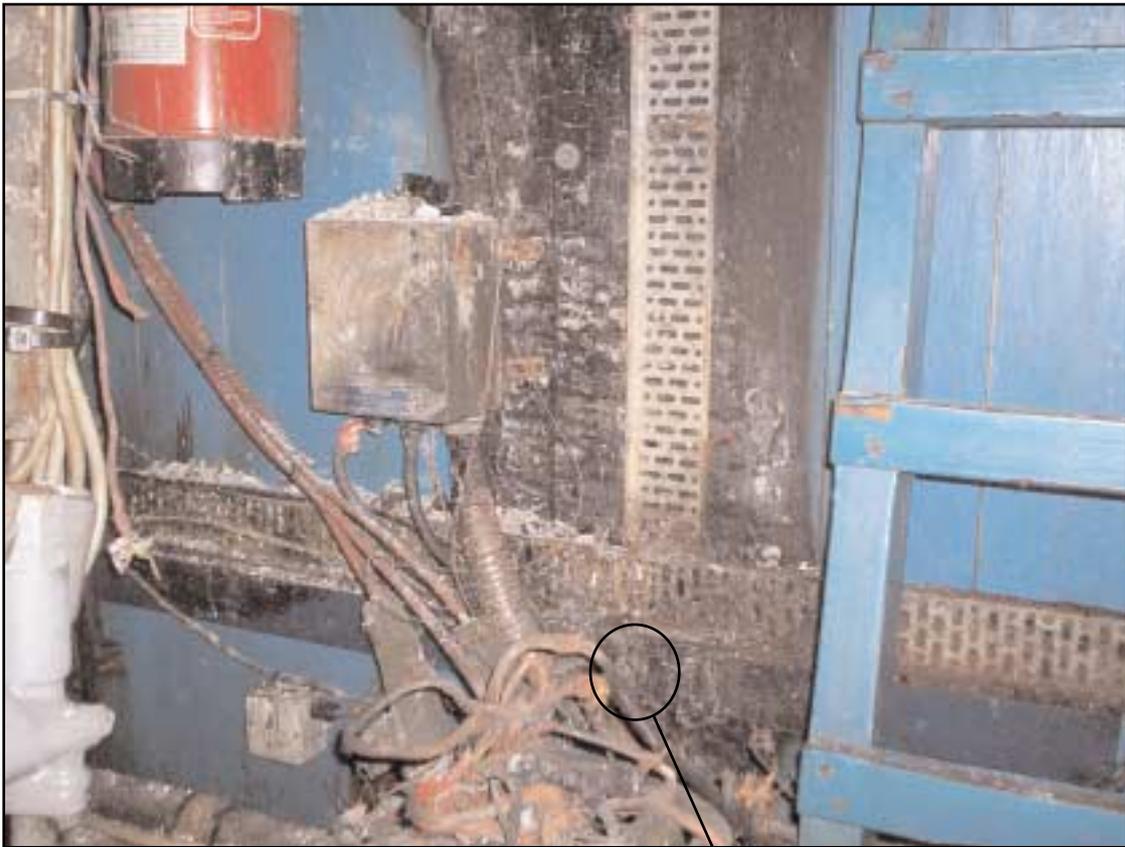
Views from engine room

The after engine room bulkhead was constructed from 15mm tongue and groove pine timber, which had no obvious fire retardant properties. The fire caused deep charring to the lower section of a vertical stiffener adjacent to the vertical cable tray leading to the electrical distribution panel. The charring pattern widened from about 150cm at the deep charring point, to about 1.2m at its widest point – behind the distribution panel.

Area of deep char
