Report of the investigation

KINGFISHER II

on 26 April 2004

**Report No 15/2004
November 2004**

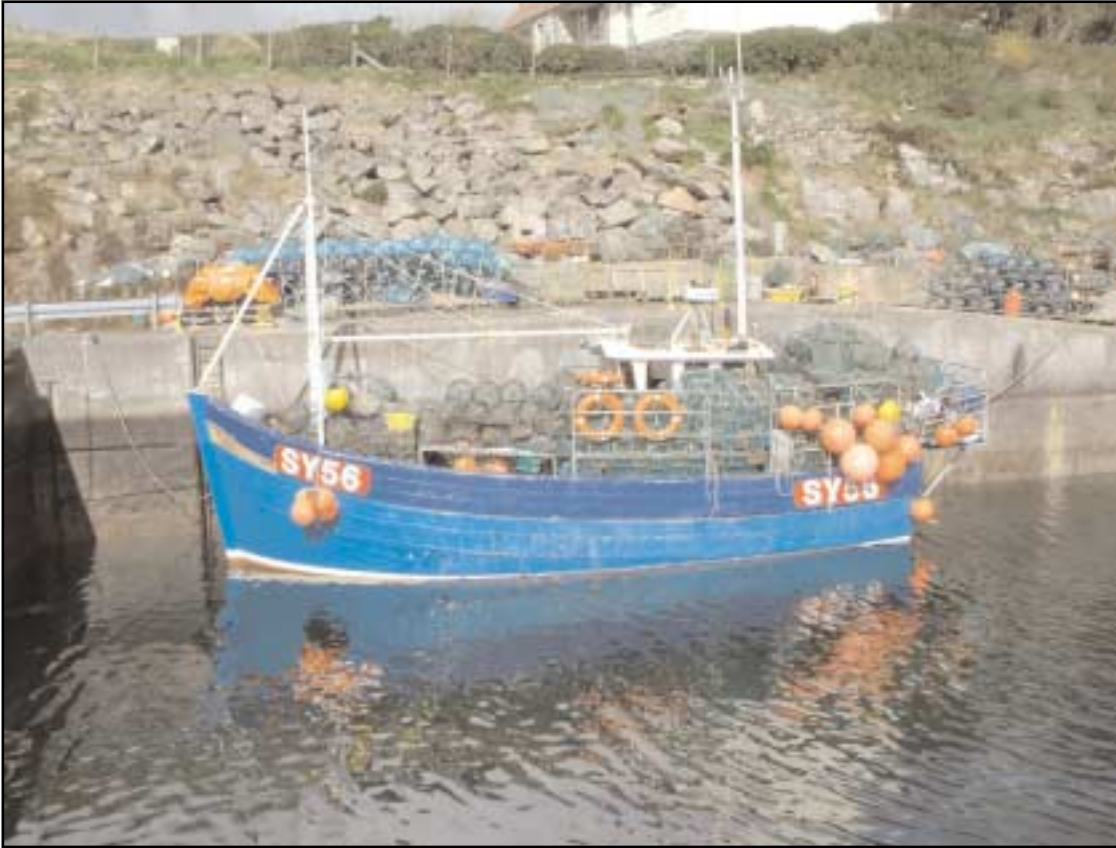
Figure 2

General view of extent of creel loading

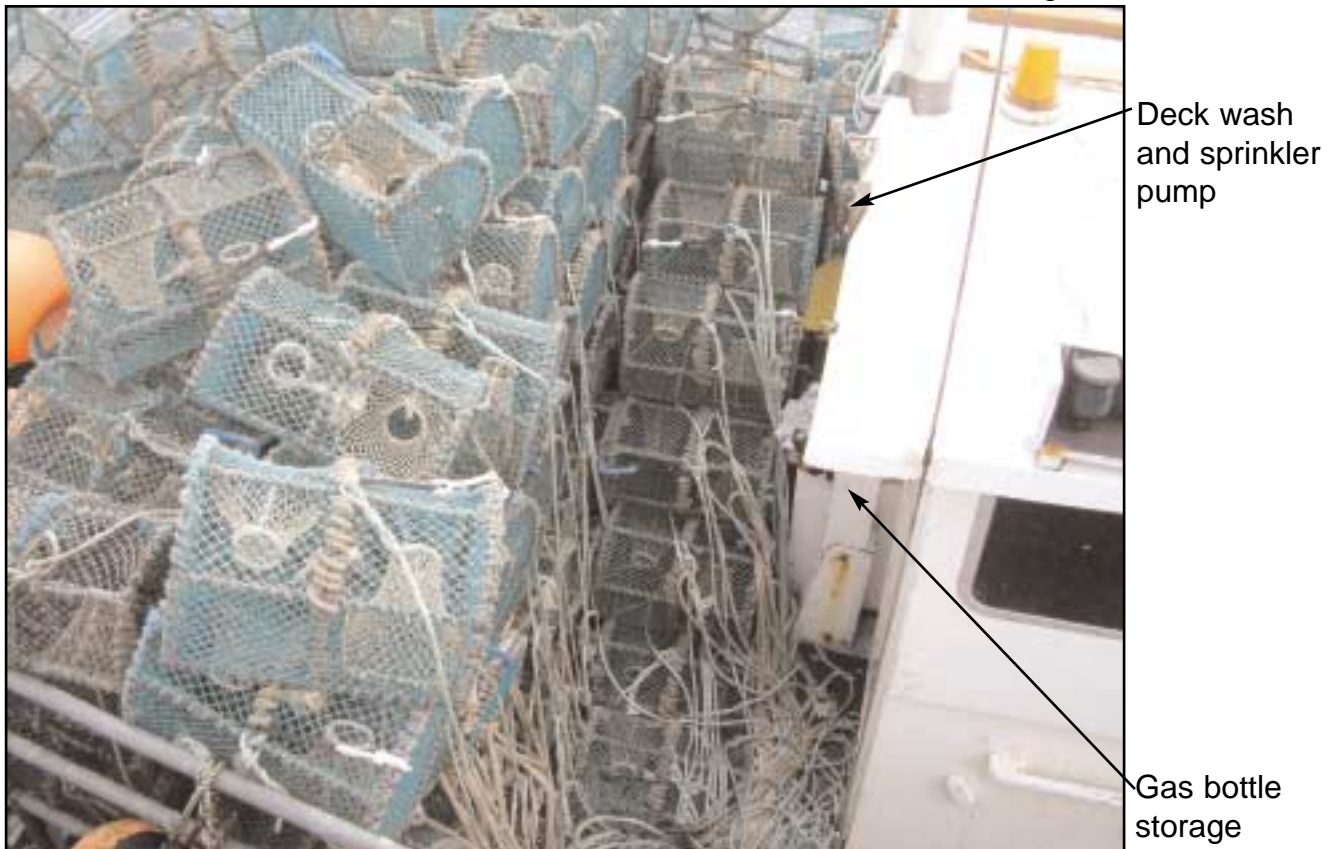
Figure 3

View of creels in the vicinity of the wheelhouse

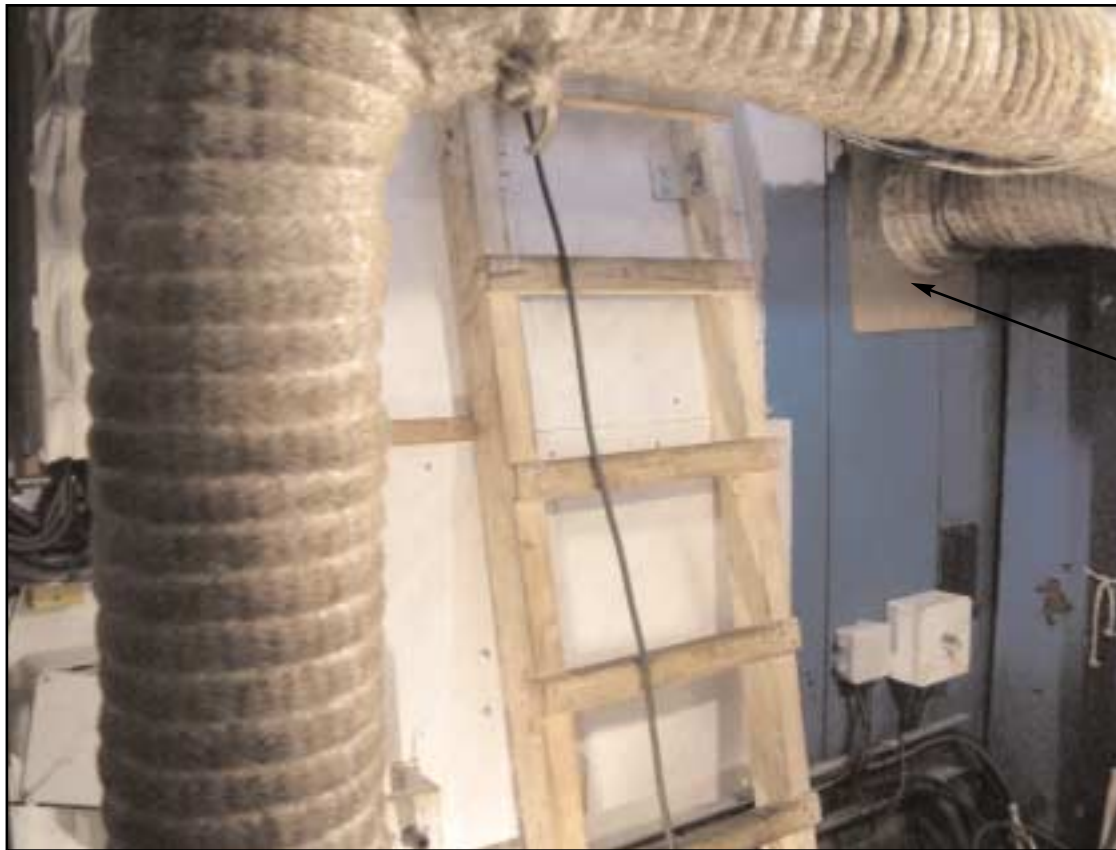
Area of bulkhead penetration. (Now shown with a post repair closure plate.)

Main engine exhaust passing through engine room/accommodation area bulkhead

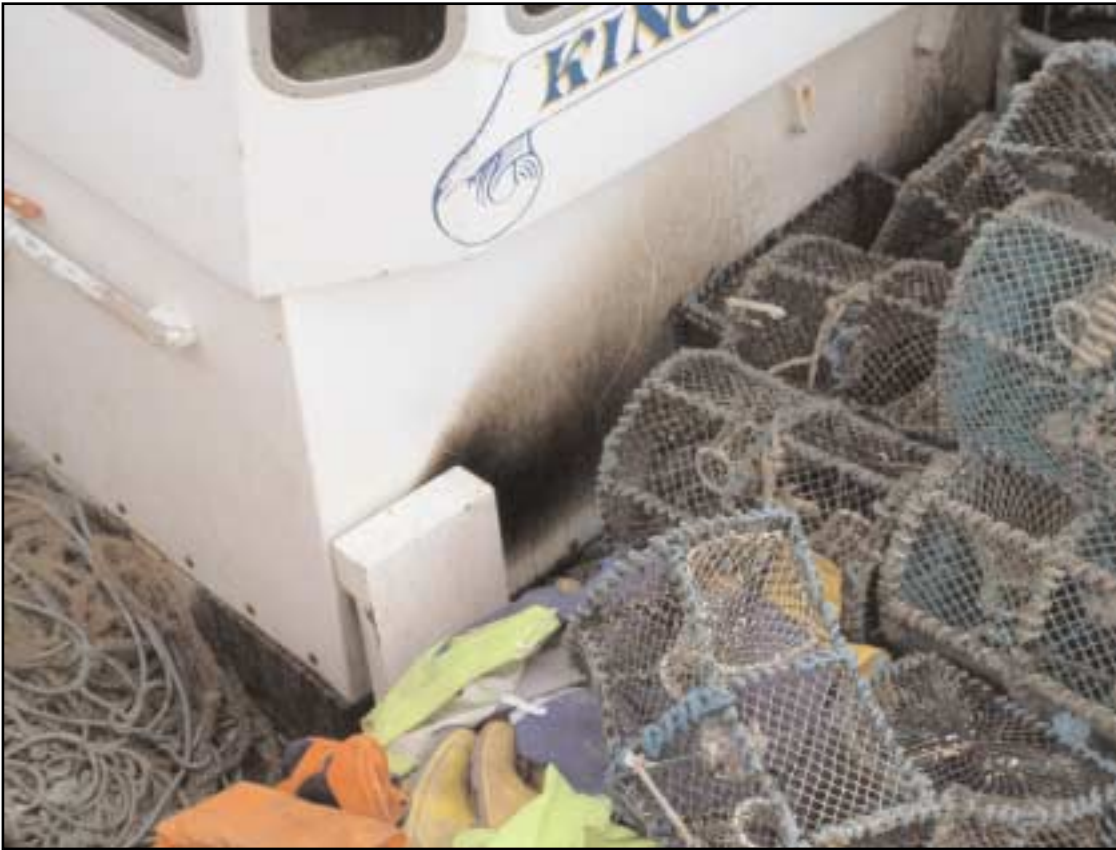
Figure 5

Creel obstruction of engine room vents

The hand pump supplying the engine room sprinkler system and deck wash and the associated selector cock were situated on the port after external bulkhead of the wheelhouse. Unfortunately, access to the system was completely blocked by the large number of creels stowed in the vicinity of the wheelhouse. Even if access could have been made, the skipper and crew were unfamiliar with the operation of the system. It was also found that the selector cock was seized through lack of operation and maintenance.

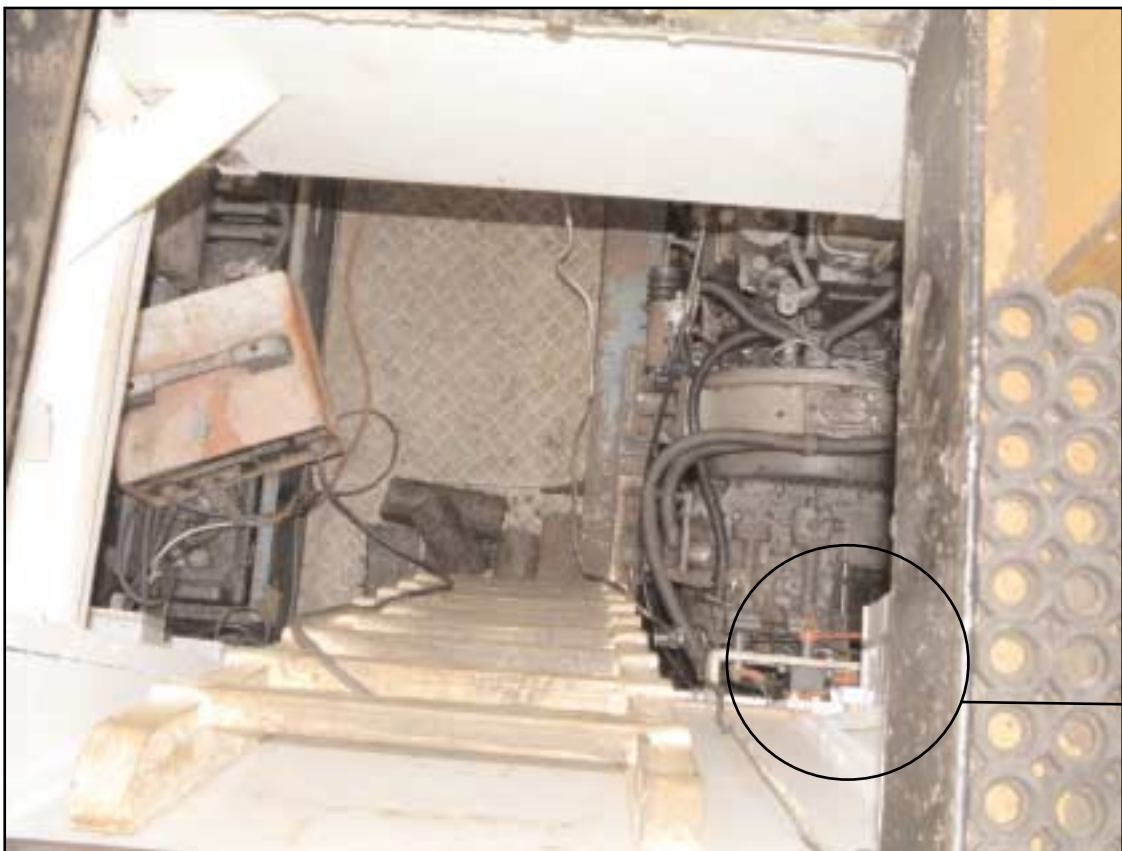
Figure 6

Seat of fire

Location of the seat of fire

It is possible that a defect in an electrical component resulted in a cable rating being exceeded, causing it to break down the cable insulation. If this cable was among the bunch situated in the vicinity of the lower part of the after bulkhead, smouldering was likely, and this would explain the deep char in this area.

Once the fire had reached the distribution panel, the plastic components would have quickly ignited. The fire would have been partially contained within the steel cladding of the panel, causing it to intensify and burn through the bulkhead at the upper level.

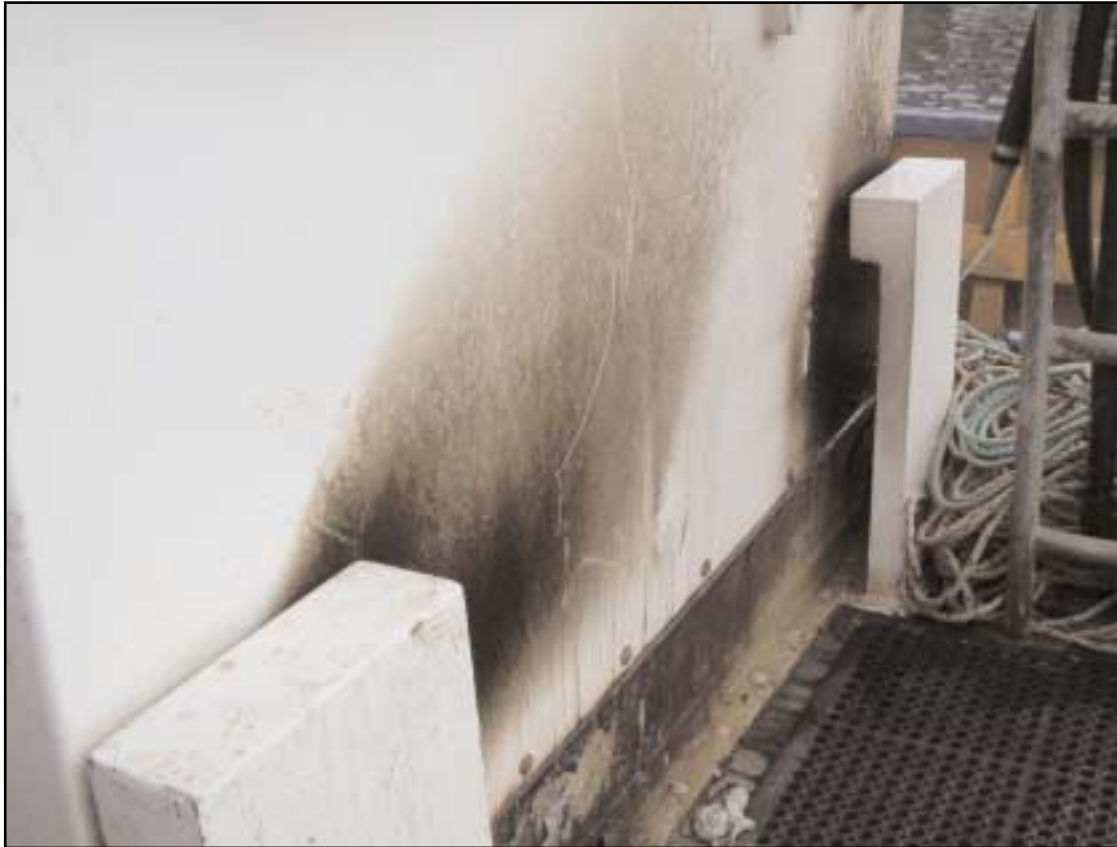
Smoke discharge marks from engine room vents

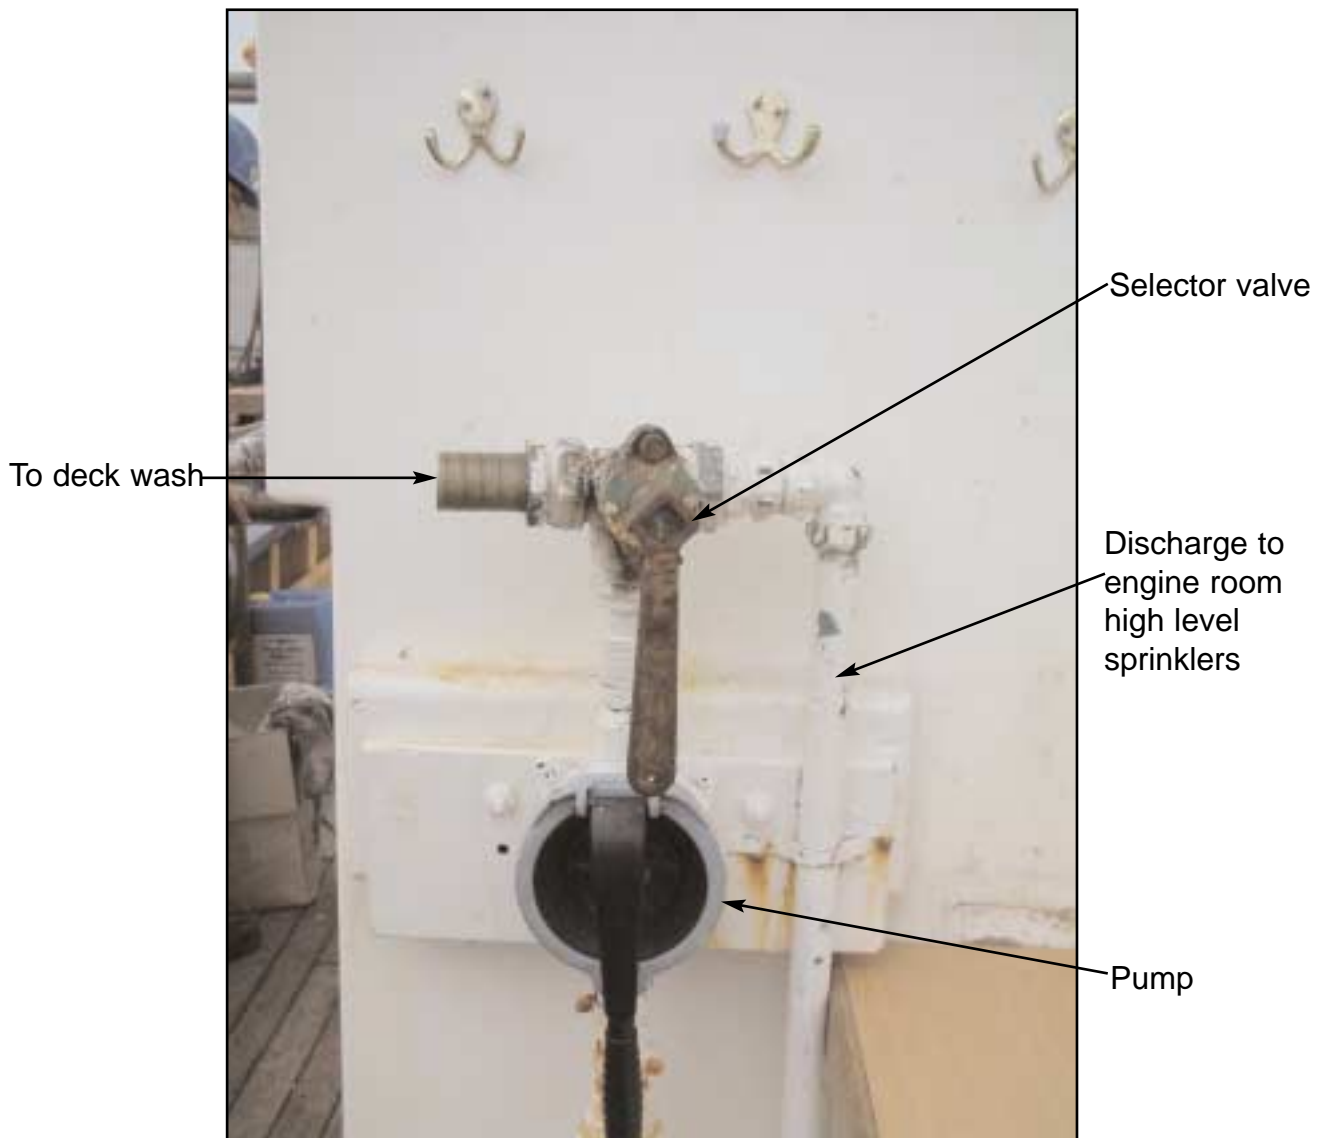
Figure 10

Deck wash pump and selector valve

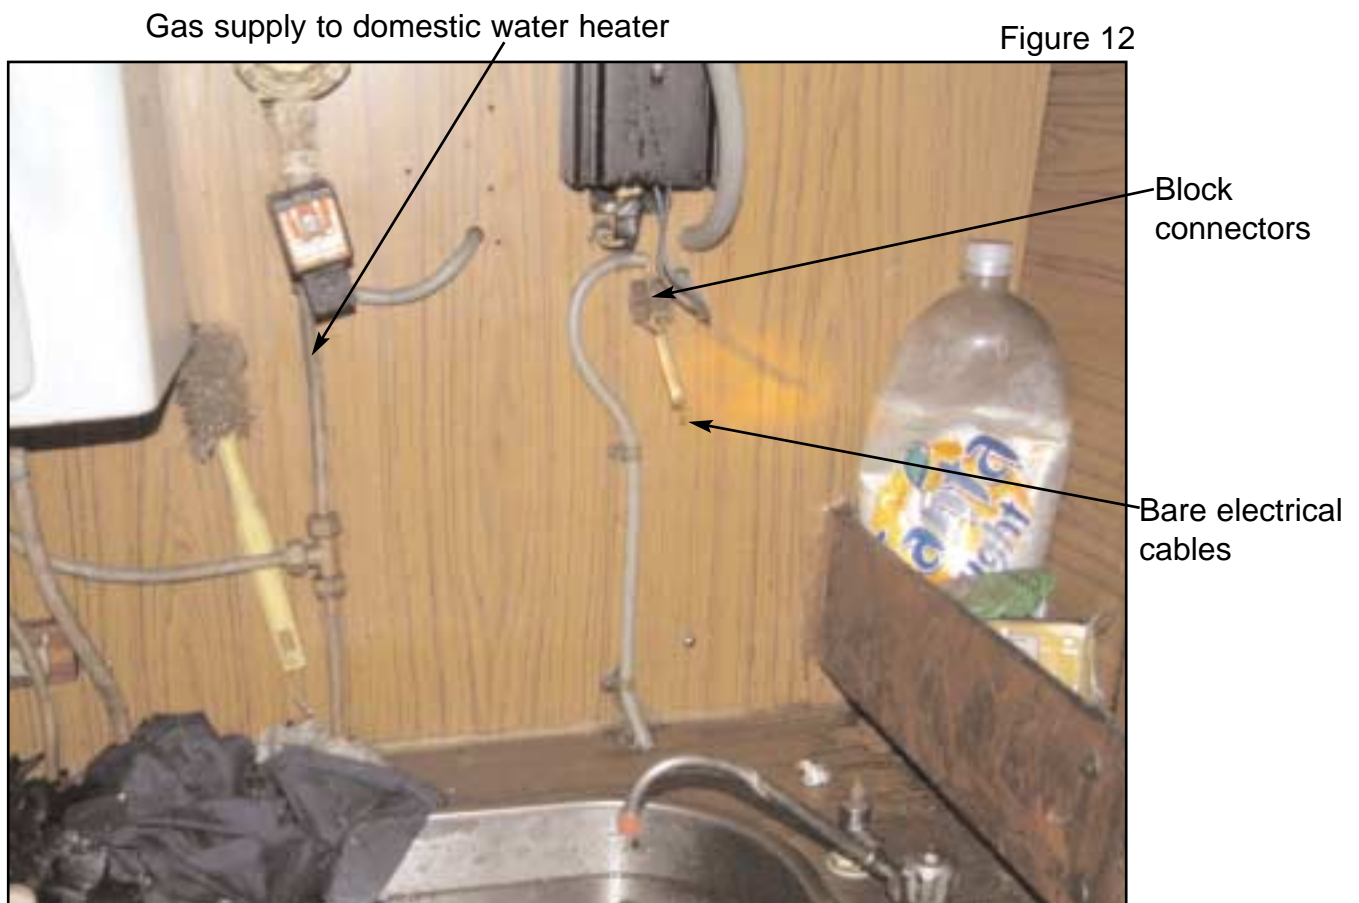
A number of nylon block connectors were fitted around the vessel. Some of these were adjacent to the domestic water heater. **Figure 12** clearly illustrates the hazard.

Example of block connector use and exposed wiring

- 2.6.1 It was evident that standards of electrical workmanship onboard *Kingfisher II* were variable. For example, there was widespread use of nylon connector blocks in the circuits. Whilst these are useful for temporary repairs, they should not be used as a permanent solution for connecting cables, especially if they are exposed. Electrical cables left bare in connectors substantially increase the risk of electrical failure and heating, particularly in the harsh engine room environment.

Various exposed wires were seen, and whilst there might have been no power to these cables, they should have been correctly insulated to prevent the risk of electrical shock through inadvertent re-connection. The earthing straps on both sets of batteries were also noted to be in poor condition.

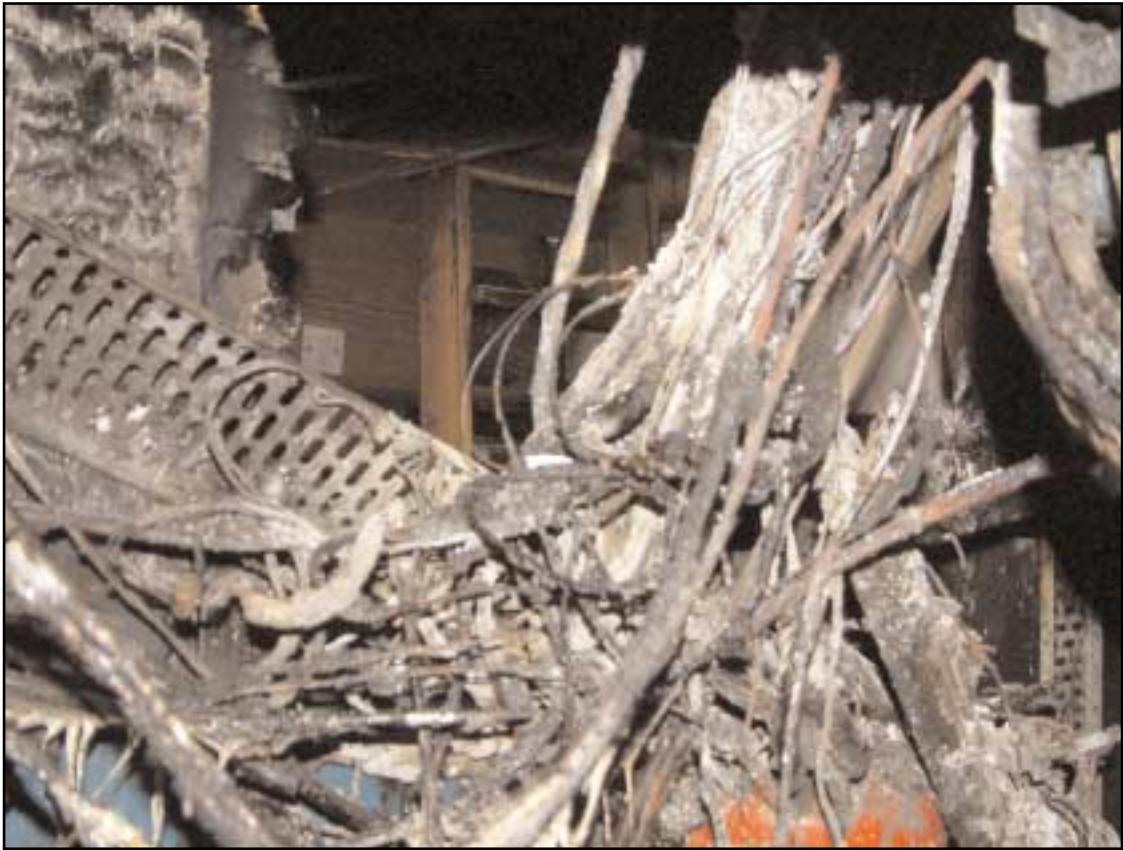
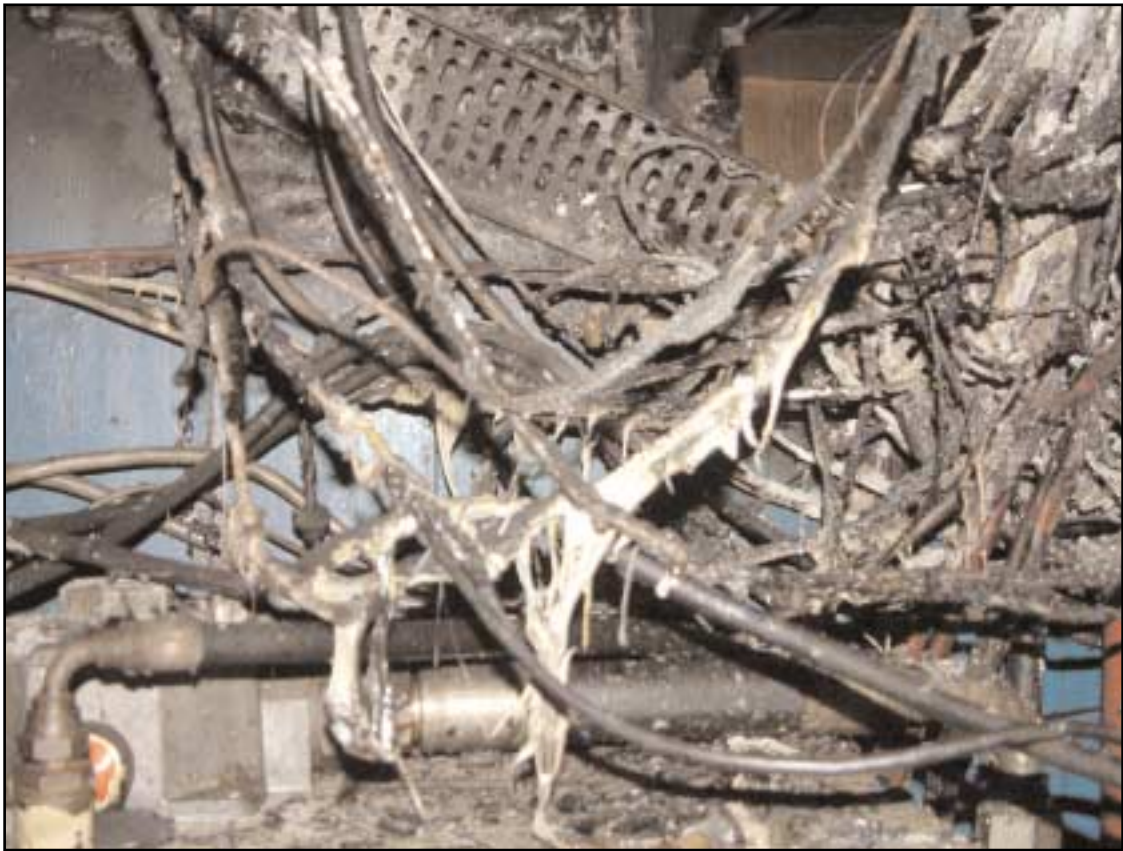
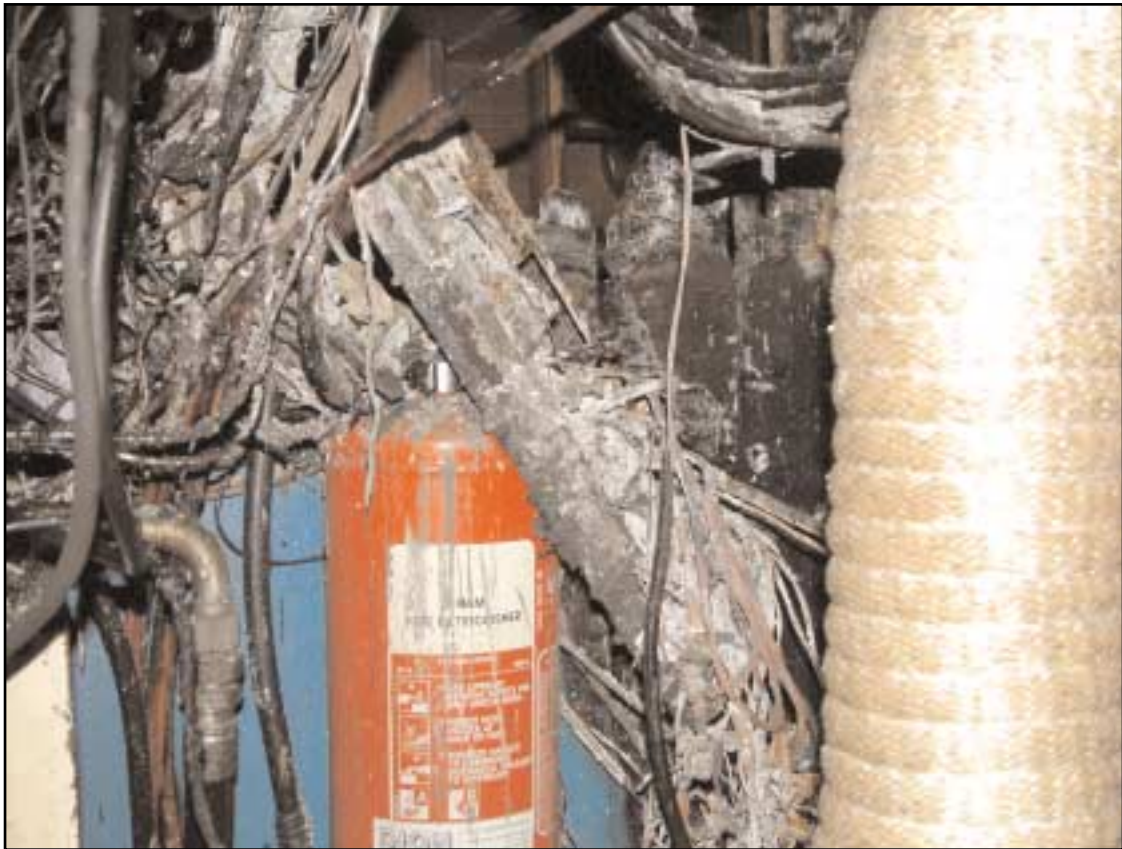
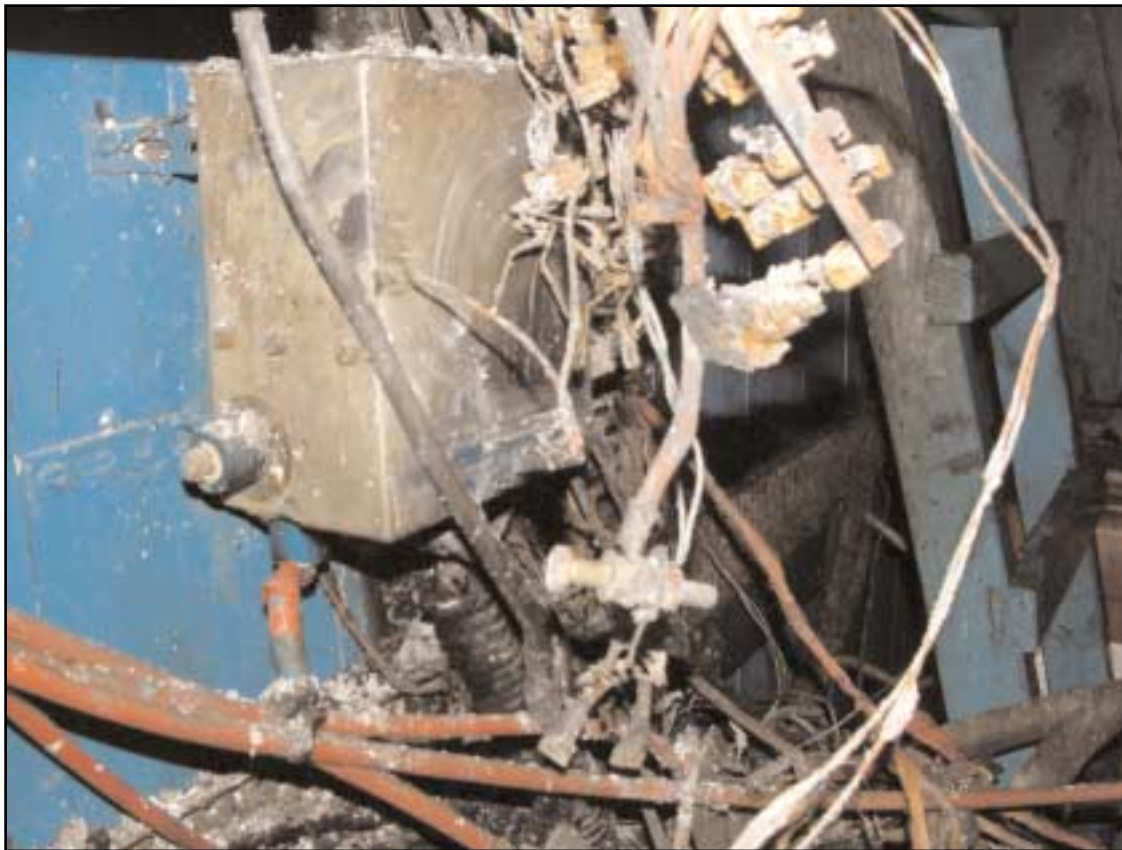
Examples of engine room electrical cable
and distribution panel damage

The fire damage to the electrical cabling situated on the after engine room bulkhead was extensive. The insulation from all the cables was completely burnt away. The nylon ties securing the cables to the vertical and horizontal cable trays were also destroyed, causing the cables to collapse haphazardly at floor plate level.

The steel clad plastic distribution panel, situated close to the top of the after bulkhead, had been completely destroyed. Panel connectors and clamps were virtually the only recognisable distribution panel components. Examples of the engine room electrical cable and distribution panel damage are at **Annex B**.

Remnants of distribution box

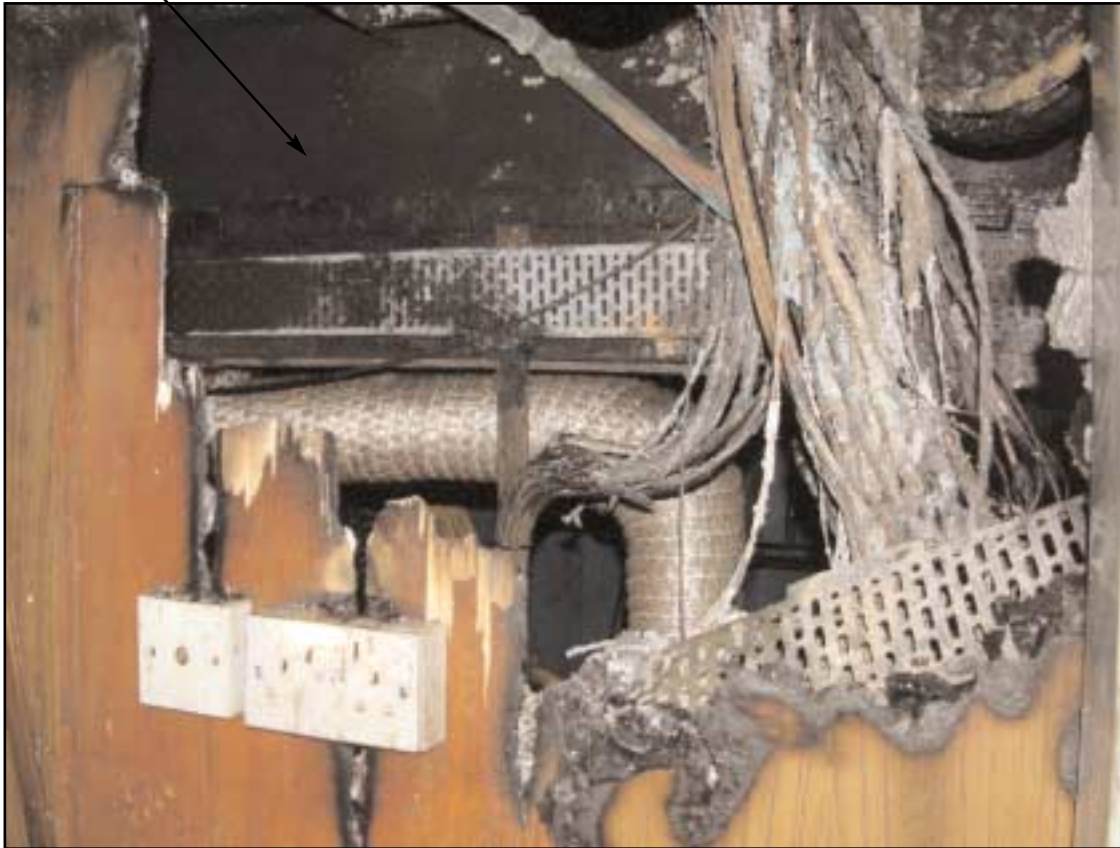
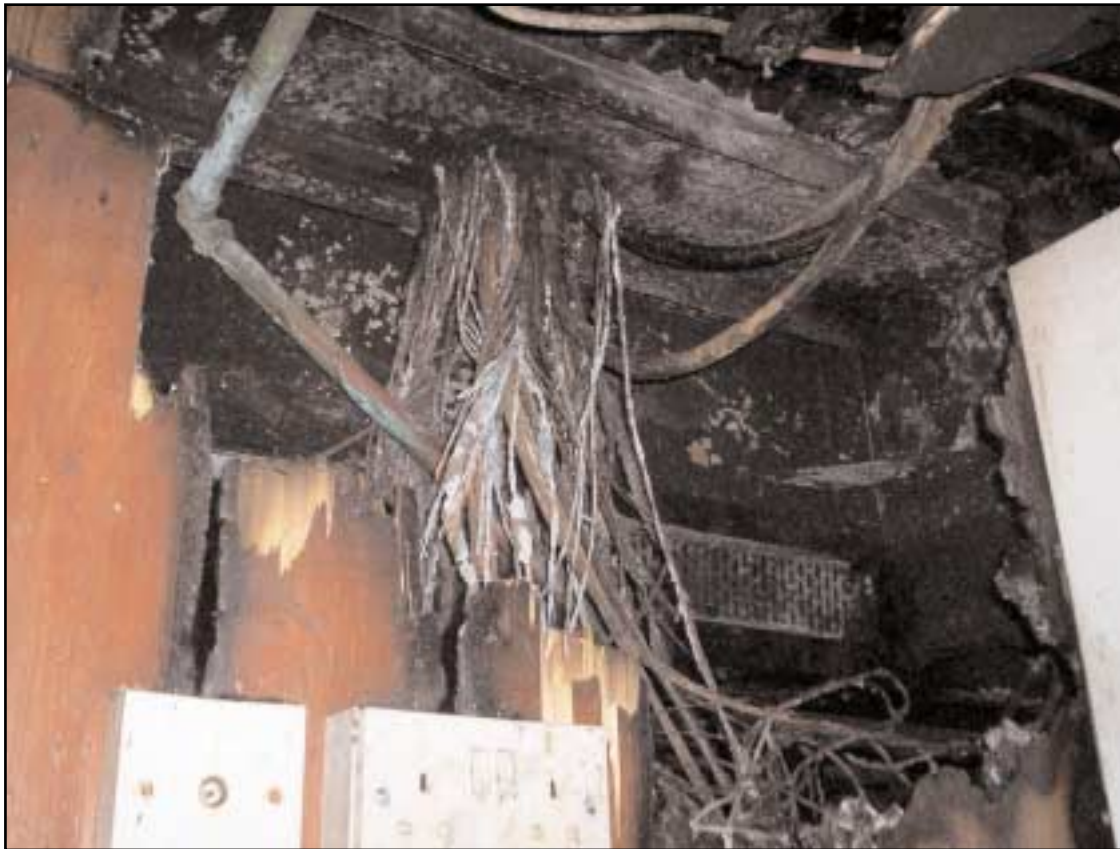
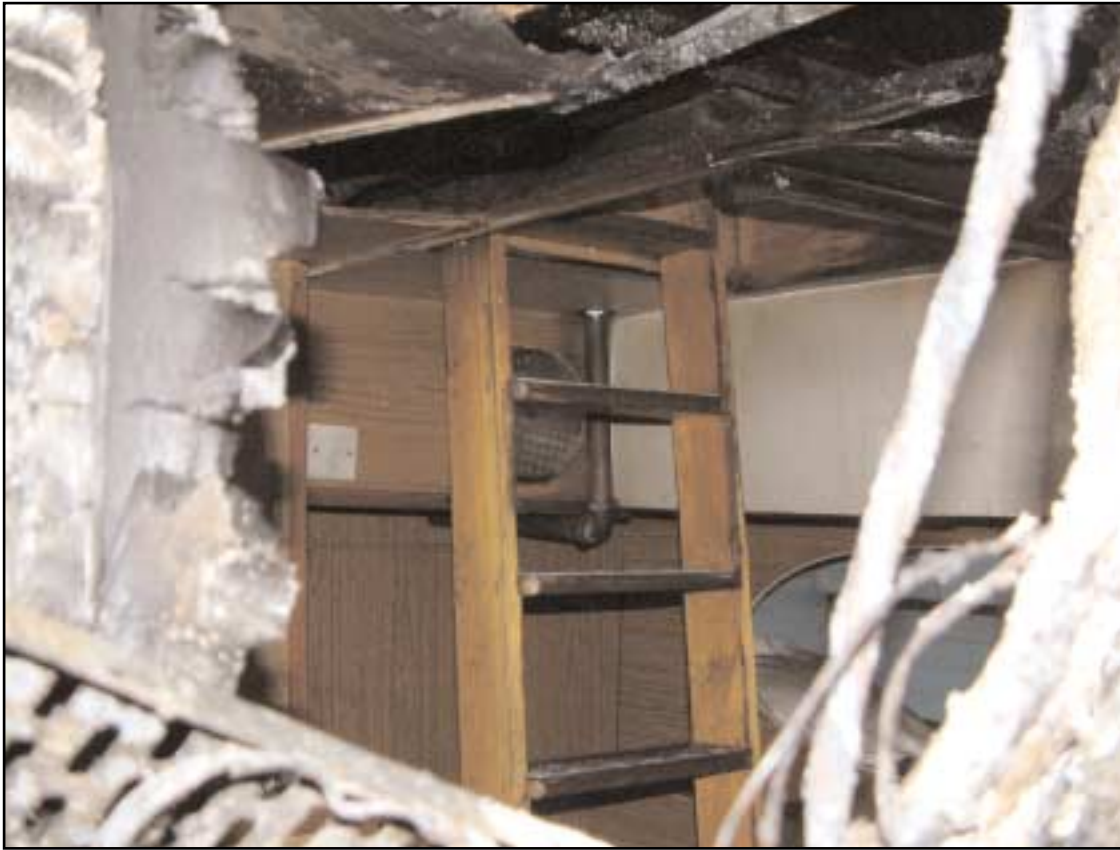
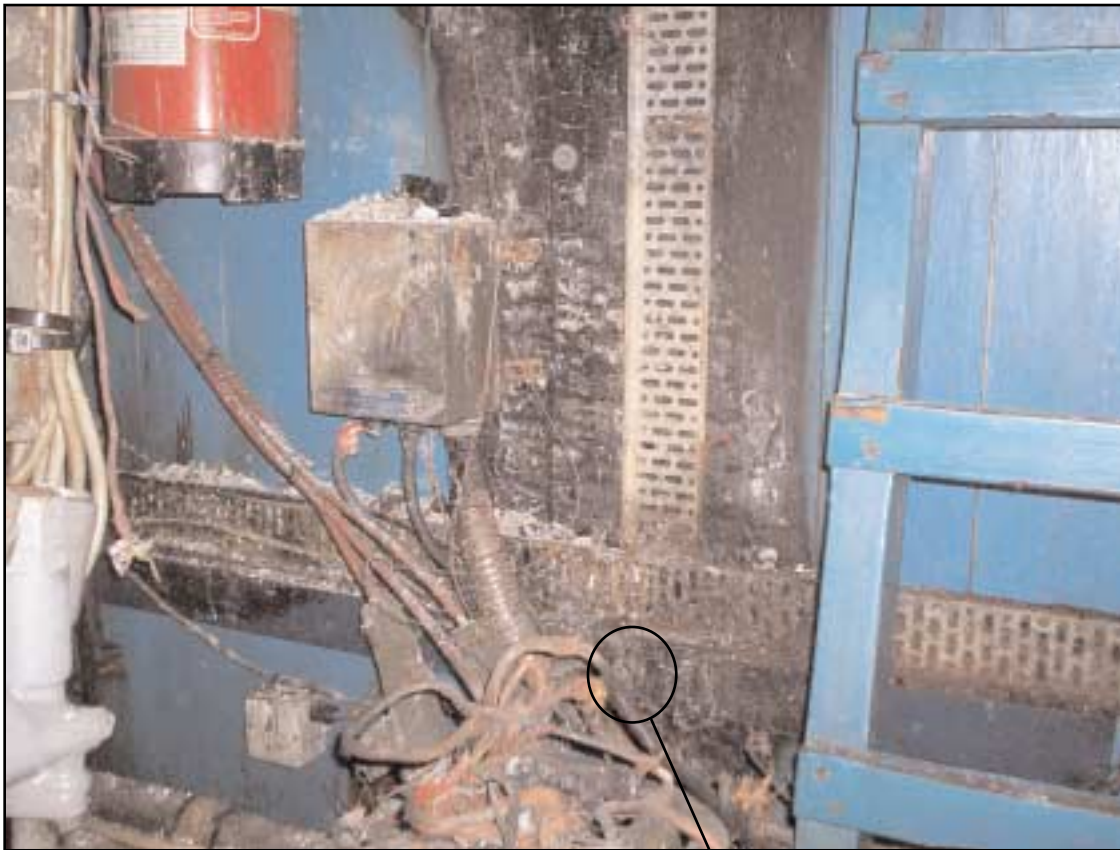
Examples of fire damage to the engine room after bulkhead

The after engine room bulkhead was constructed from 15mm tongue and groove pine timber, which had no obvious fire retardant properties. The fire caused deep charring to the lower section of a vertical stiffener adjacent to the vertical cable tray leading to the electrical distribution panel. The charring pattern widened from about 150cm at the deep charring point, to about 1.2m at its widest point – behind the distribution panel.

There was extensive damage in way of the metal clad, plastic electrical distribution board. This was situated high on the bulkhead and just to starboard of the centreline. A large portion of the bulkhead (approximately 1.2m² and about the size of the distribution panel) in this area had burnt completely away, opening the bulkhead to the accommodation area.

Site of distribution box

Views from accommodation area

Area of deep char

Views from engine room

The engine room/accommodation bulkhead has been partially renewed in way of the fire damage and cladded with material to B15 standard.
