Report on the investigation of
the injury to person on
Dart 8
while berthing at Europort Terminal, River Thames
on
21 March 2004

Marine Accident Investigation Branch
First Floor
Carlton House
Carlton Place
Southampton
United Kingdom
SO15 2DZ

**Report No 12/2004
September 2004**

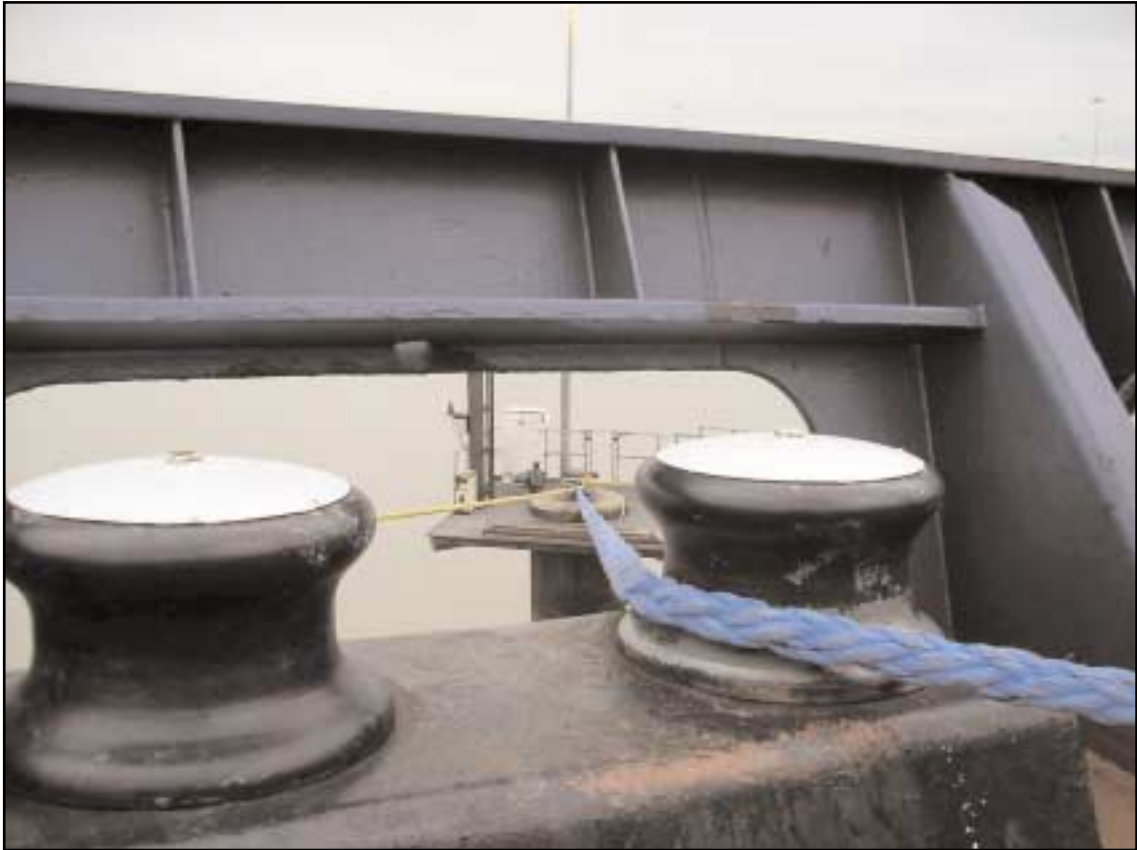
Moments later, at about 1030, the rope on the starboard winch parted where it passed through the ship's side around an open roller fairlead (**Figure 6**). The inboard end recoiled with such force that it struck the bosun's lower legs, inflicting a double fracture to his right leg and severe bruising to his left leg. As he fell, his head hit a set of mooring bits, causing his nose to bleed. One of the seamen immediately called the chief officer using the bosun's UHF radio, and, speaking Romanian, informed him of the accident. Speaking in English, the chief officer then told the master on the bridge. The off-duty master, who was also on the bridge at the time, called for an ambulance to attend *Dart 8*. The duty master then appraised the local freight office of the situation, and continued berthing the vessel.

Open roller fairlead

The rope was said by witnesses to have parted where it passed through the roller lead. Subsequent measurement of the broken parts of the rope confirmed this to be the case.

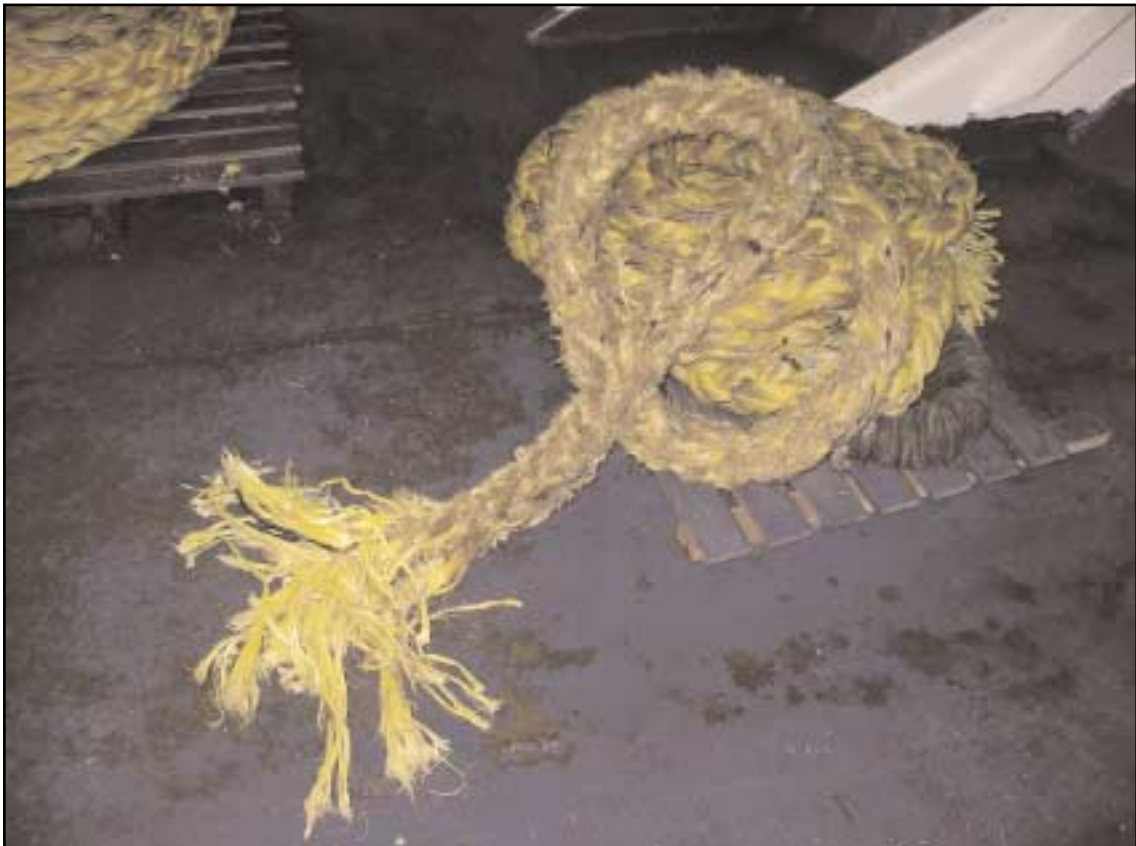
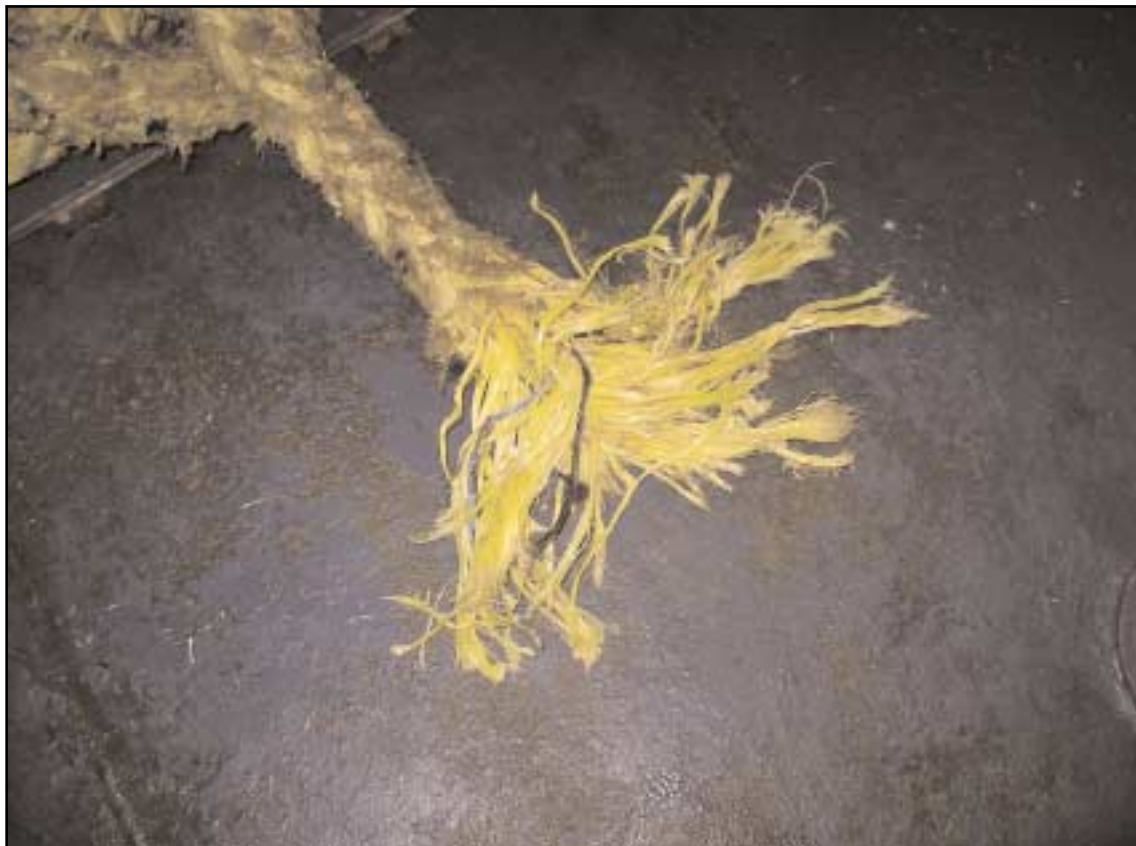
Figure 7

The report concludes that the estimated residual rope strength in the area of failure had reduced by 87.7%, from 770kN to 94.2kN. The report states that *“external abrasion damage was the dominant feature seen on all parts of this rope, being visually assessed to vary between mild remote from the failure, to extreme within the failure zone”*, and concludes that *“if the rope was in this extreme abraded condition before the failure, then the rope appears not to have been routinely inspected in accordance with industry guidelines and recommendations. Inspection according to the guidelines would have resulted in the rope being rejected as unfit for service before the failure”* (**Figures 7 & 8**).

Taking the above evidence into account, the MAIB believes that the rope was in poor condition prior to being deployed on the morning of 21 March.

Views of the parted mooring rope

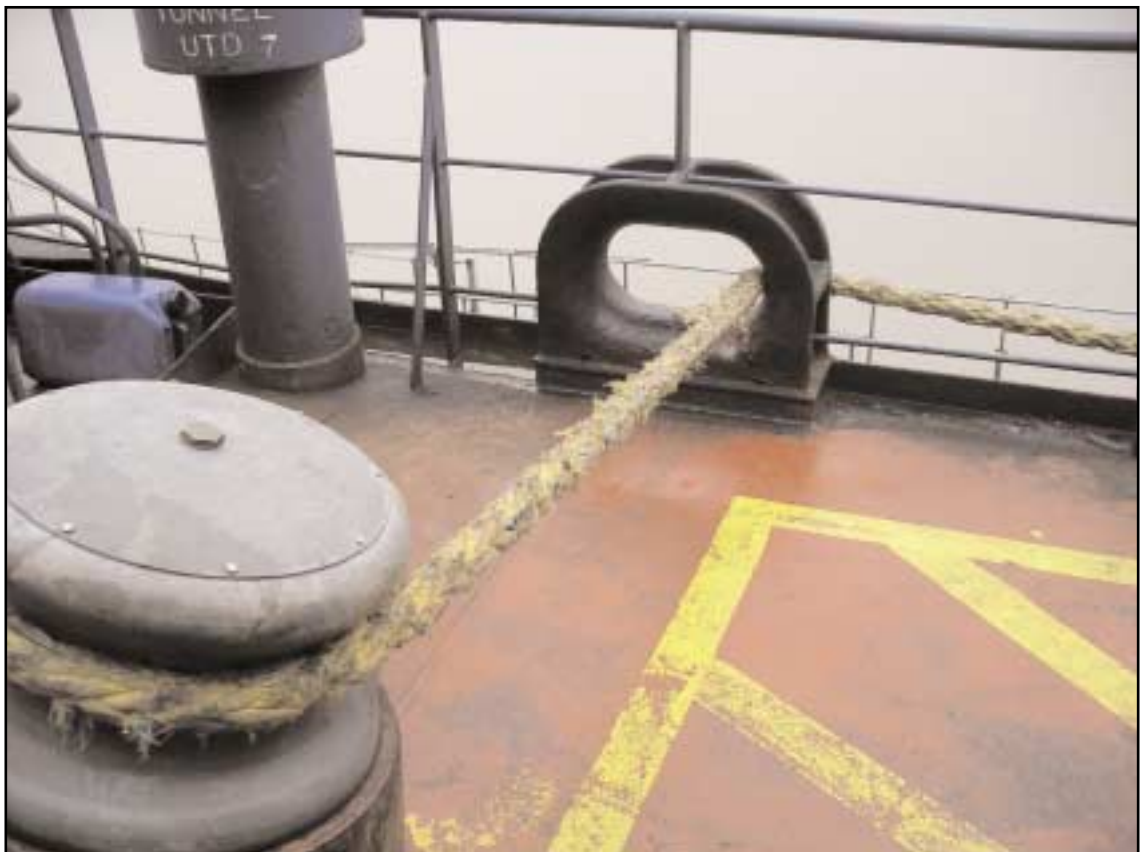
Figure 9

1. The rope was older than the ship's managers believed. It had probably been in use from the starboard winch considerably longer than they had thought, and, accordingly, severe abrasion had occurred in the area where it passed through the ship's side around the roller fairlead; or
2. The rope was used at another mooring location where it was deployed through a fixed lead, possibly at an acute angle, and had been moved to the starboard winch some time prior to the accident (**Figure 9**).

Panama lead in use for a spring

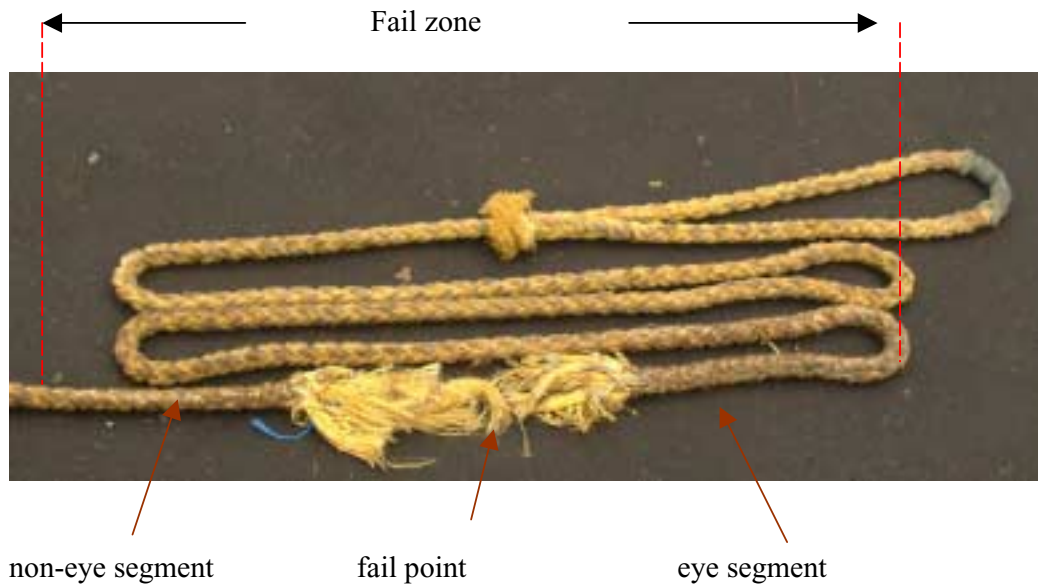
Photograph 1 General view of rope

External abrasion is clearly seen over both segments. It was found to vary both in degree and also the amount of the rope circumference affected. It was difficult to show this by photograph, and the qualitative terms 'mild, modest, severe and extreme' will be used to describe the degree of damage found.

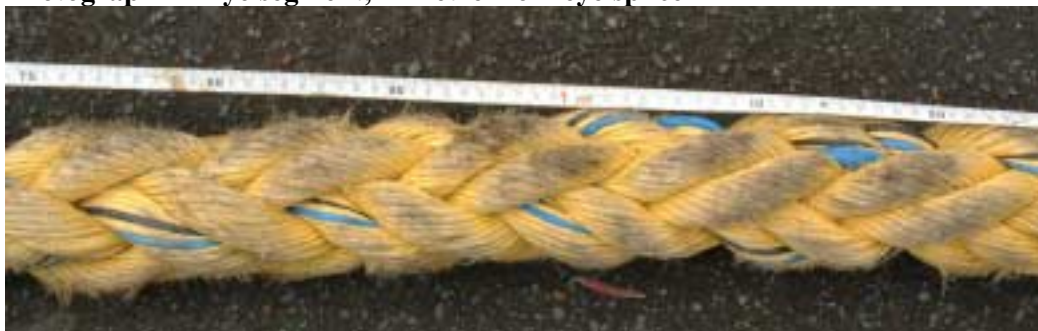
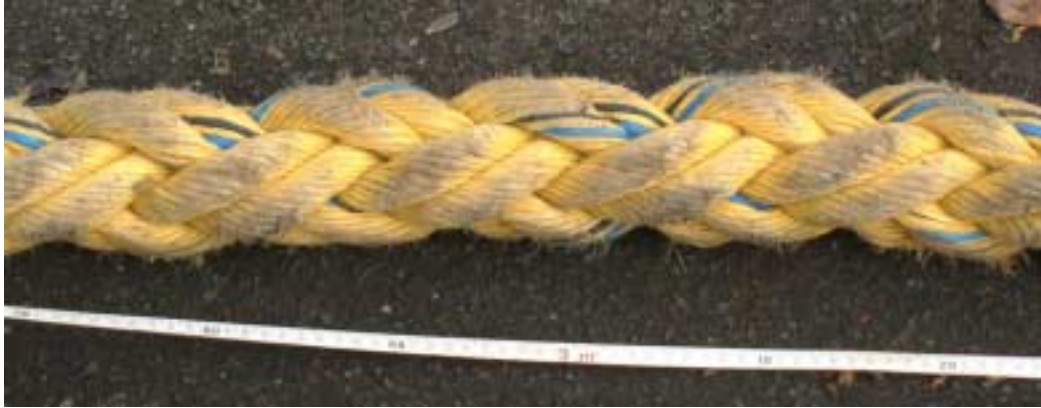
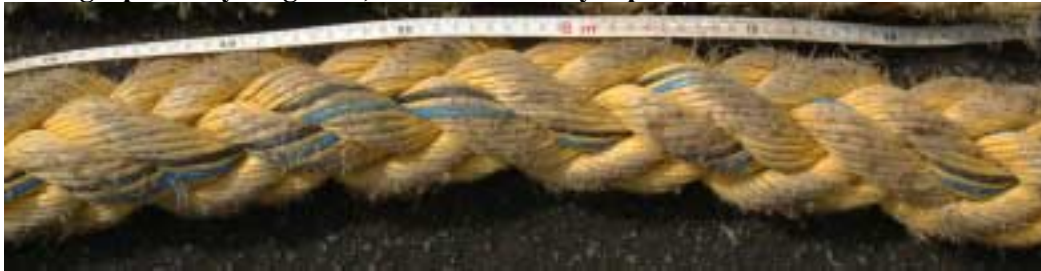
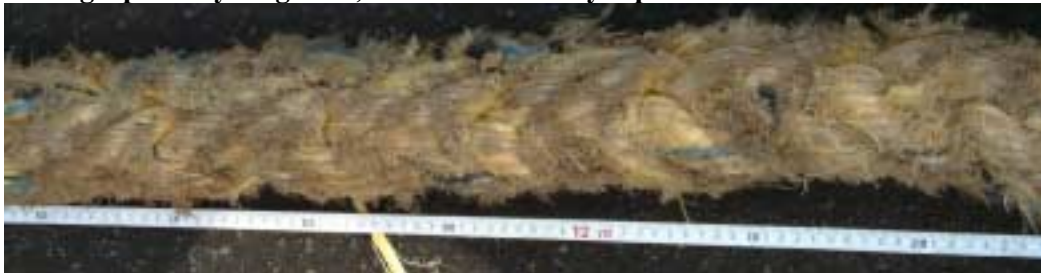
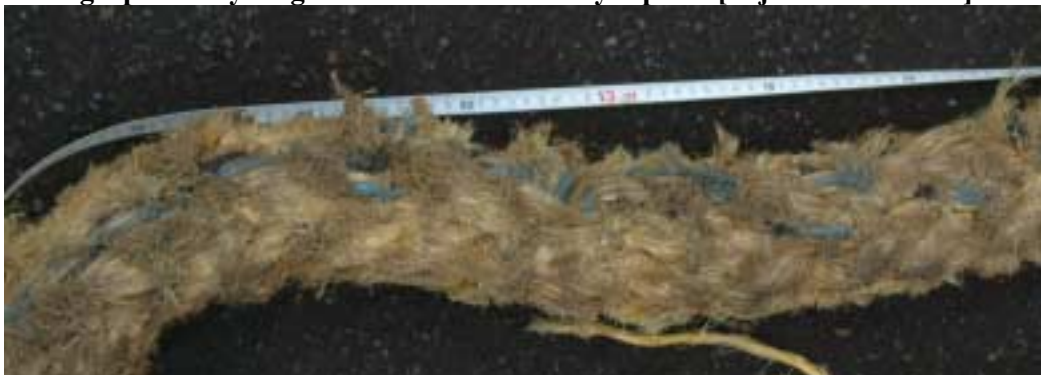
With regard to the eye segment, photographs 2-6 show the rope condition of the eye segment along its length, from close to the eye up to the fail zone. Photographs 7 and 8 show the extreme abrasion damage, over 100% of the circumference of the eye segment at the fail point.

Remote from the fail zone, this abrasion is at a relatively low level, mild, but gets progressively worse as the fail zone is approached. At about 3 metres from the fail zone, the rope has suffered extreme external abrasion, this damage extending to approximately 50% of its circumference. Severe abrasion is present over the remainder of the circumference. Extreme damage to 100% of the rope circumference occurred within the fail zone up to the fail point.

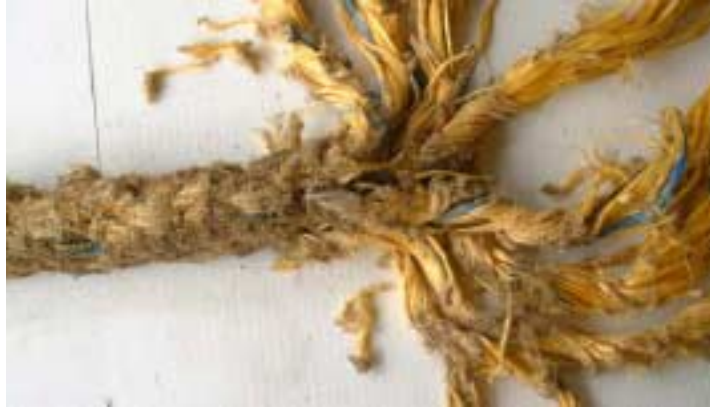
Photograph 7

View of upper face of rope close to fail zone, eye segment, showing extreme abrasion

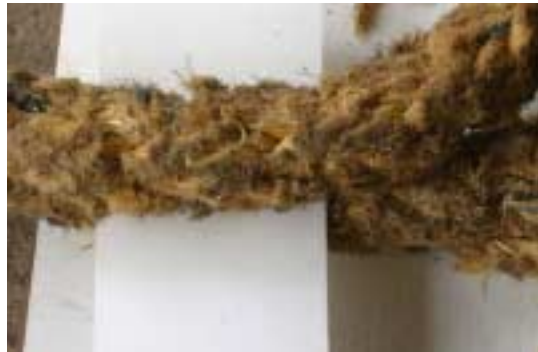
Photograph 8

View of lower face of rope close to fail zone, eye segment, showing extreme abrasion

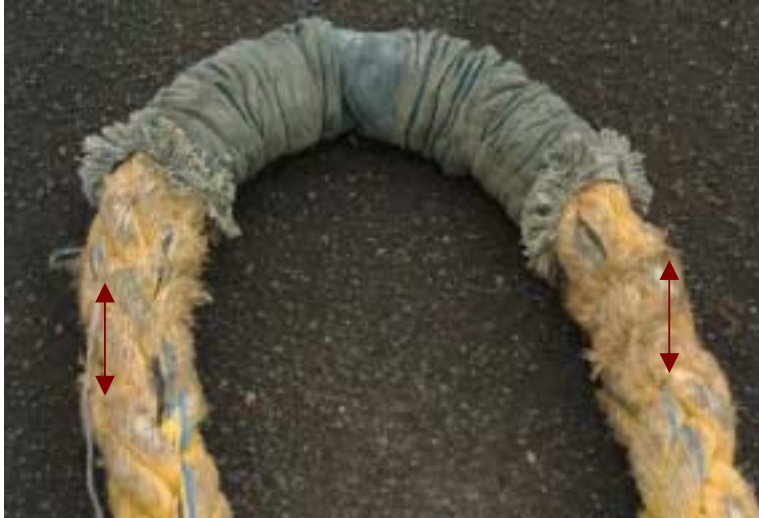
The eye was found also to have severe external abrasion damage, due to the protective sleeve having been displaced in use, exposing the eye of the rope to abrasion caused by mooring fixtures. The damage is such that it had the potential to be a source of failure in its own right. No tensile measurements were been made on the rope elements in this area.

Although not part of this investigation, it can be seen that the protective sleeve has rucked back to expose the rope to severe abrasion at the positions, highlighted by the double arrows, Photograph 9. This damage extended to about 75% of the circumference, and about 15 cm in length. If left to decline further, there would have been an increased chance of failure at the eye.

Photograph 9 Eye showing positions of excessive abrasion

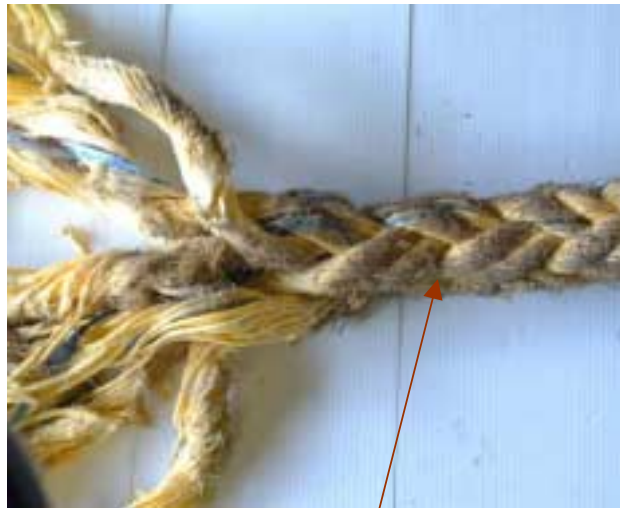
**Photograph 10
View of upper face of rope close to fail zone, non-eye segment, showing severe abrasion**

The upper face had suffered severe abrasion damage.

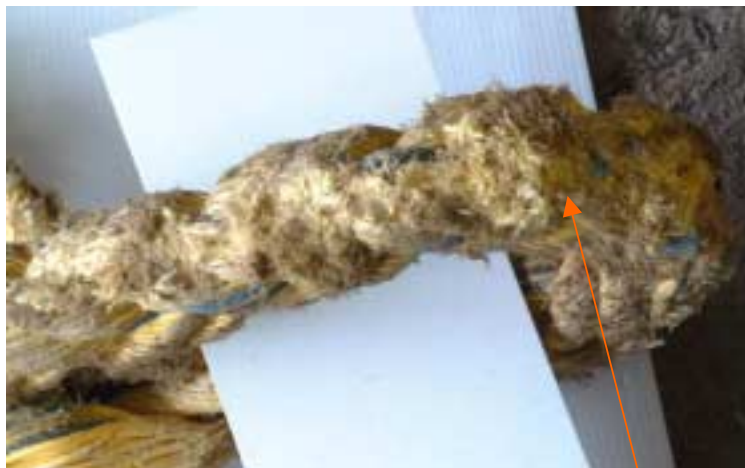
Photograph 11

View of lower face of rope close to fail zone, non-eye segment, showing extreme abrasion

Where there has been this extreme abrasion, in both segments, there are areas within these abrasion zones where large amounts of rope material have disappeared.

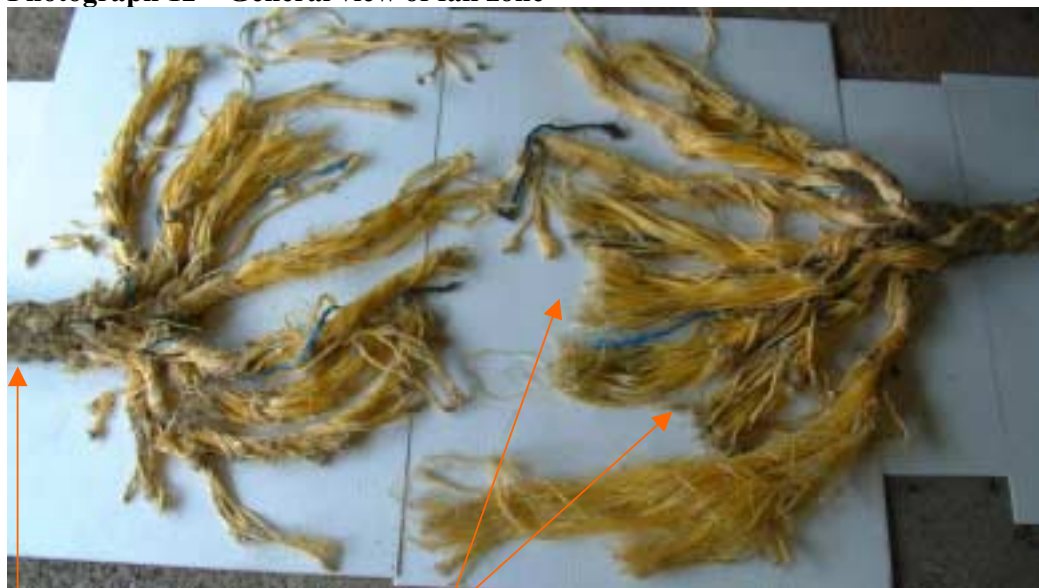
The left hand part is the eye segment, and the right hand part is the non-eye segment. It can be seen, particularly with the non-eye segment, that the yarn elements of several of the strands have all failed in a very localised area. In the case of a simple tensile failure, a more random distribution of failed ends would be expected. For the eye segment, there is a much reduced occurrence of rope elements failing in a very localised area.

Photograph 12 General view of fail zone

failed ends in close proximity to one another

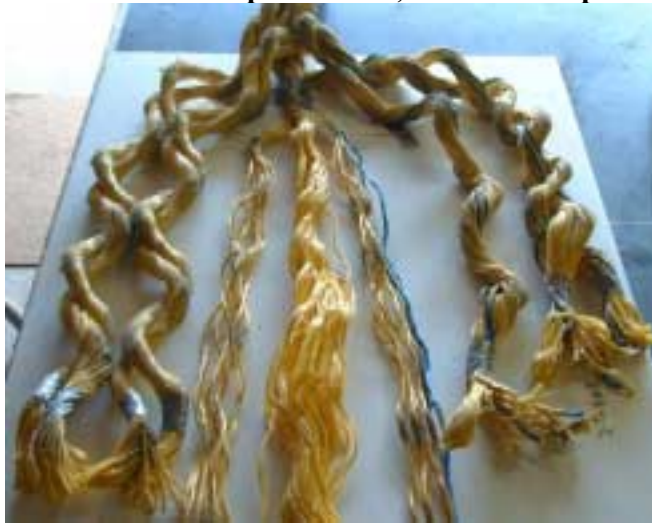
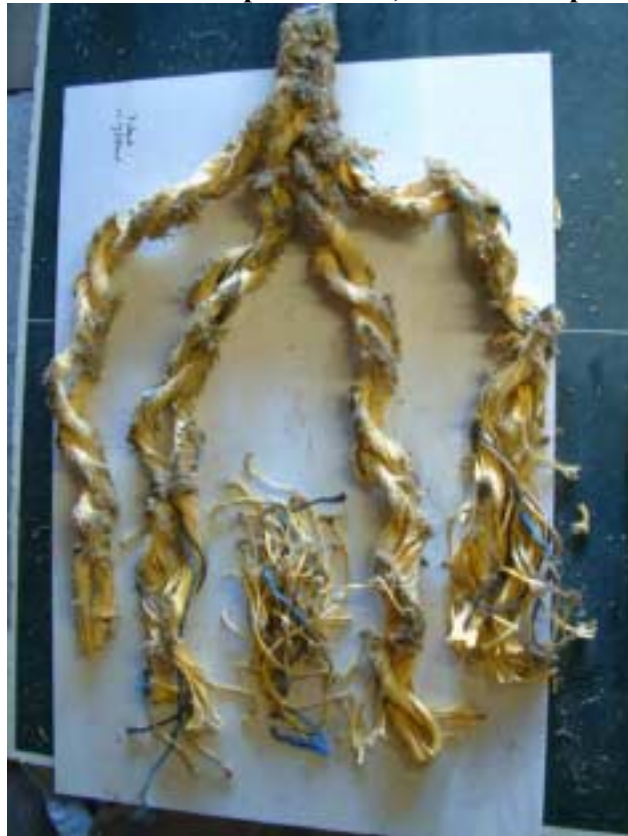
Photograph 13 General view of rope elements, 'remote' sample

Photograph 14 General view of rope elements, 'within' sample

It can be seen that a substantial quantity of completely severed rope elements were released by the opening up process on the 'within' sample. Also, the degree of damage to the strands was significantly greater when compared to the 'remote' sample.

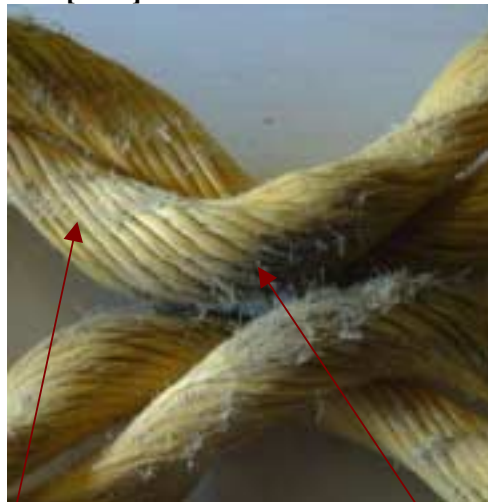
Internal abrasion, caused by touching strands moving relative to one another was also seen. Photograph 15 shows this type of abrasion damage, along with the external abrasion, as found on the 'remote' sample, and Photograph 16 shows the same abrasion mechanism as found on the 'within' sample.

Photograph 15
Internal strand-on strand [SOS] abrasion and external abrasion, remote sample

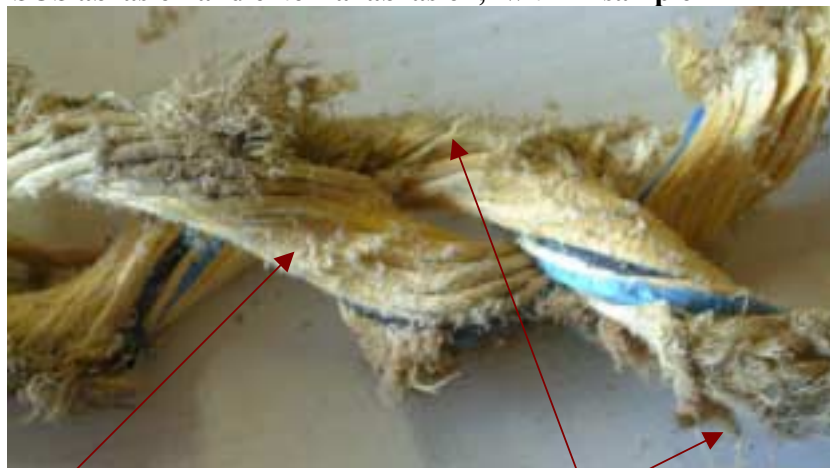
Photograph 16
Internal SOS abrasion and external abrasion, 'within' sample

severe loss of material due to external abrasion

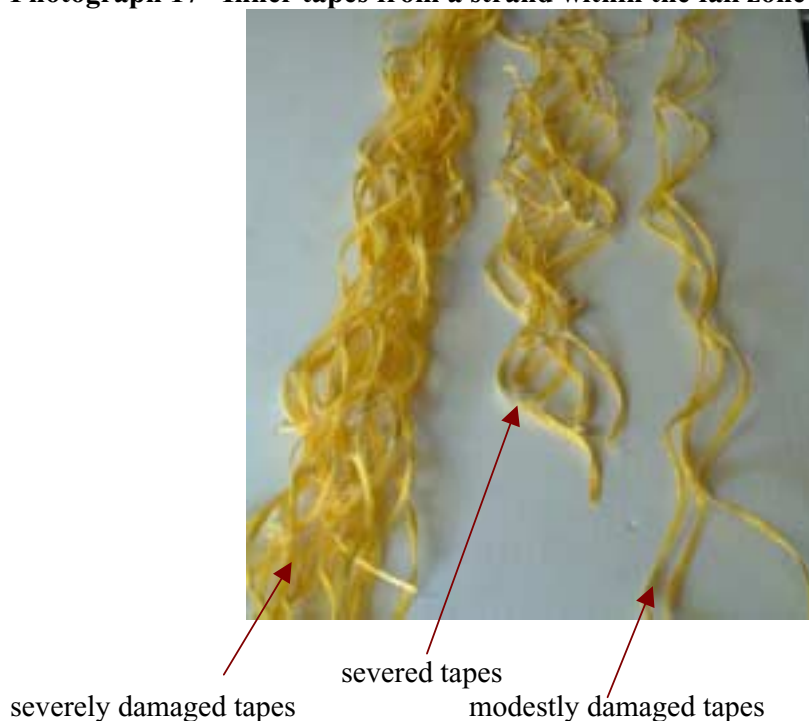
Only 3 of the 31 inner tapes, and the single core yarn, could be considered as having any integrity as load bearing elements. The remainder were either completely severed or had sufficient damage as to render their tensile performance exceedingly low.

Photograph 17 Inner tapes from a strand within the fail zone
