Report on the investigation of  
the collision between  
***Reno and Ocean Rose***  
off Whitby, North Sea  
6 March 2004

Marine Accident Investigation Branch  
First Floor  
Carlton House  
Carlton Place  
Southampton  
United Kingdom  
SO15 2DZ

**Report No 13/2004**  
**October 2004**

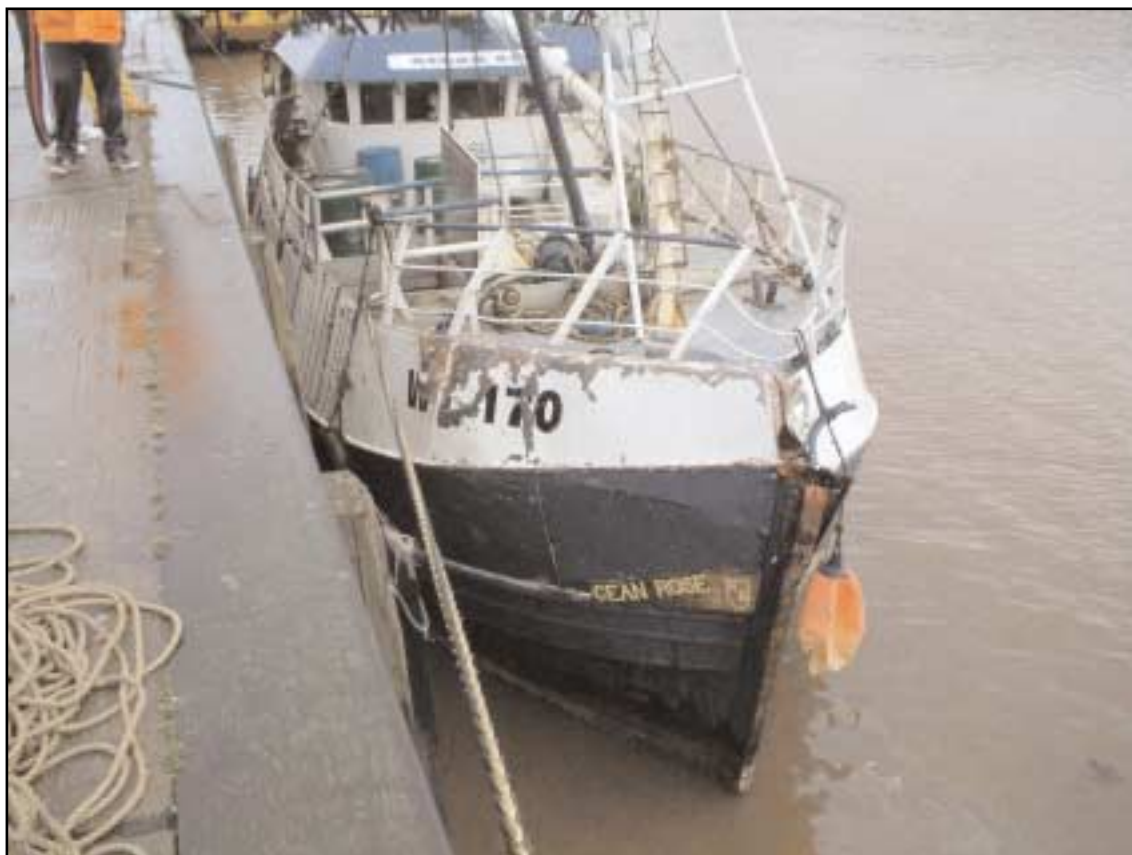
Figure 1

The collision occurred at 0052 and 38 seconds, and was almost head on. *Ocean Rose* was hit on her stem and starboard bow, which caused her to roll heavily to port. The skipper was thrown to the port side of the wheelhouse, and the deckhands fell forward on to the deck. The skipper immediately assessed that *Ocean Rose* had suffered substantial damage, and sent a "Mayday" via VHF radio, and by pressing the distress button on his Inmarsat radio. The damage to the forward part of *Ocean Rose* is shown at **Figure 1**.

Damage to *Ocean Rose* - forward

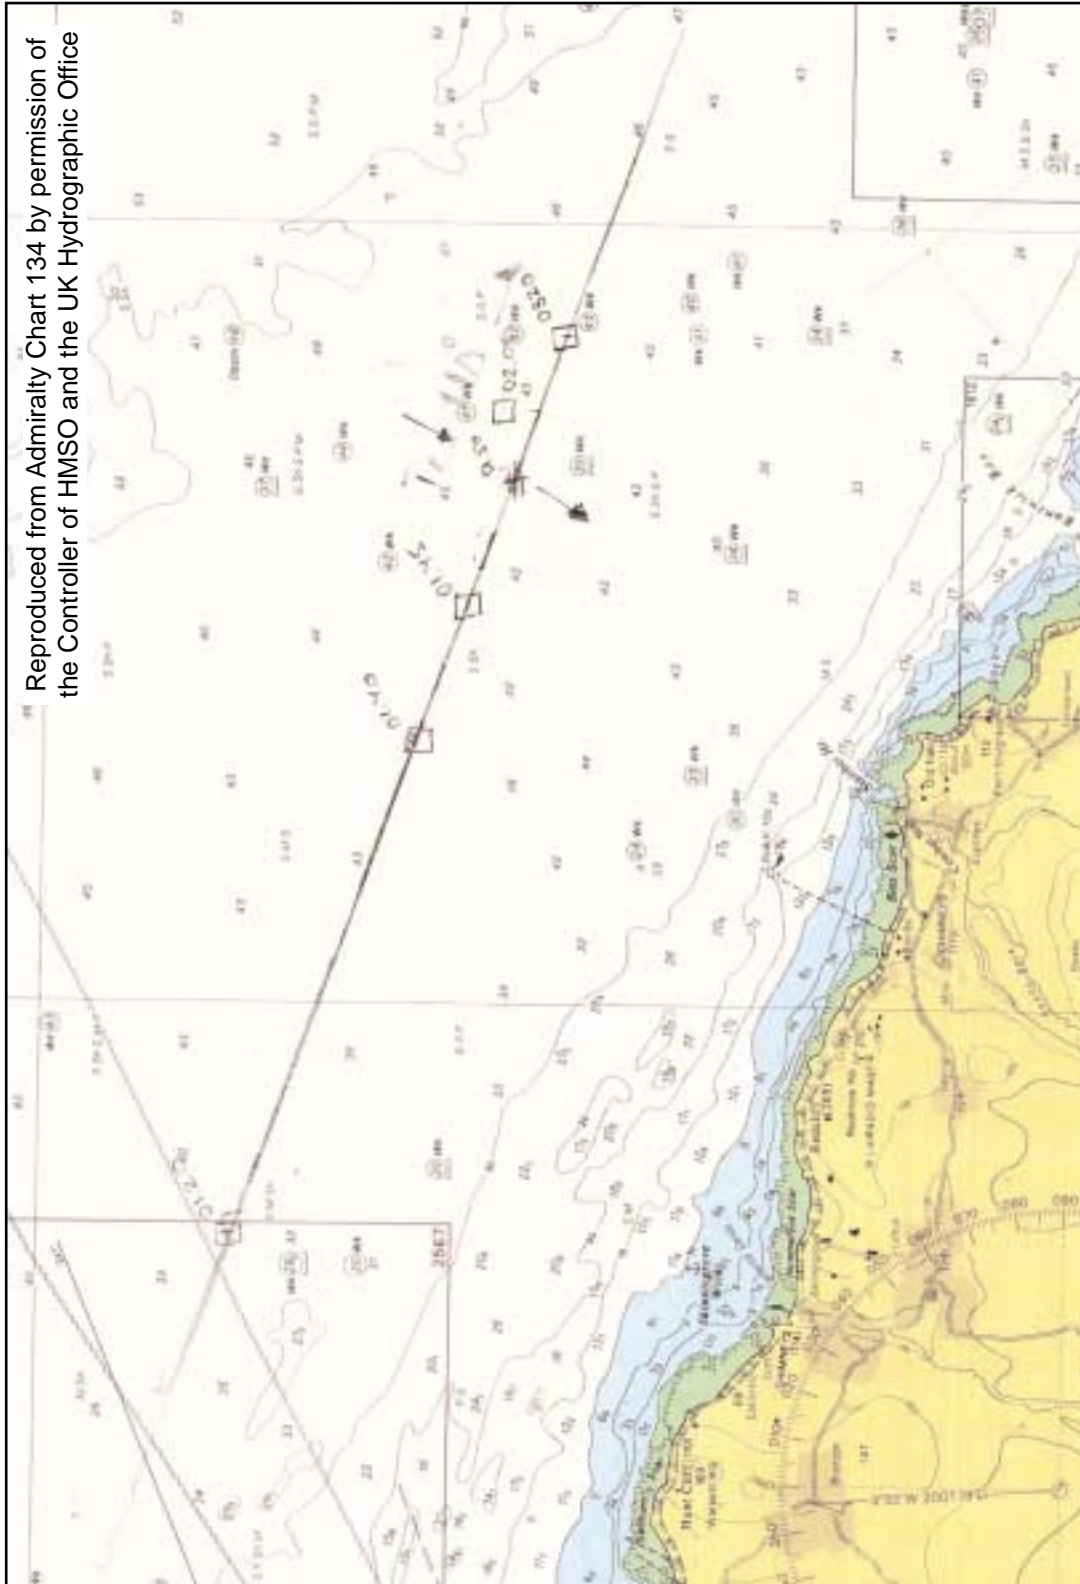
Figure 2

During this period, the second officer plotted fixes on the paper chart at 0040 (GPS), 0045 (radar) and 0050 (GPS). These are shown at **Figure 2**.

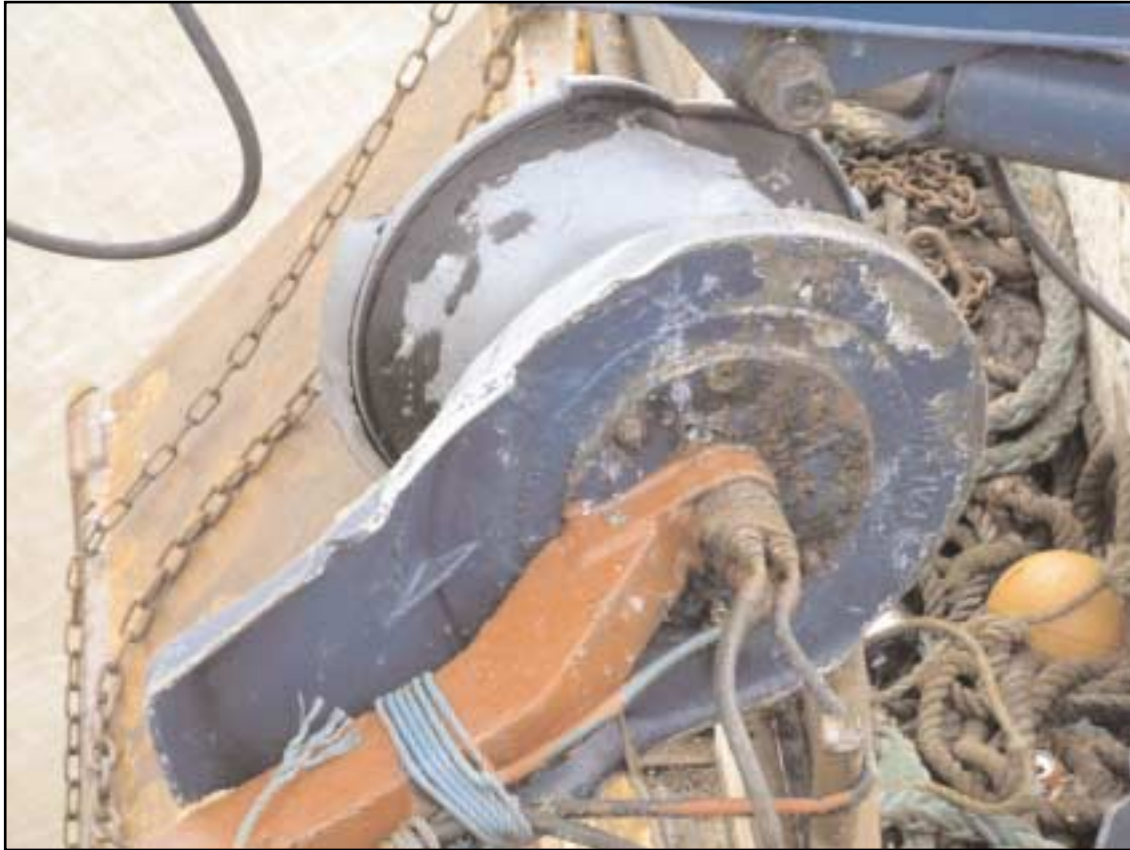
Figure 4

Photograph showing damage to power block

Flattened bracket

Both the master and second officer recall passing very close to *Ocean Rose* during this period, but were not aware of a second collision between the two vessels. Accounts differ regarding whether *Ocean Rose* disappeared from view under *Reno*'s bow as the vessels closed. *Reno*'s master estimated that the vessels came no closer than 1 cable. The crew of *Ocean Rose* recall that *Reno* approached at an angle of about 90° on their starboard side, and clipped the fishing vessel's stern at a right angle. This is reported to have damaged the power block and roller fair lead on her starboard quarter (**Figures 4 and 5**), and pushed the fishing vessel forward.

The resulting damage reported to be from this contact is difficult to confirm with any certainty. Damage to the power block (**Figure 4**) might have been sustained during the first collision. It is also possible that the damage to the roller fair lead bracket (**Figure 5**) might have been caused by the bulbous bow of *Reno* momentarily snagging the fishing warps passing over the fair lead, rather than via direct contact with the structure itself. Although the major damage in the engine room was first seen after the second collision, it is not certain how the fracture of the pipe, and water ingress via the strum box, could have been initiated by this contact.

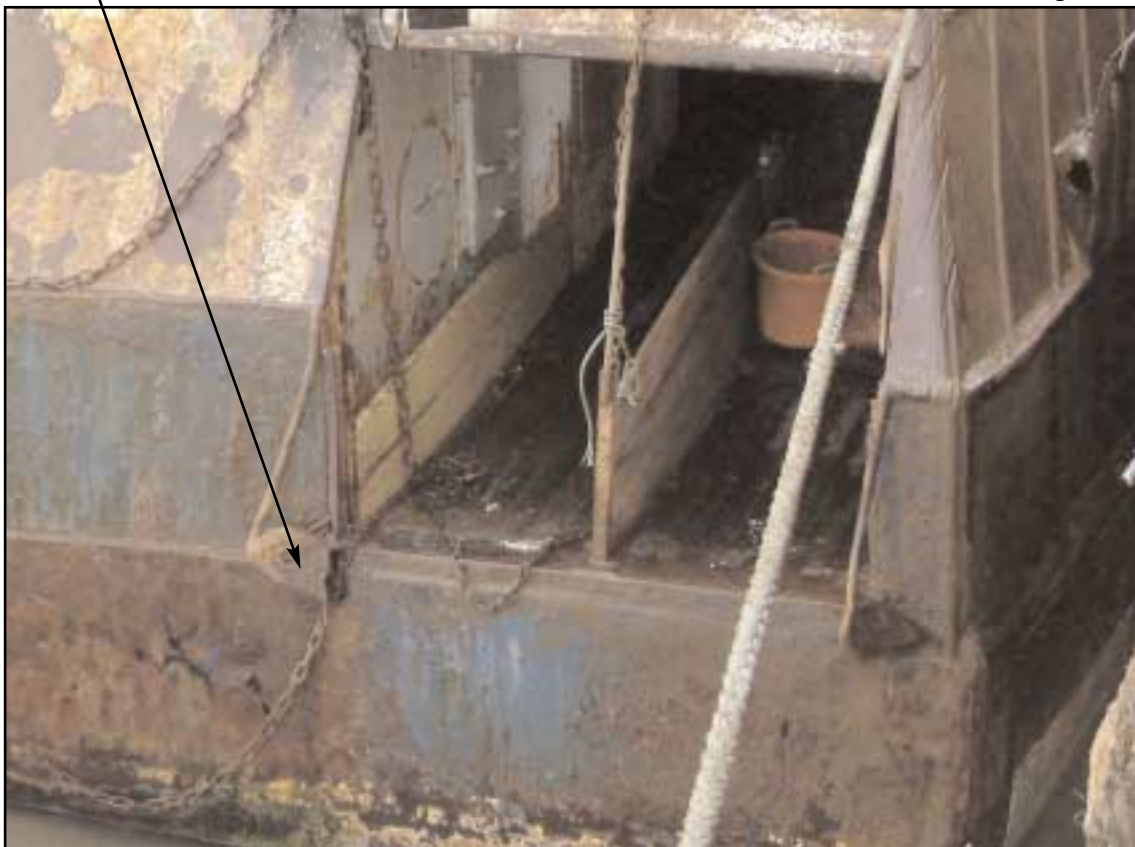
Figure 5

Photograph showing roller fairlead bracket damage

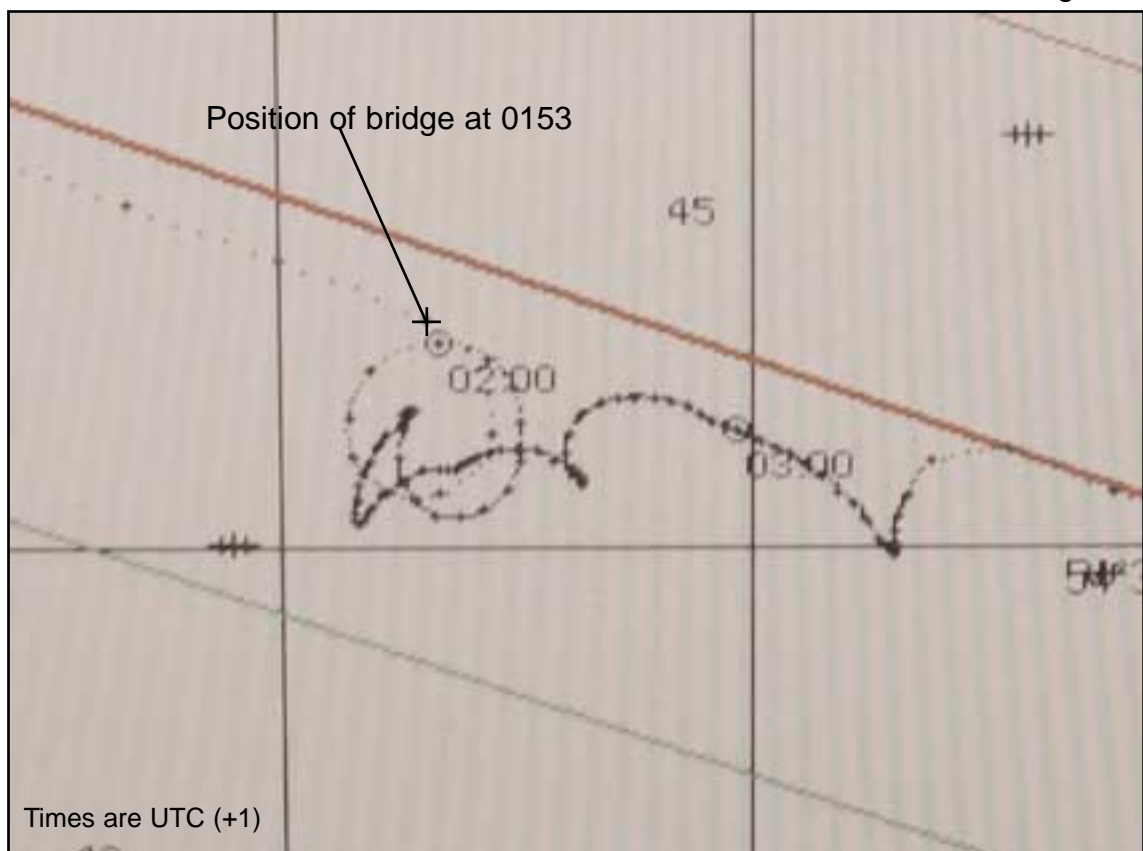
Figure 6

*Reno* was fitted with a Transas ECS. The vessel's recorded track for the period is at **Figure 6**. The following navigational data was retrieved from the system:

*Reno's recorded track from ECS*

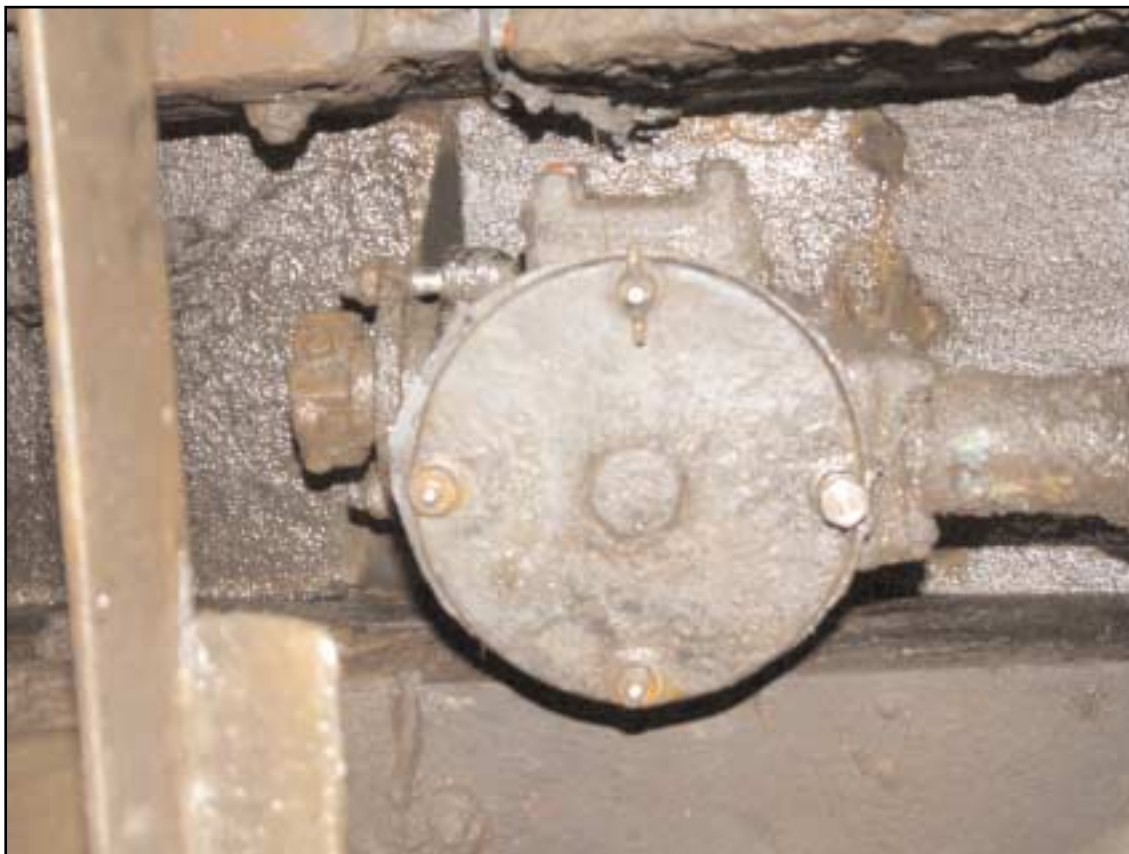
Immediately following the second collision, the crew launched, inflated, and secured the liferaft on the port side. One of the deckhands then secured the power block aft, which had been knocked from the gallows on which it had been resting; the hydraulic pipes to the power block had also been ruptured. The mate returned to the engine room and found a pipe from the deck hose system, powered by the main engine, had fractured, forcing water over an electrical distribution board. The mate covered the distribution board and isolated the fractured pipe. He then saw spray coming from a strum box (**Figure 7**) on the starboard side of the engine room. When he tried to tighten the nuts securing its cover, two of them disintegrated due to corrosion.

The bilge pump could not keep pace with the water ingress, and the water level was soon up to the deck plates. Although the mate had managed to find spare nuts, he had difficulty securing them because the strum box cover was now under water. When the Whitby lifeboat arrived, a portable pump was transferred via the inshore lifeboat at about 0137, and water was pumped from the engine room bilge. This allowed repairs to be made to the strum box. By 0152, *Ocean Rose* was able to proceed at slow speed under her own power, and was escorted by the Whitby lifeboat to Whitby, where she arrived at about 0400.

Photograph of strum box cover

On finding the water ingress in the engine room, the mate's action was positive in difficult circumstances. Subsequent inspection of the failed strum box nuts indicated that their corrosion was caused by the use of dissimilar metals. This highlights the need to ensure that all through-hull fittings are properly maintained, and that appropriate materials are used.

4. The failure through corrosion of the nuts securing the strum box cover in *Ocean Rose*, highlights the need to ensure that all through-hull fittings are properly maintained at all times, and that appropriate materials are used. [2.2]
