Report on the investigations into the
two engine room fires, subsequent flooding and foundering of the

fv Elegance

Report No 9/2004
August 2004

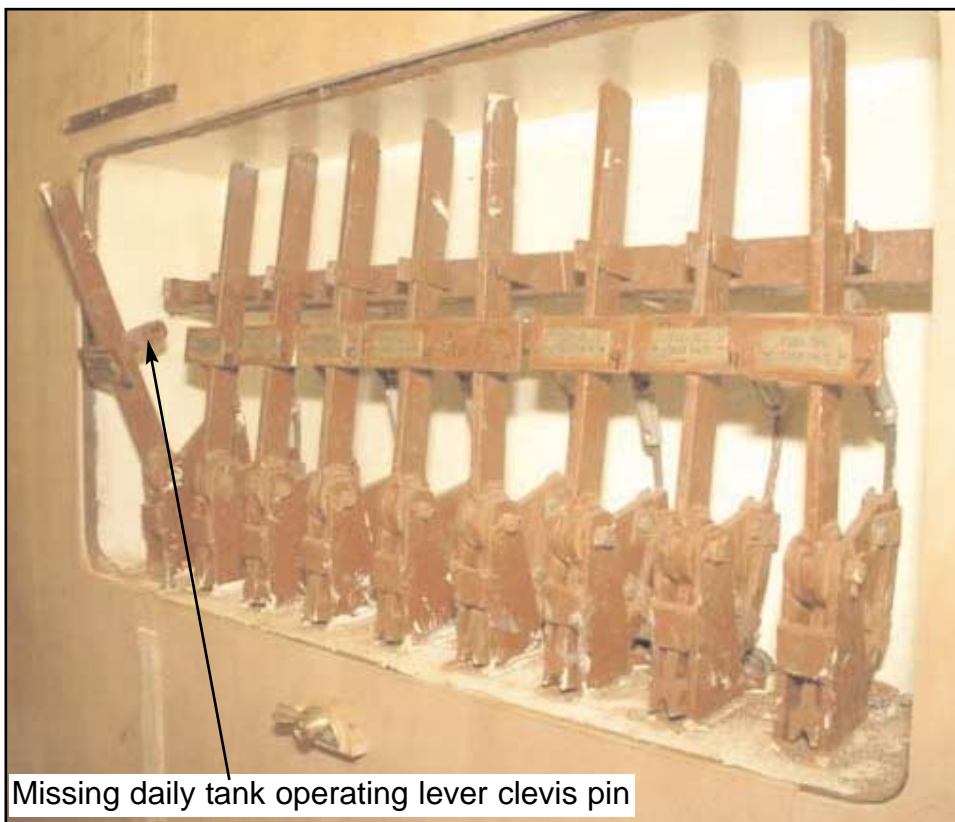
Figure 2

fuel valve, which isolates the main engine and generator, was disconnected from its operating cable. The clevis pin connecting the lever to the cable was missing (**Figure 2**). He therefore attempted to operate the valve, as best he could, by pulling on the cable. Shortly afterwards, *Elegance* was plunged into darkness.

Fuel quick shut off valve arrangement

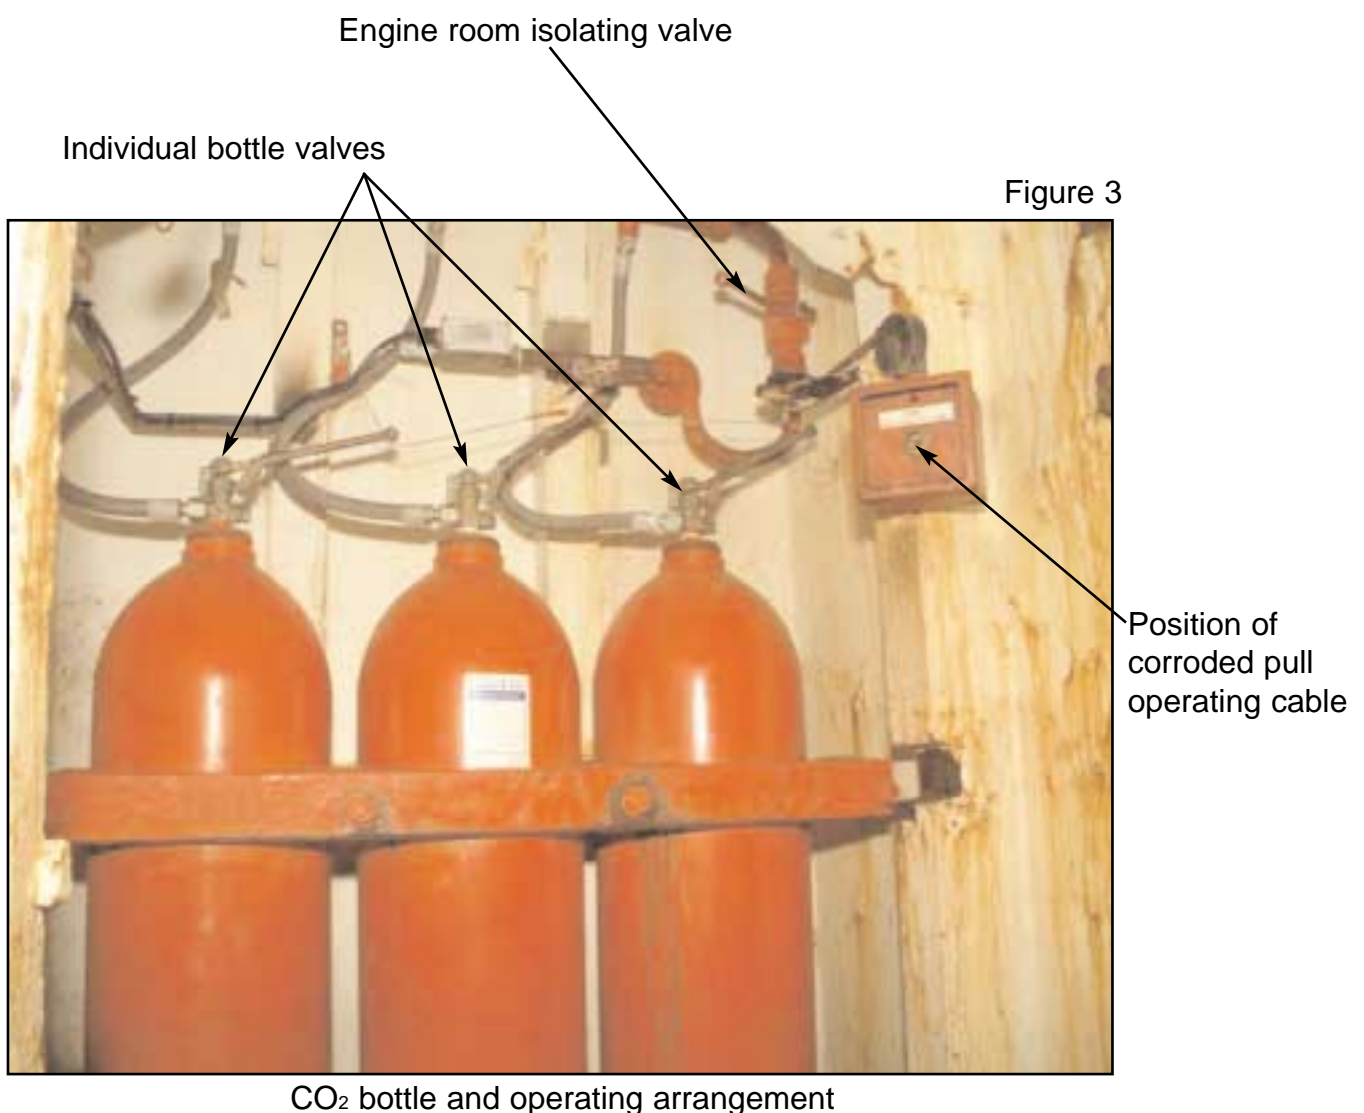
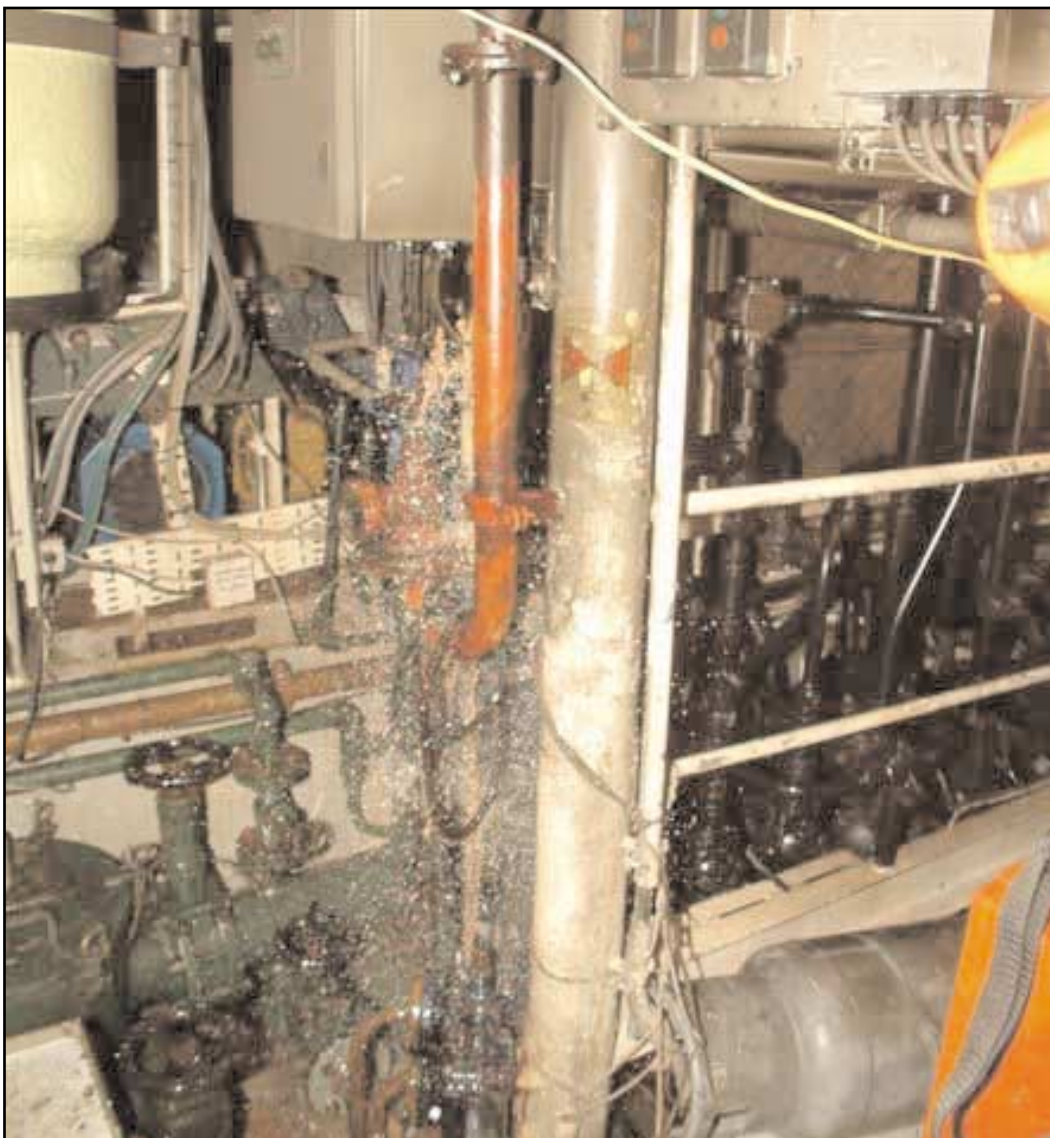
Replicated fuel leakage from main engine duplex fuel filters

Post-accident tests showed that the fuel issued approximately 1 metre vertically from the duplex fuel filter ventilation plug under daily tank gravity conditions. Some fuel drained into the bilge, with the remainder settling on the starboard tank tops adjacent the main engine.

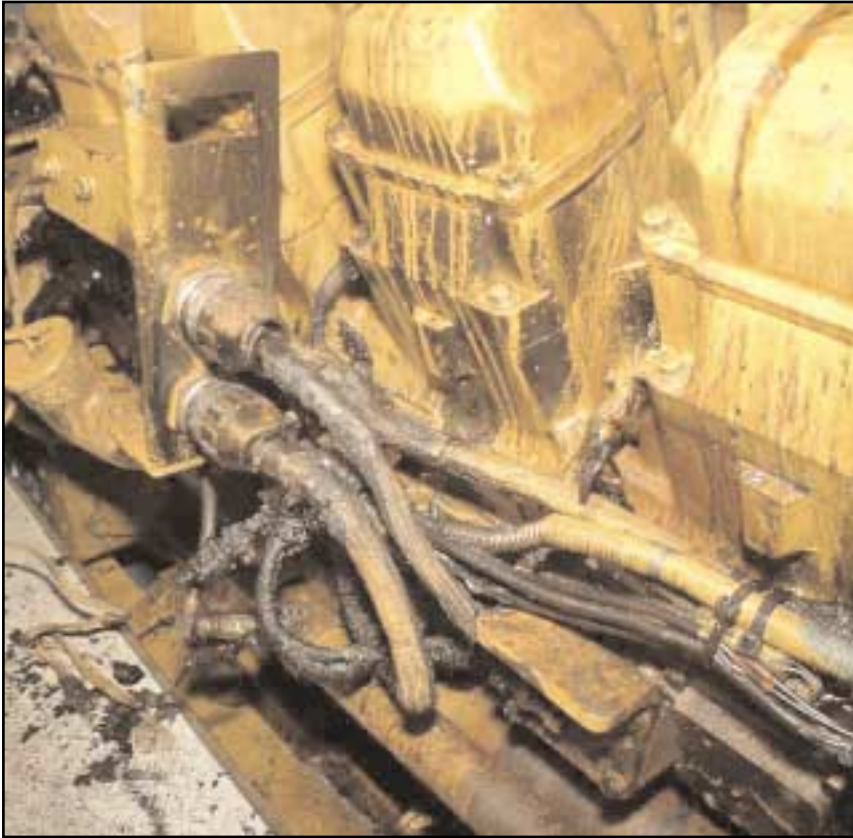
Figure 5

The numerous electric power supply cables, and the main engine surveillance and management wiring loom situated on the starboard side of the engine, were also damaged (**Figure 5**).

Damage to main engine surveillance and management system electrical loom

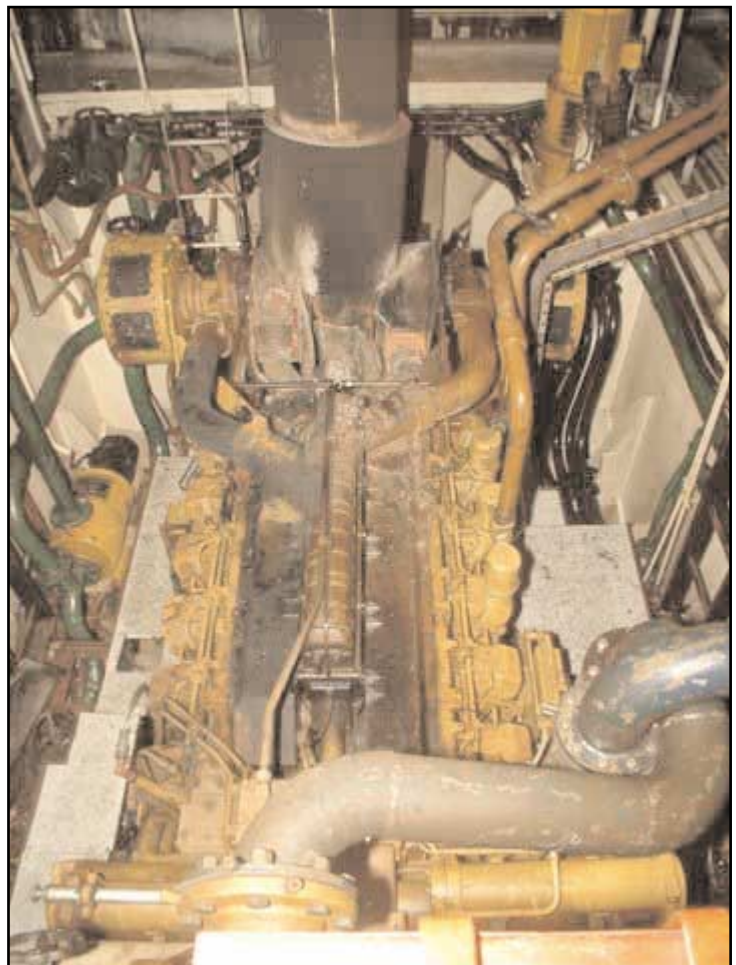
Figure 6

Main engine showing heat damage

The fire damage was concentrated above the rear of the main engine above the turbo chargers. The extent of damage in this area indicates that the seat of the fire was probably the hot exposed surface of the exhaust gas manifold.

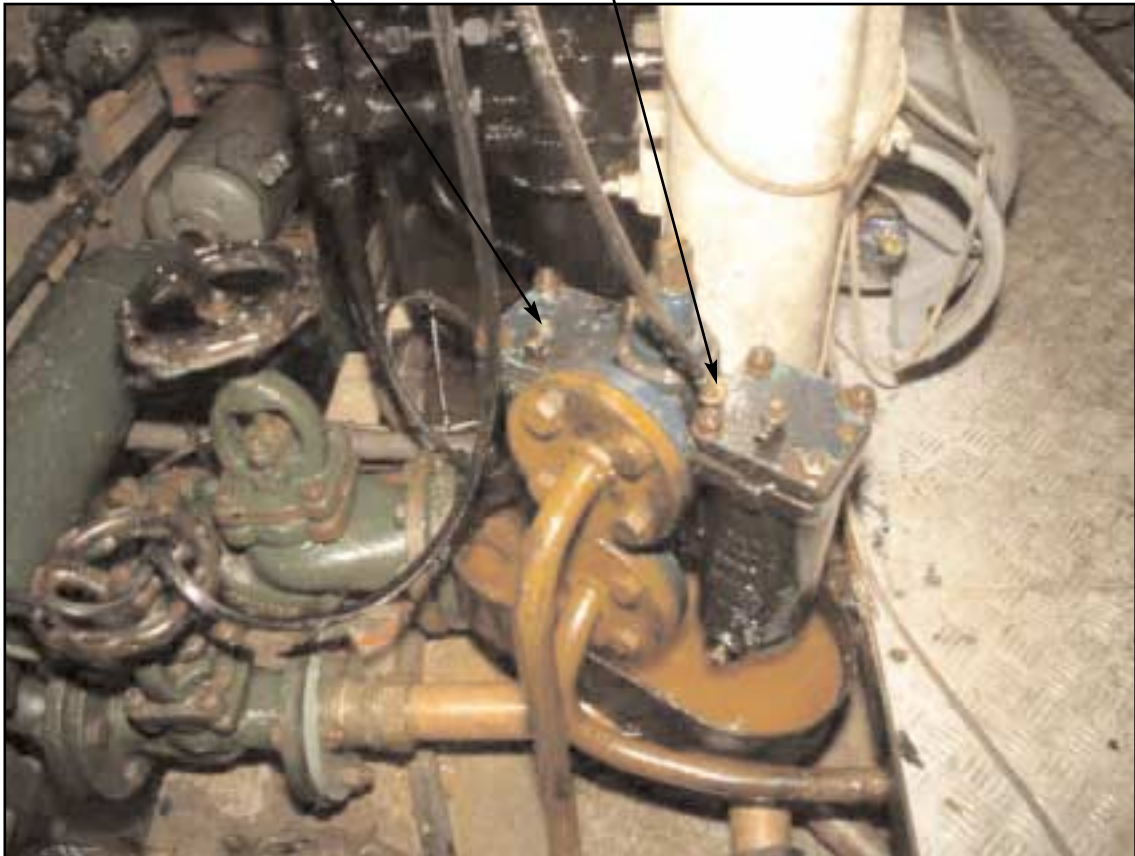
Figure 10

When, subsequent to the fire, the skipper and engineer entered the engine room, they saw fuel discharging from a missing ventilation plug on the after duplex filter. The filter was situated about 1 metre aft, and slightly to starboard of the rear of the main engine.

The ventilation plug on the after duplex fuel oil filter probably became loosened by the continued impact of the brass connection of a refrigerant charging hose. This was suspended above the plug, and swung freely under the influence of the rough sea conditions (**Figure 10**). Once loosened, the combination of vibration, and further impact with the charging hose, finally caused the plug to come away from the filter top, dropping into the scaveall under the filter, where it was later found. The threads of both the plug and filter top were found to be in good condition. There was nothing to suggest that the plug had been removed intentionally.

Missing ventilation plug
Swinging refrigerant
charging hose connection

Main engine duplex fuel oil filter arrangement

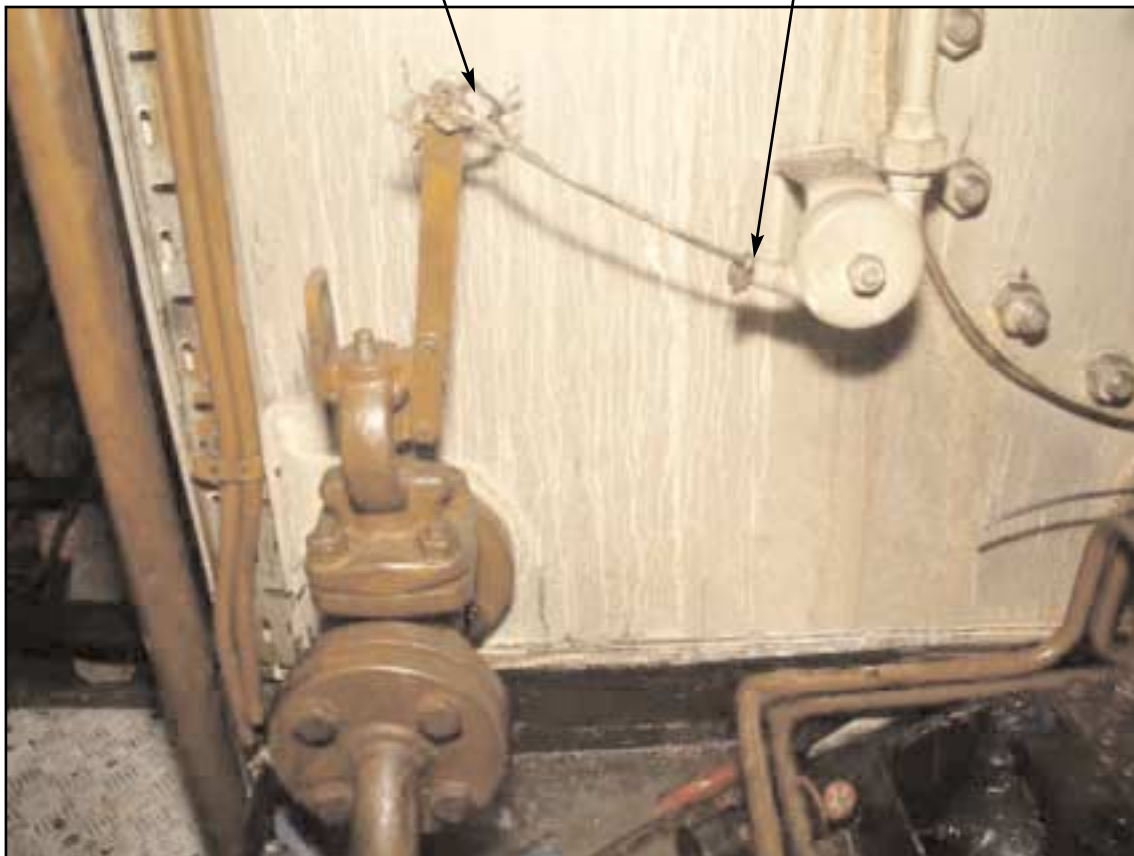
Figure 11

Slack securing clamp

Daily tank quick acting fuel oil shut off valve arrangement

There was no evidence to show, and none of the crew were able to identify, the last time the fuel valve emergency operating arrangements had been tested. In this case, the main engine and generator continued to run, but none of the crew appreciated that this was because the fuel had not been isolated. It was not until late into the incident that the engineer stopped the main engine from the wheelhouse position.

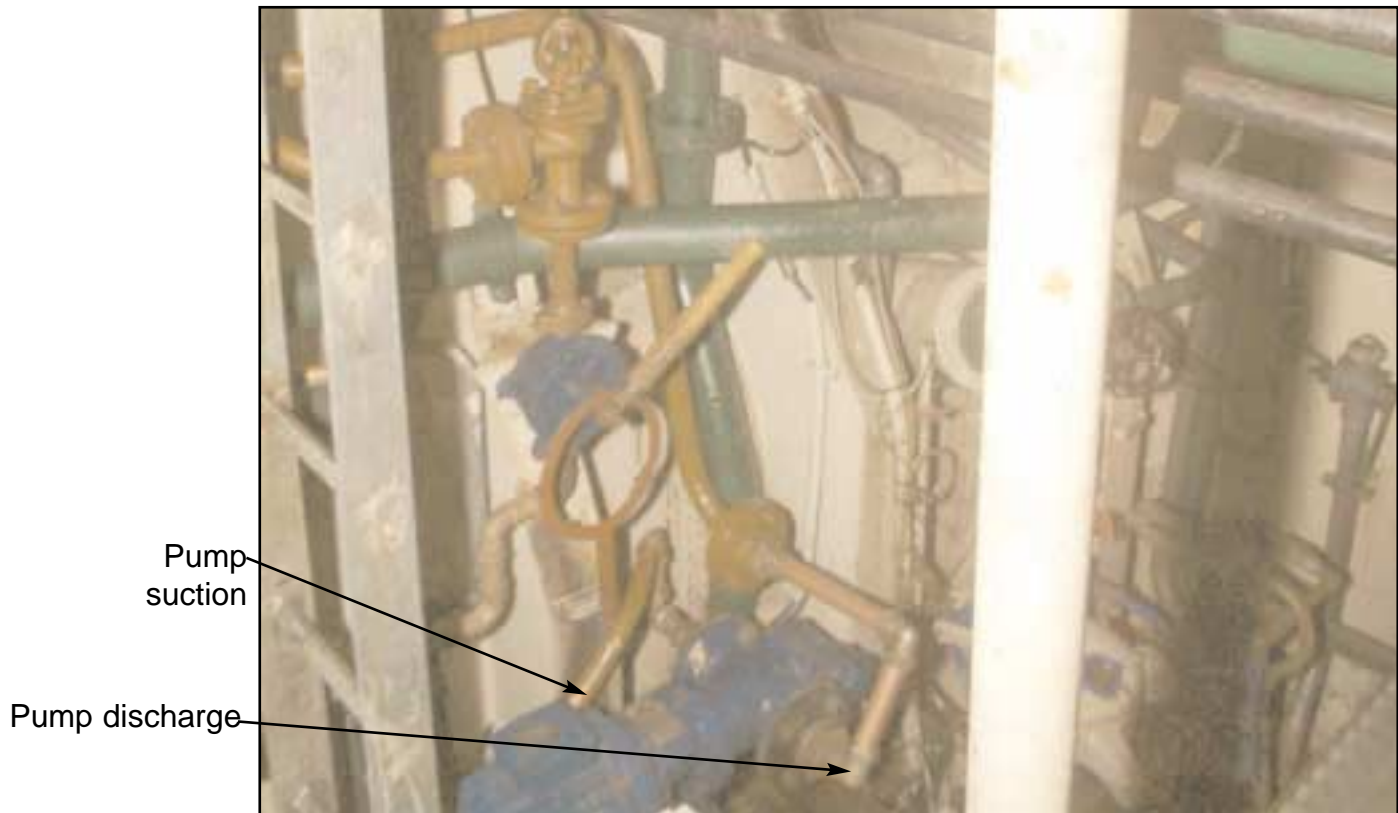
Figure 12

The skipper confirmed that when he started the pump there were no obvious leaks, and that he took special care to check the main engine fuel filter ventilation cocks to ensure that they were tight and leak free.

Fuel oil transfer pump pipework arrangement

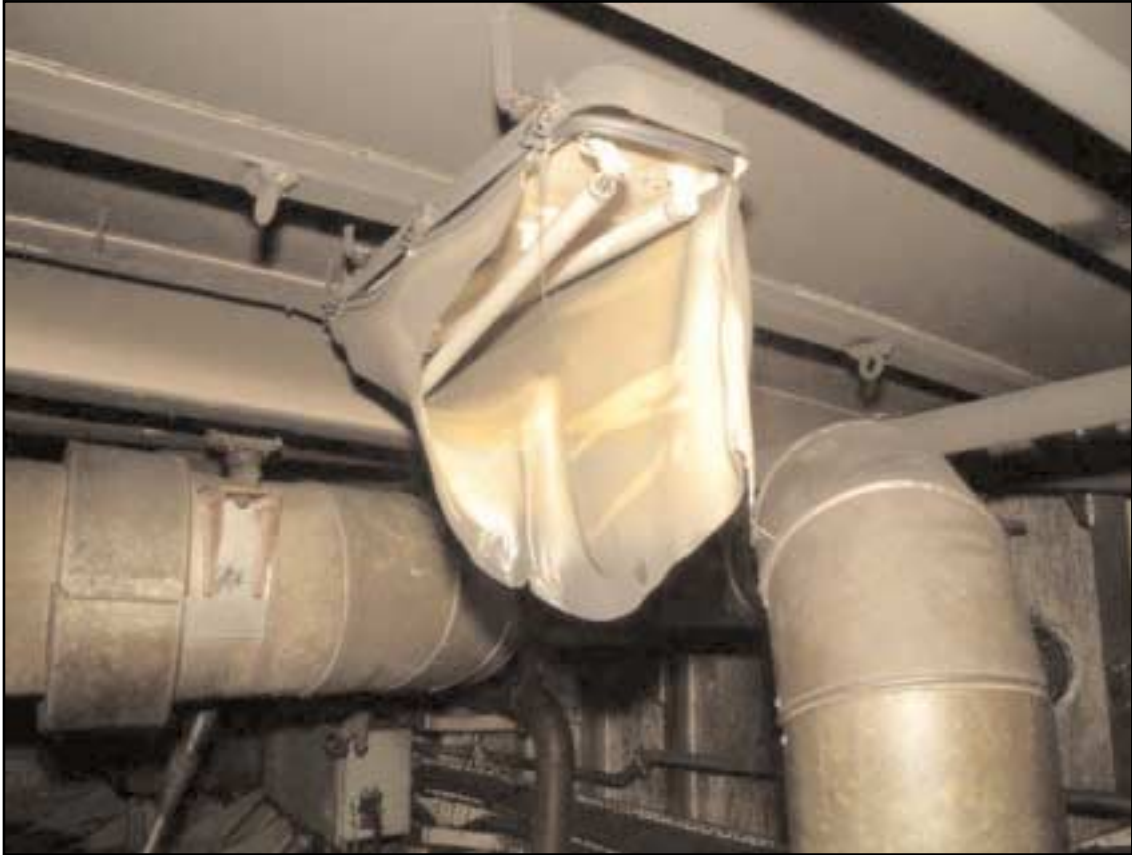
There was considerable heat damage to the pipe insulation and paintwork directly above the engine centreline and to the adjacent ventilation supply trunking. The heat detectors and light fittings sited near the engine had also melted.

Melted light fittings

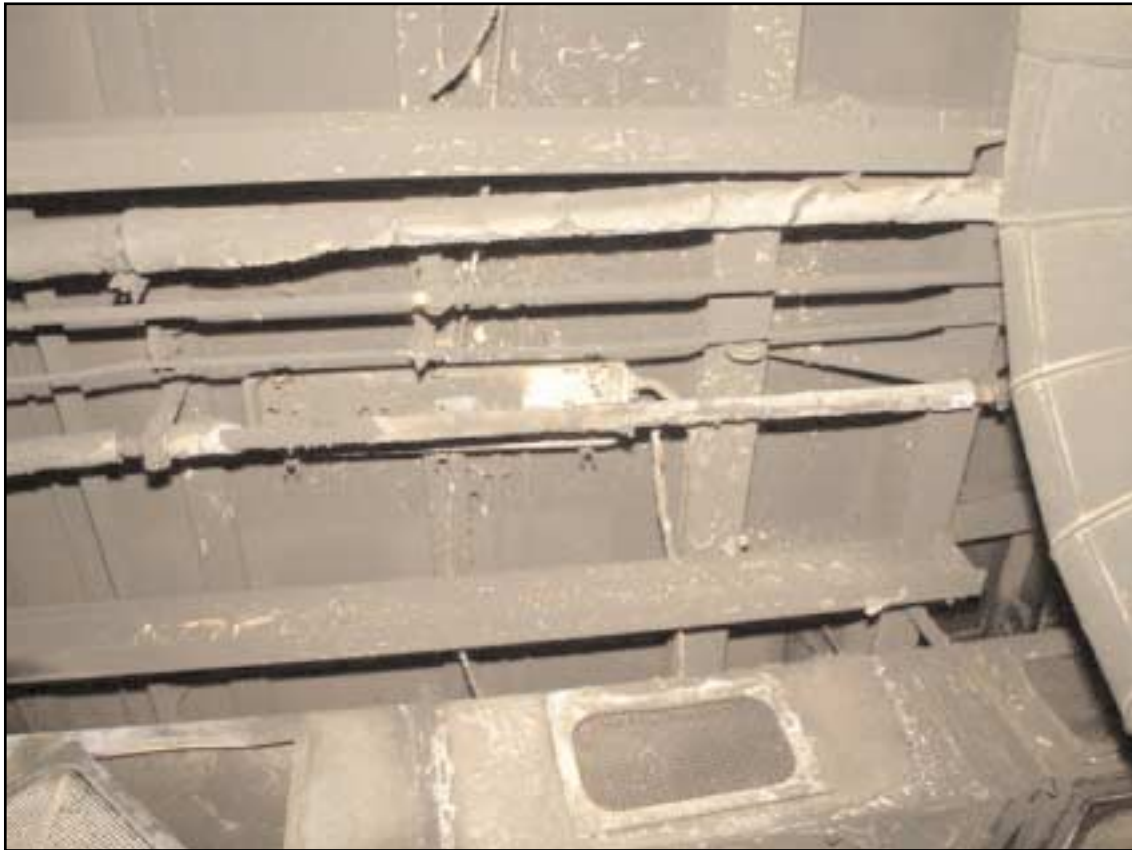
Deckhead and lagging damage

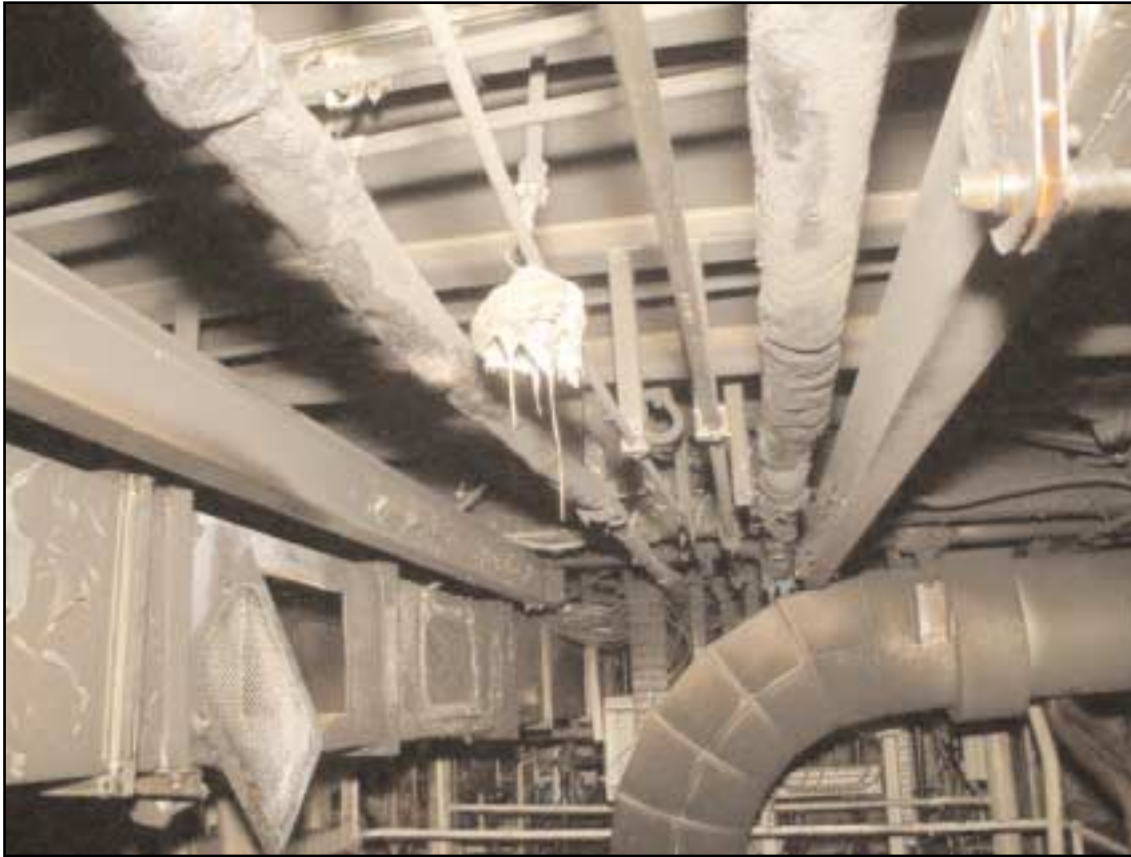
Ventilation trunking and smoke detector damage

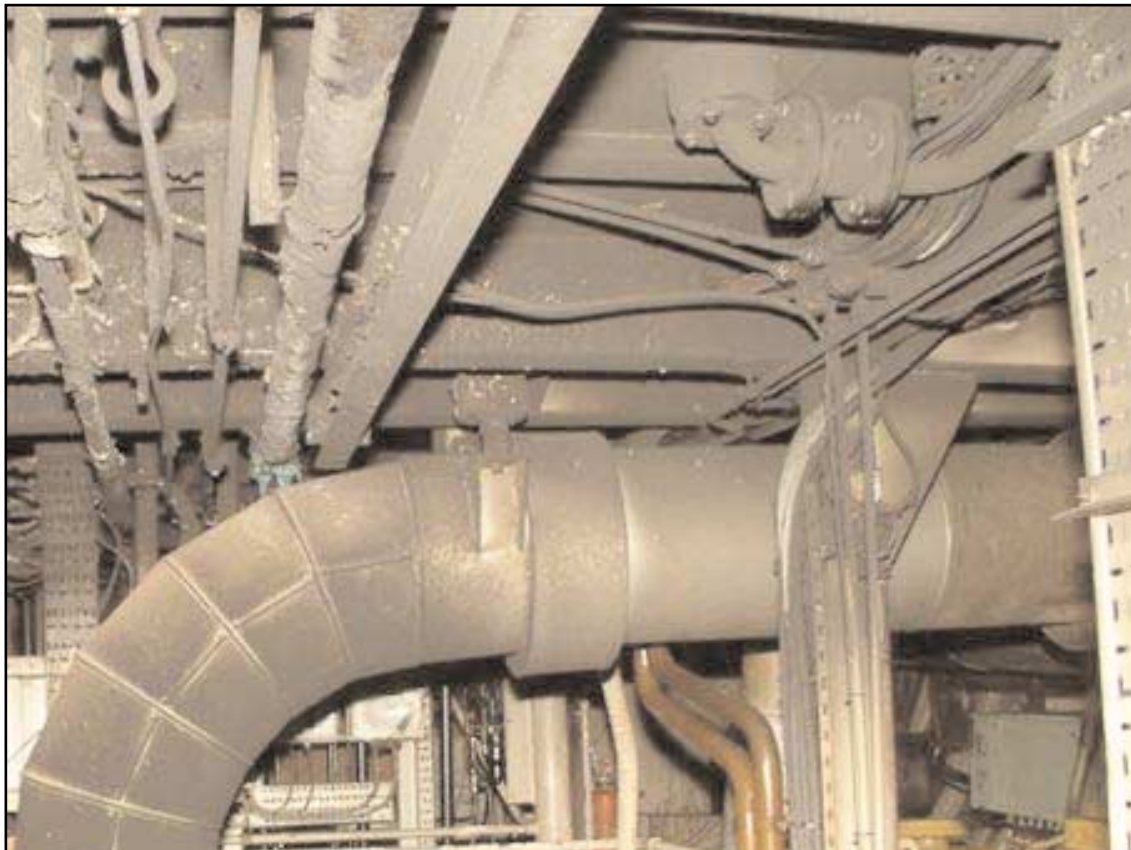
The upper areas of the engine room suffered extensive smoke damage. It extended from a line about 1½ metres above the bottom floor plate level to the deckhead.

General deckhead damage
