Report on the investigation
into the near collision between
Hoo Finch and ***Front Viewer***
off the River Humber
on
25 February 2004

Marine Accident Investigation Branch
First Floor
Carlton House
Carlton Place
Southampton
United Kingdom
SO15 2DZ

Report No 10/2004
August 2004

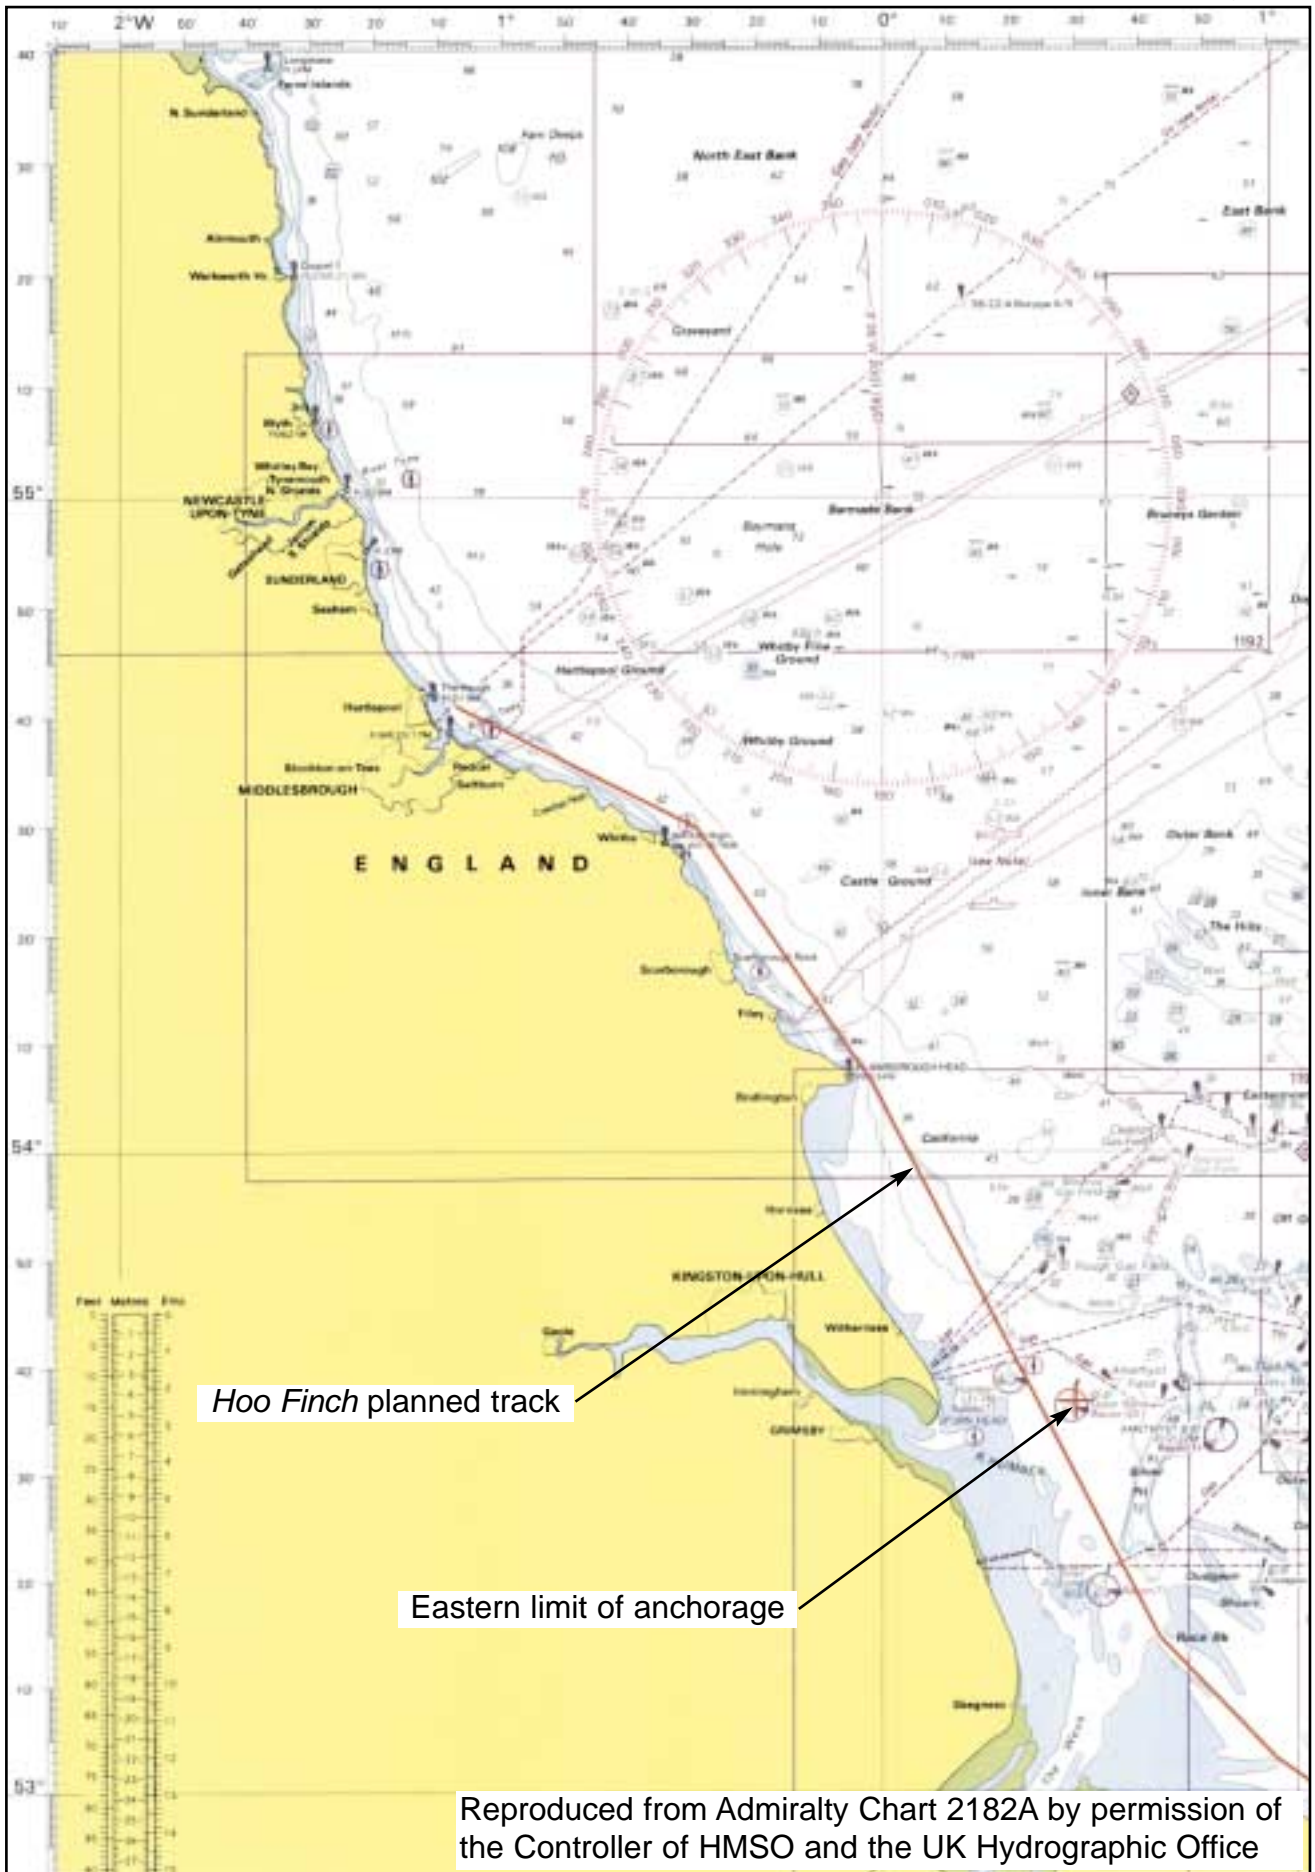
The vessel altered course off Flamborough Head at about 0150 on 25 February. The new course, about 153° towards the next way point off the Wash (**Figure 3**), took the vessel through the Humber deep water anchorage. The mate felt tired during his watch. He spent periods sitting in the bridge watchkeeper's chair (**Figure 4**), but he had to frequently get up and walk around to keep himself awake. The bridge watch alarm was operational and required acknowledgement every 20 minutes.

Chart showing *Hoo Finch's* planned track

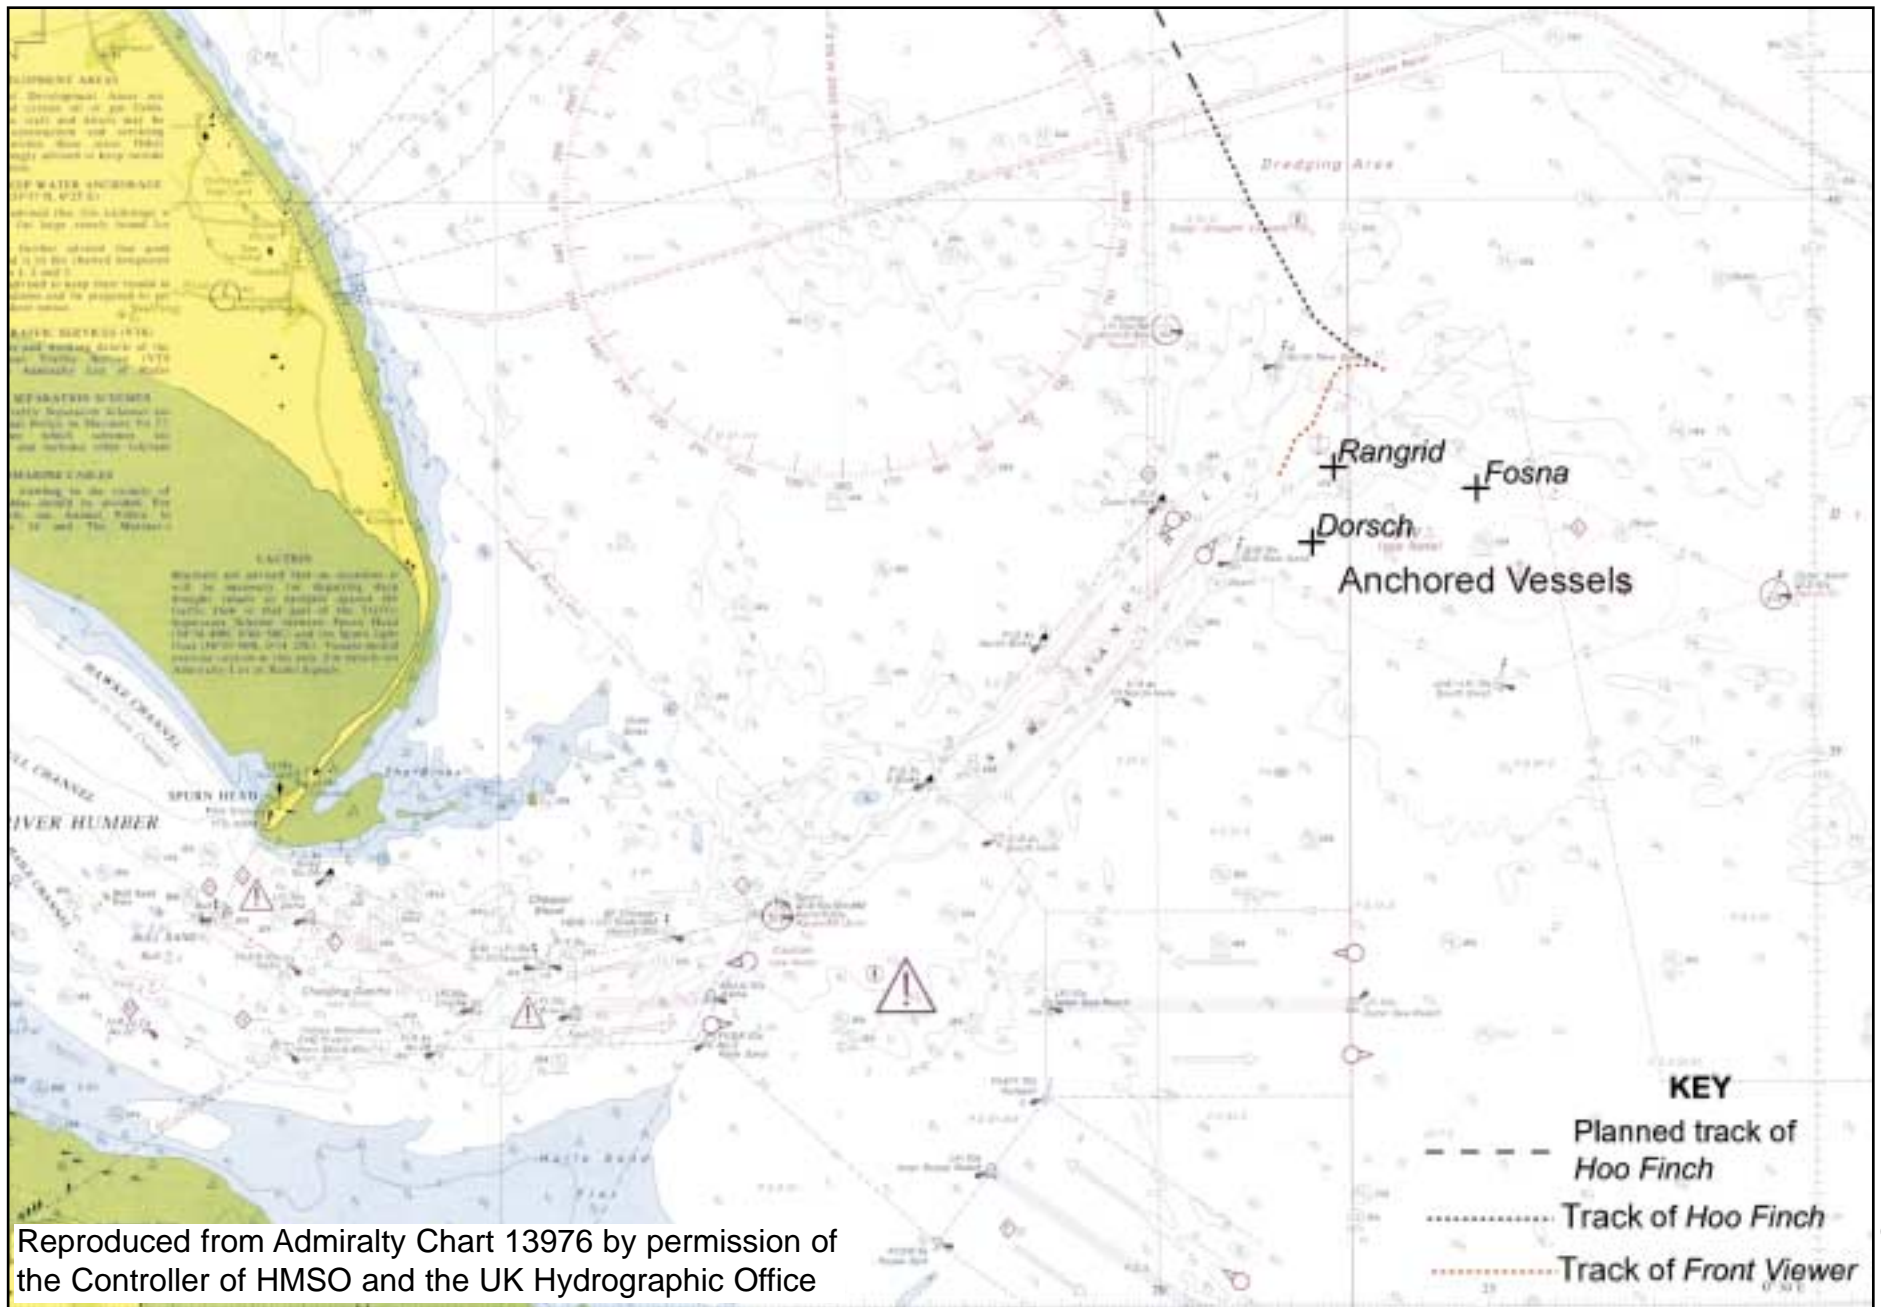
Figure 5

Chart showing tracks of *Hoo Finch* and *Front Viewer*

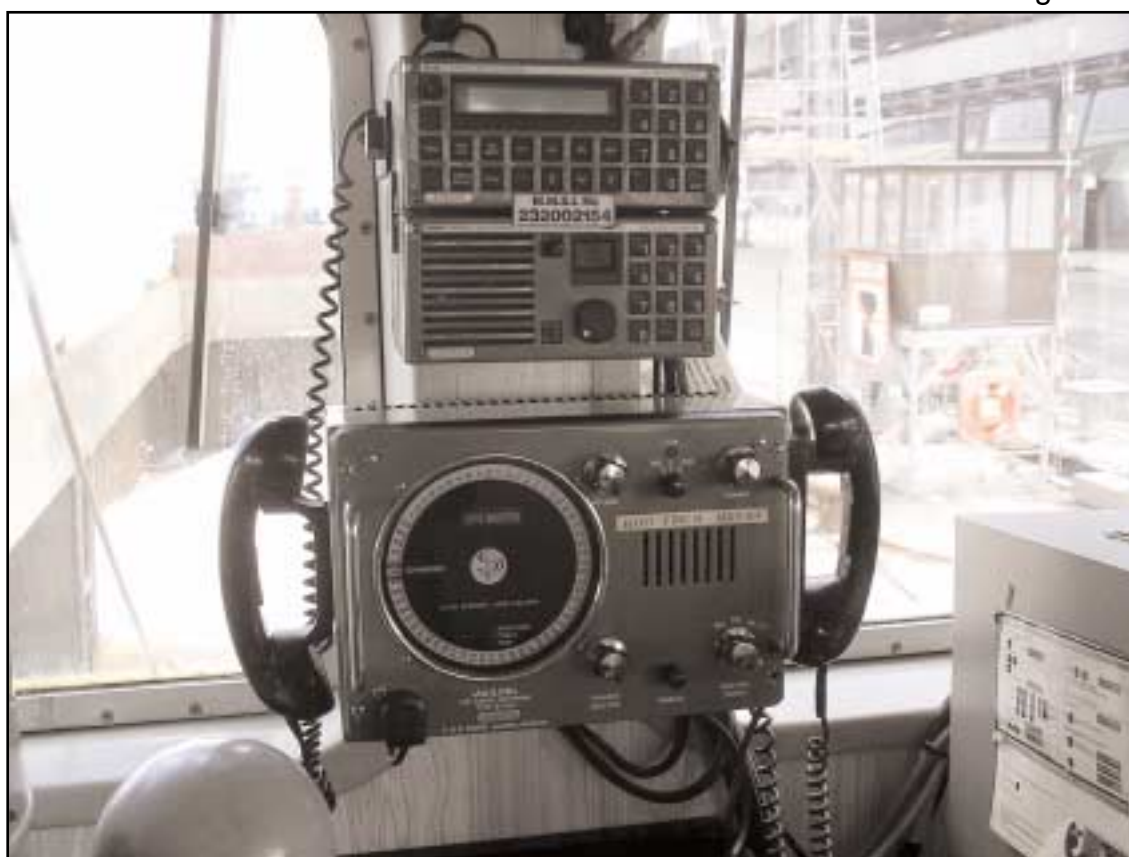
Figure 15

There was an intermittent fault with the handset of the lower radio. The press to transmit switch on the handset did not always make electrical contact. The crew were not aware of this fault at the time of the incident. It was discovered by the regular master during his next period of duty. Once the problem had been found, it was immediately rectified.

Photograph of the two VHF radios on the bridge of *Hoo Finch*
