Report on the investigation of
the failure of the starboard bow door on

Pride of Provence

at Calais

**Report No 16/2004
December 2004**

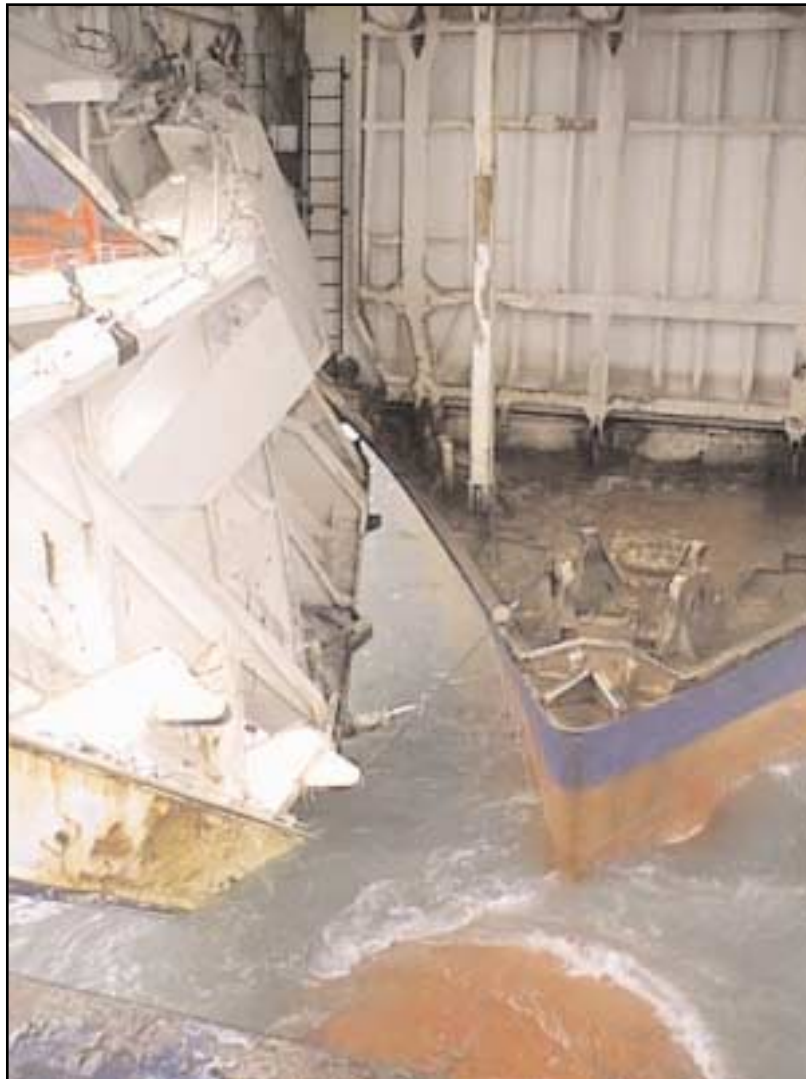
Figure 2

As soon as the operating lever for the hydraulic rams was moved to the door closed position, the starboard outer bow door upper hinge failed.

The failure of the upper hinge caused the 20 tonne weight of the bow door to bear on the hydraulic operating cylinder and the lower hinge bearing assembly, which distorted. The door came to rest against a transverse section of the “cowcatcher”, with the lower part of the door submerged about a metre in the water (**Figure 2**). Additionally, the vessel had sustained some local minor damage to her structure.

View of damaged starboard bow door

The following day, the starboard bow door was lifted back into position and the fractured hinge plate re-welded and braced. Using the hydraulic cylinder, the door was then successfully closed and secured in position.

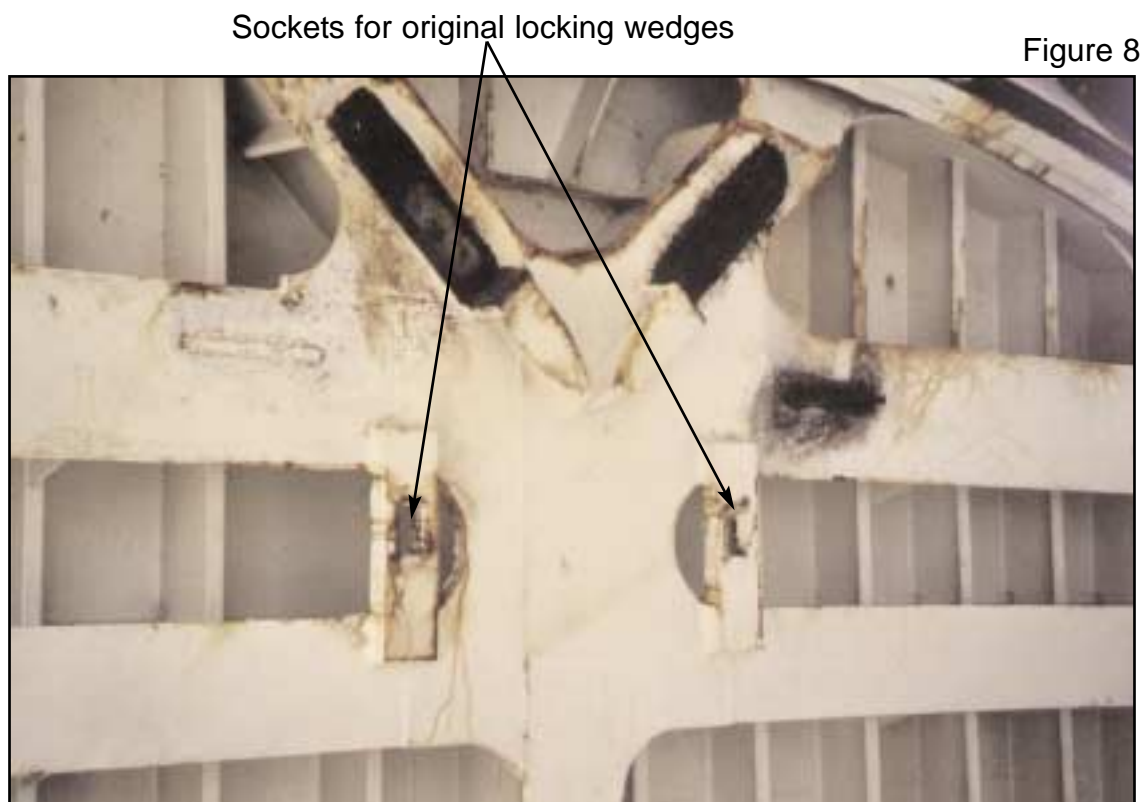
Outer bow door space deckhead showing sockets for original locking wedges

Early in the vessel's life, and possibly as a result of the damage sustained in 1984, the three locking wedges were removed. Anecdotal evidence suggests that the removal of the wedges was carried out because of difficulties in opening the bow doors. The locking wedges, on the same hydraulic circuit as the centreline cleats, had tended to open after, instead of before, the cleats. This resulted in the door seal compression load being released onto the locking wedges, which then became stuck. There are no survey records that refer to the removal of these wedges.

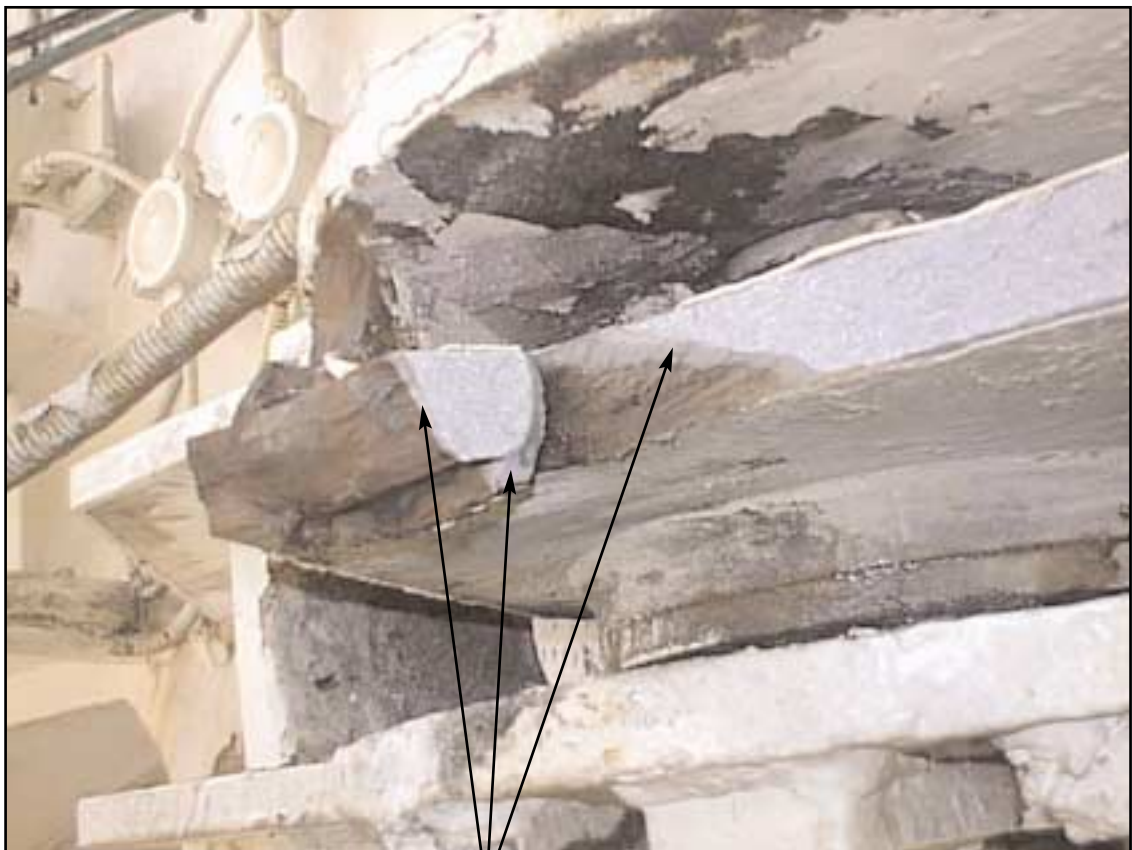
Figure 9

The upper hinge assembly on the starboard bow door connects the hinge arm, which is attached rigidly to the door, to the hull of the vessel. The upper hinge plate had fractured horizontally through the hinge plate, and vertically through the hinge plate stiffener (**Figures 9 & 10**). The darker, corroded areas, which can be seen adjacent to the fresh 'clean' fractures, indicate previous cracking.

Beach marks

Photograph of starboard upper hinge plate failure

The silver/grey crystalline areas are the fractures (**Figures 9 & 10**), which occurred at the time of the failure. The photograph was taken shortly after the incident, so the fractures had insufficient time to rust. The rusted areas show the cracks; these have been open for some time, allowing corrosion to occur.

The upper hinge assembly, which suffered the greatest damage, was totally renewed. The design of the new assembly was based on the port bow door upper hinge, effectively the original design with the addition of two stiffeners on the upper hinge plate. The material used was Lloyd's Grade A steel, as specified in the original construction drawings. Other work carried out included:

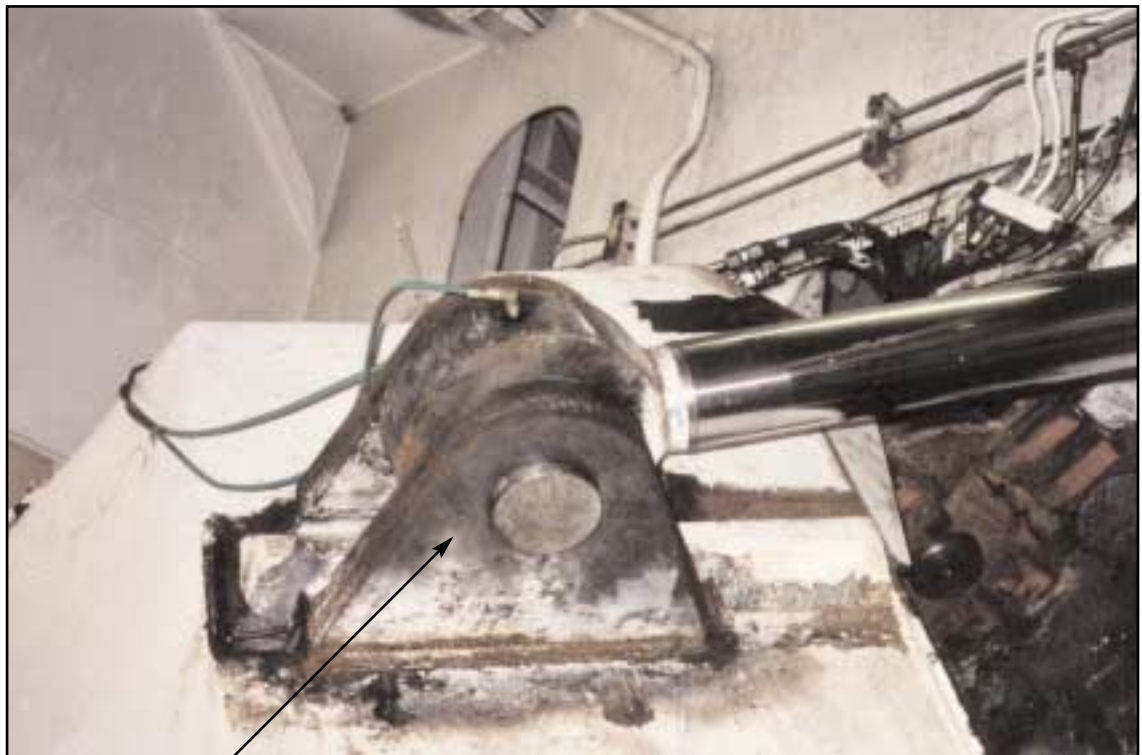
Figure 13

- Hinge bearing replacement on both doors;
- Alignment check on both doors;
- Strengthening the cheek plates for the starboard forward ram pivot due to ovality of the original cheek plates, and renewal of the hinge pin (**Figure 13**);
- Overhauling the rams including new spherical bearings on the starboard ram;
- Overhauling the hydraulic system, including the locking cleats;
- Non-destructive testing of the “cowcatcher” mounting points to the vessel’s hull.

Lower side doubler plate welded to original bearing cheek plate (matching arrangement on upper side)

Starboard operating cylinder for door attachment pivot bearing

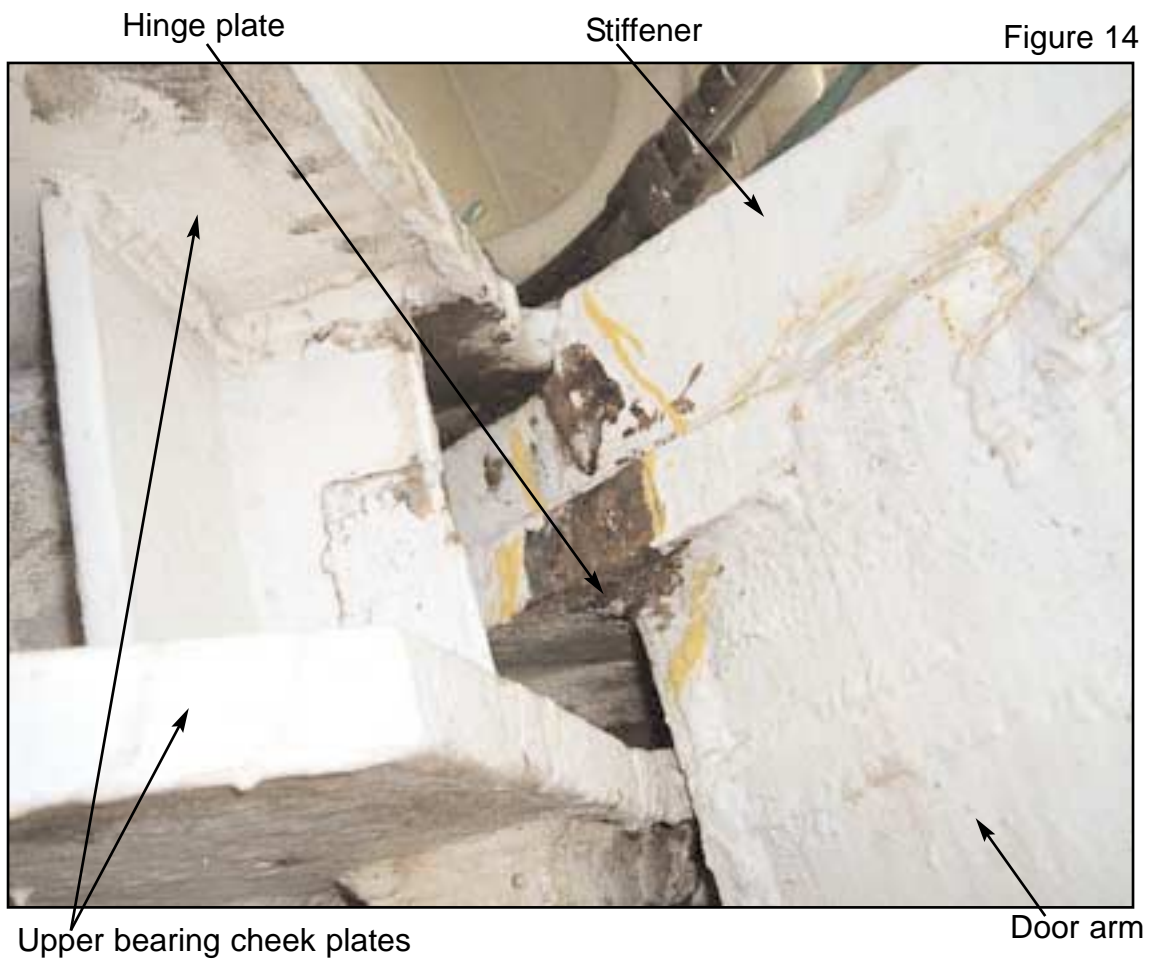
Shipboard engineers had discovered cracks in the starboard upper hinge plate on 16 February, during an investigation of a fault on the bow doors. Ship's staff estimated the cracks, which had propagated through the stiffener and part of the hinge plate, to be about 1mm wide (**Figures 14 & 15**).

Starboard door upper bearing hinge arrangement

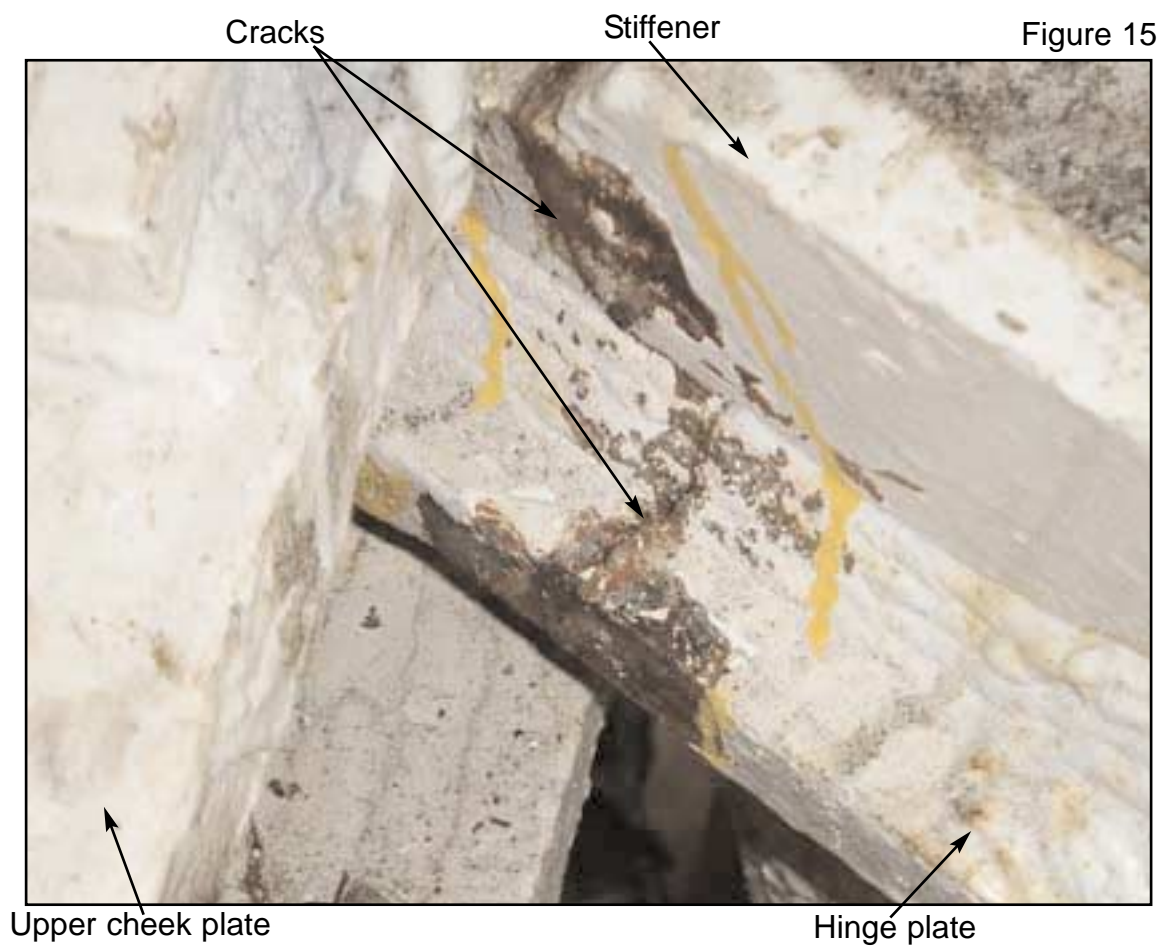
Starboard door upper bearing hinge in detail showing cracks

Figure 15 shows spike marks indicating that someone has attempted to chip the paint away from the cracks. The paint close to the cracks has chipped away because the paint had become separated from the steel. Corrosion of the steel is evidence of this separation. When steel is under high stress, which is less than the yield stress, it deforms elastically; such deformation would be enough to cause separation of paint coatings. The paint has separated close to the cracks, indicating that the steel in this area has suffered high stress levels.

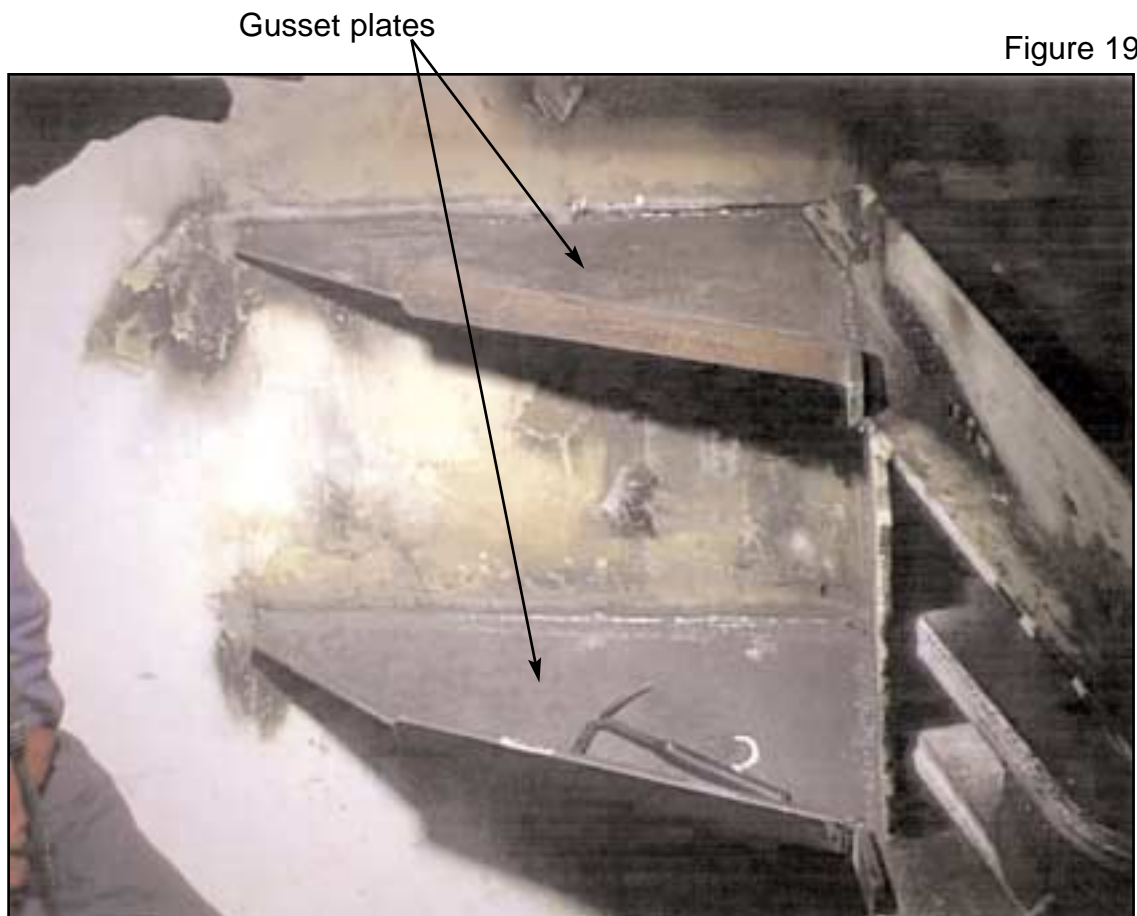
Since 2002, during the vessel's ownership by P&O Ferries, ship's staff carried out regular inspections for cracks in the bow space. Cracks in the brackets supporting the starboard ram aft pivot were noted in the planned maintenance records during a general inspection in October 2002. The cracks were weld repaired and additional gusset plates were added. No cracks were found on the port side.

Further cracking of the previous weld repairs was reported on several occasions in the planned maintenance records. Further repairs to the starboard ram aft pivot support were undertaken. Whenever cracks were identified by ship's staff, they were measured, photographed and the technical department ashore was informed before the cracks were repaired by welding contractors.

No cracks were found around the starboard ram aft pivot support for over a year, but the problem reappeared after this incident on 22 February 2004. On 15 June 2004, *Pride of Provence* was removed from service, and the starboard operating ram aft pivot support structure was further strengthened and the gusset plates were renewed (**Figure 19**).

Replacement gusset plates at collision bulkhead for starboard bow door operating ram

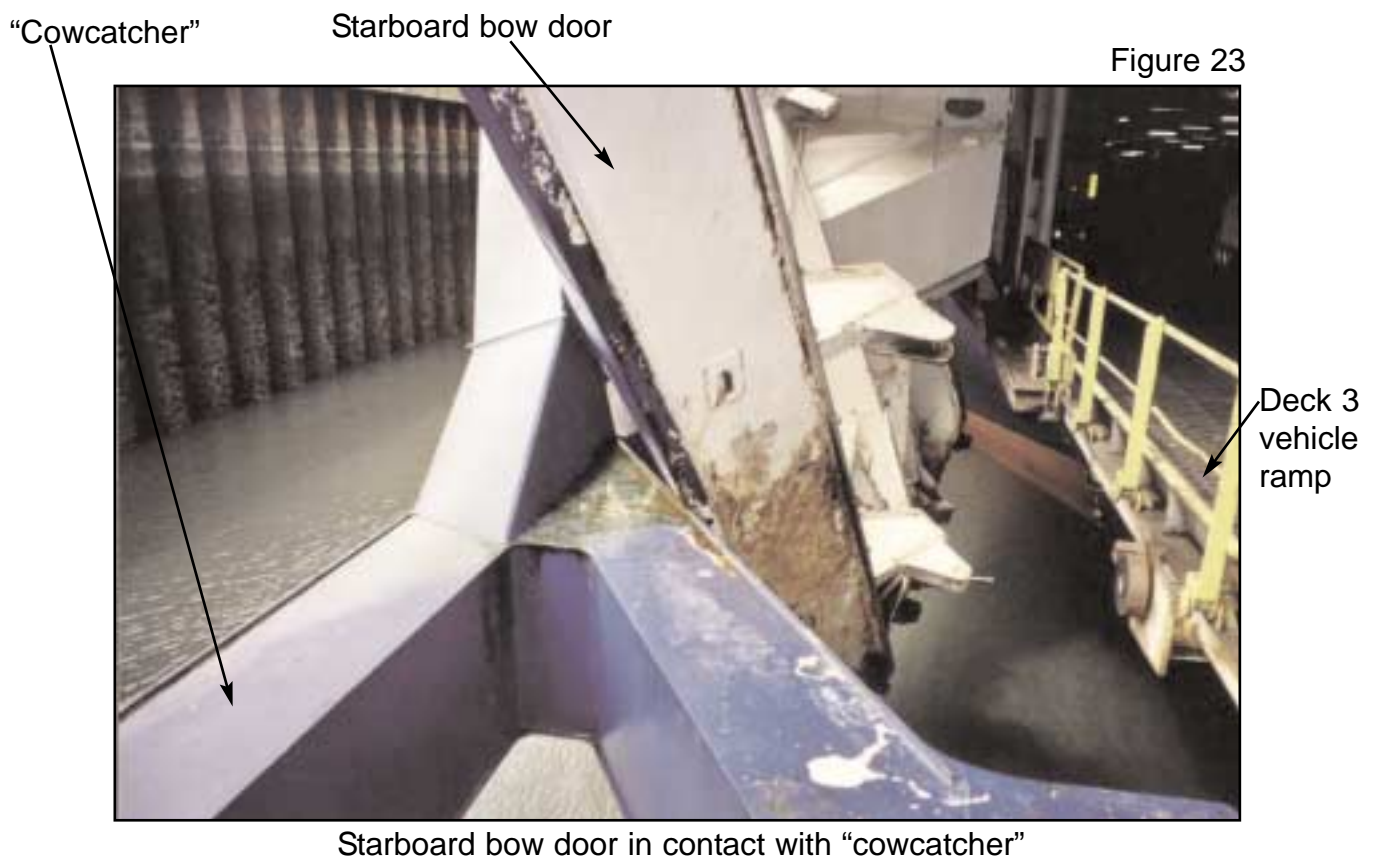
The first record of cracking in the structure around the aft pivot of the starboard hydraulic ram was in October 2002. Cracking would not necessarily have been immediately apparent once the starboard door started contacting the “cowcatcher”, but, if these structural problems began in 2002, it is unlikely that the contact was present as far back as 1996; it is more likely to have started around 1999 or 2000. The starboard door would have been opened in the region of 7,000 times since 1999/2000, and the hinge plate would have experienced this number of stress cycles. In respect of fatigue, this is not a high number of cycles. Corrosion would have hastened the propagation of the cracks and, hence, the failure.

Figure 23 shows the starboard door contacting the “cowcatcher” on 26 May 2004, which was after the hinge plate had been repaired. Structural problems persisted with the aft pivot of the hydraulic ram until July 2004, when the stroke of the hydraulic ram was shortened.

Starboard bow door in contact with “cowcatcher”

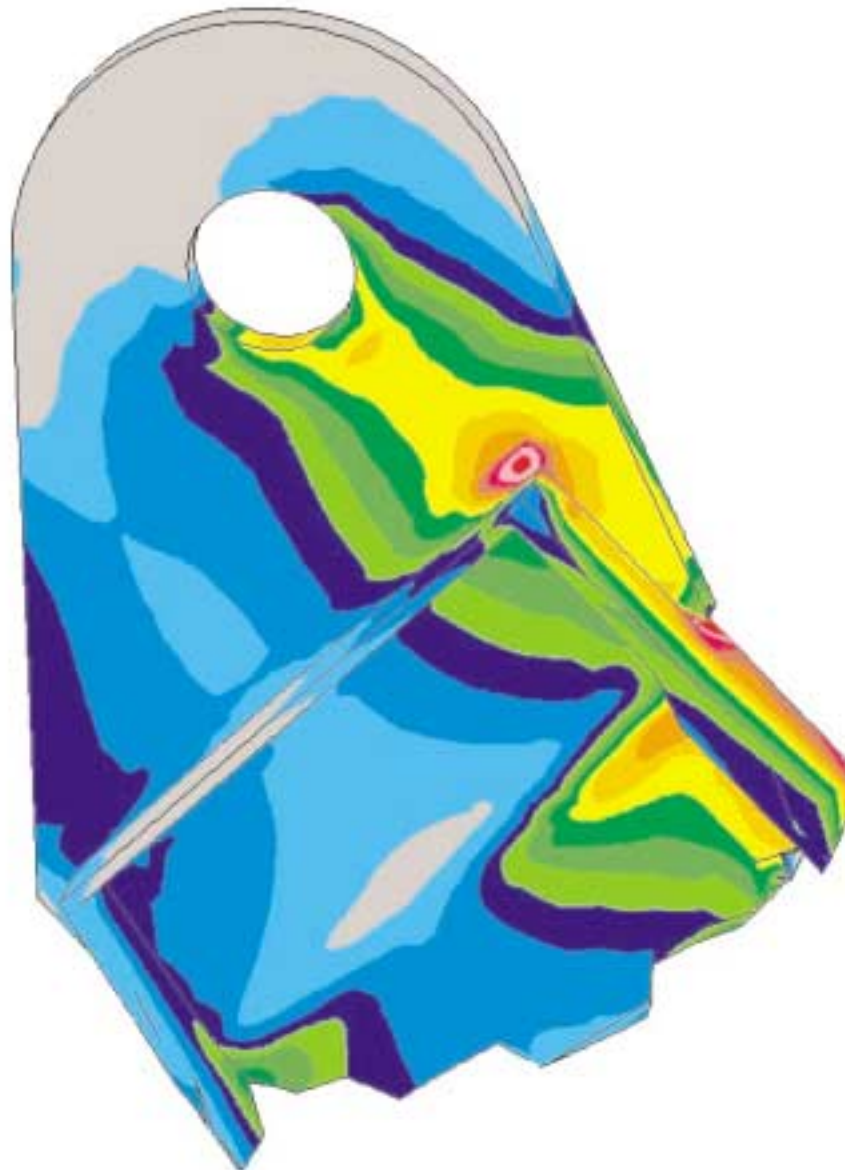
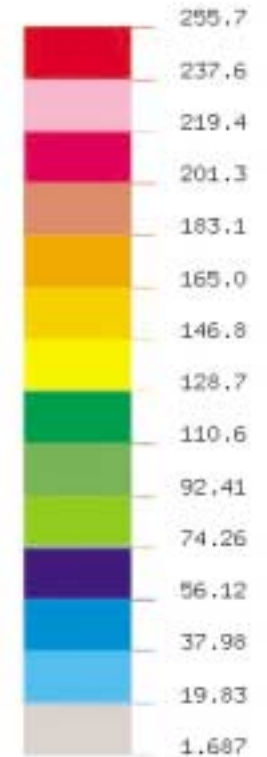
Finite stress analysis of starboard upper bearing hinge plate

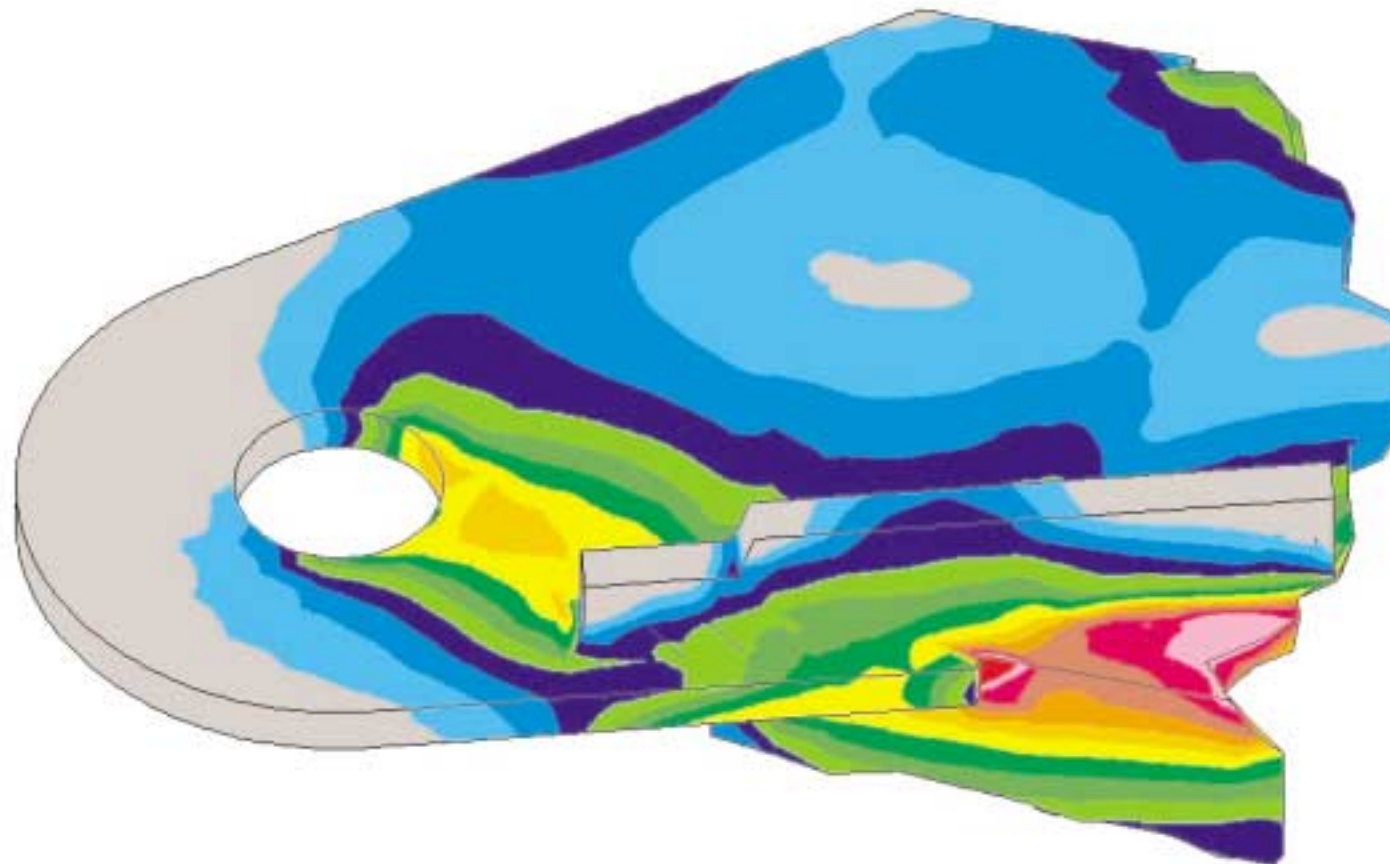
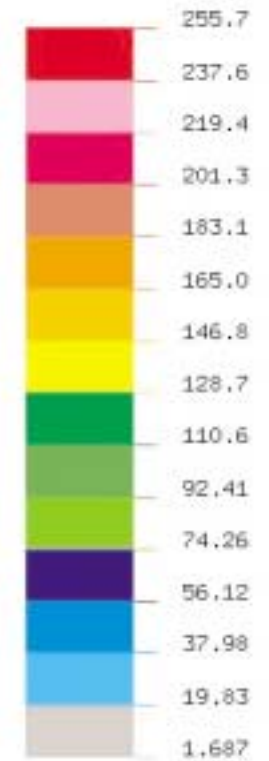
Finite stress analysis of starboard upper bearing hinge plate and stiffener
