Report on the investigation of
contact with Number 16 buoy by

Scot Venture

Drogden Channel, Denmark

**Report No 11/2004
September 2004**

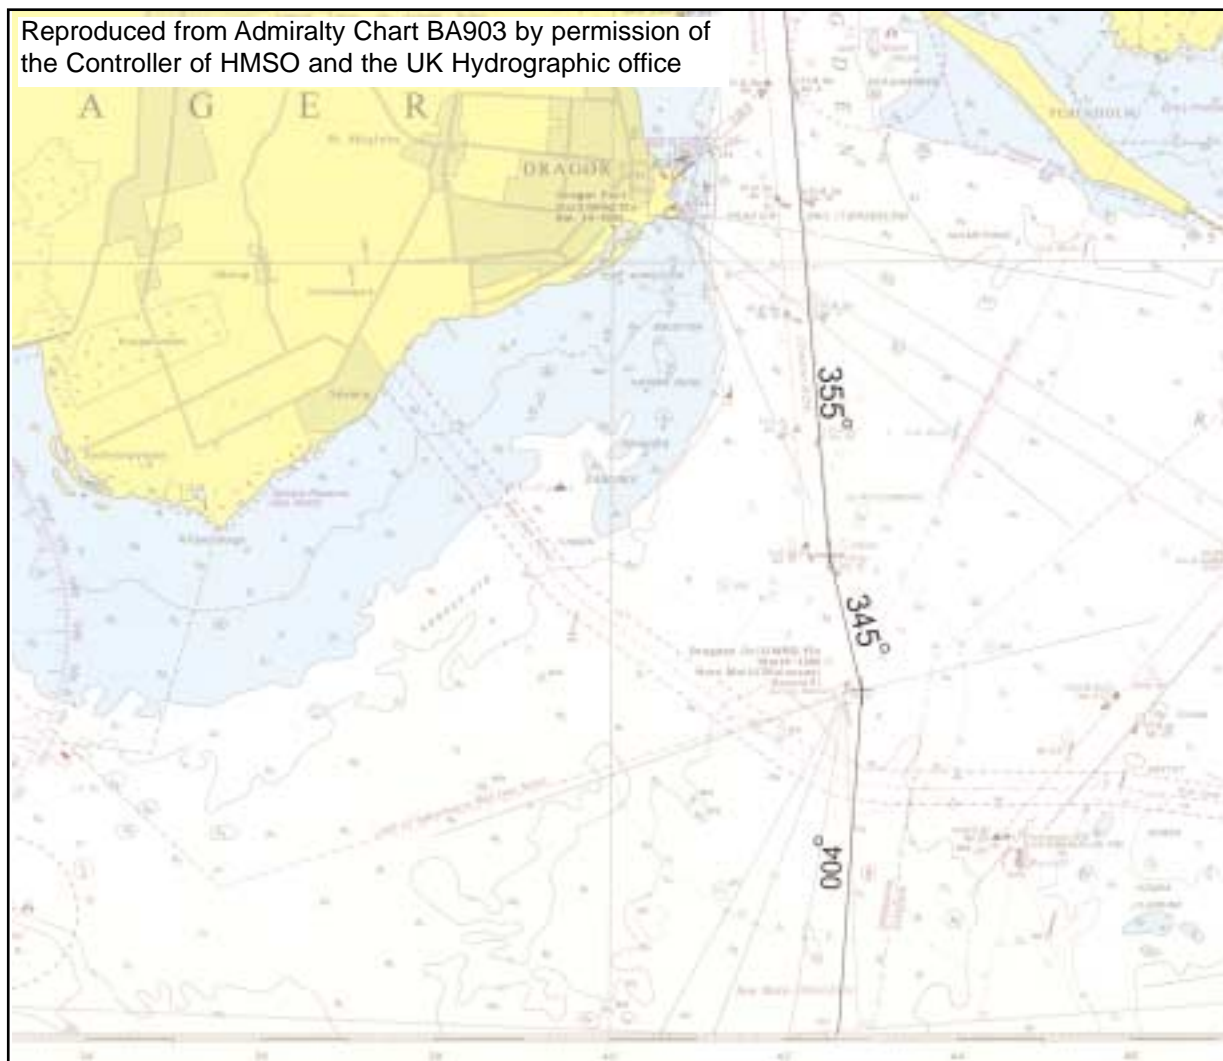
Extract of chart BA 903 showing the planned passage through the Drogden Channel

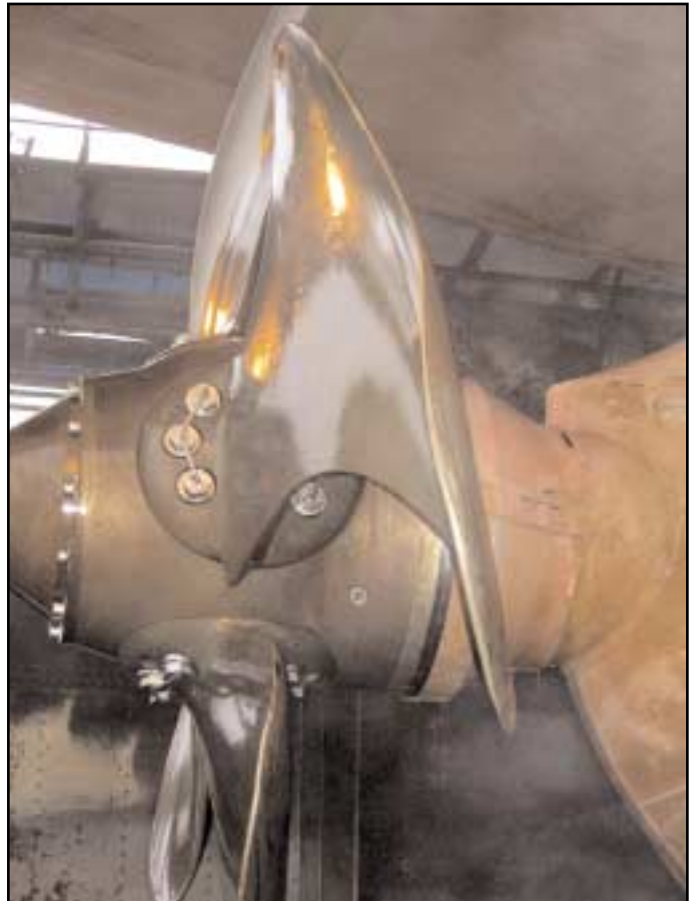
Figure 3

On arrival in Malmo at 1800, an underwater inspection by divers revealed that the ship's propeller blades were distorted. The master immediately informed Lyngby Radio that the vessel had hit a submerged object in the Drogden Channel.

Scot Venture was later towed to Valkenburg, where she was dry-docked for repair. Damage to the propeller was confirmed (**Figure 3**) and marks were evident along her starboard side (**Figure 4**), which were consistent with the vessel having made contact with the buoy.

Photograph of the damage to the propeller blades

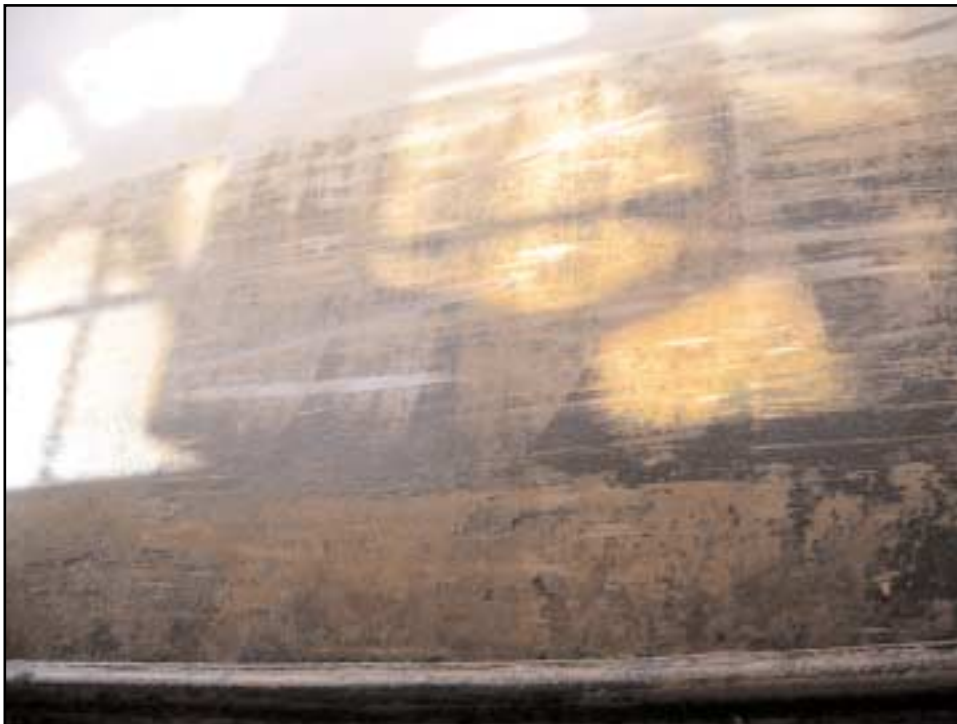
Figure 4

Photograph of marks to ship's starboard side

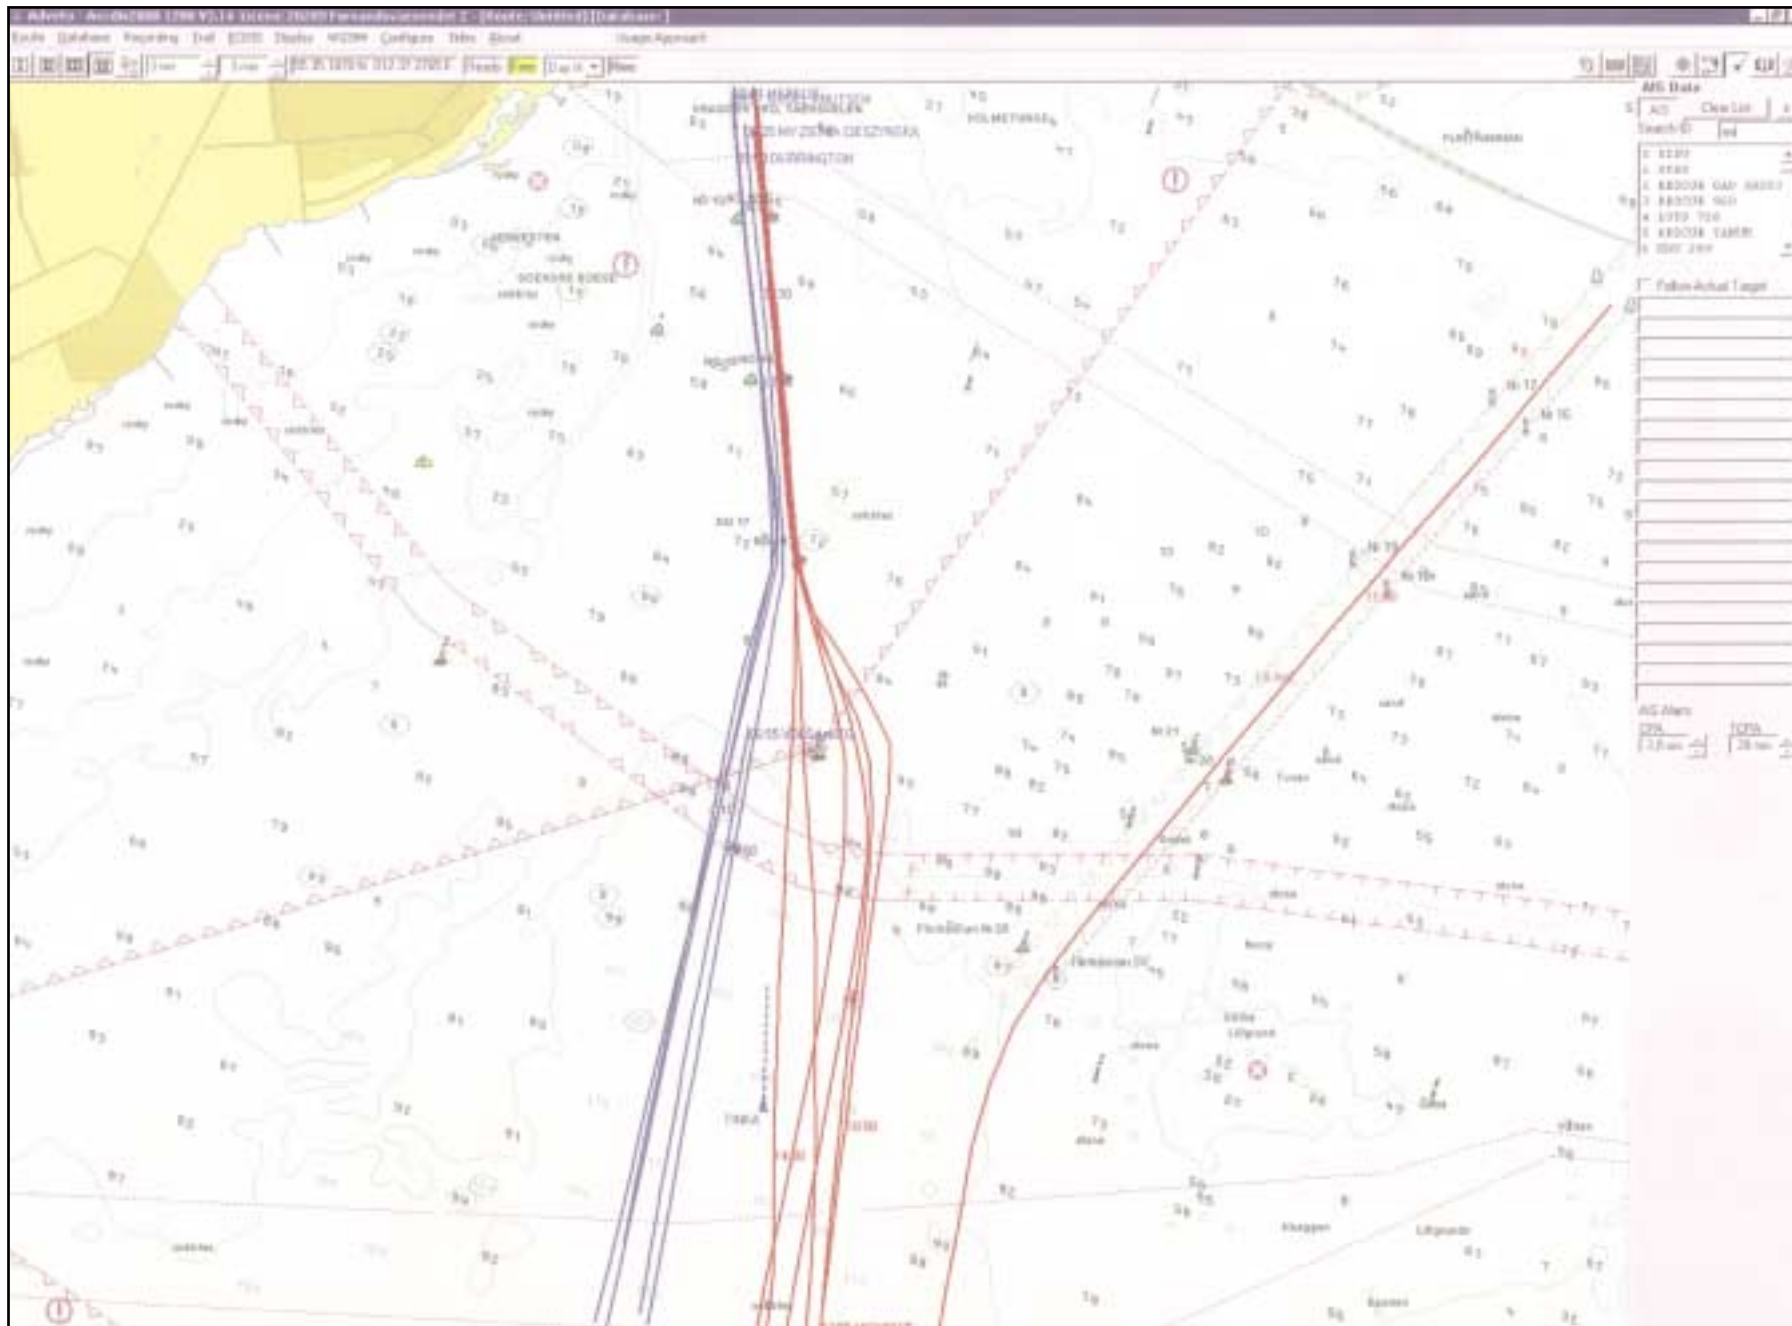
Figure 6

Extract of AIS plot

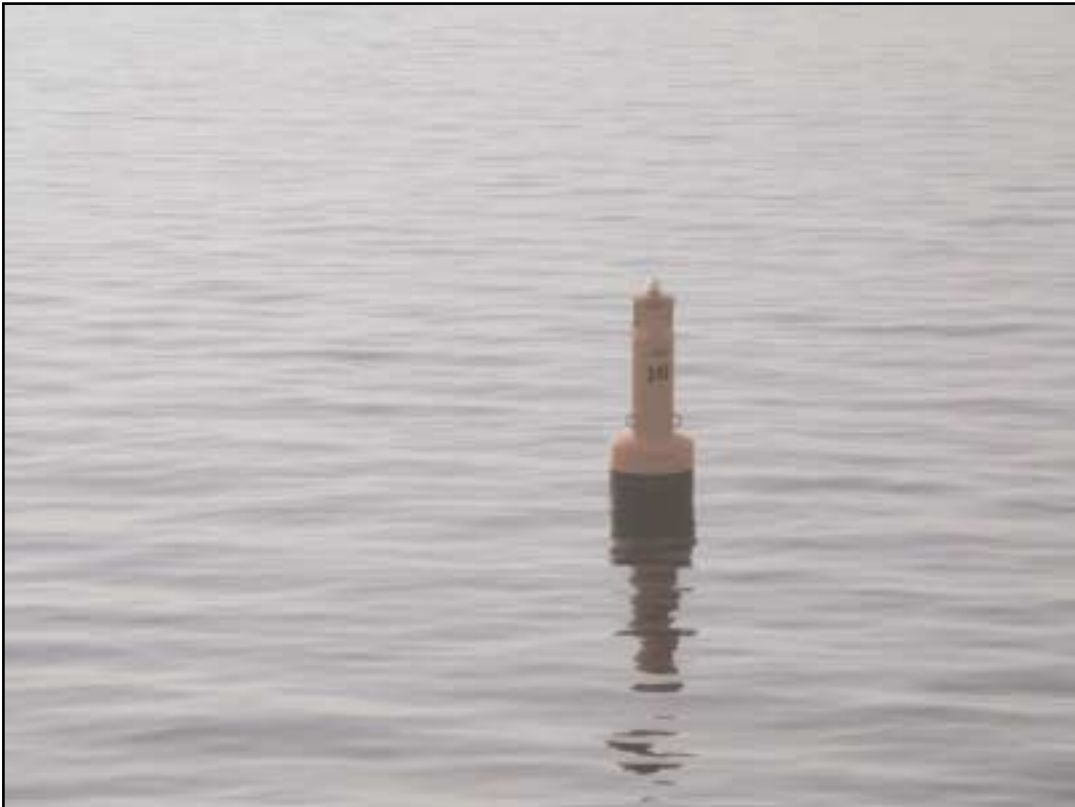
Following the accident on 29 January, the keeper of Drogden Lighthouse reported that the light on Number 16 buoy was not working, and that the buoy had become detached from its mooring. The buoy's mooring was found to be in its correct position.

Number 16 buoy is 7m in total height, with about 3.2m being above the waterline. A photograph of the buoy is at **Figure 7**.

Photograph of Number 16 Buoy
