Report on the investigation of
Nottingham Princess
striking Trent Bridge Nottingham
on 15 November 2002

Report No 21/2003
August 2003

On 15 November 2002, during an evening river cruise, the river cruiser *Nottingham Princess* collided with repair scaffolding around the centre arch of Trent Bridge, Nottingham.

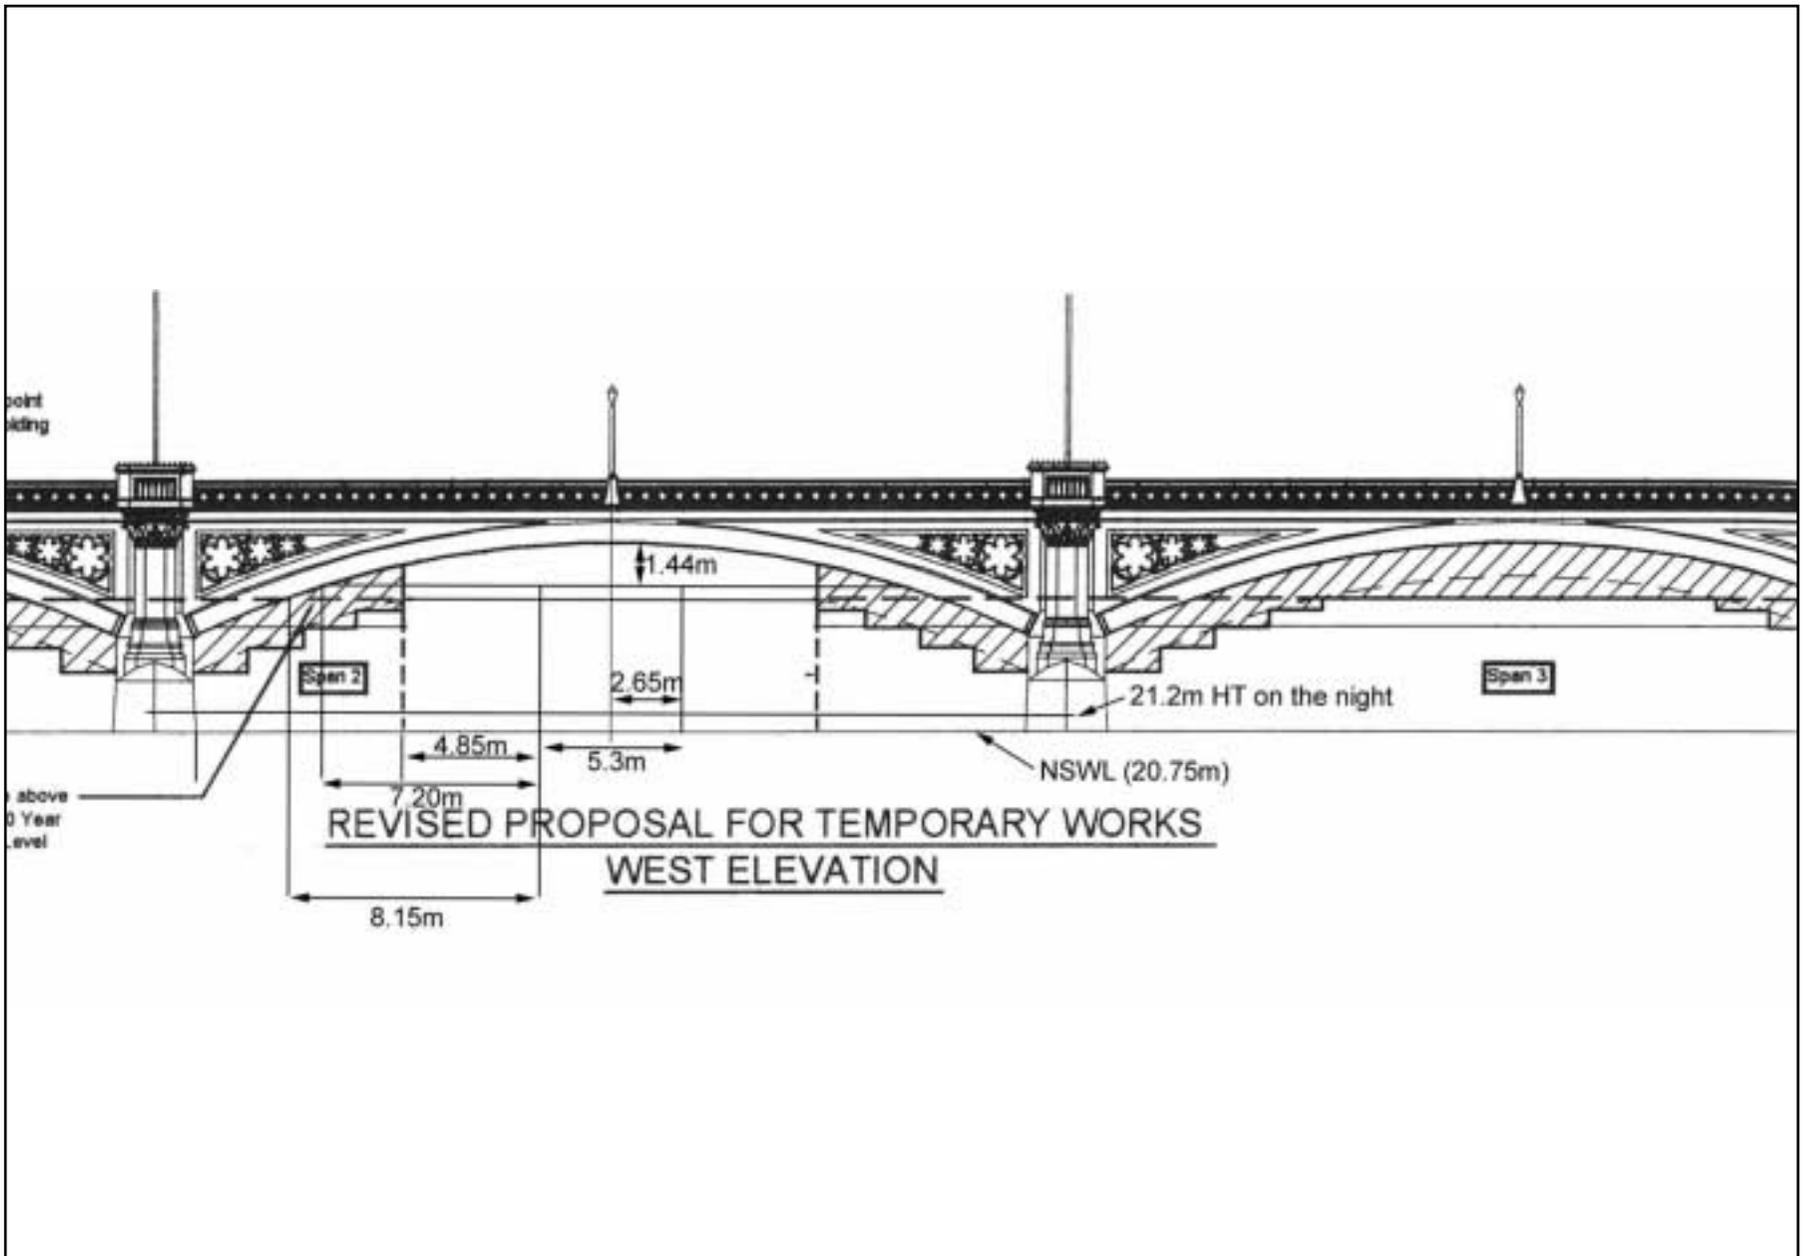
Figure 2

Because of the vessel's air draught, the maximum river level datum the vessel would attempt to pass under the bridge was 21.4m. This is 0.65m above the normal summer water level of 20.75m and normally gave a clearance of just over a metre in the centre of the arch. She could pass under about 77% of the arch, until the curvature of the arch was such that the clearance was insufficient (**Figure 2**).

Centre span from the west

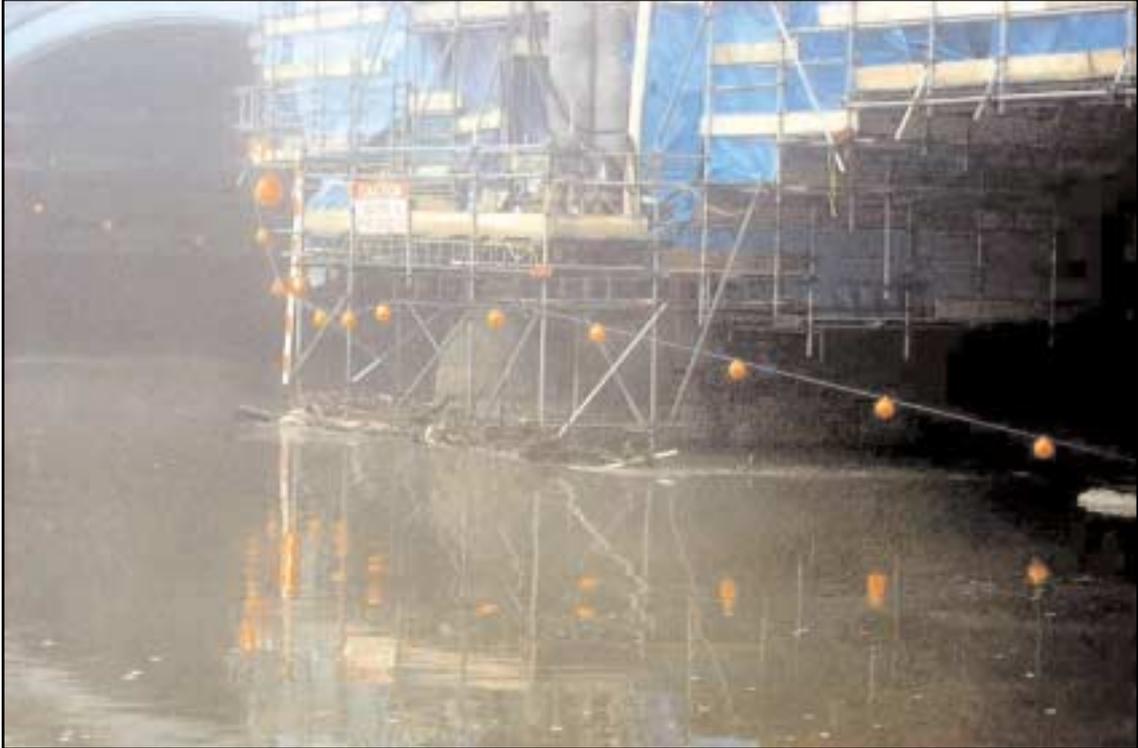
BW and the council had a period of consultation in early 2002 regarding navigation issues and river users. On 1 February 2002, the council informed *Nottingham Princess's* owners of the intention to paint the bridge during the summer of 2002, and estimated the work would last for about 16 weeks. The centre span would be reduced from 30m to 15m in navigable width, but not fully scaffolded like the other two spans. The buttresses were scaffolded to the riverbed on the upriver side (**Figure 6**).

Scaffolding around southern buttress

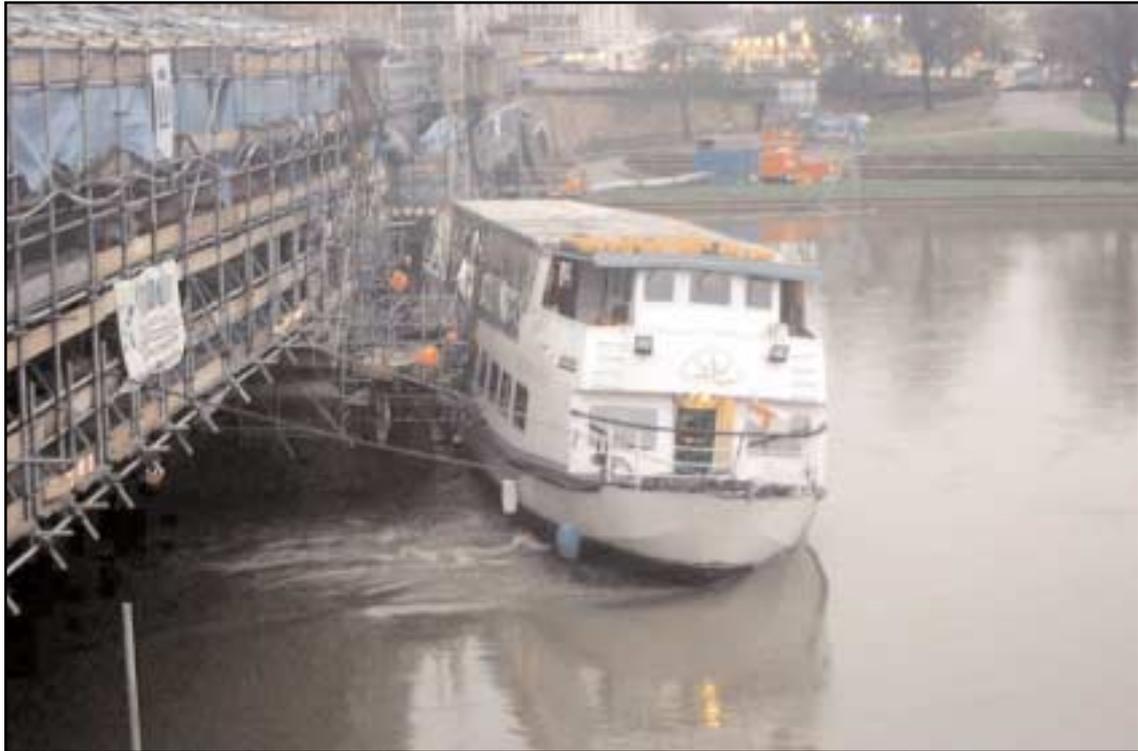
Figure 7

Vessel fast to bridge on Saturday 16th, pm (note flow by bow)

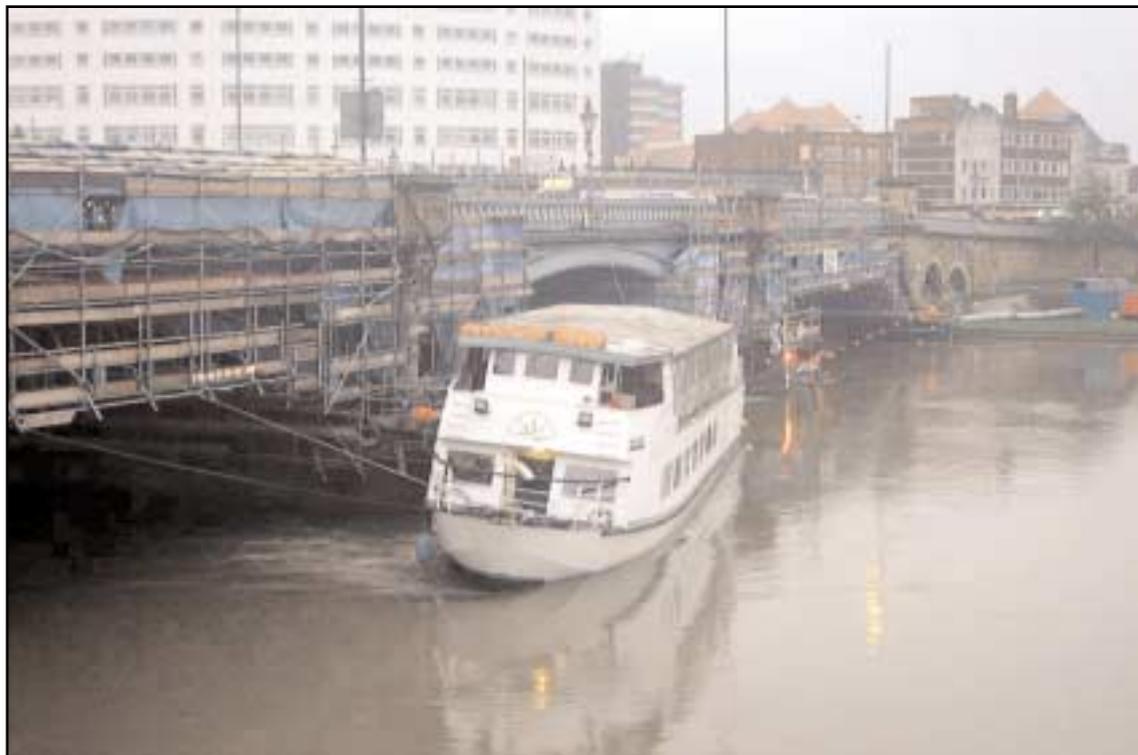
Figure 8

Vessel fast to bridge on Saturday pm

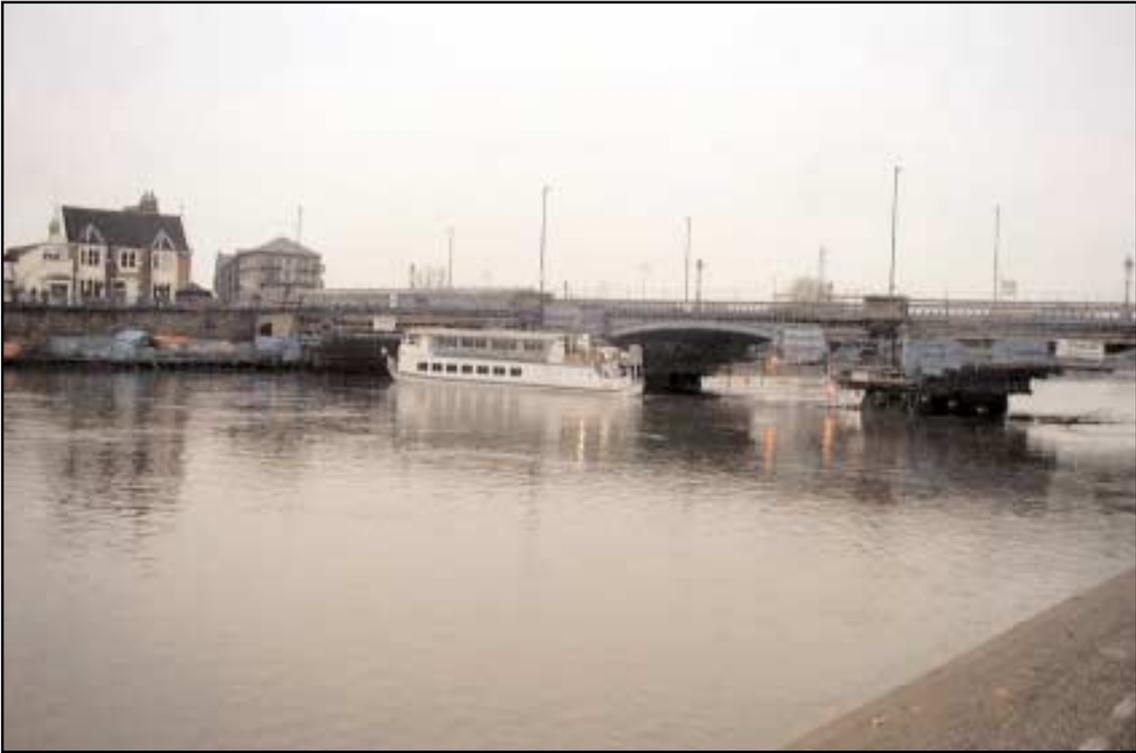
Figure 9

Vessel fast to bridge on Saturday 16th, pm

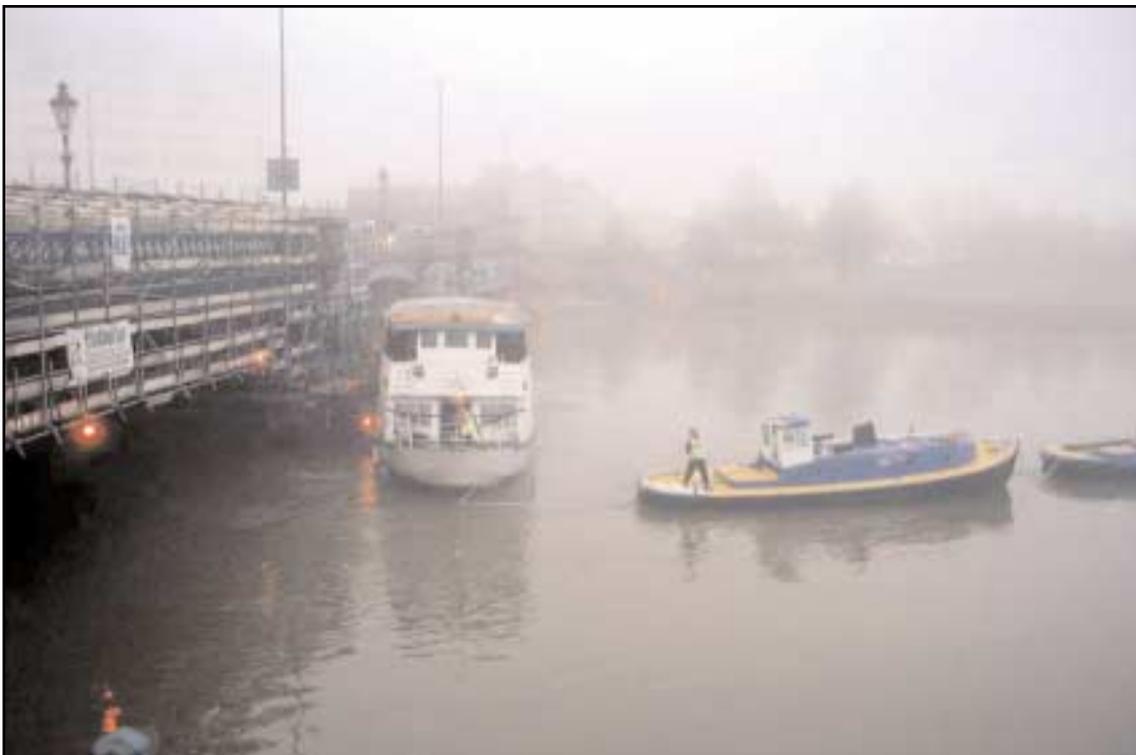
Figure 10

Vessel being removed from bridge

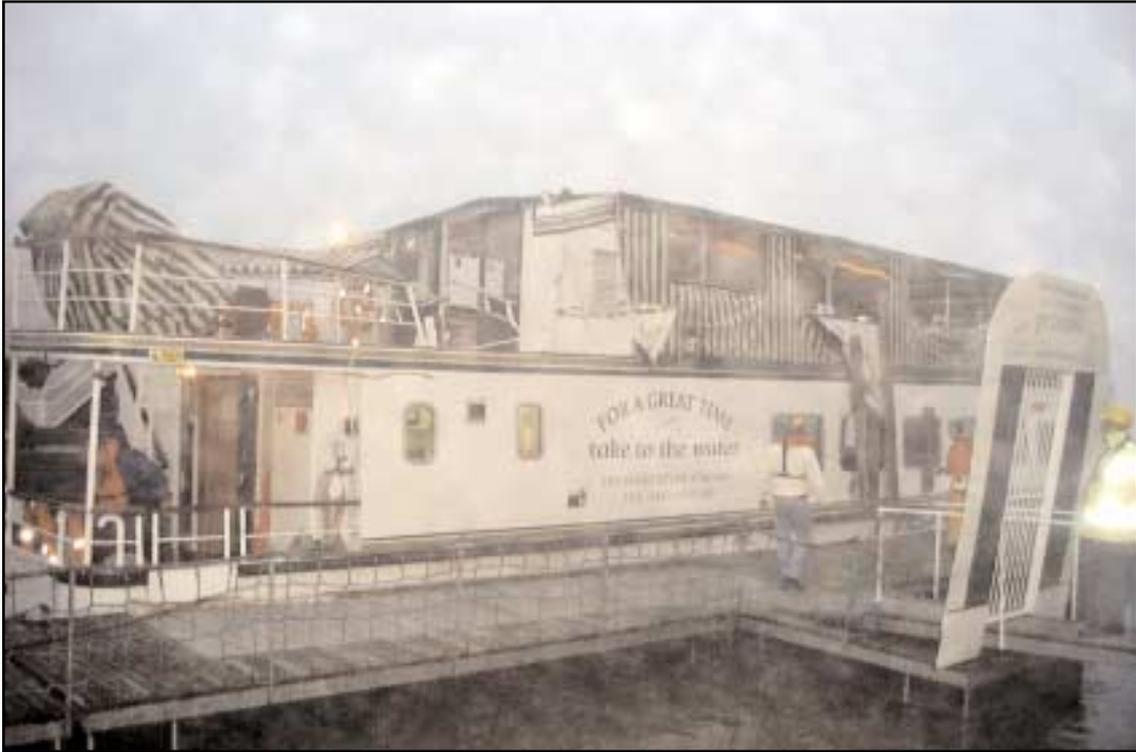
Figure 11

The vessel suffered mostly superficial damage as a result of the accident, including a broken window, a hole in the side shell, dented, twisted and scratched steelwork, damage to electrical fittings, damaged handrails and panelling (**Figures 11 & 12**). She underwent repairs and, after inspection by the Maritime and Coastguard Agency, resumed service 7 days after the accident, but did not sail under Trent Bridge while the scaffolding was in place.

Damage to starboard side of vessel

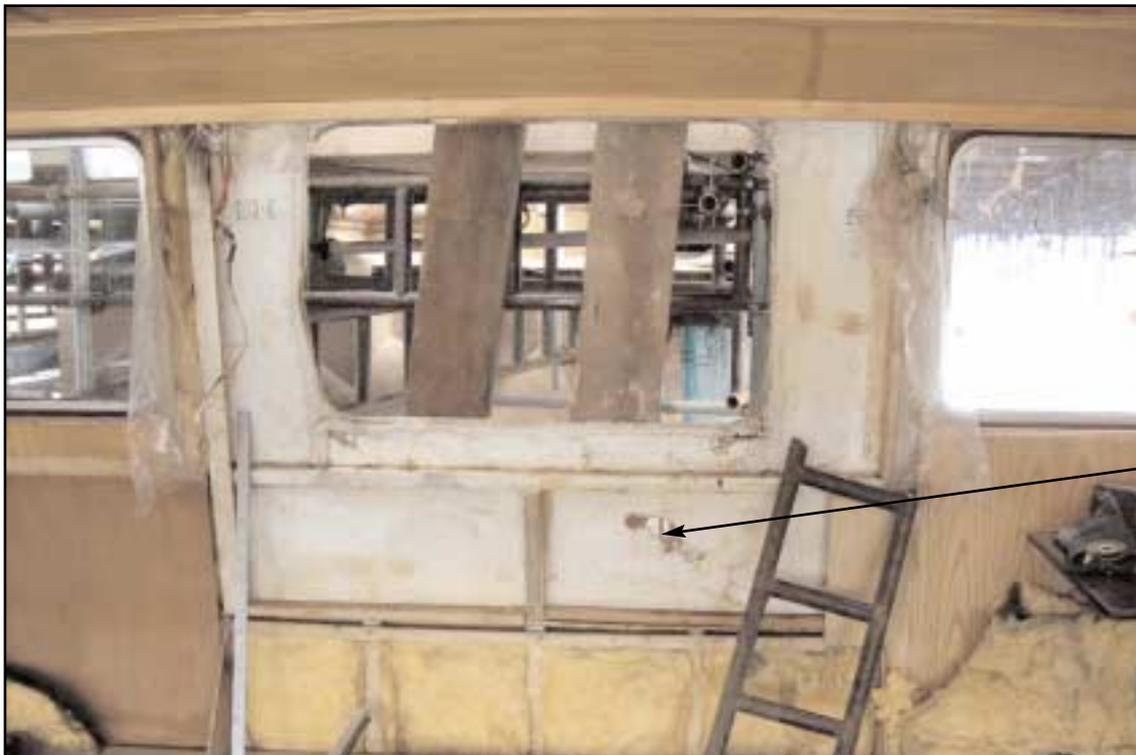
Figure 12

Hole in side plating

Damage to window on lower deck

The scaffolding was not fendered. Fendering would have protected both the vessel and the scaffolding from light impacts, but not from a heavy impact such as experienced in the accident. It might also have given false security to smaller leisure boat owners who have been known to make fast their boats, on a temporary basis, to any fendered structure. In this accident, fendering might have lessened the impact damage from the horizontal poles which caused the damage to the lower deck window and side plating.

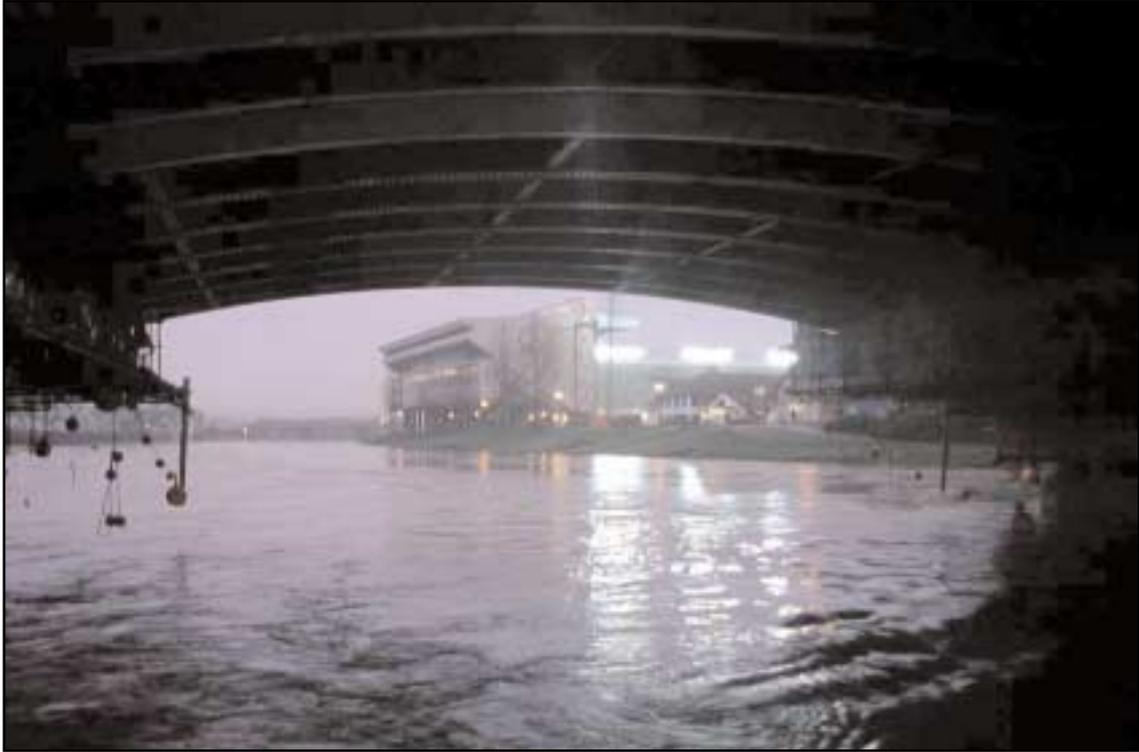
Figure 13

The flow under the bridge during high water levels is often confused, consisting of eddies and whirlpools, as the water is funnelled between the two arches. There is also a patch 1.5m deep immediately upriver of the southern buttress. For the river depths in the vicinity of the bridge (**Figure 5**).

Water flow under centre arch looking downriver

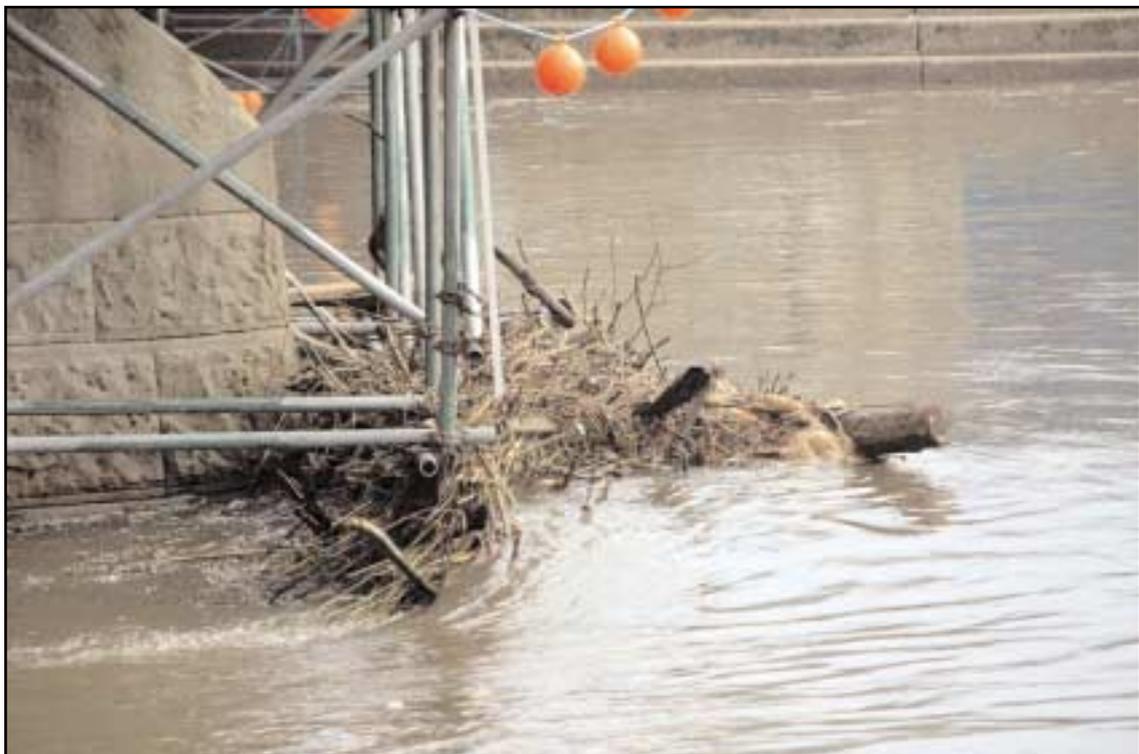
Figure 14

The two skippers consulted each other regarding these incidents and agreed that, although the river was high on the nights in question, a possible cause was the flotsam, which had gathered around the upriver southern buttress scaffolding. This diverted the flow through the centre arch and was considered to have set the vessel towards the northern buttress.

'Flotsam' on southern buttress
