Report on the investigation of
the aggregates dredger
Donald Redford
colliding with Hythe Pier,
Southampton Water
on
1 November 2003

Marine Accident Investigation Branch
First Floor
Carlton House
Carlton Place
Southampton
United Kingdom
SO15 2DZ

**Report No 6/2004
May 2004**

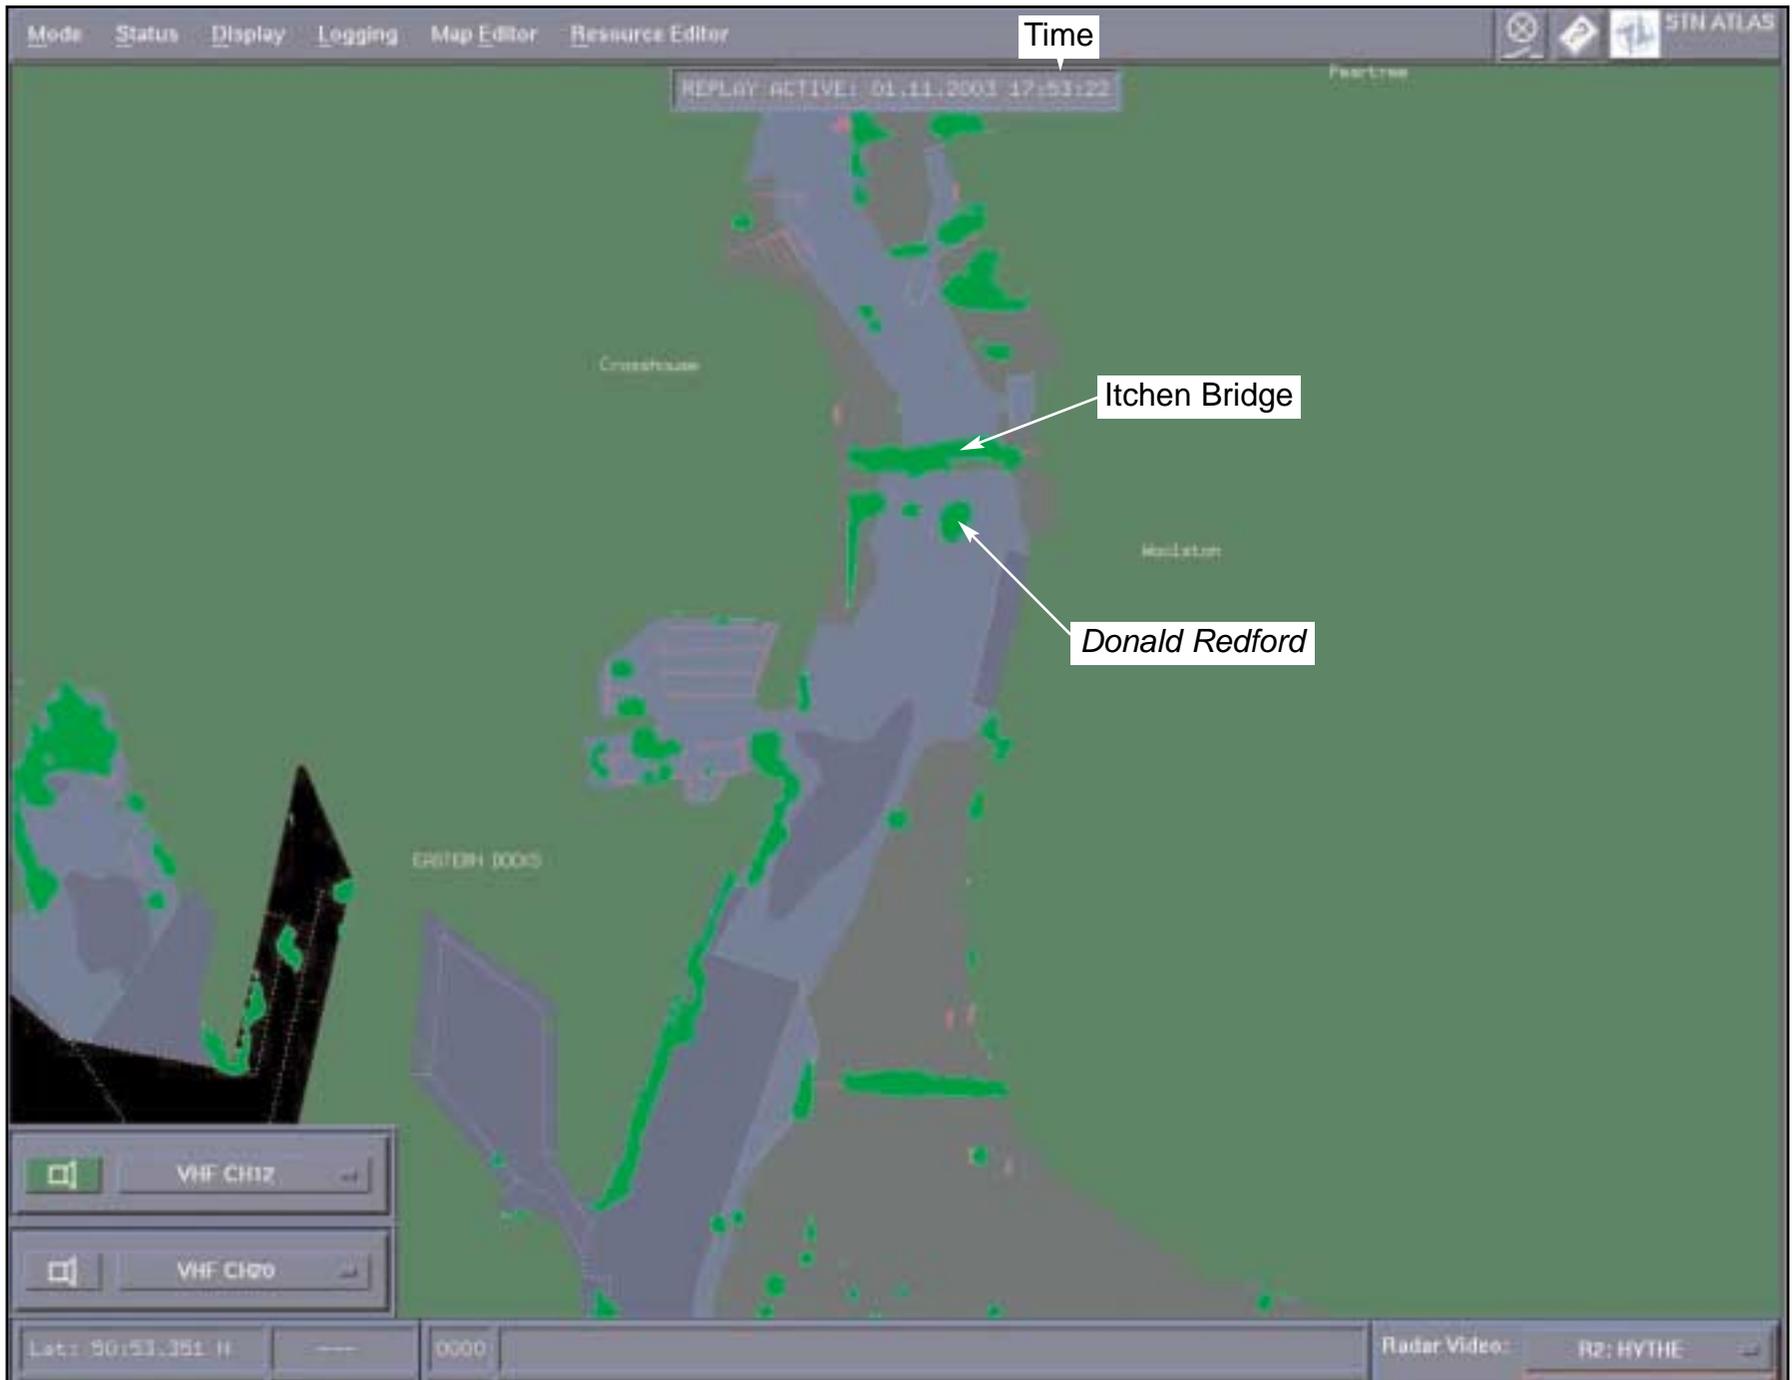
Figure 3

Magnified section of VTS radar screen

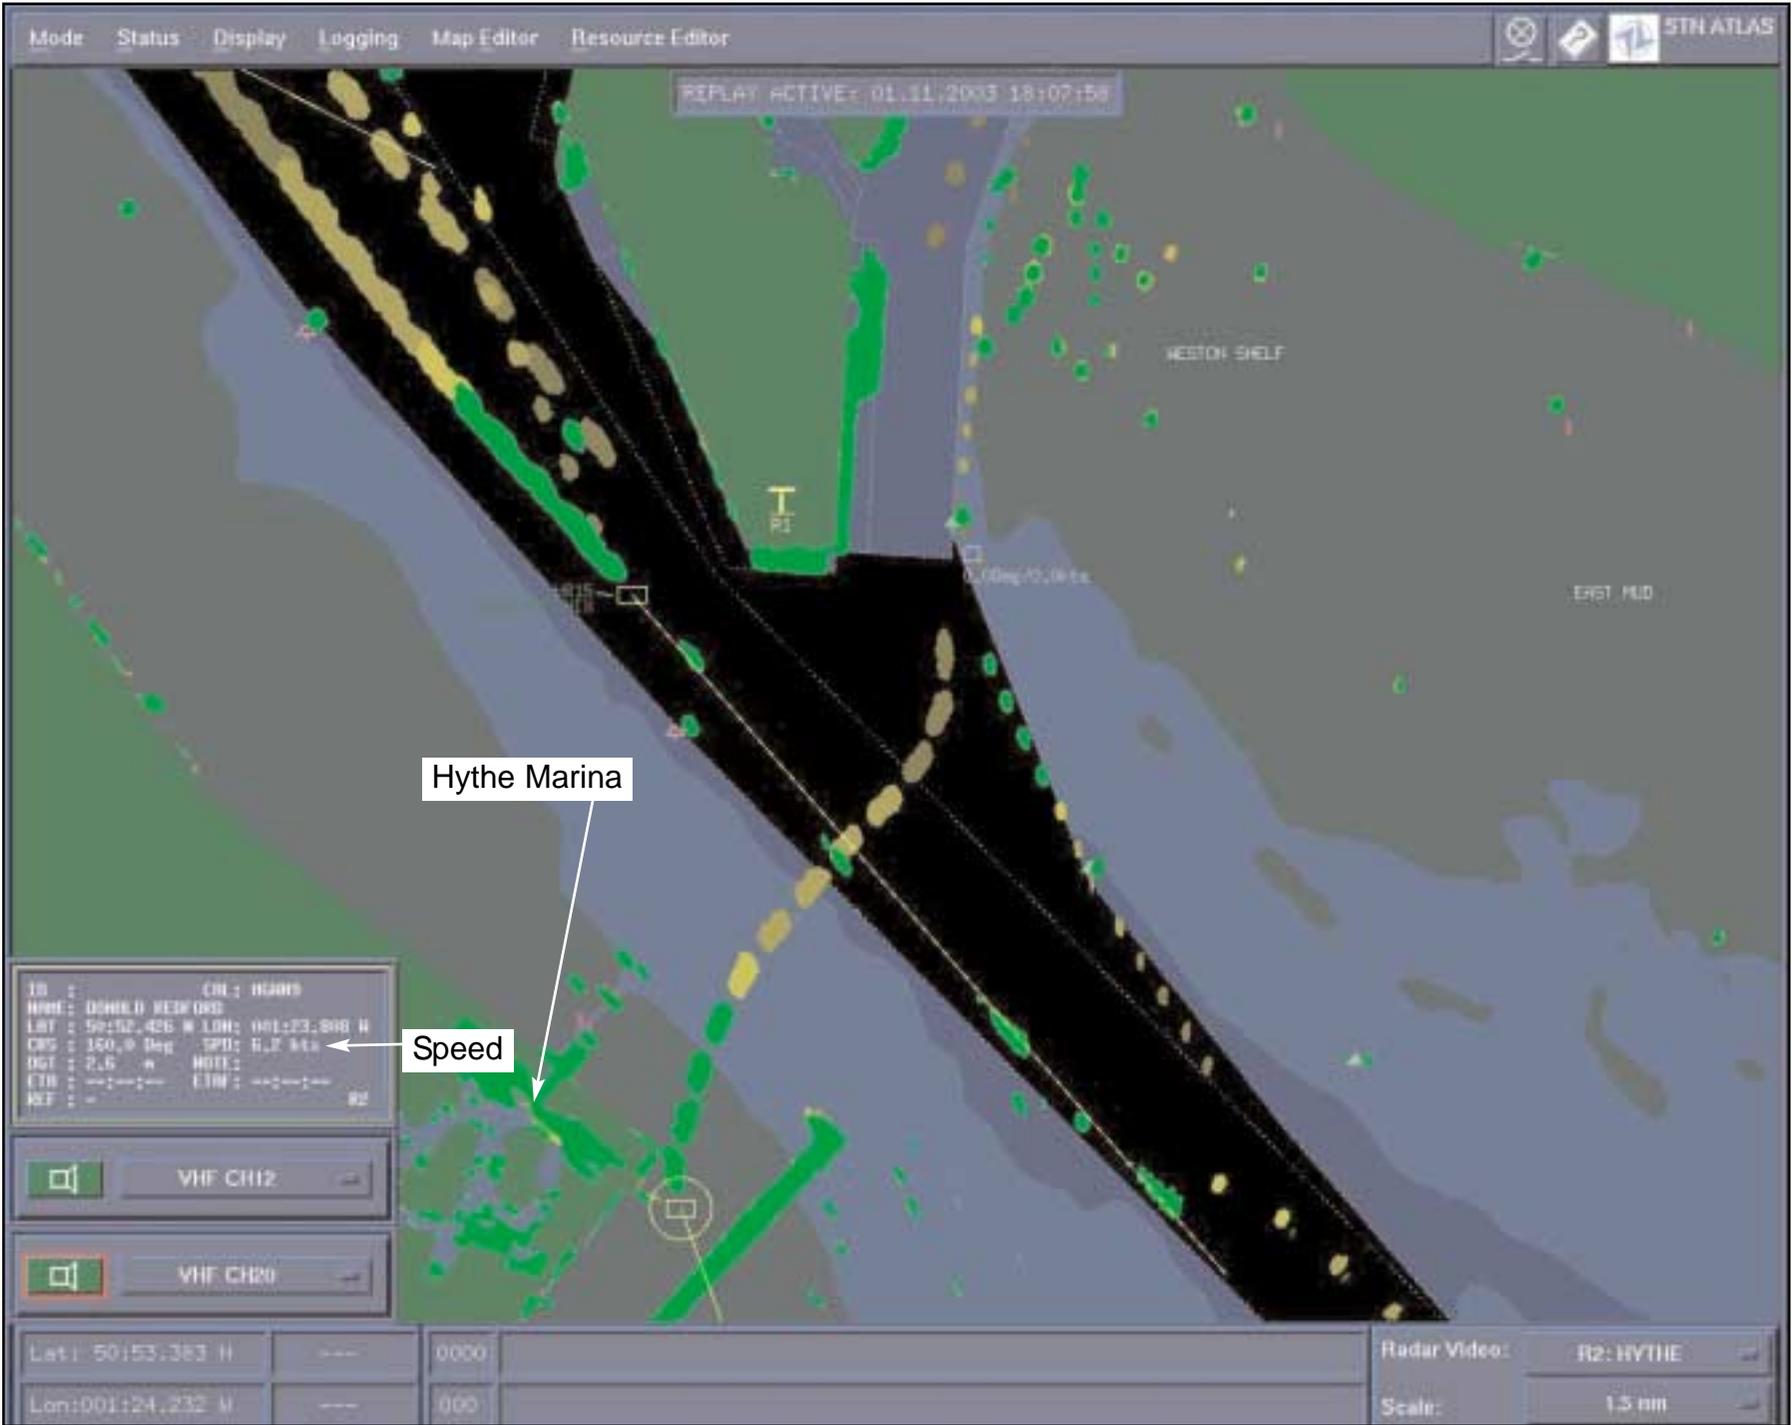
Figure 7

Magnified section of VTS radar screen

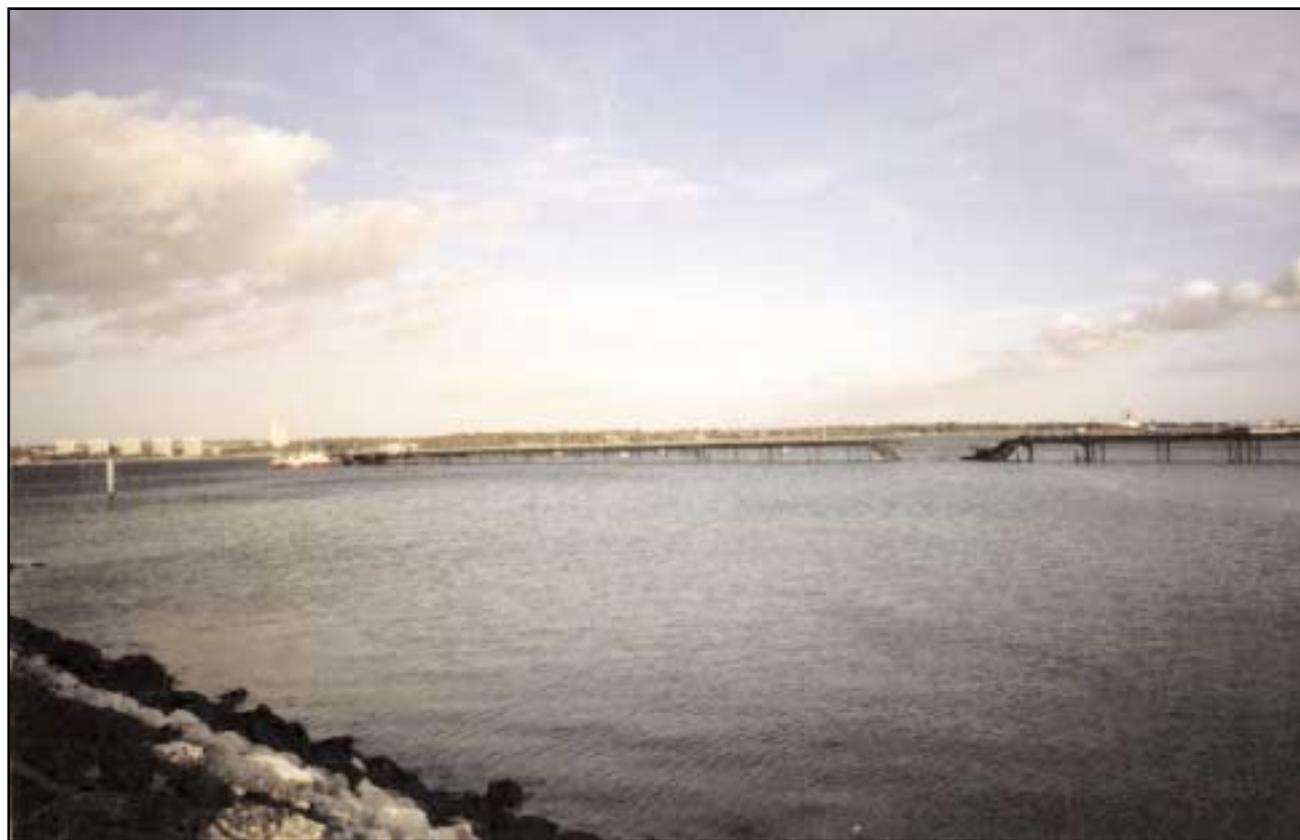
Figure 13

The pier was severed by the accident. The impact occurred about half way along its length (**Figure 13**). In the area of the collision, the structure was badly distorted and crumpled (**Figure 14**). The loss of the pier caused considerable disruption to this important commuter route, especially at the start of the next working week.

Hythe Pier looking south-east

Temporary arrangements for the ferries to run from Hythe Marina were put in place until the pier could be repaired.

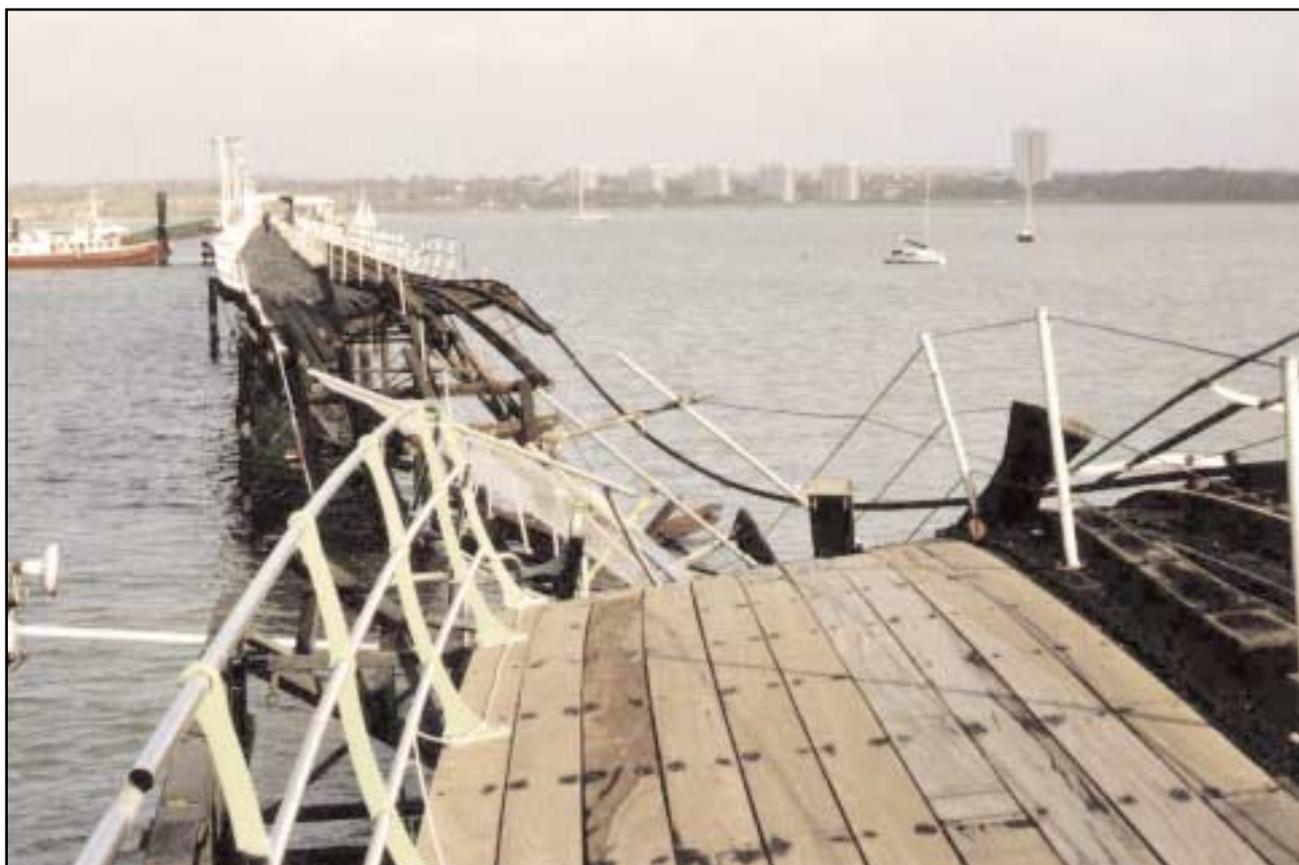
Figure 14

The damage to Hythe Pier

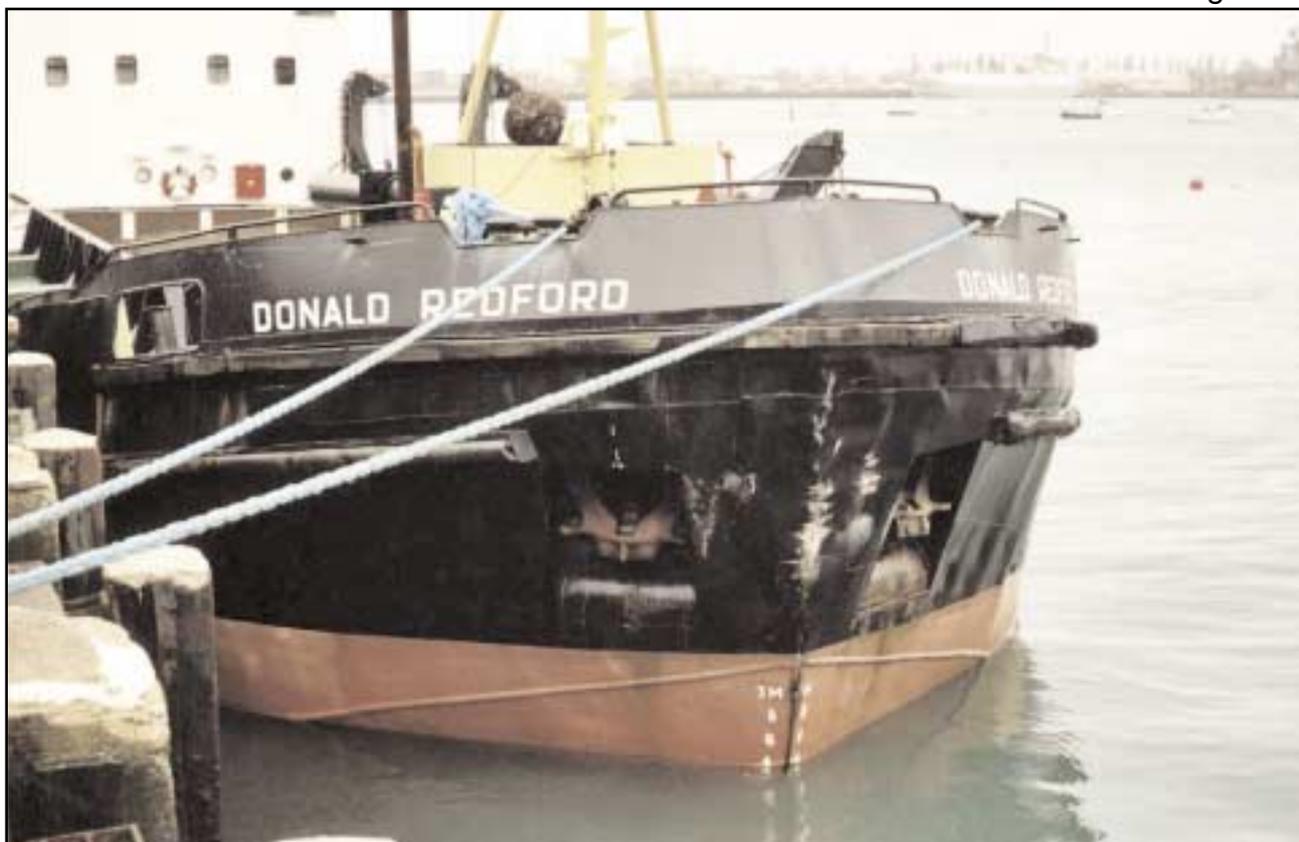
Figure 15

There was little damage to *Donald Redford's* bow (**Figure 15**). Some scrapes to the paintwork were visible, but it was difficult to know if this occurred during the accident, or as a result of her normal operations. All compartments were thoroughly checked at Marchwood, and no water ingress was found. The draughts of the vessel were monitored, and found not to be increasing. On 2 November 2003, an MCA surveyor attended the vessel and checked the steering and engine controls, which were found to be operating satisfactorily. The VHF radio was also checked, and was found to be working as it should.

The damage to *Donald Redford*
