Report on the investigation of  
the capsizing and sinking of the fishing vessel

***Chelaris J (GU323)***

1 October 2003

**Report No 7/2004**  
**July 2004**

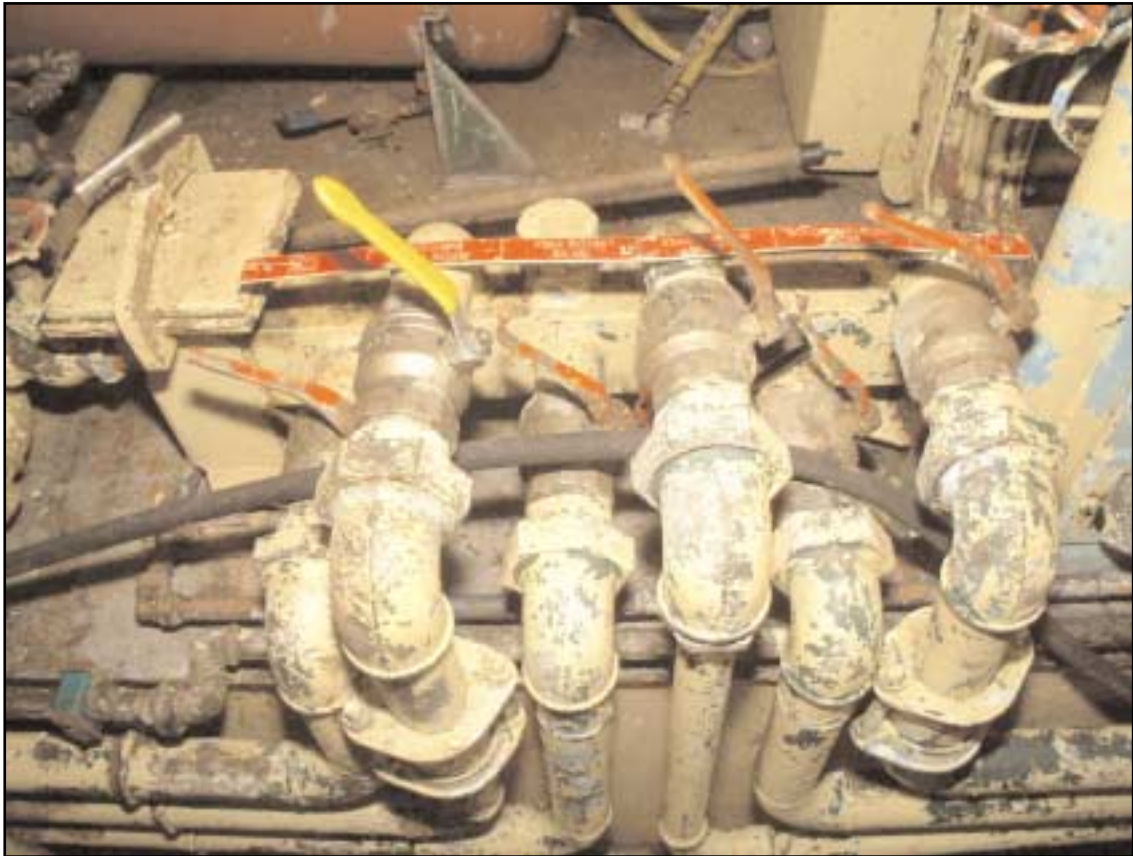
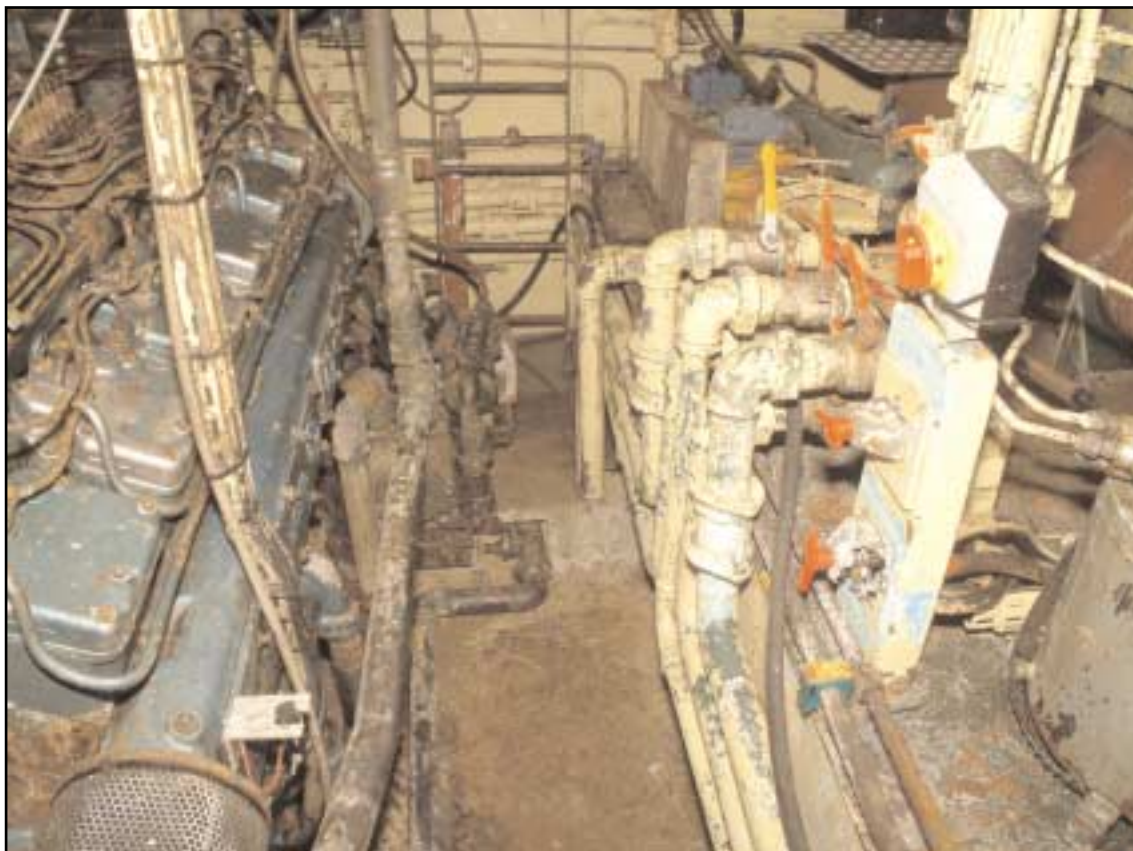
Figure 3a

Each space was served by a single bilge suction that was sited at the valve manifold in the engine room (**see Figure 3b**).

Bilge pumping Manifold

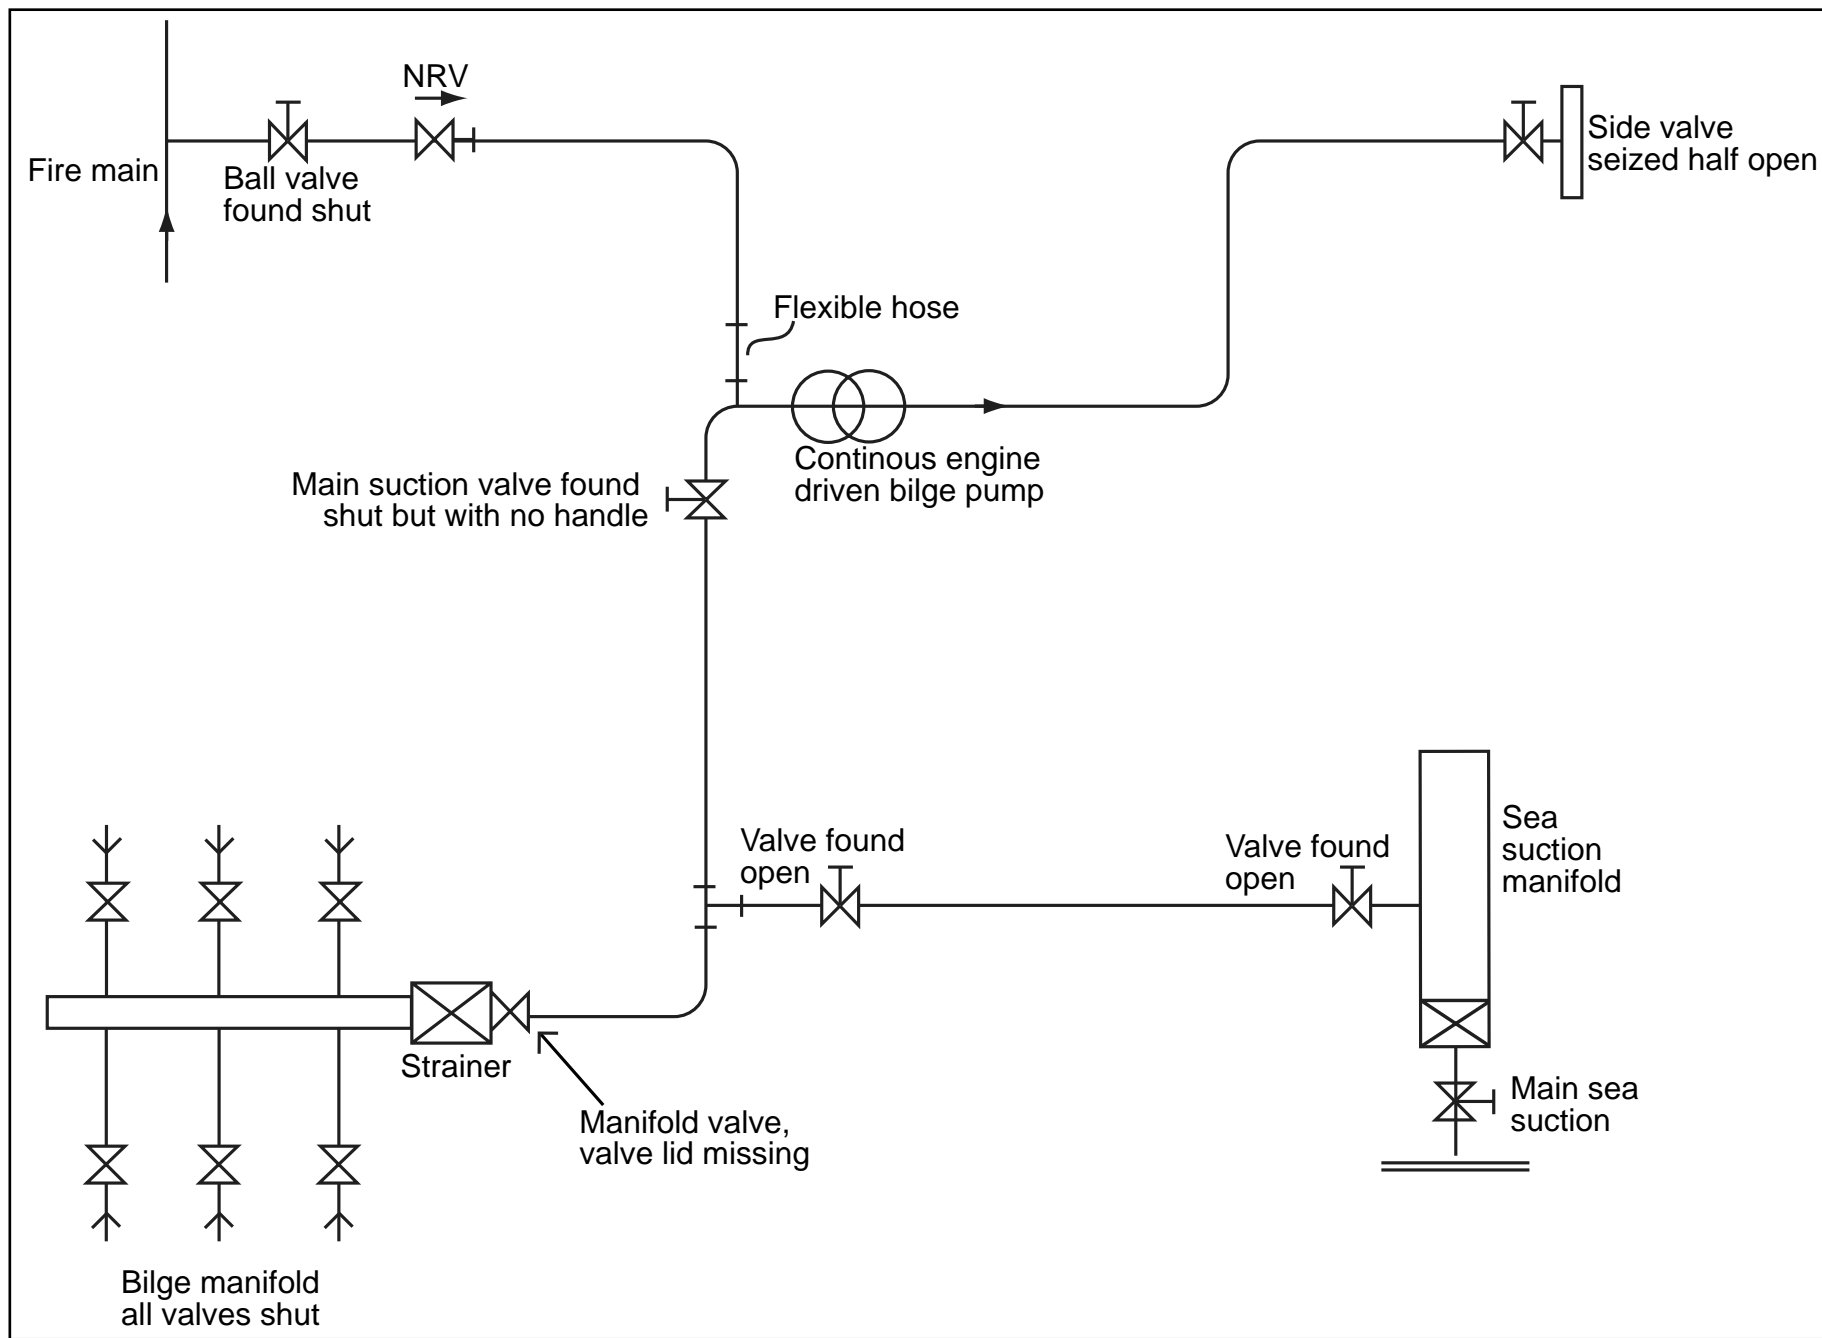
Diagrammatic sketch of bilge pumping arrangement

**Figure 4** shows a schematic representation of the bilge pumping system as found on *Chelaris J*. The system was studied closely and valves were dismantled to establish their condition and position. The following was noted:

- The bilge manifold valve, adjacent to the strainer, was found without the valve lid, rendering the valve permanently in the open position.
- The bilge discharge hull side valve was found seized half open.
- The main suction valve (**Figure 10**) was found shut. It had no handle, but could be operated with a spanner.
- The two valves between the sea suction manifold and the bilge suction line were found to operate correctly.
- The only clear bilge suction line to the bilge manifold was to the midship fish room. With the system settings as found, it was very simple to flood the fish room by simply opening the fish room suction valve.
- The system, as found, appeared to have the engine-driven bilge pump running dry.
- No leaks were apparent in the engine room when all sea inlet valves were opened.

The diagrammatic sketch (**Figure 4**) shows the bilge pumping arrangement as it was found, and it would appear that the system was completely ineffective at pumping the bilge. Only one of the suctions from the fish hold was found to be clear when tested. The strainer on the steering gear compartment had been cut off, and was lying near by. During testing, some of the pipework was found to be blocked, and this might have been indicative of the condition of other parts of the system.

The main suction valve, essential for pumping water over the side, had no handle and was shut. The manifold valve had no closure mechanism inside, and with the two valves linked to the main sea inlet open, it was very easy to fill the bilge with seawater by simply opening a valve on the valve manifold. This would account for the two flooding incidents detailed in section 1.5.5. The reason for having seawater inlets to the bilge pump, was to ensure adequate seawater lubrication and cooling of the pump. However, with the system as found, the pump was running dry, wearing it out, and dramatically reducing its effectiveness.

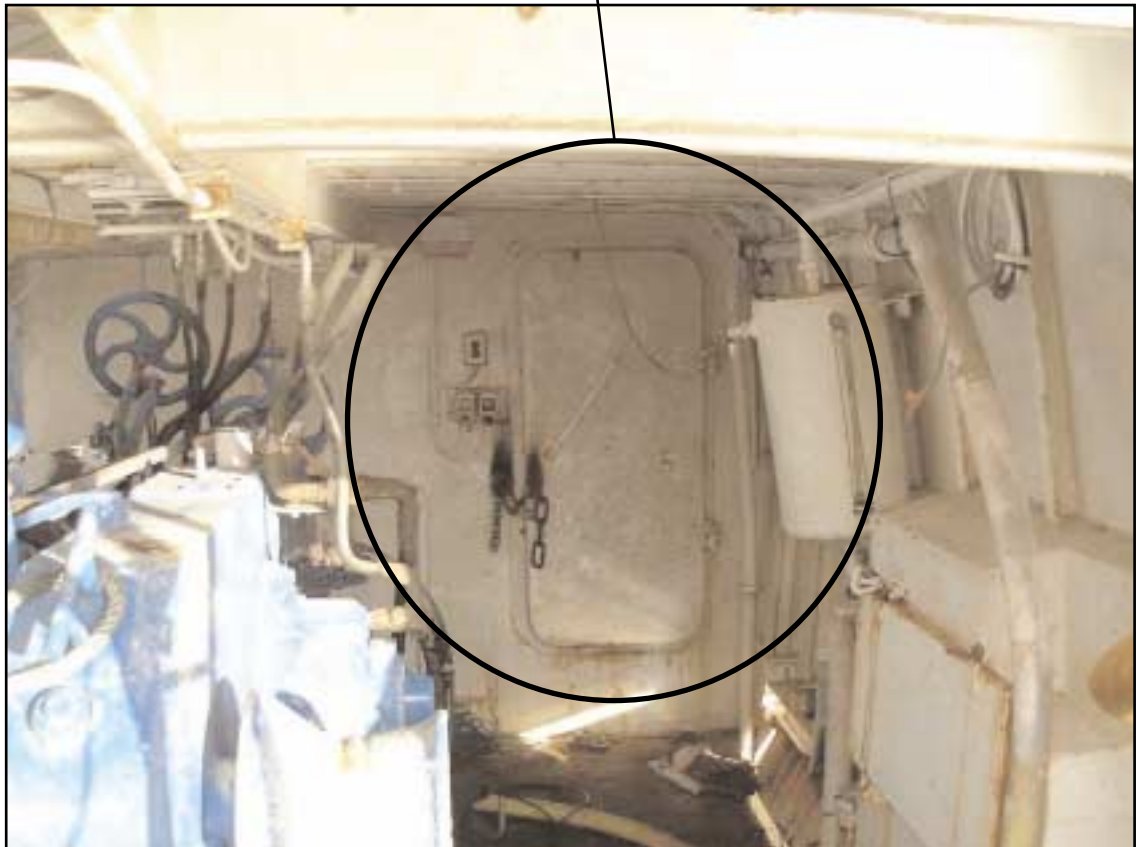
Figure 5

- All hatches, scuttles, and doors were open except the starboard passageway door (**see Figure 5**). The accommodation escape hatch was open.
- The autopilot was found engaged on a course of 57° magnetic (**see Figure 6**), and the rudder was virtually hard over to starboard.

Starboard passageway door

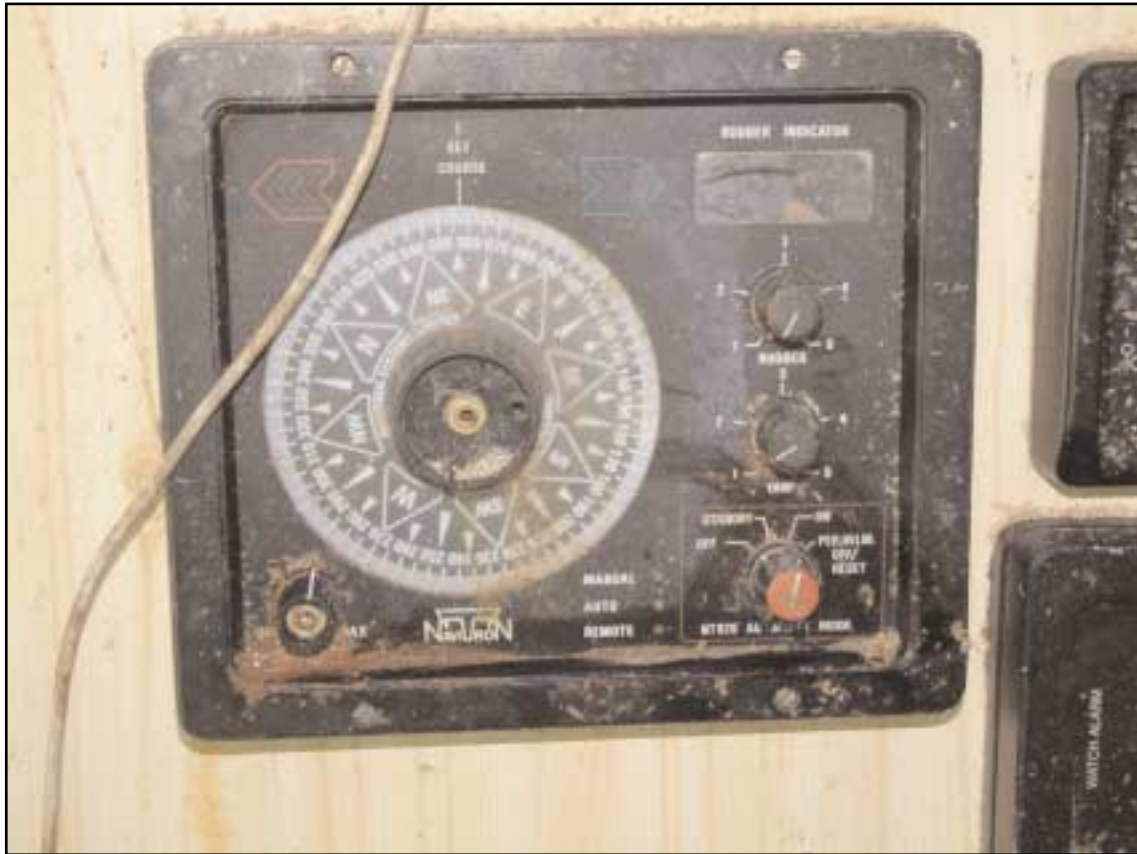
Figure 6

Autopilot control

The autopilot control settings were recorded. The course set was 057°. The autopilot rudder and yaw settings were at minimum (**see Figure 6**). The unit was then removed and taken to the manufacturers, to determine the internal gain settings. In conjunction with measurements taken in the steering gear compartment, a value of 0.5° rudder angle per degree of course error was derived. This means, for example, that for a requested course change of 20°, the autopilot would apply 10° of helm or, for a course change of 40°, 20° of helm would be applied, and so on. It was also found that the autopilot had been modified to take a GPS course input rather than the signal from the original magnetic heading sensor coil.

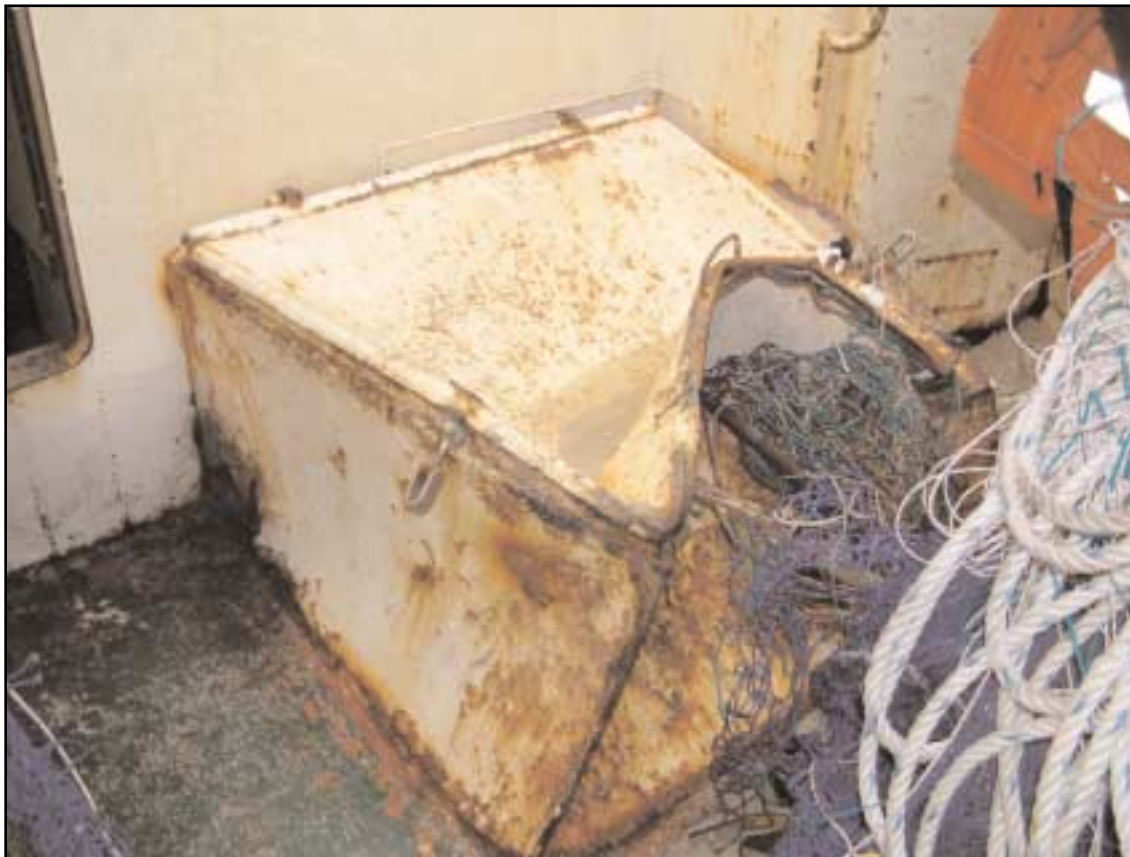
Figure 7

- The liferaft painter weak link was still attached, with the painter heading off to port under the wheelhouse door.
- The fish hold hatch, and part of the hatch coaming, had suffered implosion damage (**see Figure 7**).

Imploded fish hatch

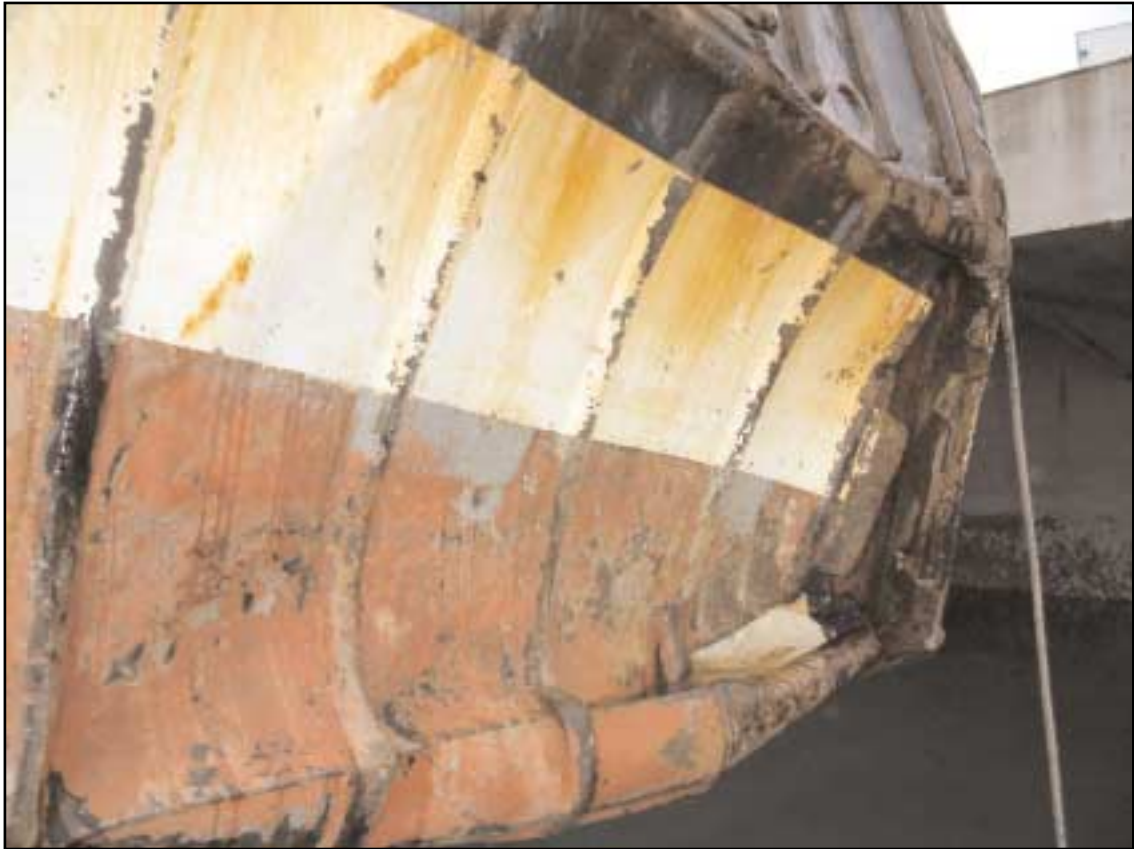
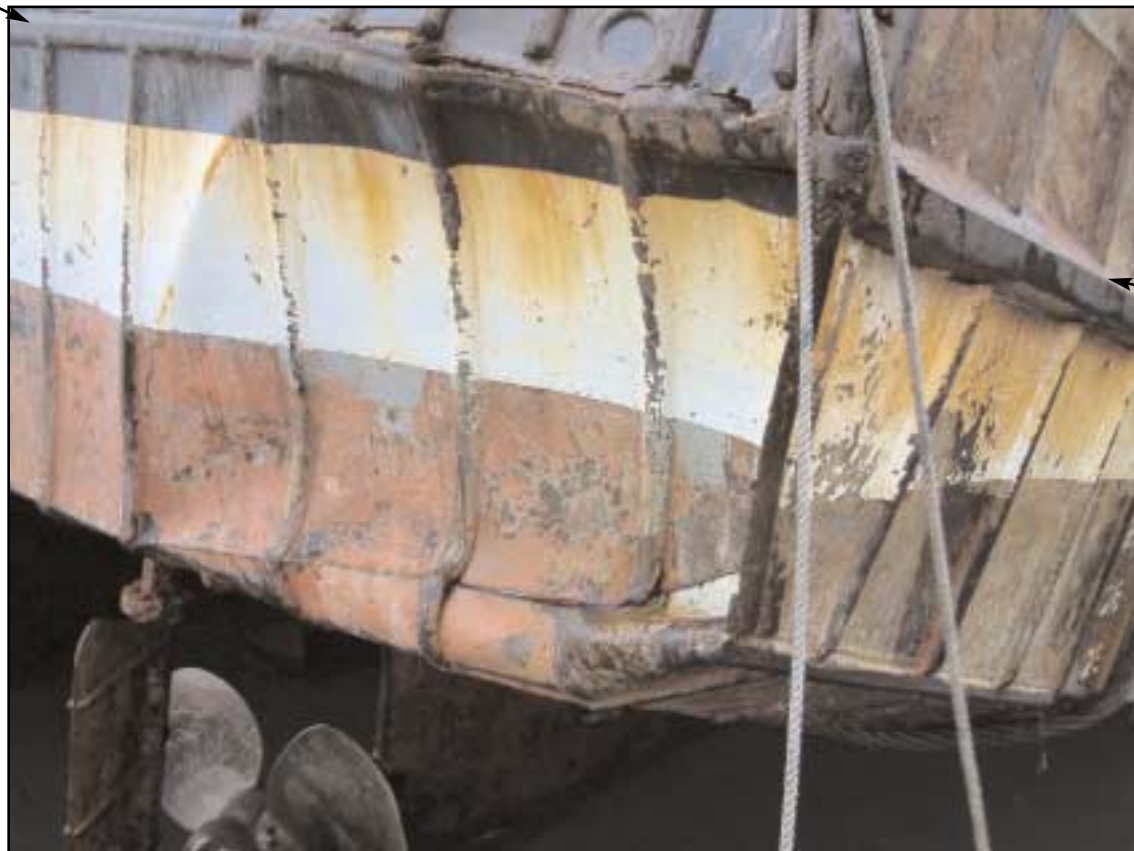
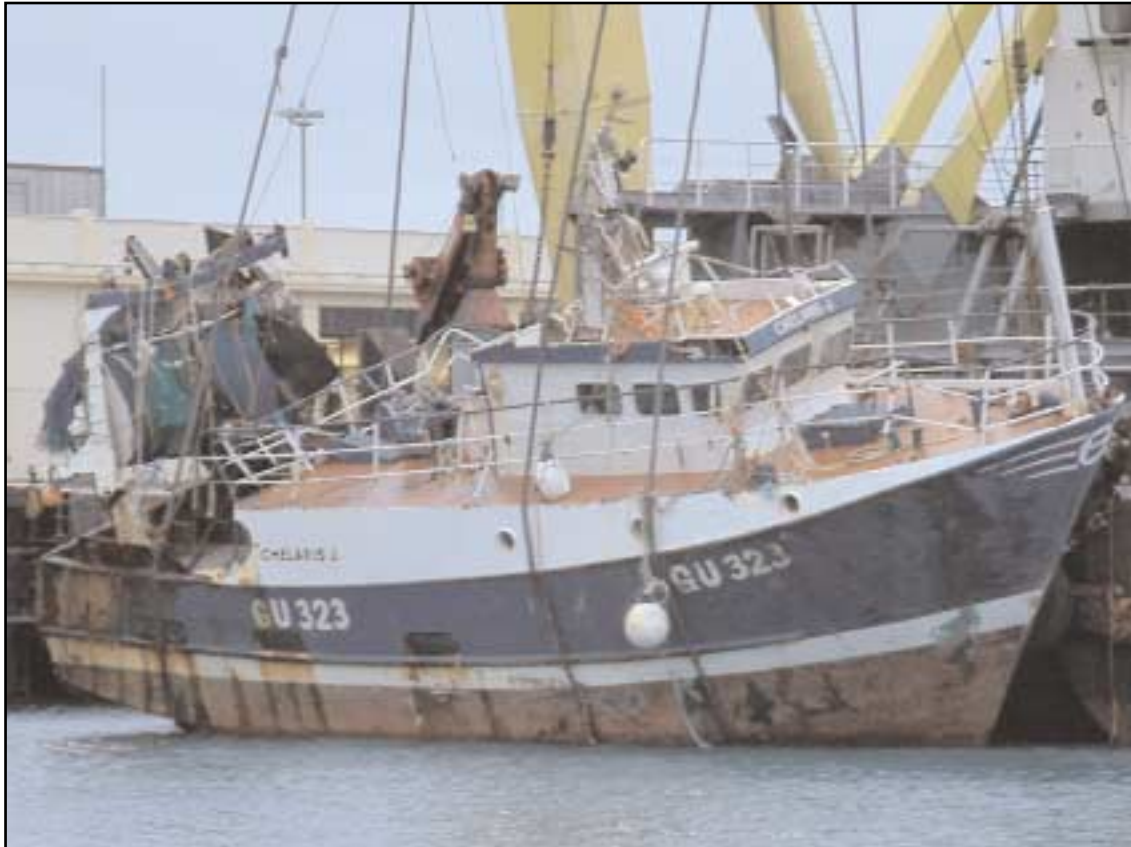
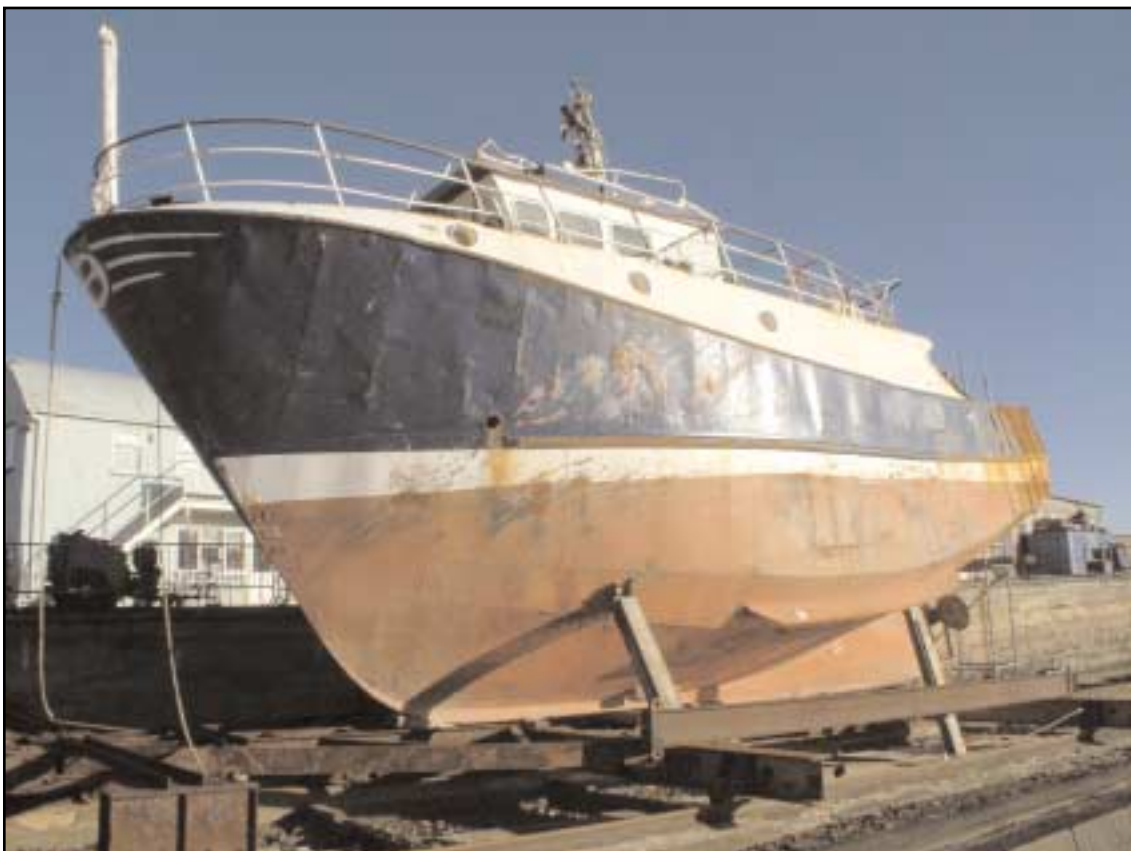
Figure 8a

- There was damage to the starboard side of the transom (**see Figure 8**).
- The seabed was sand only.

Damage to starboard side of transom

Starboard side

Port side (scraping damage from salvage)

The damaged transom was closely examined, and plate thickness measurements taken. No evidence of plate thinning could be found. Photographs were then dispatched to an expert for closer examination. The expert concluded that the damage to the transom was consistent with an impact with the seabed when *Chelaris J* sank.

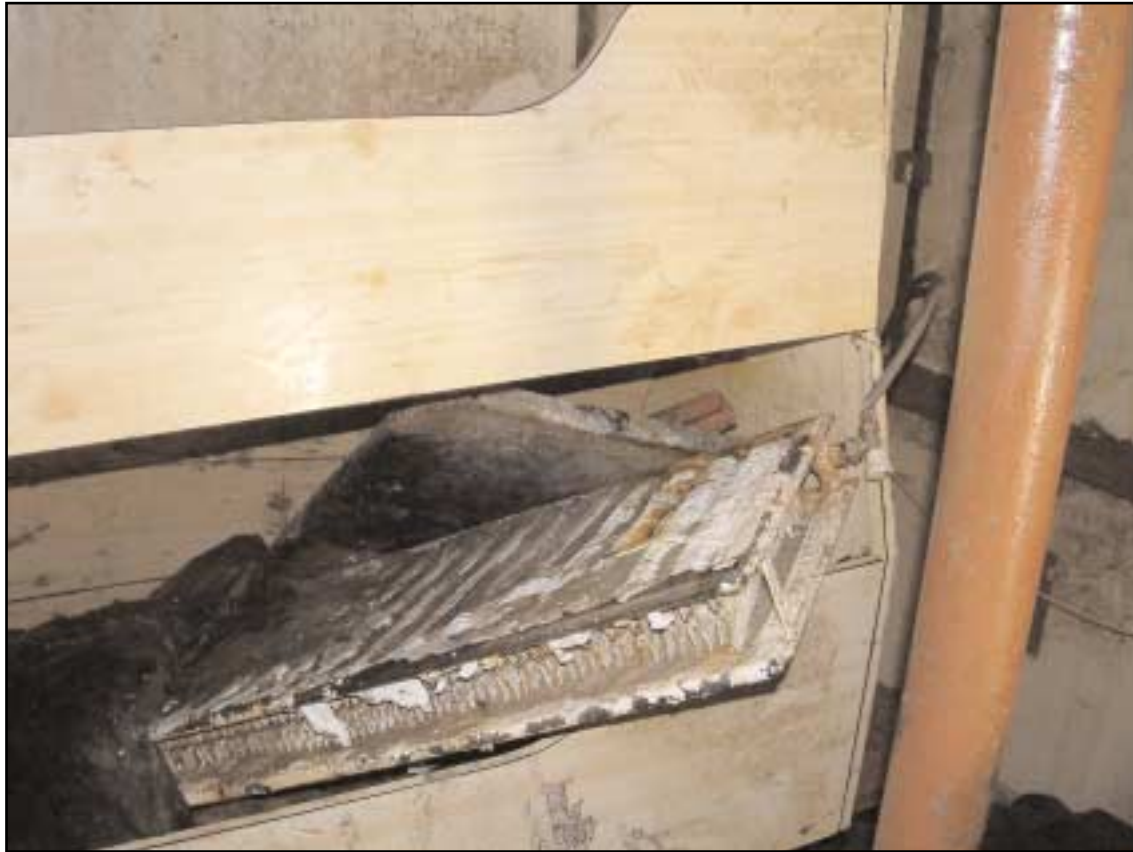
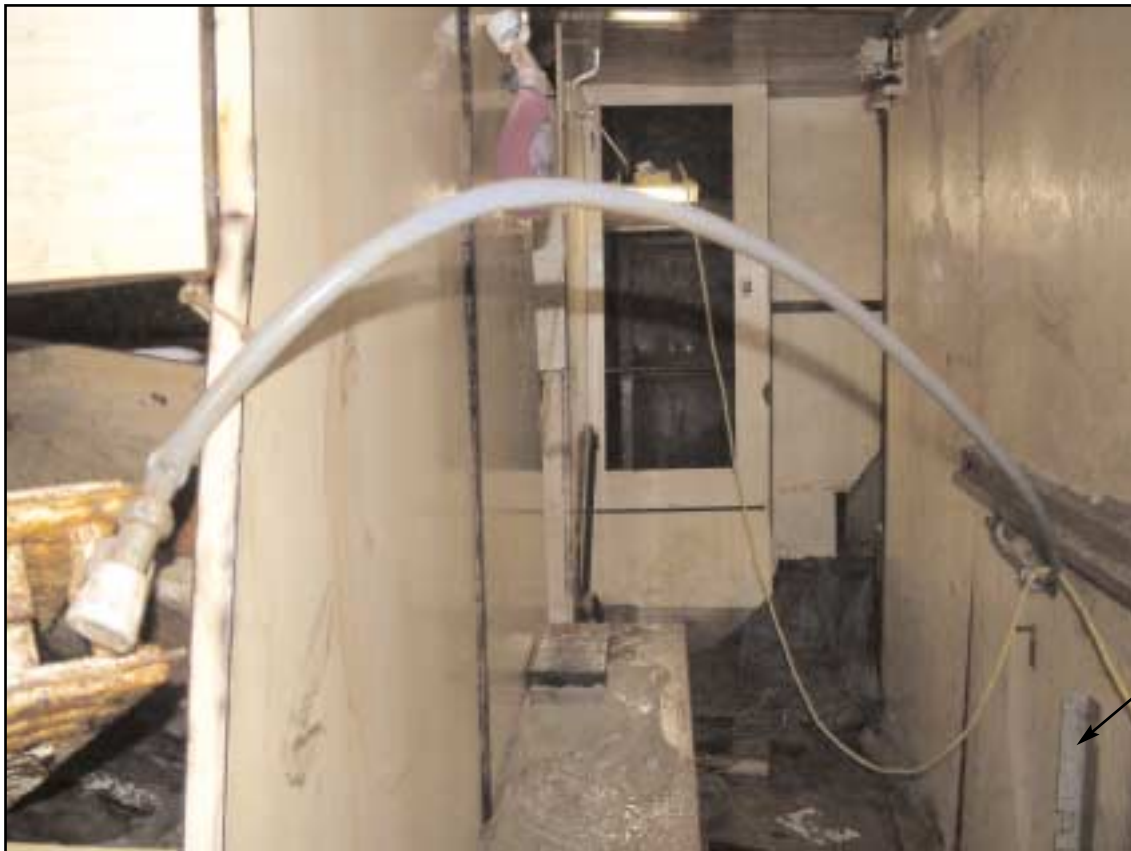
Figure 9a

Radiator  
bracket

Radiator position after capsizing

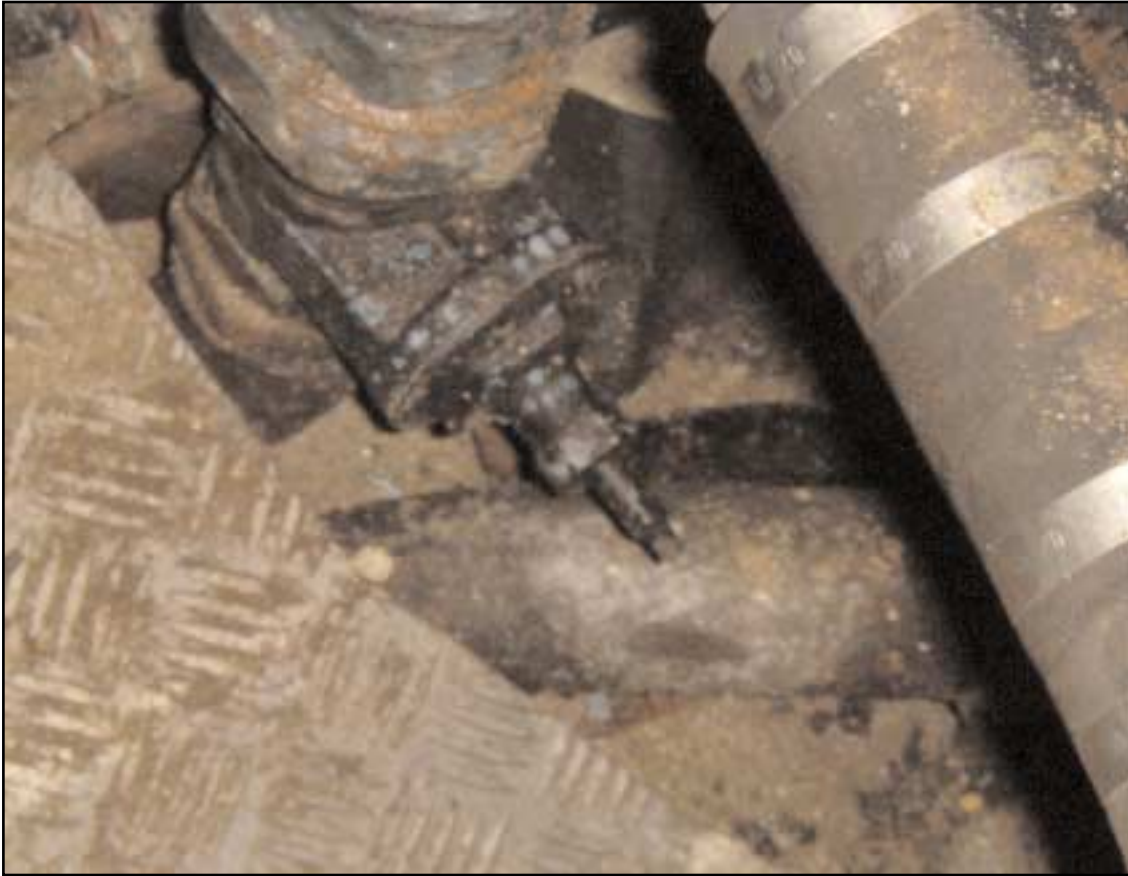
Figure 10

Main bilge suction valve

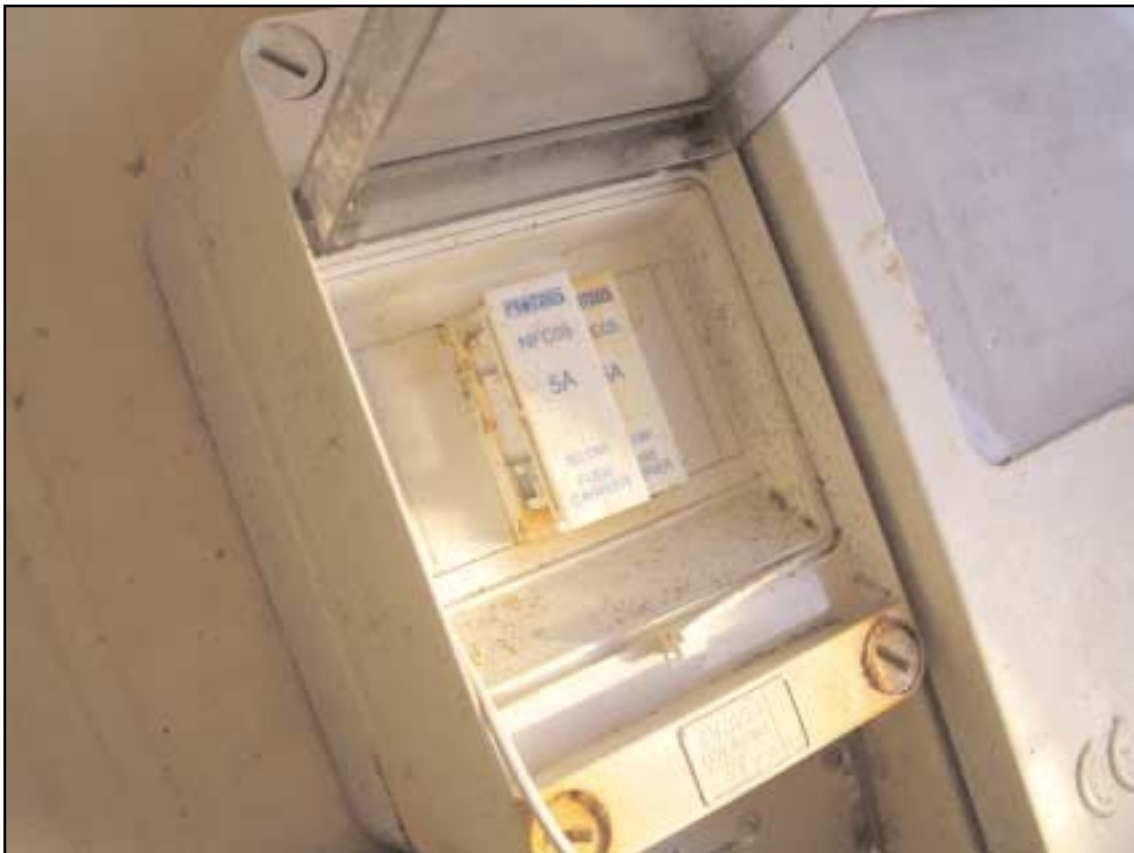
Figure 11

Fuse panel supplying bilge and fire alarms

a fault with either system might have led to the power supply being disconnected to prevent false alarms sounding. The fish hold sensor was blocked with debris, which might have been the problem, but this should have been a relatively simple job to rectify. Disconnecting a safety system, such as the bilge alarm or fire alarm, can put crews' lives at greater risk. Having the two systems on one fuse was short-sighted, considering the two systems were independent of each other and provided warnings of different hazards. The bilge system was also protected by an internal fuse and did not require additional protection.

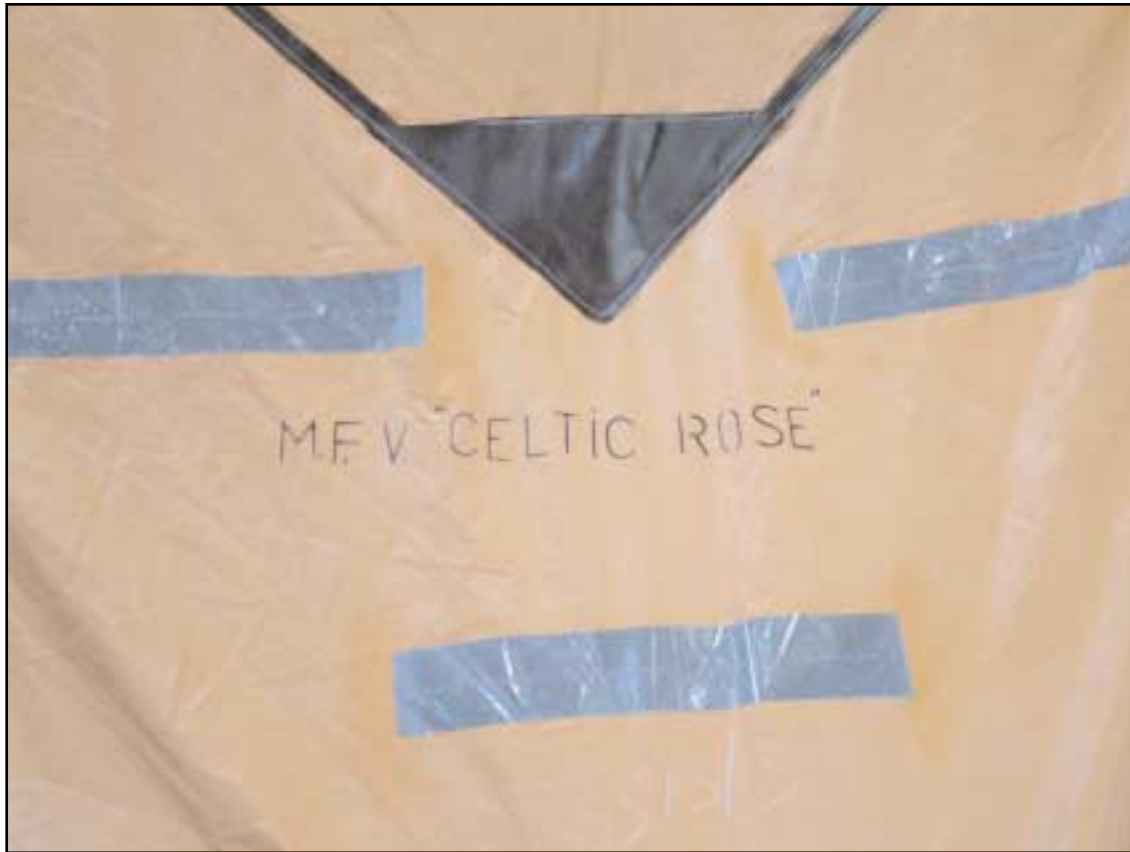
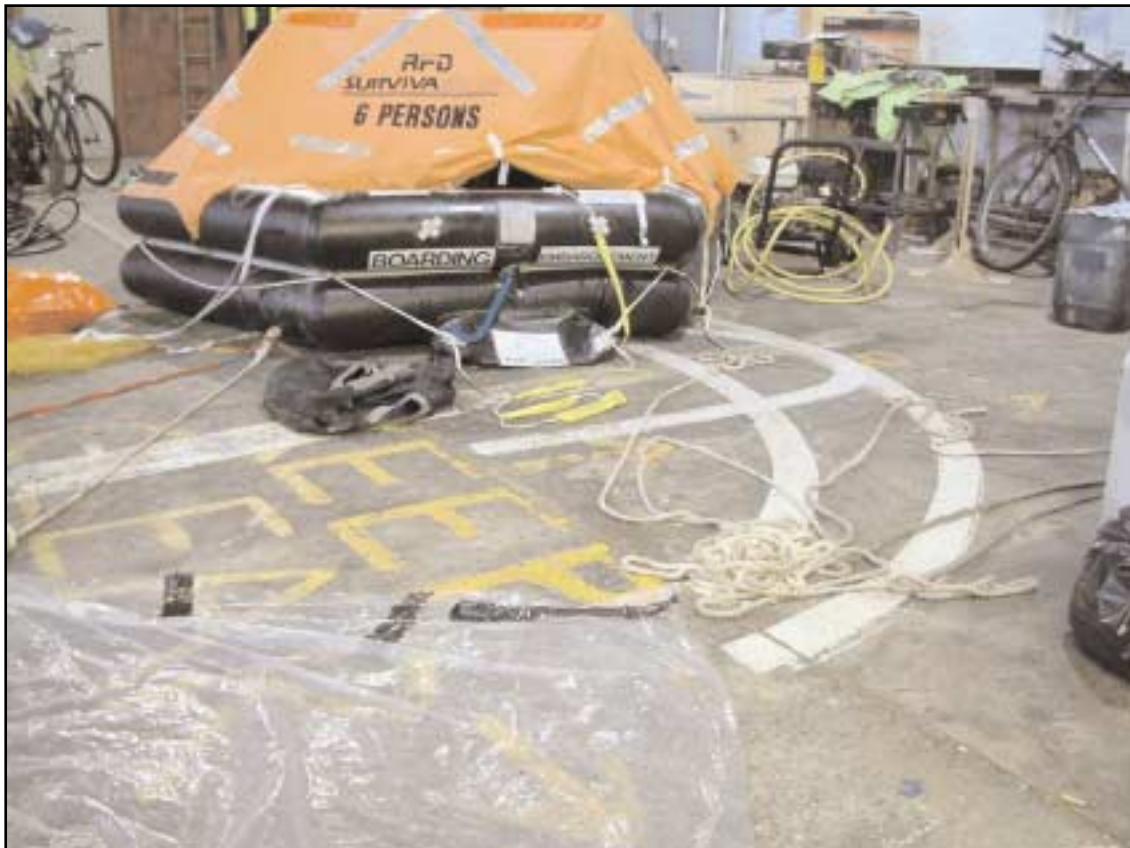
Figure 12a

The liferaft was closely examined in St Peter Port (**see Figure 12**). All associated lines were entangled. The painter had been severed and was frayed. The drogue line had also been severed, but the drogue was still entangled with the liferaft. The name 'MFV *Celtic Rose*' was still stencilled on the canopy. The service log was recovered, which detailed that a service had taken place in February 2002. The log also had the name 'MFV *Celtic Rose*' on it. This type of liferaft is required to be inspected/surveyed annually.

Liferaft from *Chelaris J*

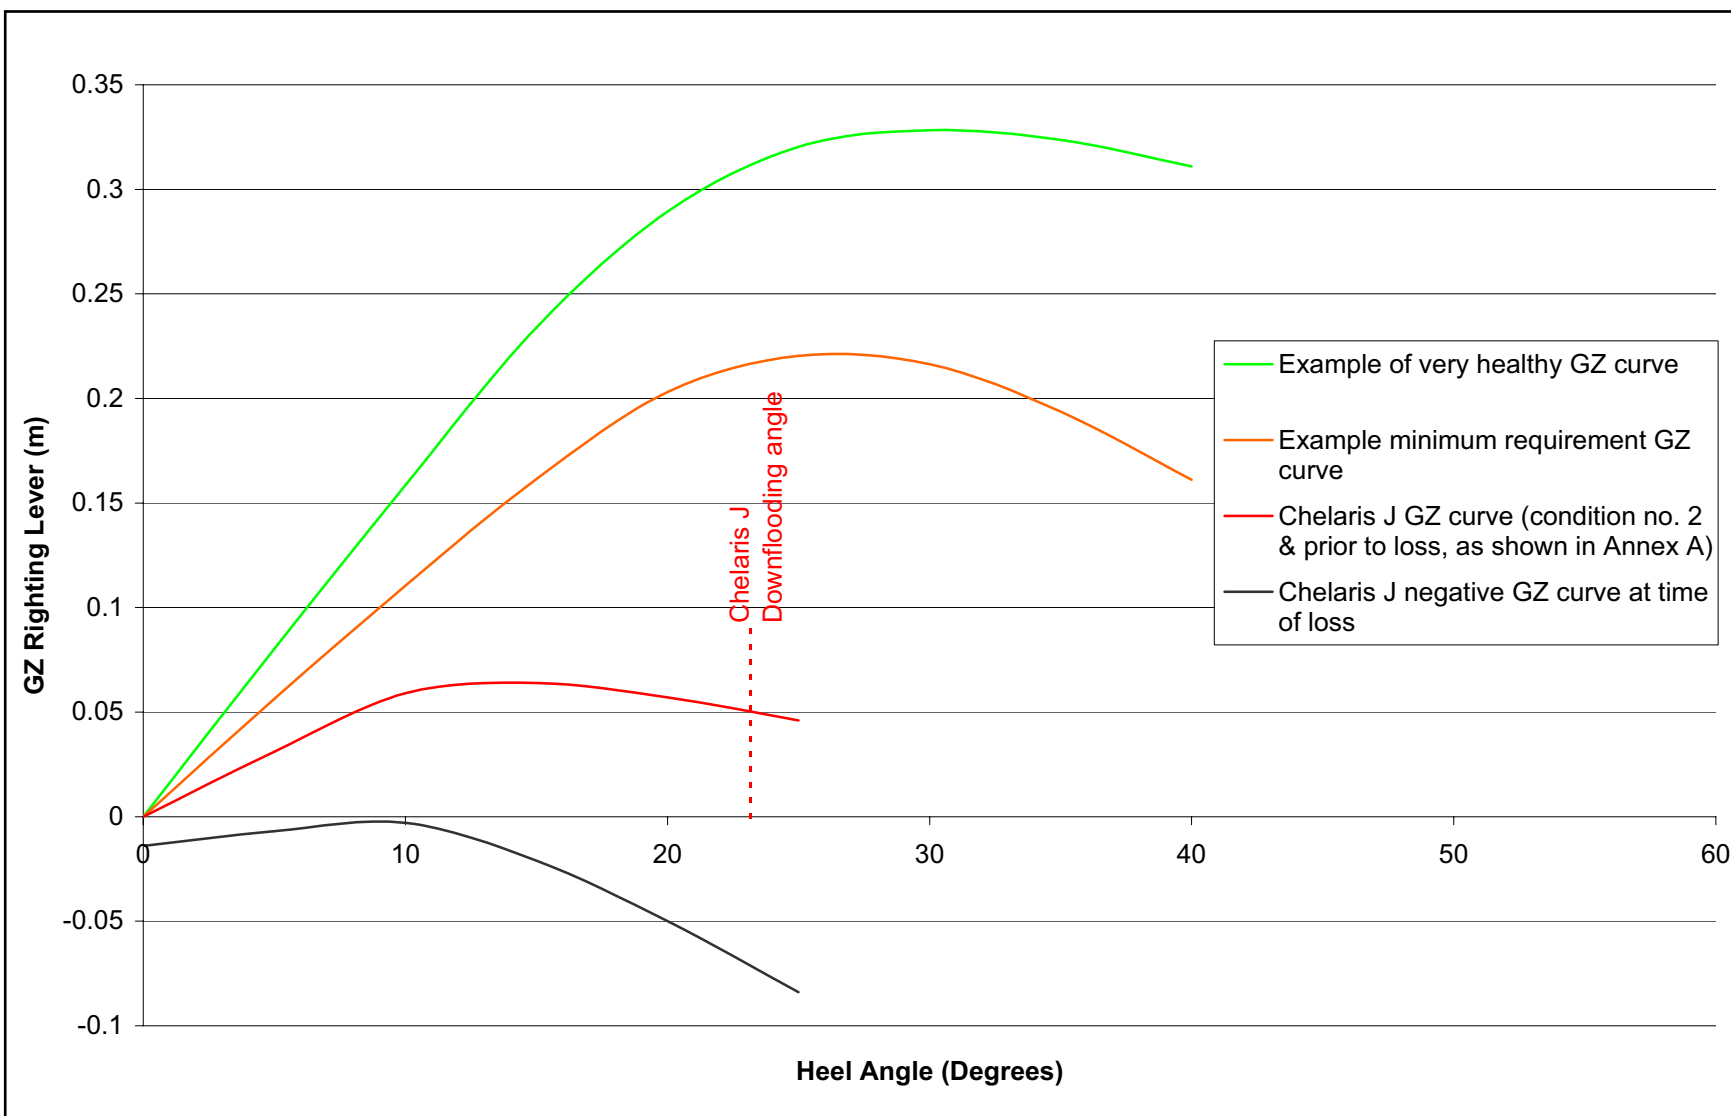
Figure 13

Table 1 of **Annex A** shows that *Chelaris J* fails to meet the stability requirements of the Fishing Vessels (Safety Provisions) Rules 1975, SI 1975 330 in any of the standard conditions. Condition 2 (depart port 100 % consumables, 3.5 tonnes of ice and 4 crew) was the best seagoing condition, but it still falls well below the required standard. **Figure 13** includes four fishing vessel GZ curves. One is an example of a curve with a good healthy margin of safety. The next is an example of a GZ curve that just meets the requirements as detailed in Section 6 of **Annex A**. The next curve is for *Chelaris J*, condition 2. It can be seen that the engine room vent immerses at just over 20° of heel, causing downflooding, and effectively cutting off the GZ curve. Condition 2 also happened to be very similar to the derived condition immediately prior to the loss. The last GZ curve is for the loss condition, which was created by splitting the load between the trawl blocks 70:30 to starboard, adding 0.1 tonne of water in the engine room and fish hold bilges, and including 0.1 tonne of water on the aft deck. This last righting lever never becomes positive, indicating *Chelaris J* would have capsized.

The stability analysis has shown that *Chelaris J* had very poor stability, so why did she not capsize before? One factor may be the effect of the bulwarks and shelter aft of the watertight bulkhead. In reality, these would have provided extra righting lever, temporarily improving her stability, but only as long as the vessel was not held over at an angle of heel greater than deck edge immersion for more than a few seconds.

Fishing vessel GZ curve comparison

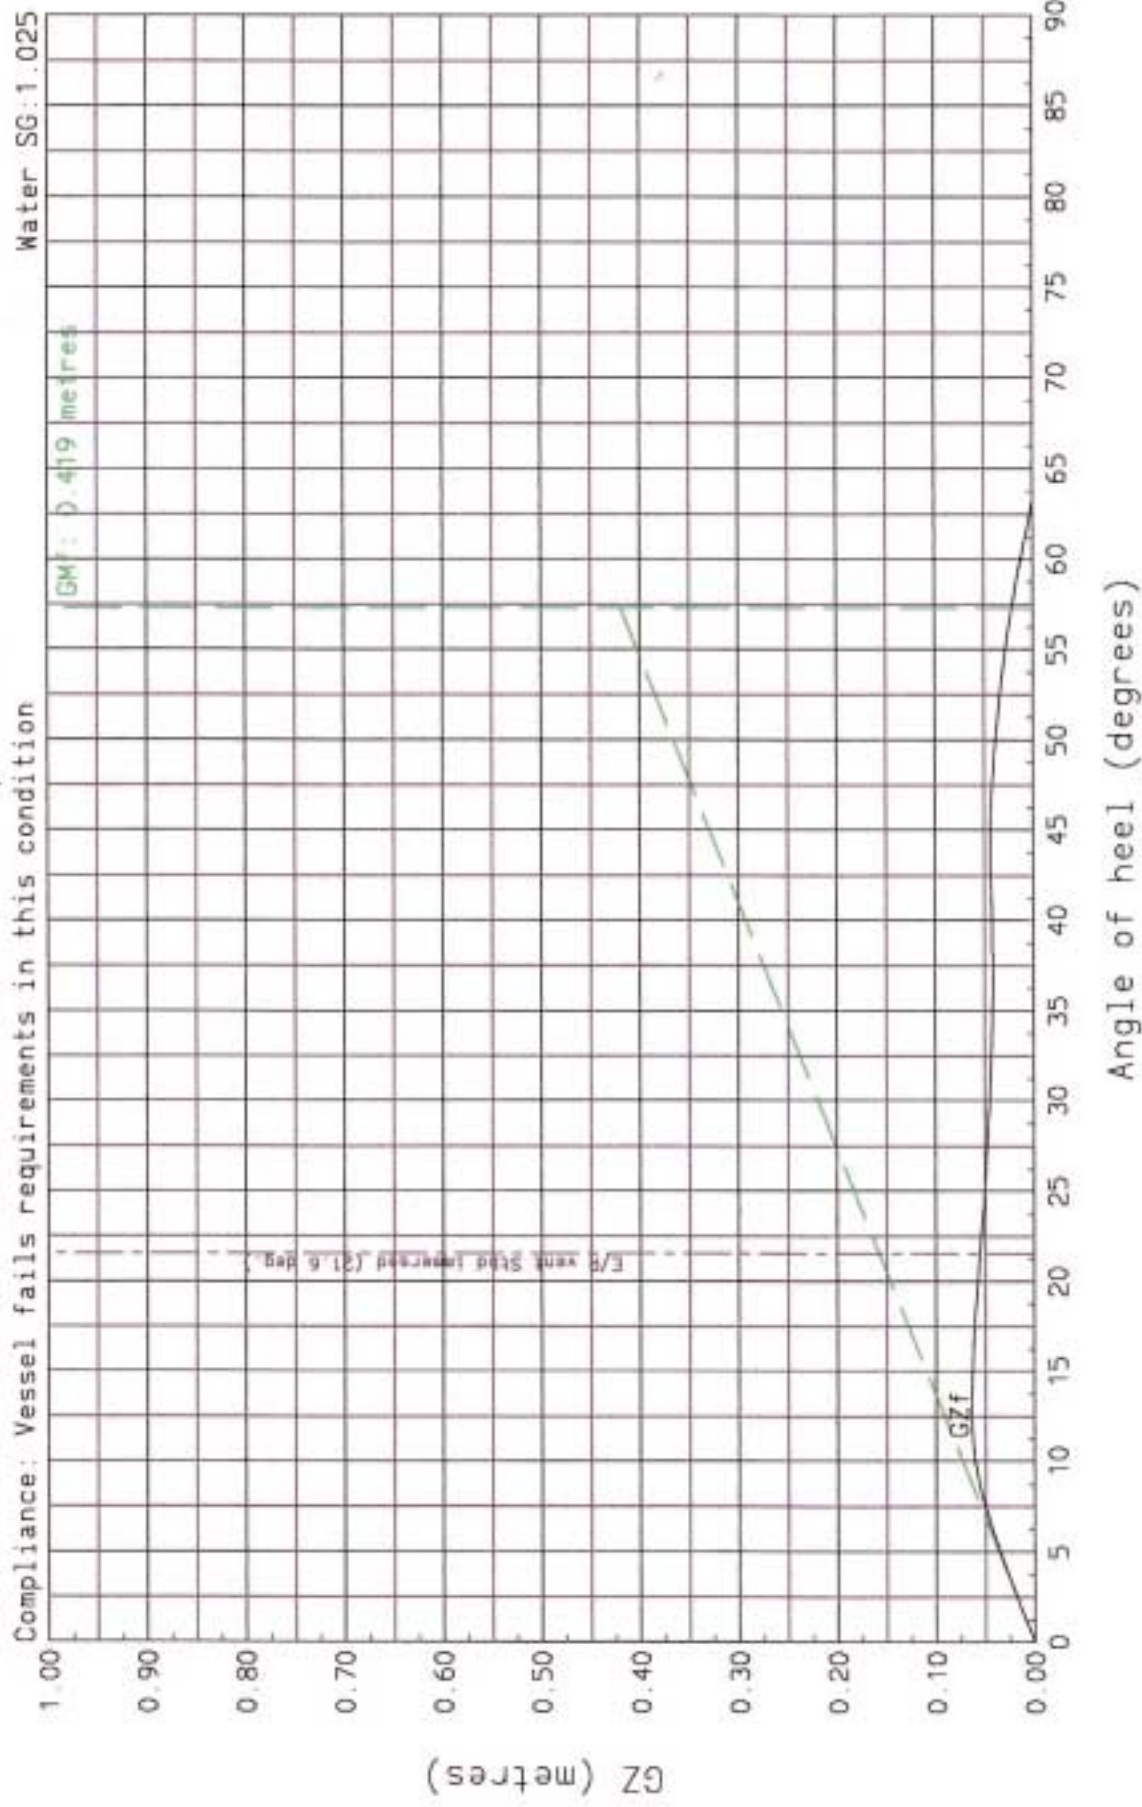
Condition.: Depart Port, 100% Consumables, 3.5 tonnes ice  
 State.: Intact inc. shelterdeck volume, exc. W/H volume  
 Compliance: Vessel fails requirements in this condition
