Report on the investigation of  
the capsizing and sinking of the fishing vessel

***Chelaris J (GU323)***

1 October 2003

**Report No 7/2004**  
**July 2004**

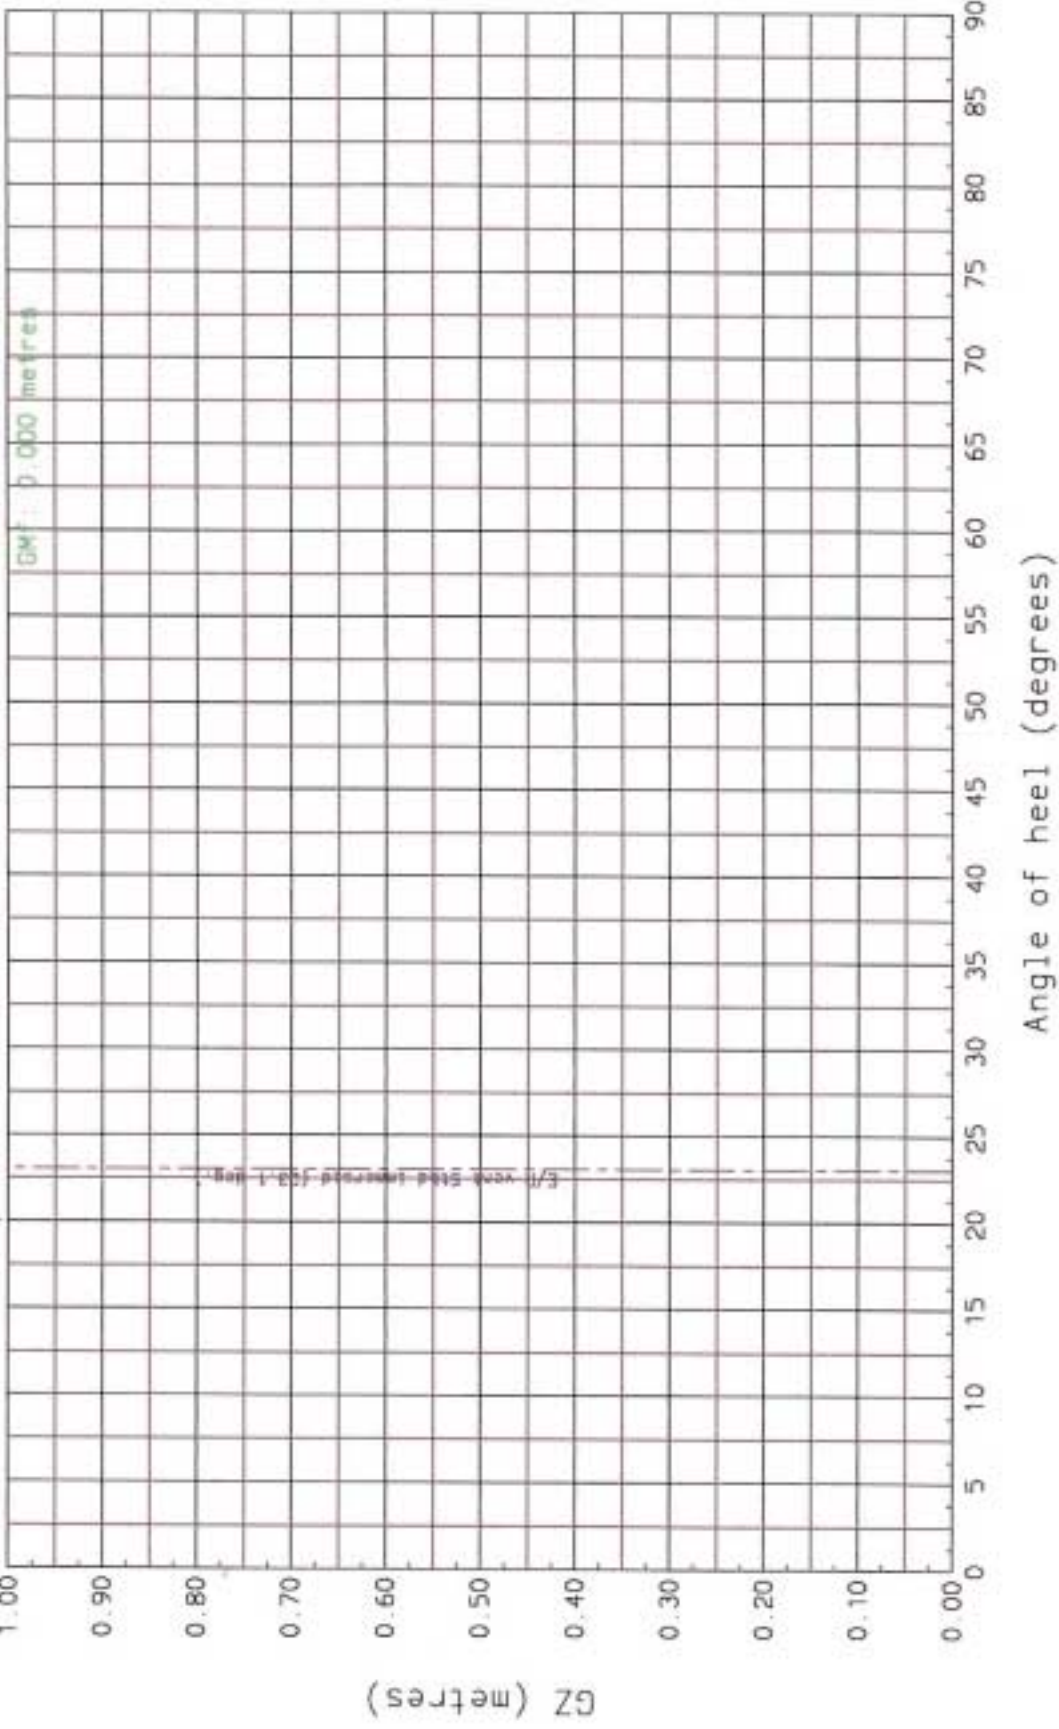
Condition.: Vessel condition immediately prior to accident  
 State.: Intact inc. shelterdeck volume, exc. W/H volume  
 Compliance: Vessel fails requirements in this condition

WARNING....: Vessel capsizes in this condition
