Report of investigation into swamping of

**unnamed cabin cruiser**

in Lady Bay on Loch Ryan,

**Report No 4/2004**  
**April 2004**

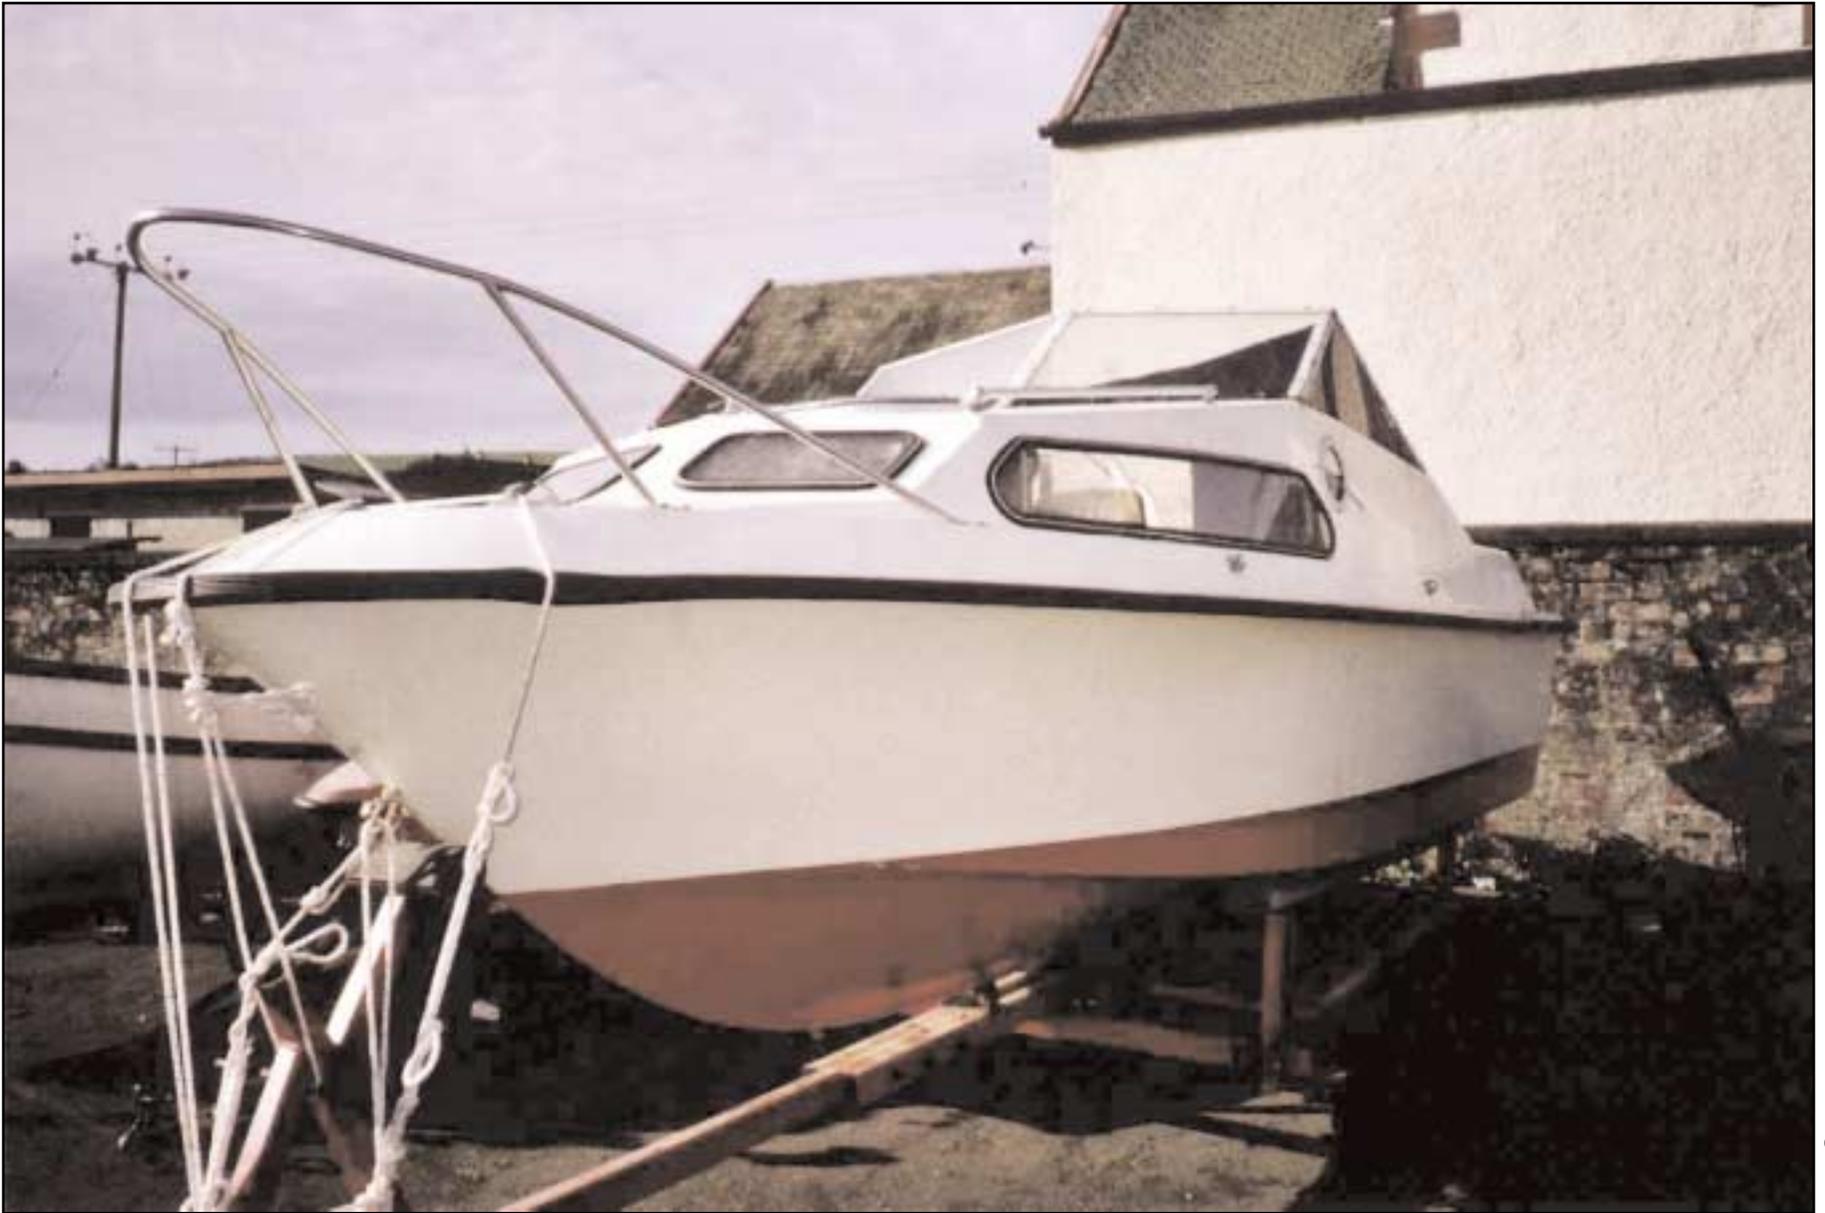
Figure 1

The cabin cruiser

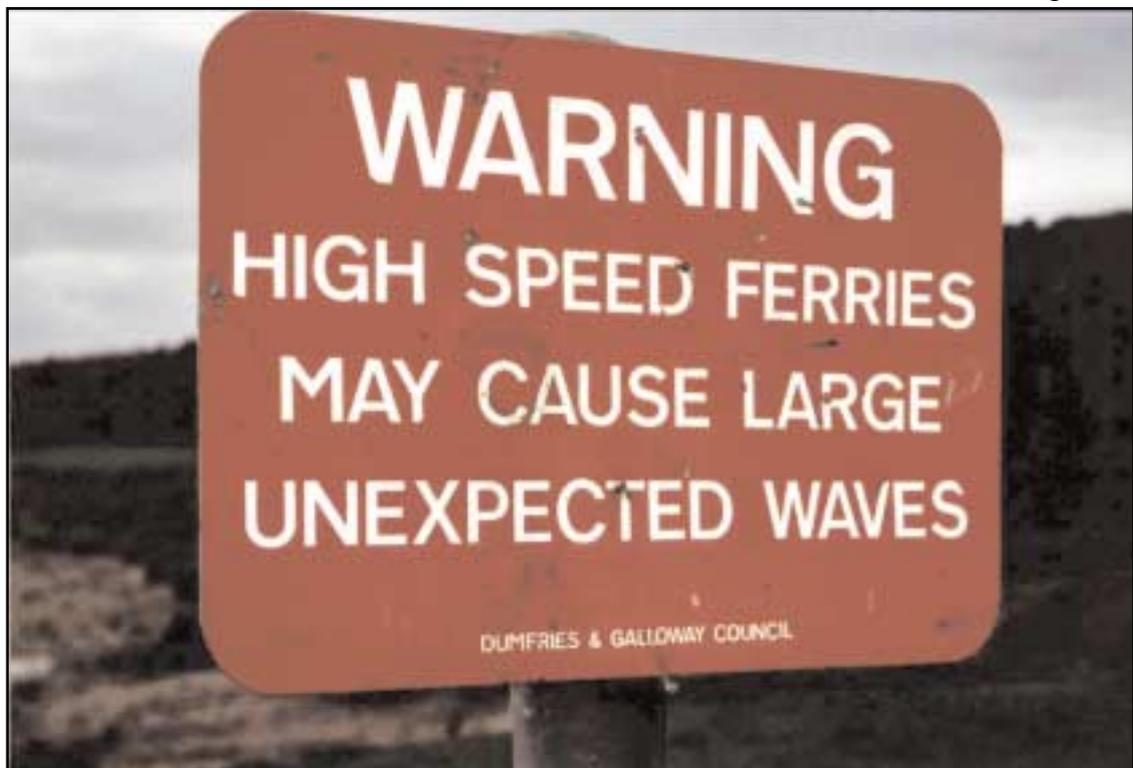
Figure 3

Two warning signs are displayed on posts. These warn of the possibility of waves being generated by passing high-speed ferries (**Figure 3**).

Warning sign

The aim of warning signs is, to a degree, the education of visitors to potential dangers. In view of the possible size of waves, and the delay between the ferry passing and the waves striking the shoreline, it is considered that the wording of the existing signs is inadequate.

The wording of these signs gives only a very limited indication of the possible severity and type of hazard. Even less does it indicate when the waves might appear. Few non-mariners would realise that the waves might appear several minutes after a ferry has passed; even fewer would realise they could appear from a smooth water surface.

It is considered that the present warning signs around Loch Ryan are of little value, even to persons who read them conscientiously. As such, the concept of warning signs has not been given a fair test as to whether it is a worthwhile and effective control measure for reducing the risks generated by waves. It is recommended that, as an immediate step, all the existing signs be replaced by some which vividly and immediately convey the necessary message. Any signs that offer sufficient information to understand the nature and level of danger need to be carefully and imaginatively worded and illustrated. Examples are the images used on road signs.

- 2004/153      Replace the existing signs warning of waves generated by fast ferries, with signs which fully reflect the nature, level and timing of the potential hazard.

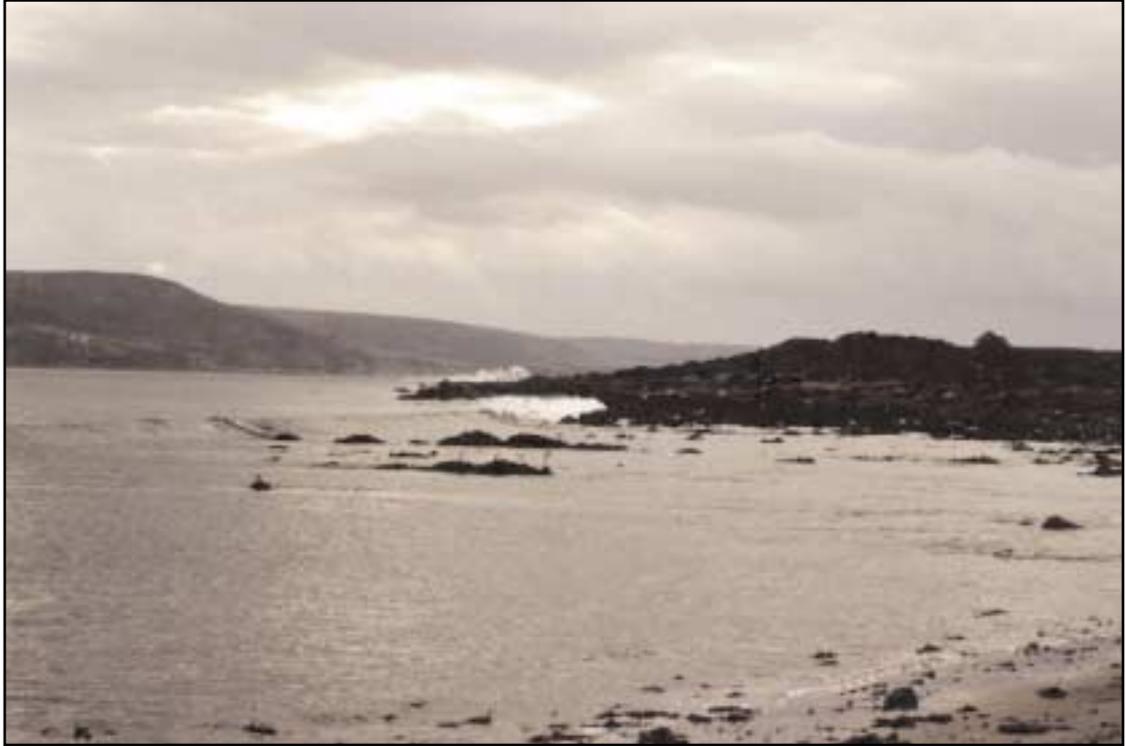
Figure 4

From the car park at Lady Bay, it is possible to see about 2 miles to the south-east, almost to Cairn Point on the opposite side of the loch (**Figure 4**). However, because of adjacent cliffs, visibility to the north is very restricted, and the opposite side of the loch cannot be seen much further north than Finnart's Bay (**Figure 5**).

View to the south from the car park at Lady Bay

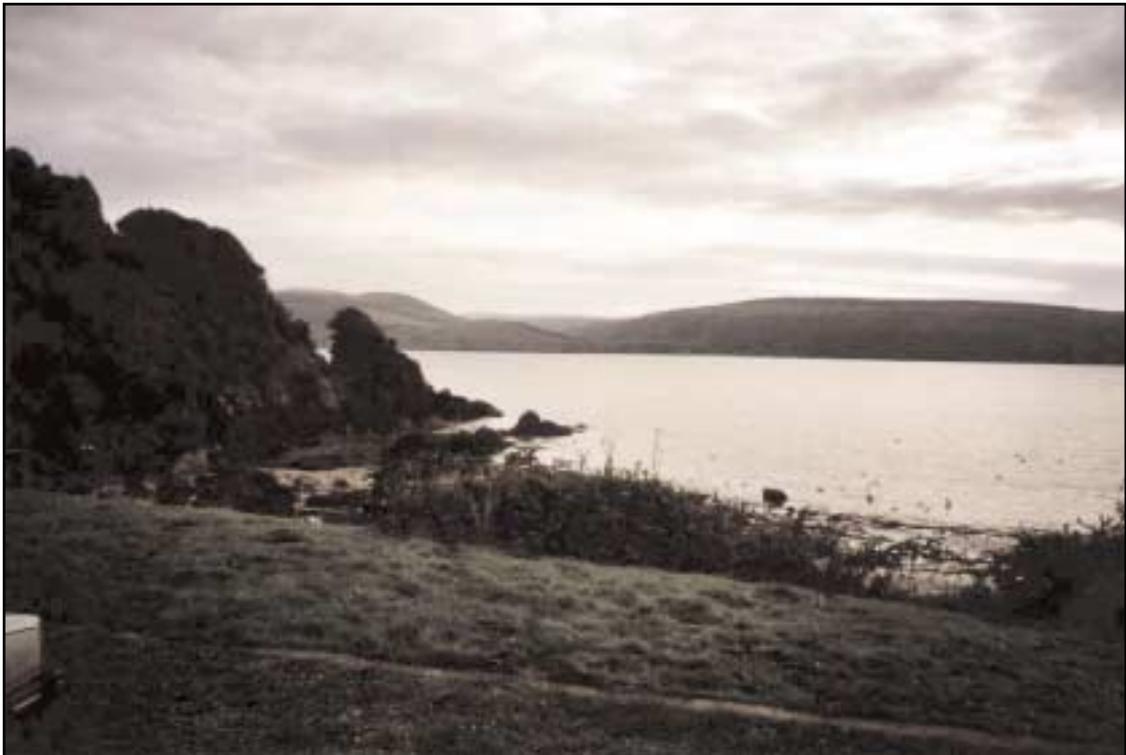
Figure 5

View to the north, restricted due to the adjacent cliffs

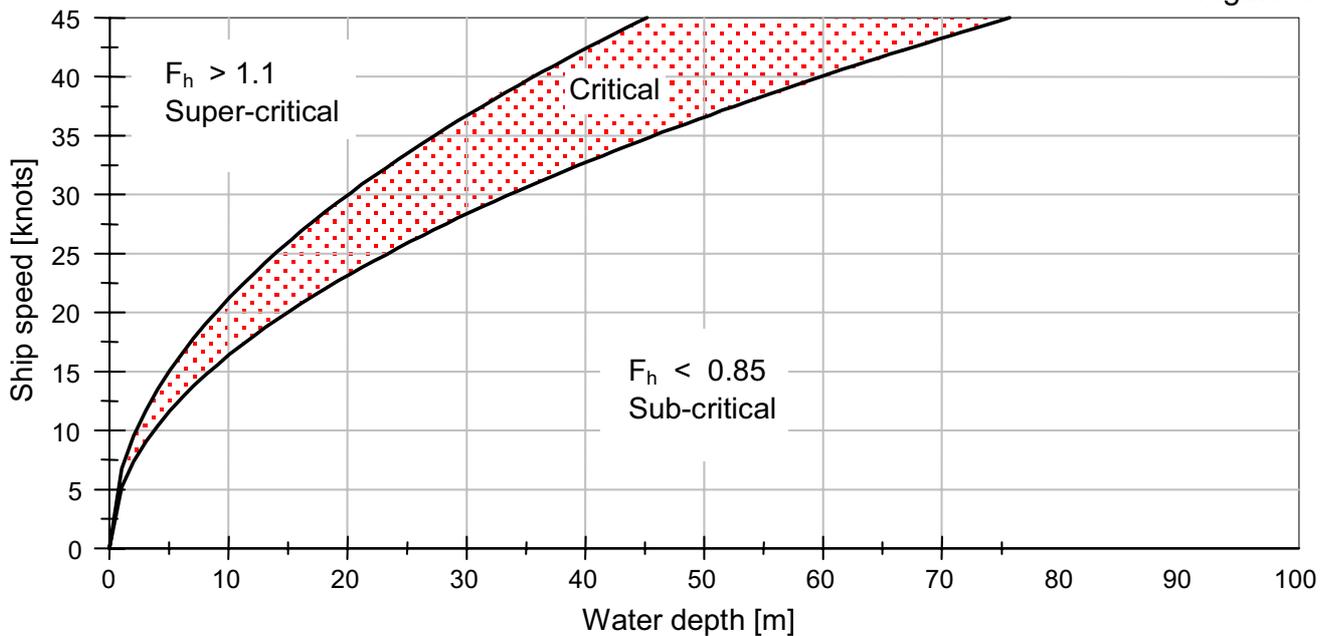
Repeated observations plotted in this way show that there are values of  $F_h$  between which the waves may be at their most troublesome. These are between 0.85 and 1.1, the critical speed range. Either side of this range, the speeds are referred to as super-critical and sub-critical (**Figure 6**).

Ship speed / water depth curves

Thus, any vessel of significant displacement running in the critical speed range, for the water's depth, could cause wave problems which have been frequently attributed to only high-speed craft. This is shown on the speed/depth curves in **Figure 6**, where a vessel running at 15 knots in water 7 metres deep is within the critical speed range. A conventional ferry might comfortably and regularly operate under such conditions.
