Report of investigation into swamping of

unnamed cabin cruiser

in Lady Bay on Loch Ryan,

Report No 4/2004
April 2004

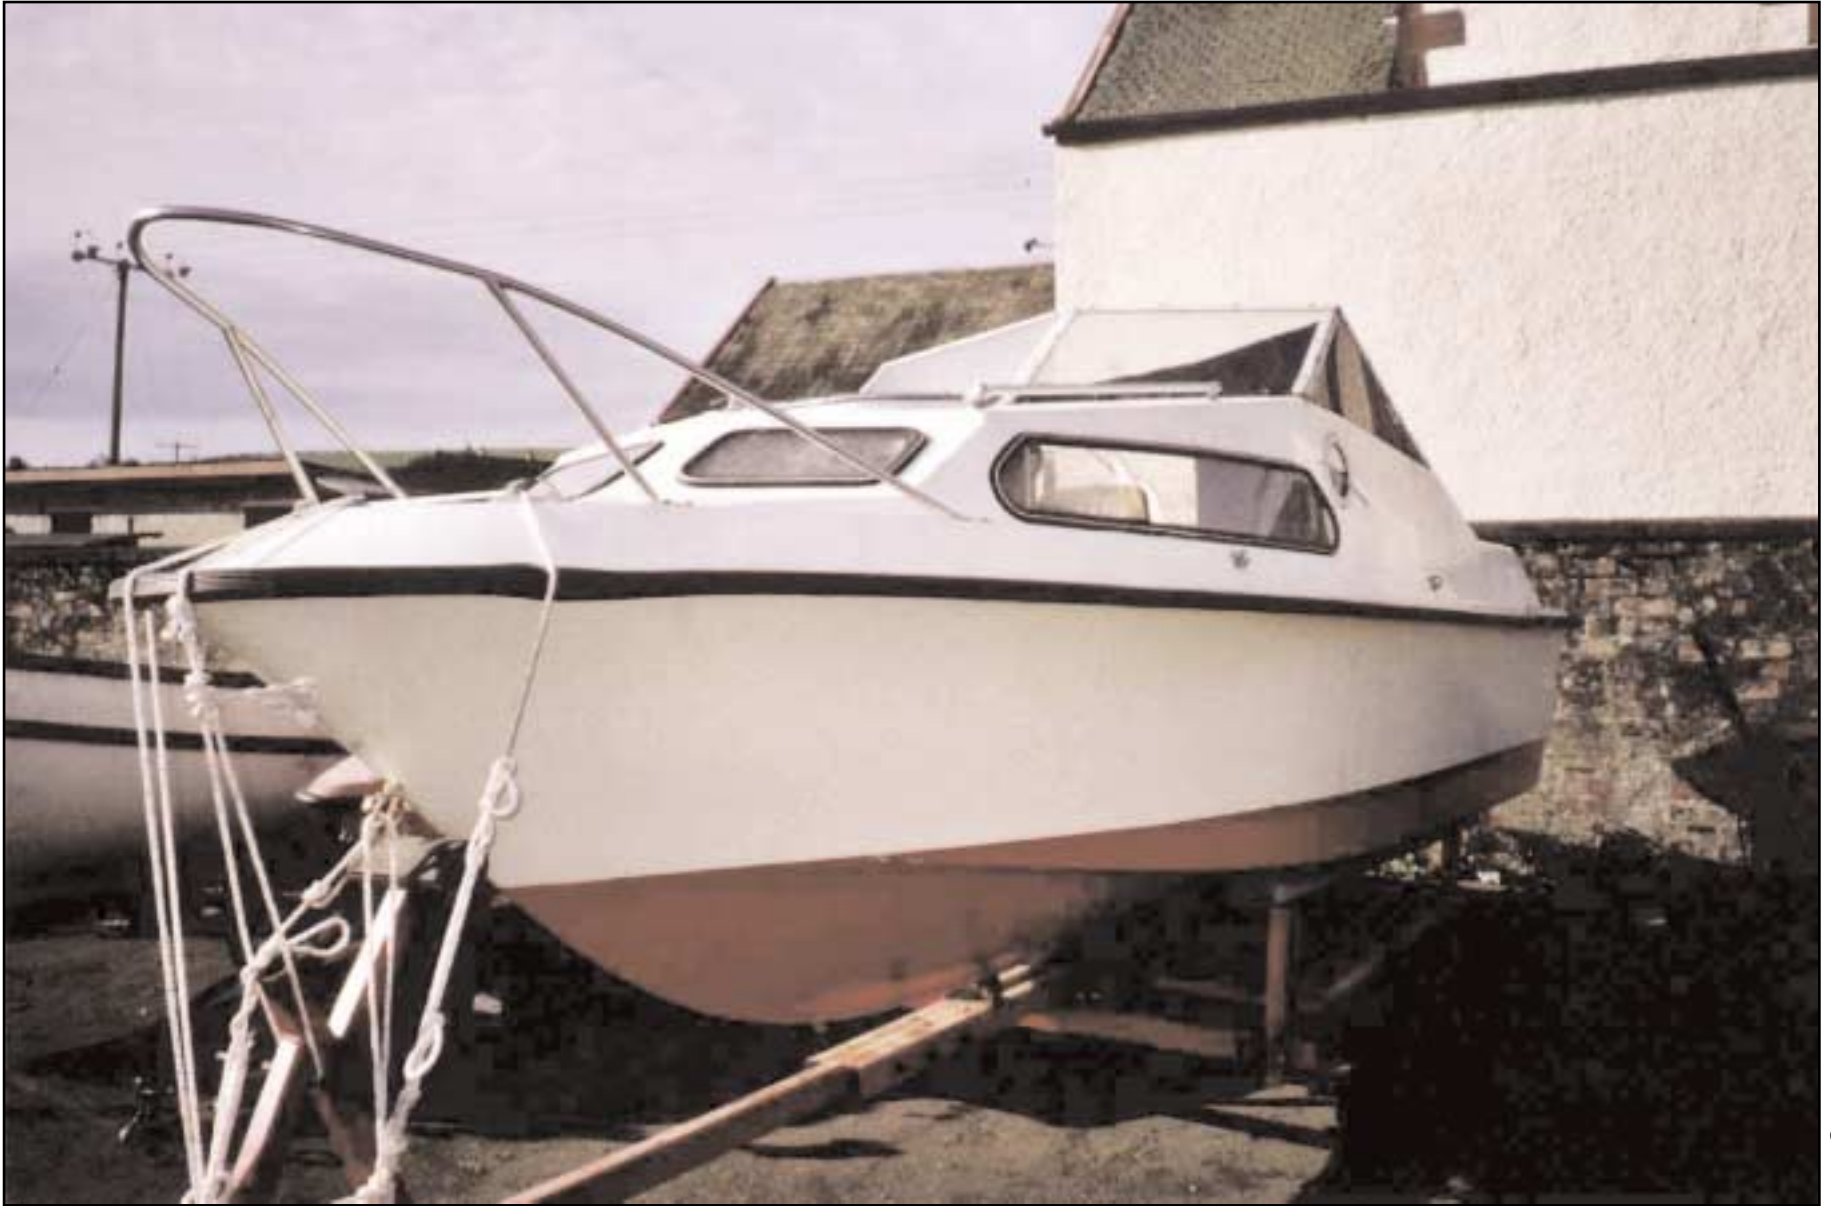
The cabin cruiser

However, the owner turned and saw a wave a few metres away approaching the stern of the boat. The wave contacted the boat, swung her stern around and drove it towards the beach. A second wave then struck the boat. The result was that the boat grounded in very shallow water.

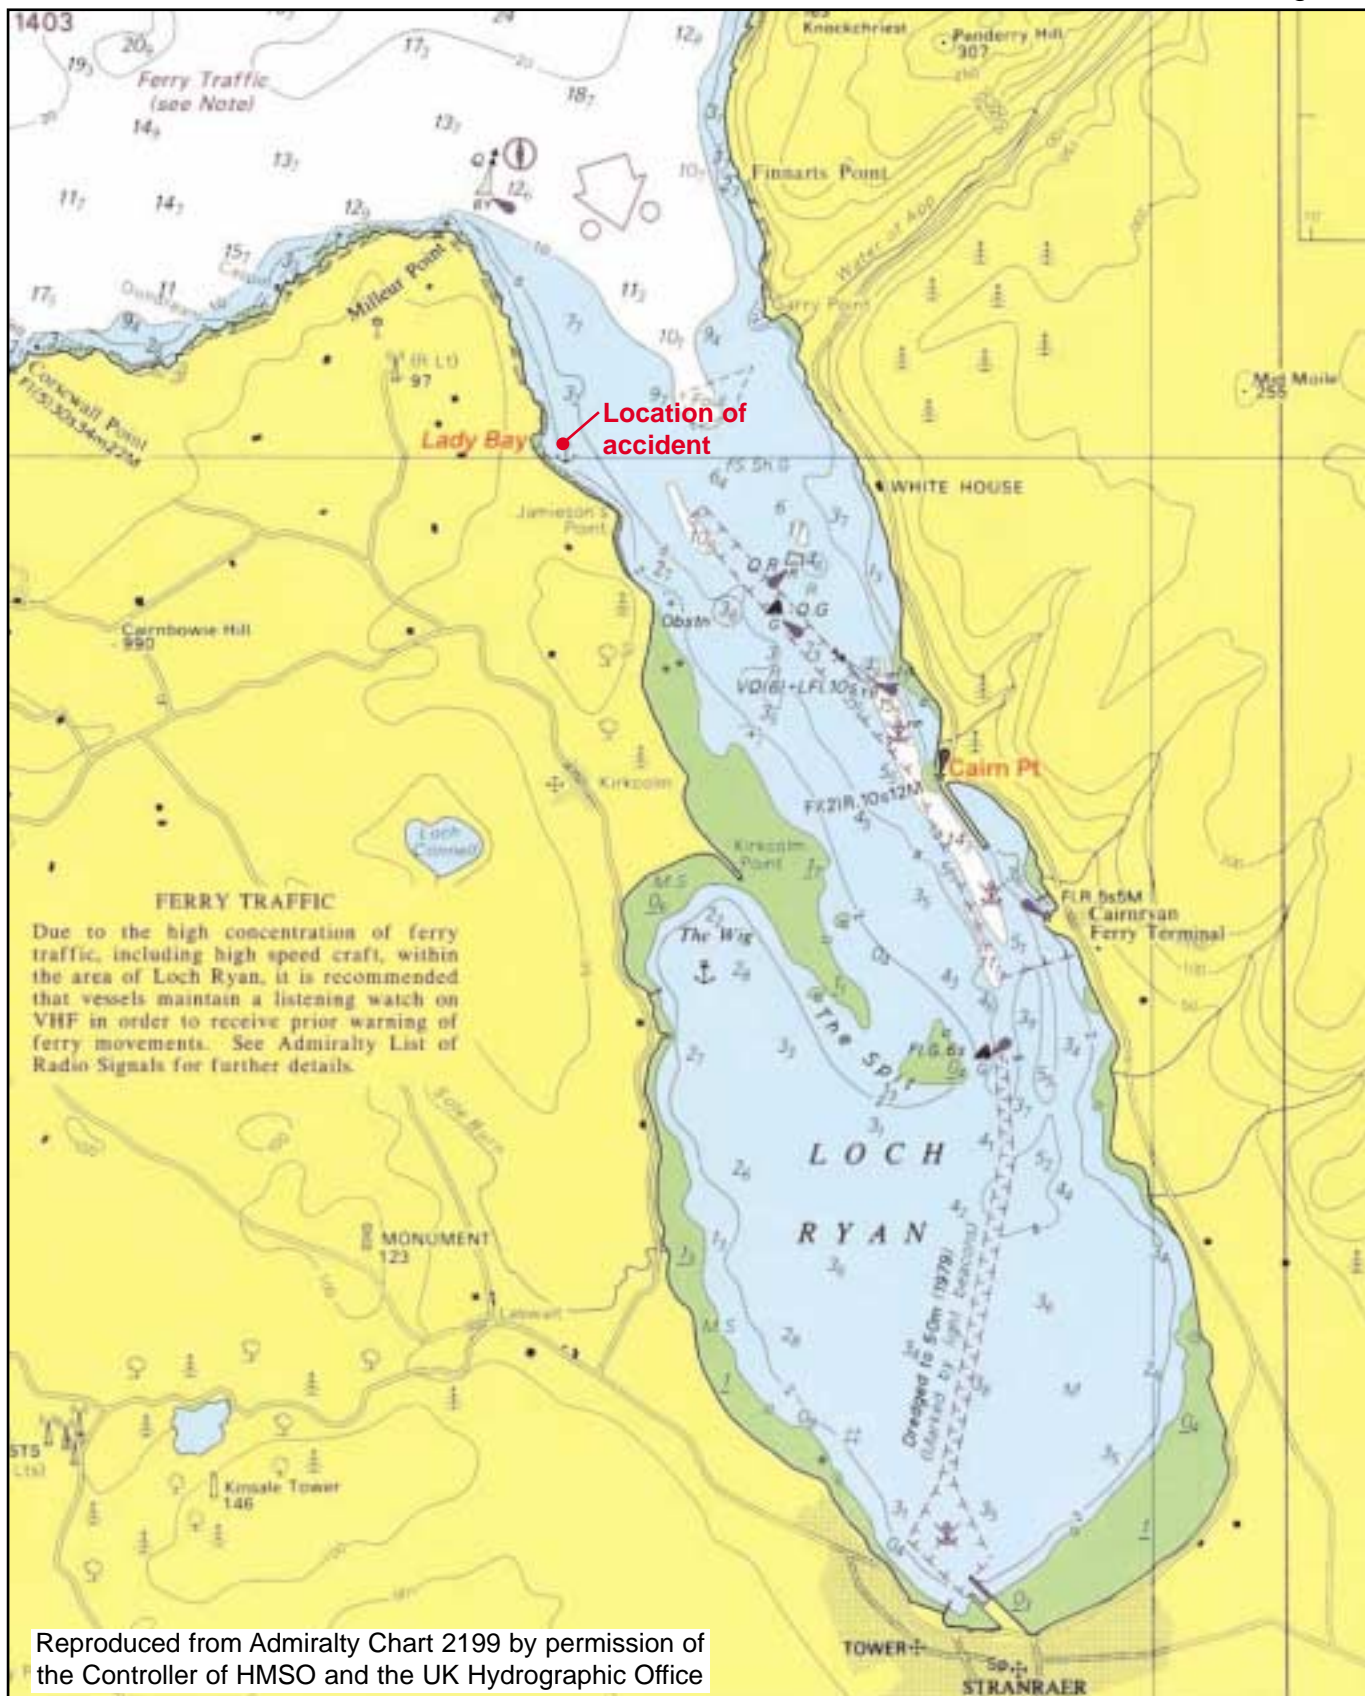
Figure 2

Chart of Loch Ryan showing the location of the accident

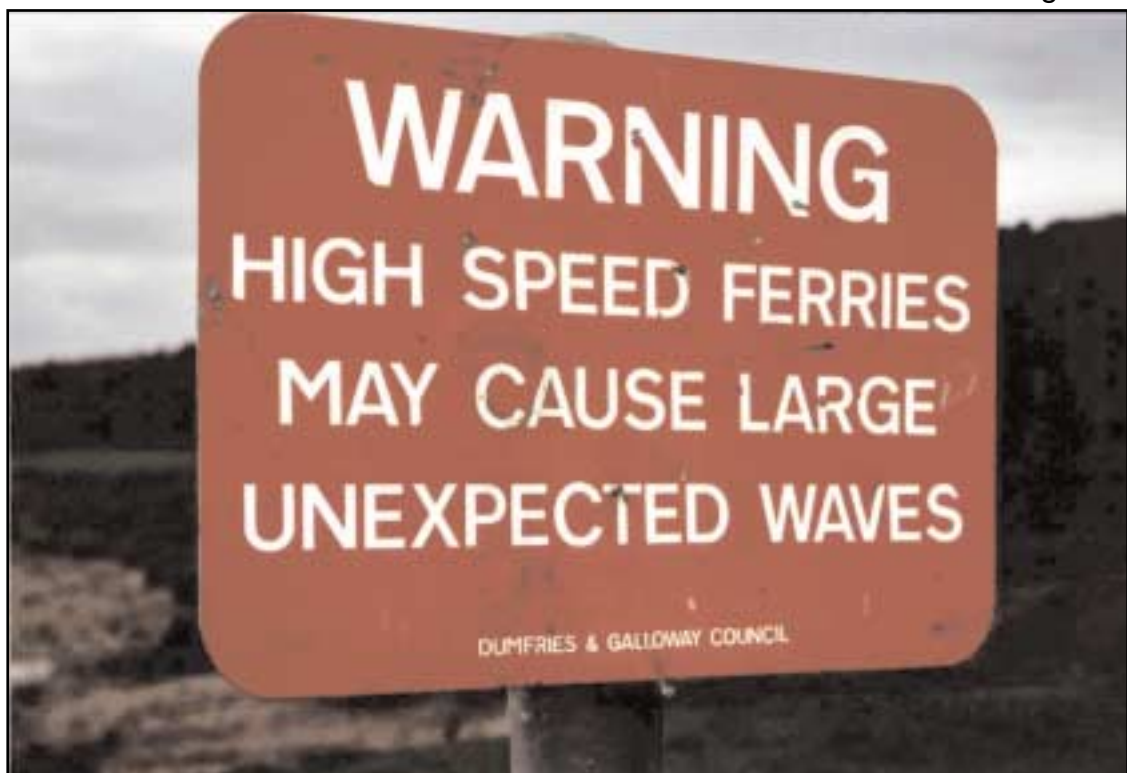
Figure 3

Warning sign

The aim of warning signs is, to a degree, the education of visitors to potential dangers. In view of the possible size of waves, and the delay between the ferry passing and the waves striking the shoreline, it is considered that the wording of the existing signs is inadequate.

The wording of these signs gives only a very limited indication of the possible severity and type of hazard. Even less does it indicate when the waves might appear. Few non-mariners would realise that the waves might appear several minutes after a ferry has passed; even fewer would realise they could appear from a smooth water surface.

It is considered that the present warning signs around Loch Ryan are of little value, even to persons who read them conscientiously. As such, the concept of warning signs has not been given a fair test as to whether it is a worthwhile and effective control measure for reducing the risks generated by waves. It is recommended that, as an immediate step, all the existing signs be replaced by some which vividly and immediately convey the necessary message. Any signs that offer sufficient information to understand the nature and level of danger need to be carefully and imaginatively worded and illustrated. Examples are the images used on road signs.

- 2004/153 Replace the existing signs warning of waves generated by fast ferries, with signs which fully reflect the nature, level and timing of the potential hazard.

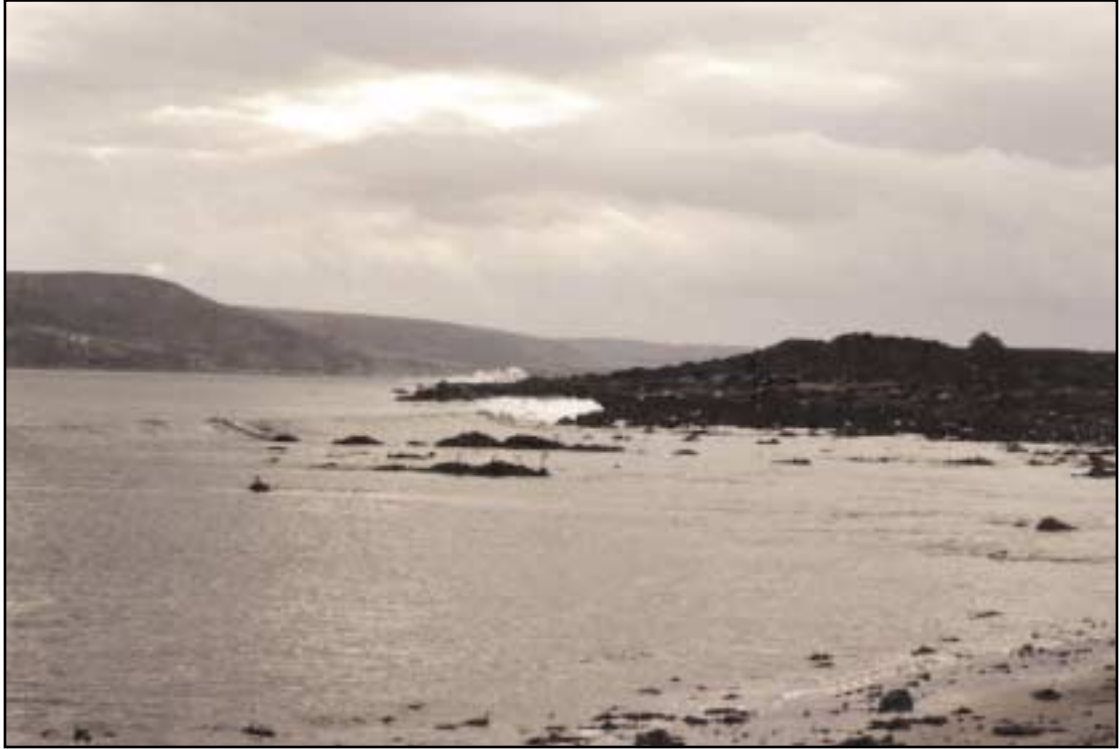
Figure 4

From the car park at Lady Bay, it is possible to see about 2 miles to the south-east, almost to Cairn Point on the opposite side of the loch (**Figure 4**). However, because of adjacent cliffs, visibility to the north is very restricted, and the opposite side of the loch cannot be seen much further north than Finnart's Bay (**Figure 5**).

View to the south from the car park at Lady Bay

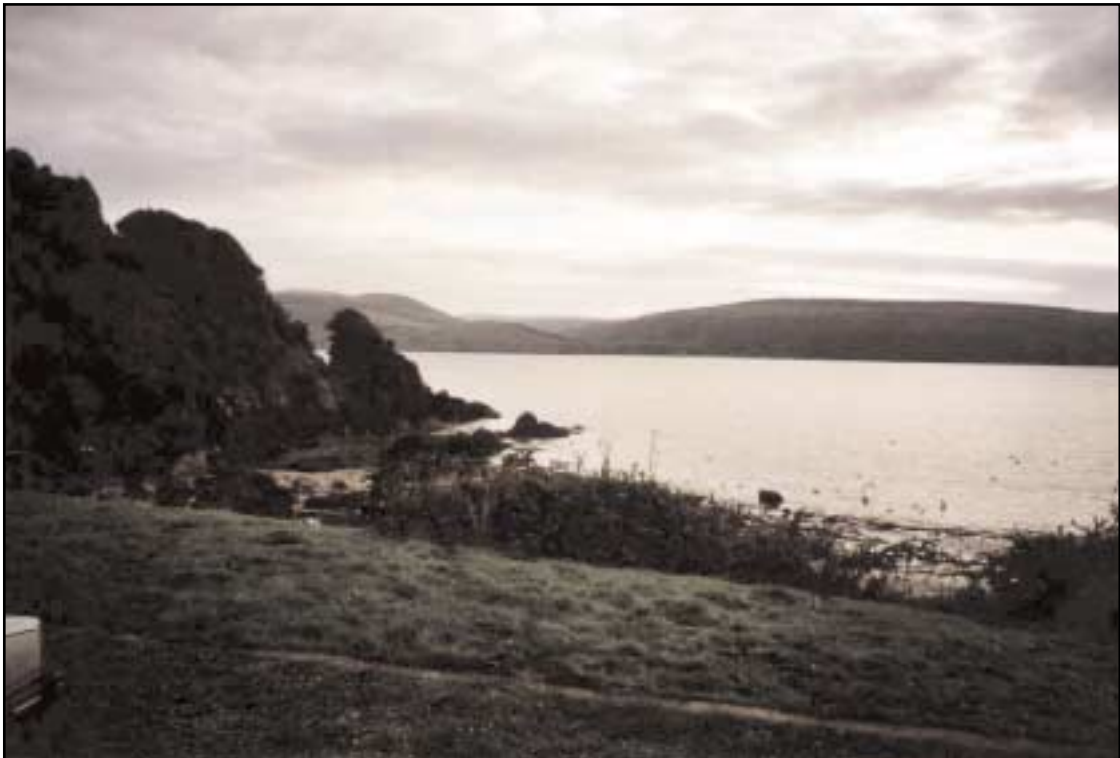
Figure 5

View to the north, restricted due to the adjacent cliffs

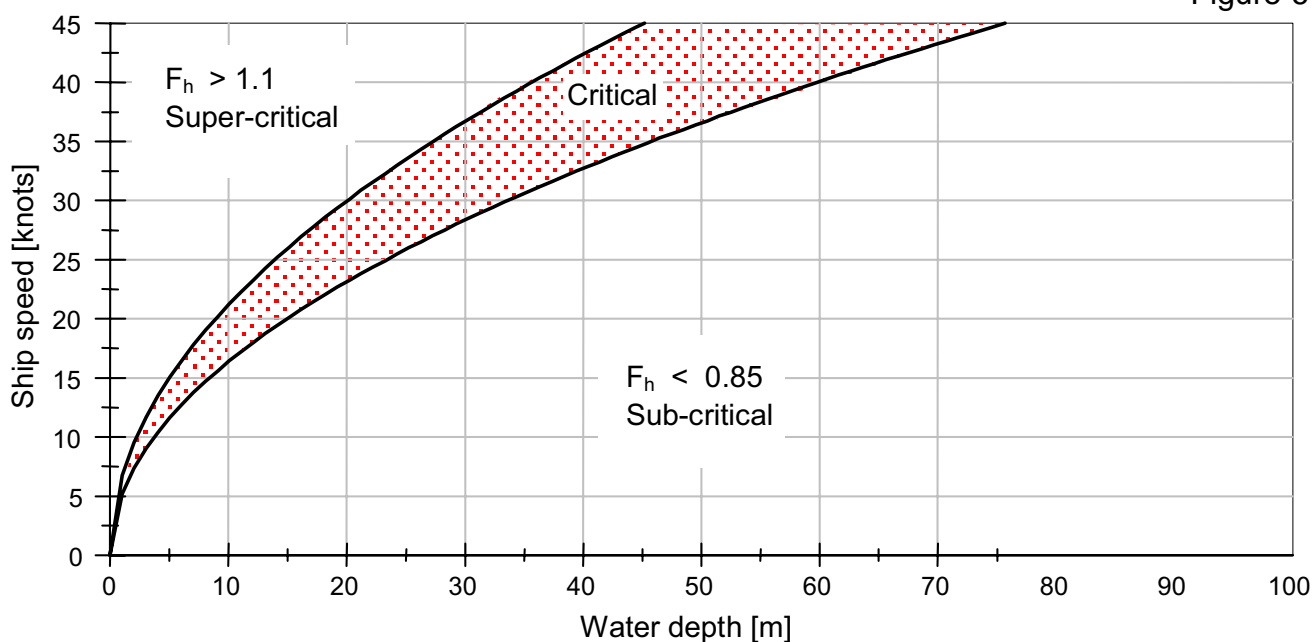
Repeated observations plotted in this way show that there are values of F_h between which the waves may be at their most troublesome. These are between 0.85 and 1.1, the critical speed range. Either side of this range, the speeds are referred to as super-critical and sub-critical (**Figure 6**).

Ship speed / water depth curves

Thus, any vessel of significant displacement running in the critical speed range, for the water's depth, could cause wave problems which have been frequently attributed to only high-speed craft. This is shown on the speed/depth curves in **Figure 6**, where a vessel running at 15 knots in water 7 metres deep is within the critical speed range. A conventional ferry might comfortably and regularly operate under such conditions.
