Report on the investigation into the flooding
and foundering of the fishing vessel

Elhanan T

about 110 miles east-north-east of Fraserburgh
on 14 August 2003

**Report No 3/2004
March 2004**

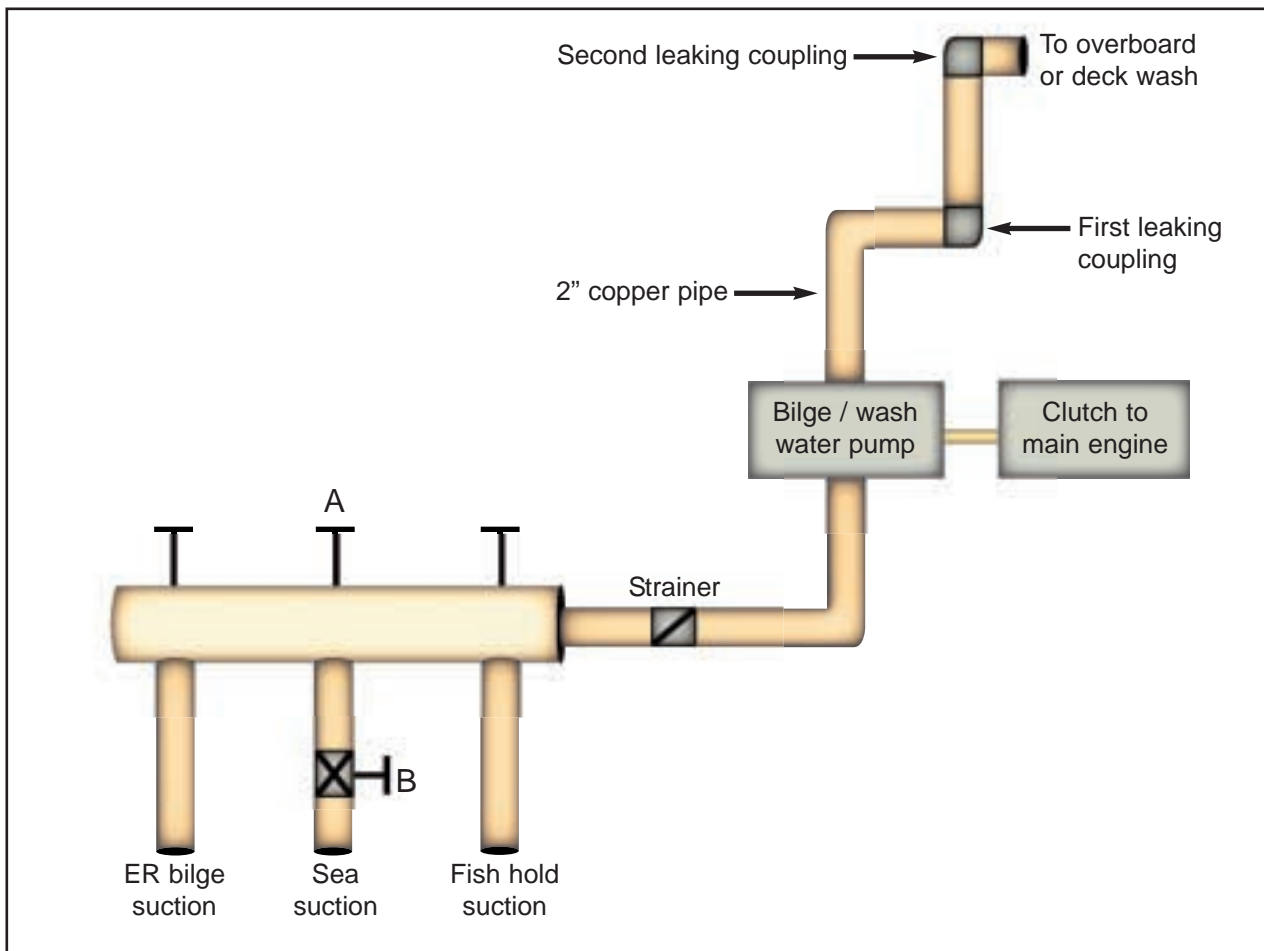
Figure 1

The skipper then attempted to halt the flow of water by closing the relevant seacock (B on **Figure 1**), but it was seized in the open position.

Diagrammatic illustration of the primary bilge and deck wash pumping system

The skipper then tried to stop the flooding by operating the appropriate seacock. However, the seacock was seized. Seacocks on *Elhanan T* were not regularly operated and maintained. Seacocks are vital for safety. They should be operated regularly, to ensure that they are free. It is good practice to close all the seacocks when a fishing trip is complete. This will help to prevent problems while alongside. Pipework can fail in harbour; vessels have sunk as a result. The seacocks were not routinely operated on *Elhanan T* and, for this reason, it is not surprising that the seacock referred to earlier was seized shut. If it could have been closed, this vessel would have been saved.

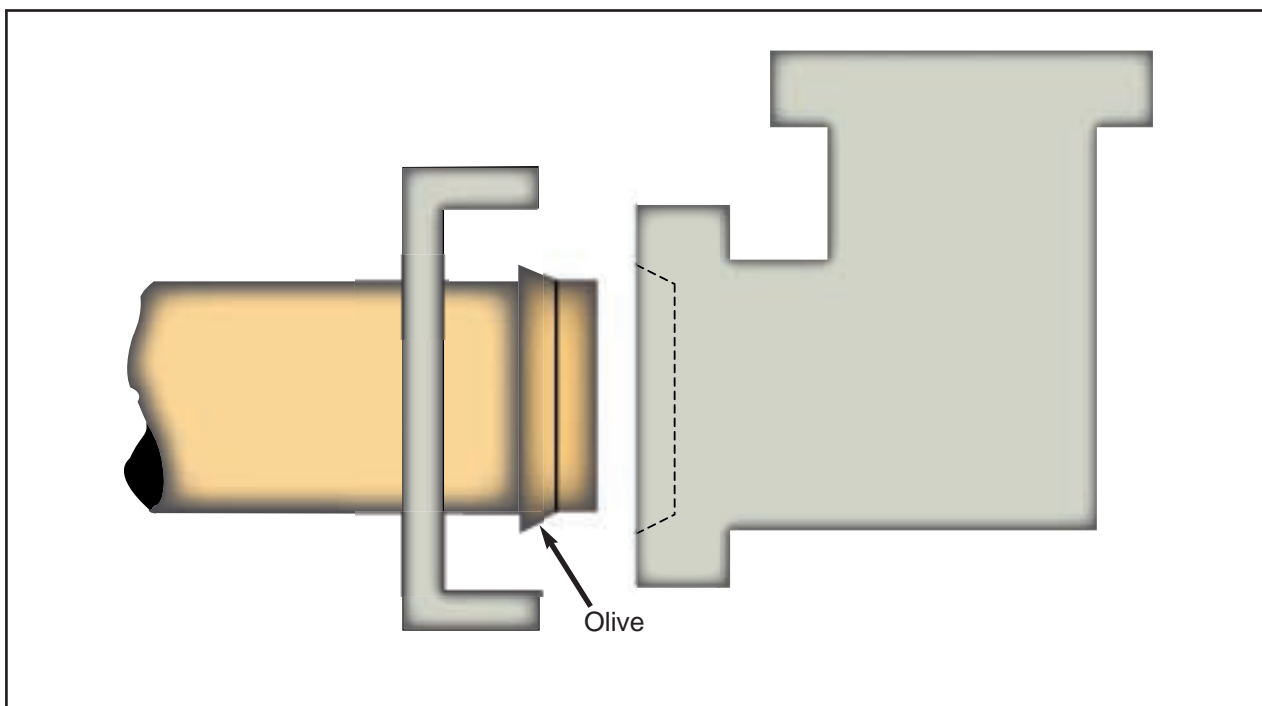
Figure 2

A compression fitting on the discharge side of the deck wash pump, which supplied the deck water and also doubled as the bilge pump, had failed, and the water which should have been supplied to the deck hose was being discharged into the engine room (**Figure 1**). The pump was declutched from the main engine, and the appropriate valve (A in **Figure 1**) on the valve box was closed to stop any water flow caused by static head from the sea. The pipe in this position was below the waterline. The skipper wound plumbers' tape around the olive (**Figure 2**), which was his usual practice, and then re-connected the compression fitting, tightening it firmly. He then opened valve A and "rapidly clutched in the pump" to pulse-test the coupling. The coupling appeared tight, so he returned to the wheelhouse.

About 30 minutes later, electrical systems in the wheelhouse, including the fish plotter, started to fail. Once again, the skipper went below to the engine room. He found that the next compression fitting to the one just repaired had burst open (**Figure 1**). This time, water sprayed across the entire engine room. Some of the electrical fittings, including fuse boxes, were being soaked. The pipe and its joints had caused problems in the past, and had been replaced 3 years previously.

Diagrammatic illustration of the compression coupling arrangement on *Elhanan T*

It is evident in *Elhanan T's* case that the connections for the discharge pipe from the main engine bilge pump were not sufficiently robust. They had caused problems in the past, which resulted in the pipe being renewed. However, it was only about 3 years after the work had been undertaken that failures of the joints caused the loss of *Elhanan T*. Compression fittings were not suitable for such a critical pipe; bolted flanged joints should have been used.

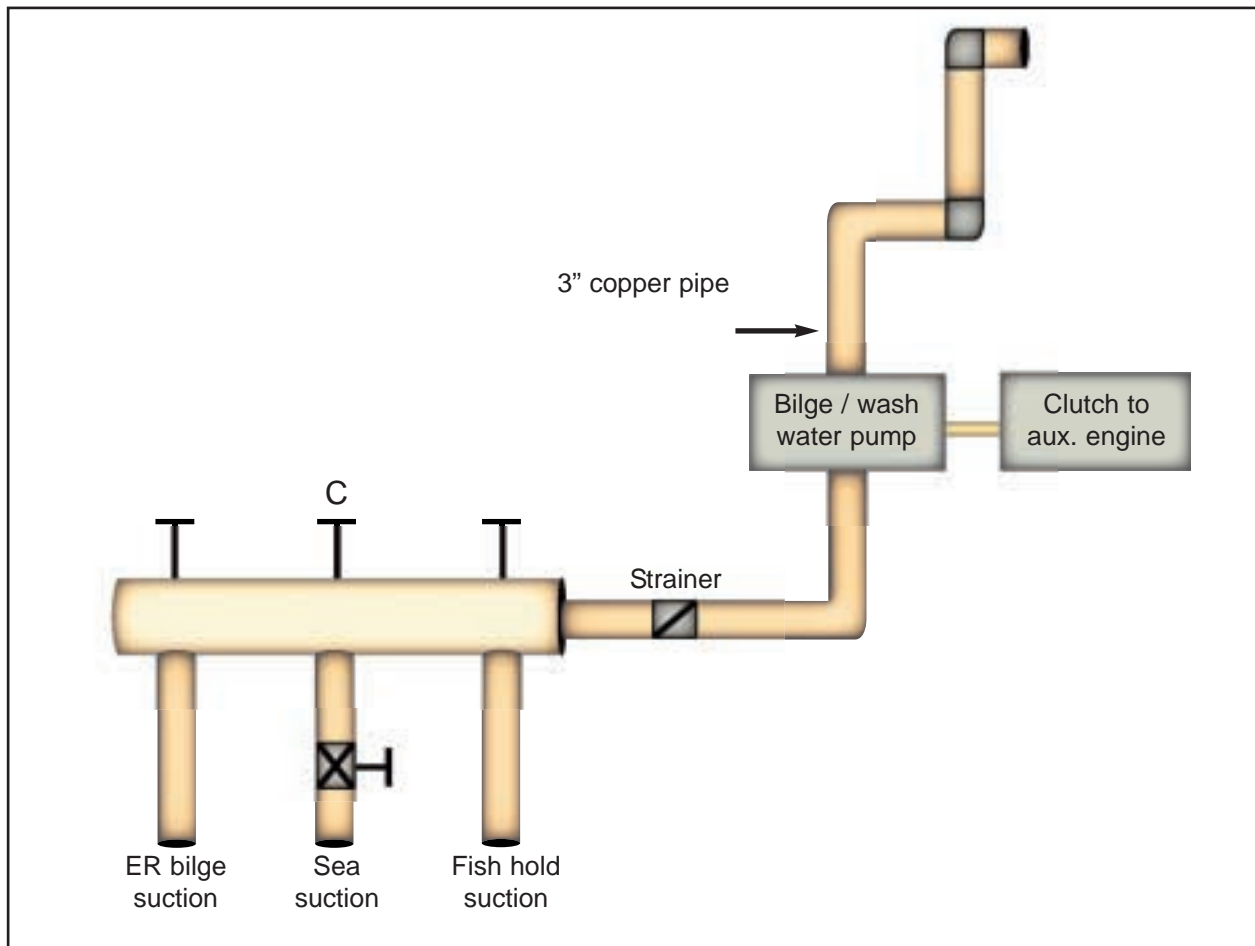
The skipper then started the other bilge pump (**Figure 3**), which was powered from the auxiliary engine. He took suction from the sea to prime it, he then opened the engine room bilge suction, and shut-in the sea suction so that only one turn remained open (C on **Figure 3**), (this was normal practice when the vessel's bilges were pumped out, because it prevented possible damage to the pump if the bilge ran dry). The skipper did not close the sea inlet valve fully at the time of the accident. Had he done so, the pump might have been more efficient. He tried to shut the jammed valve on the valve box again, but without success. The flooding could not be stopped, and the skipper realised the problem was serious. Bearing this in mind, he returned to the wheelhouse and, using the portable VHF radio, he called the skipper of the vessel *Deliverance*, which was fishing nearby, and told him about the situation. The skipper of *Deliverance* called the coastguard on his medium frequency (MF) radio and, at 1140, the coastguard designated the incident a "Mayday".

Diagrammatic illustration of the secondary bilge and deck wash pumping system

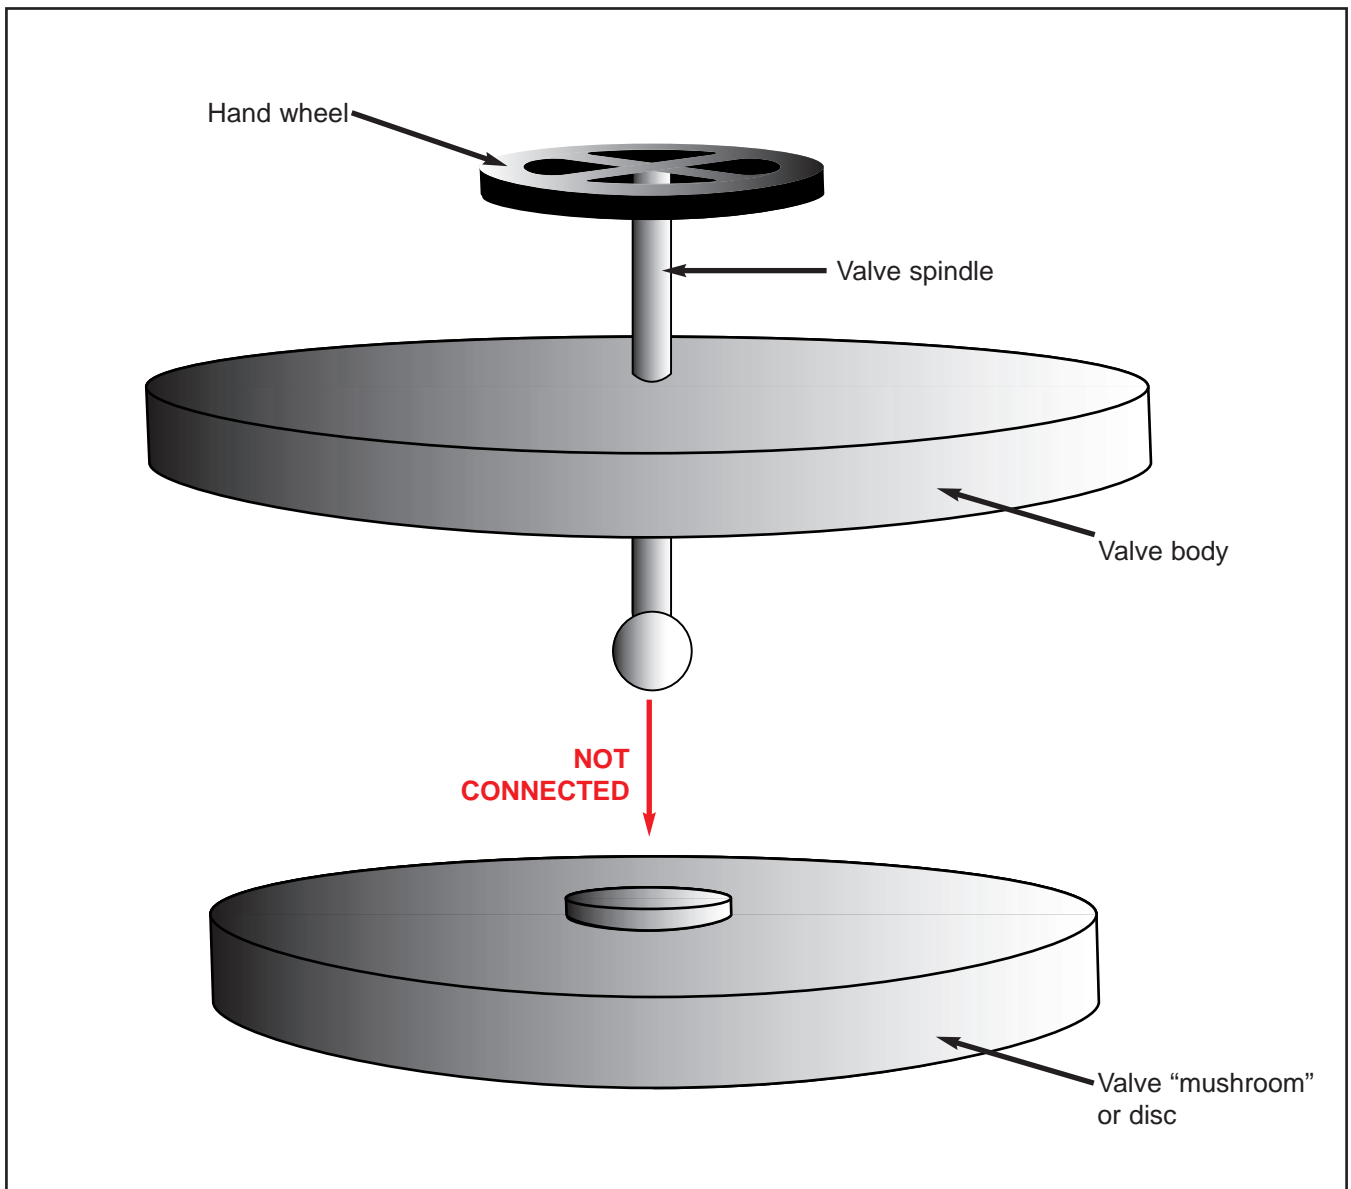
Figure 5

Diagrammatic illustration of the valve

After the second compression coupling failure on board *Elhanan T*, the skipper tried unsuccessfully to isolate the pipe using the same local valve he had used previously; he found the valve was jammed. Each valve in the valve box consisted of a disc, referred to as a mushroom (**Figure 5**), which sat on the valve seat when the valve was closed. To open the valve, a wheel turned a threaded spindle, which allowed the mushroom to lift off the valve seat under the pressure head; water could then flow through the valve. The end of the spindle bore down on the mushroom, but was not connected to it. The mushroom was fitted in a guide on each side and, if the spindle was screwed too far out, the mushroom could tilt and jam at an angle in the guides. If this happened, screwing the spindle back down would not close the valve; it would merely jam the mushroom more firmly into the wrong position. When the mushroom was at an angle it did not seat properly. The skipper believed that he might have opened the valve too far, causing the mushroom to jam in the guides.
