Report on the investigation of the grounding and loss of the  
Cypriot-registered general cargo ship

***Jambo***

off Summer Islands

**Report No 27/2003  
December 2003**

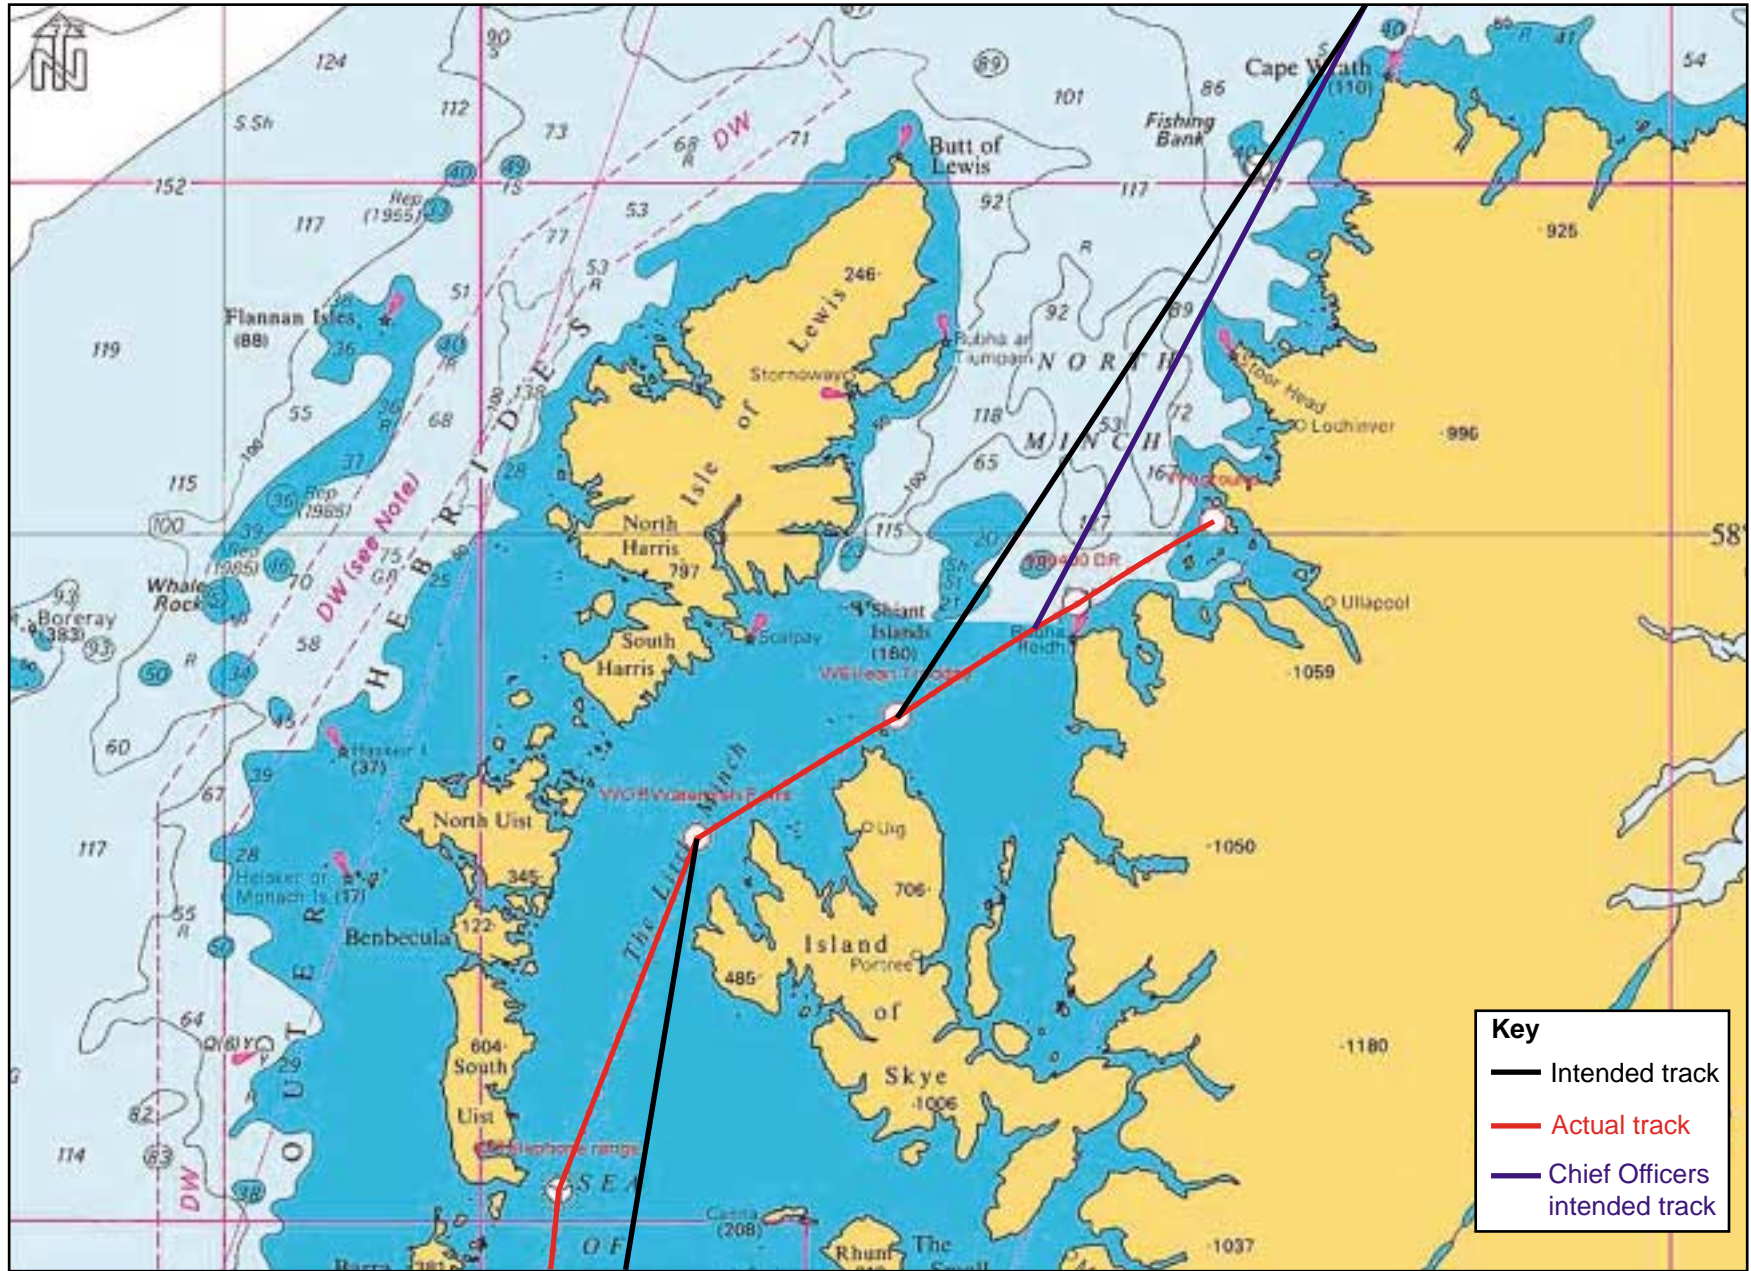
Figure 1

The vessel was on a course of 012° and the next course alteration to 058° was due at about 0030 on 29 June 2003. This was off Waternish point (**see Figure 1**). The next course alteration shown on the chart was to 032° at a position 1.5 miles north-east of the Eileen Trodday light. This track took the vessel up clear of Cape Wrath.

At about 0220, the vessel passed the course alteration shown on the chart (**see Figure 1**) 1.5 miles north-east of the Eileen Trodday light. However, the chief officer intended to alter course for Cape Wrath off Rubha Reidh.

Mv Jambo - navigational tracks

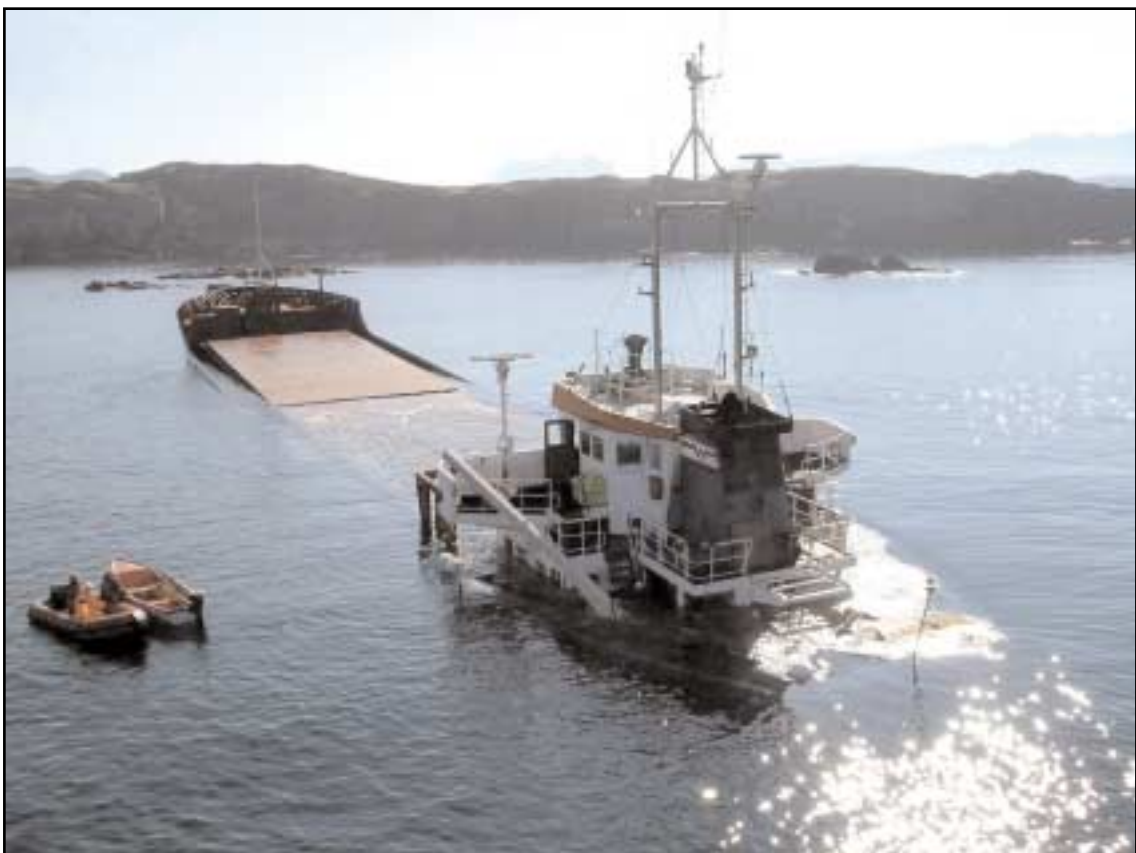
Figure 2

Mv *Jambo* aground at the entrance to Loch Broom about 0730, 29 June 2003

The Lochinver lifeboat arrived on scene at 0721 and evacuated four of the seven crew. Members of the lifeboat crew then assisted the master in assessing the situation. *Jambo* had a 5° list to port and the decks were awash on both sides (**Figure 2**).

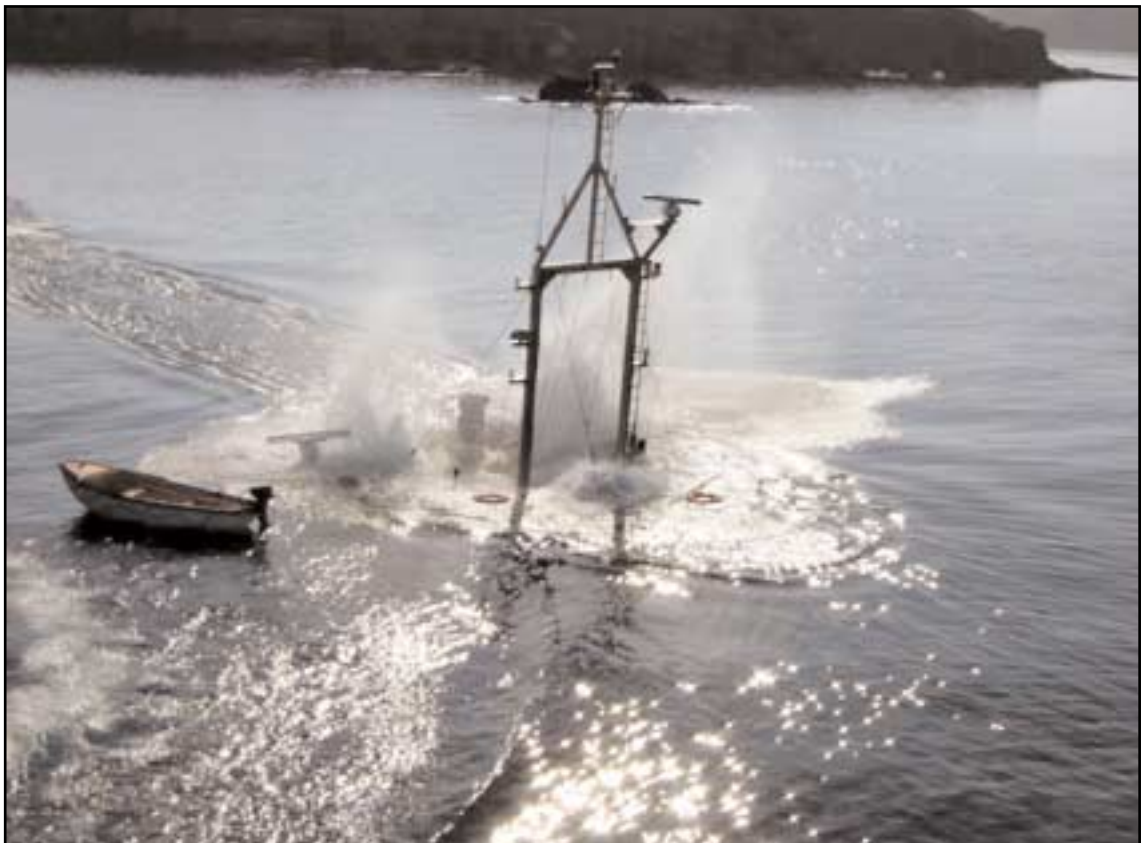
Figure 4

*Jambo* continued to take on water and sink by the stern. At 0859, the remaining three crew were taken off by the Lochinver lifeboat. *Anglian Prince* arrived on scene at 0909 and, at 0955, her master reported that *Jambo* had sunk with her bow out of the water and lying on the port side (**Figures 4, 5 and 6**).

Mv *Jambo* sinking, about 0930, 29 June 2003

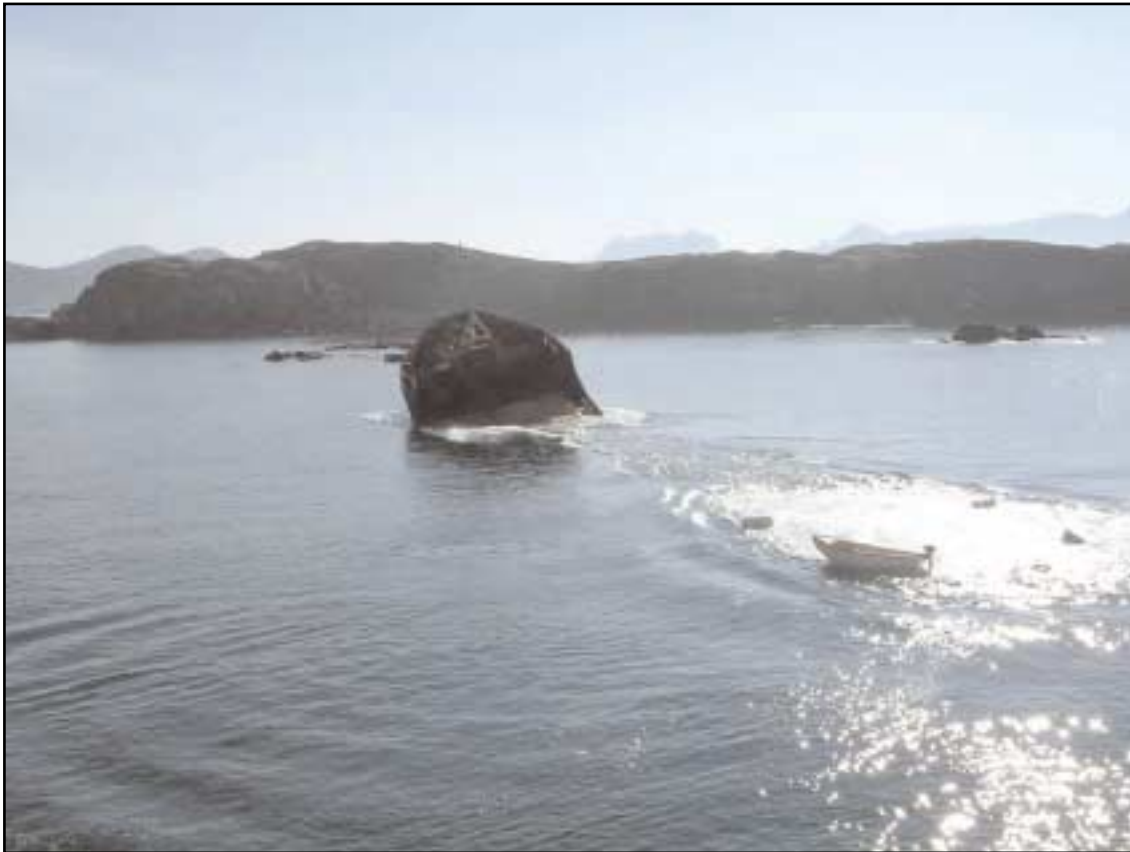
Figure 5

Mv *Jambo* sinking, about 0945, 29 June 2003

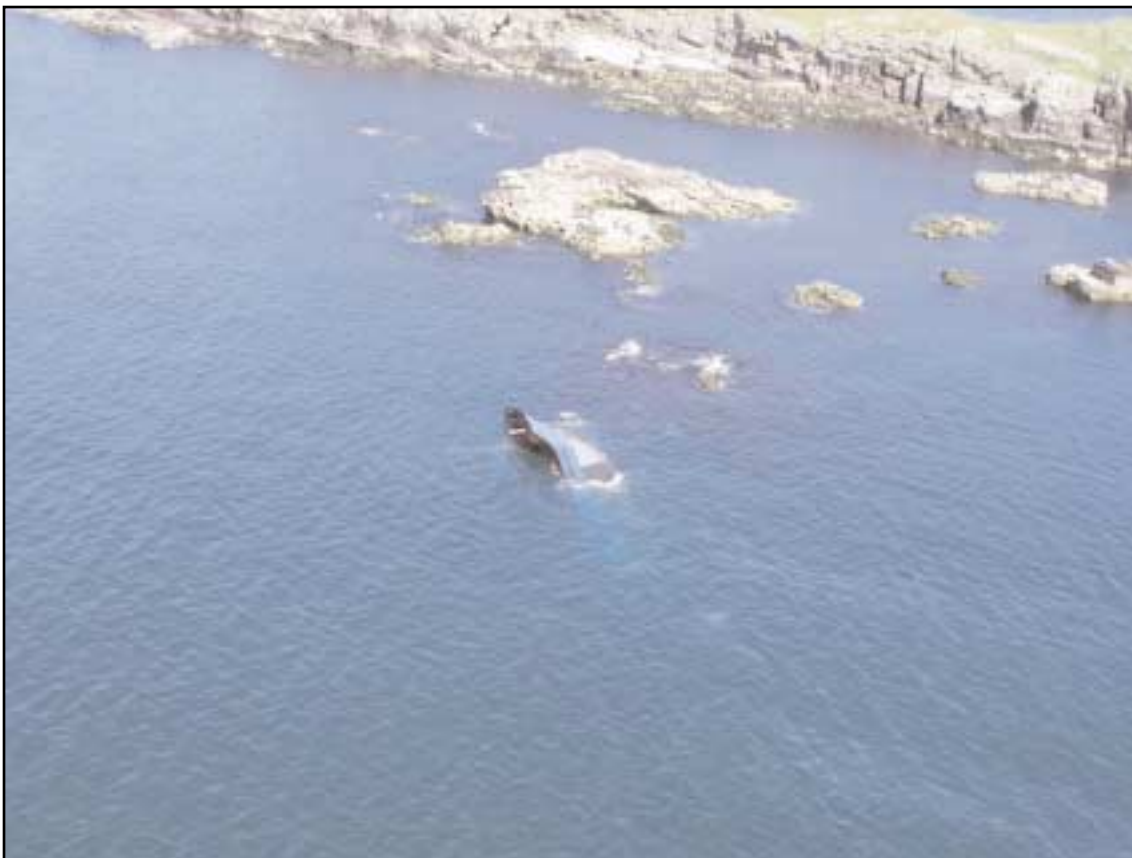
Figure 6

Mv *Jambo* - lying on port side with bow showing, about 1130, 29 June 2003
