Report on the investigation of  
the collision between  
the container ship

***P&O Nedlloyd Vespucci***

***Wahkuna***

**Report No 28/2003  
December 2003**

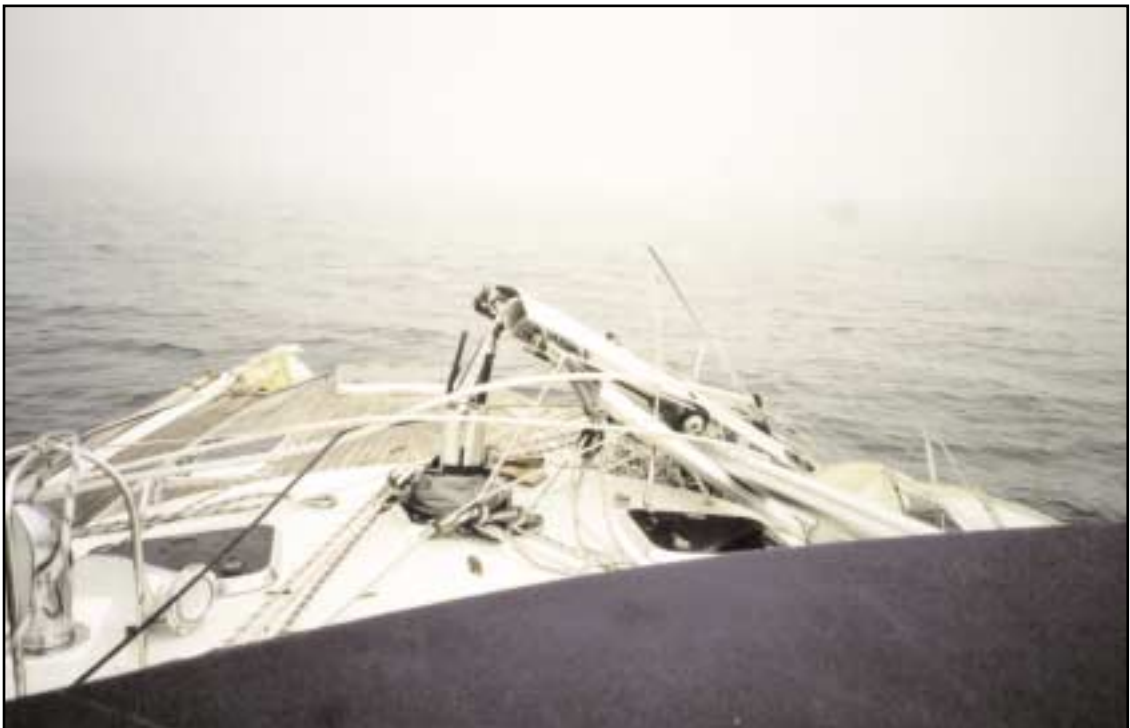
Figure 5

Minutes later, the vessels collided and the bulbous bow of *P&O Nedlloyd Vespucci* struck the forward part of *Wahkuna*'s hull, demolishing the first 3m of her hull and dismasting her. Despite having sent a lookout to the port bridge wing, the master of the container ship was not aware that a collision had occurred, and continued on passage. The yacht crew had to abandon to a liferaft, where they stayed for 5.5 hours before being rescued.

Unfortunately, his actions were unable to prevent a collision. The container vessel's bulbous bow struck the forward part of *Wahkuna*'s port hull, demolishing the first 3 metres of her bow (**Figure 5**).

Photograph of the damage to *Wahkuna*

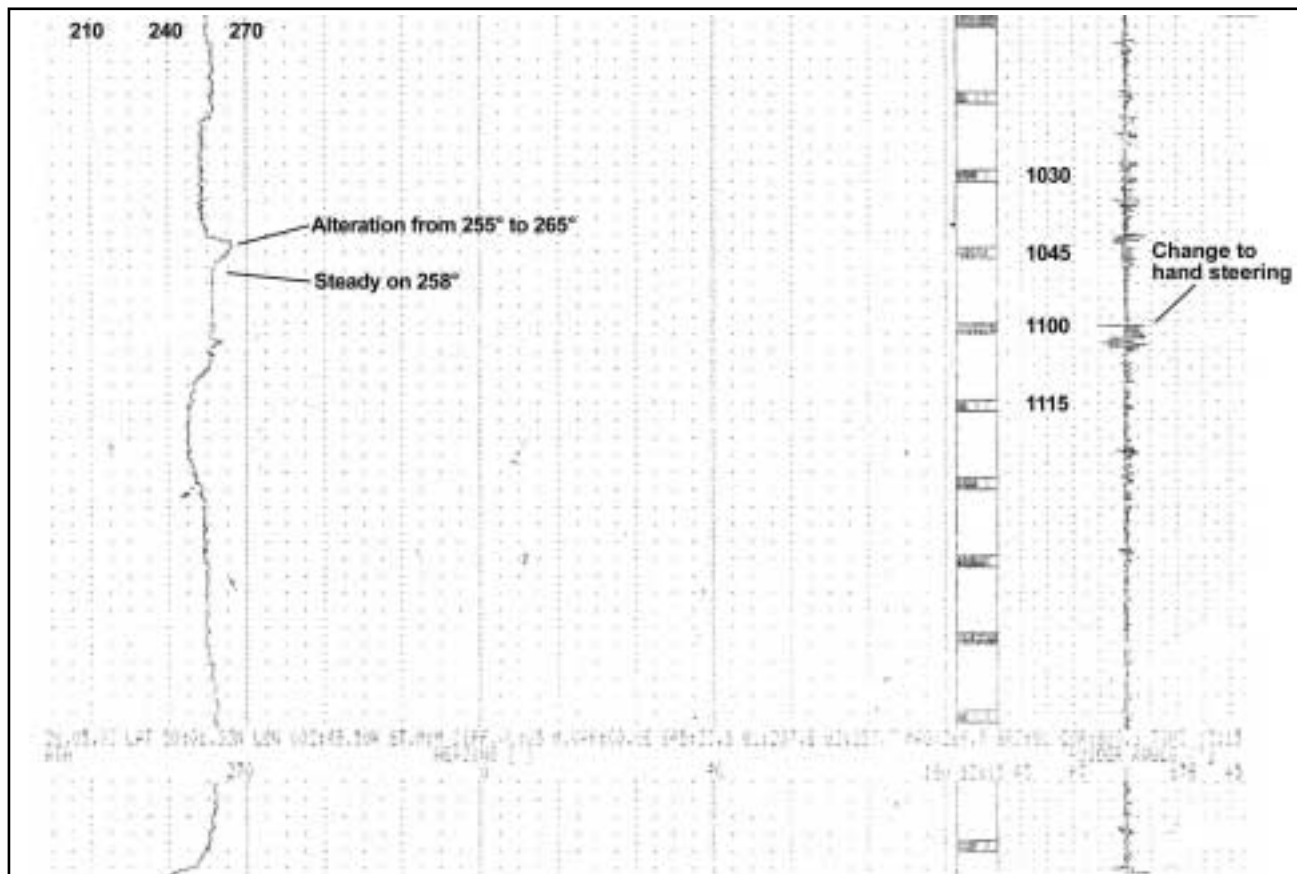
Soon after, another contact was detected on the port bow at a range of between 5 and 6 miles. By ARPA, its course was northerly and speed was 6.5 knots; the master estimated it would cross 8 cables ahead. However, when about one point on the port bow at a range of between 1.5 and 2 miles, the contact slowed quickly and the ARPA vector indicated that it had also altered course towards the north-east. Its speed by ARPA reduced to zero. This concerned the master,

Extract of *P&O Nedlloyd Vespucci*'s course recorder

who immediately started the second steering motor and ordered the second officer, who was then the OOW, to change to manual steering. This was done, but neither course nor speed was adjusted.

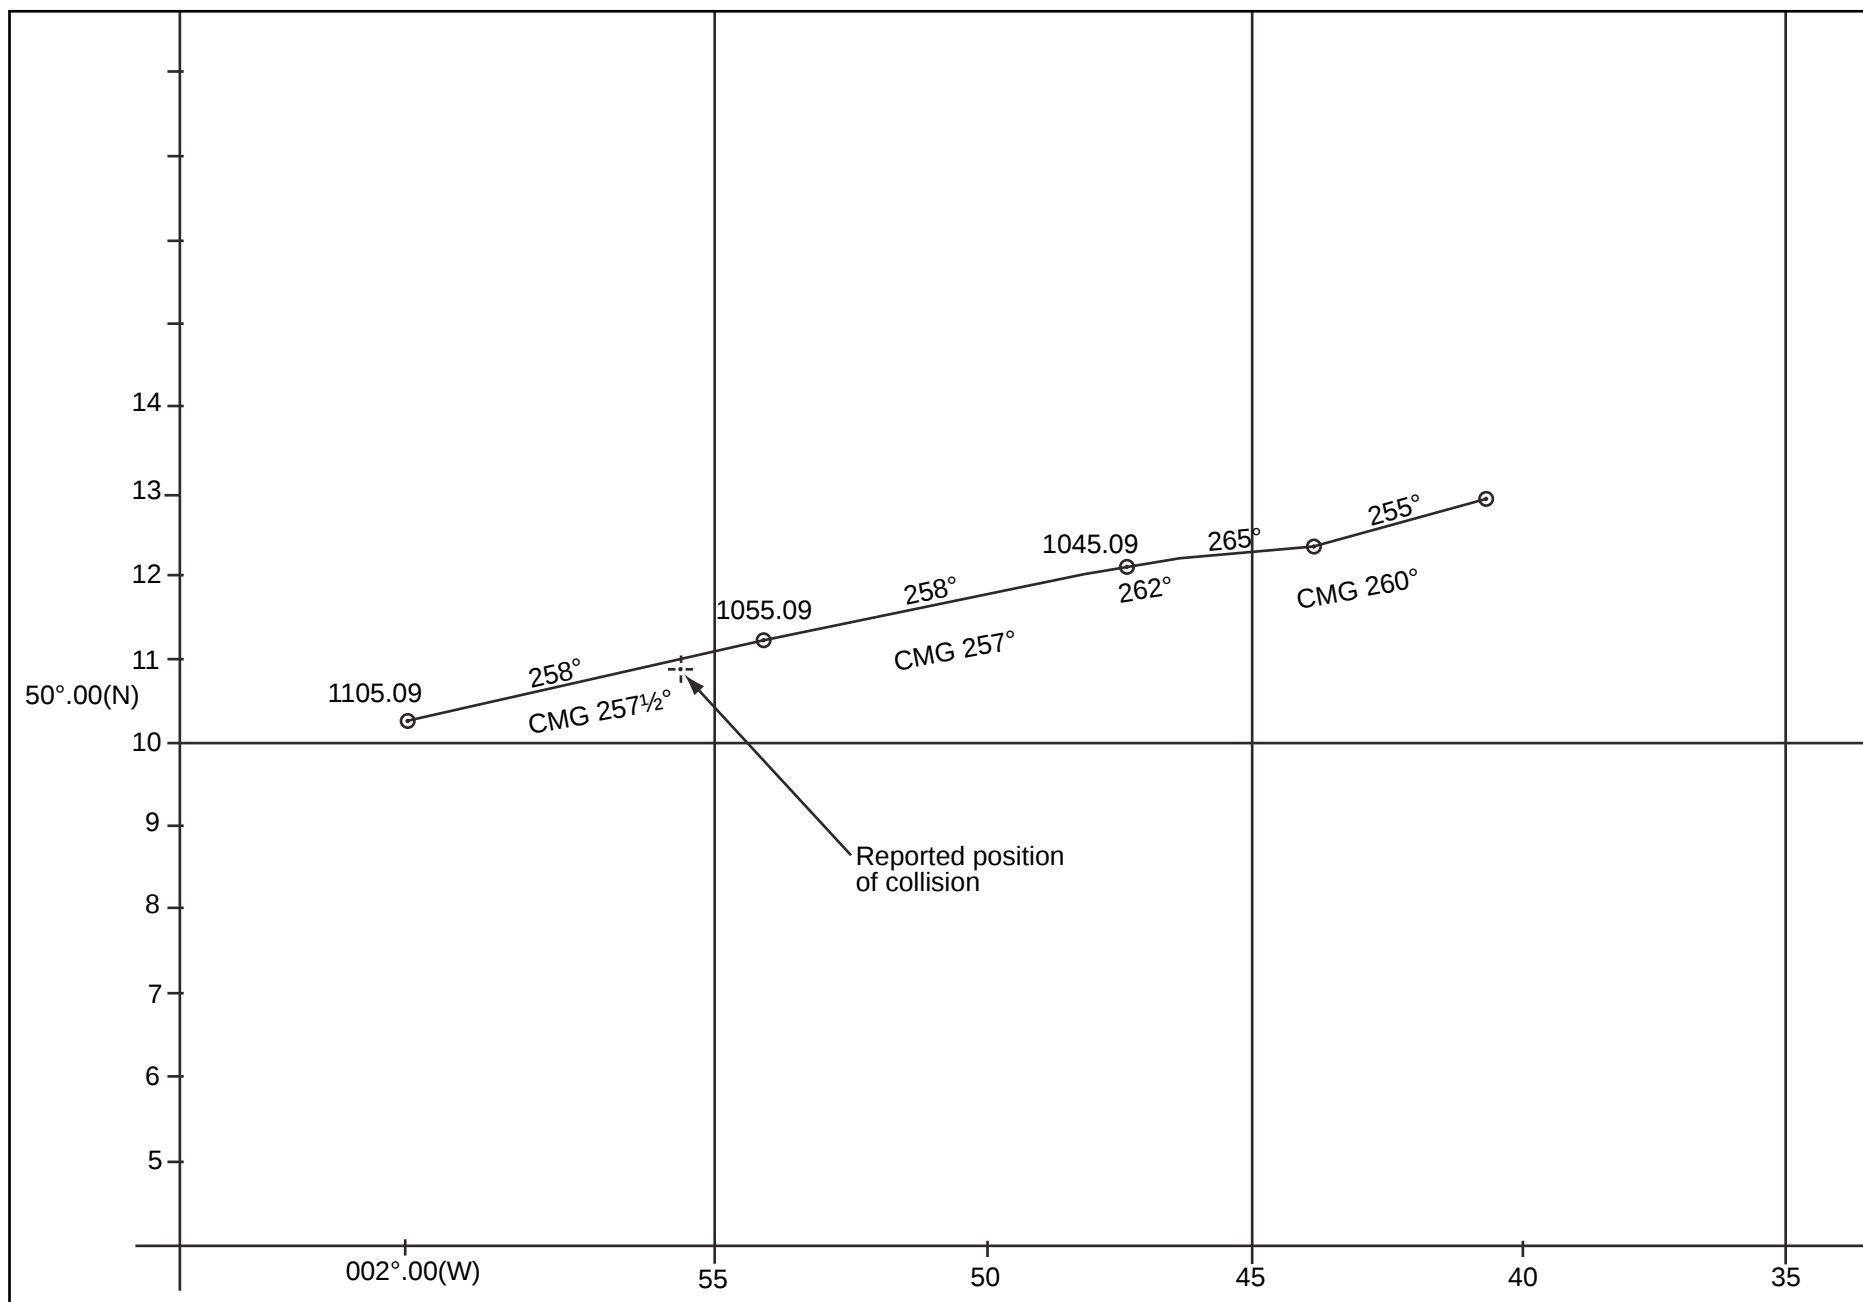
After the yacht had reduced speed and the CPA by ARPA had changed to 2 cables to port, the master became so concerned by *Wahkuna*'s actions, which were unexpected, that he considered it necessary to change to manual steering and put the OOW on the helm. However, he was confused by the unexpected actions of the yacht to the extent that he was reluctant to take any manoeuvring action because of the uncertainty of what the yacht would do next.

Estimation of the track of *P&O Nedlloyd Vespucci*
