Report on the investigation of  
the contact between  
***Pride of Provence***  
and  
The Southern Breakwater,  
Dover Harbour, eastern entrance  
on  
18 April 2003

Marine Accident Investigation Branch  
First Floor  
Carlton House  
Carlton Place  
Southampton  
United Kingdom  
SO15 2DZ

**Report No 26/2003  
November 2003**

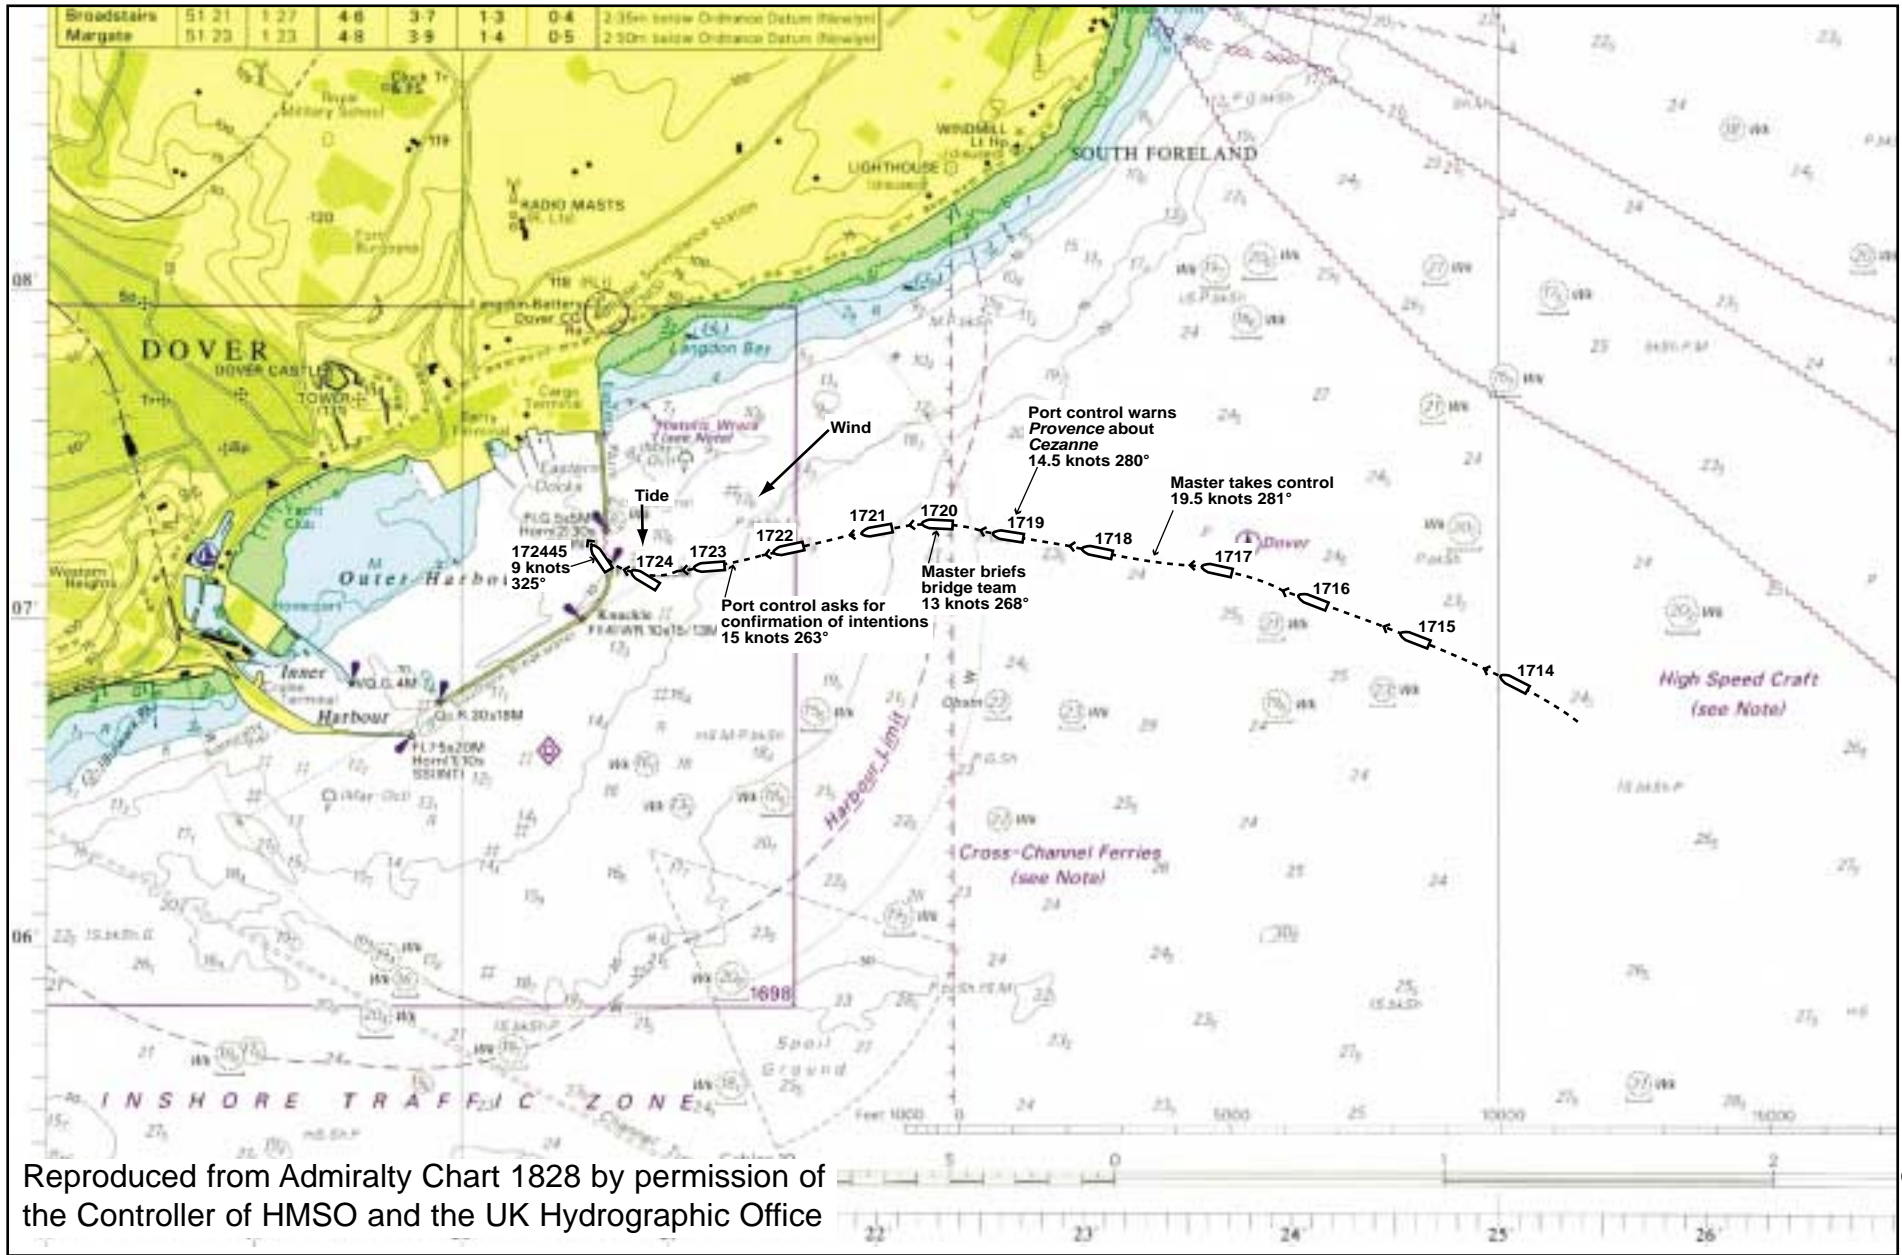
Figure 1

Port Control gave *Pride of Provence* permission to close to 1 mile and told the vessel that *Seafrance Cezanne* still had to berth and *Pride of Aquitaine* would be leaving. *Pride of Provence* was told that her berth would be No 2 and that Port Control would call back. Her speed at this time was about 19.5 knots (**see Figure 1**).

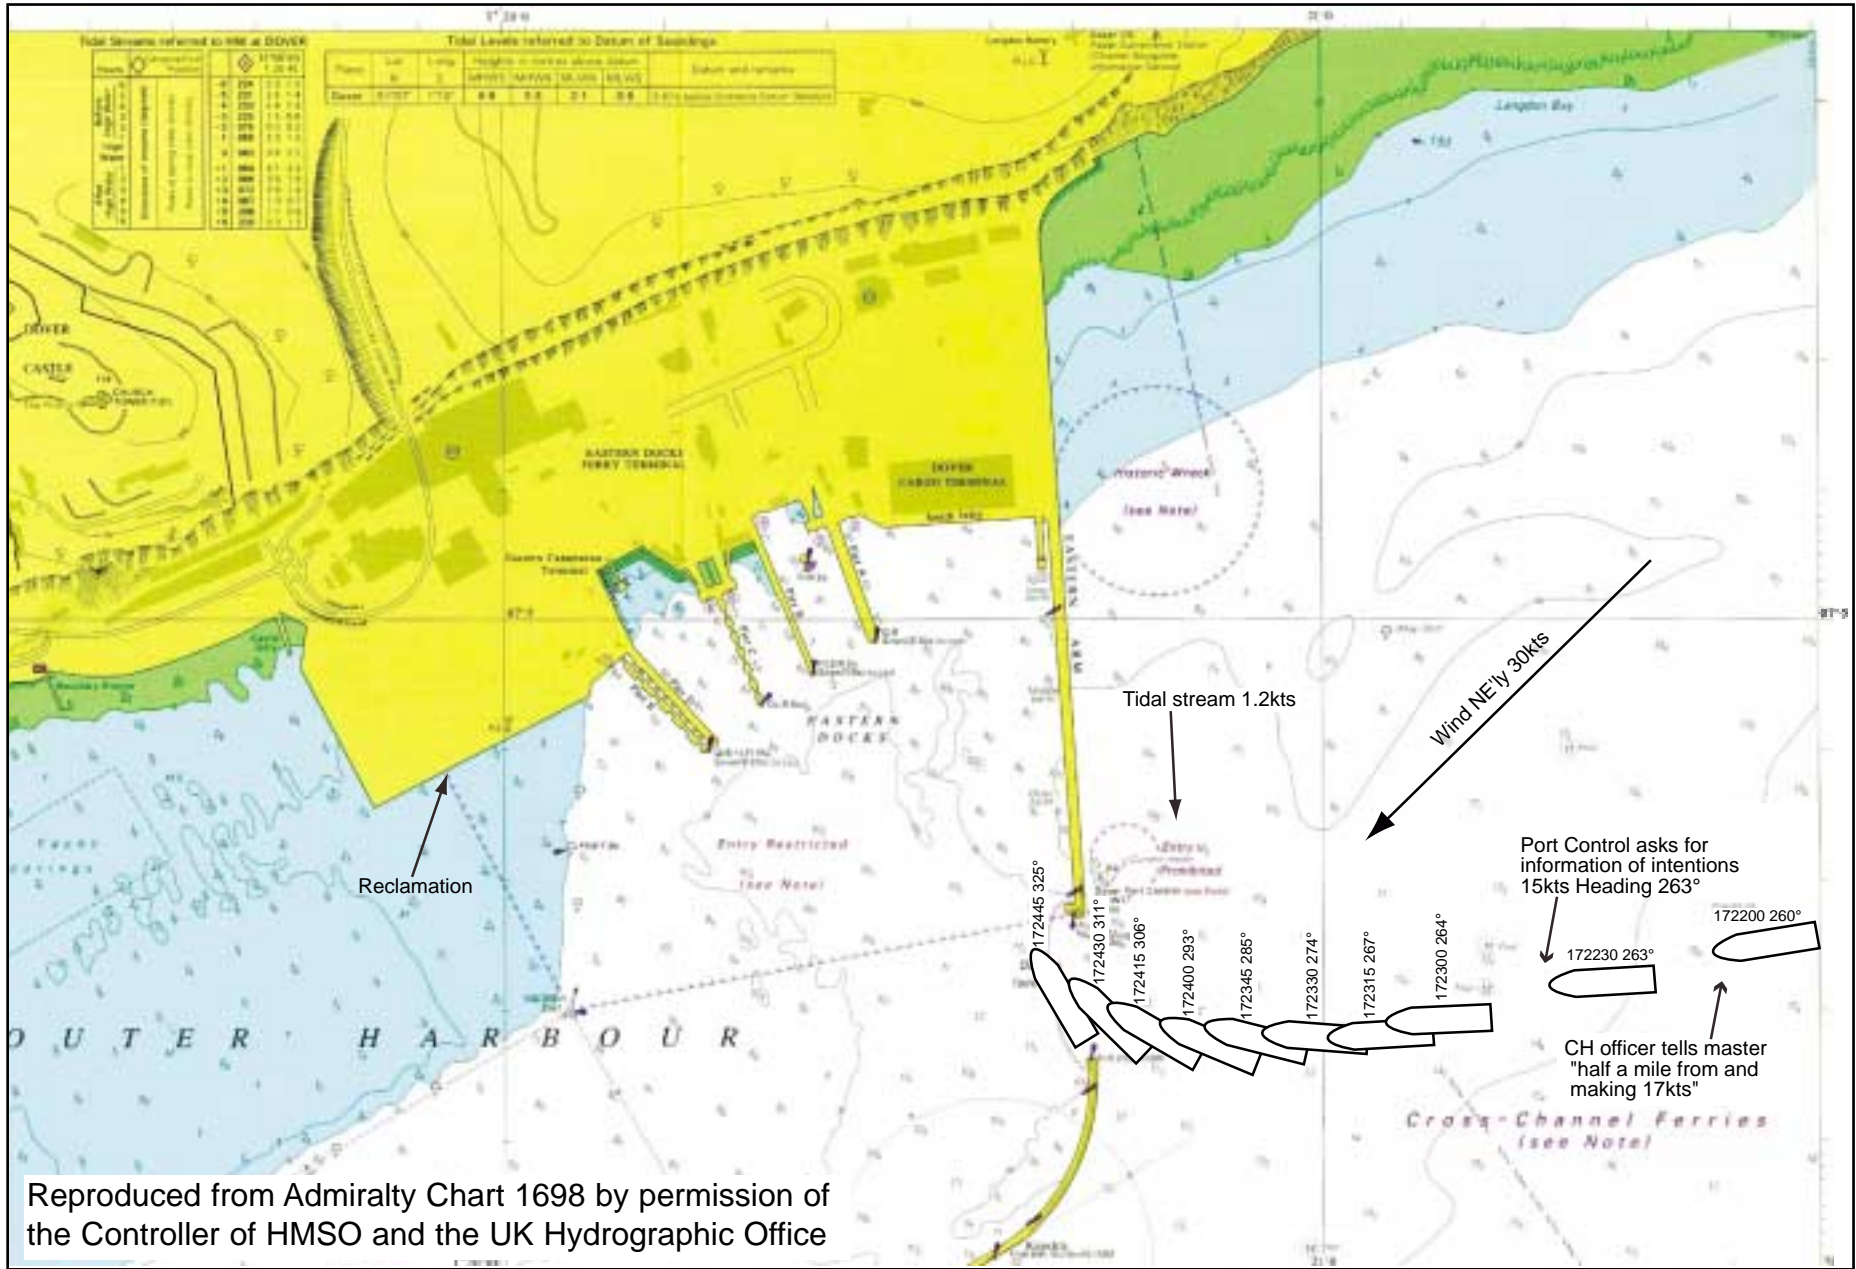
Figure 1A

At 1722, the chief officer told the master that they were ½ mile from the entrance and making 17 knots (**Figure 1A**). At this time *Seafrance Cezanne* was still manoeuvring off Nos 3/4/5 berths in preparation to berth in No 6. *Pride of Provence* was still on a heading towards the end of the southern breakwater of about 260°. The master reduced the propeller pitch.

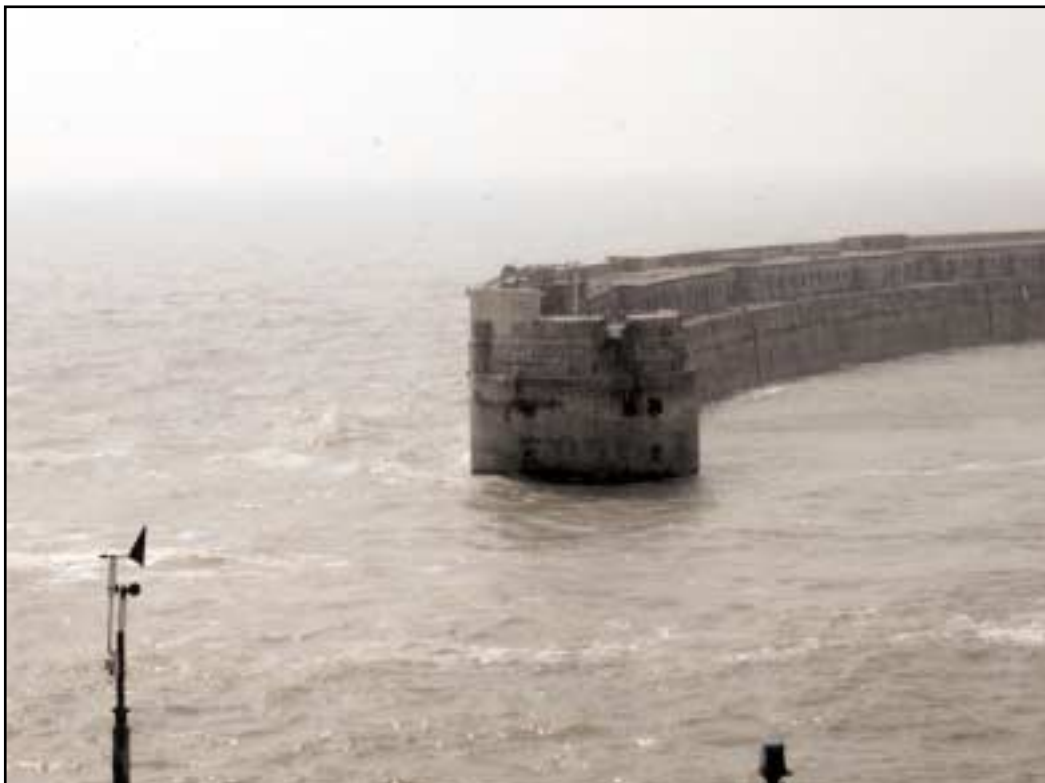
Photograph 3

The end of the Southern Breakwater

The master ordered hard-to-port but the rudder only had time to reach 5° to port before there was a heavy contact between the vessel’s port quarter and the end of the southern breakwater. The time was 1724:45 and the heading at that moment was about 325°. The vessel’s heading had still been swinging rapidly to starboard.

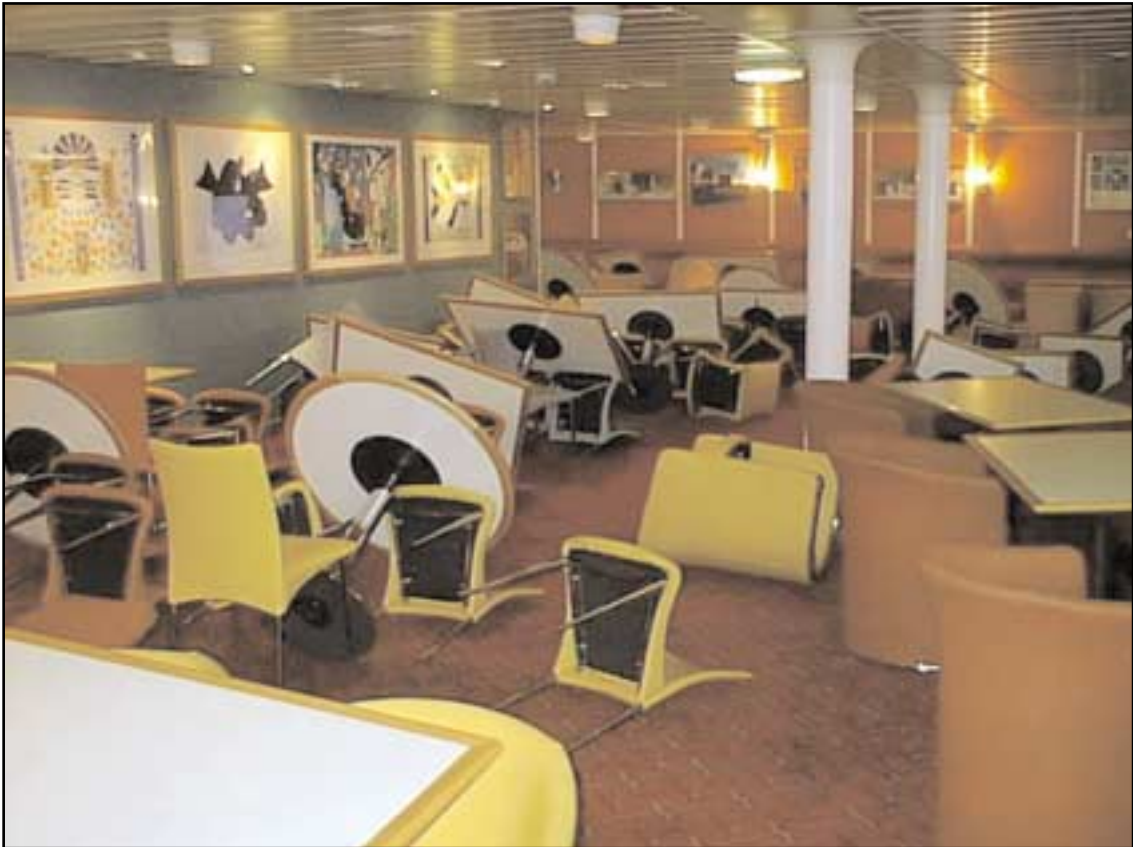
Photograph 4

A number of passengers and crew were thrown to the deck; chairs and tables were overturned and stock was thrown from the displays in the duty paid shopping area (**Photographs 4 & 5**). At least 30 passengers and crew were injured.

Overtured tables

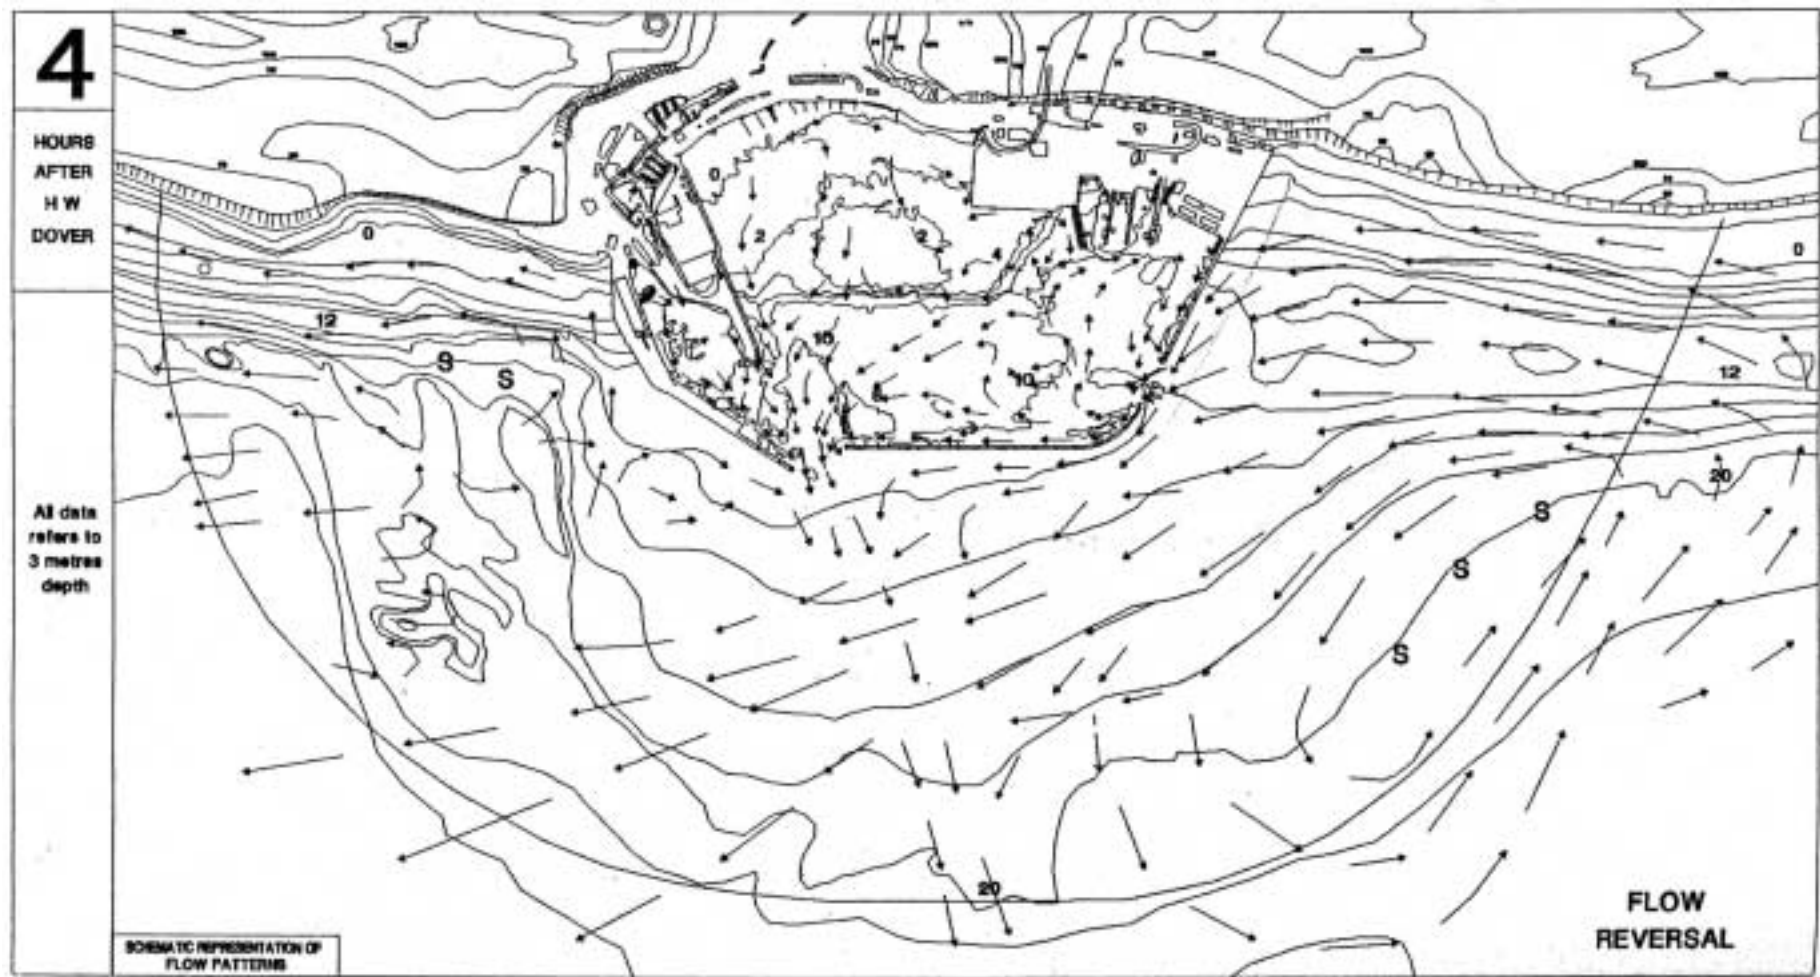
Figure 2

At the time of the accident it was daylight, the visibility was good and the sea state moderate in sheltered conditions. The wind was north-north-easterly 24 knots gusting to 33 knots. High water at Dover had been at 1257. It was a time of spring tides and the ebb tidal stream, running south across the harbour entrance, was measured at 1.6 knots at 2m depth and 1.2 knots at 4m depth (**see Figure 2**).

The tidal streams at about 1700

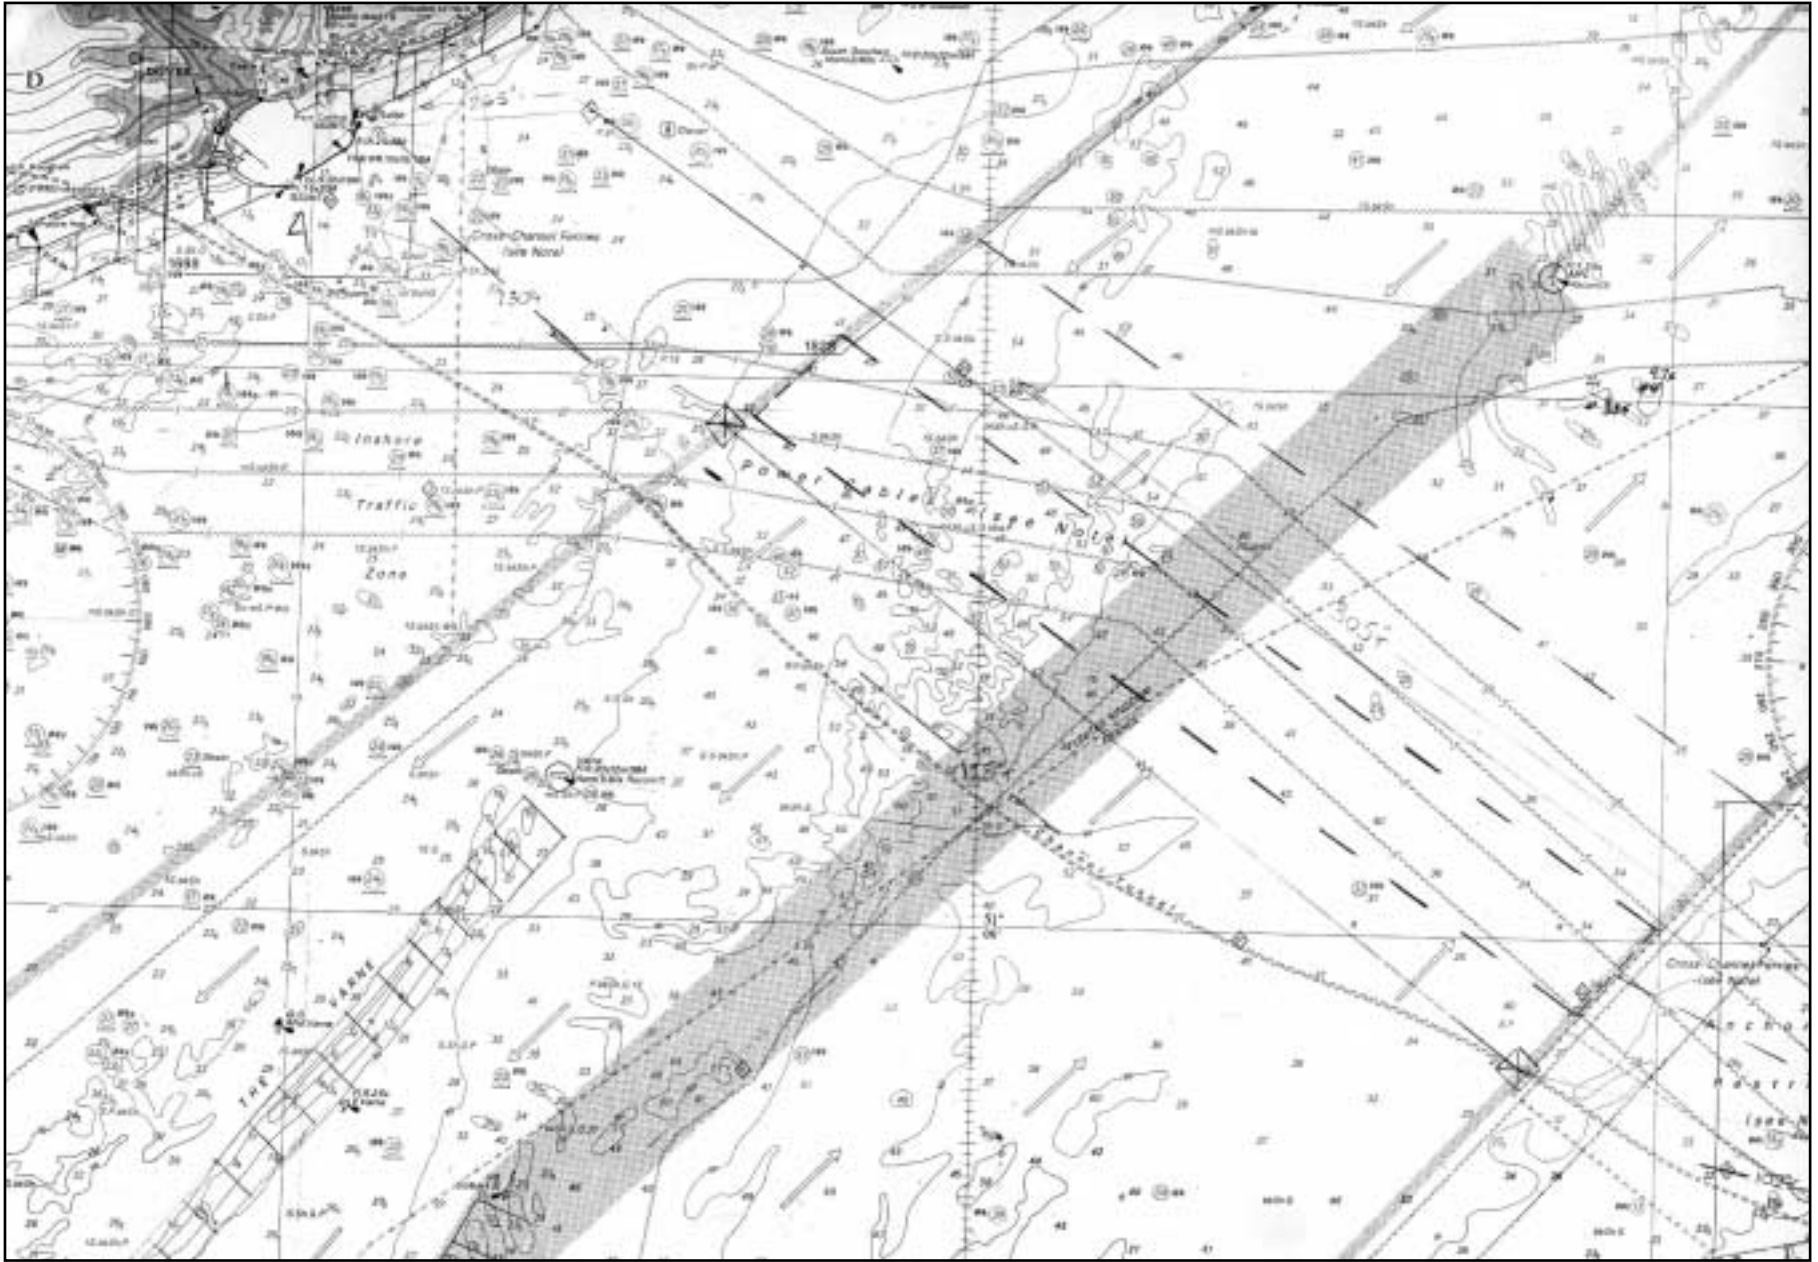
Figure 3

The chart in use on *Pride of Provence* at the time of the accident (**Figure 3**) shows a course of 265° for the final approach to the entrance. No positions were marked on the chart and it is not known whether this course was relevant to the particular voyage in question.

Copy of the chart in use at the time - showing voluntary separation scheme and some courses
