Report on the investigation of  
the entanglement in moorings of

***mv Claymore***

11 March 2003

**Report No 24/2003  
October 2003**

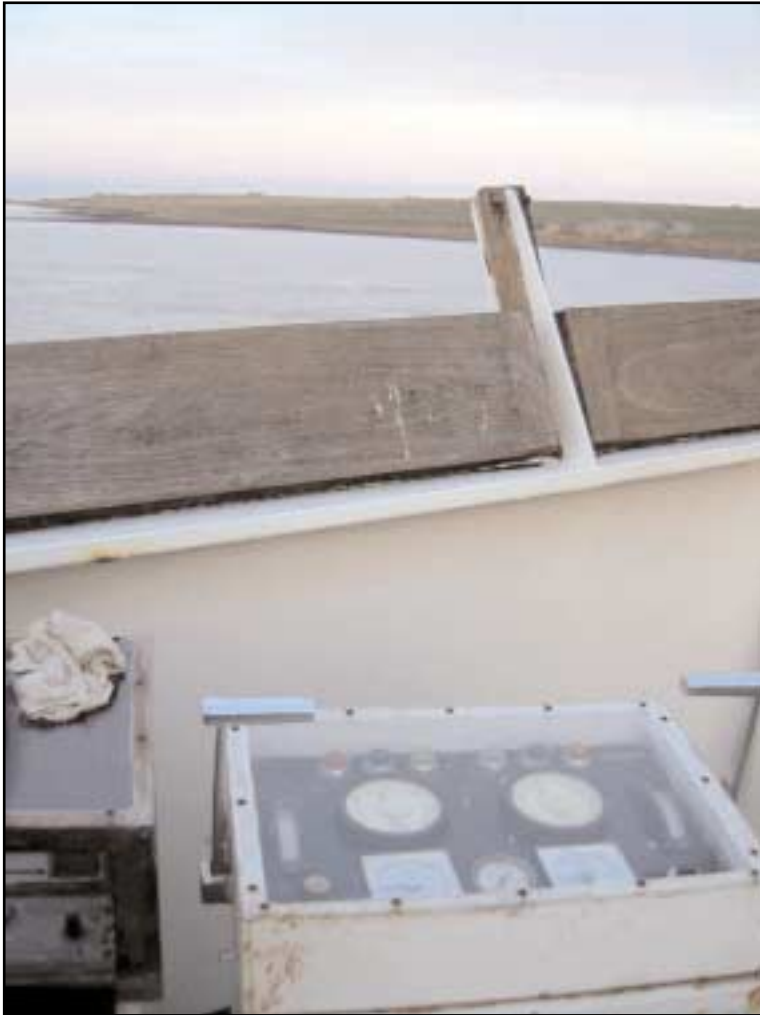
Figure 6

The master manoeuvred the vessel throughout using the engine and helm controls sited on the port bridge wing. From this position, he had only a limited view of the fore deck (**Figures 6 and 7**), and could not see the forward mooring team or hear the bridge intercom system.

Control position on the port bridge wing

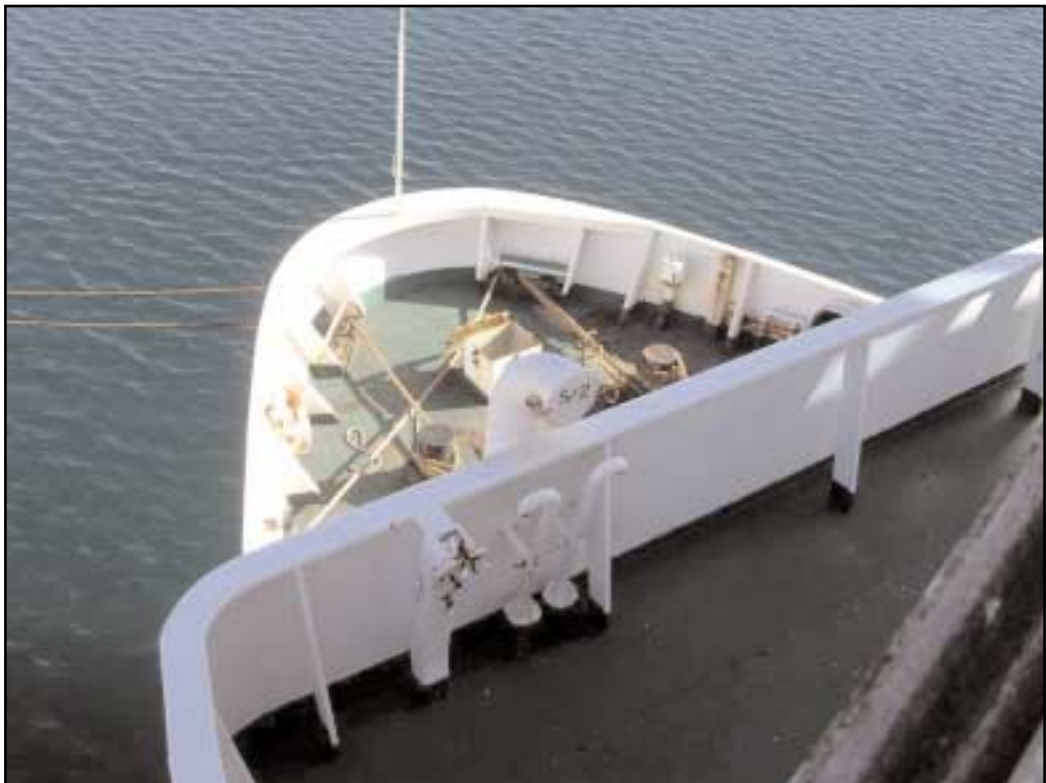
Figure 7

View of the foredeck from the port bridge wing

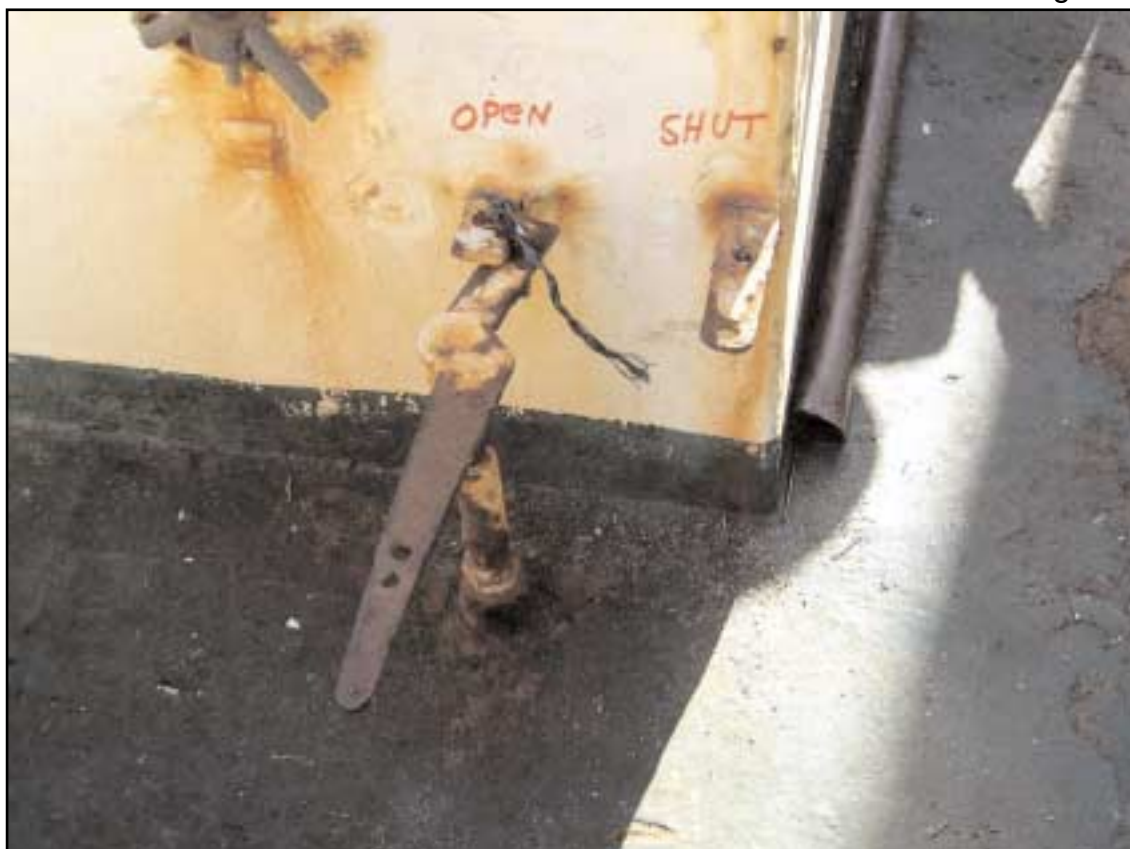
Bow thruster exhaust vent lever

The vent flap was opened and closed by a lever on the fore deck (**Figure 8**). It had been operated on two occasions during the ship's lay up, and although stiff, it had worked correctly. It was usual practice for the flap to be closed during passage, and opened when entering and leaving port, to allow the bow thruster to be used. The bosun had operated this control lever accordingly on sailing from Scrabster and on going to stations for arrival in St Margaret's Hope, and had reported his actions to the chief officer.

The bosun, however, was aware that, although the lever on deck moved freely, the vent flap sited below the deck was not operating. He had informed the marine superintendent of this deficiency. The defect had also been noticed by a deckhand on 2 March, and had been verbally reported to the ship's engineers.

Examination in St Margaret's Hope, following the accident, showed that the pins in the flap's drive assembly had sheered and, although the control lever on the deck was moving, the flap was not. The flap itself was half-open and, in the rough seas, seawater had passed through.

The exhaust vent flap was fitted to prevent seawater from entering the bow thruster. As the sheer pins of the drive assembly had sheered with the flap half-open, water passed through the flap into the thruster during the heavy weather experienced on leaving Scrabster. Had the defect been avoided using planned maintenance, or repaired before 11 March, the bow thruster would not have become saturated and would have been available for use.

Preparations have been made to replace the bow thruster exhaust vent flap with a gate valve.
