Report on the investigation of  
a fatal accident on board

***Arco Adur***

on the River Medway

**Report No 23/2003  
September 2003**

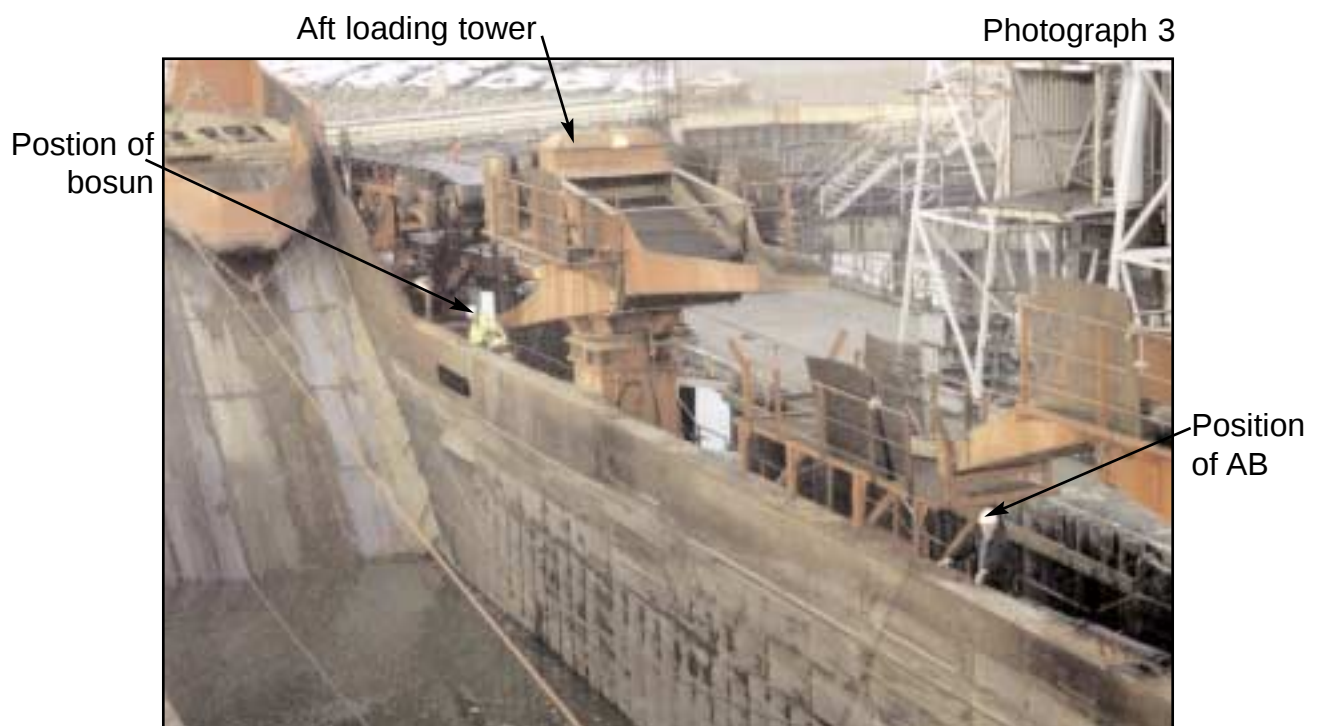
The second mate, realising that Sid Mattingley had been standing on a platform between the aft tower reject chute and the coaming (**Photograph 3**), immediately swung the aft tower in the opposite direction.

Enlarged view of crew positions immediately before the accident

1. A fleet-wide risk assessment of shipboard activities was instigated.
2. The operation which caused the accident was stopped, and the bucket wire access platforms moved so as to keep crew members clear of danger, regardless of the operation of the loading towers.

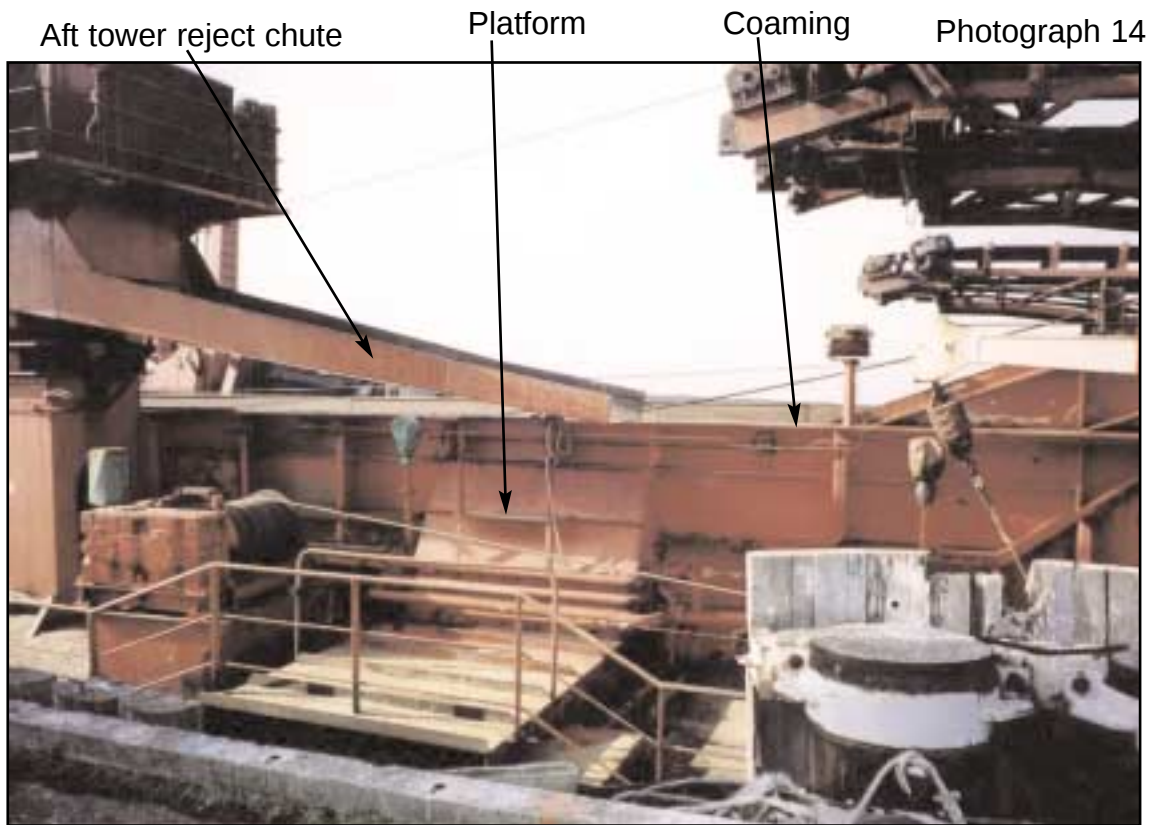
View of aft tower reject chute and platform

Due to the orientation of the dredge control panel in relation to the platform adjacent to the aft tower reject chute, it is probable that Sid Mattingley stepped on to the platform at the same time as the second mate looked down to the tower controls to rotate the aft tower. As the bosun was wearing a fluorescent yellow jacket, it is unlikely he would not have been spotted had he already been on the platform when the second mate looked out of the window.

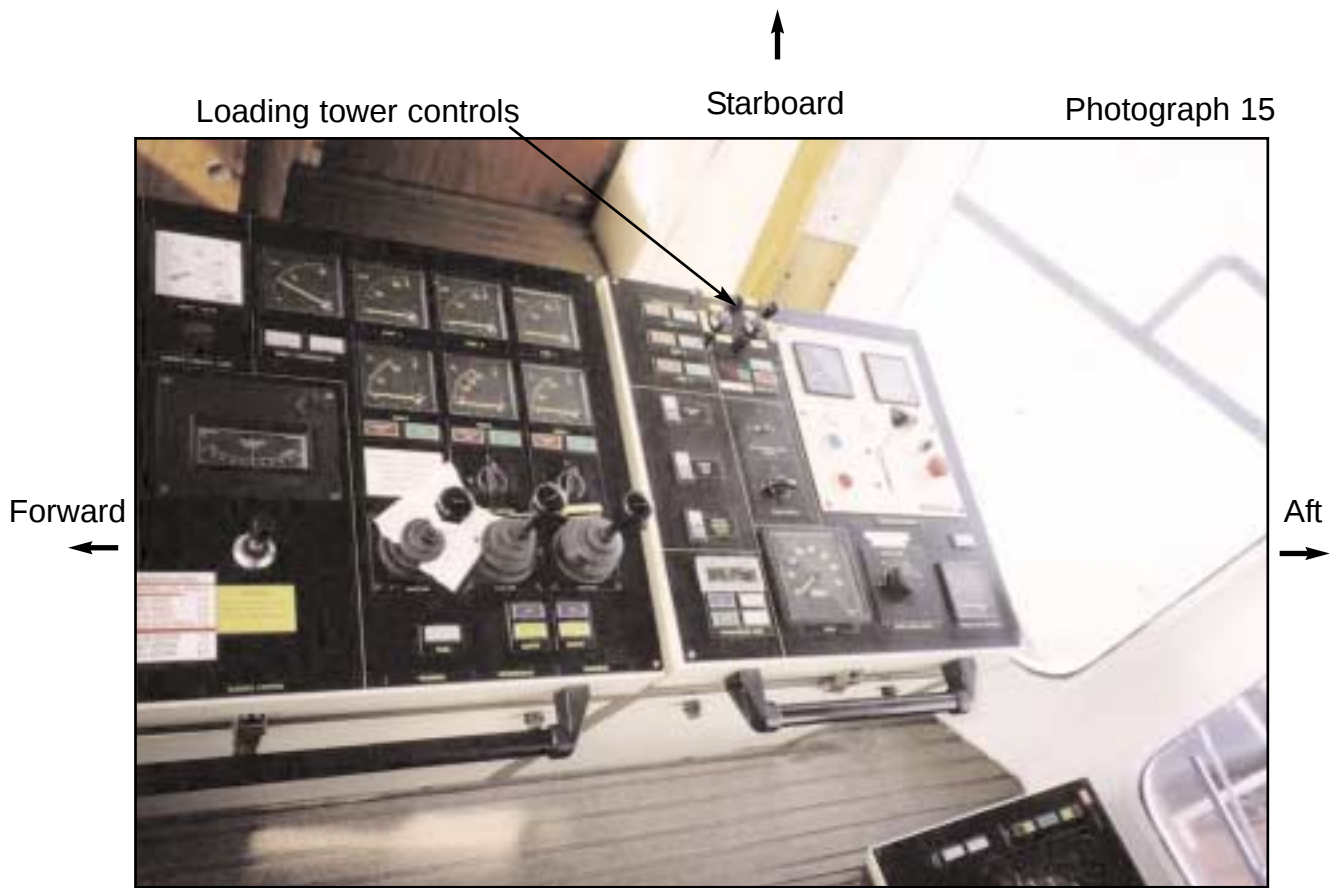
There was no proportional speed control for the towers and they could rotate 90° in about 3 to 5 seconds. This resulted in fast jerky movements as the tower rotated.

View of cargo loading console, starboard bridge wing

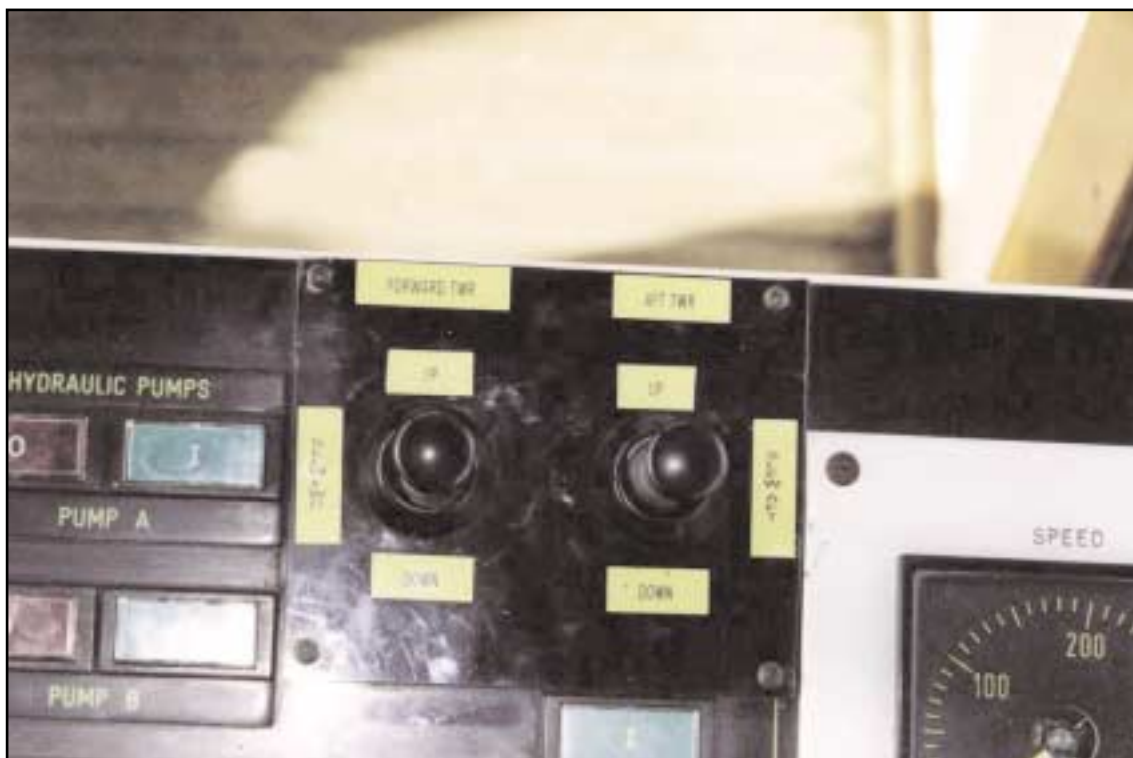
Photograph 16

To rotate the aft tower in a clockwise direction to bring the loading chute over the hold, the aft joystick was pulled up and then pushed in an aft direction, labelled 'slew aft'.

View of loading tower controls
