Report on the investigation of
the loss of the fishing vessel

Amber (PH78)

6 January 2003

**Report No 25/2003
October 2003**

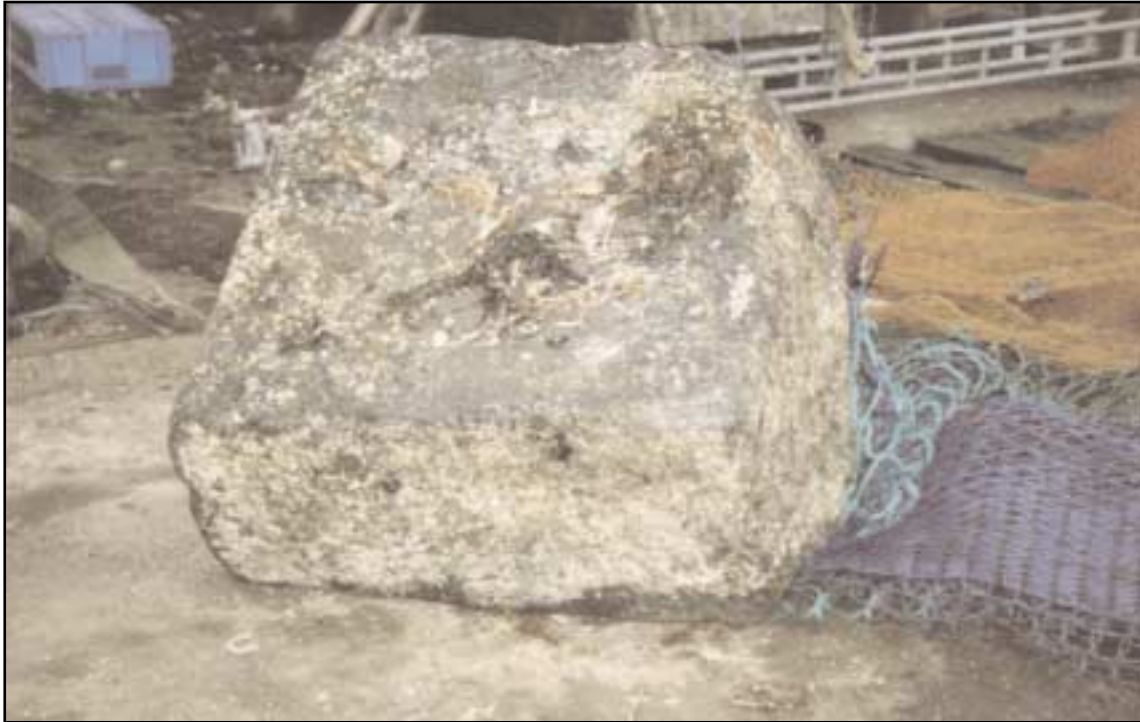
Figure 2 - Rock recovered from net

The object in the net was found to be a rock (**Figure 2**) which, after recovery, was weighed at Methil harbour and was found to be 1.775 tonnes.

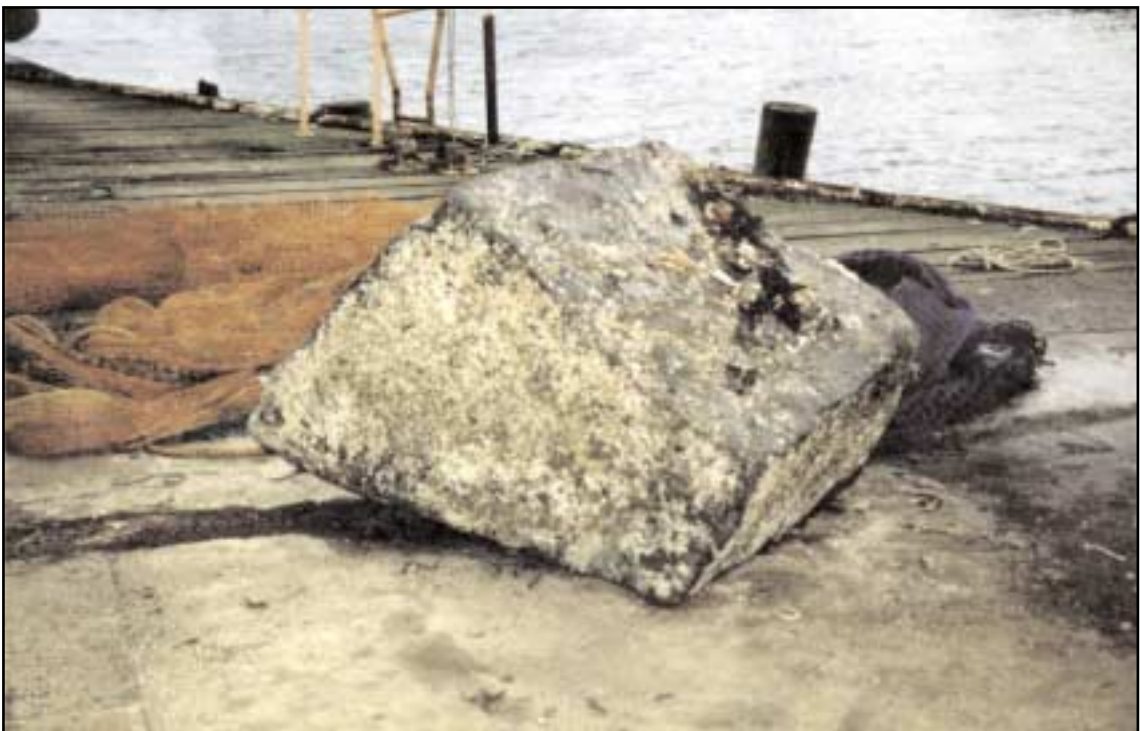
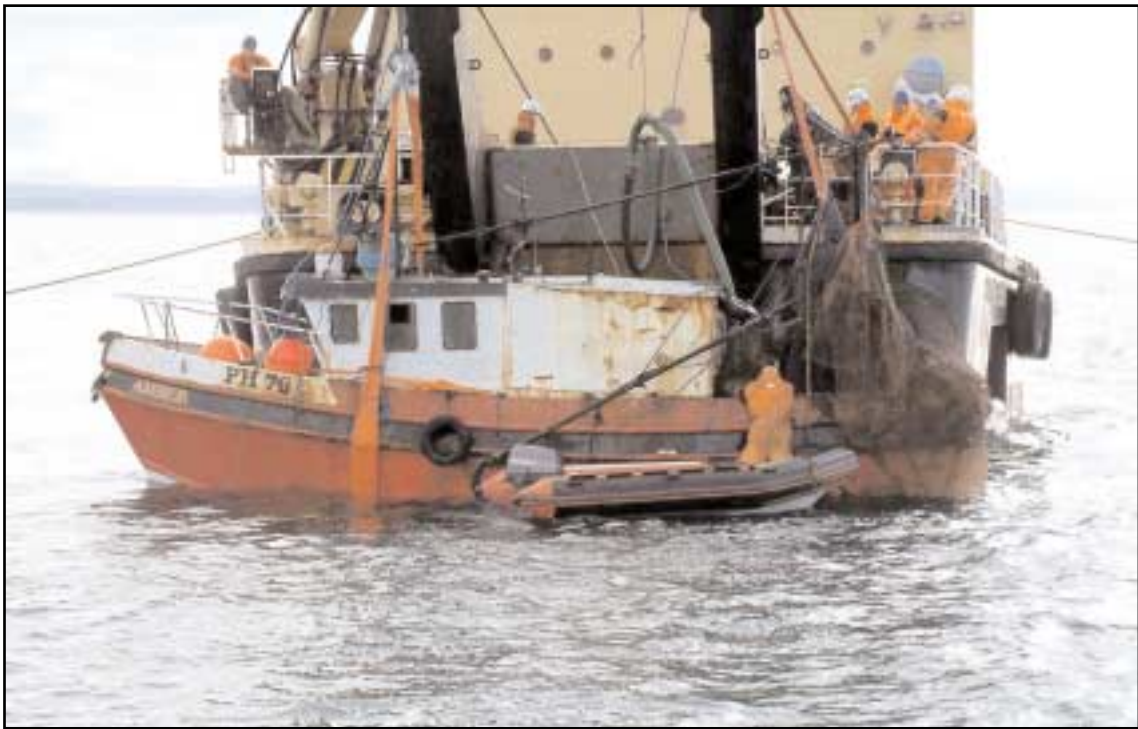
The MAIB then arranged for *Amber* to be lifted using a mooring tender (**Figure 3**). This was done successfully and she was pumped out and towed to Burntisland to allow a detailed survey and inclining experiment to take place.

Amber being raised

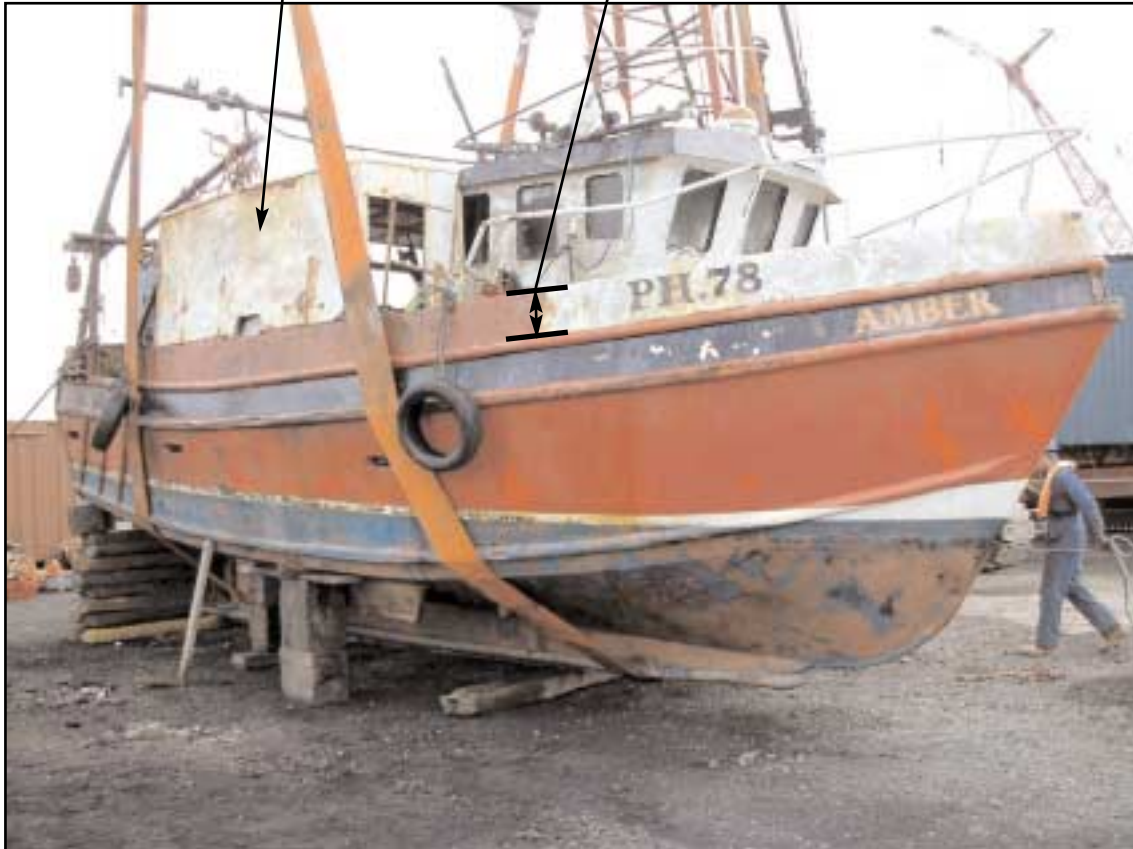
Figure 4

In August 1999, the gunwale was raised by approximately 0.23m, to increase crew protection when they were working on deck (**Figure 4**).

Amber showing raised gunwale and shelter

The stability performance when the vessel was built is unknown, but what is certain is that the modifications carried out since 1999, which were completed with crew protection in mind, effectively degraded the stability and lowered the freeboard. Having spare gear on board is essential to conduct running repairs.

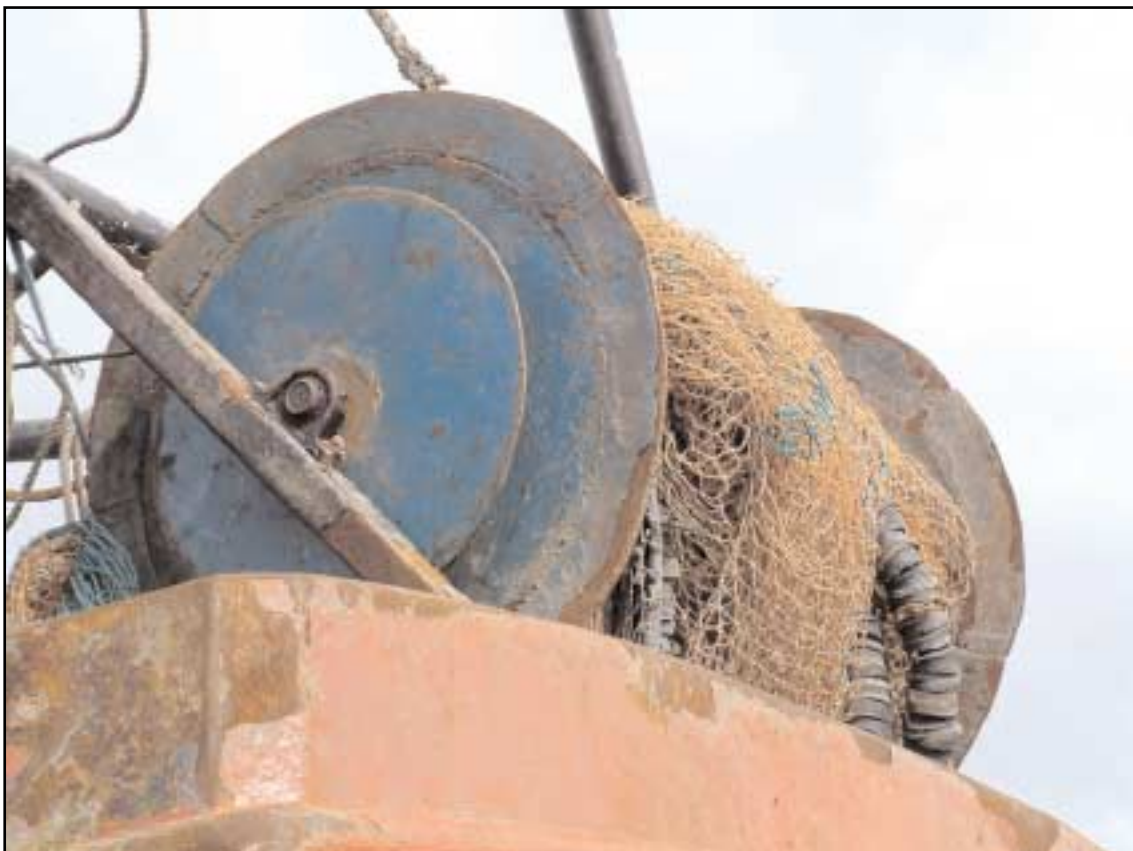
Figure 5

Net drum on *Amber*

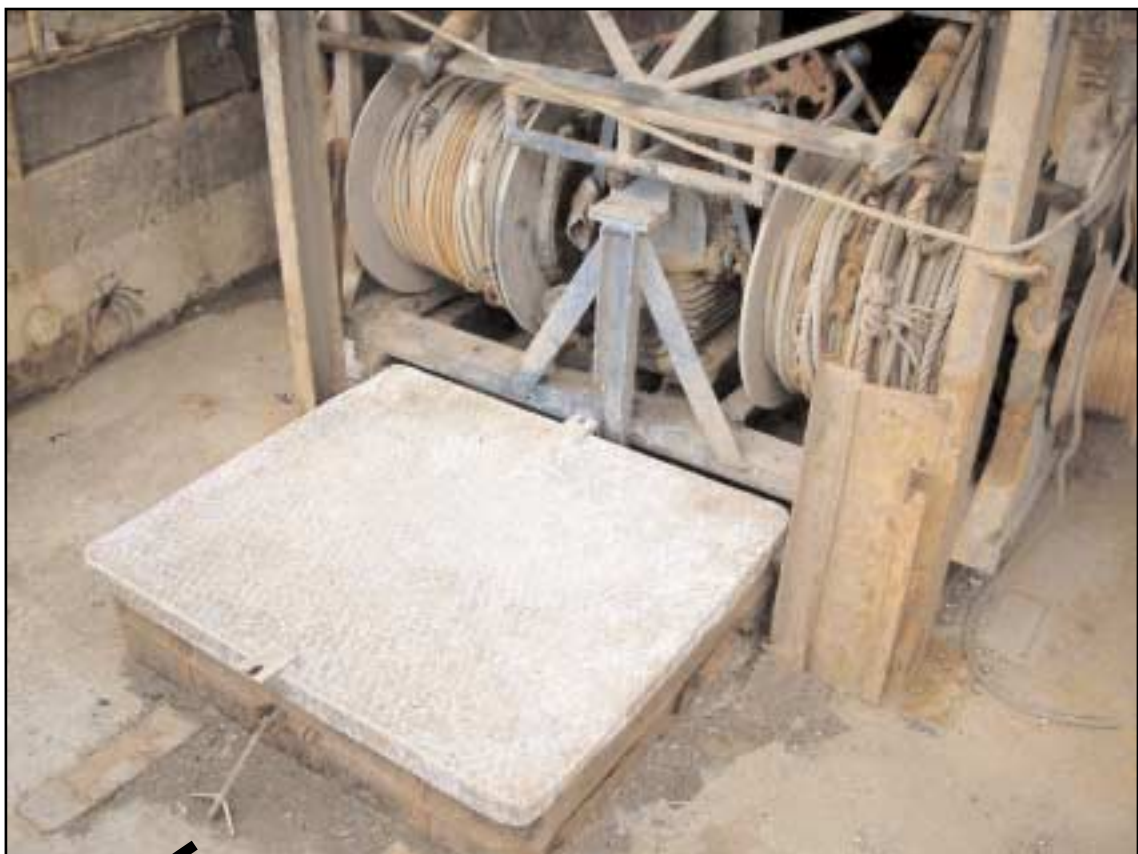
Figure 6

Amber main winch and fish hatch

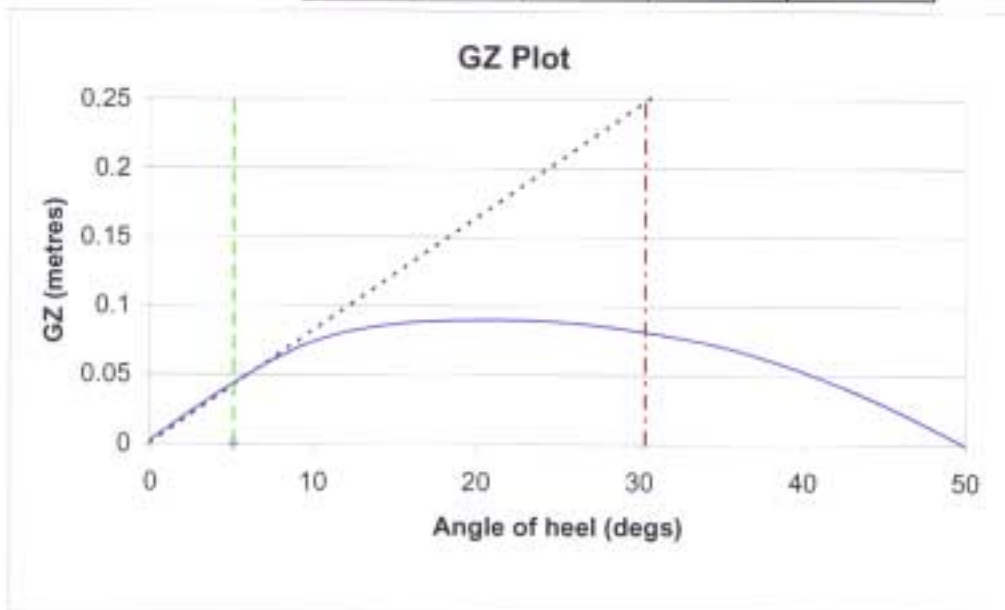
Vessel: **AMBER (PH78)**
 Condition: **At sea 6/1/03**

Minimum	Actual	f/p- immerse
Angle of immersion of fish hatch and stbd fwd f/p (degrees)		30.342	5.11
Area under GZ curve between 0 & 30 degrees (metre.radians)	0.055	0.038	
Area under GZ curve between 0 & 40 degrees (metre.radians)	0.09	0.038	
Area under GZ curve between 30 30.34 & 40 degrees (metre.radians)	0.03	0	
Maximum GZ (metres)	0.2	0.09	
Angle of heel at which maximum GZ occurs (degrees)	30	20.908	
Positive GZ heel range (degrees)		50.00	
GMF (metres) (upright)	0.35	0.469	
Key f/p- freeing port

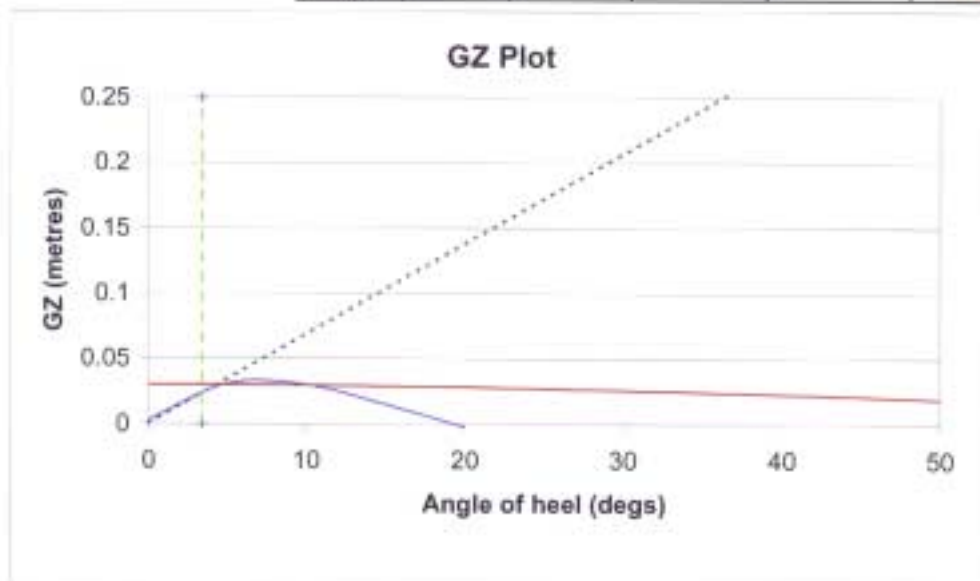
Vessel: AMBER (PH78)
 Condition: Rock in net 6/1/03

The results of the stability analysis at **Annex 2** demonstrate that *Amber* had poor stability. Had the 1.775 tonne rock, which was in the net, been lifted off the seabed, the combination of its weight, a high suspension point, and the likely offset from the centreline, could have caused *Amber* to capsize. In reality, the rock might never have left the seabed as the length of net was greater than the depth of water. Instead, the rock might have muddied up as it was dragged on the up-slope of the seabed towards Methil harbour, increasing the drag that was experienced by the vessel.

Minimum	Actual
Angle of immersion of midships freeing port (degrees)		3.375
Area under GZ curve between 0 & 30 degrees (metre.radians)	0.055	0.007
Area under GZ curve between 0 & 40 degrees (metre.radians)	0.09	0.007
Area under GZ curve between 30 & 40 degrees (metre.radians)	0.03	0
Maximum GZ (metres)	0.2	0.034
Angle of heel at which maximum GZ occurs (degrees)	30	7.4
Positive GZ heel range (degrees)		19.514
GMF (metres) (upright)	0.35	0.395
