Report on the investigation of
the loss of the fishing vessel
Amber (PH78)
in the Firth of Forth on
6 January 2003
with the loss of one life

**Report No 25/2003
October 2003**

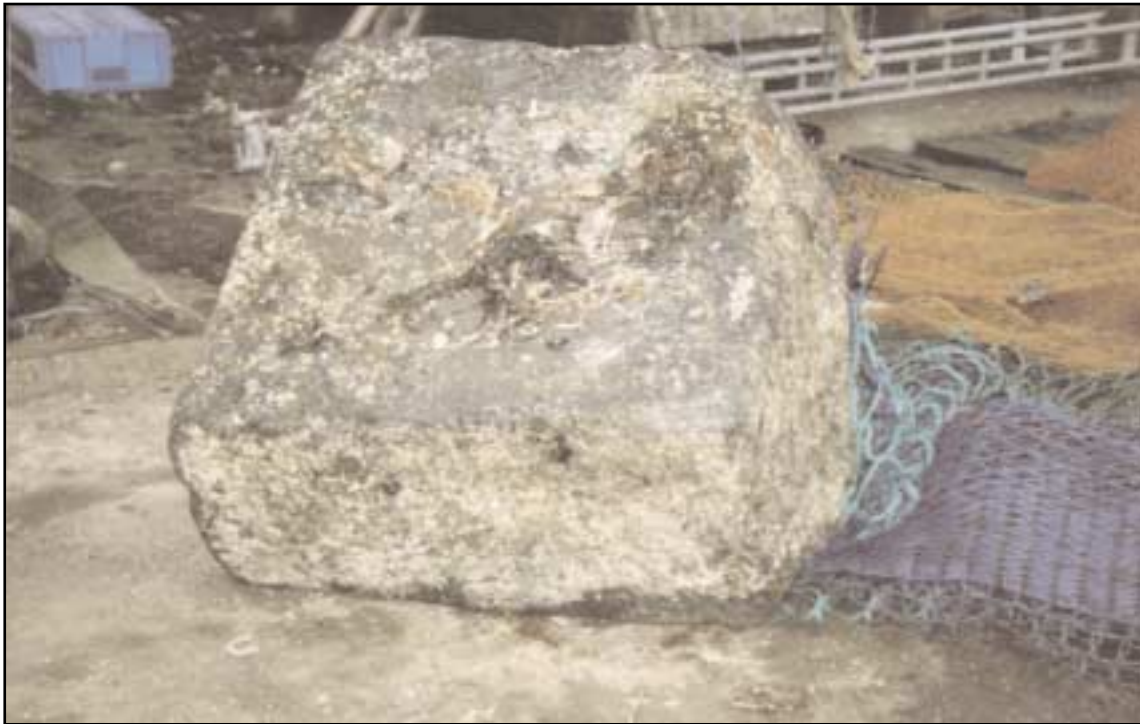
The object in the net was found to be a rock (**Figure 2**) which, after recovery, was weighed at Methil harbour and was found to be 1.775 tonnes.

Figure 2 - Rock recovered from net

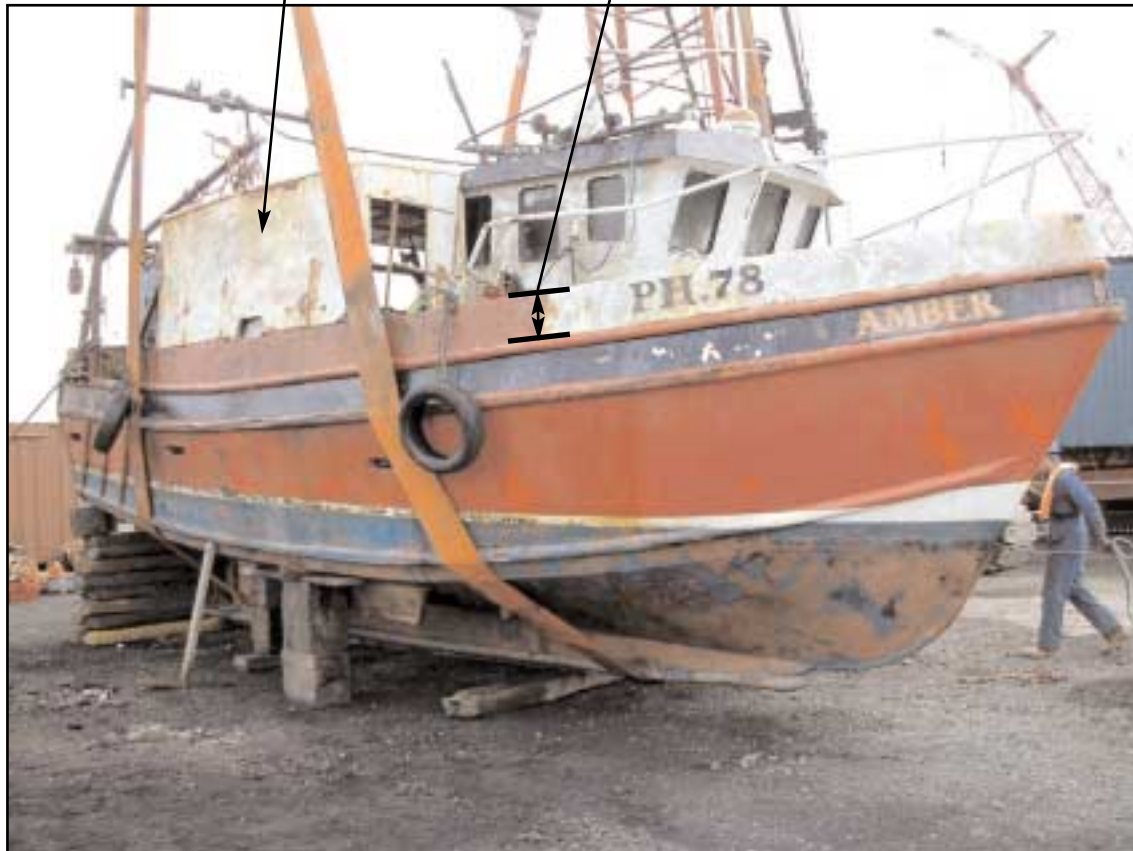
Figure 4

In August 1999, the gunwale was raised by approximately 0.23m, to increase crew protection when they were working on deck (**Figure 4**).

Amber showing raised gunwale and shelter

The stability performance when the vessel was built is unknown, but what is certain is that the modifications carried out since 1999, which were completed with crew protection in mind, effectively degraded the stability and lowered the freeboard. Having spare gear on board is essential to conduct running repairs.

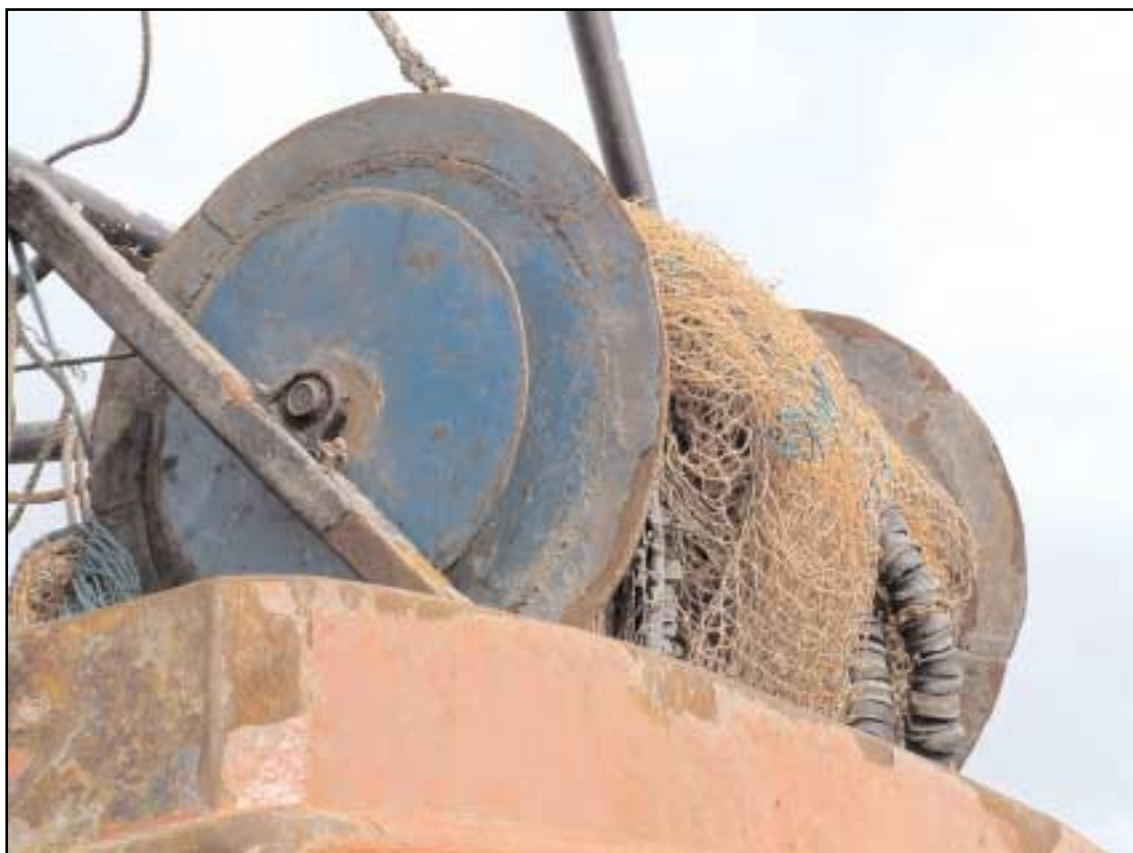
Figure 5

Net drum on *Amber*

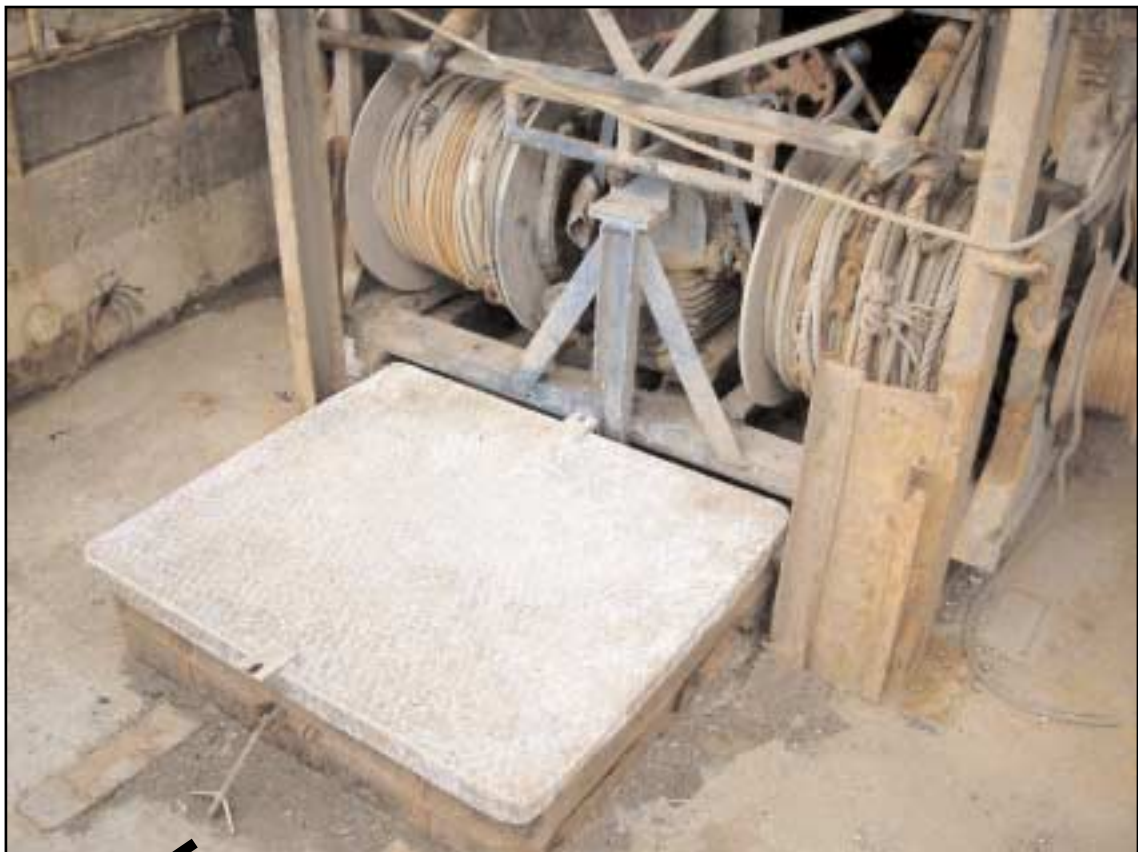
Figure 6

Shortly after fitting the new engine, the skipper and his son were fishing off the coast of Sunderland. They caught a trawl door on a wreck and had to cut the trawl wire on that side. They then retrieved the gear on the opposite side, although the snagged trawl door was lost. That terminated the fishing for the trip, and on return to the Forth it was found that the main winch (**Figure 6**) needed to have its main bearings replaced. This was carried out in November-December 2002. It appears that the fatal accident was the first occasion on which *Amber* had put to sea since having the winch refurbished.

Amber main winch and fish hatch

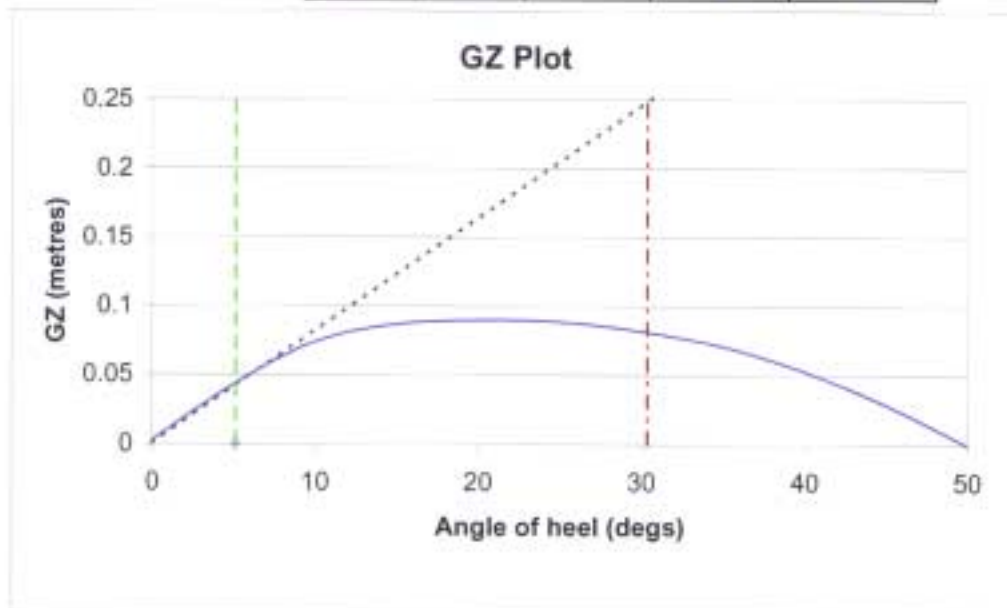
Vessel: **AMBER (PH78)**
 Condition: **At sea 6/1/03**

The results of the stability analysis at **Annex 2** demonstrate that *Amber* had poor stability. Had the 1.775 tonne rock, which was in the net, been lifted off the seabed, the combination of its weight, a high suspension point, and the likely offset from the centreline, could have caused *Amber* to capsize. In reality, the rock might never have left the seabed as the length of net was greater than the depth of water. Instead, the rock might have muddied up as it was dragged on the up-slope of the seabed towards Methil harbour, increasing the drag that was experienced by the vessel.

Minimum	Actual	f/p- immerse
Angle of immersion of fish hatch and stbd fwd f/p (degrees)		30.342	5.11
Area under GZ curve between 0 & 30 degrees (metre.radians)	0.055	0.038	
Area under GZ curve between 0 & 40 degrees (metre.radians)	0.09	0.038	
Area under GZ curve between 30 30.34 & 40 degrees (metre.radians)	0.03	0	
Maximum GZ (metres)	0.2	0.09	
Angle of heel at which maximum GZ occurs (degrees)	30	20.908	
Positive GZ heel range (degrees)		50.00	
GMF (metres) (upright)	0.35	0.469	
Key f/p- freeing port

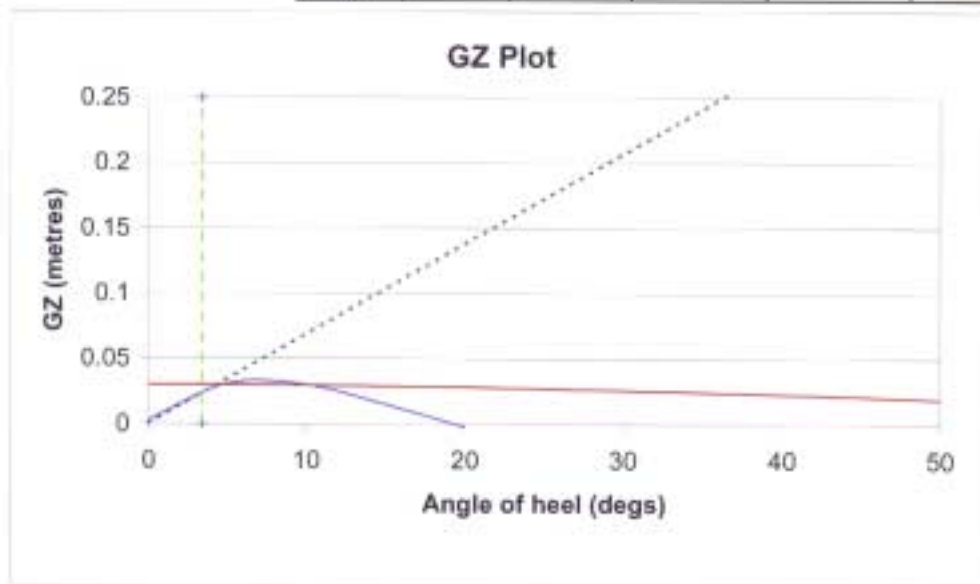
Vessel: AMBER (PH78)
 Condition: Rock in net 6/1/03

Minimum	Actual
Angle of immersion of midships freeing port (degrees)		3.375
Area under GZ curve between 0 & 30 degrees (metre.radians)	0.055	0.007
Area under GZ curve between 0 & 40 degrees (metre.radians)	0.09	0.007
Area under GZ curve between 30 & 40 degrees (metre.radians)	0.03	0
Maximum GZ (metres)	0.2	0.034
Angle of heel at which maximum GZ occurs (degrees)	30	7.4
Positive GZ heel range (degrees)		19.514
GMF (metres) (upright)	0.35	0.395
