Report on the investigation of
the near miss between
Bro Axel/Noordhinder
and the subsequent grounding of
Bro Axel
at
Milford Haven
5 December 2002

Report No 22/2003
September 2003

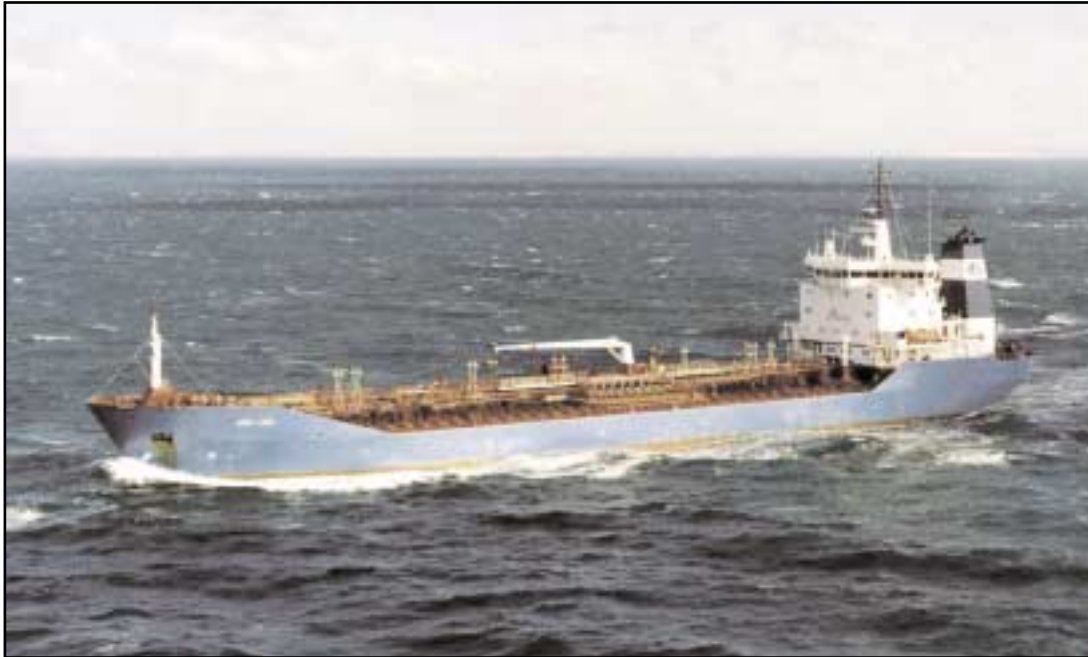
Figure 1

Bro Axel

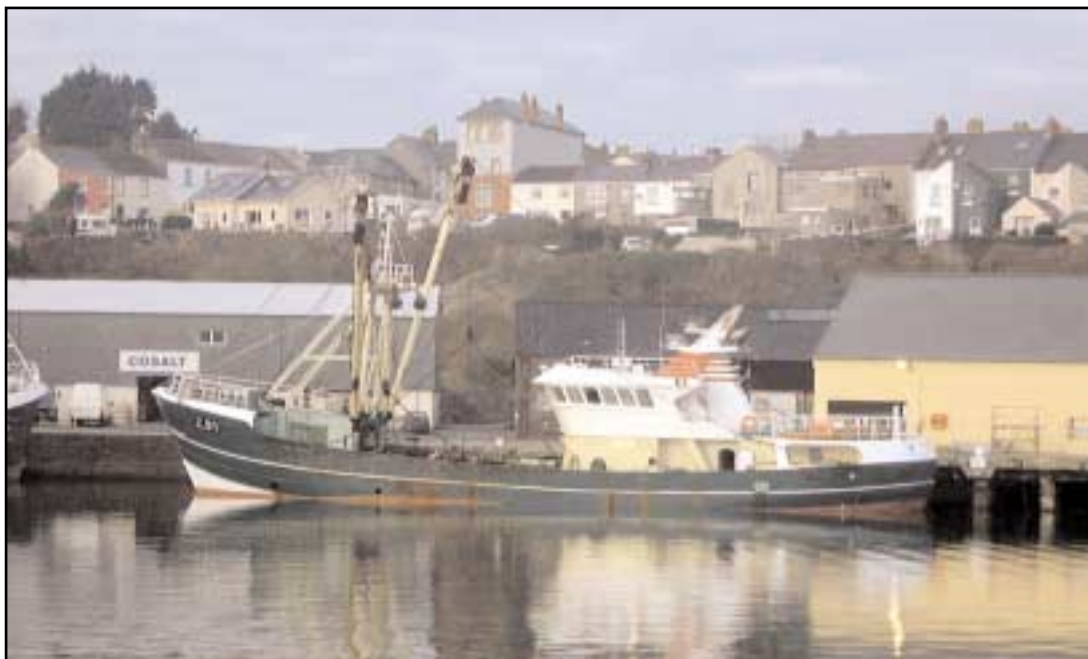
Figure 2

Noordhinder

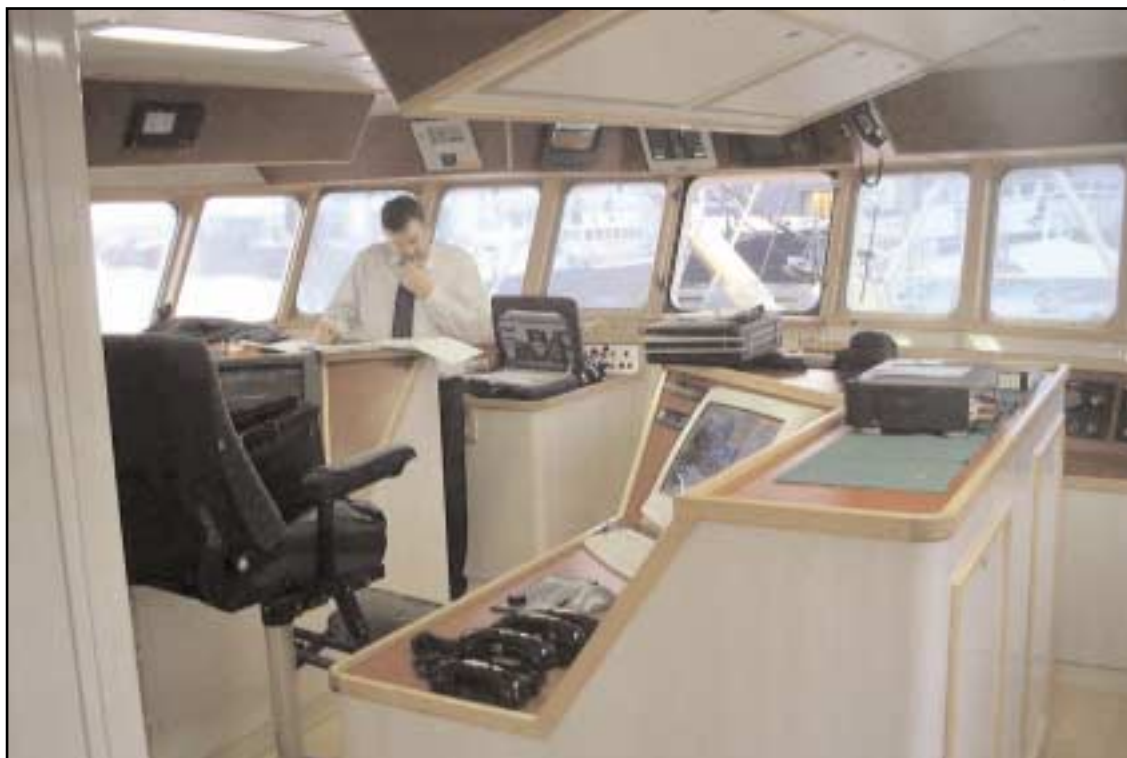
In the wheelhouse, the helm position, controlled by a small electronic tiller, was situated forward in the centre, directly behind the bulkhead which housed the wheelhouse windows. However, the navigational equipment which included an ARPA radar, DGPS and GPS navigators, ECDIS magnetic and gyro compasses, auto pilot, echo sounder, sonar, MF and VHF radios were situated in an operating console in the centre of the wheelhouse (**Figure 4**). Seating was available in the wheelhouse.

Noordhinder's wheelhouse

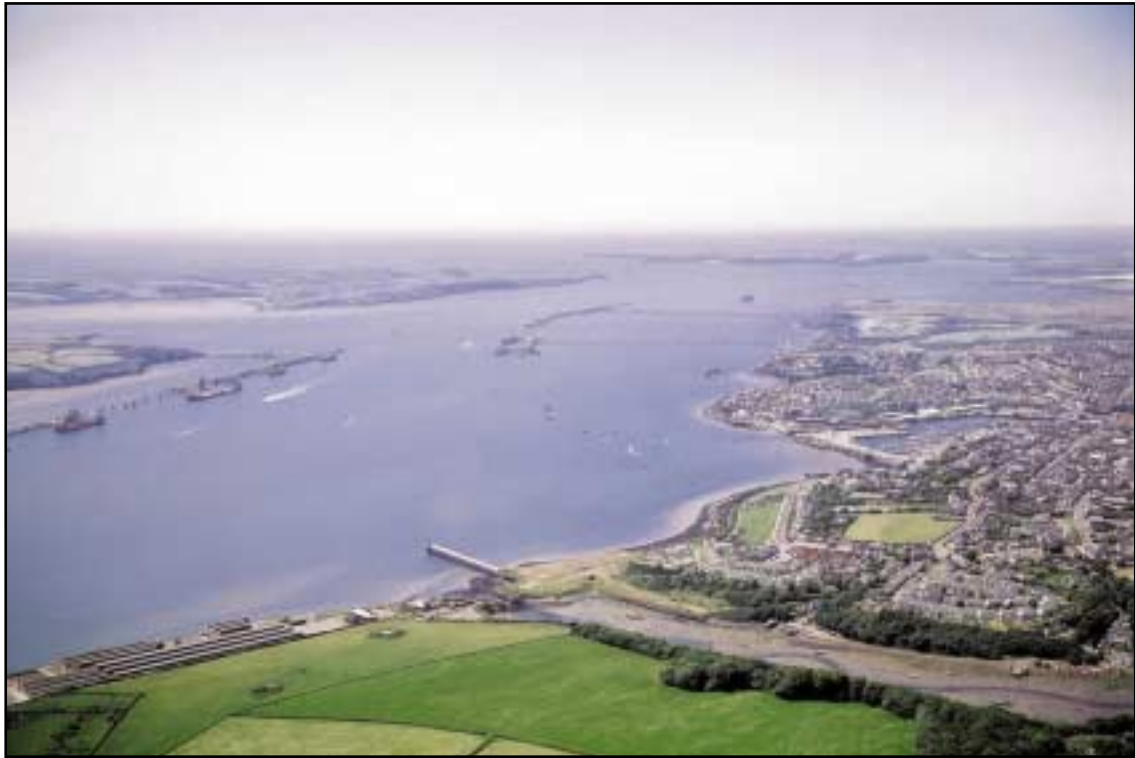
The port of Milford Haven (**Figure 5**) includes the whole of the Haven, and its area extends from the inner limits on the upper reaches of the River Cleddau, to the outer seaward limits some 6 miles south-east and south-west of St Anne's Head. It is a major oil terminal, and is one of the few ports in the UK accessible to fully laden VLCCs with draughts up to 20m. Aggregates and general cargo are handled at Pembroke Dock, where there is a ro-ro ferry terminal for services to Ireland.
