Report on the investigation of

the collision between

***Pride of Portsmouth***

***HMS St Albans***

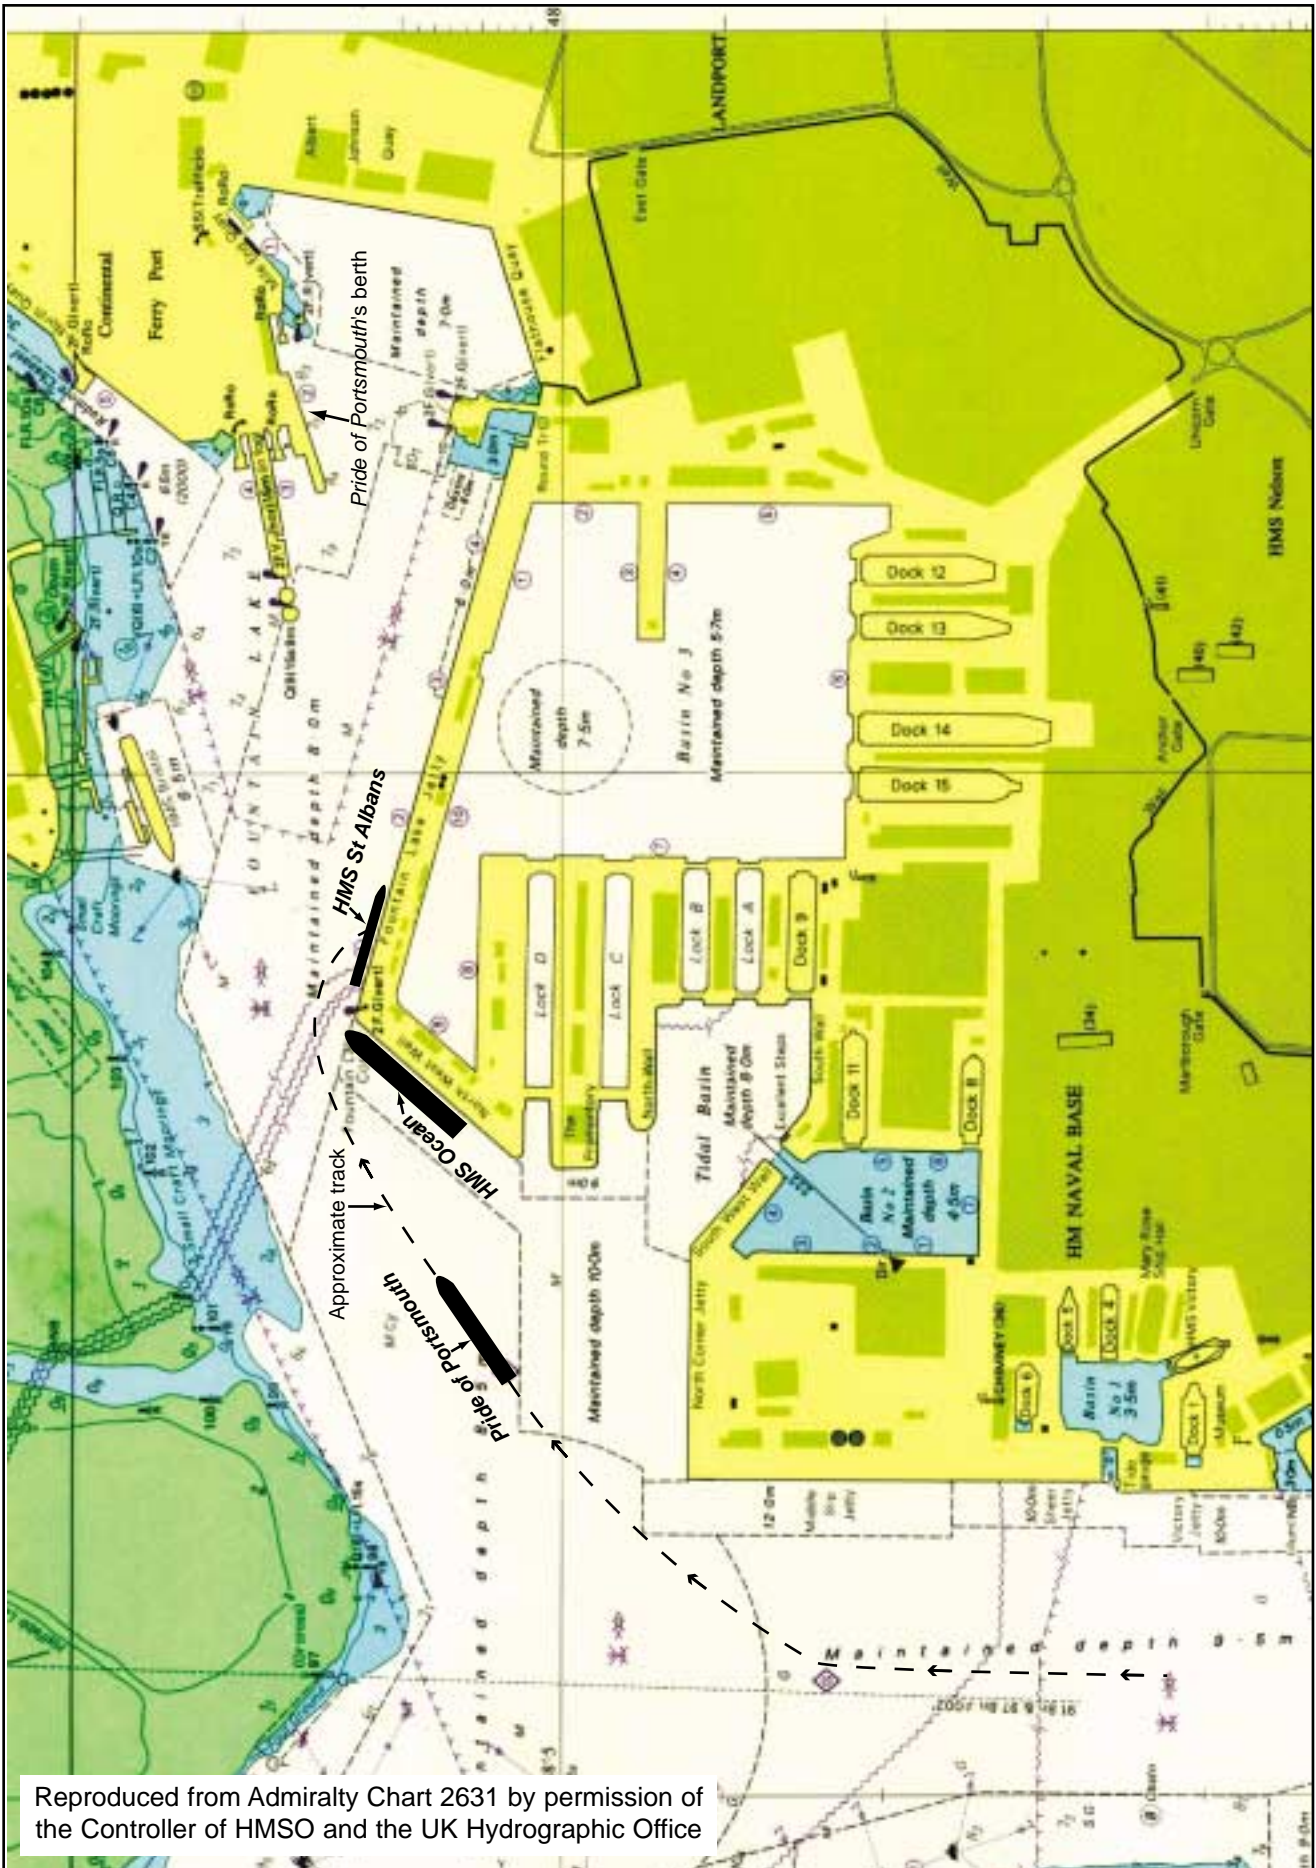
Harbour plan

The vessel began to turn to starboard to round North Corner at about 0530, making about 8.5 knots over the ground (**see harbour plan**). The chief officer took up a position forward of the manoeuvring console at the starboard wing of the bridge at about that time. He reported that the vessel was "*looking good*" and about 120' (37 metres) clear [of North Corner] just before 0532.

At 0534, when *Pride of Portsmouth's* bow was about due west of Fountain Lake Corner, the master ordered hard to starboard to increase the rate of turn. The vessel was making about 8 knots over the ground against an ebb tide of less than half a knot and the wind was almost directly astern. The helm was returned to amidships 10 seconds later. The single bow thruster was operational at this time probably thrusting the bow to port. A further 10 seconds later, the chief officer reported that they were “*moving quite close to the stern of the frigate*”.

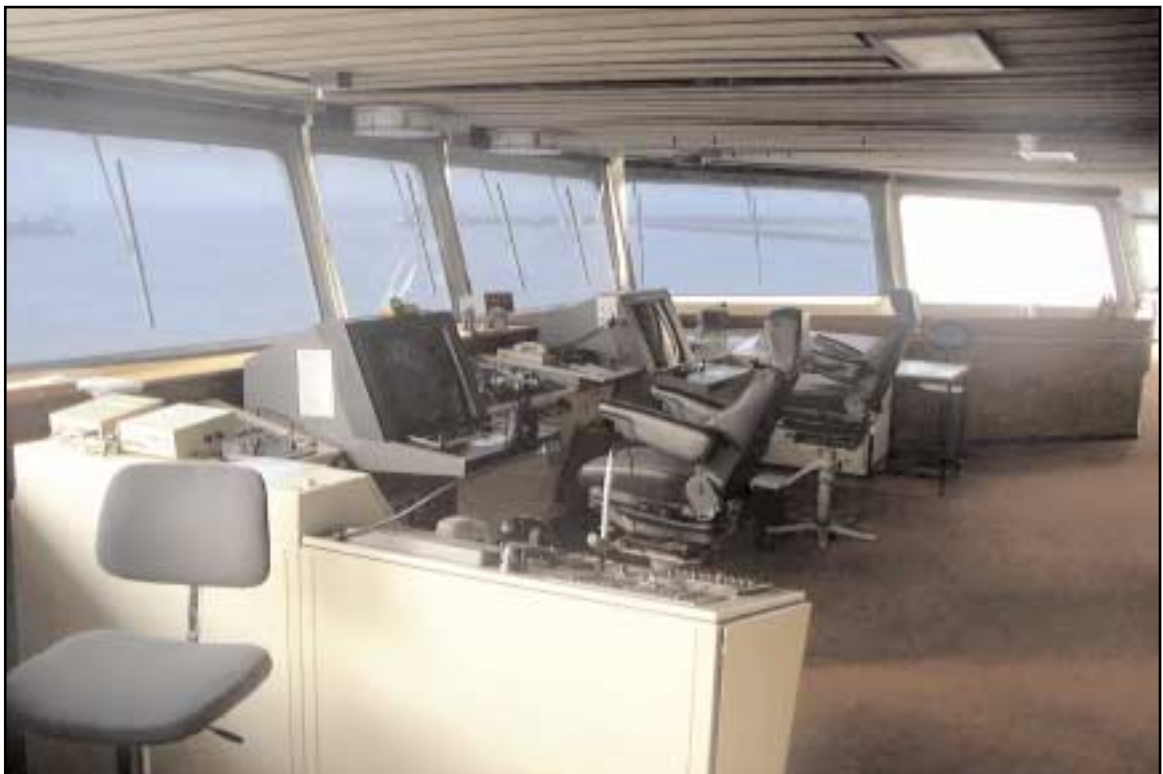
Photograph 2

The central manoeuvring console (**see photograph 2**) was sited against the forward bulkhead, in an area protruding forward from the main bridge. The engine and thruster control panel was sited on the centre line (**see photograph 3**) with an ARPA radar sited adjacent on either side. Rudder controls (**see photograph 4**) were sited to port of one of the radars about 2m from the engine and thruster controls. Bridge chairs were situated behind each of the radars; it is understood that they were rarely used.

The central manoeuvring console

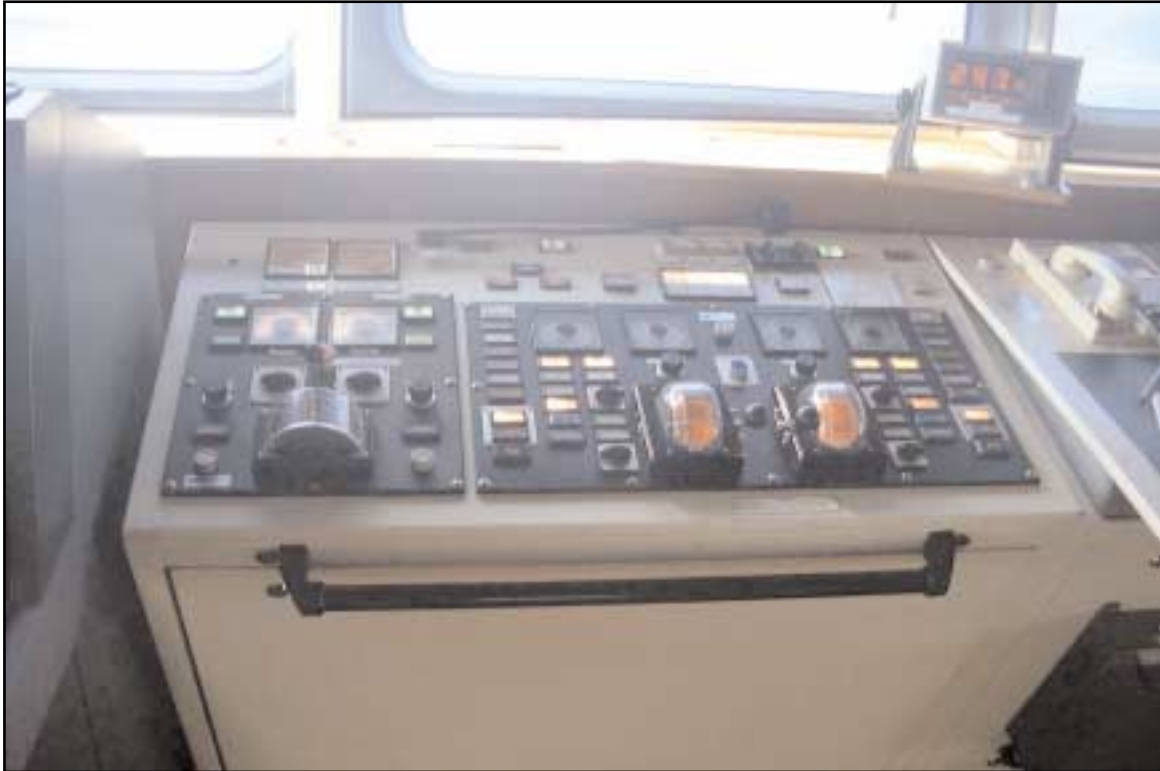
Photograph 3

The engine and thruster panel

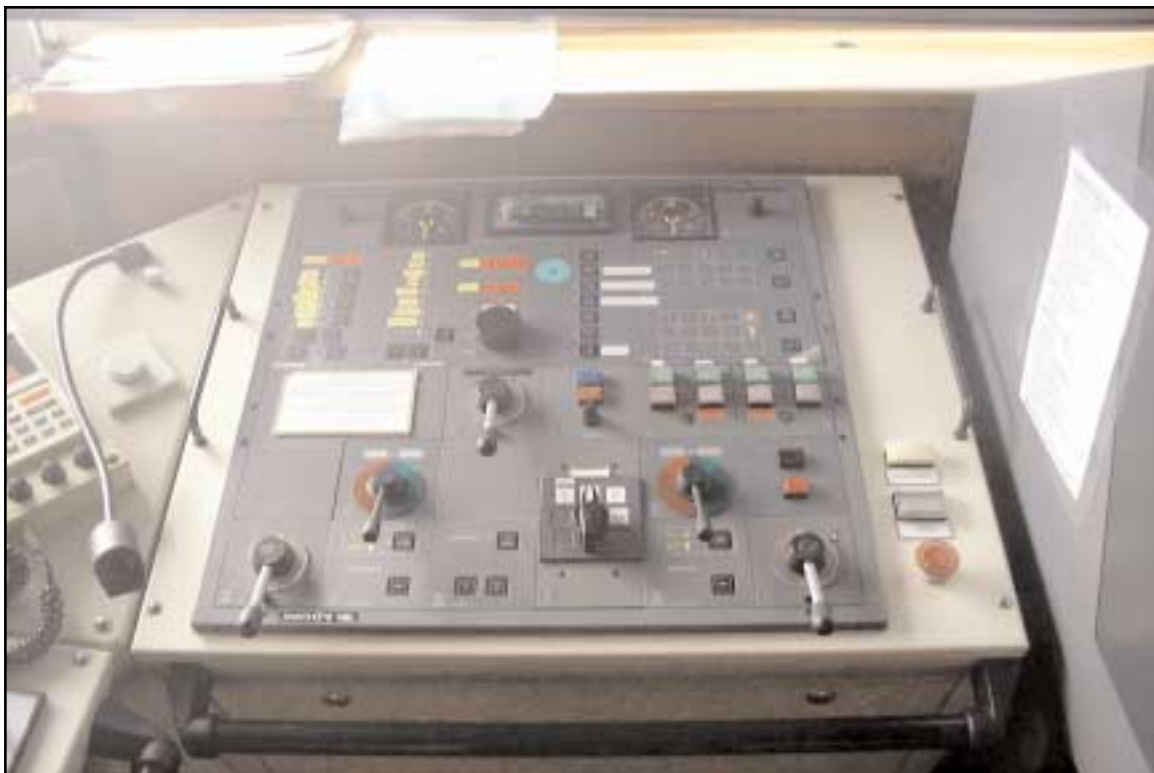
Photograph 4

The steering panel

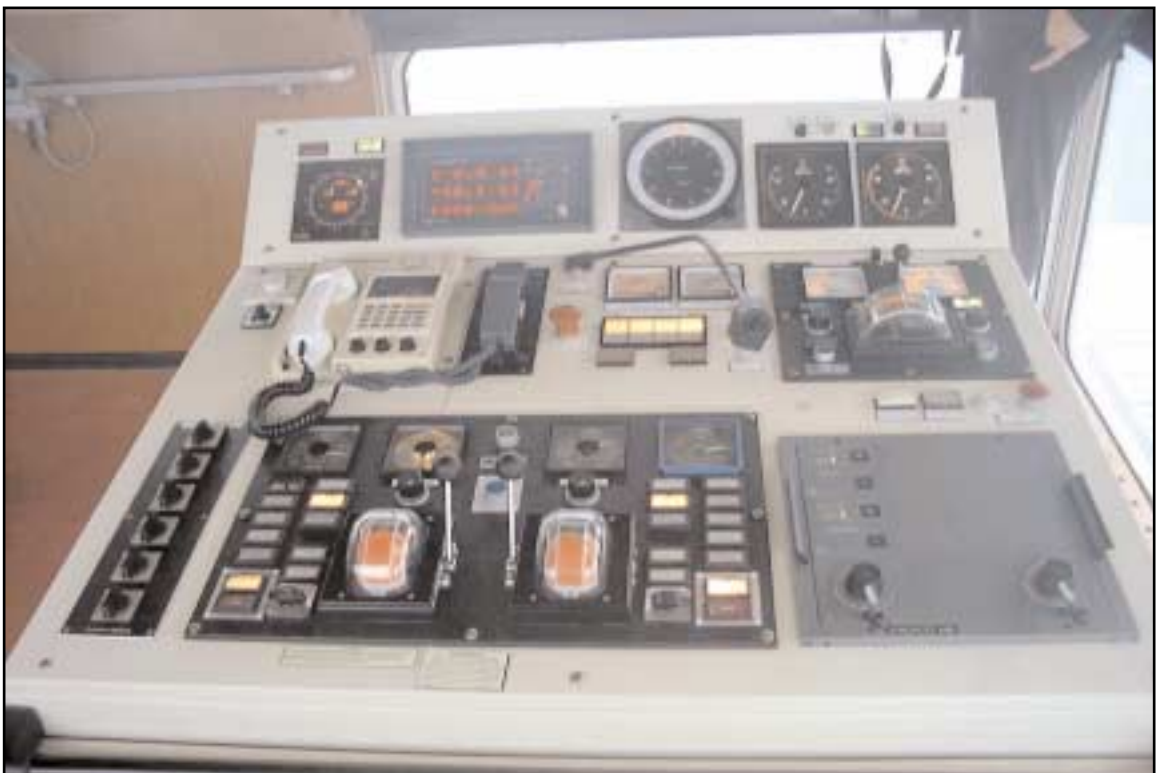
Photograph 5

When approaching the berth, the officer with the con moved to one of the bridge wing control stations (**see photograph 5**) where he took control of the engines, thrusters and rudders to bring the vessel alongside. All the necessary controls and gauges could be reached or be seen from one standing position. Windows were arranged so that from a position behind the console the officer had a good view fore and aft, down the side of the vessel.

A bridge wing control console

Additionally, both the master and the chief officer need a direct view of an RAI from their respective conning and monitoring positions. In the case of the chief officer on the bridge wing, this could be achieved by standing behind the existing control console, assuming an adequate view over the side can be obtained from that position. The master could not see the panoramic RAI situated directly above his conning position without moving away from the control console. This is an undesirable condition. The provision of an additional RAI in direct sight of someone operating the engine and thrusters controls from the central position would improve the safety and efficiency of bridge operations on *Pride of Portsmouth*.

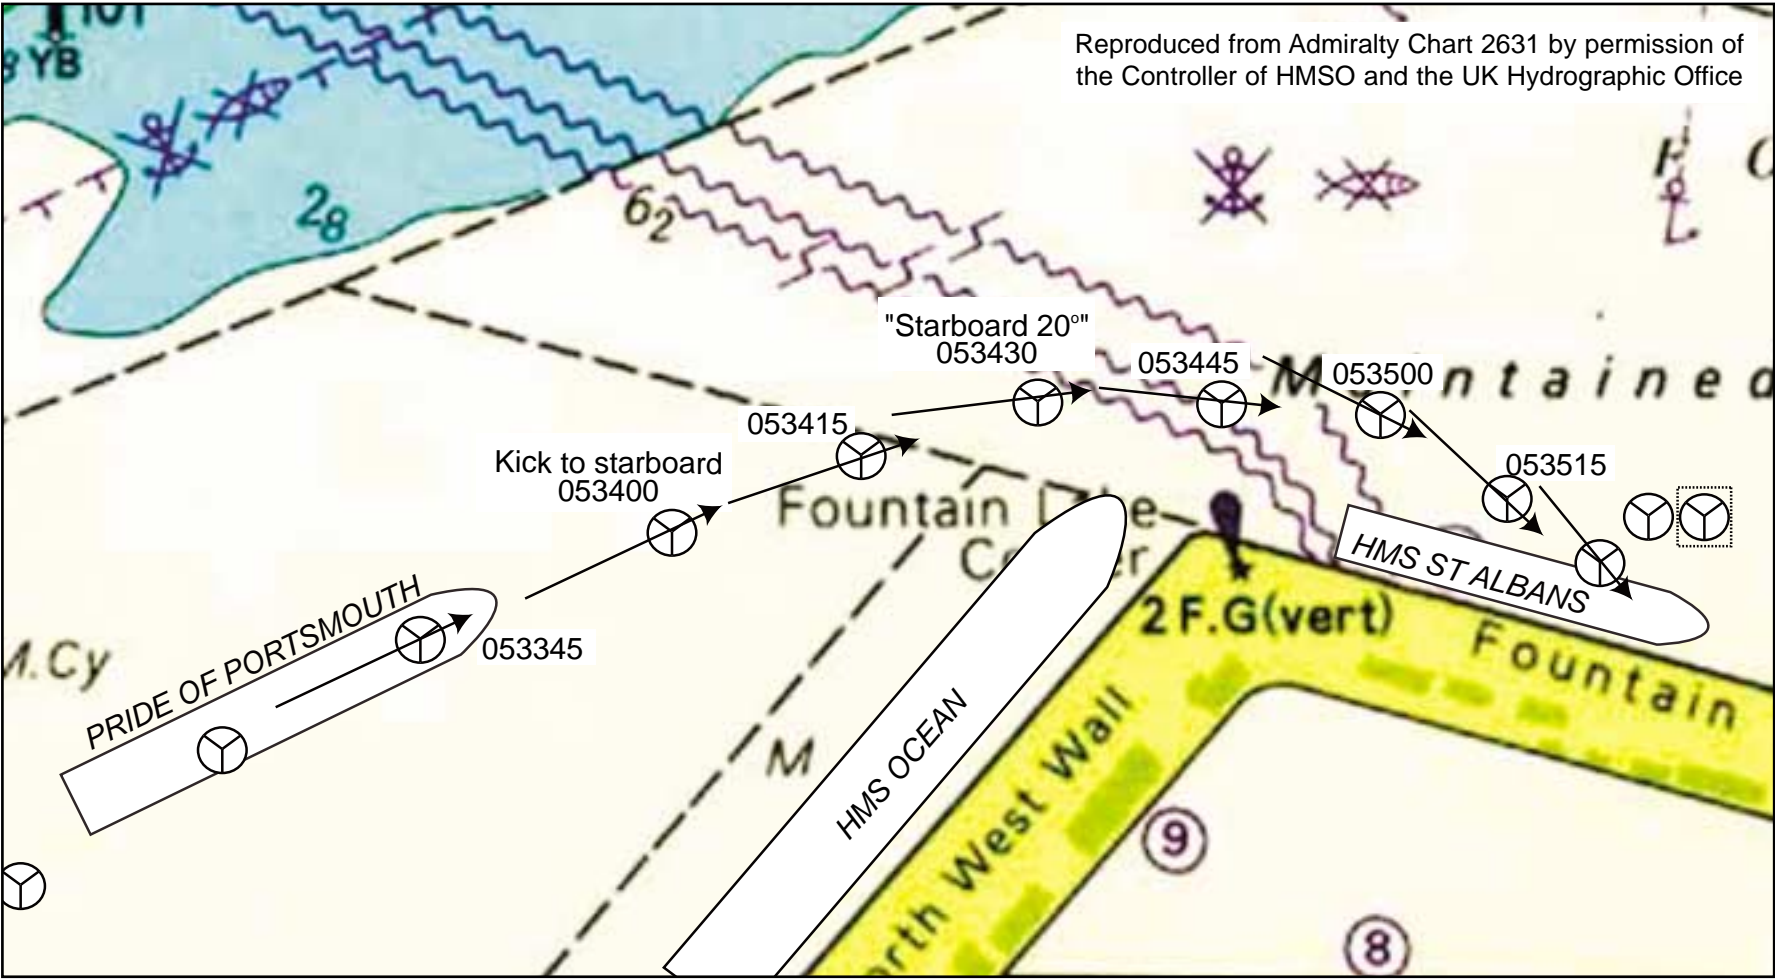
Diagram 1

Detailed track from VDR data showing *Pride of Portsmouth's* heading

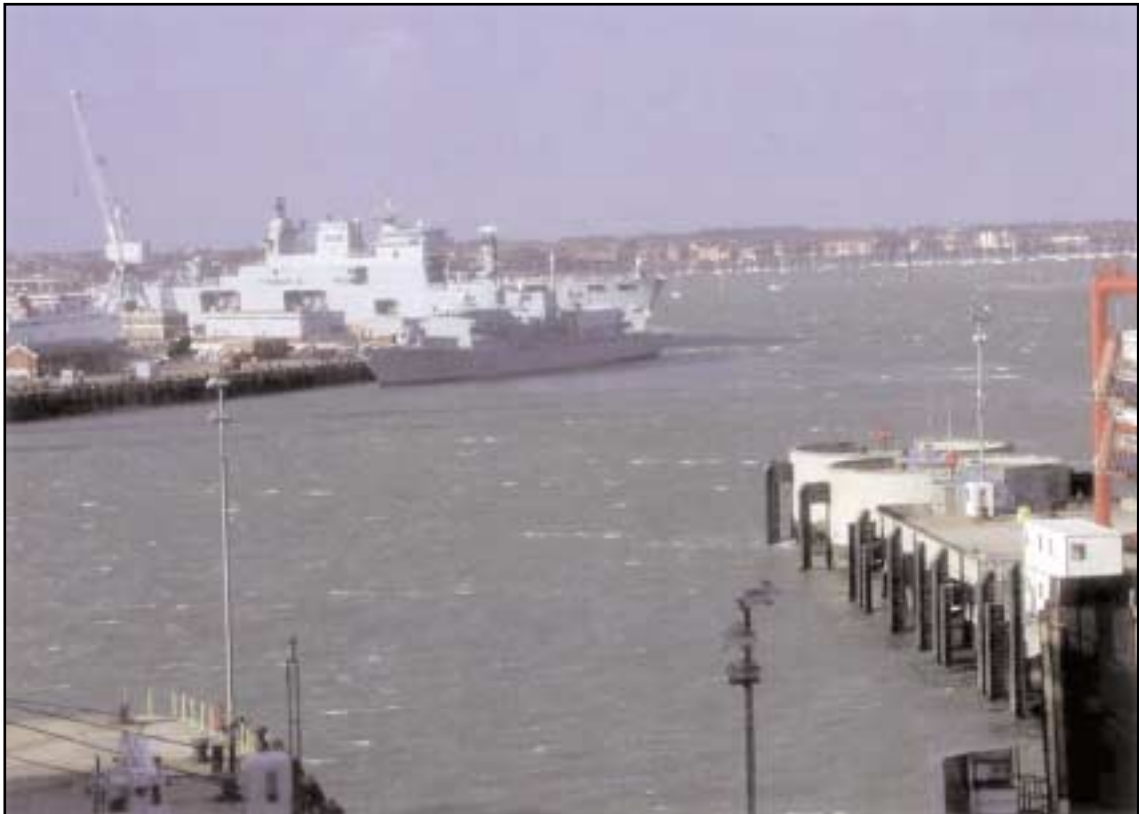
Figure 1

Damage	:	Severe damage to port side superstructure and, on the starboard side, substantial impact damage with the quay fendering.
--------	---	--

*HMS Ocean and HMS St Albans from the ferry berth soon after the accident*
