Report on the investigation of  
the collision between  
***Pride of Portsmouth***  
and  
***HMS St Albans***  
Portsmouth Harbour  
27 October 2002

Marine Accident Investigation Branch  
First Floor  
Carlton House  
Carlton Place  
Southampton  
United Kingdom  
SO15 2DZ

**Report No 20/2003**  
**July 2003**

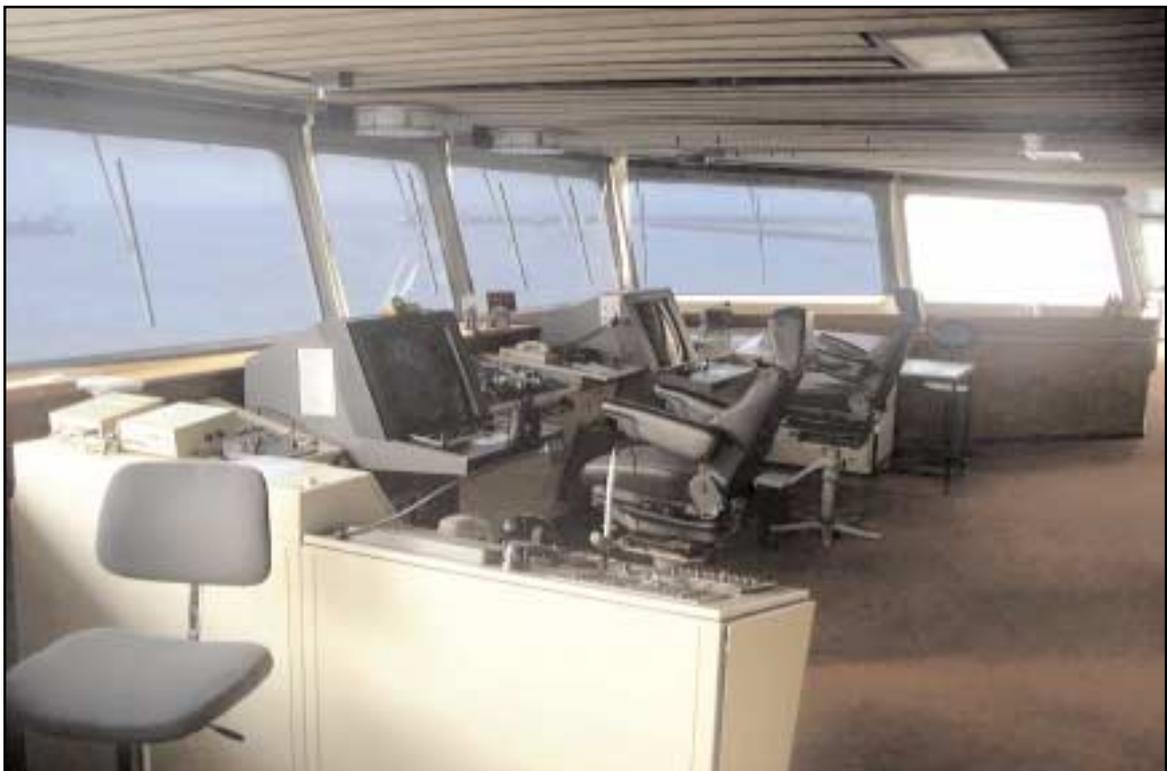
Photograph 2

The central manoeuvring console (**see photograph 2**) was sited against the forward bulkhead, in an area protruding forward from the main bridge. The engine and thruster control panel was sited on the centre line (**see photograph 3**) with an ARPA radar sited adjacent on either side. Rudder controls (**see photograph 4**) were sited to port of one of the radars about 2m from the engine and thruster controls. Bridge chairs were situated behind each of the radars; it is understood that they were rarely used.

The central manoeuvring console

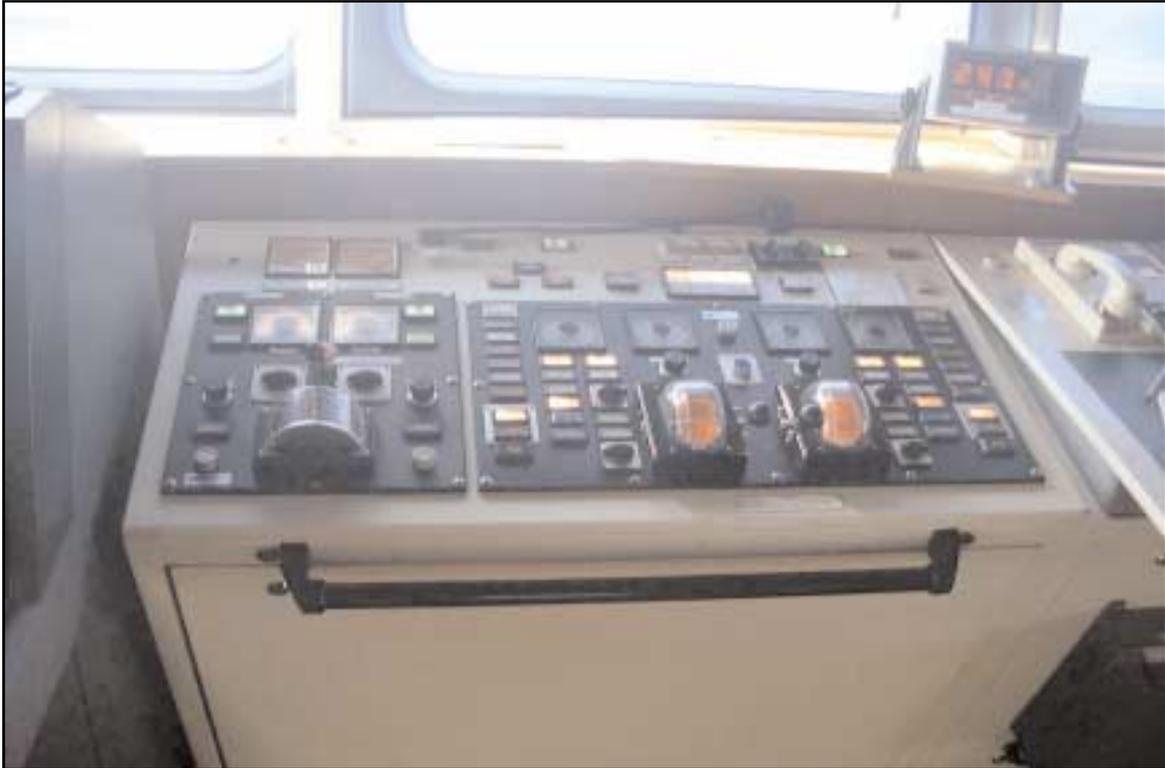
Photograph 3

The engine and thruster panel

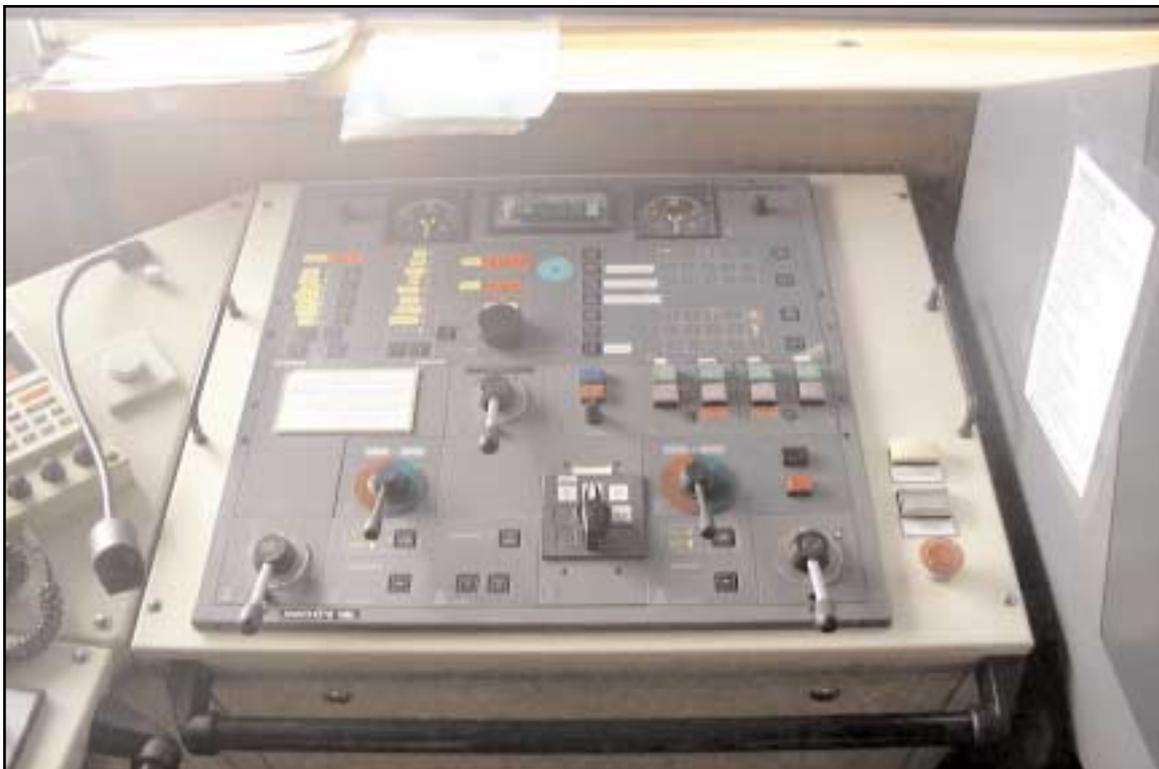
Photograph 4

The steering panel

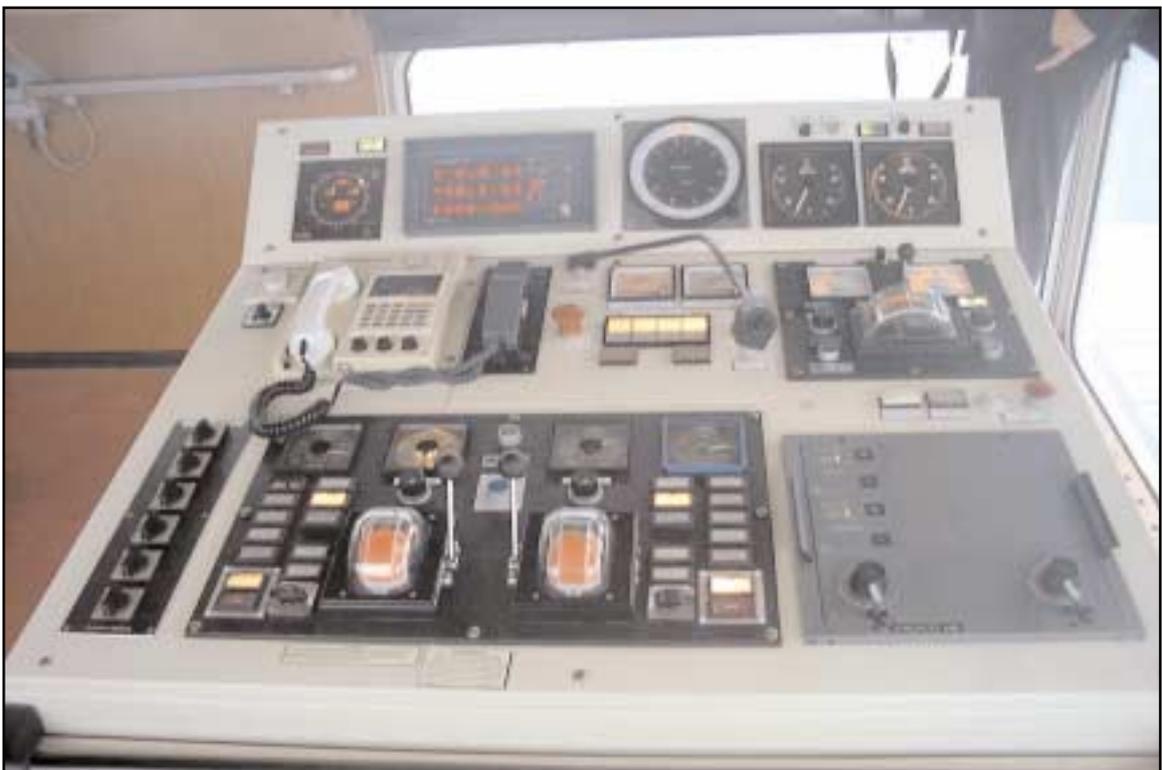
Photograph 5

When approaching the berth, the officer with the con moved to one of the bridge wing control stations (**see photograph 5**) where he took control of the engines, thrusters and rudders to bring the vessel alongside. All the necessary controls and gauges could be reached or be seen from one standing position. Windows were arranged so that from a position behind the console the officer had a good view fore and aft, down the side of the vessel.

A bridge wing control console

With the benefit of hindsight, the accident could have been avoided if the master had had direct control of the vessel from the starboard bridge wing console. Before the event, the master considered that the major danger in the turn around Fountain Lake Corner in the wind conditions lay in being swept across to port and down on to the moored warship *HMS Bristol*. It is understandable, therefore, that he chose to maintain a conning position in the centre of the bridge. However, both possible dangers, that is, the very close proximity to the unsighted warships at Fountain Lake Corner, and being swept across to port, could have been catered for by temporarily changing control positions and strategic positioning of the chief officer.

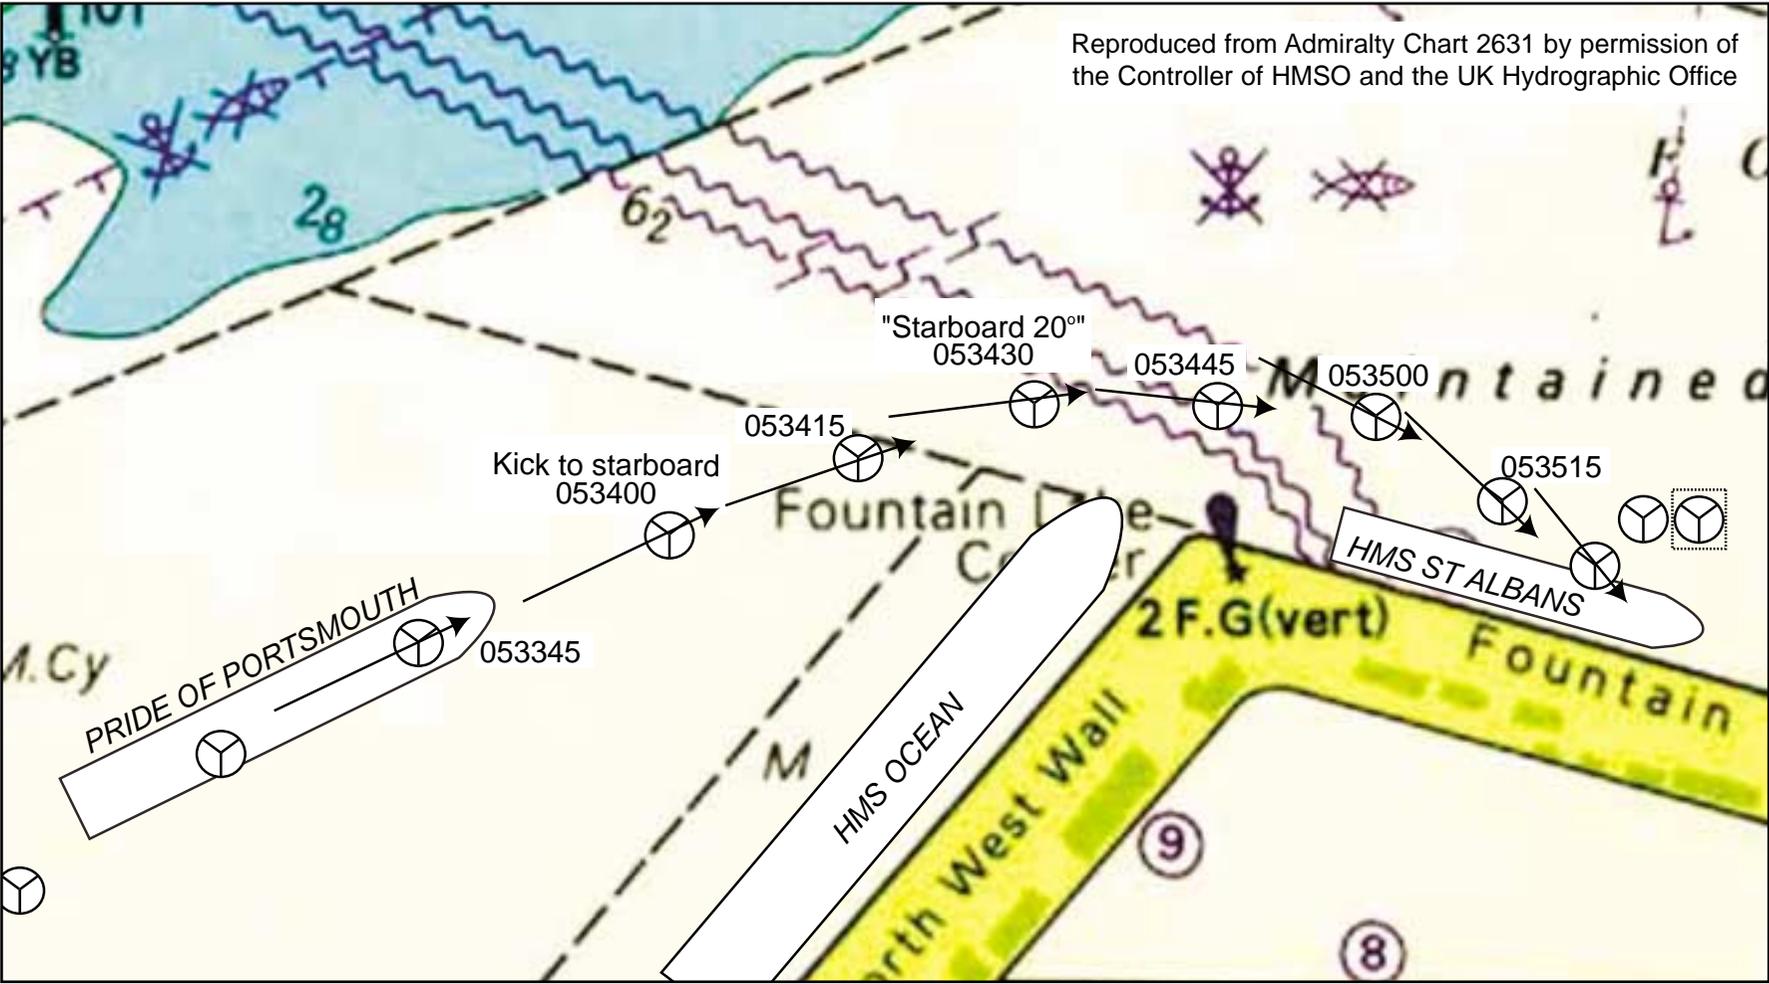
Diagram 1

Detailed track from VDR data showing *Pride of Portsmouth's* heading

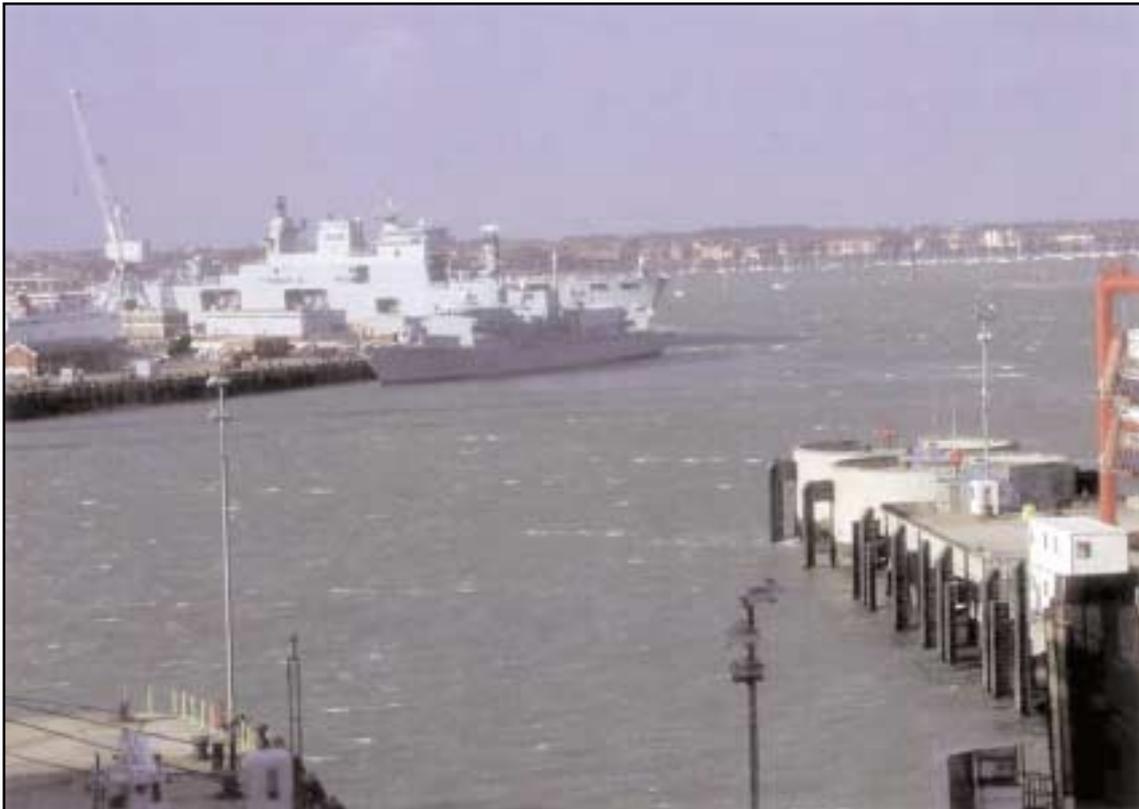
Figure 1

It is likely that the strong winds played a part in bringing about the collision. As the vessel began the swing to round Fountain Lake Corner, the wind moved from directly astern to come to bear on the starboard quarter. This caused an increase in the rate of turn to starboard. This effect could have been exacerbated when the bow came into the substantial lee created by *HMS Ocean* (see photograph 6). The lack of one bow thruster also reduced control authority. Whether or not these environmental factors were significant, recordings of the activity on the bridge suggest that human factors contributed to the accident. Most significantly, the master's last helm command before the collision was "Starboard 20", ie the vessel was steered into the collision further increasing the rate of turn induced by the environmental factors. At the time "Starboard 20" was ordered, the vessel's heading was about 087°, and the required heading for the approach to the ro-ro berth was about 105° plus some allowance for leeway. The master did not have a clear view of either *HMS Ocean* or *HMS St Albans* from the central conning position and it is possible, therefore, that in the demanding and rapidly changing situation "Starboard 20" was the intended order. However, the master had just acknowledged a warning from the chief officer that the vessel was "moving quite close to the stern of the frigate" and the vessel already had an accelerating swing to starboard and was turning at 44° a minute (see Figure 1) at the time the order was given. Despite the fact that on a bridge sited far forward like the one on *Pride of Portsmouth*, it is sometimes difficult to appreciate the amount that the stern is swinging, the master should have been aware, as an indicator was within his view. However, it is considered that the master lost situational awareness at about this time and the "Starboard 20" order was inappropriate. Under the circumstances, a large port helm order was appropriate to begin to arrest the accelerating swing to starboard. In any event, the master was unaware of the rudder position in the time between giving the order and the collision.

*HMS Ocean and HMS St Albans from the ferry berth soon after the accident*
