Report of investigation  
into a fire in the aft engine room of ro-ro ferry  
**Norsea**  
on 2 September 2002

Marine Accident Investigation Branch  
First Floor, Carlton House  
Carlton Place  
Southampton  
SO15 2DZ

**Report No 16/2003**  
**June 2003**

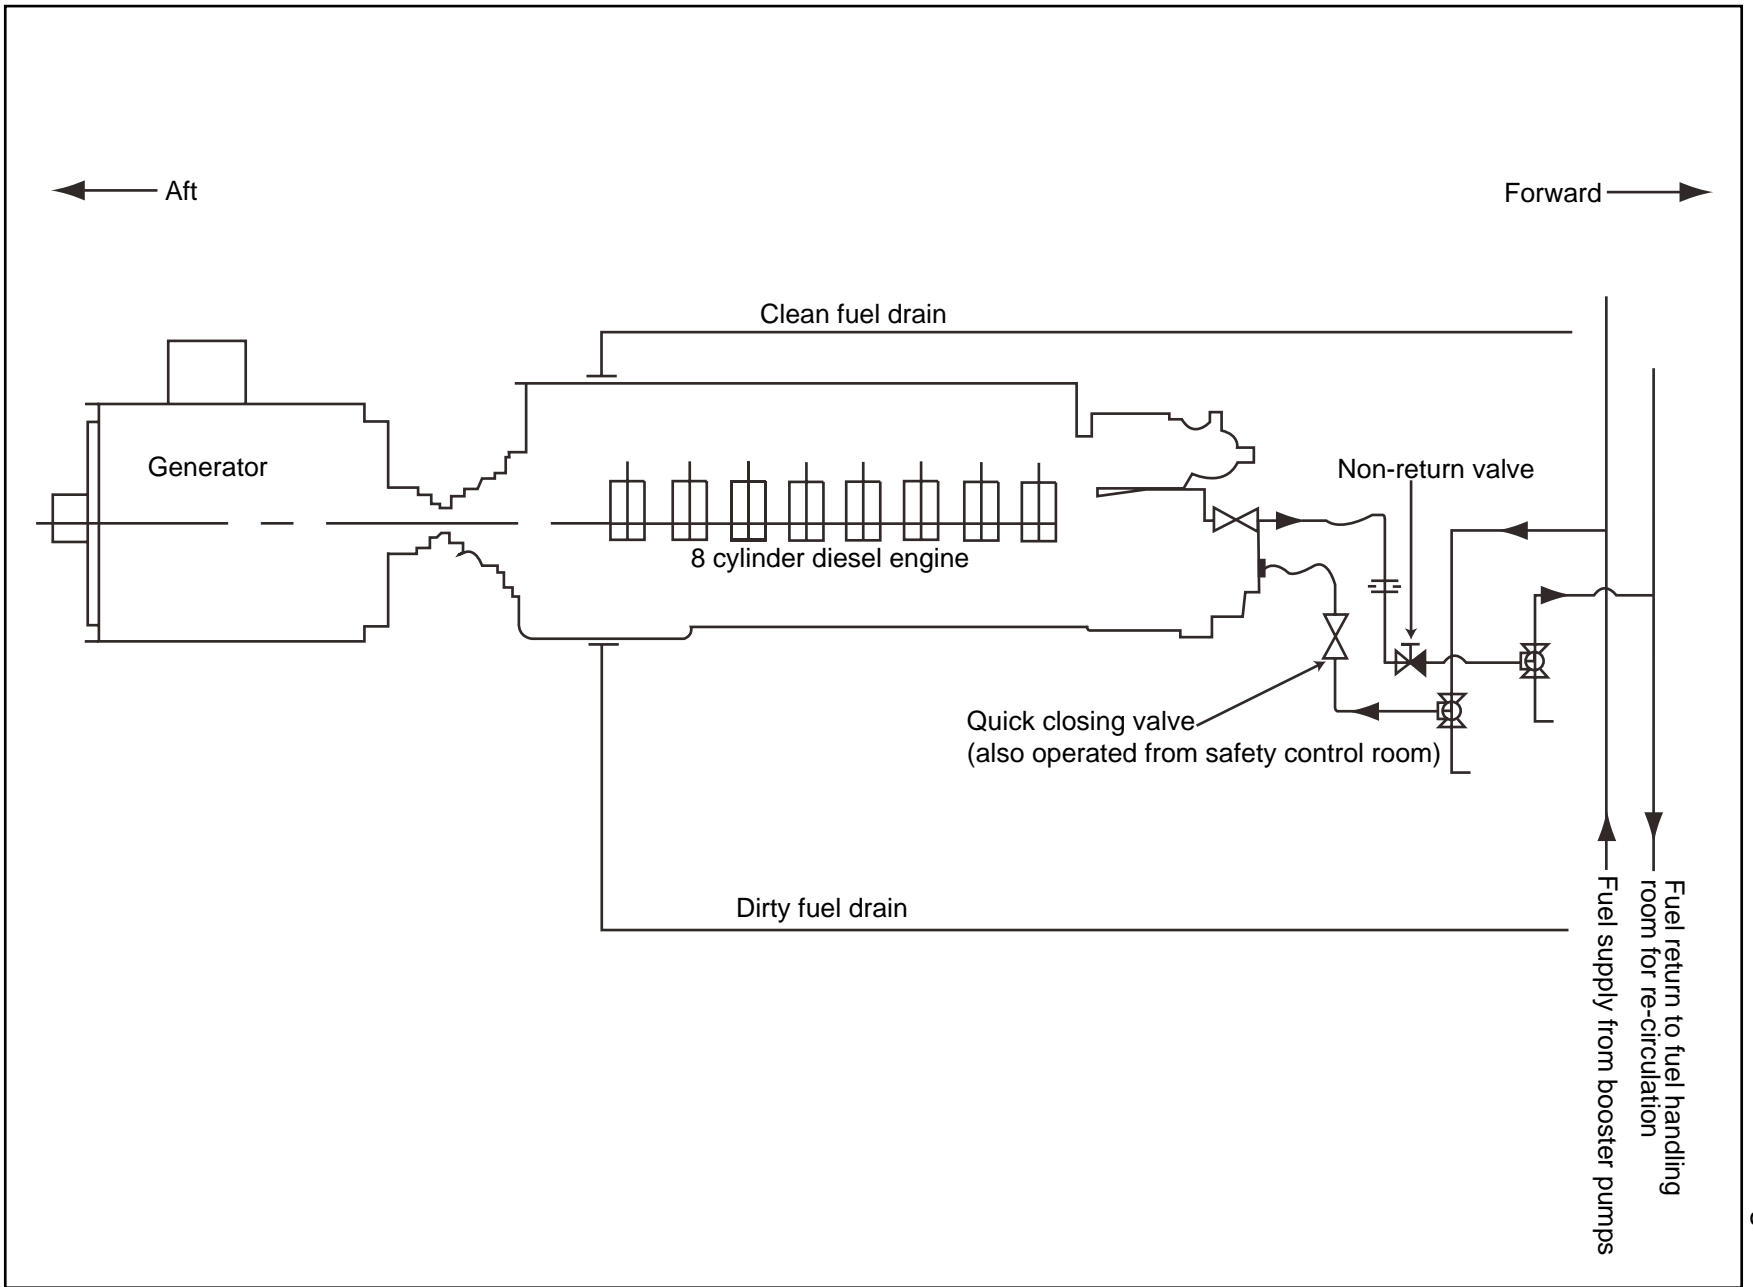
Figure 5

Fuel system for aft generator

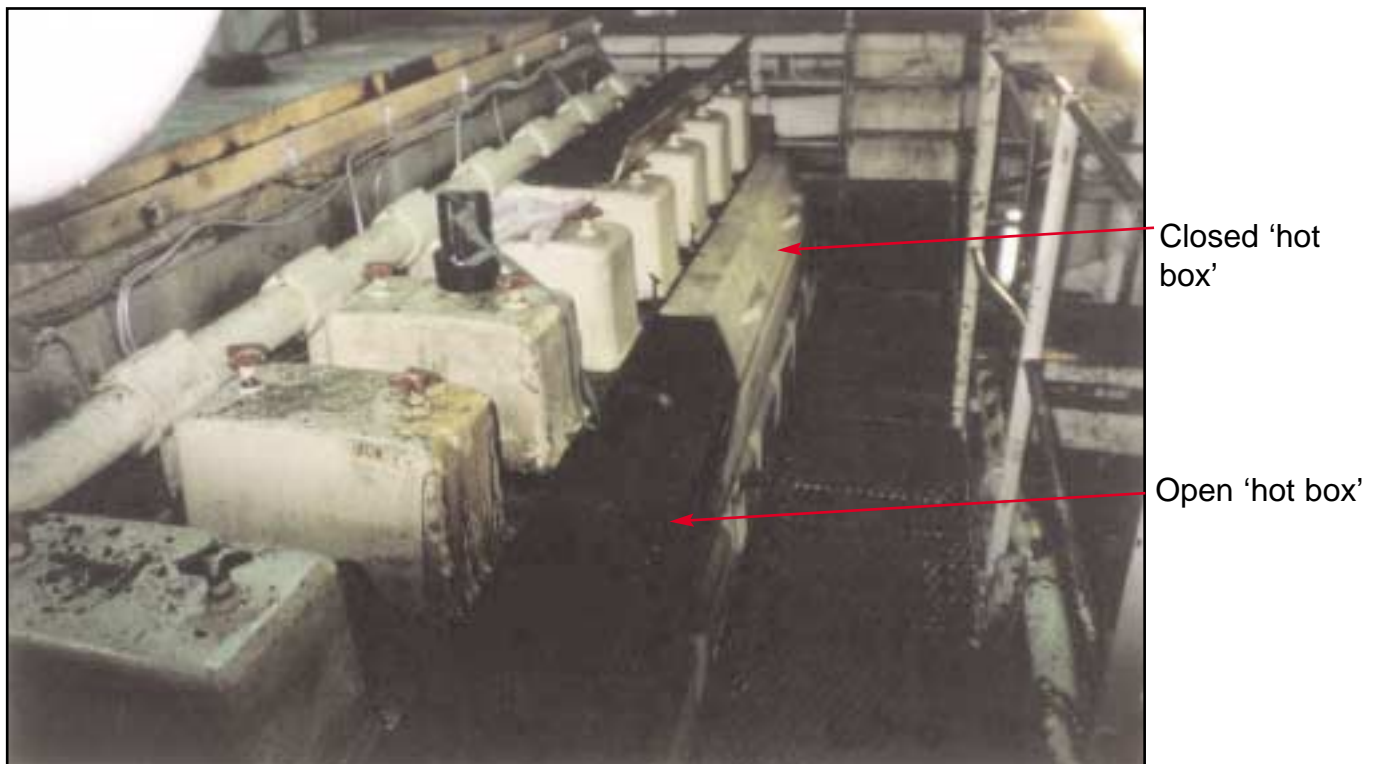
Figure 6

Aft diesel generator engine (port side)

There was no obvious sign of fuel leakage in the hot box until fuel oil pressure was restored to the engine. Once pressurised, the low-pressure fuel pipe running fore and aft by No 7 cylinder leaked. This was in way of a securing clamp for the pipe. Removal of the clamp and pipe showed that the clamping screws were loose, some clamps were incomplete, and the pipe was worn in this area. It was concluded that the pipe had been allowed to fret, wear, and this resulted in its failure.

After the vessel's arrival in Zeebrugge, a simple pressure test on the low-pressure fuel lines on the generator's engine, confirmed the reports of the watchkeeping 3/E, that the fire was caused by a fuel oil leak. A low-pressure fuel pipe clamped to the inside of the engine's hot box had fretted against its clamp and housing, so wearing a small hole in the pipe's wall.

Before this accident, there was no formal procedure for checking the security of the fixing arrangements on low-pressure fuel lines on the engines and generators of *Norsea*. Following their own investigation of the accident, the owners have introduced a monthly procedure for checking the security of these pipes, clamps, mounting bolts and inspection of pipework for chafing. They have also fitted additional clamps to this pipework. As a result, it is judged that MAIB needs to make no further recommendation to the owners.

Because of this patchy level of awareness, Wartsila, the manufacturer of the Vasa 32 engines, is recommended to consider including instructions in its engine user manuals that the security of fuel lines should be checked during hot box inspections. Although this recommendation is directed at Wartsila, it should not be assumed that other types and makes of diesel engines are immune to the problem of failing low-pressure fuel lines.

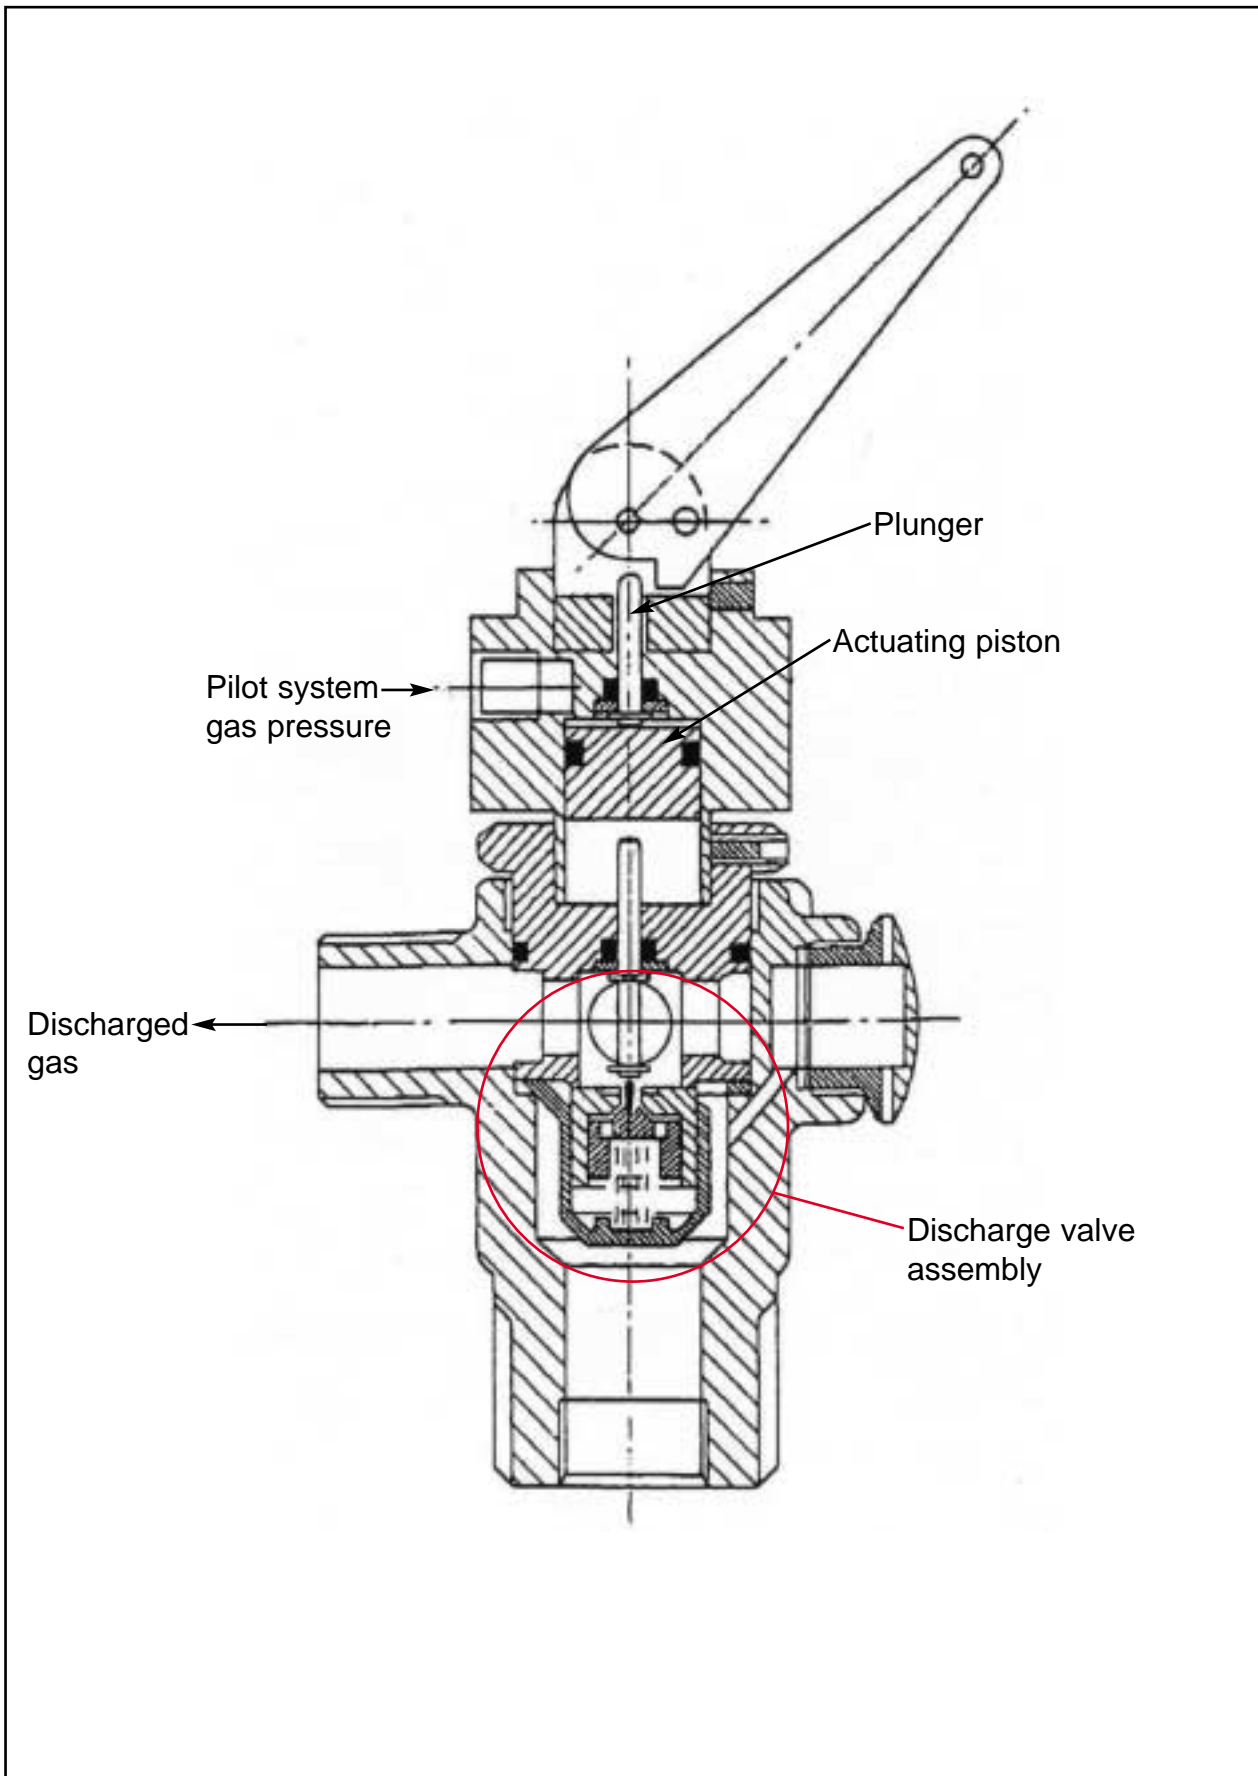
CO<sub>2</sub> bottle actuating head assembly (shown in the closed position)

Further, once the frost had melted from the activated CO<sub>2</sub> bottles, there was no clear or obvious indication in the CO<sub>2</sub> room of which cylinders had been released. The indication available was a small plunger on the actuator head of each cylinder. Unless a close examination was made of each actuator head, it was not possible to assess which cylinders had been released. There is no diagram or written instructions in the CO<sub>2</sub> room to assist in judging whether these plungers are in the 'gas released' position. The 2/E later went to the CO<sub>2</sub> room to identify the cylinders that might be needed for a second injection of gas. Nevertheless, without a reason to make a close examination of all, or a majority of, the cylinders, it is unreasonable to have expected him to identify the system's failure.

Consideration could possibly be given to modifying the system so that there is a clear and prominent mechanical indication of whether or not cylinders have been released. This might not be practicable on existing systems. However, a requirement that new systems have this facility could be introduced. Thus, the MCA is recommended to consider making a proposal to the IMO that all fire-fighting systems, of the gas smothering type, should give a clear indication that the discharge mechanism of the storage cylinders have activated.

In the meantime, the MCA is recommended to issue advice, in a Marine Guidance Notice (MGN) or similar, that the method of assessing the activated state of existing CO<sub>2</sub> systems should be posted up in CO<sub>2</sub> rooms of vessels.

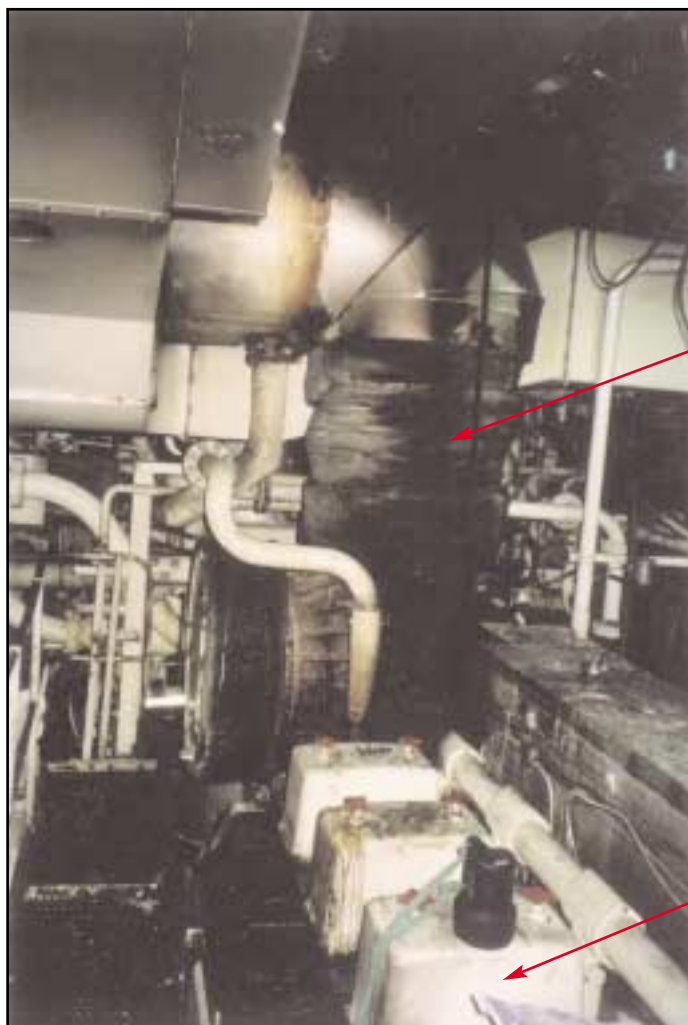
Figure 11

There was no obvious heat damage at the rocker box level of the engine. However, at the engine's forward end the turbocharger's lagging had been affected by smoke (**Figure 11**) and plastic fittings on an adjacent manometer had been affected by heat. Immediately above the engine, a detector head for the fire detection and alarm system had been heat damaged.

Smoke damage to the turbocharger's lagging

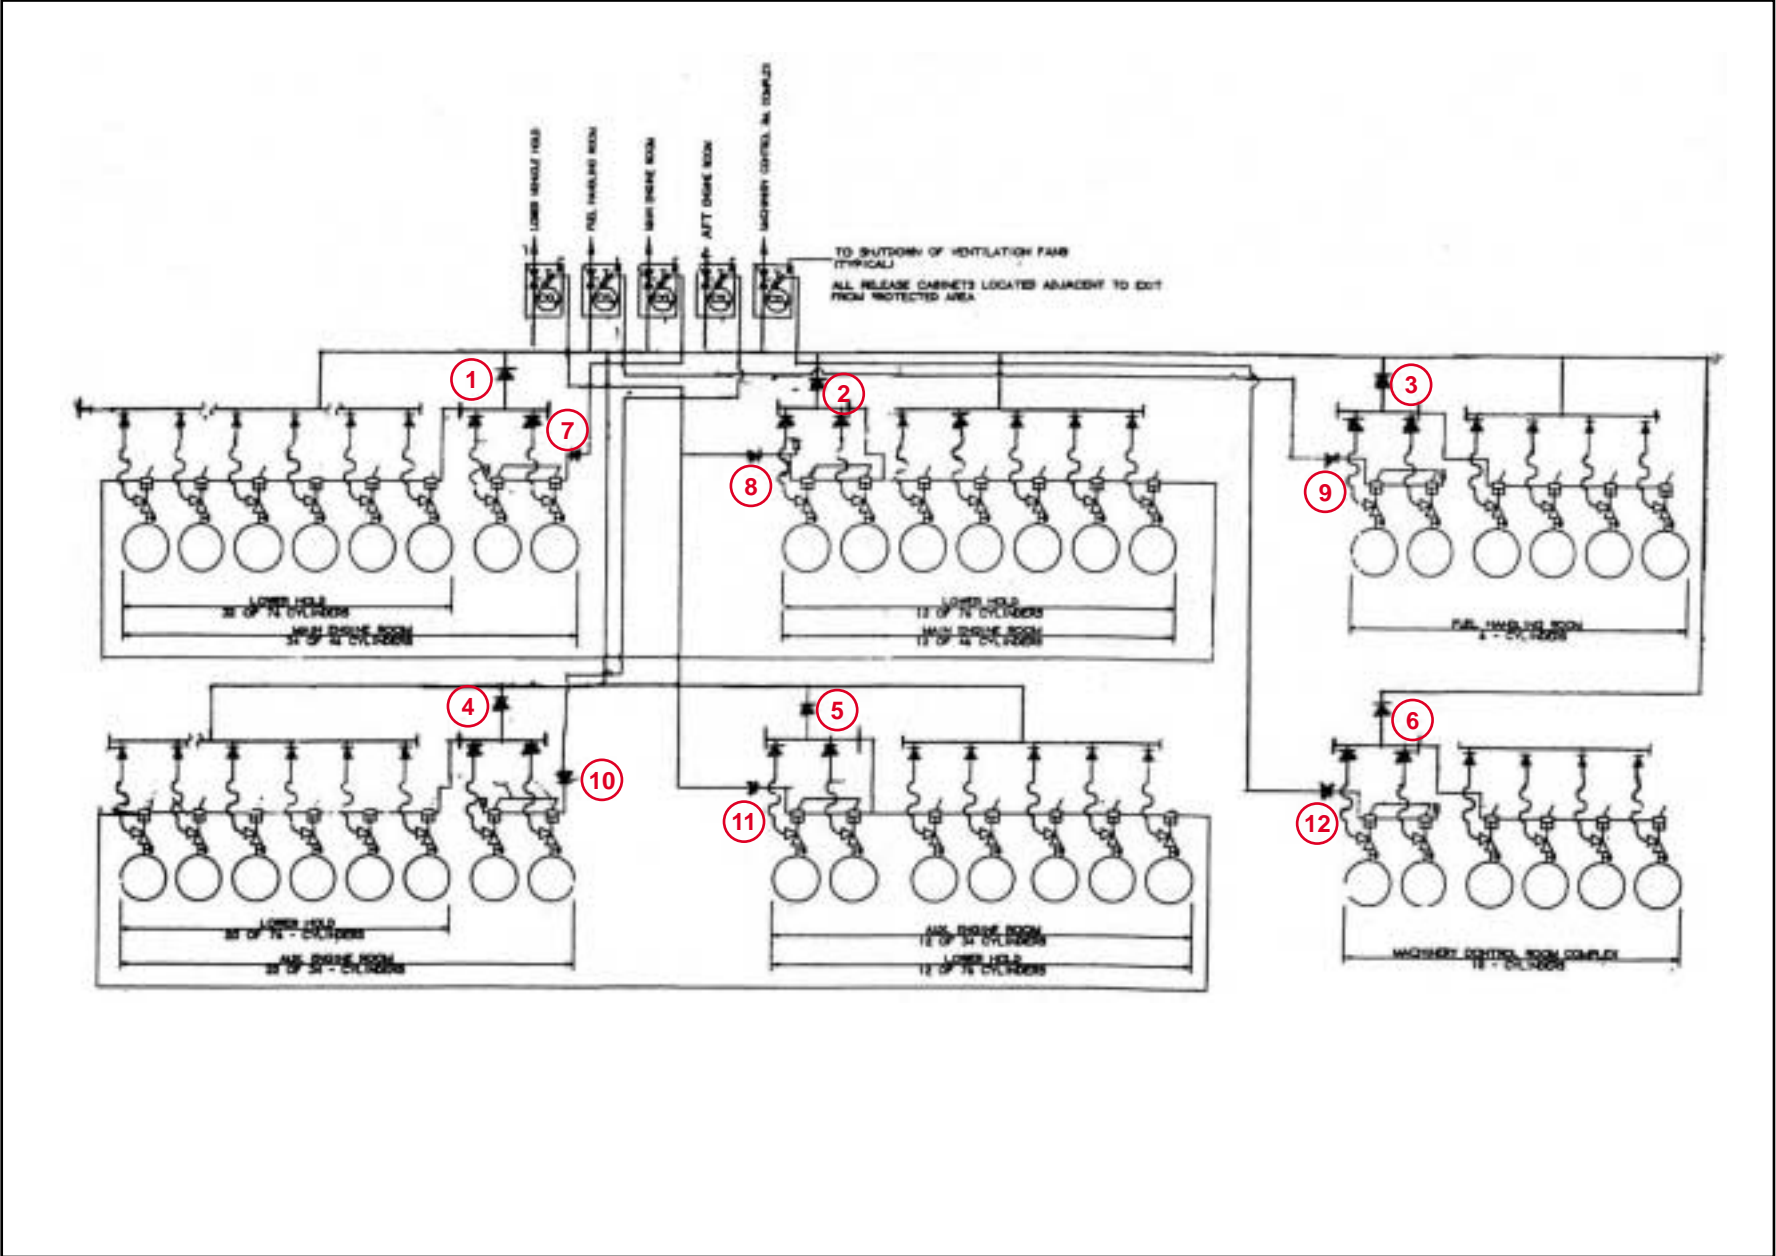
Figure 12

An initial assessment of the system concluded that 86 bottles could be released, if three of the manifold in-line check valves had leaked. These are valves 1, 2 and 6 on the manifold (**Figure 12**). This could have caused the corresponding three banks of bottles to be released.

Further consideration of the system showed that 86 bottles might also be released if only one of the check valves leaked, No 6, together with one non-return valve in the pilot-gas line leading from the lower hold release cabinet, No 11. These pilot line valves were renewed.

The system's failure was attributed to the effects of water and dirt on non-return valves in the gas distribution lines. In turn, the presence of water was attributed to the use of humid air during system testing.

These problems have now been recognised and, following the replacement of all systems' non-return valves, the vessel's owners propose to use dried air for system testing.
