## SYNOPSIS

Shortly after starting a pleasure cruise on the River Avon in Bath, *Pride of Bath* suffered a galley fire, which required the evacuation of her passengers and crew.

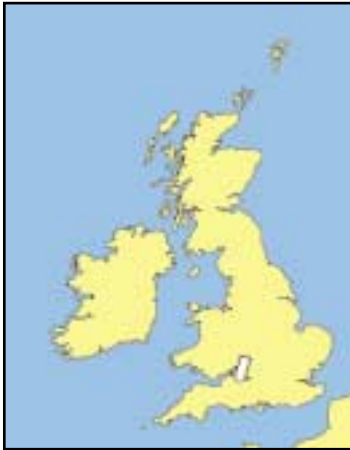
At about 1245, hot fat, from the greasy food, dripped on to the hot coals of the barbecue and ignited. Although the gas to the barbecue was turned off, the flames continued to flare up, and eventually reached the overhead extract filters. They were drawn through the filters by the extractor fan located further along the galley exhaust duct. The flames ignited residual grease in the ductwork.

The welldeck of the vessel was extensively damaged, and required a complete refit. Fortunately, there was no structural damage.

The MAIB investigation found that the extract filters were cleaned daily. However, the twice yearly cleaning of the duct work was not enough to maintain the duct clear of grease, thus increasing the risk of a fire within it. The structural fire protection of the vessel was minimal, so smoke and flames were able to pass freely into the passenger accommodation from the galley. The material structure of the welldeck was composed largely of varnished wood, which probably assisted in the spread of flames.

The owner has refitted the vessel with fire resistant materials, to limit the spread of smoke and flame through its interior, and is conducting a review of crew training.
