Report on the investigation of  
a barbecue fire in the galley of

***Pride of Bath***

on the River Avon, Bath

**Report No 6/2003  
February 2003**

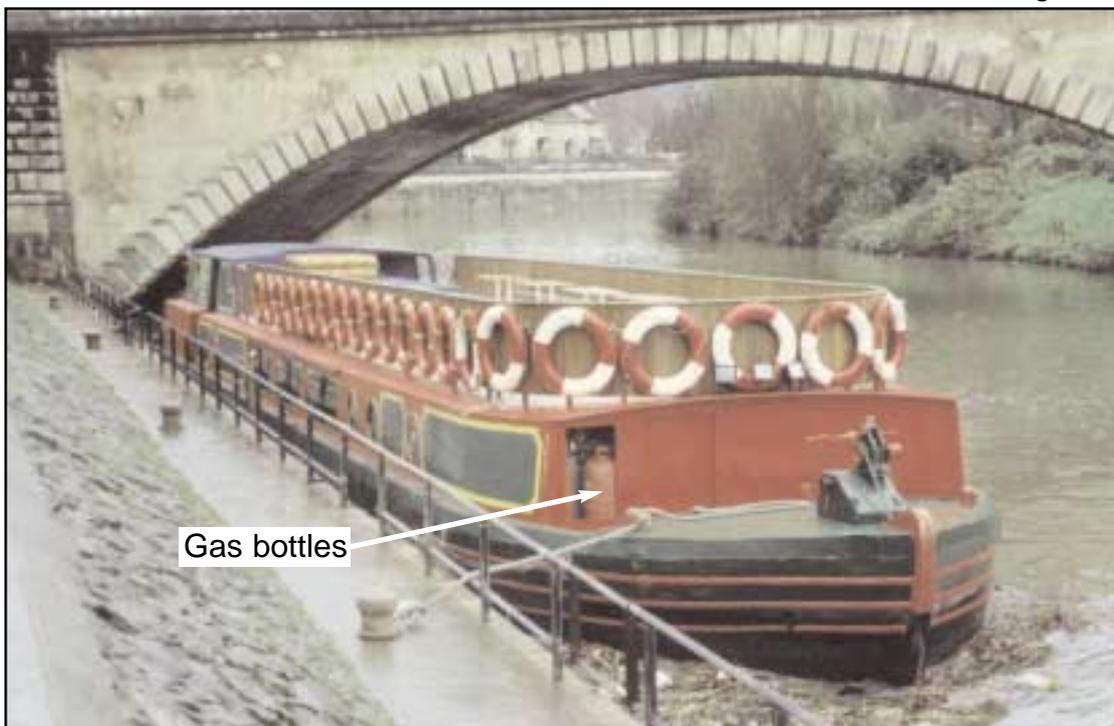
Figure 6

The gas for the barbecue was supplied from two bottles situated in a locked cabinet on the forward end of the weatherdeck (**Figure 6**). The bottles were turned off with a bottle spanner kept in the cabinet. From the bottles, the gas passed through a three-way valve. This arrangement allowed both bottles to be connected, but with only one in use. After this valve, the gas pipe passed through to the galley via the main isolating valve located at the forward end of the galley. From there, the gas pipe was connected to the barbecue, and the local control valve to control the gas flow.

Photograph showing the stowage position of the gas bottles on the forward end of the weatherdeck

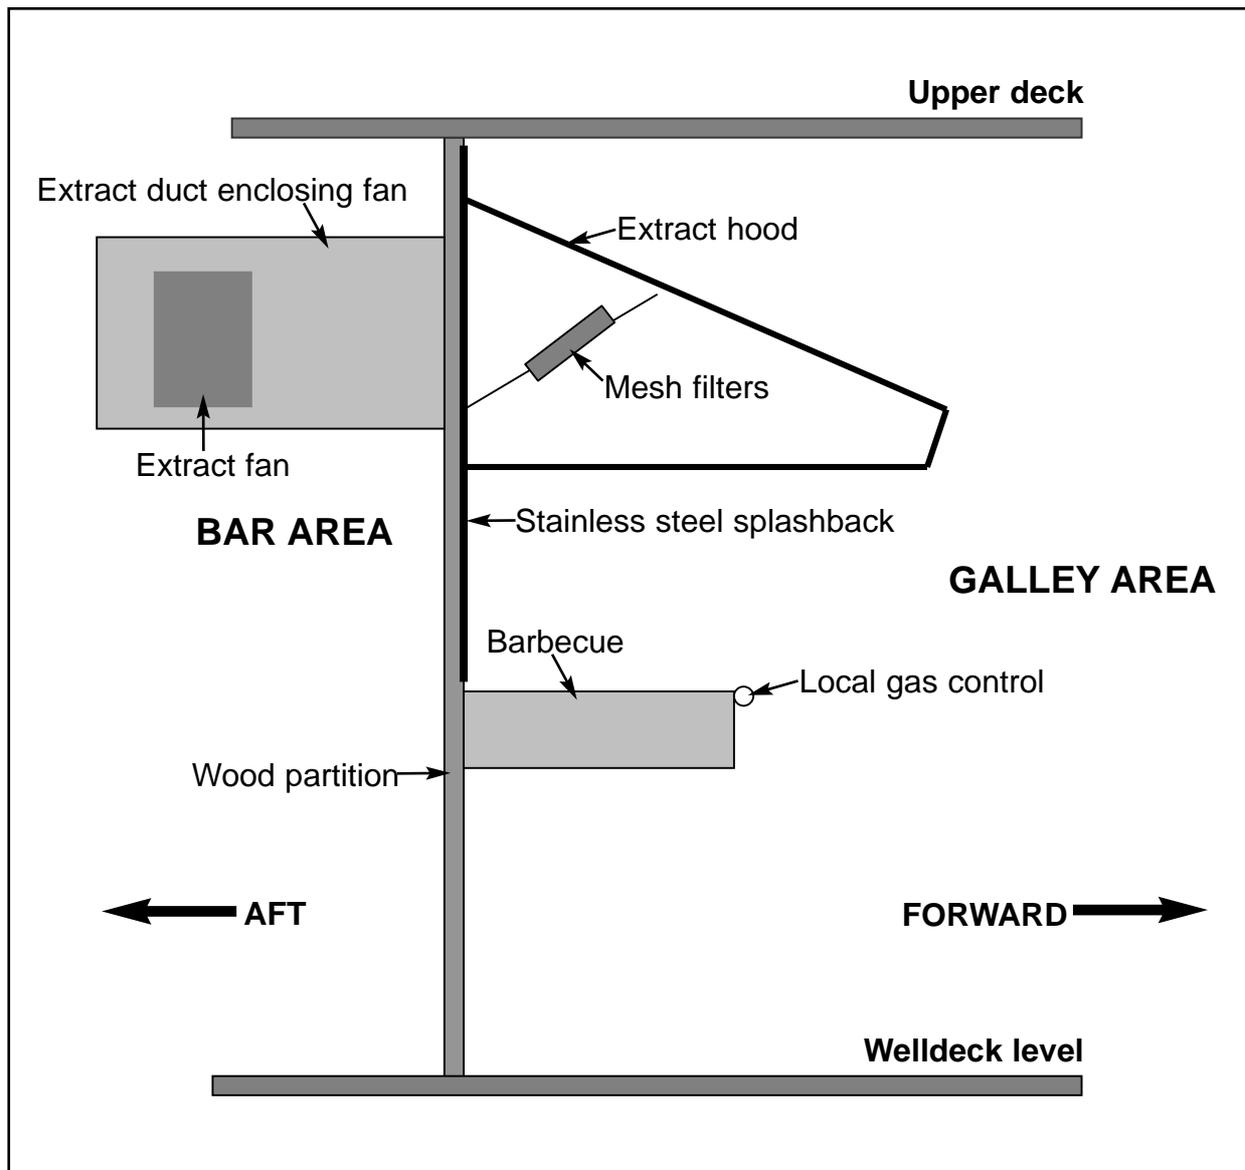
Figure 7

The stainless steel ductwork attached to the extract hood passes through a wood partition to the bar area located aft of the galley. From the bar area, the duct turned 90° and passed through the port side of the vessel.

There was no means of closing down the ductwork or injecting a fire-fighting medium in case of fire in the duct. There is no such requirement for Class V vessels.

The fire in the extract duct was probably because of a 'blow torch' effect as the flames were drawn through the filter by the suction effect of the extract fan. The intense flame would inevitably ignite any grease deposit lining the internal surface of the duct.

If vent flaps had been fitted to the inlet and outlet sides of the duct, with a facility to inject an extinguishing agent into the duct space, it could have been possible to, at least, effect timely and effective action to extinguish the duct fire. Or, at most, prevent a fire outbreak in the duct.

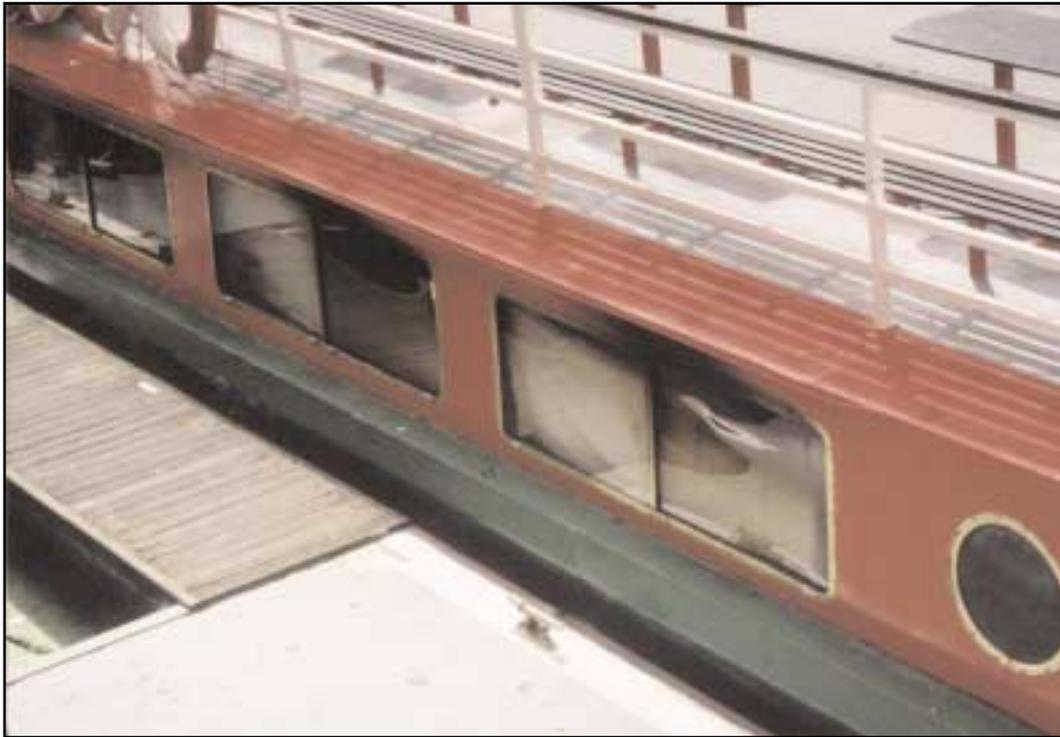
Figure 8

The galley and bar areas were badly damaged by the fire. The fire melted plastic bar equipment, producing black smoke. There was extensive smoke damage throughout the welldeck. The side windows in the saloon were blackened, and the temporary polycarbonate windows bowed with the heat (**Figure 8**).

Smoke and heat damage to the side windows in the saloon

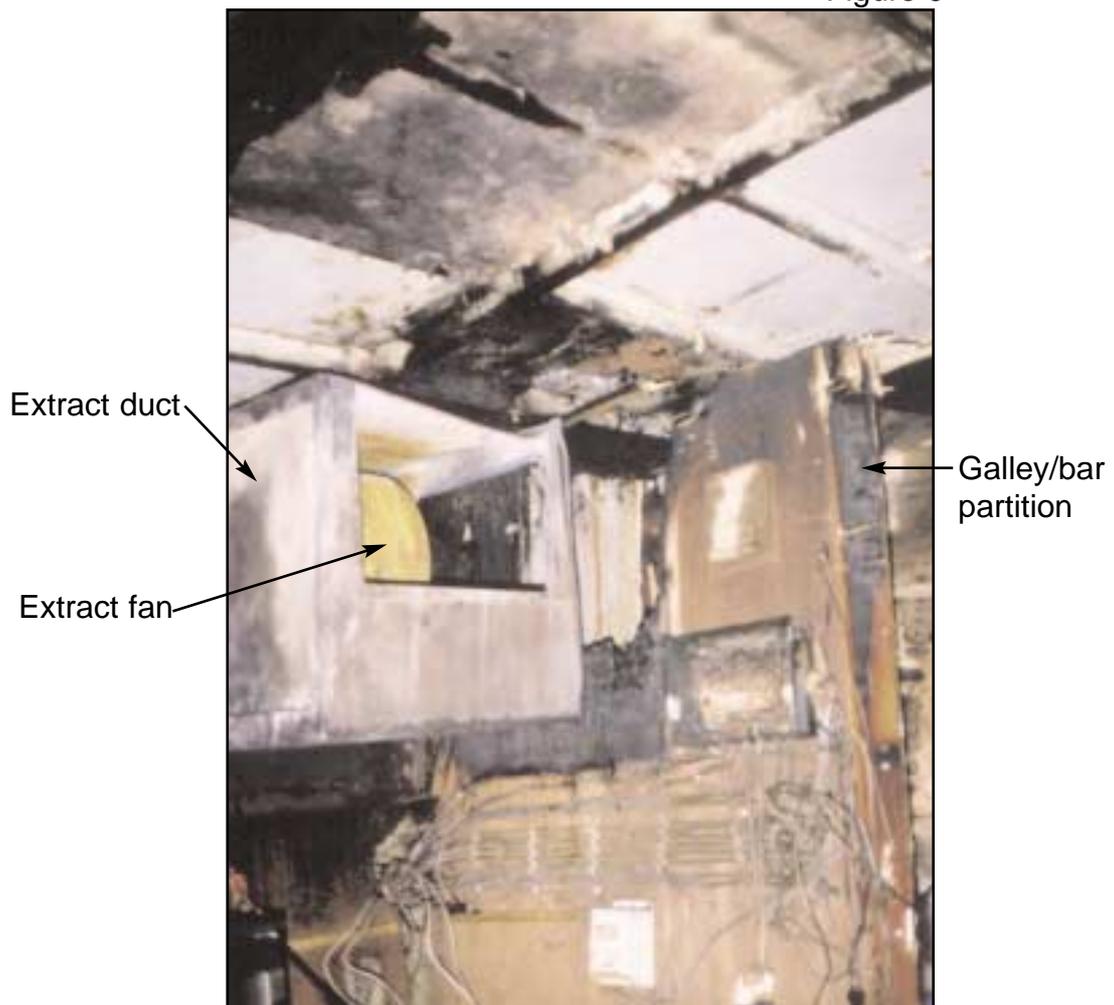
Figure 9

Fire damage in the passenger accommodation of the welldeck included charring of the wood deckhead, which, in the area above the galley extract ductwork, fell away from the steel supports (**Figures 9 and 10**).

Charring of the wood deckhead, which fell away from the steel supports above the galley extract ductwork

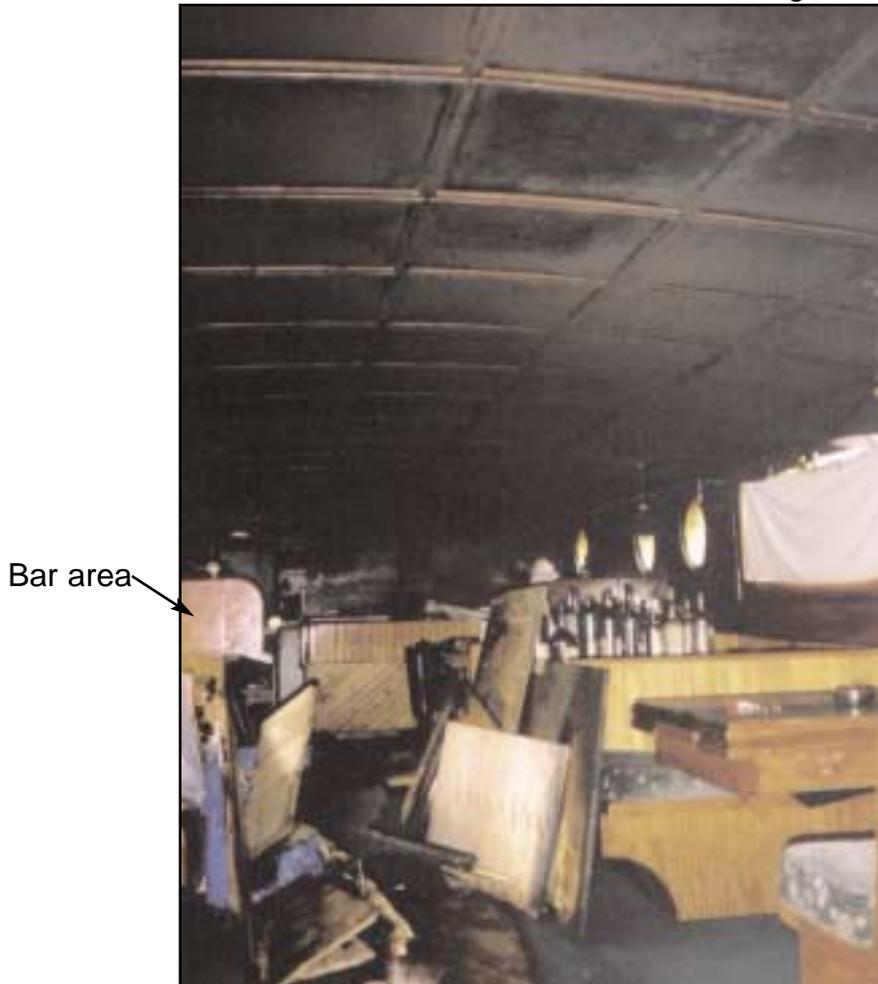
Figure 10

Fire damage in the passenger accommodation of the welldeck, looking forward
