Report on the investigation into a  
wash wave accident involving

***Portsmouth Express***

off East Cowes

**Report No 14/2003  
June 2003**

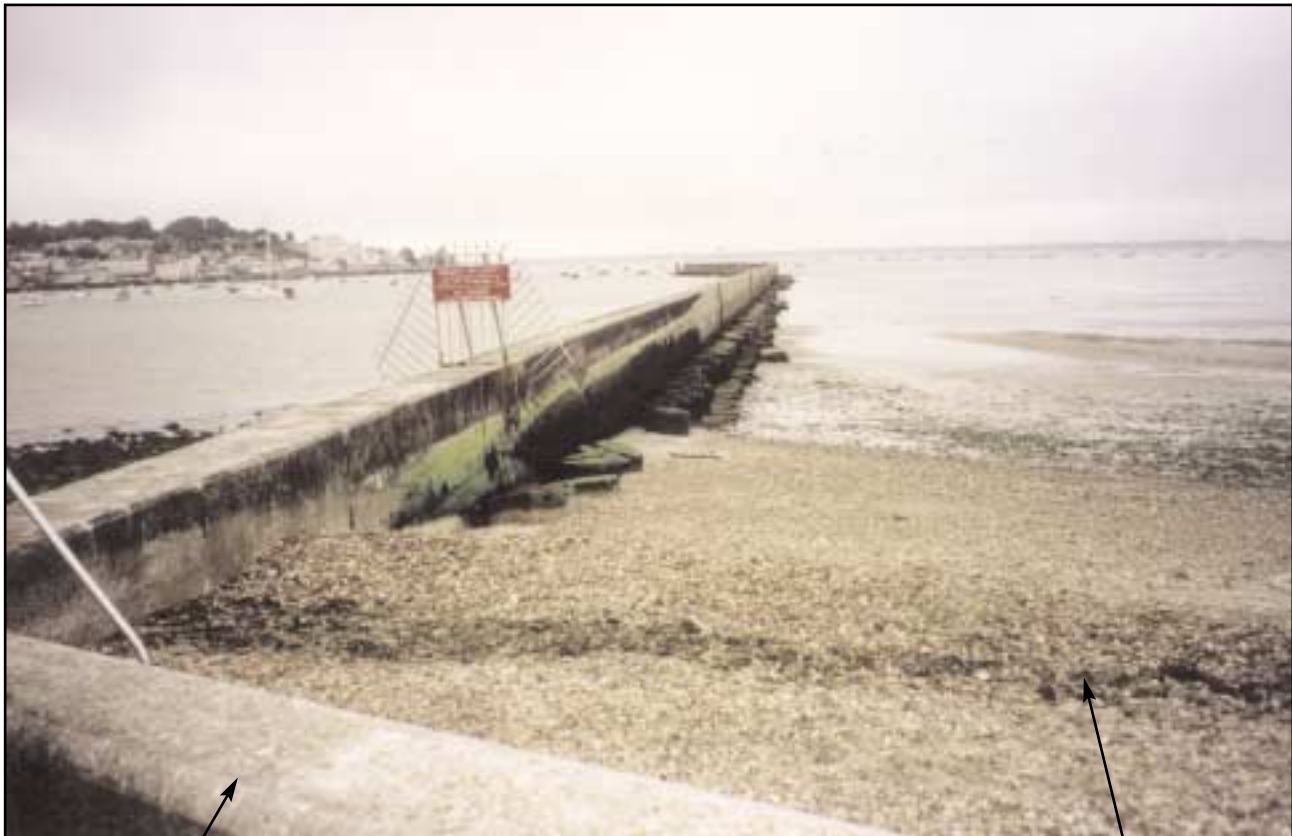
Figure 3

Just to the east of the junction between the breakwater (**Figure 3**) and the sea wall, two men, one aged 30 and the other 27, were on the beach with a small inflatable boat. It was high water, so the exposed beach was only about 10m (33 feet) wide. They planned to go rod fishing just offshore. As *Portsmouth Express* went by, one of them thought she was going too fast for that distance offshore.

East Cowes breakwater at low water

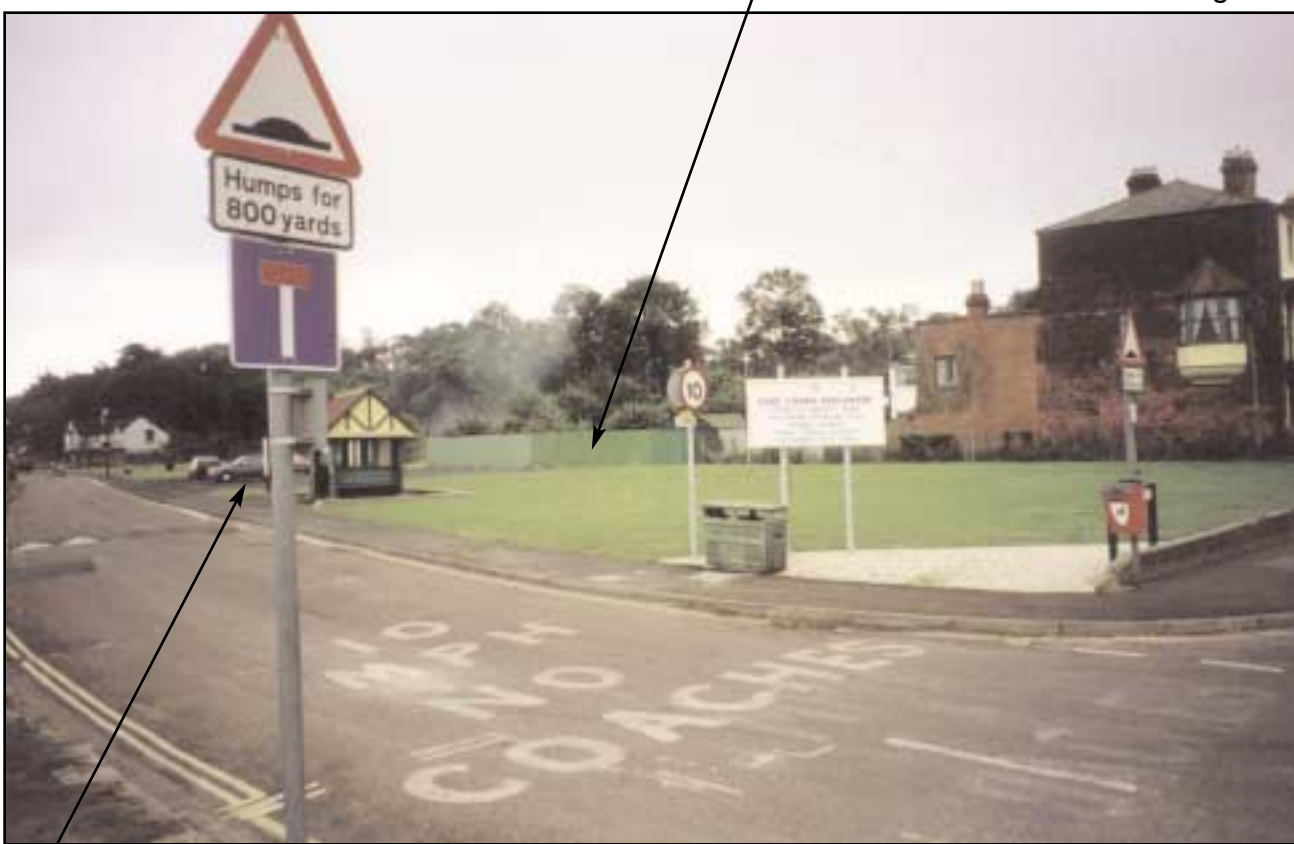
Figure 6

A witness in a parked car saw *Portsmouth Express* go by and, shortly after, observed the wash running along the breakwater. He believes that the breakwater funnelled the waves to the junction between the breakwater and the sea wall (**Figure 2**). When the waves arrived at East Cowes Point, they had nowhere to go, apart from over the sea wall. The witness estimates that the plume of spray was as high as a bungalow after the waves hit the junction. The sea wall absorbed most of the force, but the waves still had enough energy to wash over the road and into the car park where this person was located (**Figure 6**).

Road and park at East Cowes

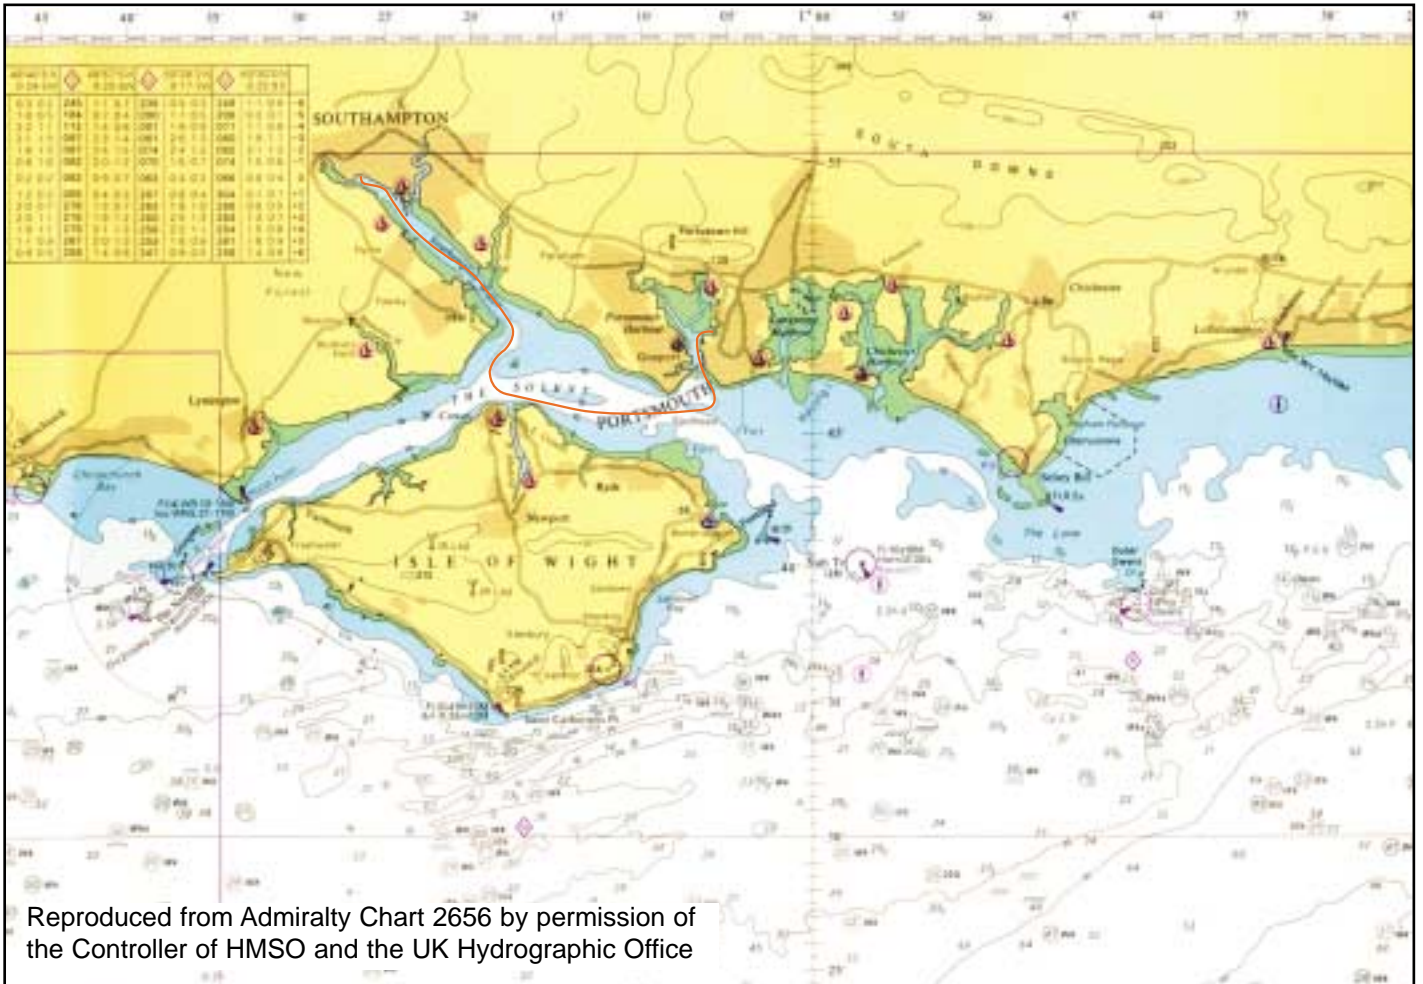
Approximate track of *Portsmouth Express* on 18 July 2002

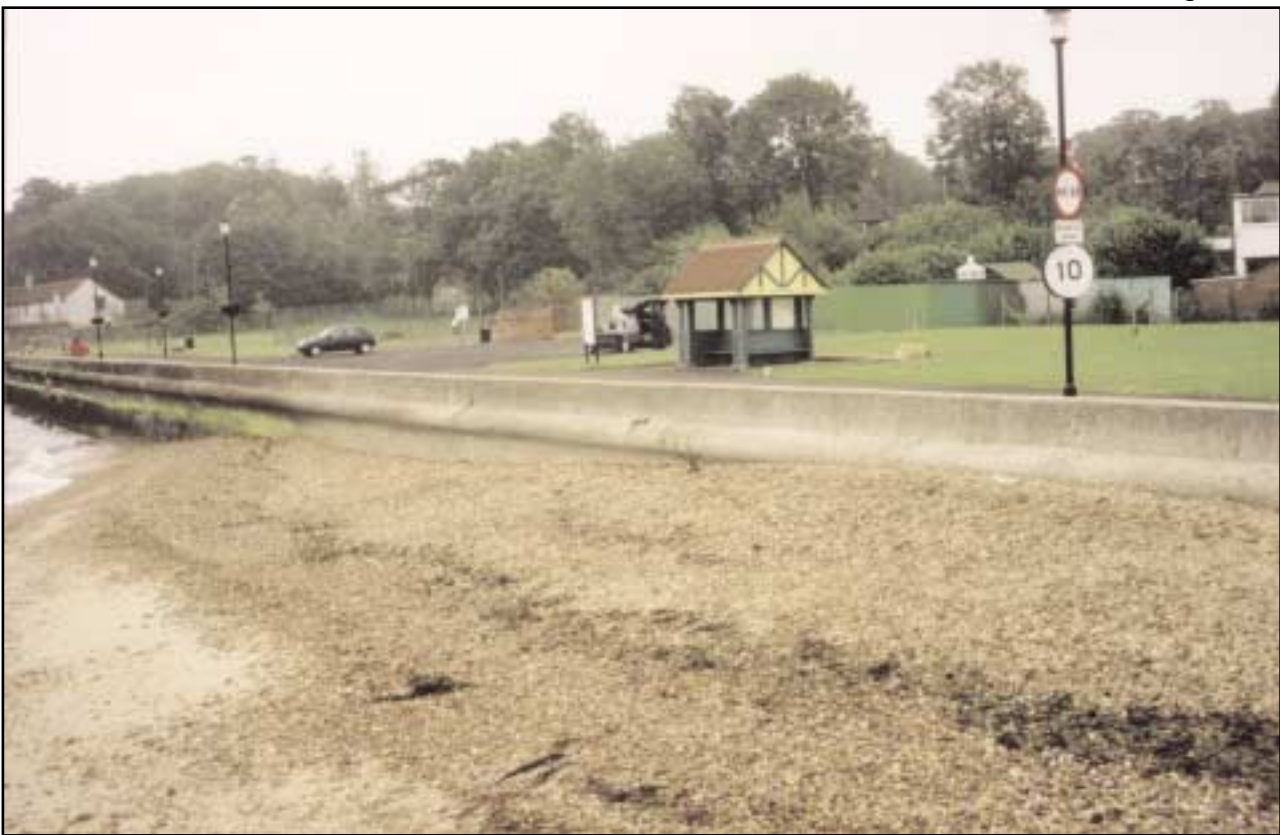
Figure 11

The effect of the breakwater at East Cowes might have been significant. It appears that this sea defence funnelled the waves to the point where the breakwater joined the sea wall, amplifying the wash problem at this section of the seafront. This is where the people were injured. The breakwater also appears to have caused shingle to build up at East Cowes Point (**Figure 11**). The effective height of the sea wall is reduced in this area. This is another reason why the wash waves were able to rise over the sea wall there.

Beach at East Cowes point
