Report on the investigation  
of the capsizing of  
***fv Flamingo***  
East of Harwich  
on 7 July 2002  
with the loss of four lives

Marine Accident Investigation Branch  
First Floor  
Carlton House  
Carlton Place  
Southampton  
United Kingdom  
SO15 2DZ

**Report No 15/2003  
June 2003**

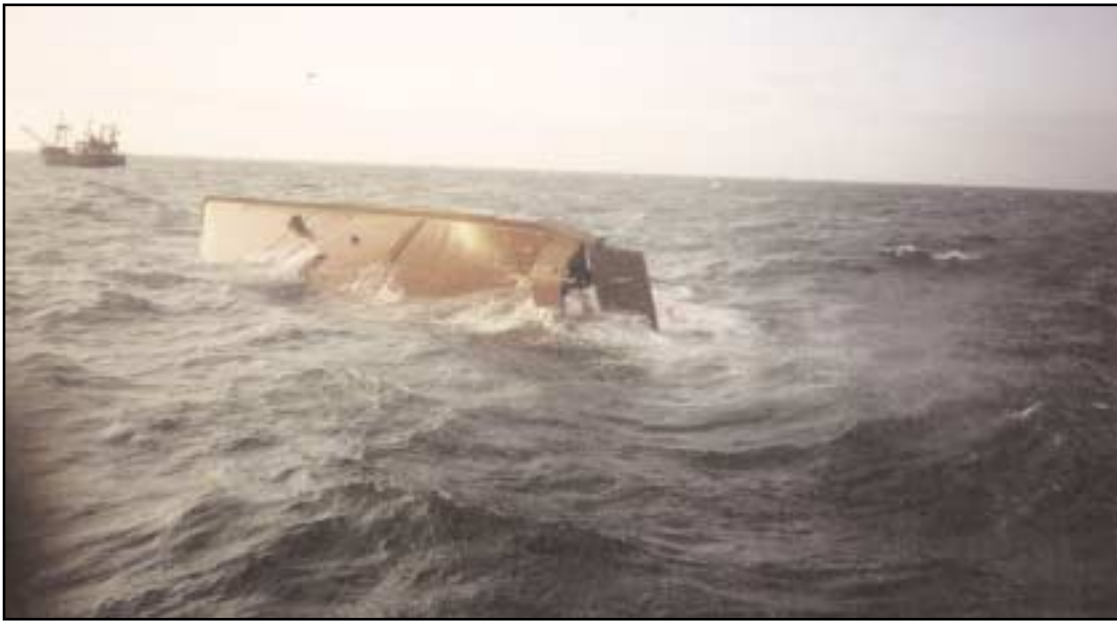
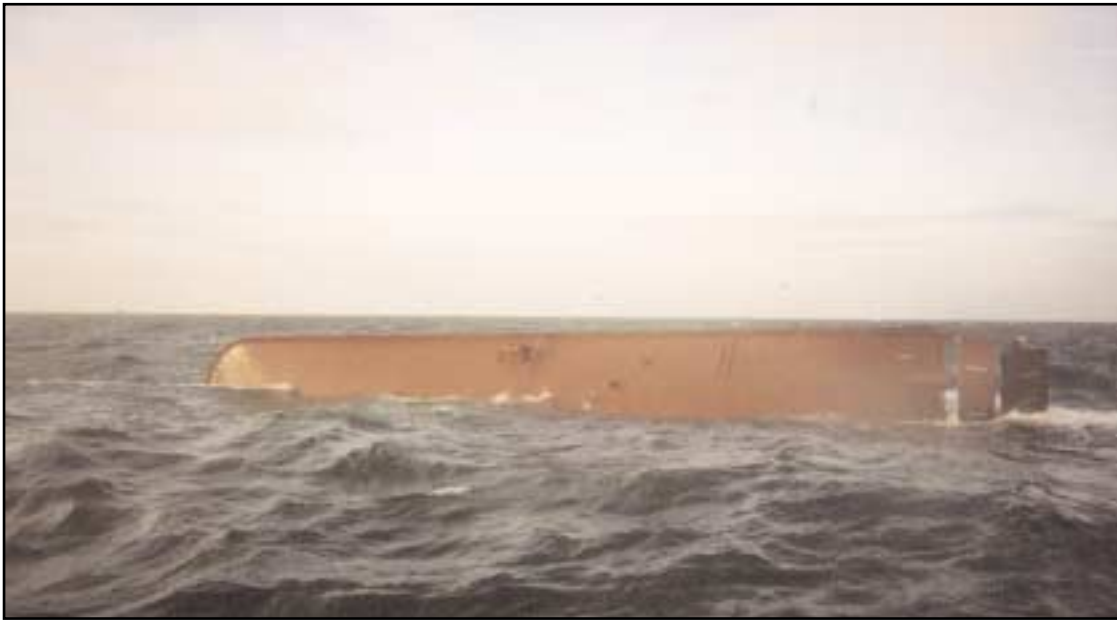
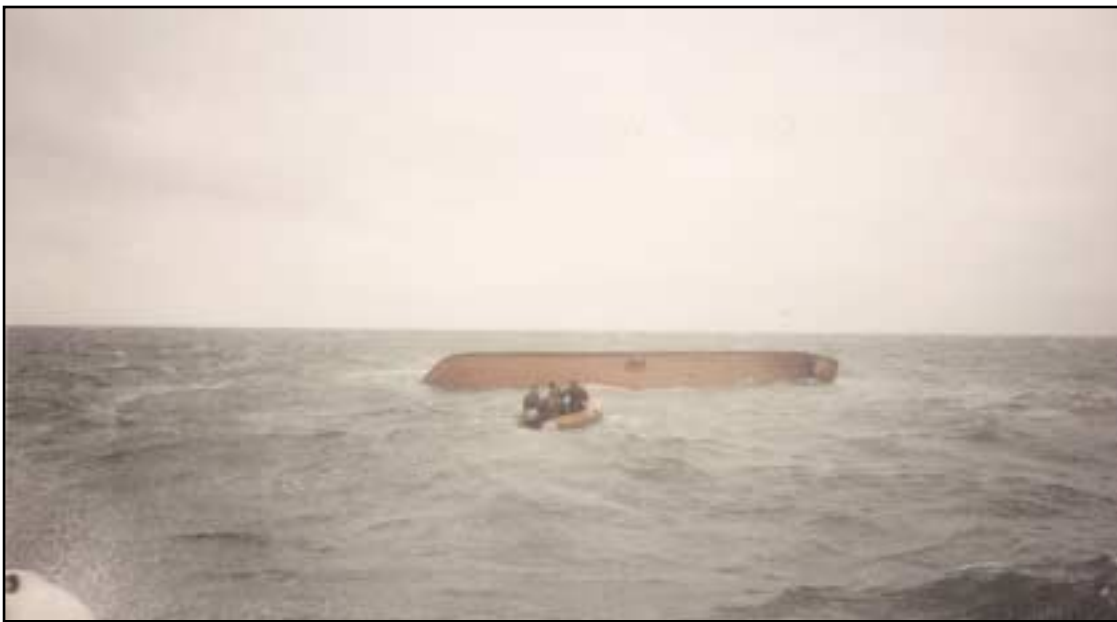
At daylight, Harwich lifeboat launched its daughter boat and sounded around *Flamingo*'s hull with a hammer. Nothing was heard from inside the hull. The hull was in very good condition, the rudder appeared to be over to port and the propeller was turning slowly with the sea. A green line under tension was running across the hull from one side to the other. The hull was drifting with the tide (**see Figures 1, 2 & 3**).

Figures 1, 2 and 3 - The capsized hull prior to sinking

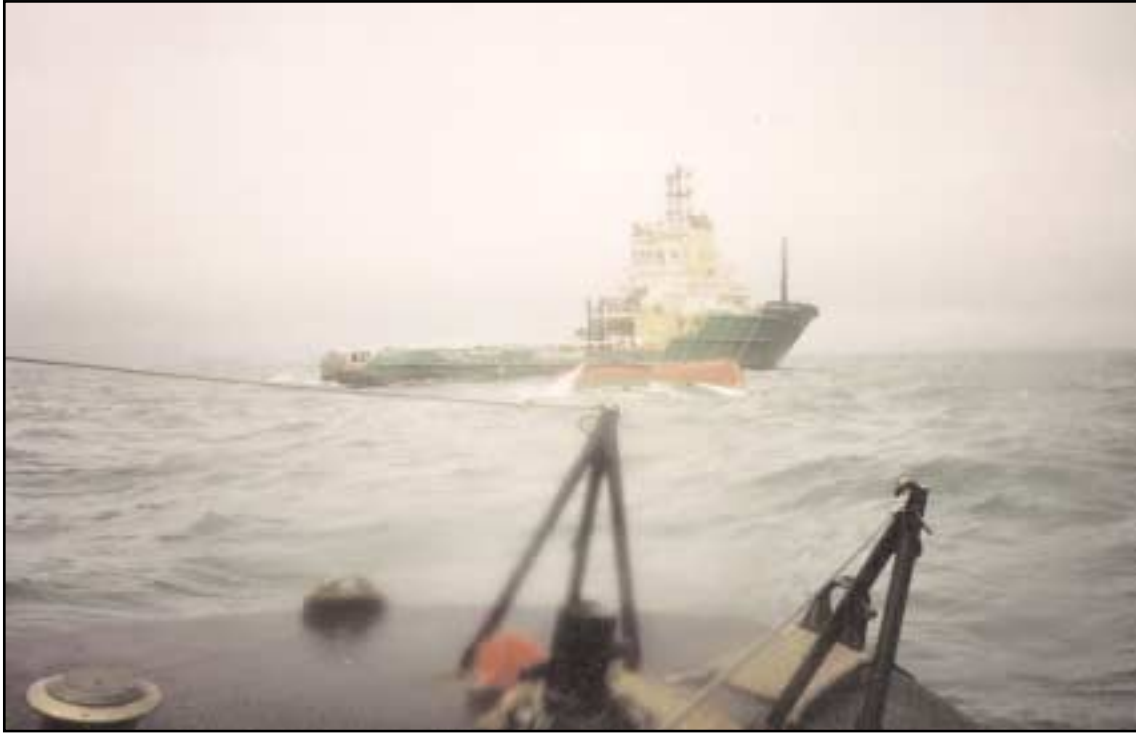
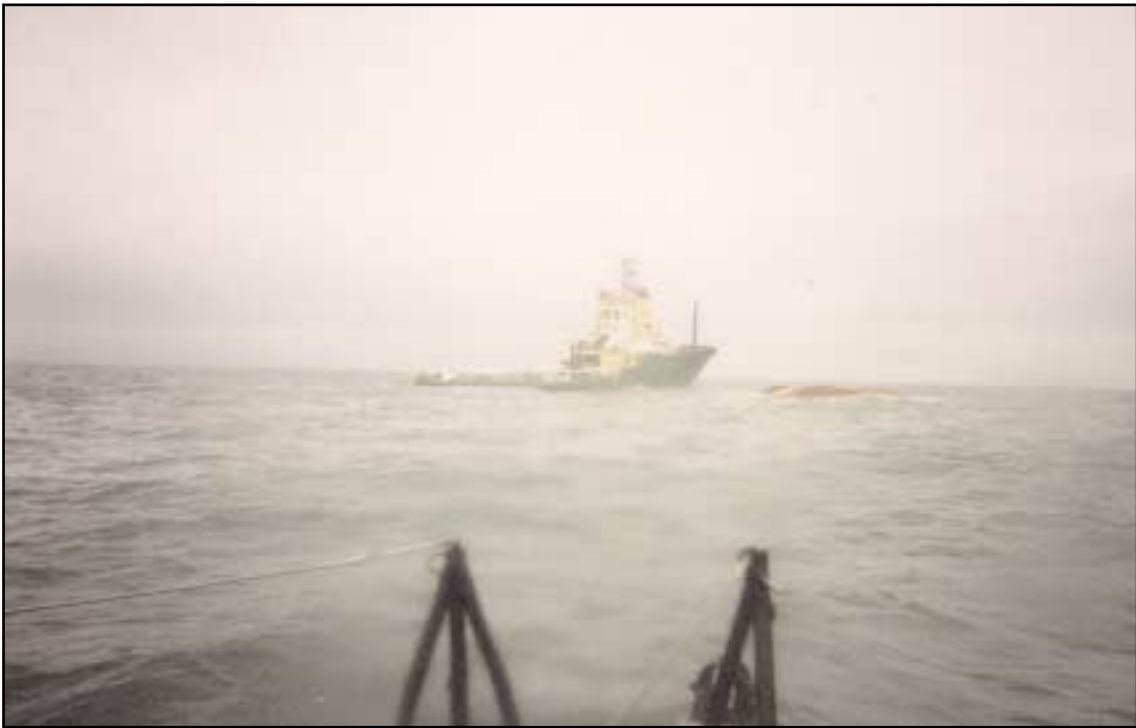
Figures 4 and 5 - The ETV preparing to tow the capsized hull

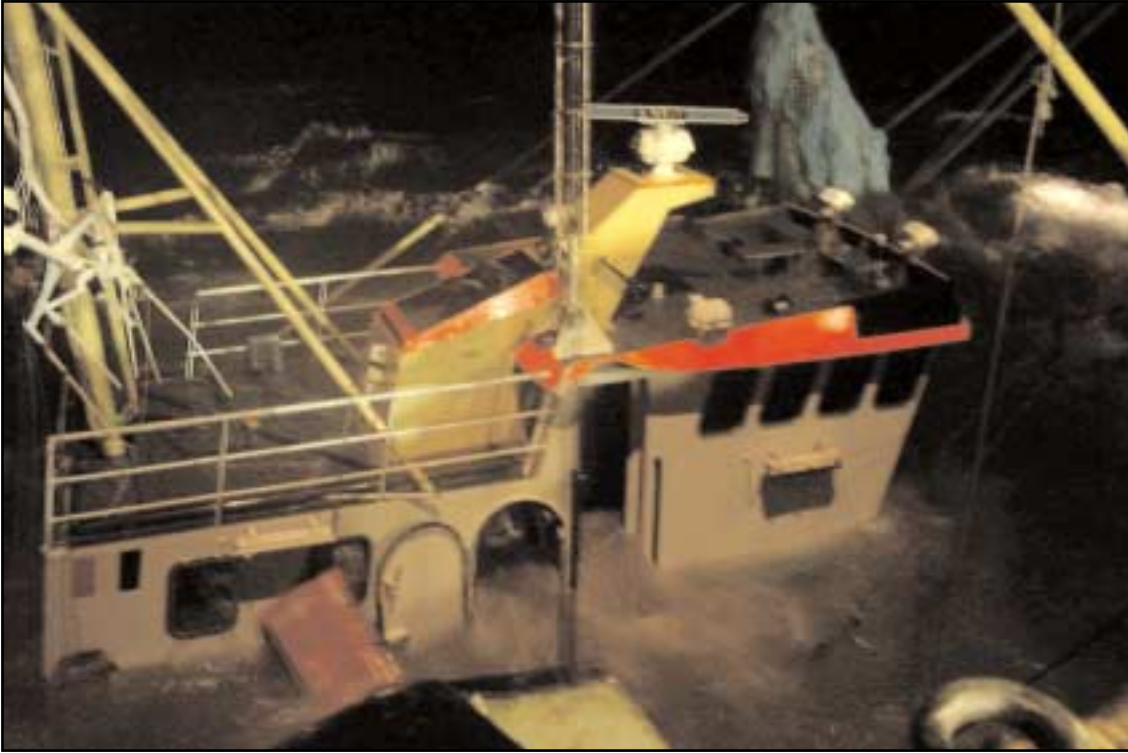
Figure 6

The vessel being raised

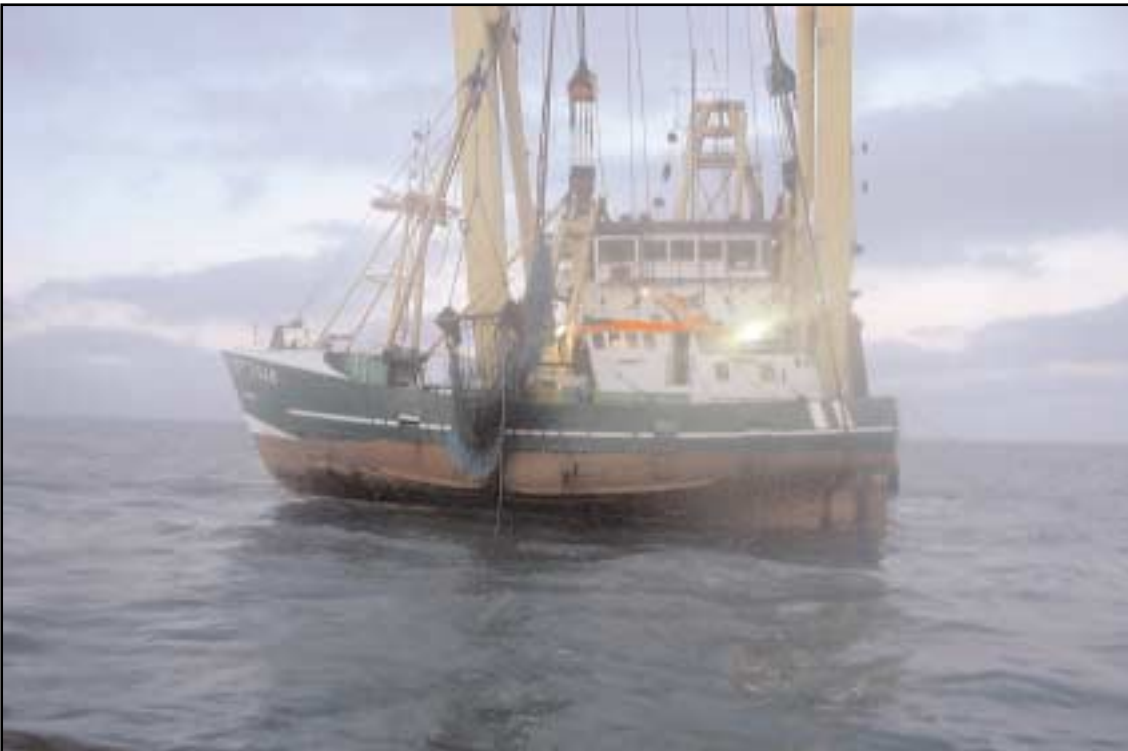
Figure 7

*Flamingo* after raising

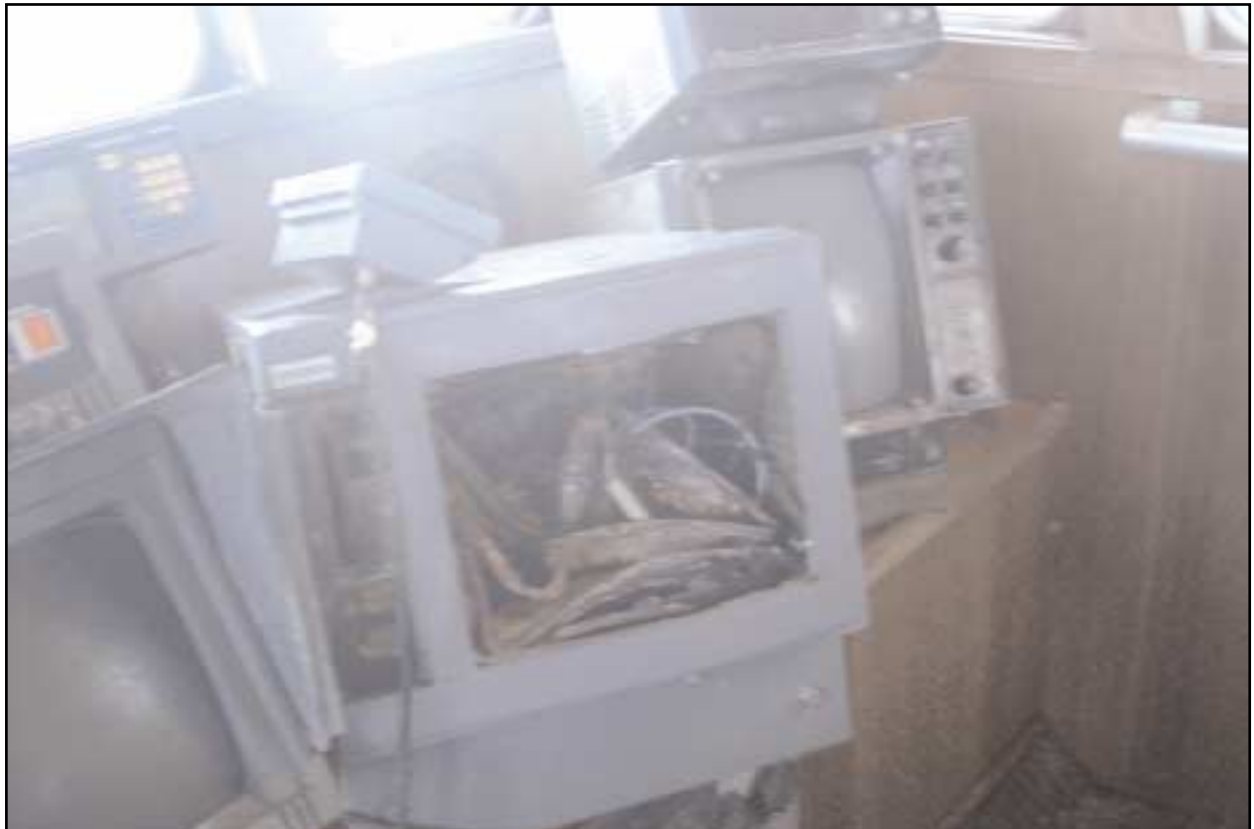
Figure 9

The cathode ray tube was imploded on this unit. The power control knob was in the “on” position, indicating that it was operational at the time of the accident. There was no floppy disc in the disc drive (**see Figure 9**).

Decca fishplotter with cathode ray tube imploded

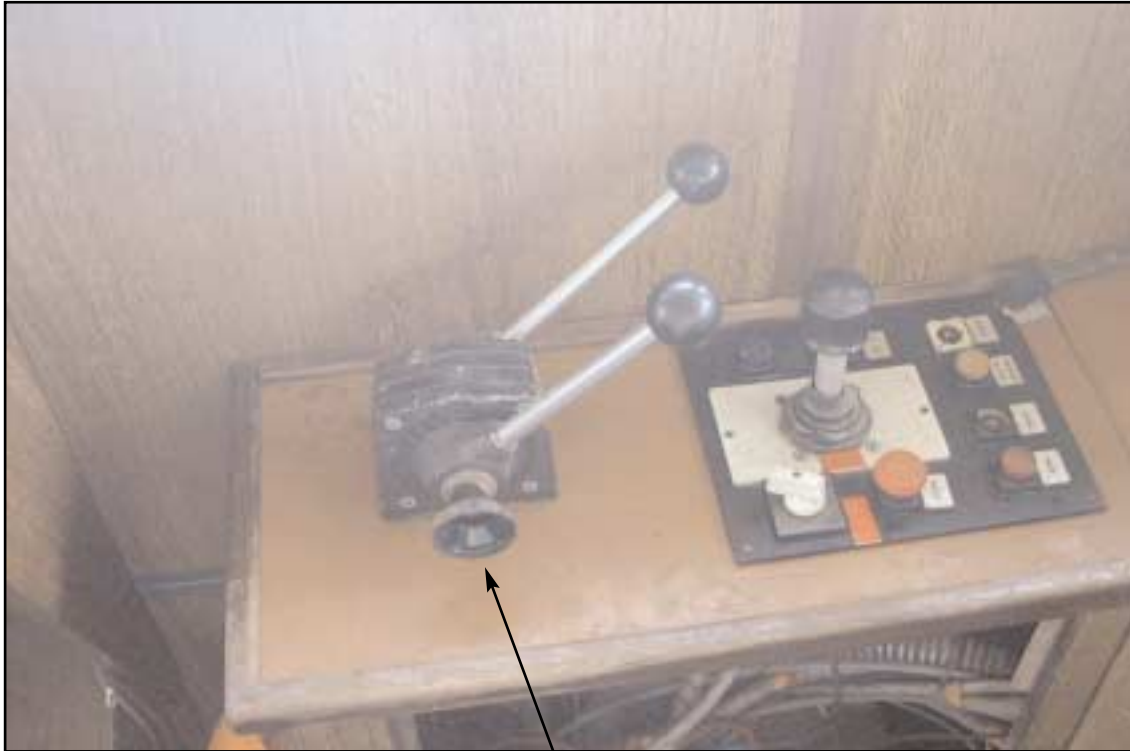
Figure 10

The main engine throttle control was found at about 60% ahead. The main engine was clutched in (**see Figure 10**).

Main engine clutch and throttle controls

That food was found in the microwave points to the possibility that no-one was in the wheelhouse when the net parted. This possibility is reinforced by the fact that the throttle controls had not been put into neutral. If the capsizing had been immediate, however, there would have, most probably, been no time for the person in the wheelhouse to adjust any controls.

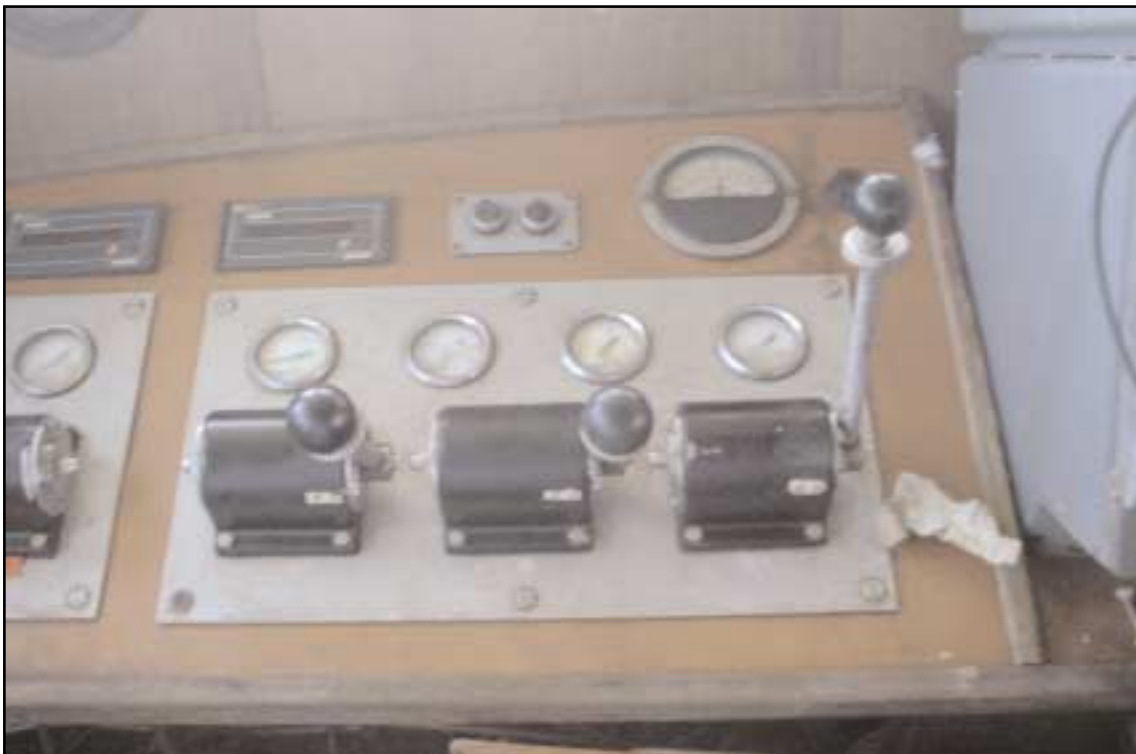
Figure 11

The six winch controls were all found in the "brake on" position, except for the outboard starboard control, the gilson, which was found forward in the "freefall" position (**see Figure 11**).

The starboard fishing controls (as found after raising)

Had capsize not been immediate, those on board would have had a limited period to react to the situation. The person in the wheelhouse, when he realised the port net had parted, would have instinctively put the throttle to neutral and, quite possibly, "freefall" the starboard gear into the water. When the vessel was raised, the throttle was found in 60% ahead. This is the normal setting expected when cleaning the nets. However, the only fishing control that was not in the "brake on" position was the starboard gilson line. This was in the "freefall" position. This line was not in use and was found secured to the bulwark.

It is possible that this lever was knocked, during the capsize, by one of the panels found loose in the wheelhouse. It is also possible that the person in the wheelhouse went to put the fishing line into freefall but, as a result of the shock and stress of the accident, moved the wrong lever.

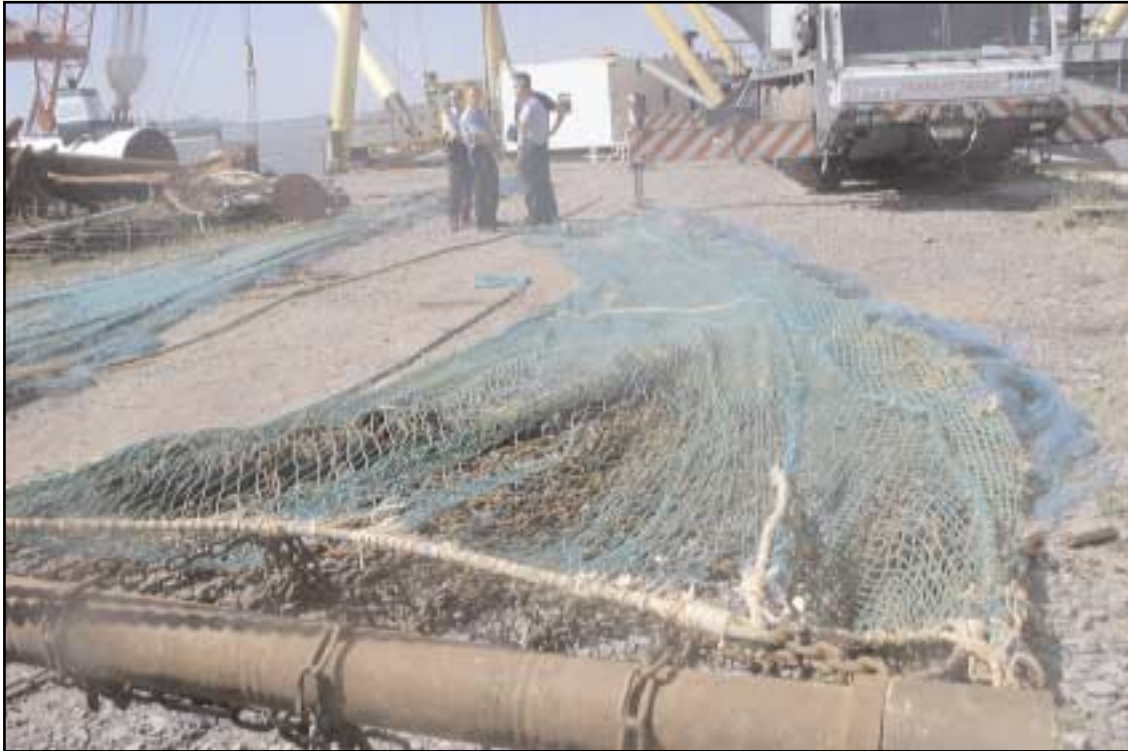
Figure 12

The starboard side gear was intact. There was a hole of about 1.6 metres diameter, centred about 4 metres from the cod end. Some recent repairs were noted around the hole. The cod end was secured, some dead fish and about 250 – 500kg of stones were in it. The beam and chains appeared to be undamaged.

The port side gear appeared to be undamaged, however, the bottom 6 metres of the net was missing. The break had occurred at the “weak link”, designed to break first in the event of excess weight (see Section 2.6).

Port net and beam (starboard net in background)

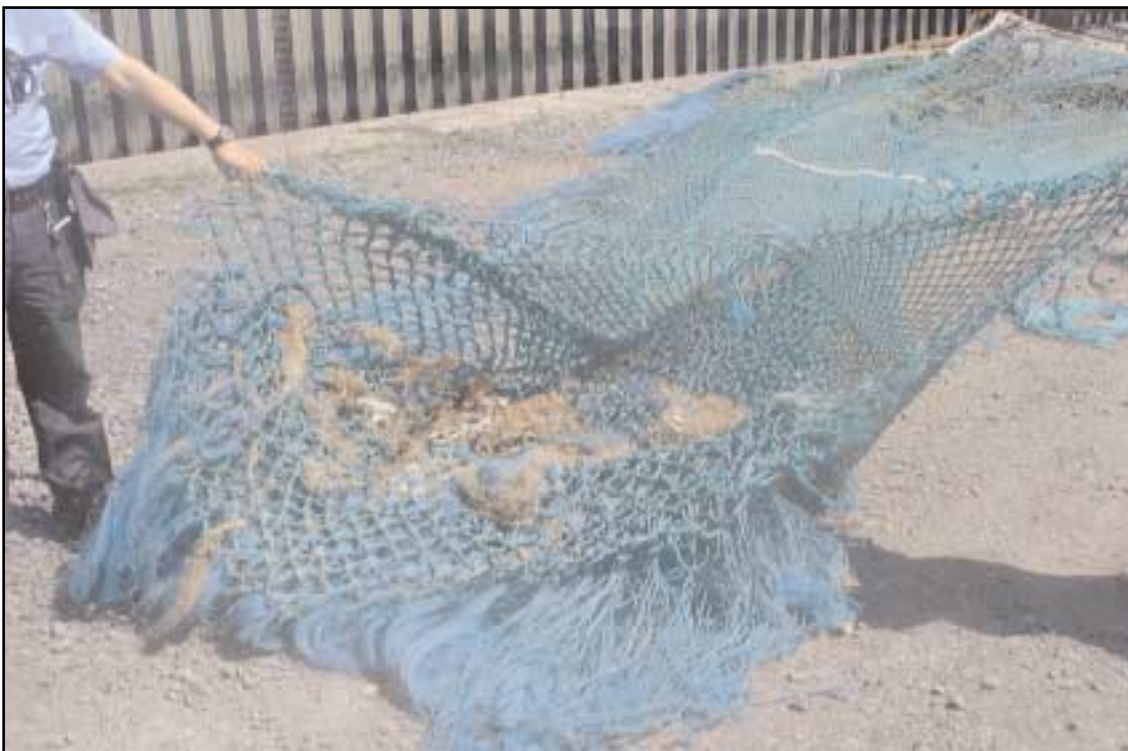
Figure 13

Port net parted end

It is highly probable that a substantial quantity of rocks and shells remained in both the starboard and port nets, of similar composition to the small quantity found in the starboard cod end, when the vessel was brought back to Zeebrugge. It is probable, therefore, that the weight of rocks and shells in the port net caused it to come apart at the weak link. The vessel capsized as a result.

When the weak link parted, most of the contents in the port net would be thrown out. Consequently, the vessel would heel immediately to starboard, because of the weight remaining in the starboard net. The weight in either nets is unknown, but it could have been several tonnes. Given that the starboard net held rocks and shells, its weak link was, quite possibly, close to breaking point. It is also apparent that the lazy decky parted, as the bottom section of the net was not found. When this occurred is not known, but it might have been after the vessel sank. A green line under tension was noted to be running across the hull from one side to another when the vessel was floating inverted. This might have been the port side lazy decky.

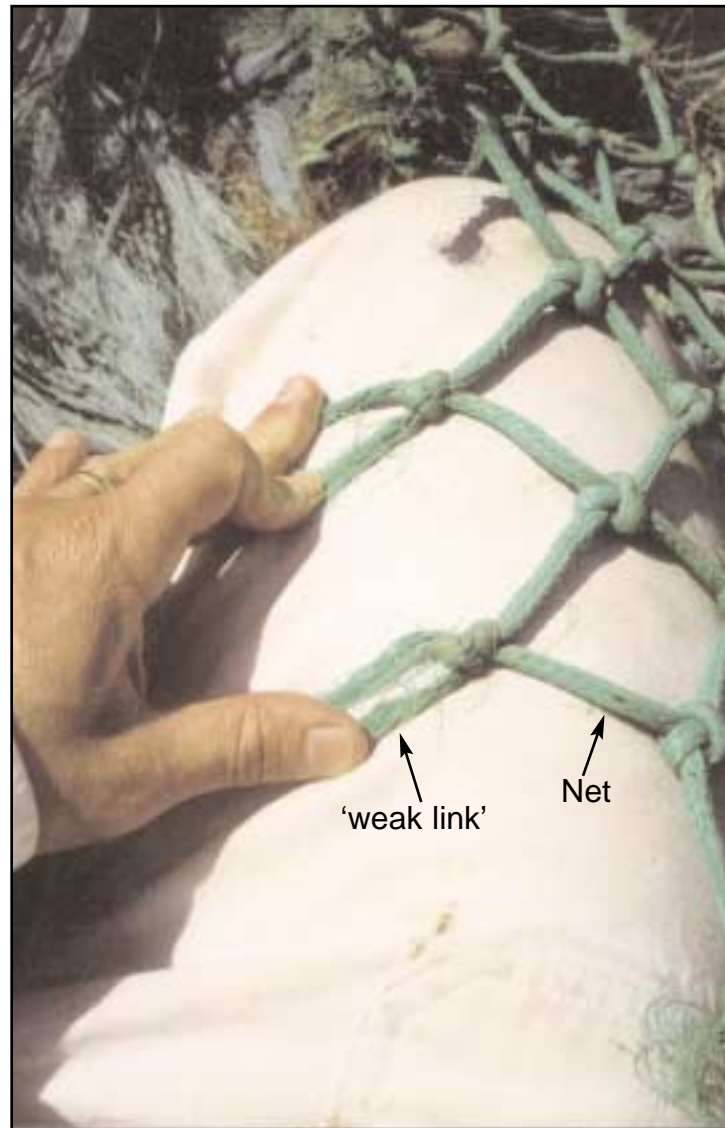
Port net
