Report on the investigation of
the grounding of
the class VI passenger vessel
Pride of the Dart
on Mew Stone rocks
near the entrance to the River Dart
on 28 June 2002

**Report No 12/2003
April 2003**

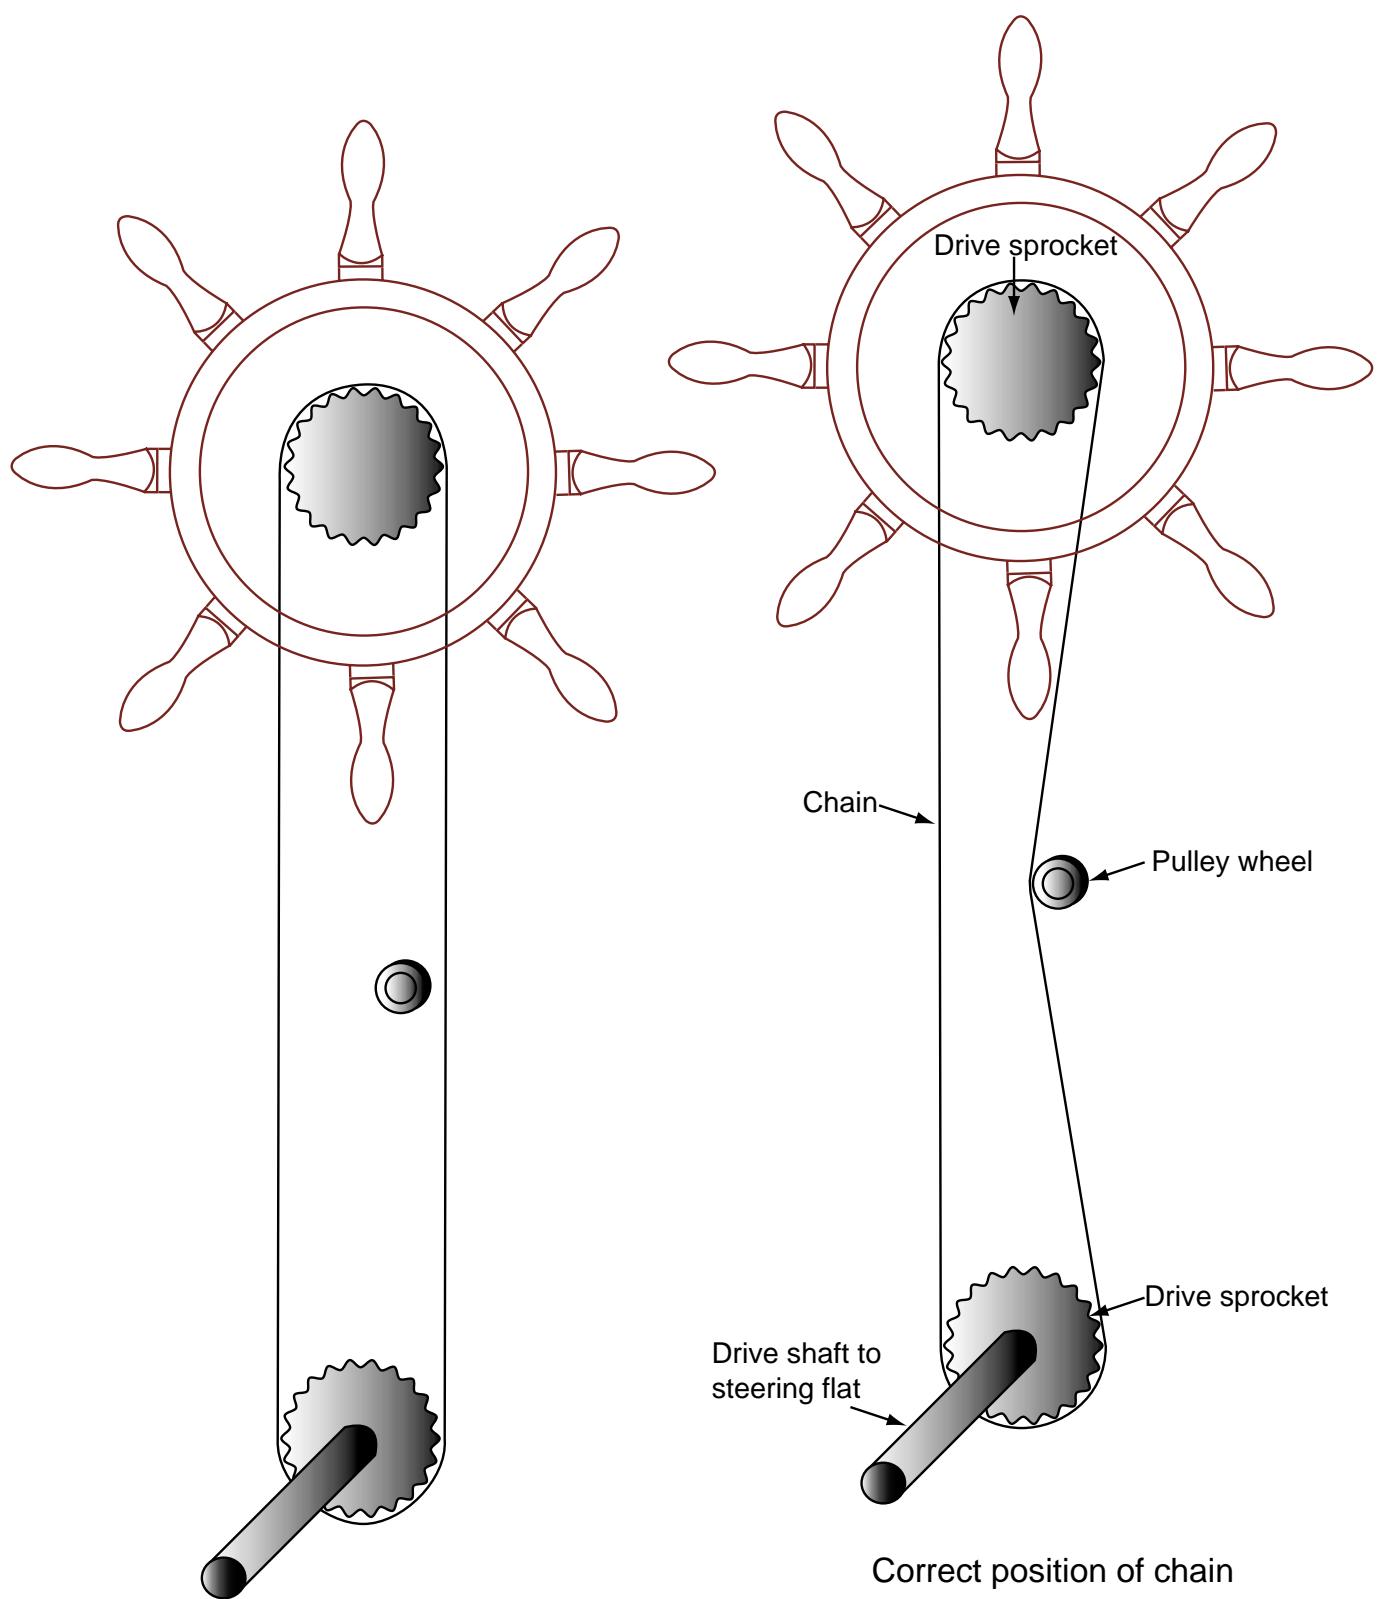
Diagram of the steering system

After the accident, the front panel beneath the steering wheel was removed to reveal the chain and, about half way down, a round pulley wheel. The chain was found to be to the starboard of, and away from, the round pulley wheel. The purpose of the round pulley wheel was to provide a guide and tensioning to the chain (**diagram 1**).

Position of chain was
found to be incorrect

When the chain was found to be off the tensioning pulley, the wheel could not be turned to port but it could be turned to starboard. The section of the vertical chain to port (when looking forward) was tight and, therefore, on the tension side, so that when the wheel was turned to starboard, the drive shaft could be turned as normal.

However, the section of the vertical chain on the right side, which should have passed around the pulley, was slack, so that when the wheel was turned to port the chain slipped over the teeth of the sprocket of the drive shaft.

The reason why the chain had suddenly slipped off the tensioning pulley was possibly due, in part, to gradual wear on the chain, giving excessive fore and aft movement. There was no mechanism to keep the slack chain on the tension pulley. Inspection, during routine maintenance, might have identified the potential problem, and measures could then have been taken to prevent it.

1. Possibly due, in part, to gradual wear, the chain between the steering wheel and the drive shaft had slipped off the tensioning pulley allowing only steering to starboard but not to port. [2.2]

- Ensure a voyage plan, including contingency plans, is formulated for each passage;
- Conduct routine emergency drills; and
- Routinely inspect and maintain the steering gear system.

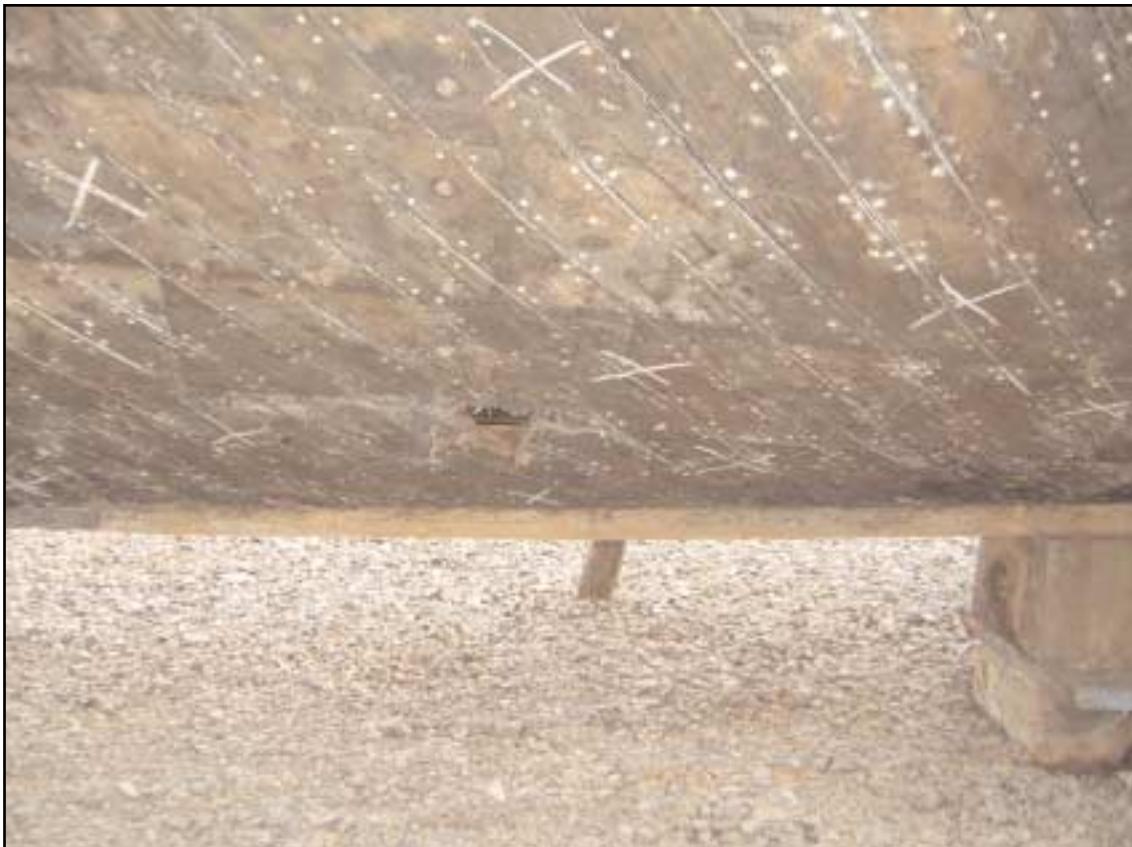
Photograph 2

A number of wooden hull planks were pushed up and split over a length of about 8.4 metres between the keel and the turn of the bilge on the port side, starting from just aft of the stem to nearly amidships. There was one small hole in way of the bar/buffet space (**see diagram 2**).

A hole in the port side of the hull in way of the bar/buffet space

Damage extended along three spaces: the forepeak, bar/buffet and engine room. The penetration to the hull and, therefore, the main flooding, was in way of the bar/buffet space. There was limited flooding through the gaps between the planks, which had been pushed up in the grounding.

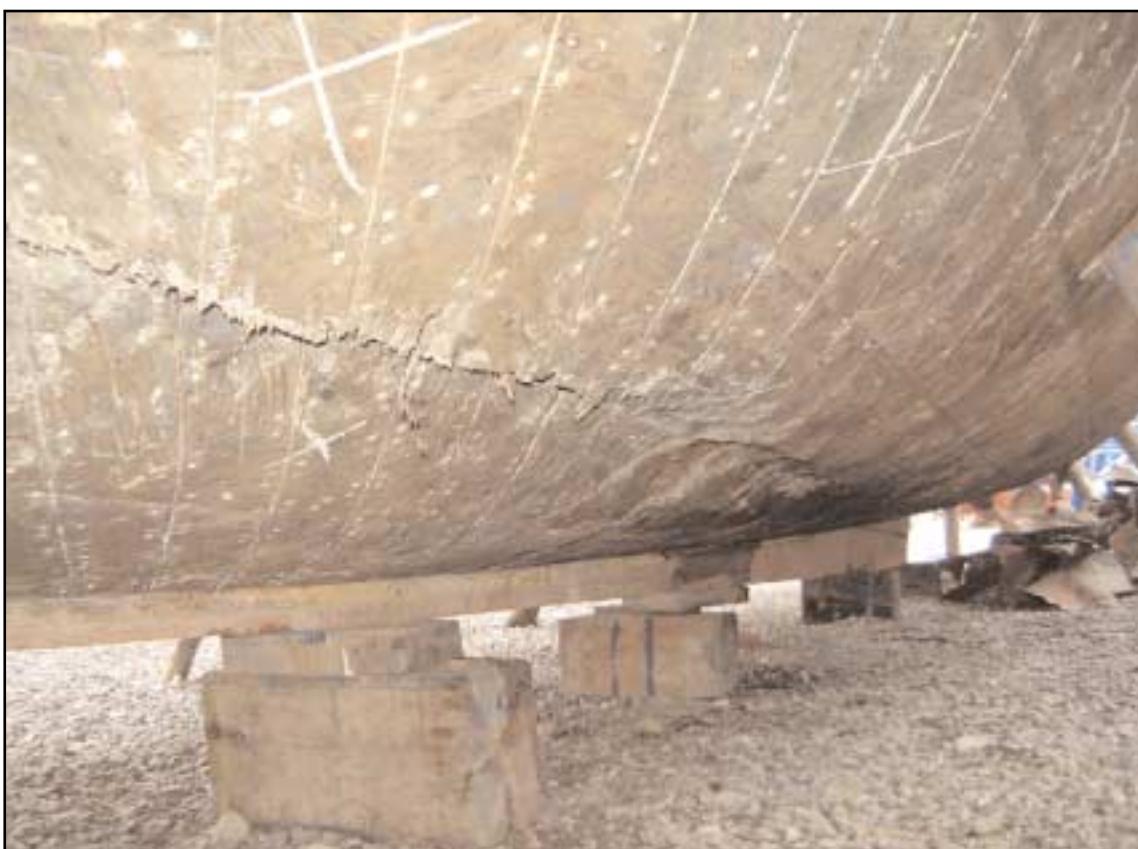
Photograph 3

A view of the damage of the port side looking aft showing a longitudinal tear

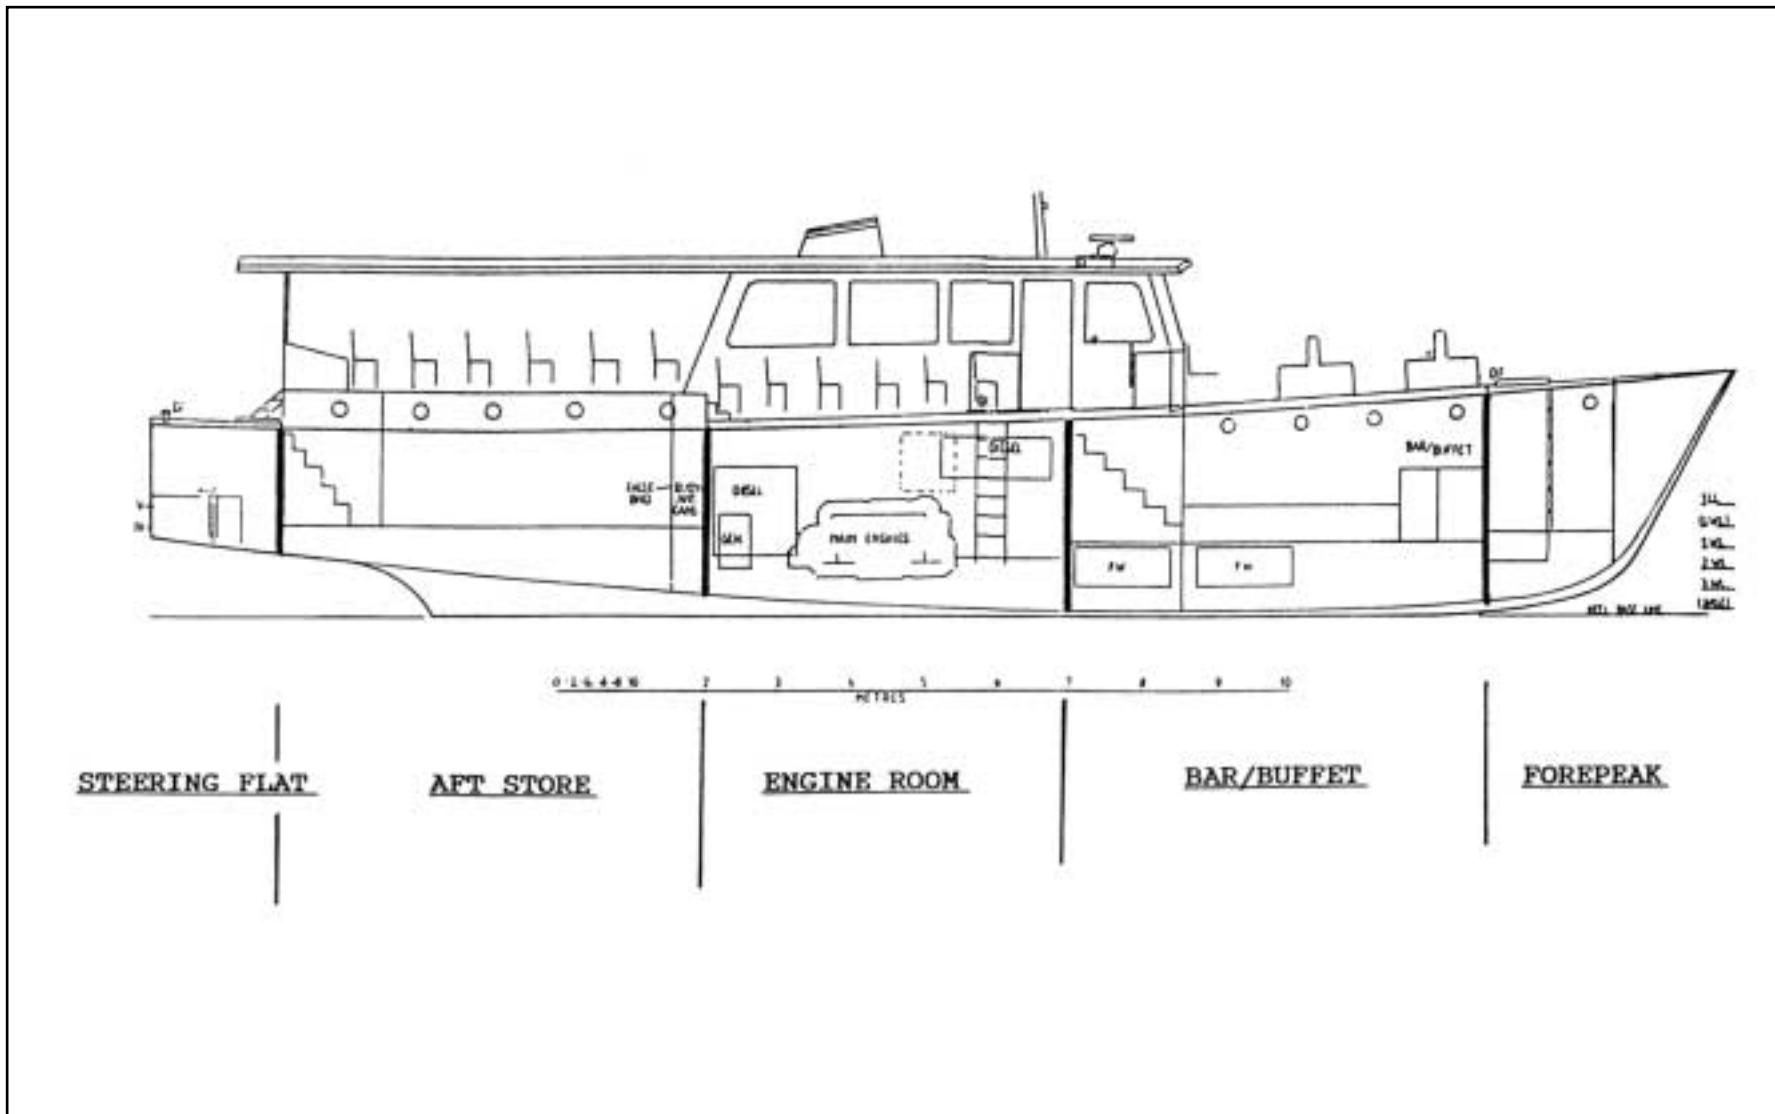
Diagram 2

Watertight bulkheads subdivided the vessel into five compartments: forepeak, bar/buffet, engine room, aft store and steering flat (**see diagram 2**).

Total flooding of more than one compartment would have resulted in the vessel foundering. However, the flooding into the three spaces was not sufficient for her to founder, and the vessel was able to remain afloat until she was beached. In view of the extent of damage, and the rate of flooding, beaching was a wise option.
