Report on the investigation
of the escape of steam and hot water on board

Queen Elizabeth 2

in the mid Atlantic
resulting in one fatality

**Report No 17/2003
July 2003**

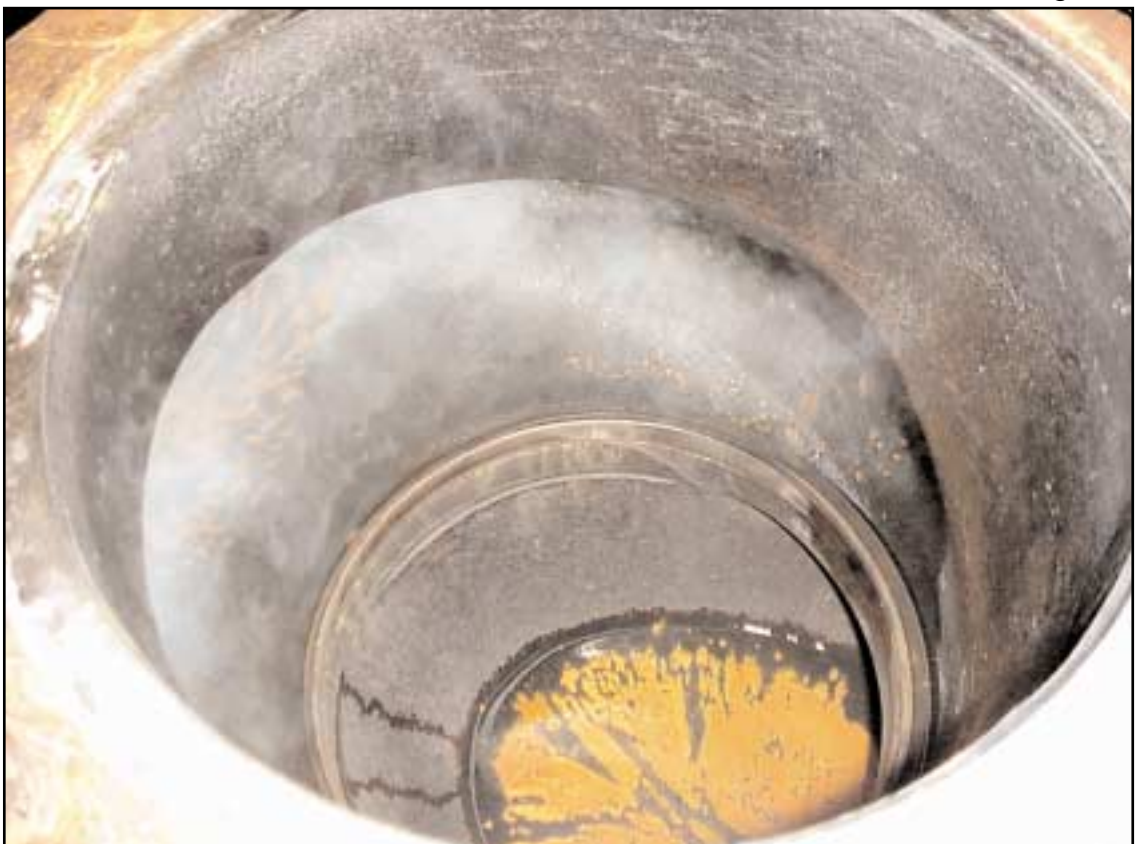
Figure 1

He observed that the valve was still dismantled, and that about every 30 seconds, wafts of steam emitted from the opening in the valve body (**see Figure 1**).

The following day, 24 June, steam was still emitting from the valve body. There was no sign of water around the valve, or on the deck level below the valve, to suggest there had been a further discharge of water since the accident.

Photograph of valve taken by ships staff

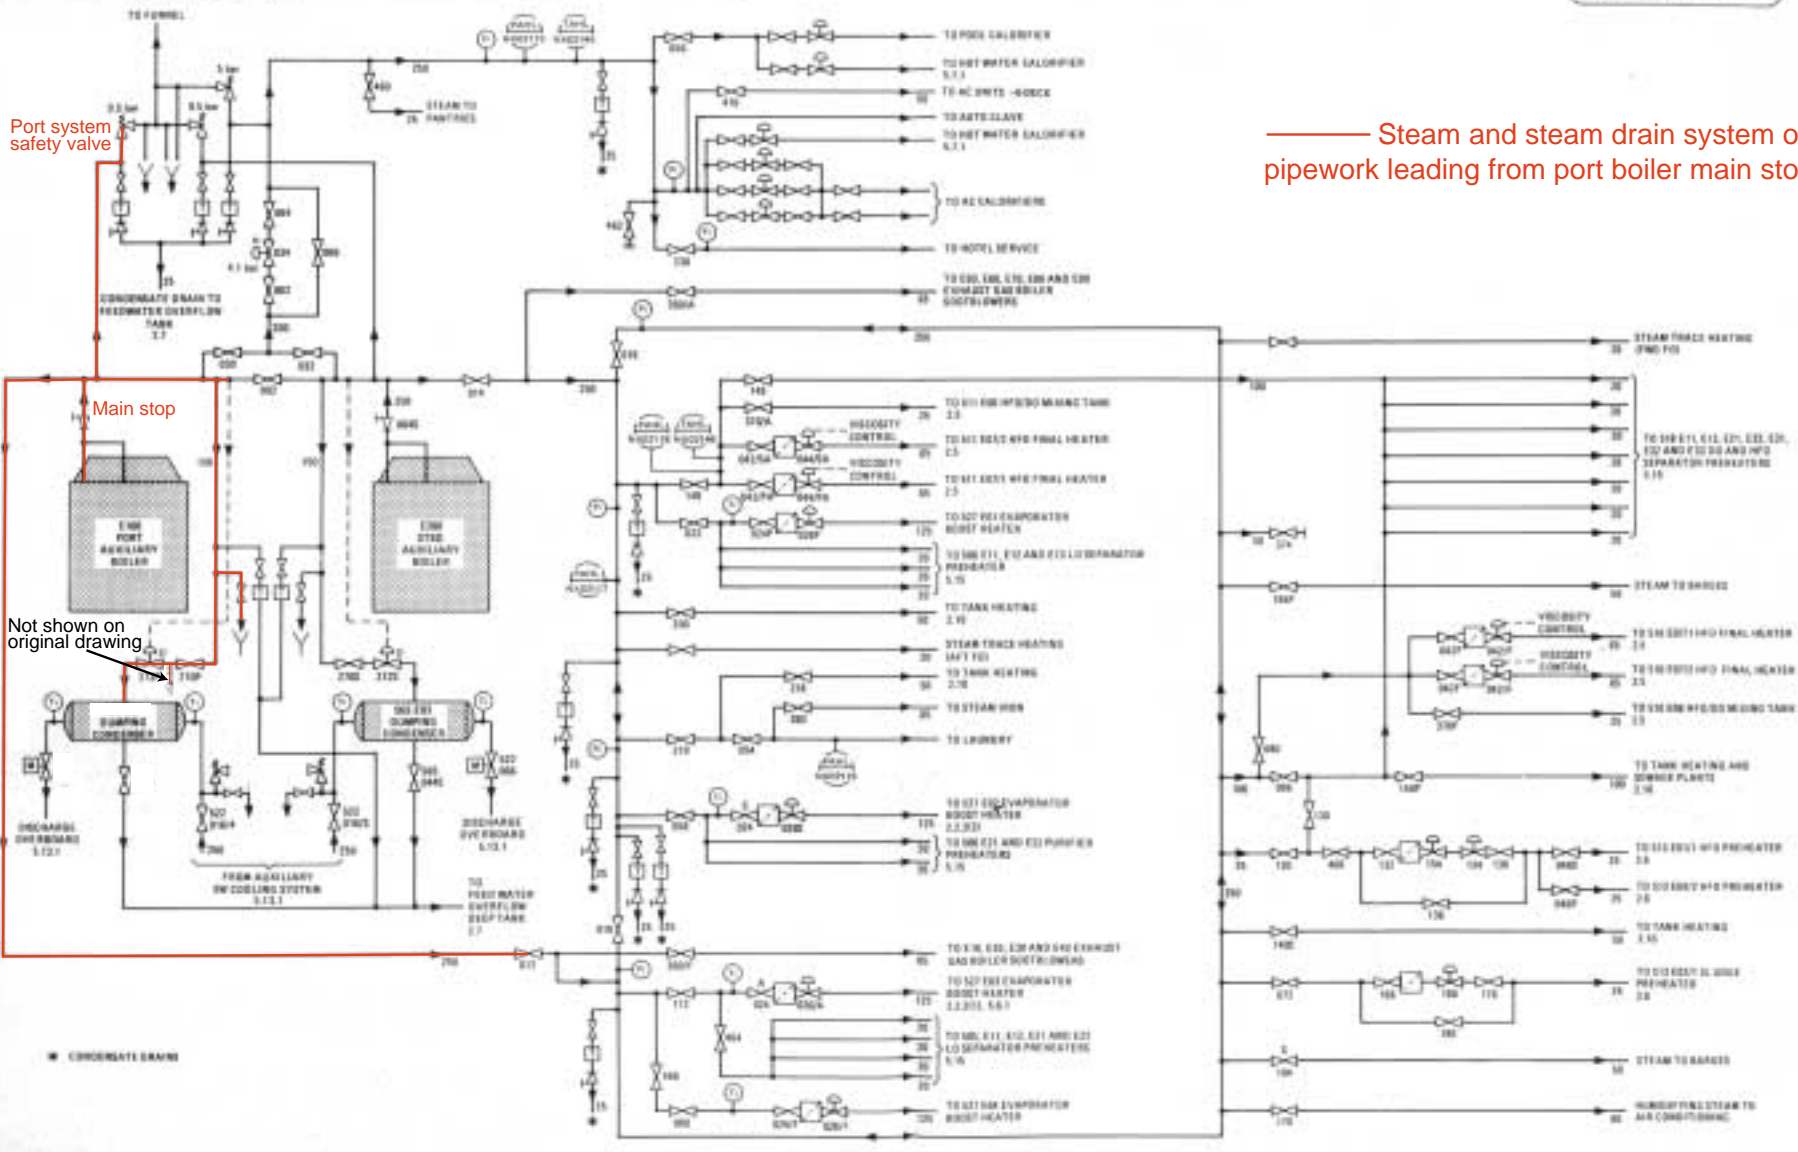
Diagram 1

— Steam and steam drain system of pipework leading from port boiler main stop

This was a 12mm bore drain which opened directly to bilge. It was not correctly marked on the drawing (**see Diagram 1**), but the vessel's engineering staff knew of it. It was not open at the time of the accident as it was usually only open when the condensers were changed over.

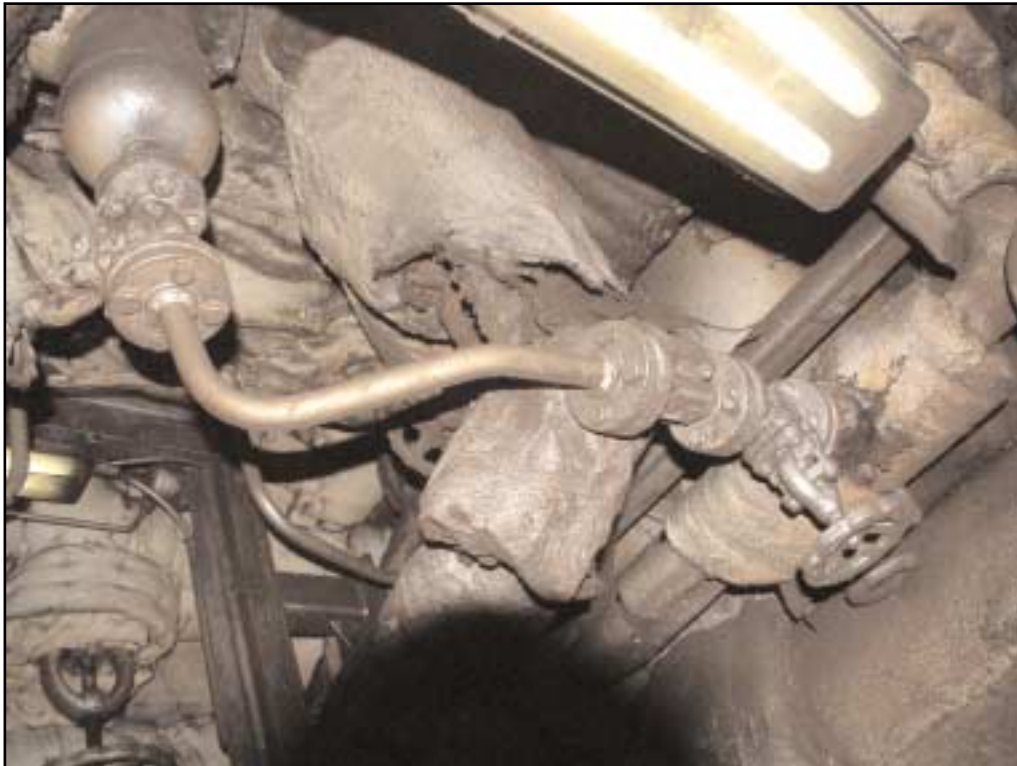
Figure 11

Drain from below port system safety valves

In their post-accident examination of the steam plant, the inspectors found that the isolated steam line, leading to the port boiler, was fitted with two drain lines. One was fitted below the system safety valve, but at the top of the line: useful as a vent, but incapable of draining the line.

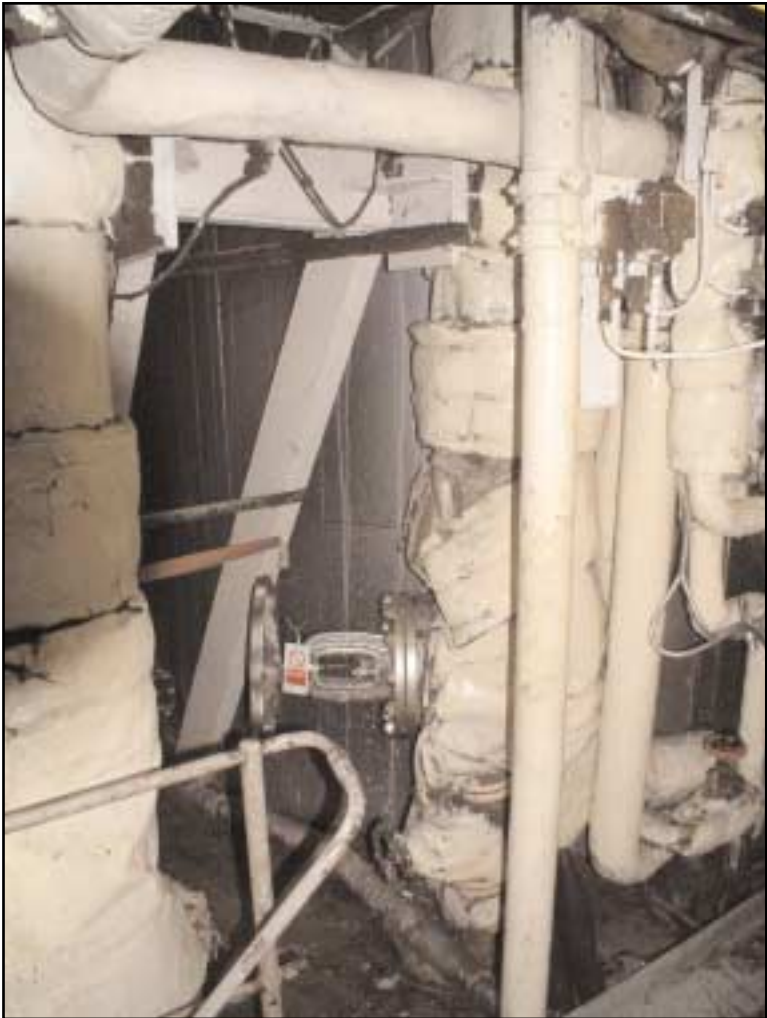
Figure 14

Port boiler supply to the engine room steam ring main

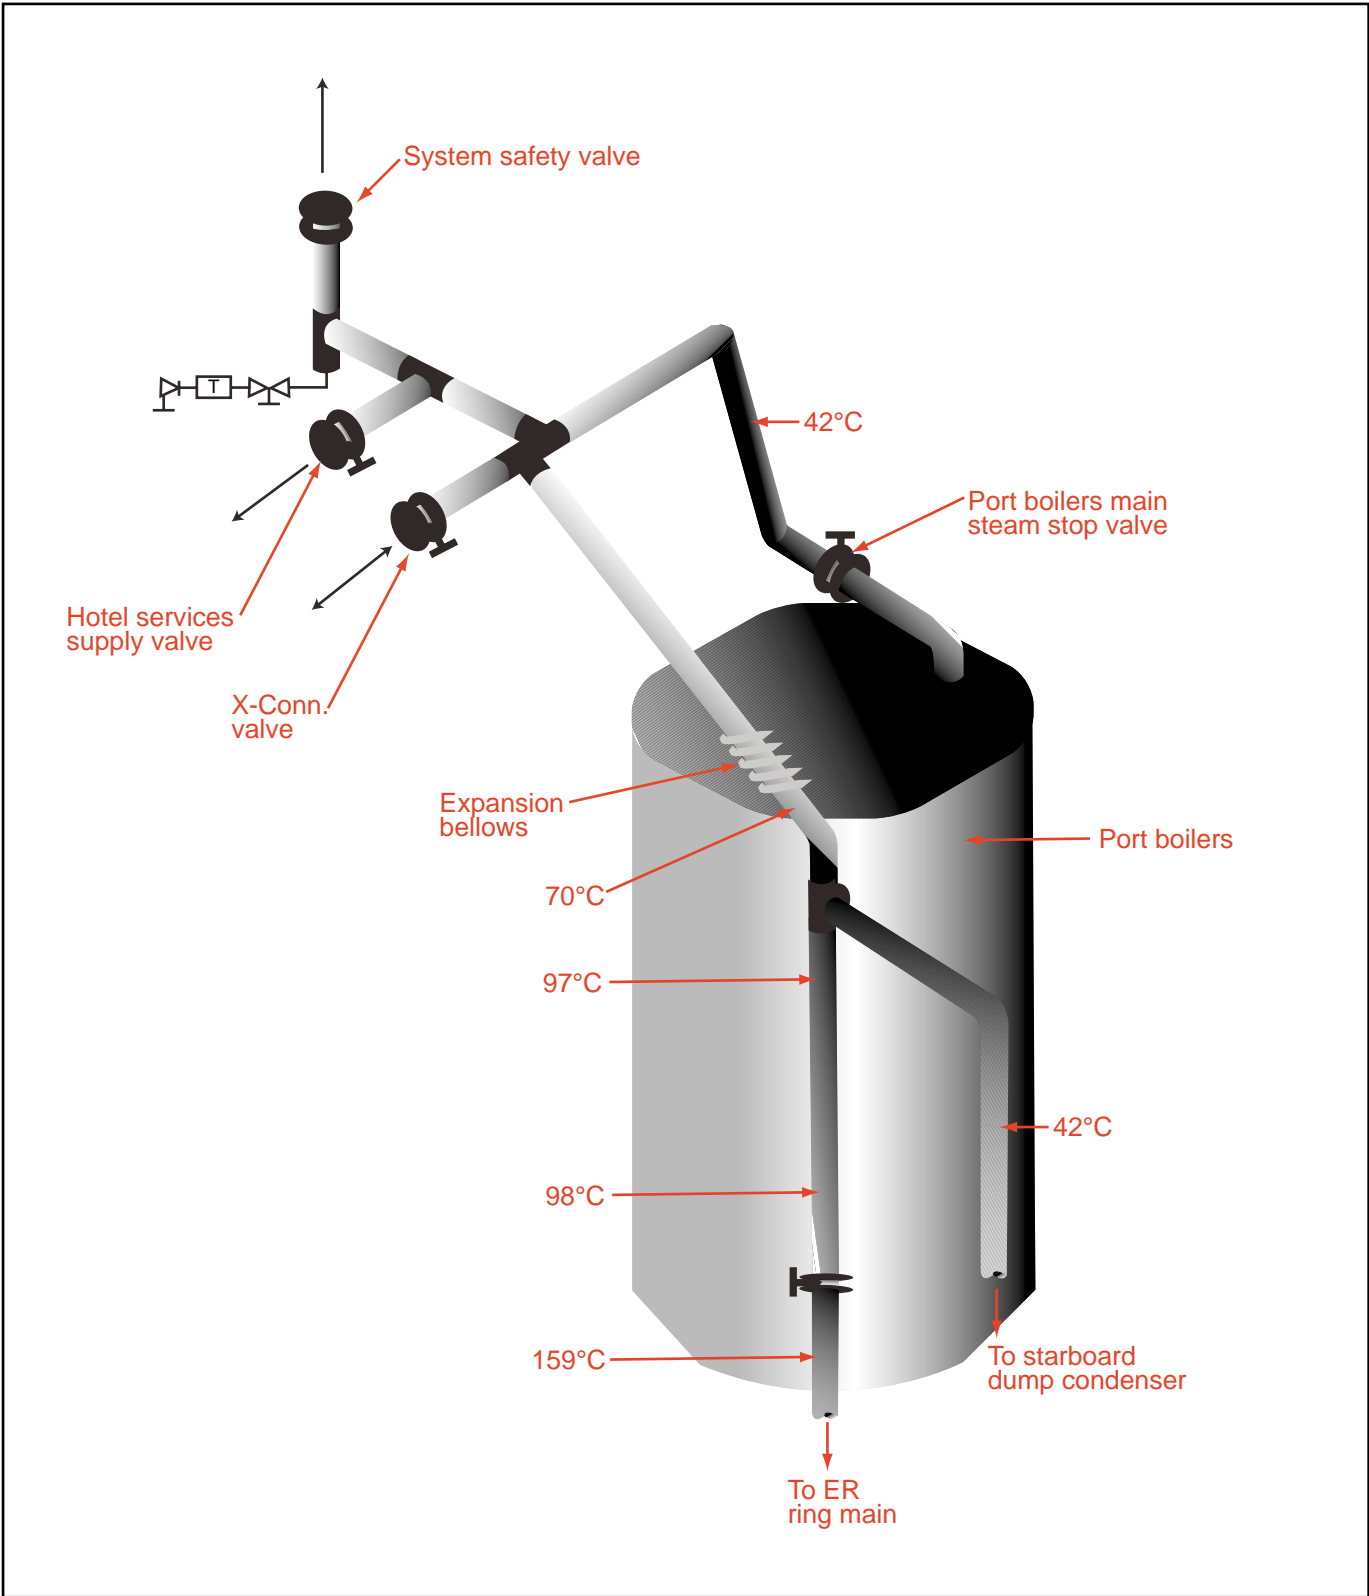
The inspectors found that the vertical length of pipe leading from the port boiler to the engine room steam ring main isolating valve (as shown in **Diagram 3** showing temperatures), was hot above this valve. The figure shows the temperatures of the pipe wall taken with a calibrated hand-held non-contact temperature sensor. The ambient temperature in the space at the time of these measurements was 41° to 46°C. The temperature readings indicate that the ring main isolating valve was passing steam in the reverse direction of flow, and that the level of hot condensate was up to the expansion bellows, some 6.5 metres above the top flange of the valve. The pipe was 250mm nominal bore.

3-dimensional sketch showing layout of port oil-fired boiler, steam pipework and temperatures

The inspectors found that the vertical section of pipeline, leading up from the leaking isolating valve, was full of hot water to the level of the steam branch line leading to the starboard dump condenser. The water temperature was near to boiling point at atmospheric pressure. The pipe surface temperature of this section is shown in **Diagram 3**.
