Report on the investigation of
Maria H
striking the Keadby railway bridge
29 May 2002

Marine Accident Investigation Branch
First Floor
Carlton House
Carlton Place
Southampton
United Kingdom
SO15 2DZ

Report No 8/2003
March 2003

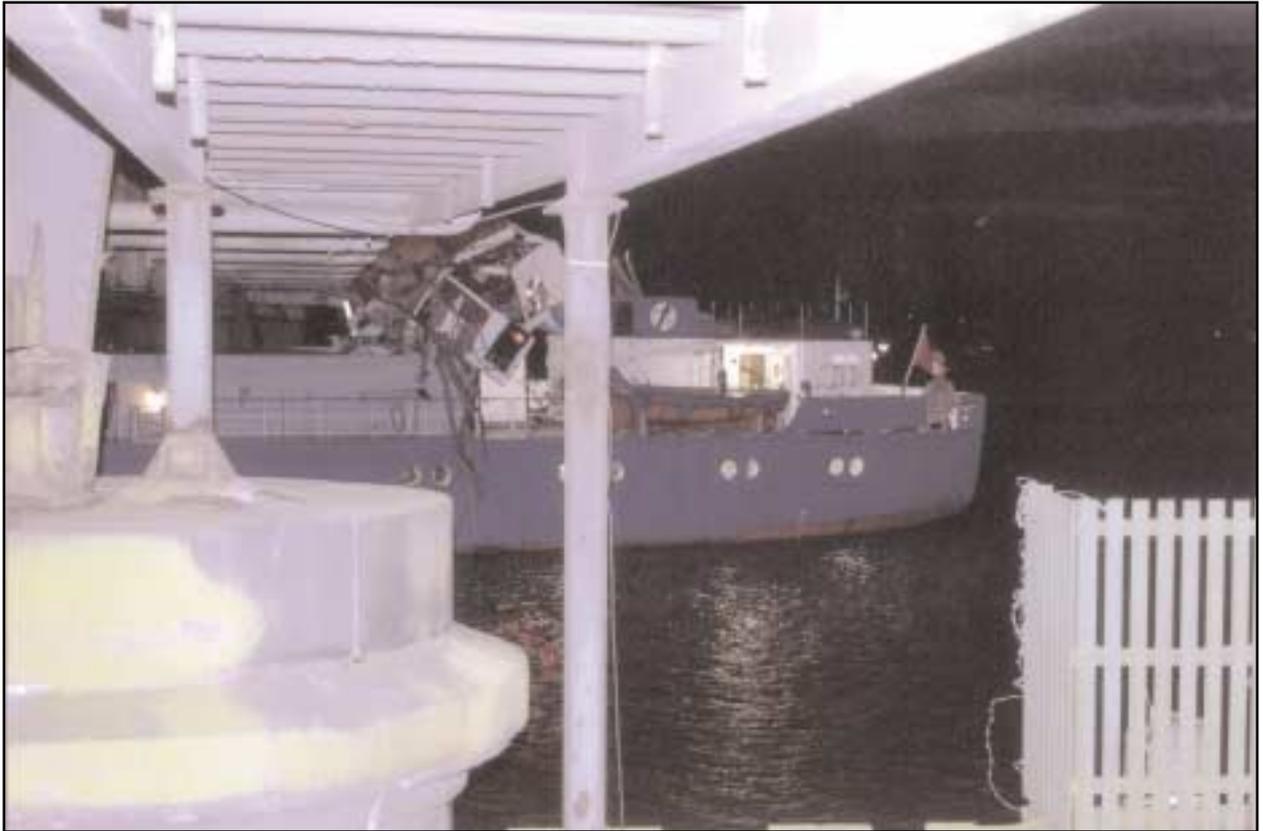
The vessel then pivoted on the central buttress of the railway bridge and was, at one stage, lying starboard side alongside the bridge. The bow then went under the eastern side of the bridge, removing the foremast, and the vessel was then wedged in position with the wheelhouse remains preventing the entire vessel from moving upriver under the bridge (**see Figure 5**).

Vessel stuck under bridge (taken from east bank)

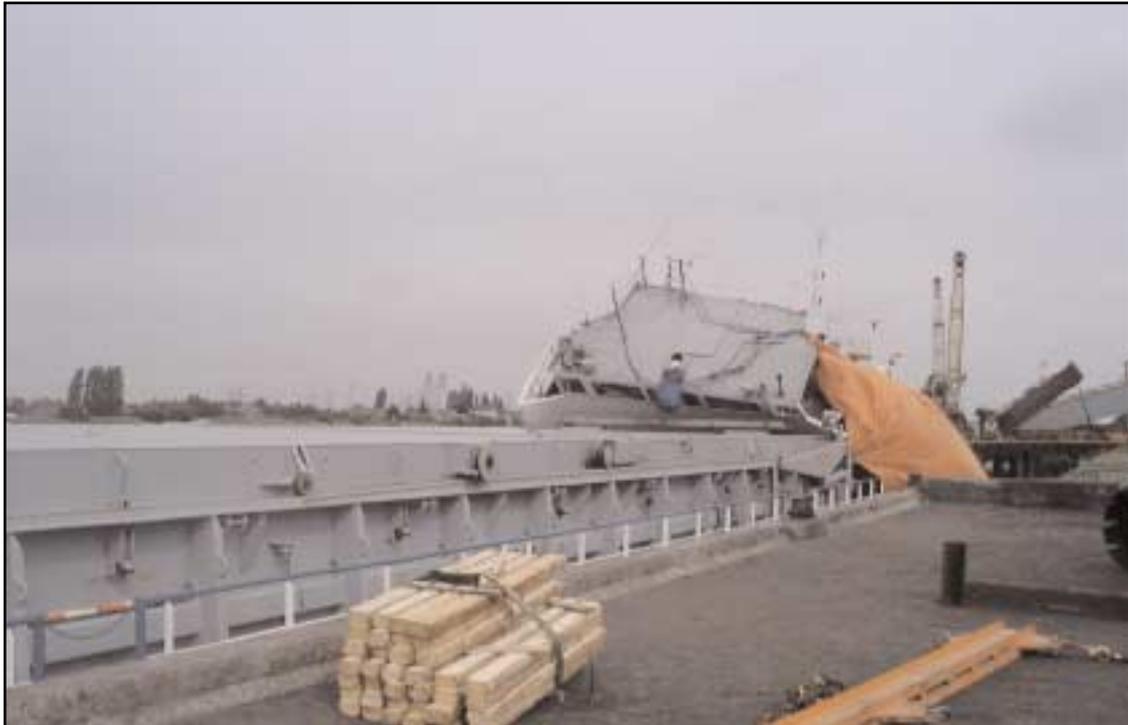
Figure 6

Shortly after 2100, the vessel struck the bridge from astern. The mainmast was badly damaged and the wheelhouse was pushed forward about 45°. The wheelhouse windows shattered and the master's left leg was lacerated.

The master required further medical attention to his leg. The vessel suffered extensive damage to her wheelhouse, foremast and mainmast (**see Figures 6 & 7**). The bridge sustained only superficial damage and was closed for 2 hours until inspections were completed. No pollution occurred as a result of the accident.

Damage to vessel

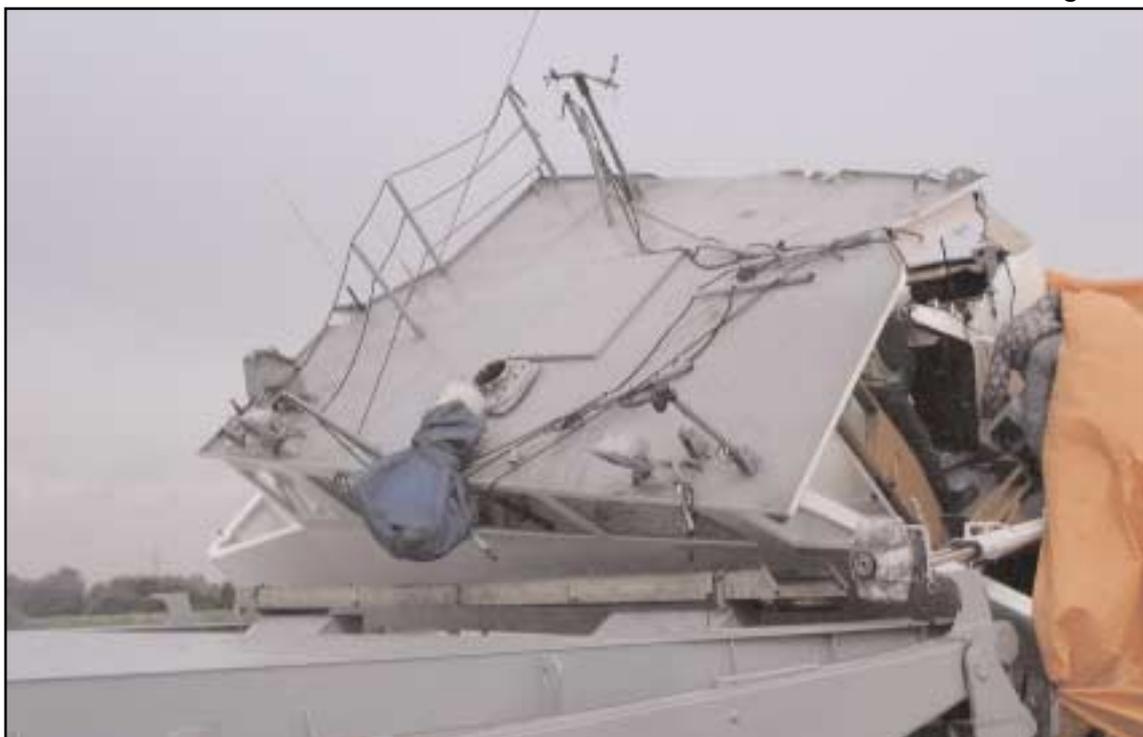
Figure 7

As the tide continued to rise, the wheelhouse became more compacted and further damage occurred. A barge was contacted, and came alongside the starboard quarter and took the master back to the berth. An ambulance then took him to hospital.

Damaged wheelhouse
