Report of investigation
into flooding of aft engine room
of passenger cruise ship
Queen Elizabeth 2

21/22 May 2002

Report No 9/2003
March 2003

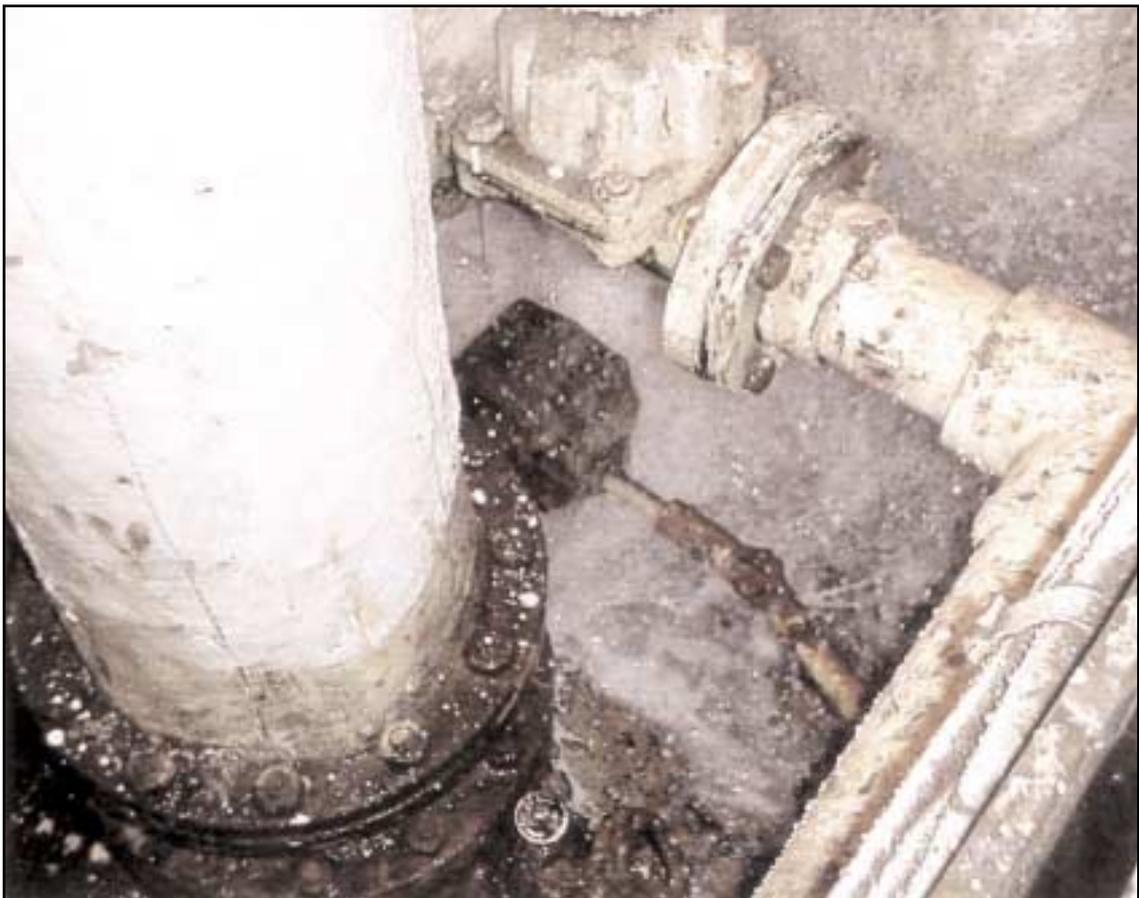
Figure 1

Following the arrival of the chief and first engineers and other engineering staff, it was found that the leak was in a short length of 250mm diameter sea water pipe serving the starboard sea water evaporator (**Figure 1**).

Leak from 250mm sea inlet

As this pipe, some 210mm long, was between the sea inlet isolating valve and the vessel's shell, it was impossible to isolate the leak by closing this valve.

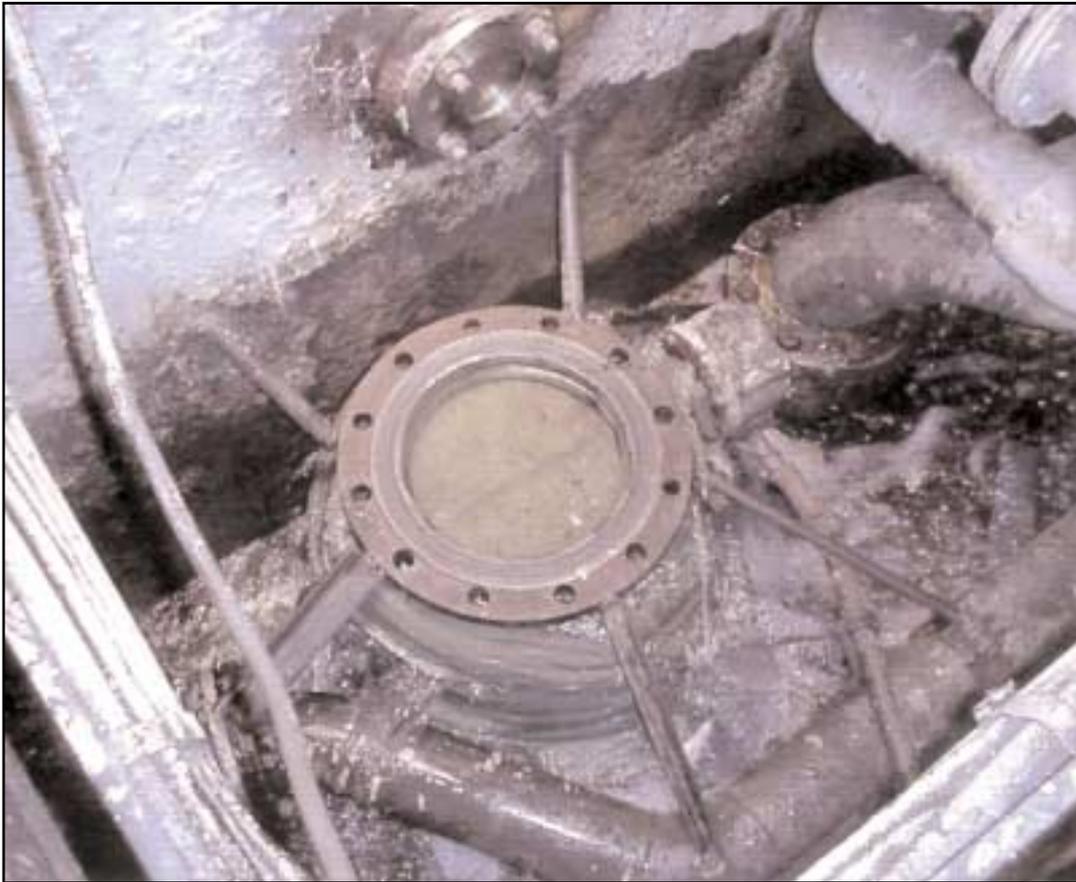
Figure 3

Reinforcing stays between valve flange and surrounding structure (inboard piping and strainer removed)

The fragility of the failed pipe was also a concern. To reinforce the pipe, to prevent fracture and loss of the isolating valve, stays were welded between the upper flange of the valve and the surrounding structure (**Figure 3**).

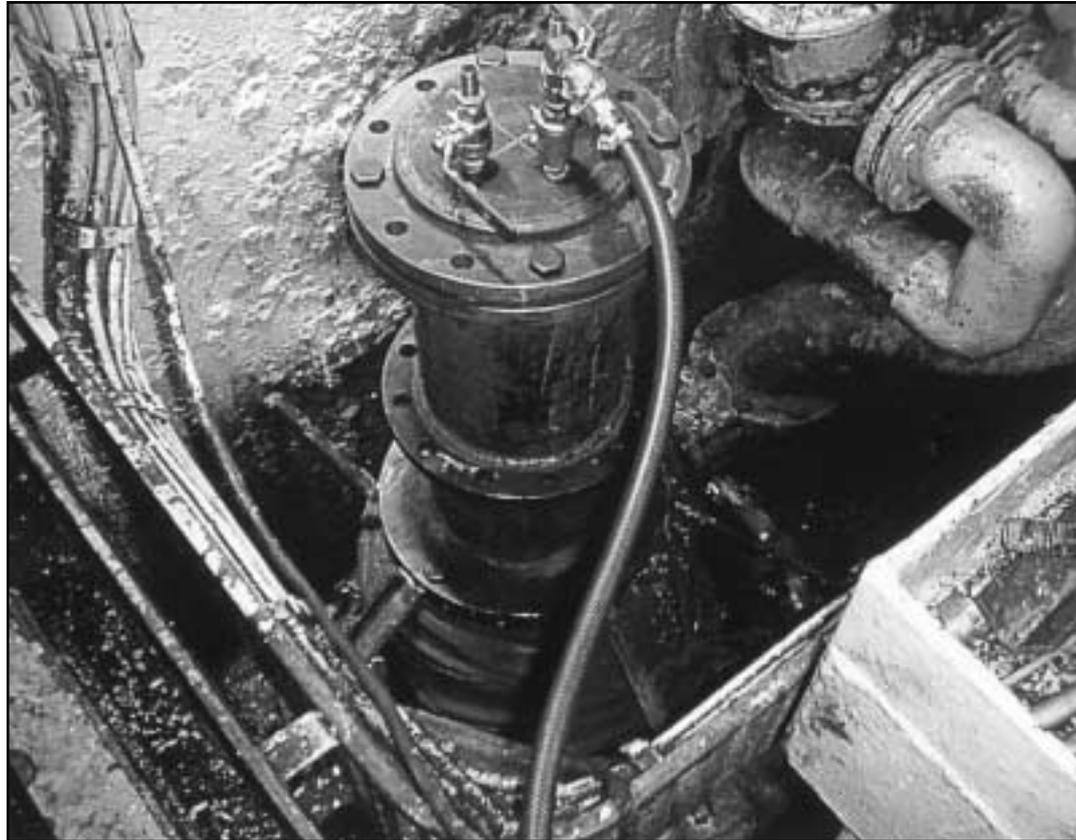
Figure 4

'Top hat' device to insert bellows into leaking pipe

The main component of this device had the form of a 'top hat' made of steel (**Figure 4**). Its rim was a drilled flange suitable for bolting to the upper flange of the butterfly valve on the leaking pipe. The crown was a flat plate through which a tube was passed, and which could slide through the plate. Water leakage around this tube was prevented using a sealing gland arrangement.

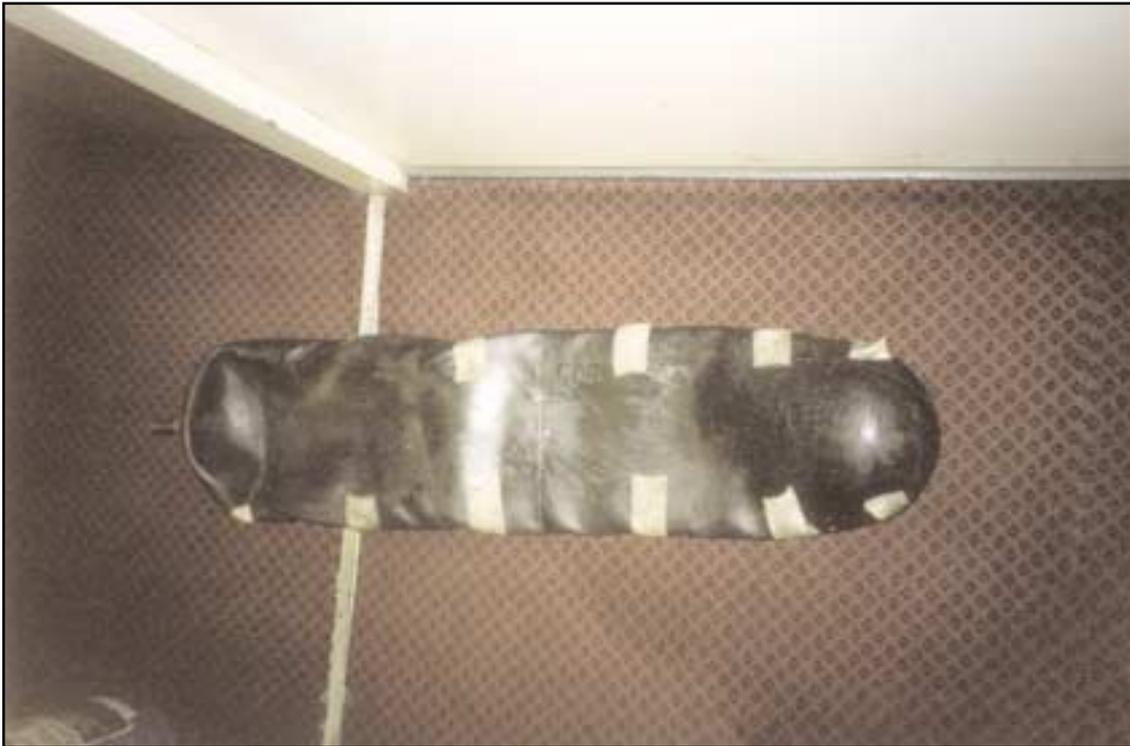
Figure 5

Bladder used to stem flooding (compressed air connection at left hand end)

The sliding tube was then pushed down so that the bladder passed the valve's disc and into the leaking sea water pipe. Once the bladder was in position, compressed air was supplied to the bellows causing it to expand and fill the bore of the leaking pipe.

The first bladder failed after several hours. However, the method was used again and proved effective until more permanent repairs were made. The second effort required some slight modification to the arrangements. The bladder used was longer than the first, and, to ensure it could be inserted into the leaking pipe lower than the area of perforation, and any sharp edges which might again cause a puncture, the sliding tube was increased in length.

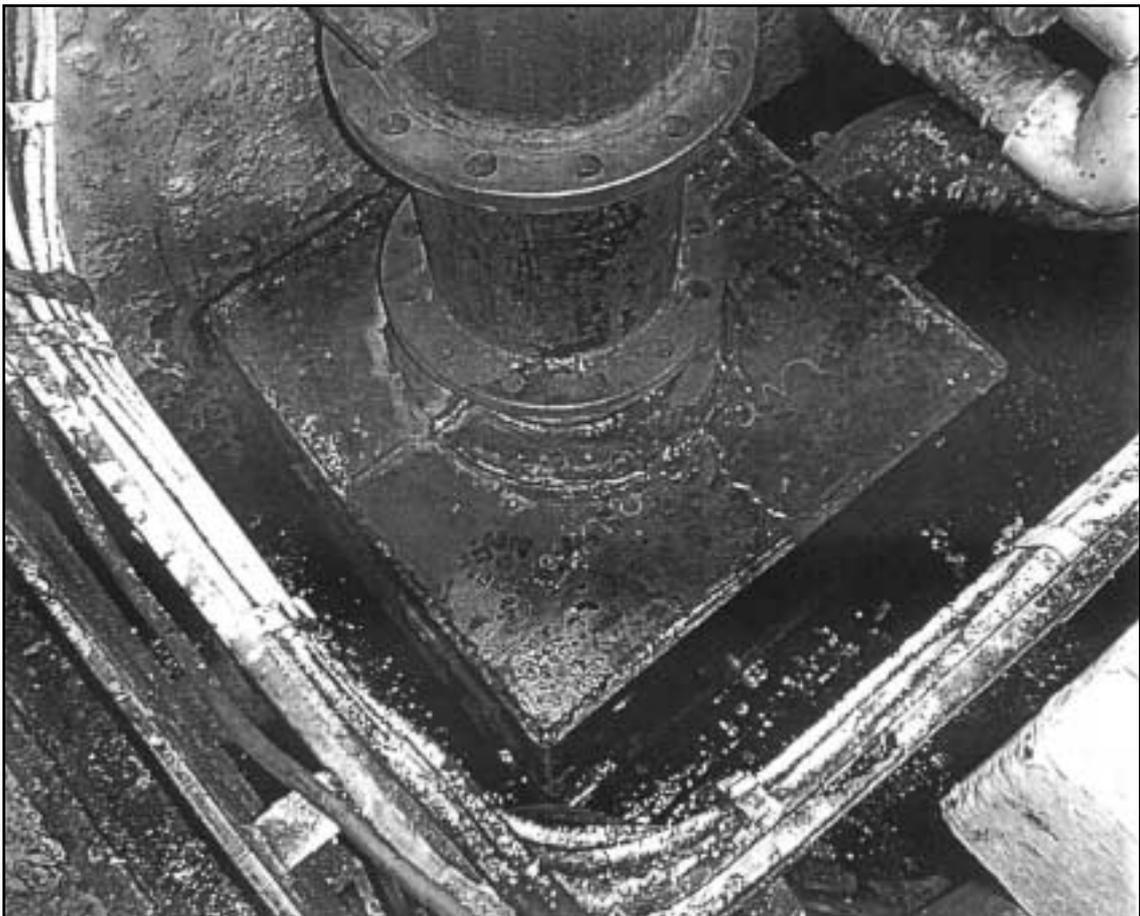
Figure 6

Box enclosing failed pipe

Once the water inflow was completely stemmed, a steel box was built around the failed pipe. The tank top and sewage tank side were used as two sides of the box. To these, and the pipe's flange, were welded the other four sides of the box (**Figure 6**). This totally enclosed the failed pipe and remained in place until the vessel's arrival in New York, where permanent repairs were made.

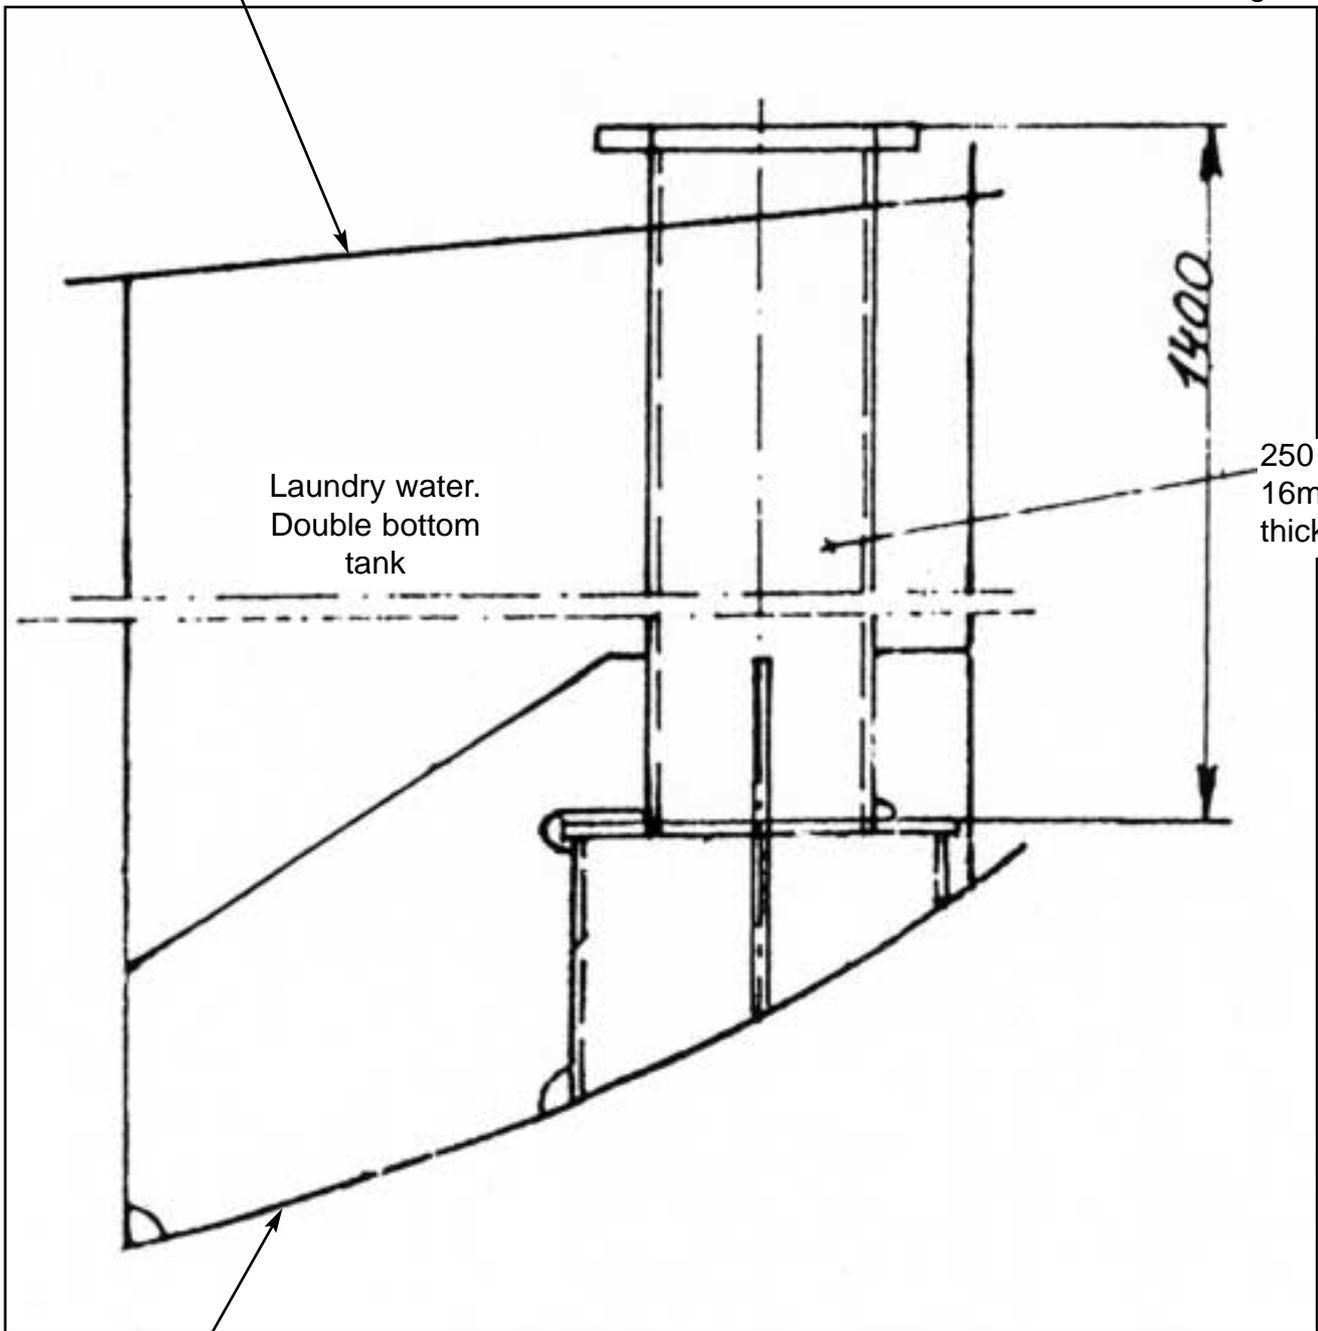
Figure 7

The pipework associated with the evaporator sea water system, including the length of pipe that failed in this incident, was installed during this work (**Figure 7**).

Evaporator sea inlet

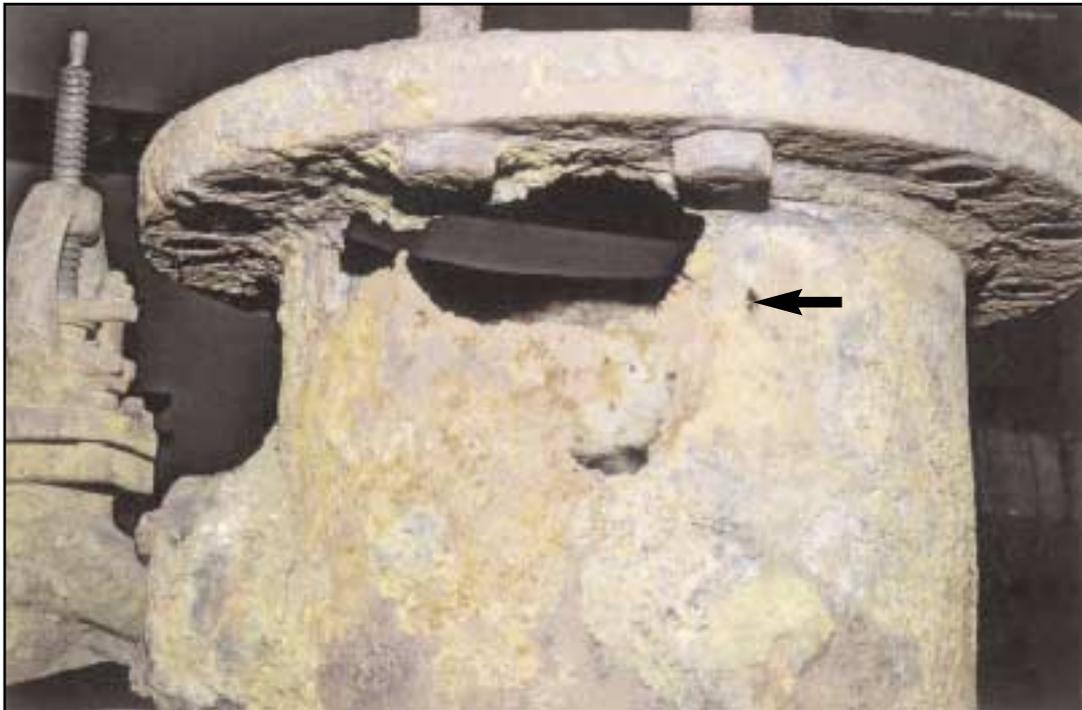
Figure 8

Detail of principal leak site showing corrosion of flange underside and local loss of the outer flange to pipe fillet weld. The figure also shows a close proximity secondary pipe wall perforation site (arrowed)

A specimen removed from the perforation site confirms that the pipe end, the pipe end to flange sealing fillet weld, and most of the flange underside to pipe fillet weld had been consumed by corrosion. Loss of the pipe's end over the full flange height had exposed the inner flange edge to sea water corrosion, resulting in significant and long standing end-grain corrosion into the flange. The underside flange-to-pipe fillet weld had been largely consumed by sea water corrosion.

Based on what remained of the flange underside weld metal and heat affected zone (HAZ), it appears that corrosion had proceeded from inside to outside and preferentially along the fillet weld fusion line.

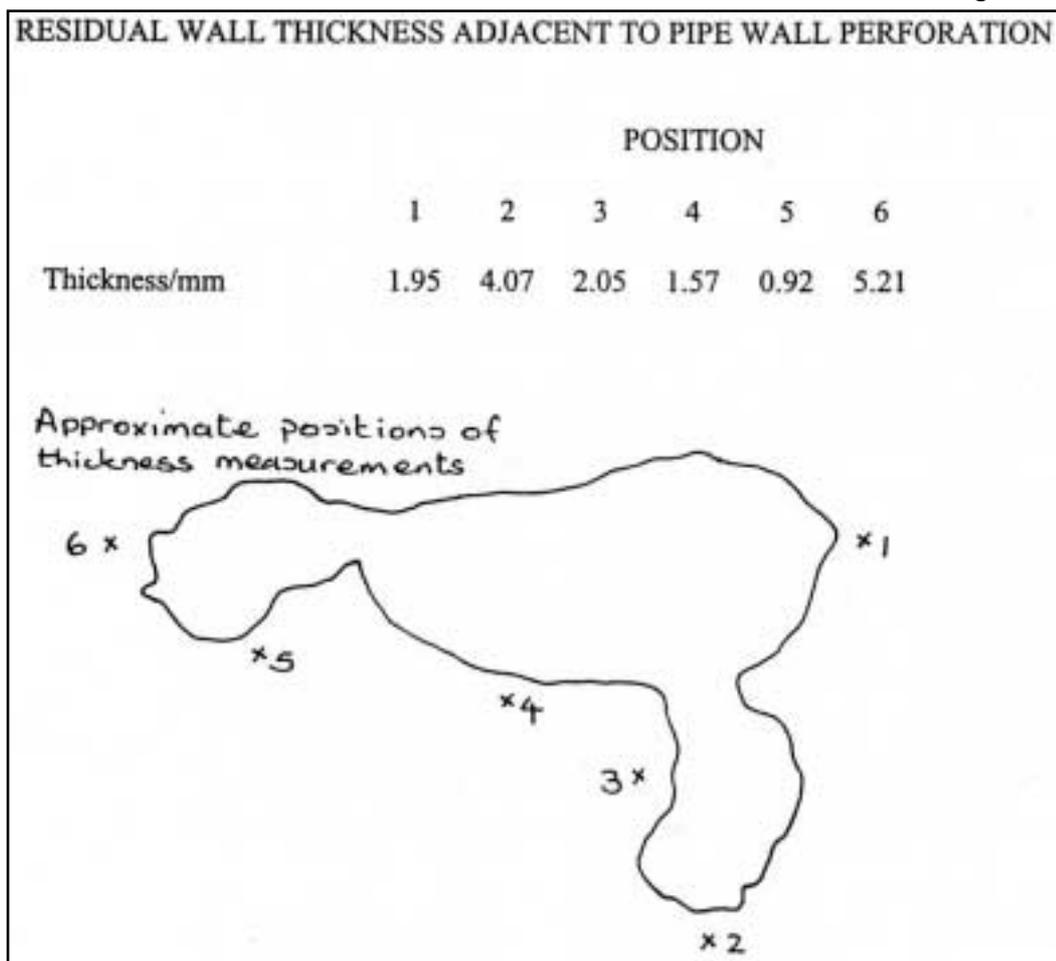
Figure 9

Residual pipe thickness was measured at a selection of points around the pipe circumference (**Figure 11**). All measurements were made from the outer diameter, with minimal surface preparation, using an ultrasonic thickness meter. Additional UT measurements were made around the pipe wall perforation (**Figure 9**).

Outline of perforation

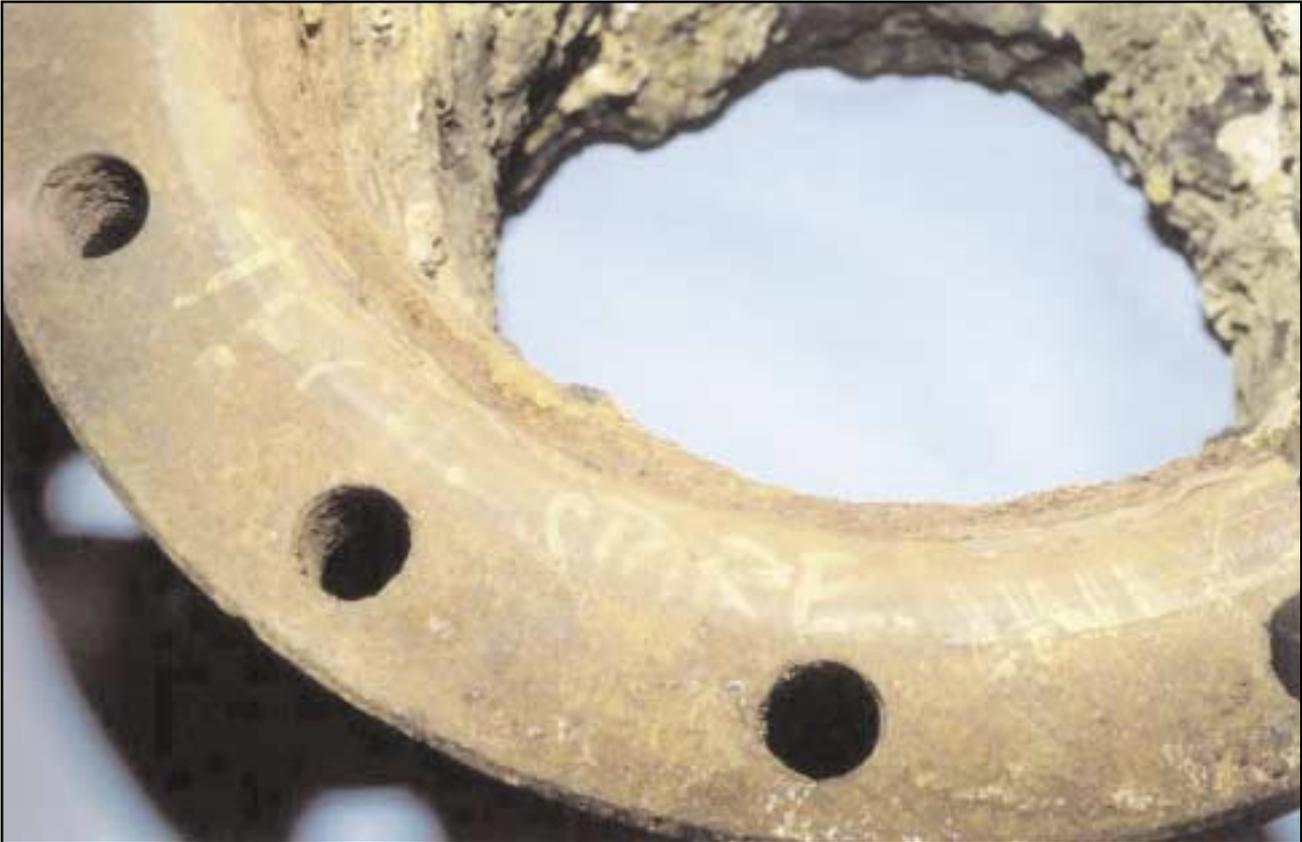
Figure 10

Internal surfaces clear of the immediate leak sites are coated with heavy laminated corrosion products of up to 12mm thickness. The iron corrosion products are overlaid by hard marine fouling (**Figure 10**). The pipe end, within the flange, is severely wasted.

Corrosion damaged pipe end, and absence of any remnants of the inner flange to pipe sealing fillet weld. Heavy marine growth and corrosion products at top of picture

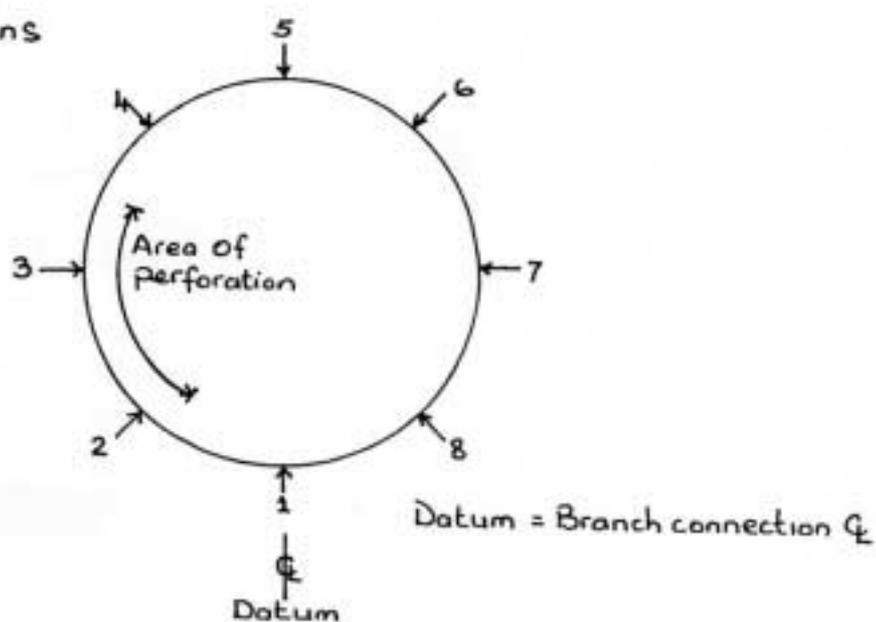
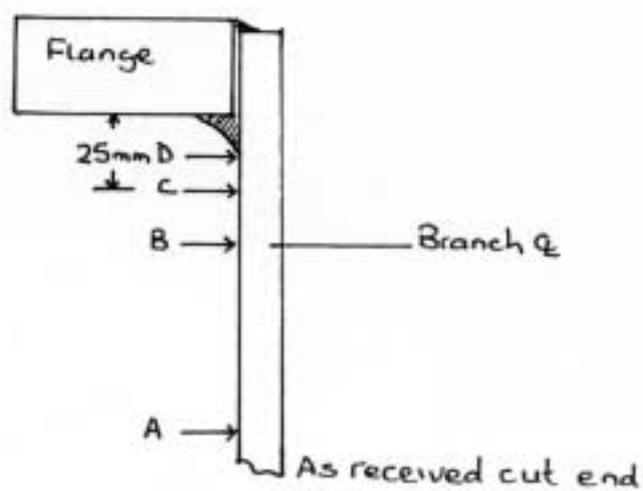
RESIDUAL PIPE WALL THICKNESS MEASUREMENTS AND KEY TO LOCATIONS AND POSITIONS

POSITION	LOCATION AND THICKNESS/mm							
	1	2	3	4	5	6	7	8
A	9.58	8.15	9.26	8.29	12.31	10.15	8.13	8.51
B	-	9.52	4.97	9.29	9.30	7.12	11.98	11.69
C	5.03	7.29	-	-	5.52	6.48	6.58	6.83
D	4.06	-	-	5.12	6.40	6.76	5.90	7.95

The pipe thickness data serve to confirm that the pipe had suffered heavy internal general corrosion wastage of up to 12mm and severe wastage local to the perforation site.
