Report on the investigation of
flooding of the forward machinery space of
P&OSL Canterbury
as she entered Dover Harbour
on 17 May 2001

Marine Accident Investigation Branch
First Floor, Carlton House
Carlton Place
Southampton
SO15 2DZ

Report No 16/2002
April 2002

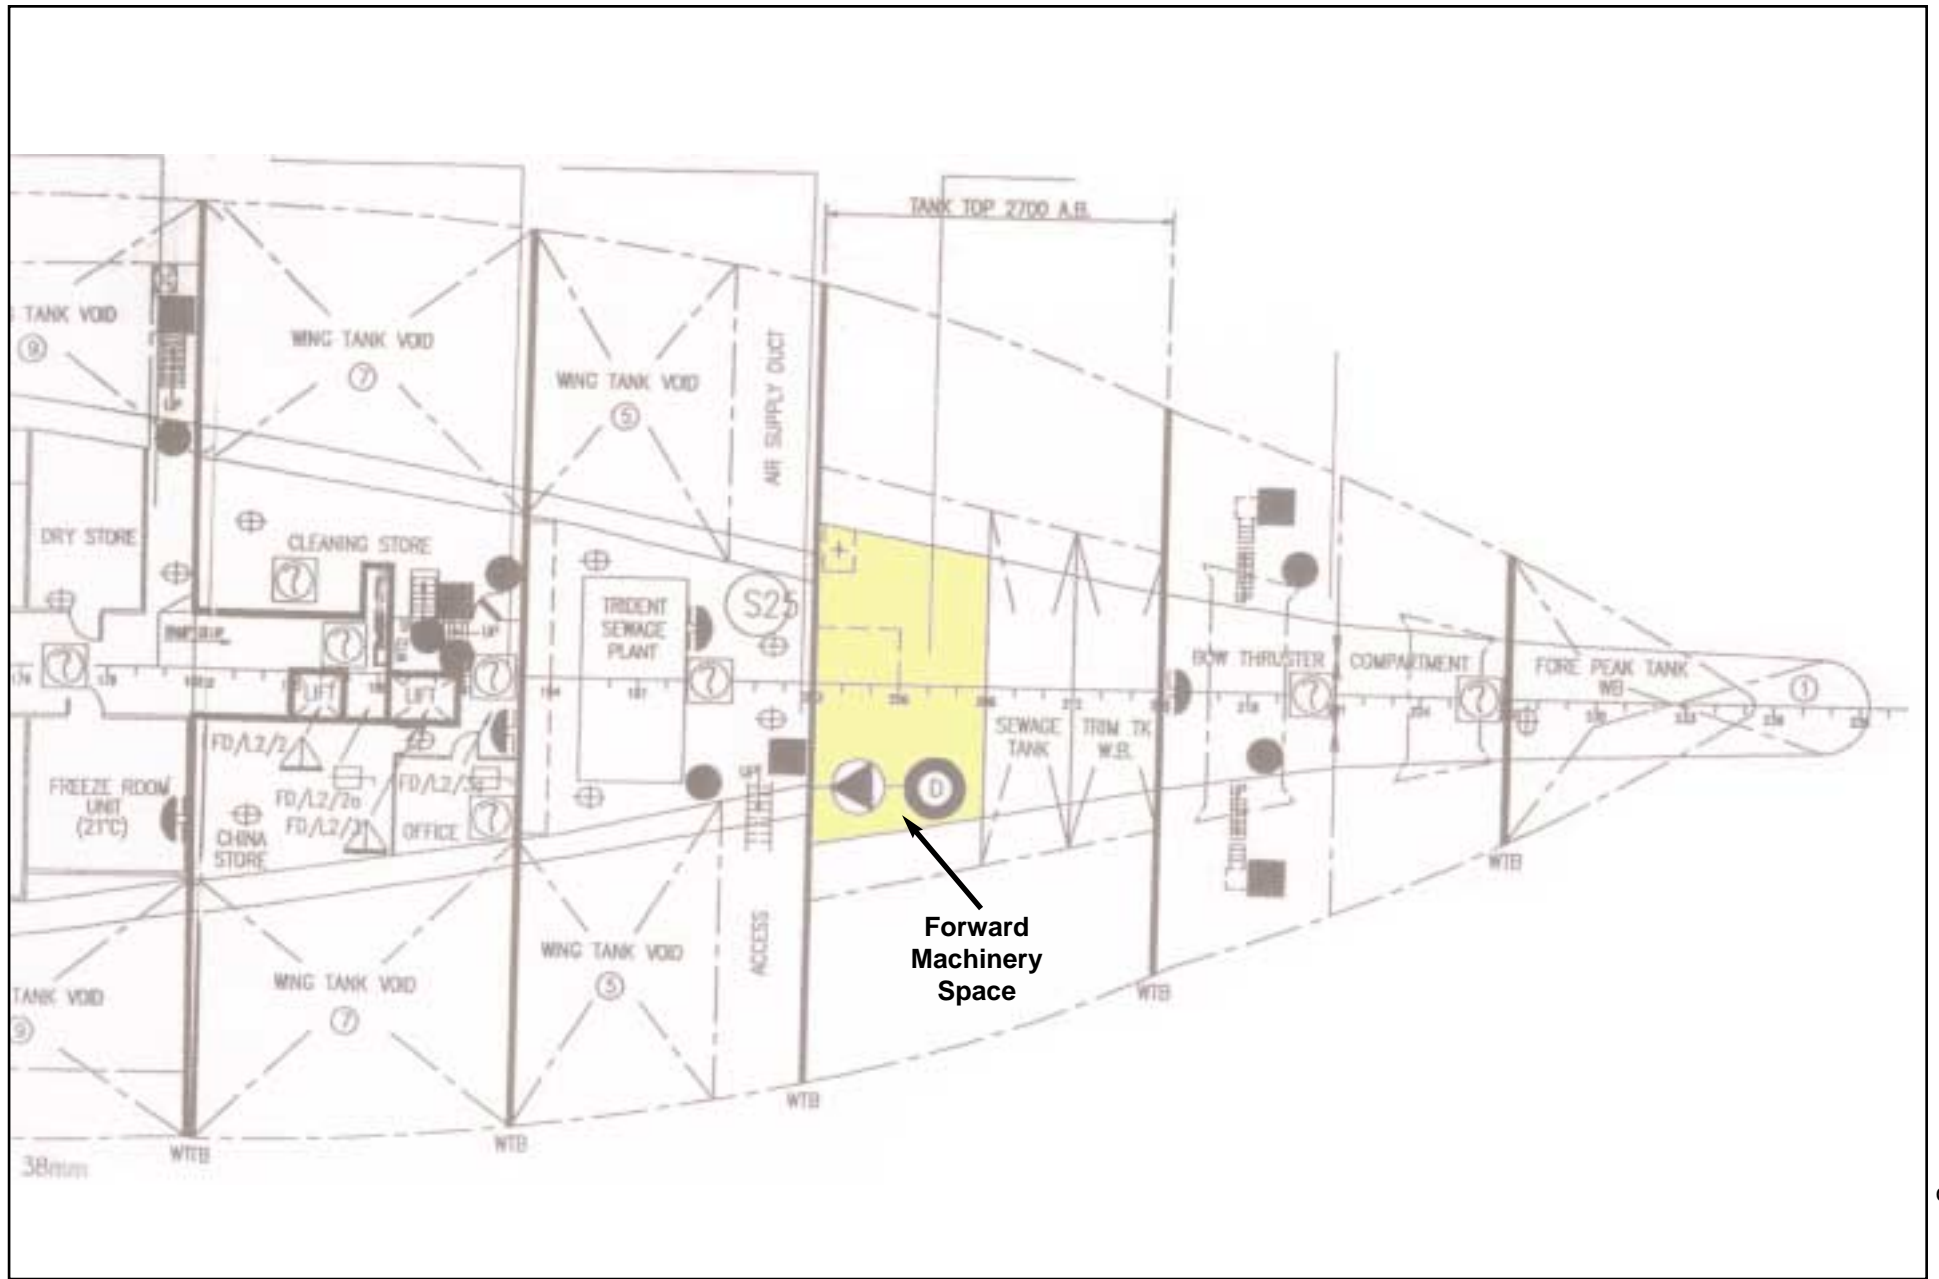
Figure 1

Position of forward machinery space (plan)

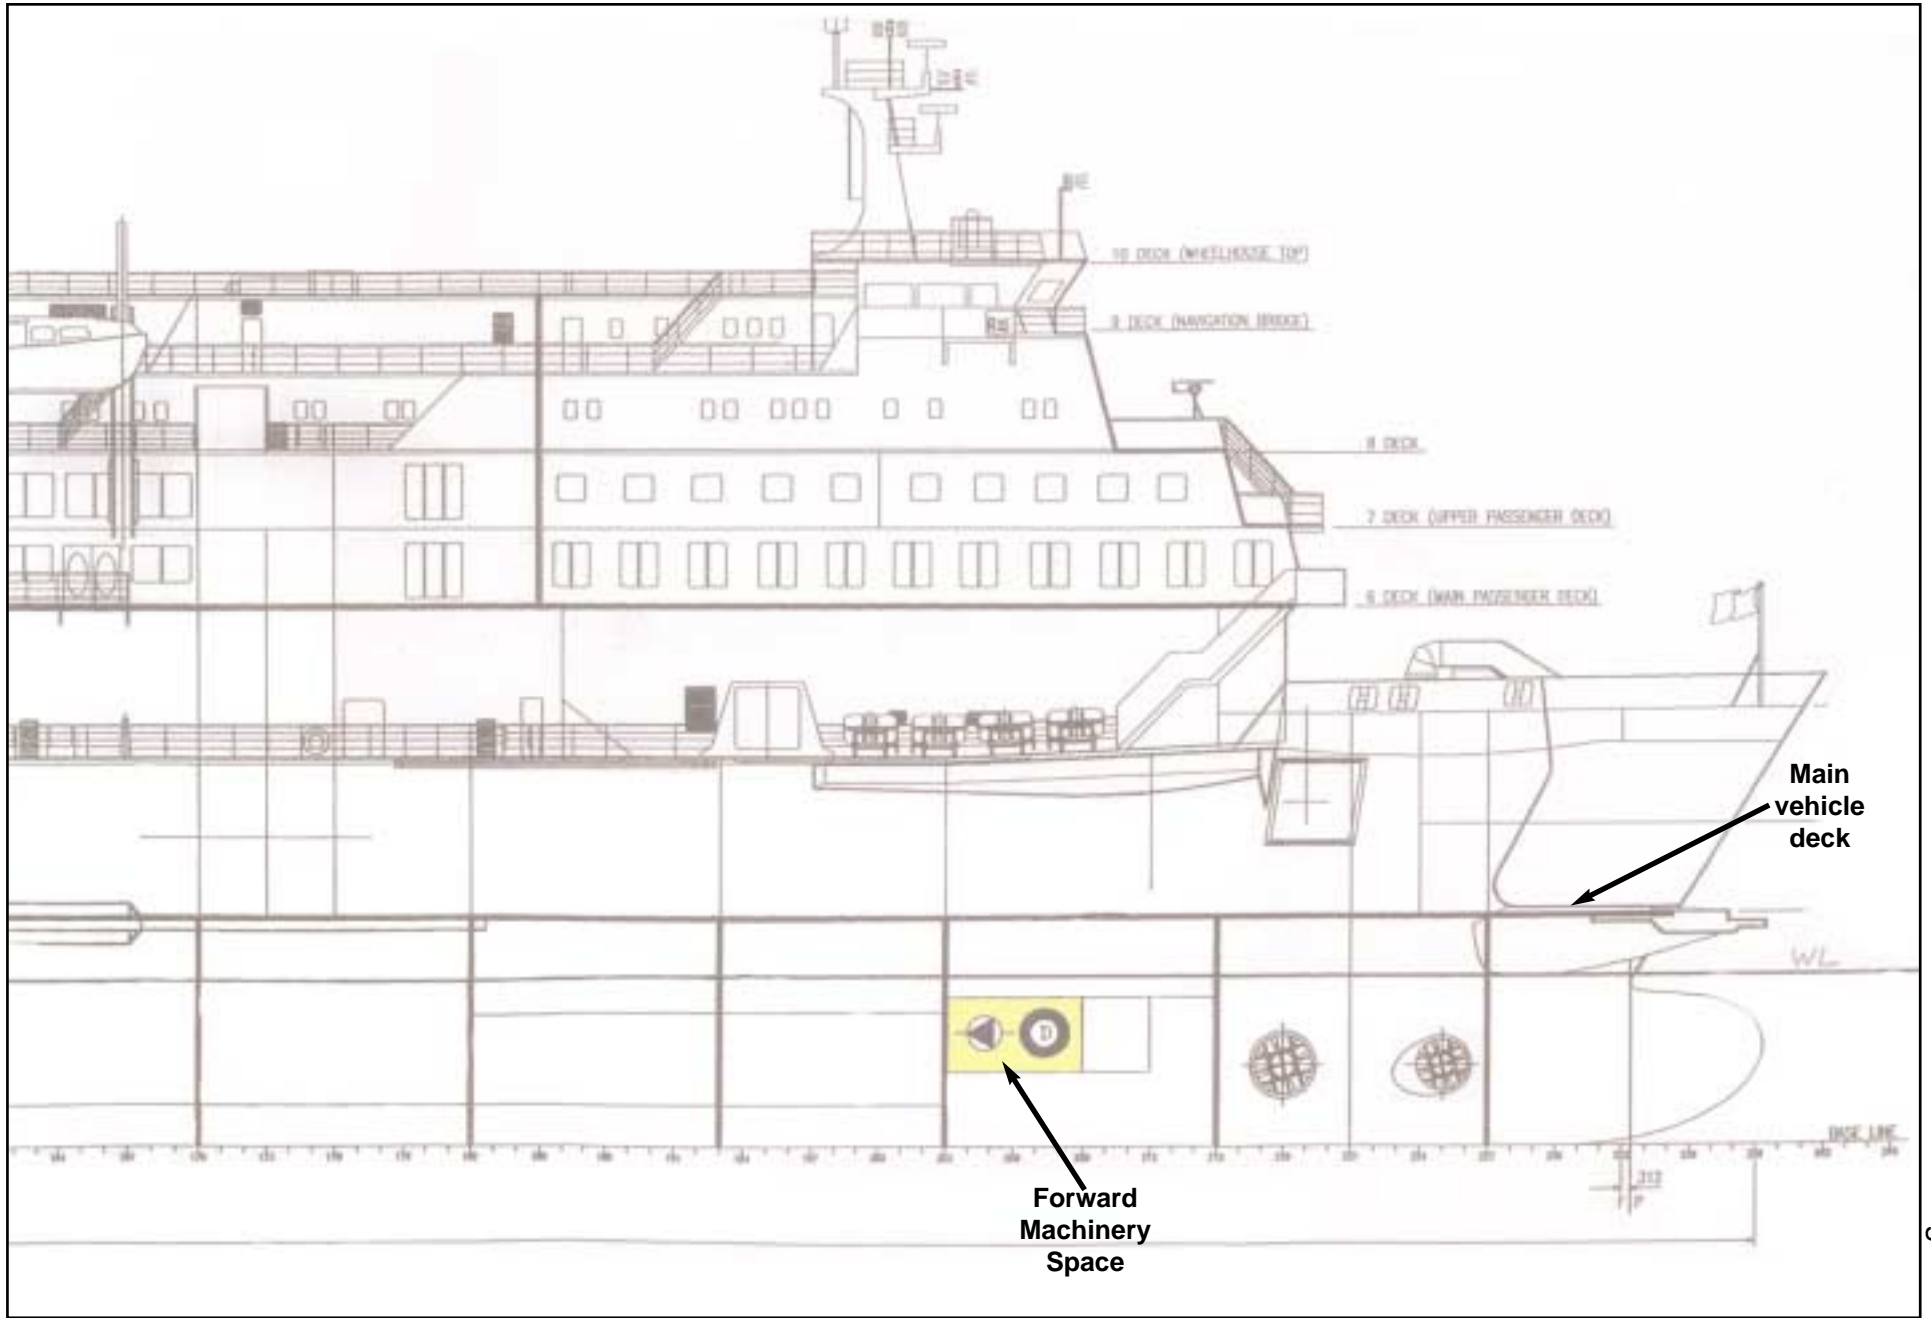
Position of forward machinery space (elevation)

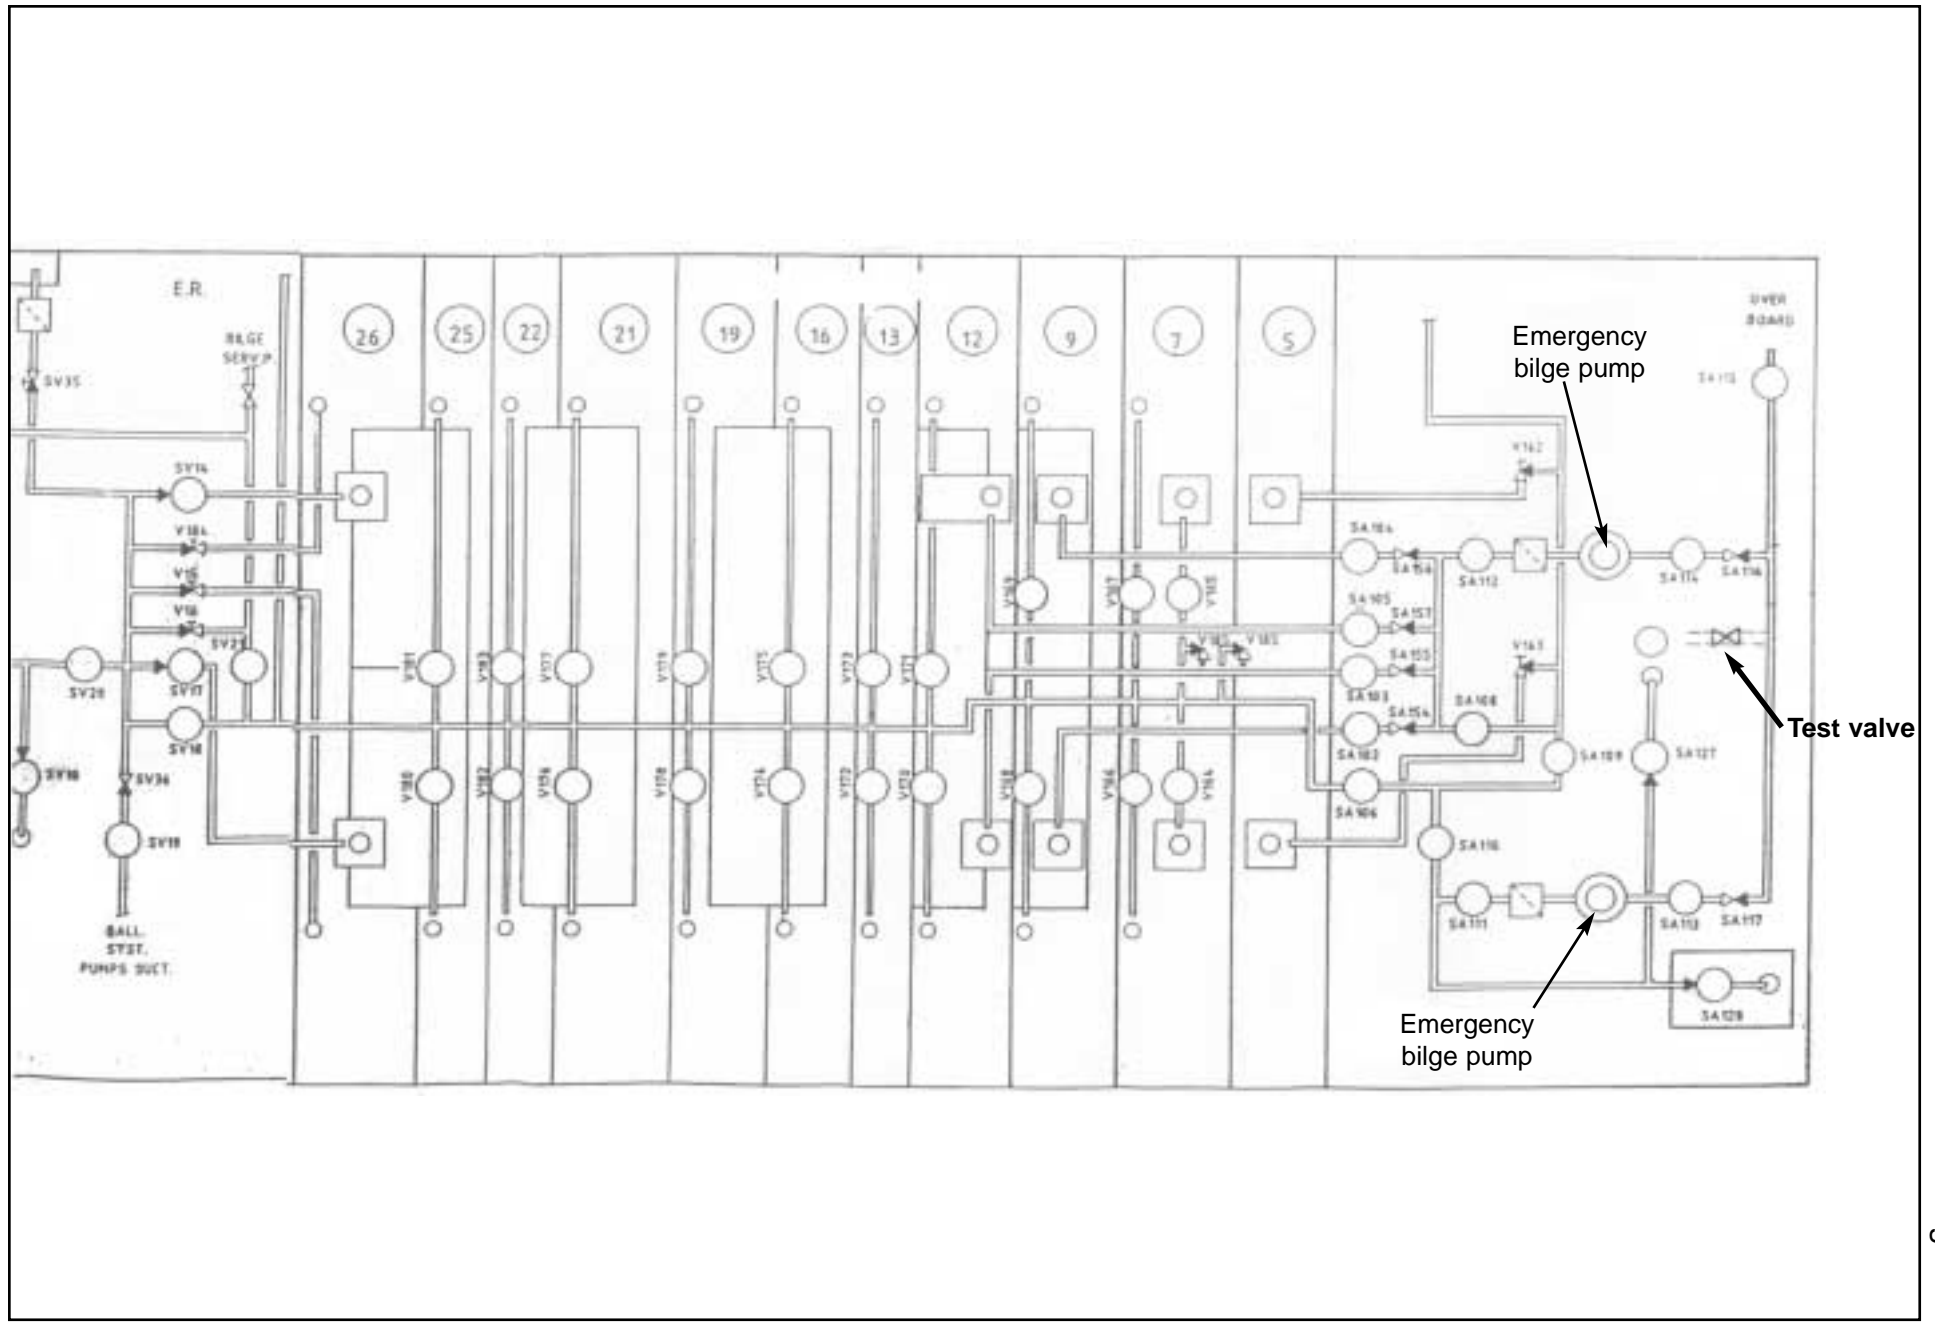
Figure 3

The overboard discharge valve from the emergency bilge pumps is a remotely-operated valve with no non-return capability. There was no separate non-return valve in series with this discharge valve.

The bilge system (part only)

The overboard discharge valve is remotely-operated, but has no non-return capacity. Without a second valve in series, with a non-return capability, there is no barrier to prevent water entering the vessel through this discharge valve when the bilge pump test valve is open. This arrangement does not comply with the requirements of the Load Line Regulations.

However, the vessel might have other overboard discharge valves which do not satisfy the requirements of the Load Line regulations. Hence, the owners are recommended to check the overboard discharges of the vessel are in compliance with the regulations, at the next opportunity.

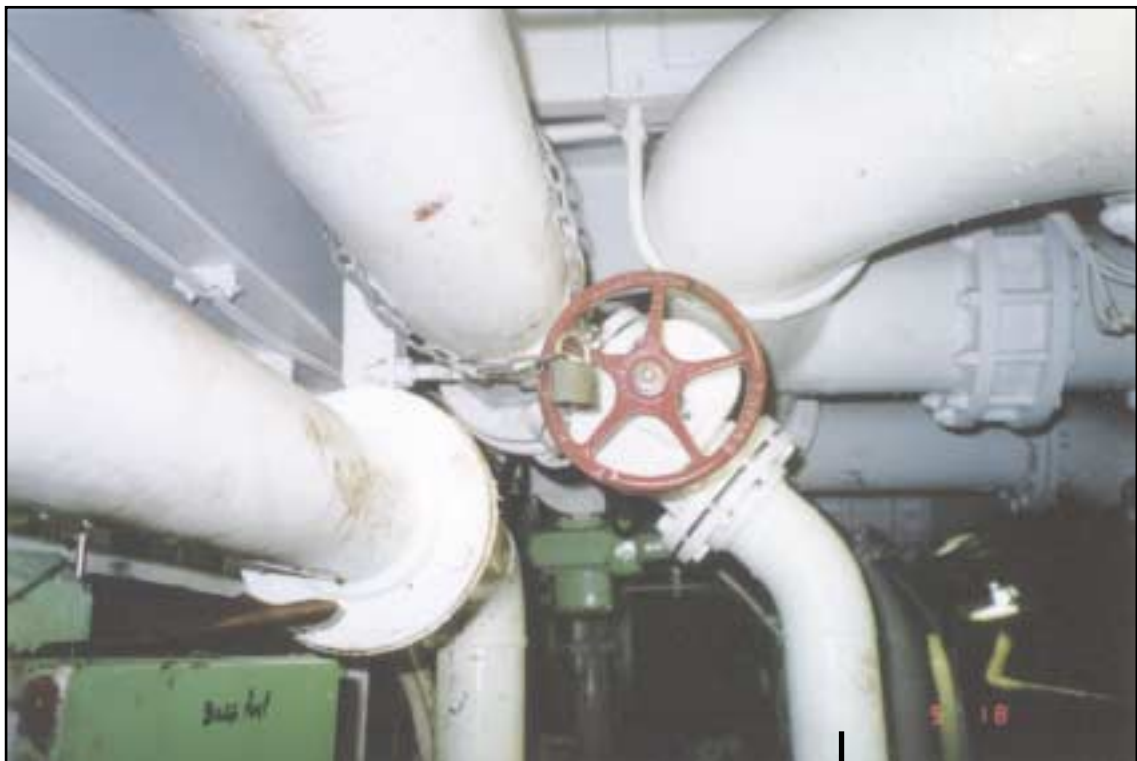
Discharge to
bilge

The locked test valve

Fitting of this padlock and chain called for no major modification to the test procedures. The test valve is still required to be closed after testing is complete, but the chain and padlock are then to be fitted and locked. In this case the chain and padlock secured the valve, but in the open position.

method is to connect this test line to a holding tank, or similar. This would avoid the possibility of pumping into the bilges. The owners are recommended to consider such a possibility.
