Report on the investigation of
the collision between the
UK registered fishing vessel
Marbella
and the
Bravo Delta offshore platform
in the Rough Gas Field
about 25 miles south-east of Flamborough Head
8 May 2002

Marine Accident Investigation Branch
First Floor
Carlton House
Carlton Place
Southampton
United Kingdom
SO15 2DZ

**Report No 11/2003
September 2003**

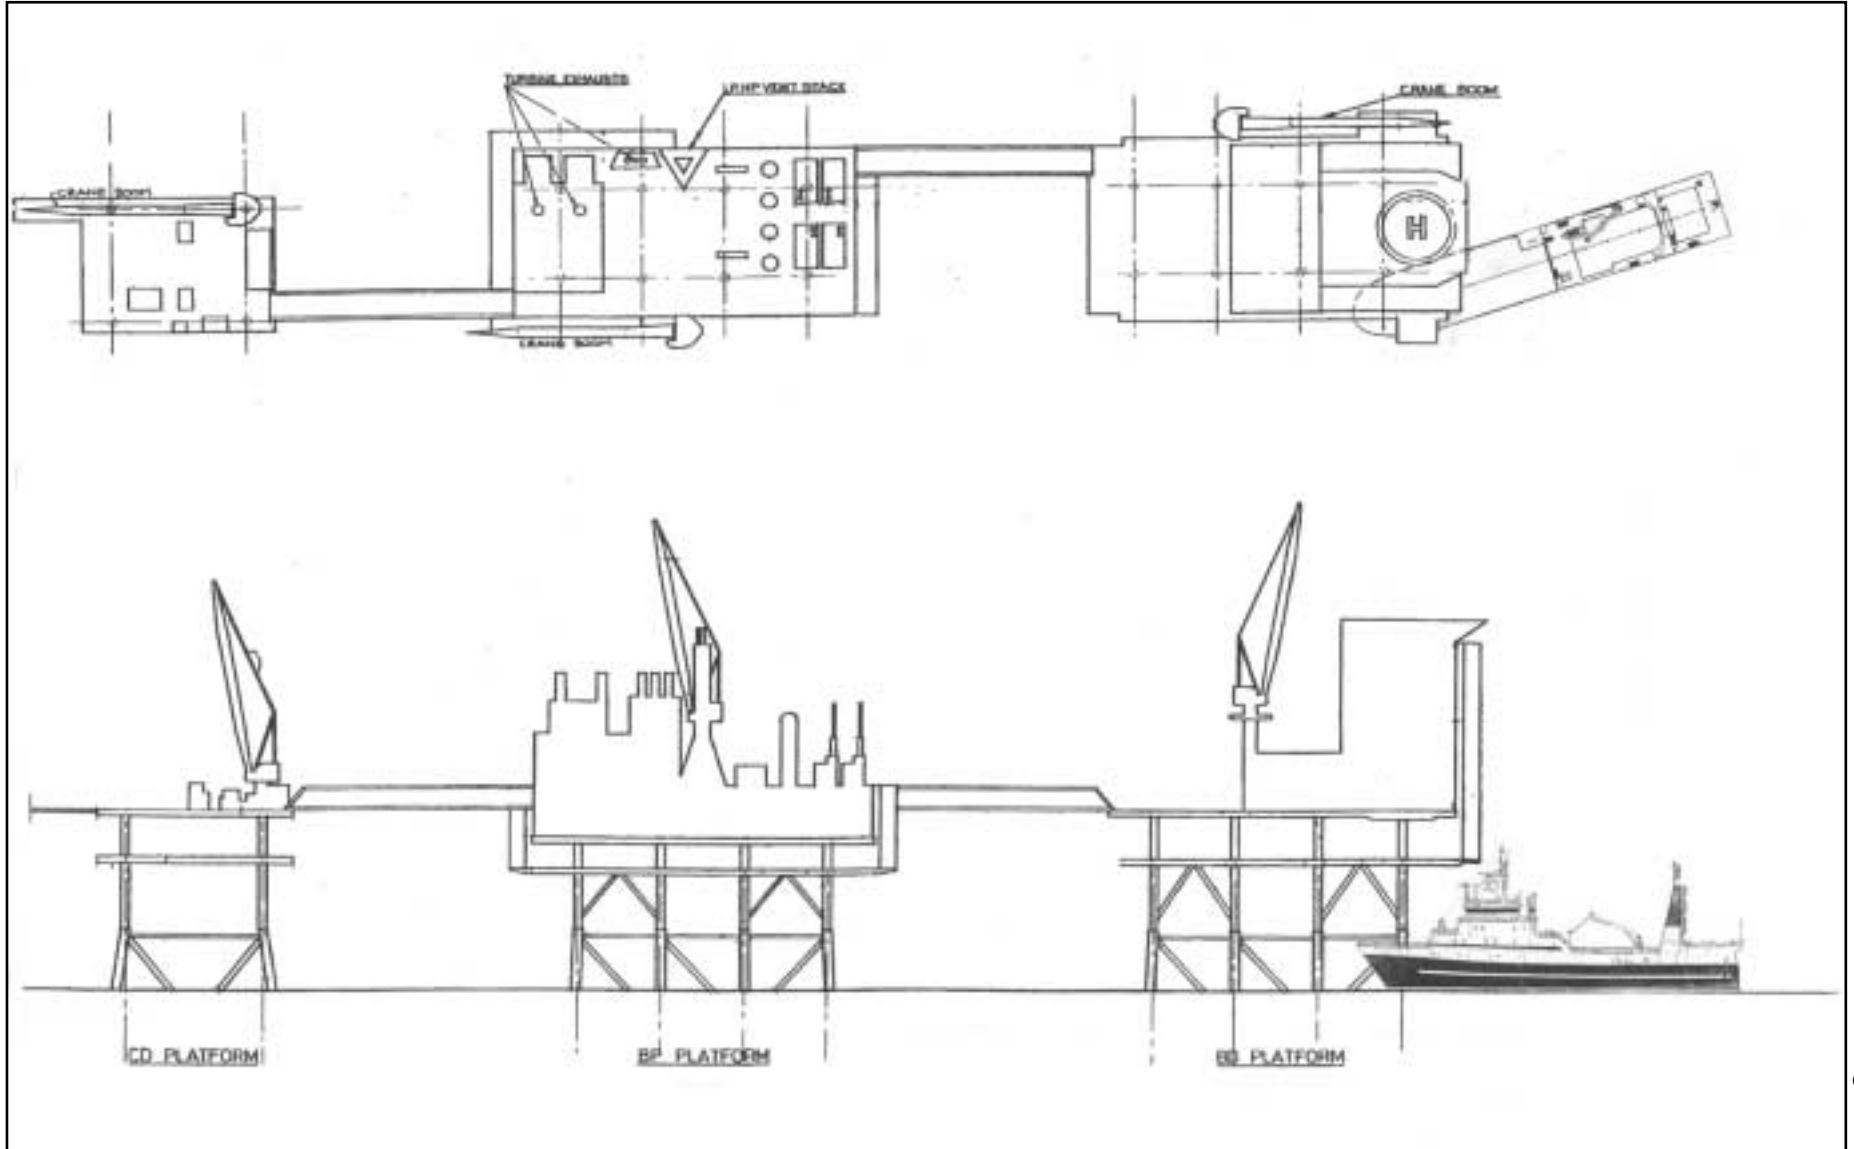
A reconstruction of the collision of *Marbella* with BD platform

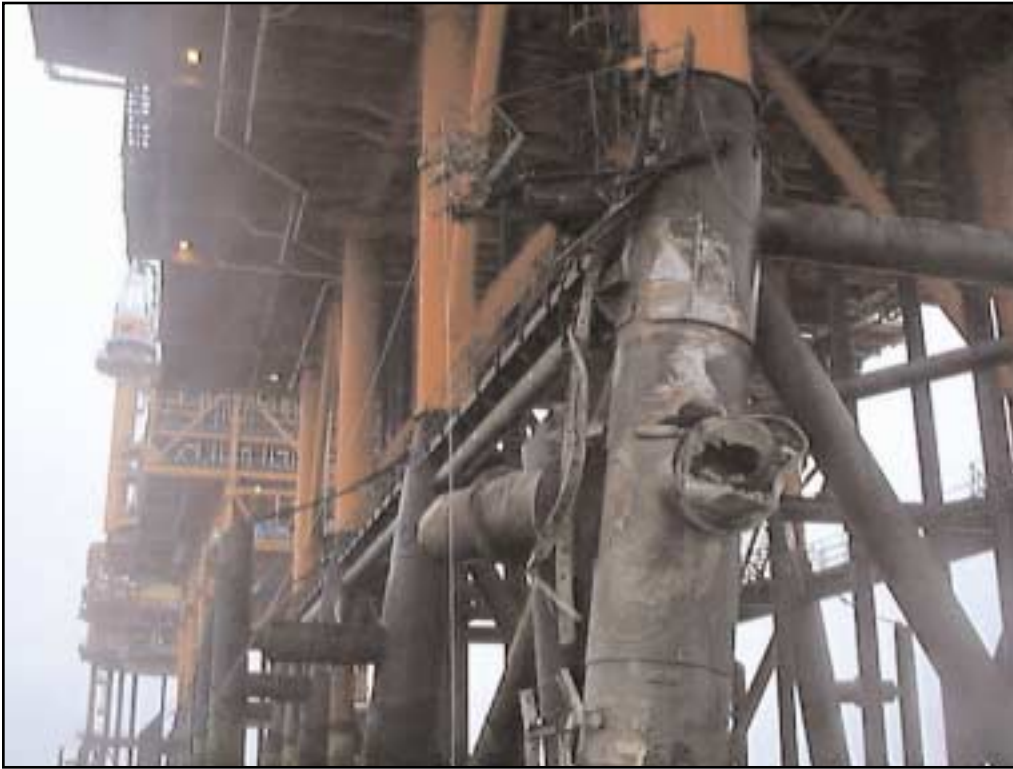
Marbella struck the south-west corner of the BD jacket in the vicinity of leg B4 and caused the following damage:

destruction of the two barge fenders and some other B4 leg appendages;

superficial damage to the B4 leg; and

damage to some secondary steelwork forming part of a navigational-aid platform located just above the point of collision.

The overall conclusion from the assessments was that the jacket was robust and that structural integrity of the installation had not been unduly affected. Apart from a minor dent to a brace member, no damage to the primary structure was evident and the damage was limited to the leg appendages.

General view of damage to BD jacket

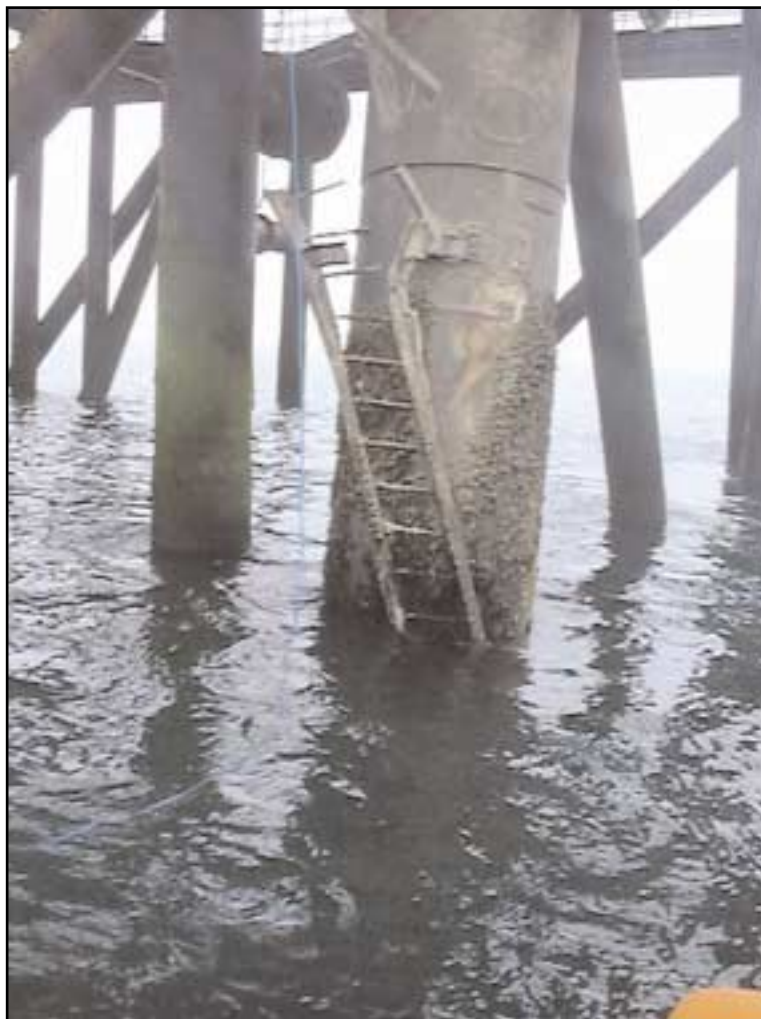
Close view of damage to BD jacket

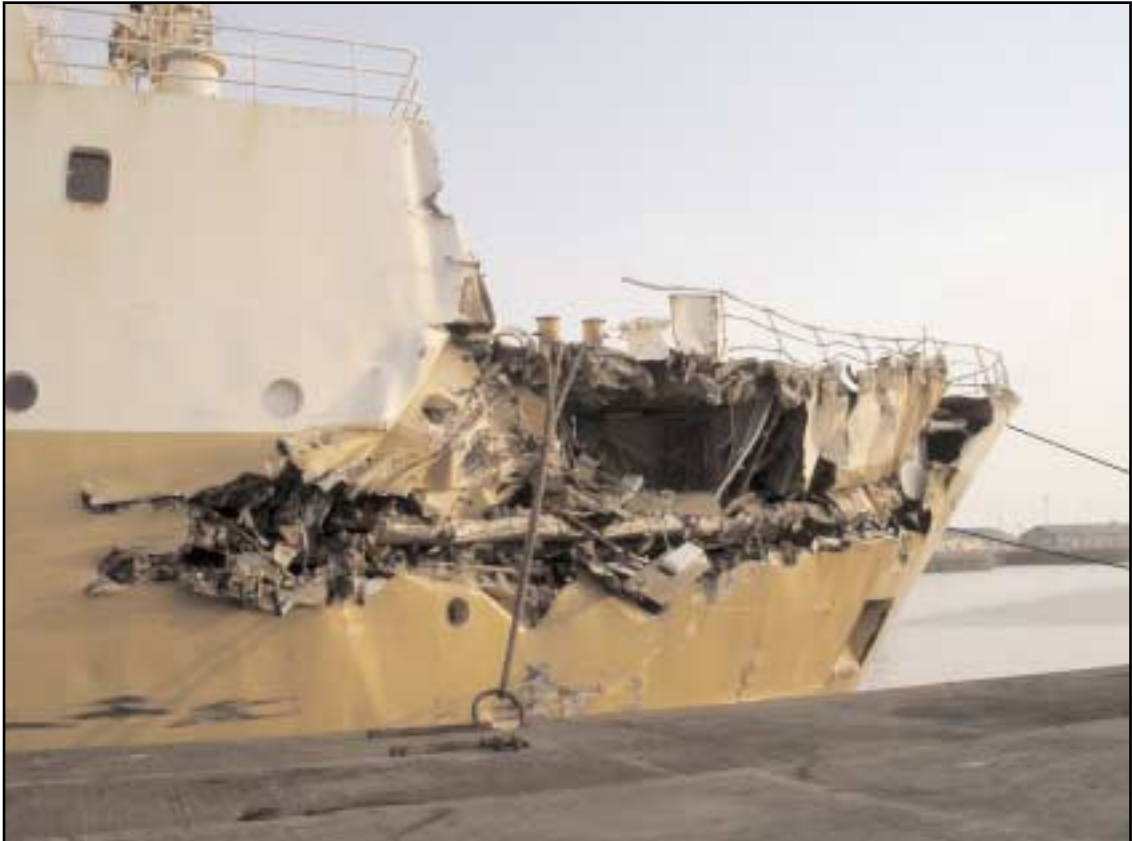
Photograph 4

Marbella suffered substantial damage to the starboard bow, especially in way of the hospital and the first two-man cabin, both of which were on the shelter deck. Damage was also sustained to the masts and aerials on the accommodation superstructure and the after gantry.

Damage to starboard bow of *Marbella*

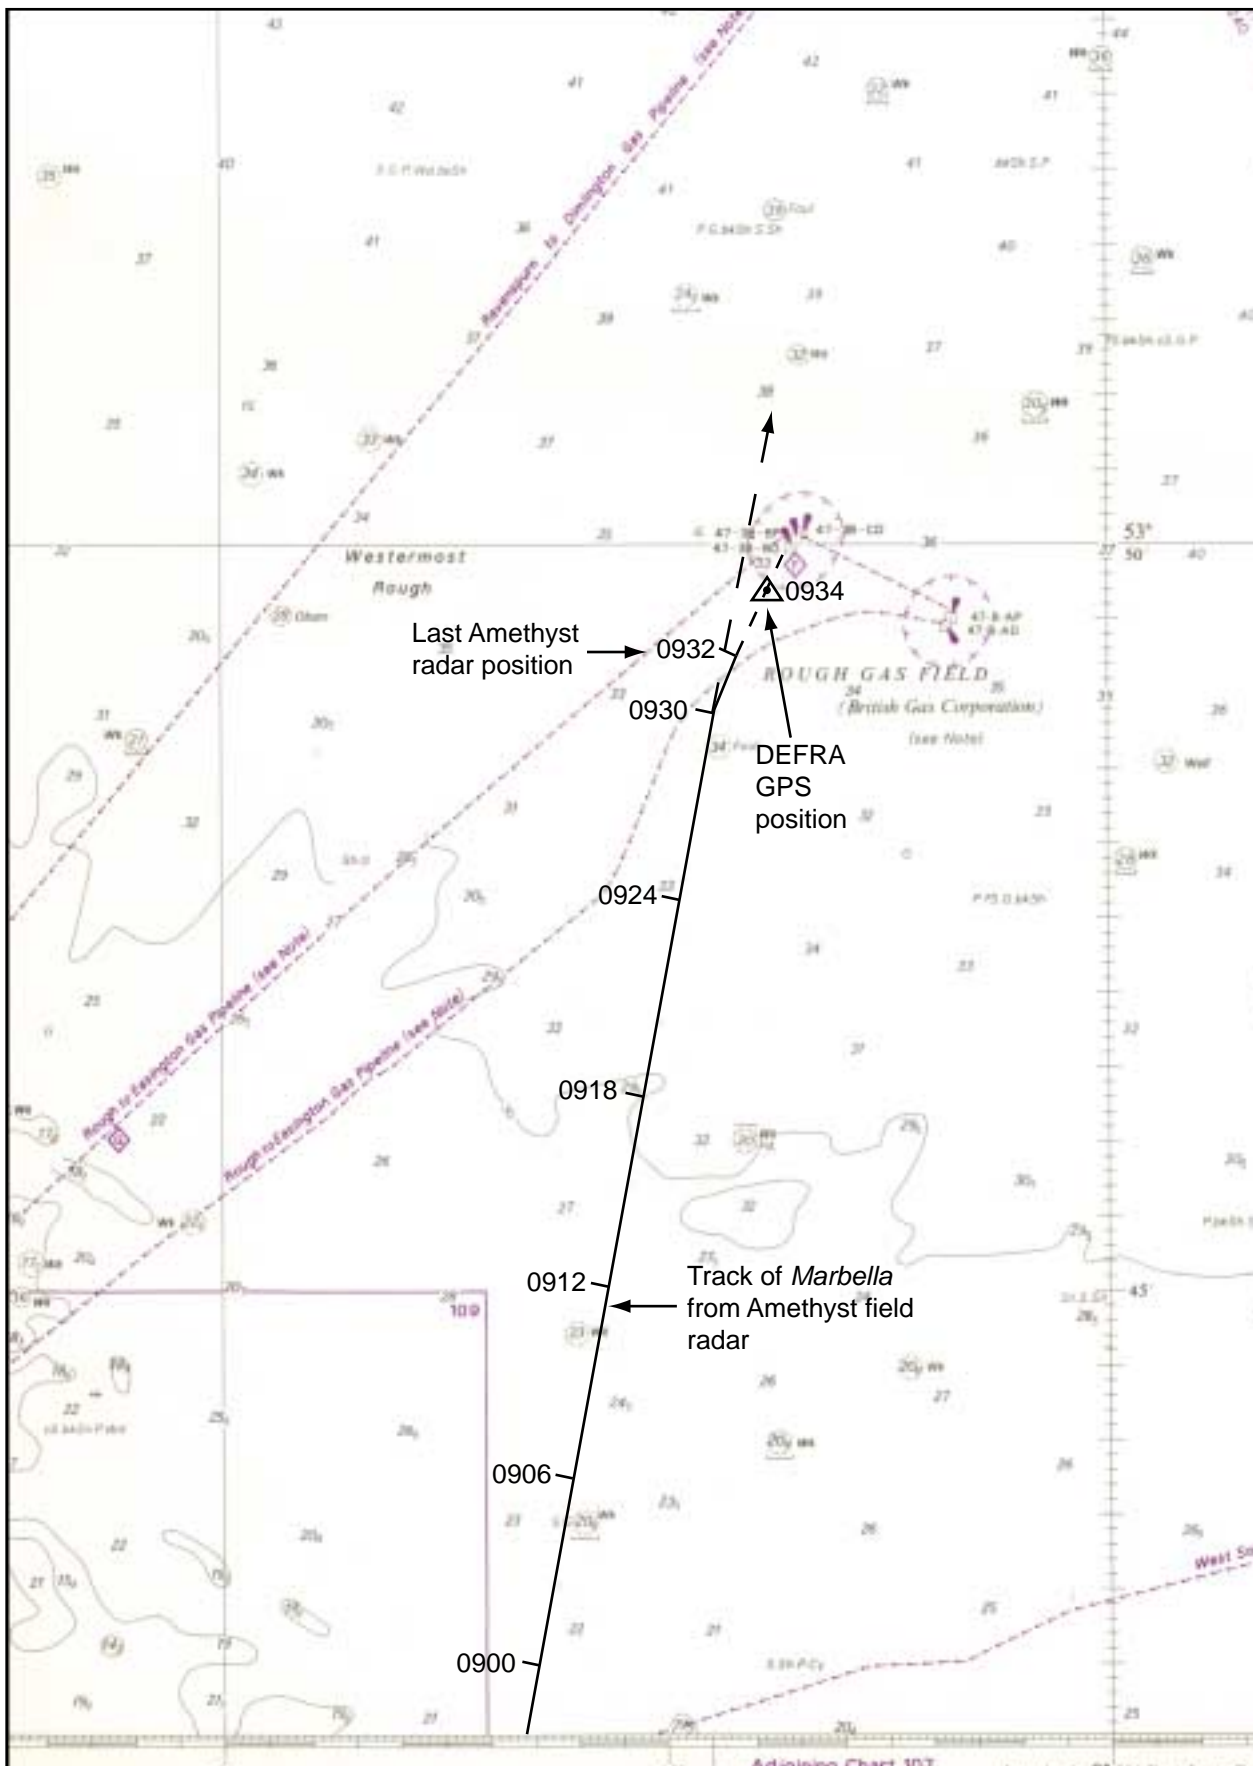
Diagram 3

Track of Marbella from Amethyst field radar

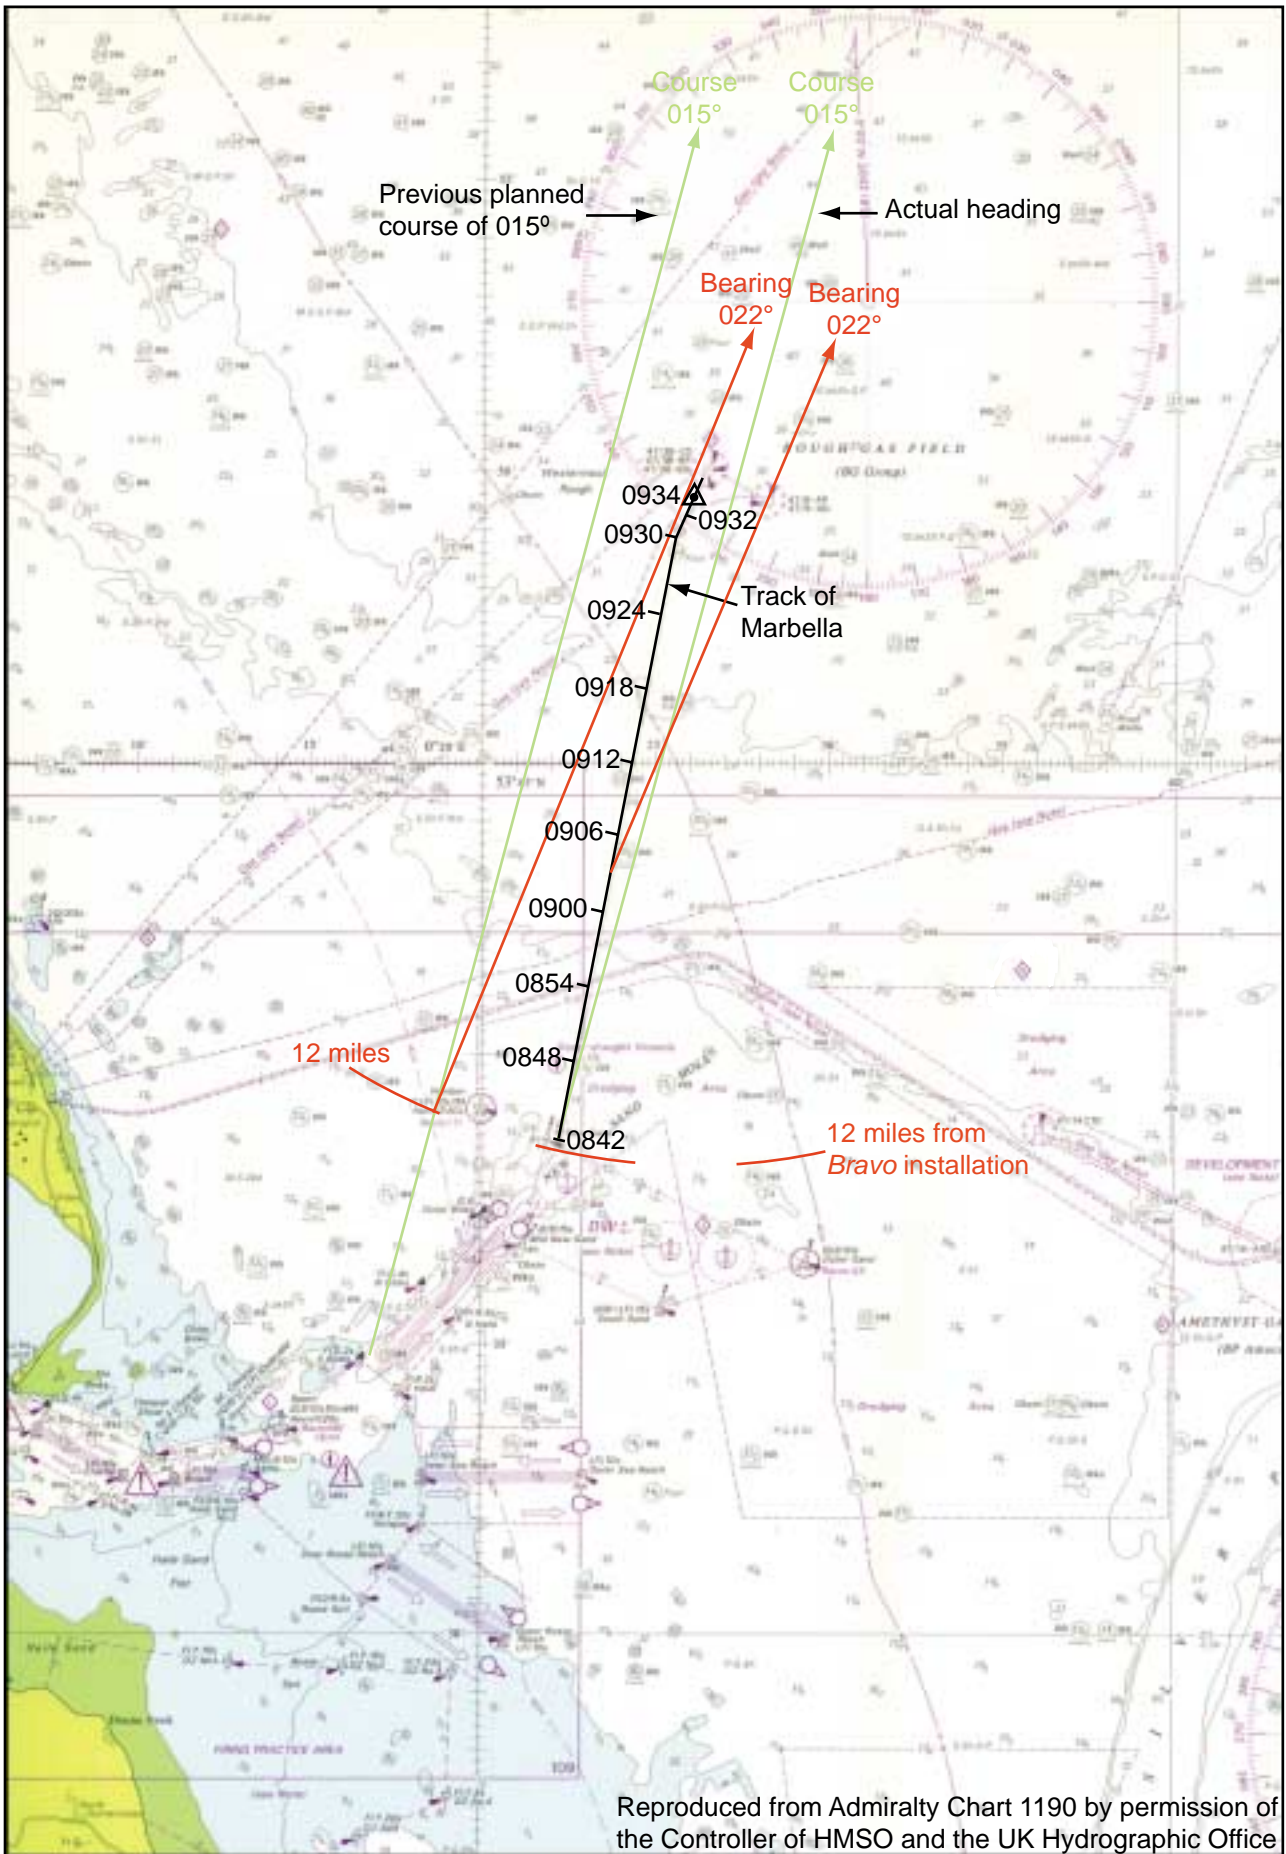
Tracks taken from VTS Humber and Amethyst radars

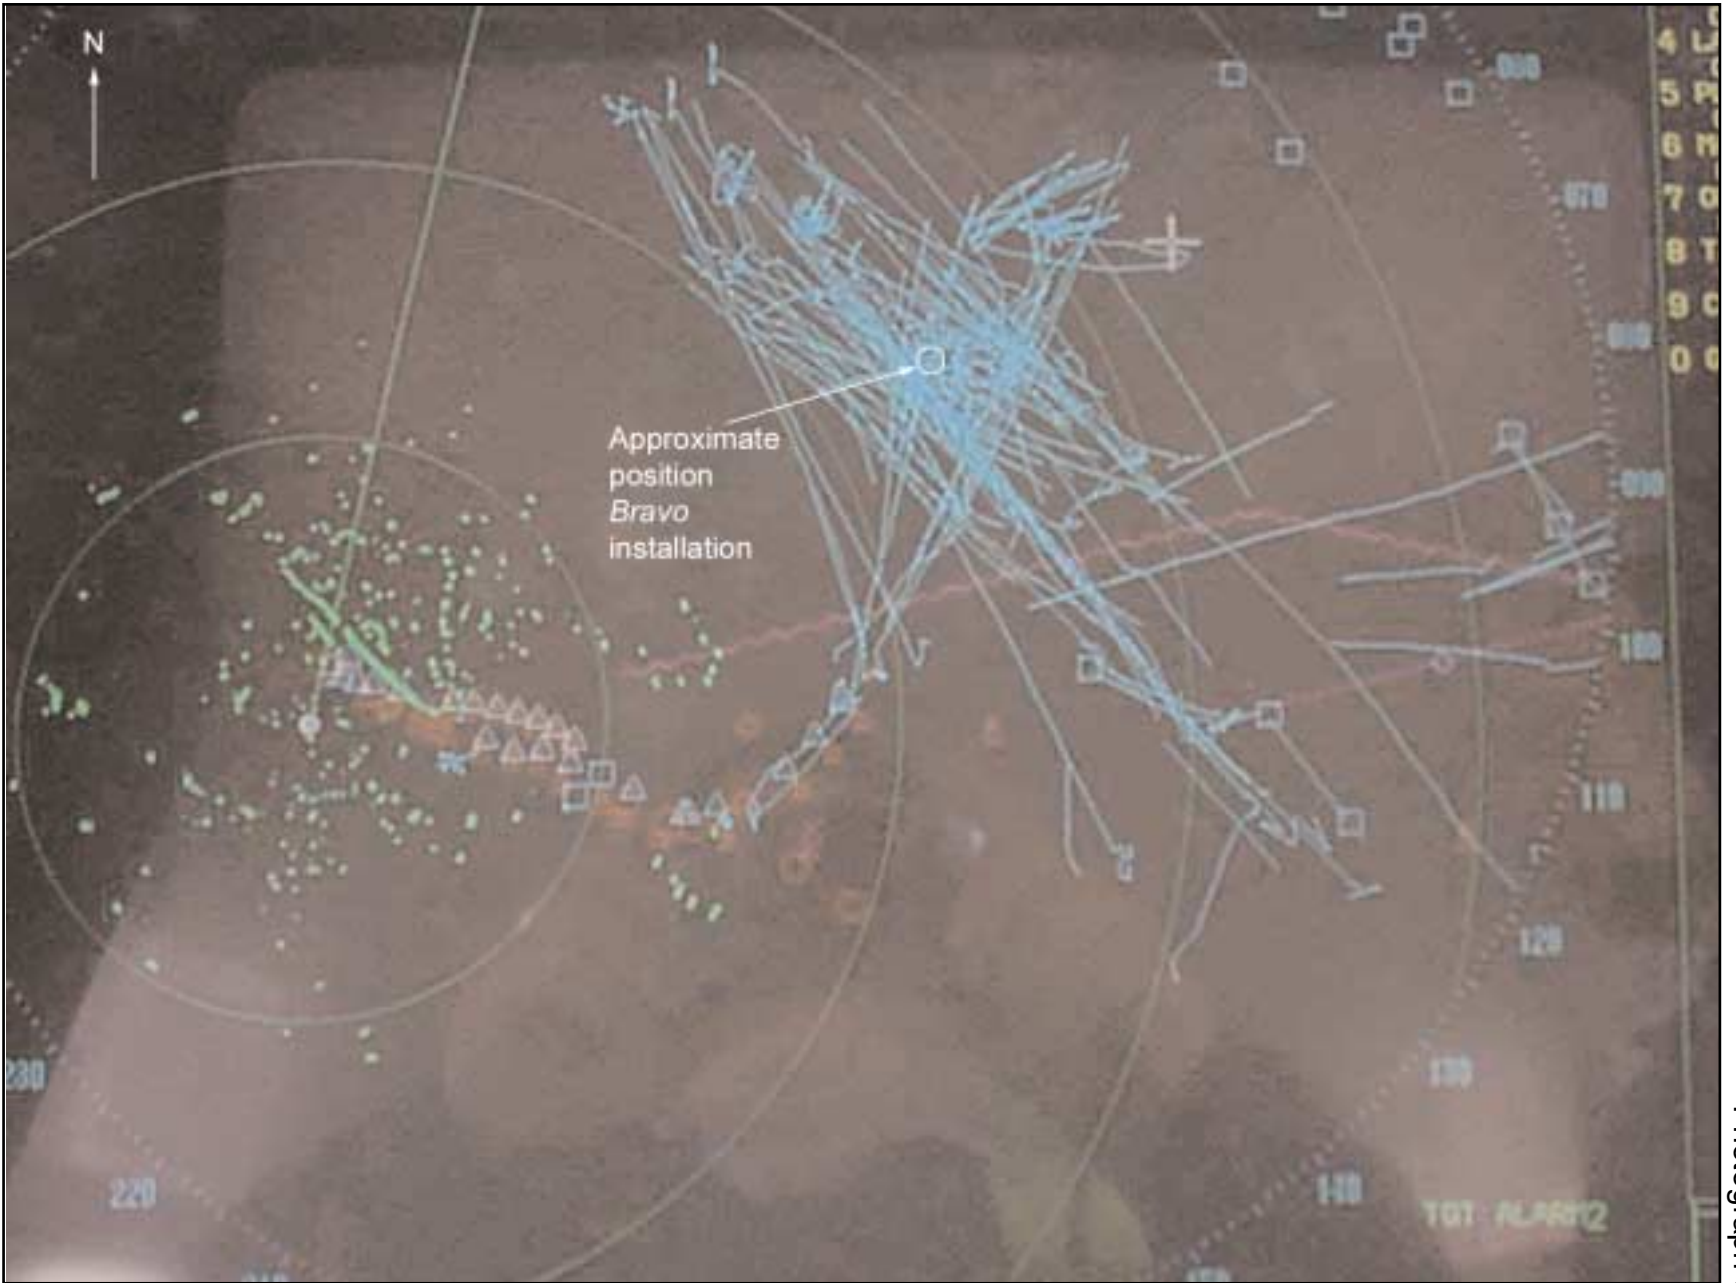
Photograph 5

At the time of the accident, the master had chosen not to use the radar guard zone because of the fishing vessel activity in the area. However, he had noted the movement of *Marbella's* echo from about 12 miles away. He thought this was yet another fishing vessel closing the Rough Gas Field and would stop at some time and begin fishing. However, he was sufficiently concerned that he manually plotted the echo when it was 3.15 miles and about 15 minutes away (the ARPA had been dropping targets from the screen) and made the third plot when the vessel was 1.15 miles and about 5 minutes before the collision, the results of which showed that the vessel would pass to the west of the installation (**see Section 2.2.1**). However, in accordance with *Putford's* operating procedures, the plots should have been completed when the vessel was 15 minutes away from the installation so that the master could give the required notice to the OIM in the case of a potential collision and personnel could be mustered (**see Section 1.6.5**). Between the plots, the master tried to call *Marbella* on VHF radio channels 16 and 72 but without response. Had the master made contact with *Marbella*, it would have alerted the second mate that he was going to pass too close to the installation, and he would probably have altered course to give a much larger passing distance. The master's plot showed that the other vessel would pass through the 500m zone and close to the

Recorded vessel tracks from *Putford Achilles* ARPA
