Report on the investigation of
the grounding of
mv *Lysfoss*
Sound of Mull, Scotland
7 May 2001

Marine Accident Investigation Branch
First Floor
Carlton House
Carlton Place
Southampton
United Kingdom
SO15 2DZ

**Report No 23/2002
July 2002**

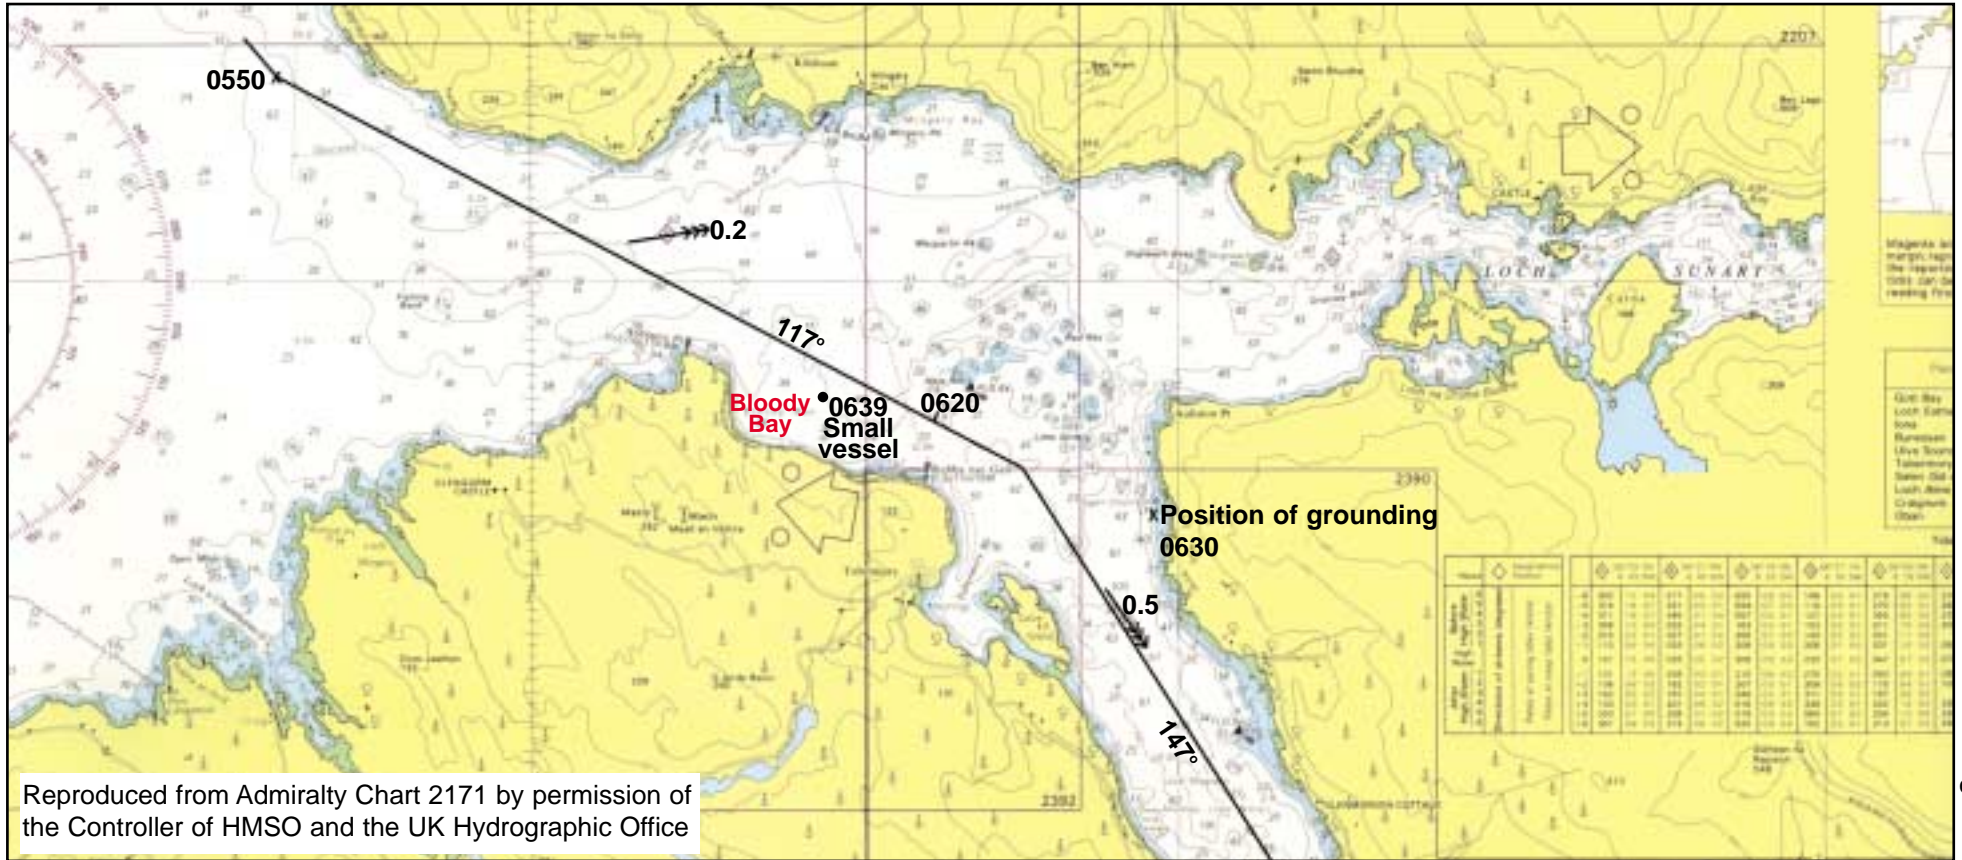
Figure 1

Chart extract showing position of grounding

The last recorded GPS position plotted on the chart was at 0550. A mark was also annotated across the planned track to indicate the ship's position at 0620 as she passed the New Rocks buoy (**Figure 1**).

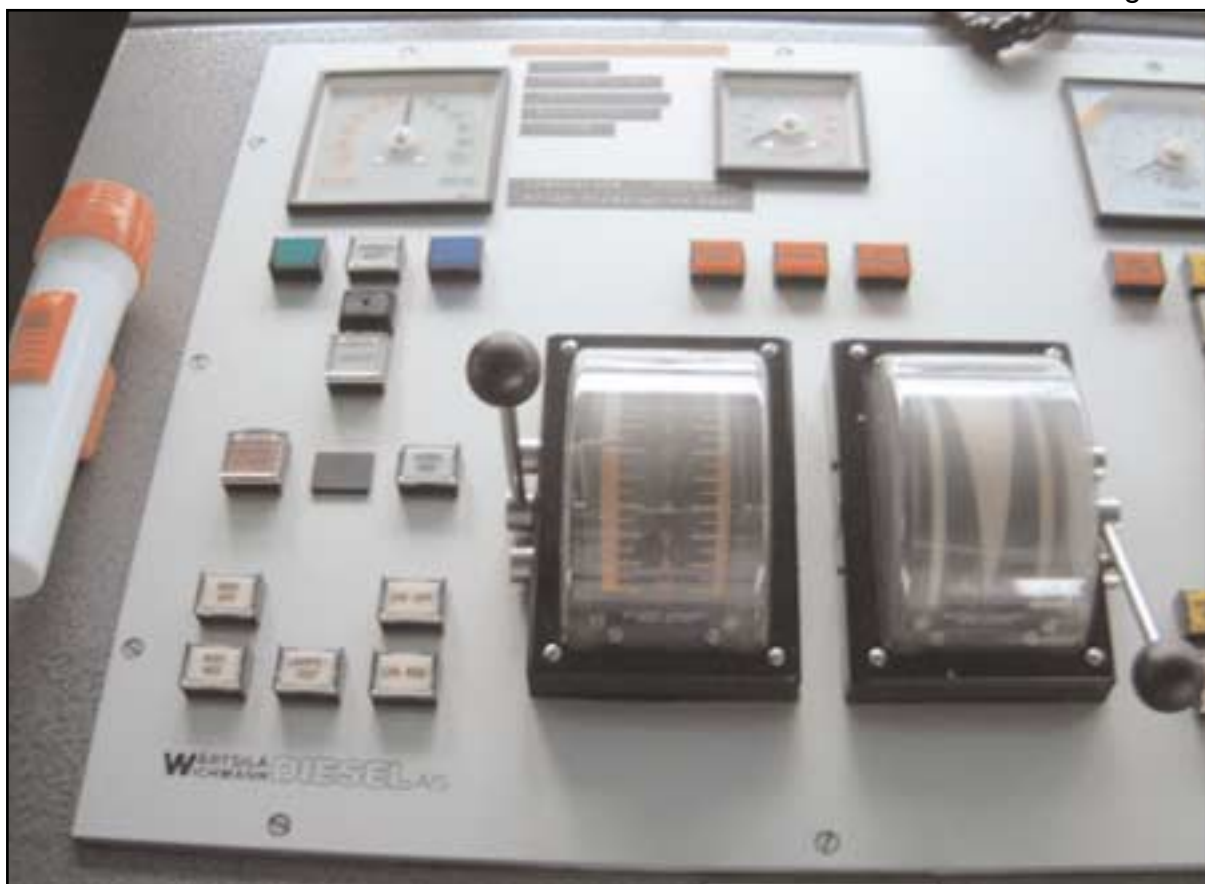
Figure 2

When the chief engineer arrived in the engine room, the main engine and CPP pumps had already stopped, and the diesel generators had automatically cut in to restore power. The propeller pitch was observed to be about 60% ahead.

Pitch control lever

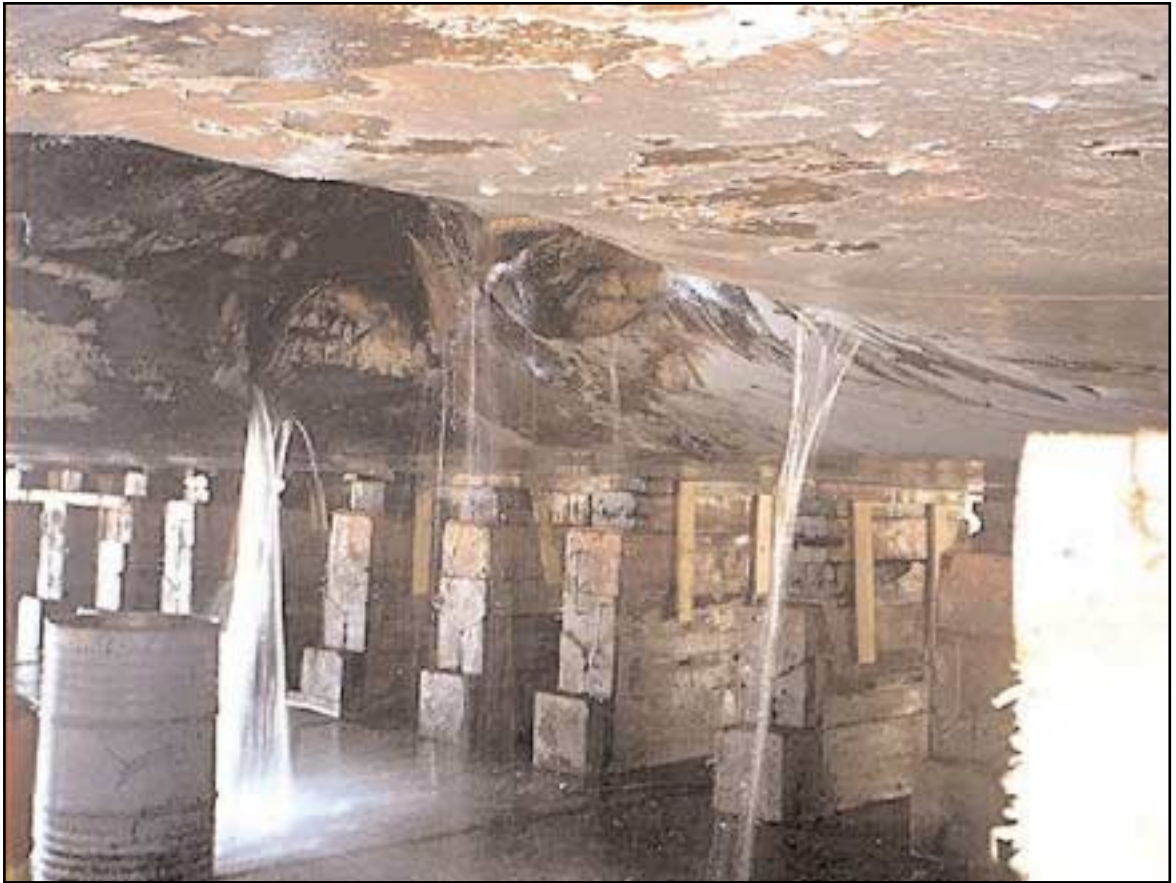
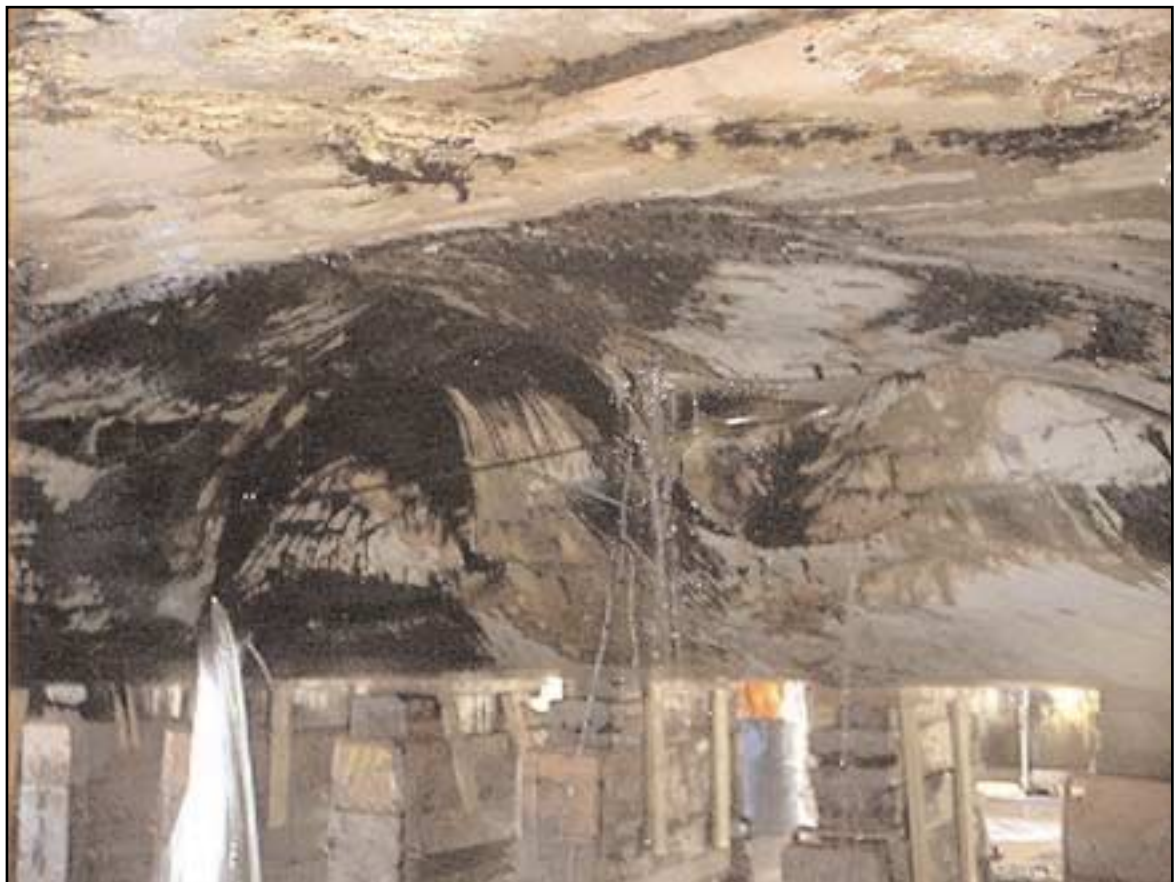
Figure 3 - Bottom damage to *Lysfoss*

After discharging her cargo, *Lysfoss* was permitted to proceed in ballast and under escort to Drammen in Norway, for permanent repair. The permission to sail was given on the provisos that a passage plan for the voyage was made, and that the voyage was undertaken in favourable weather conditions. Initially, MCA surveyors considered the proposed passage plan to be too sparse, and that two of the course intersection waypoints were unnecessarily close to land. As a result, the plan was amended. Concern was also expressed that, up to 12 hours before sailing, the master had made no attempt to obtain medium range weather forecasts to cover a voyage estimated to take 3.5 to 4 days. *Lysfoss* arrived in Drammen on 23 May 2001.

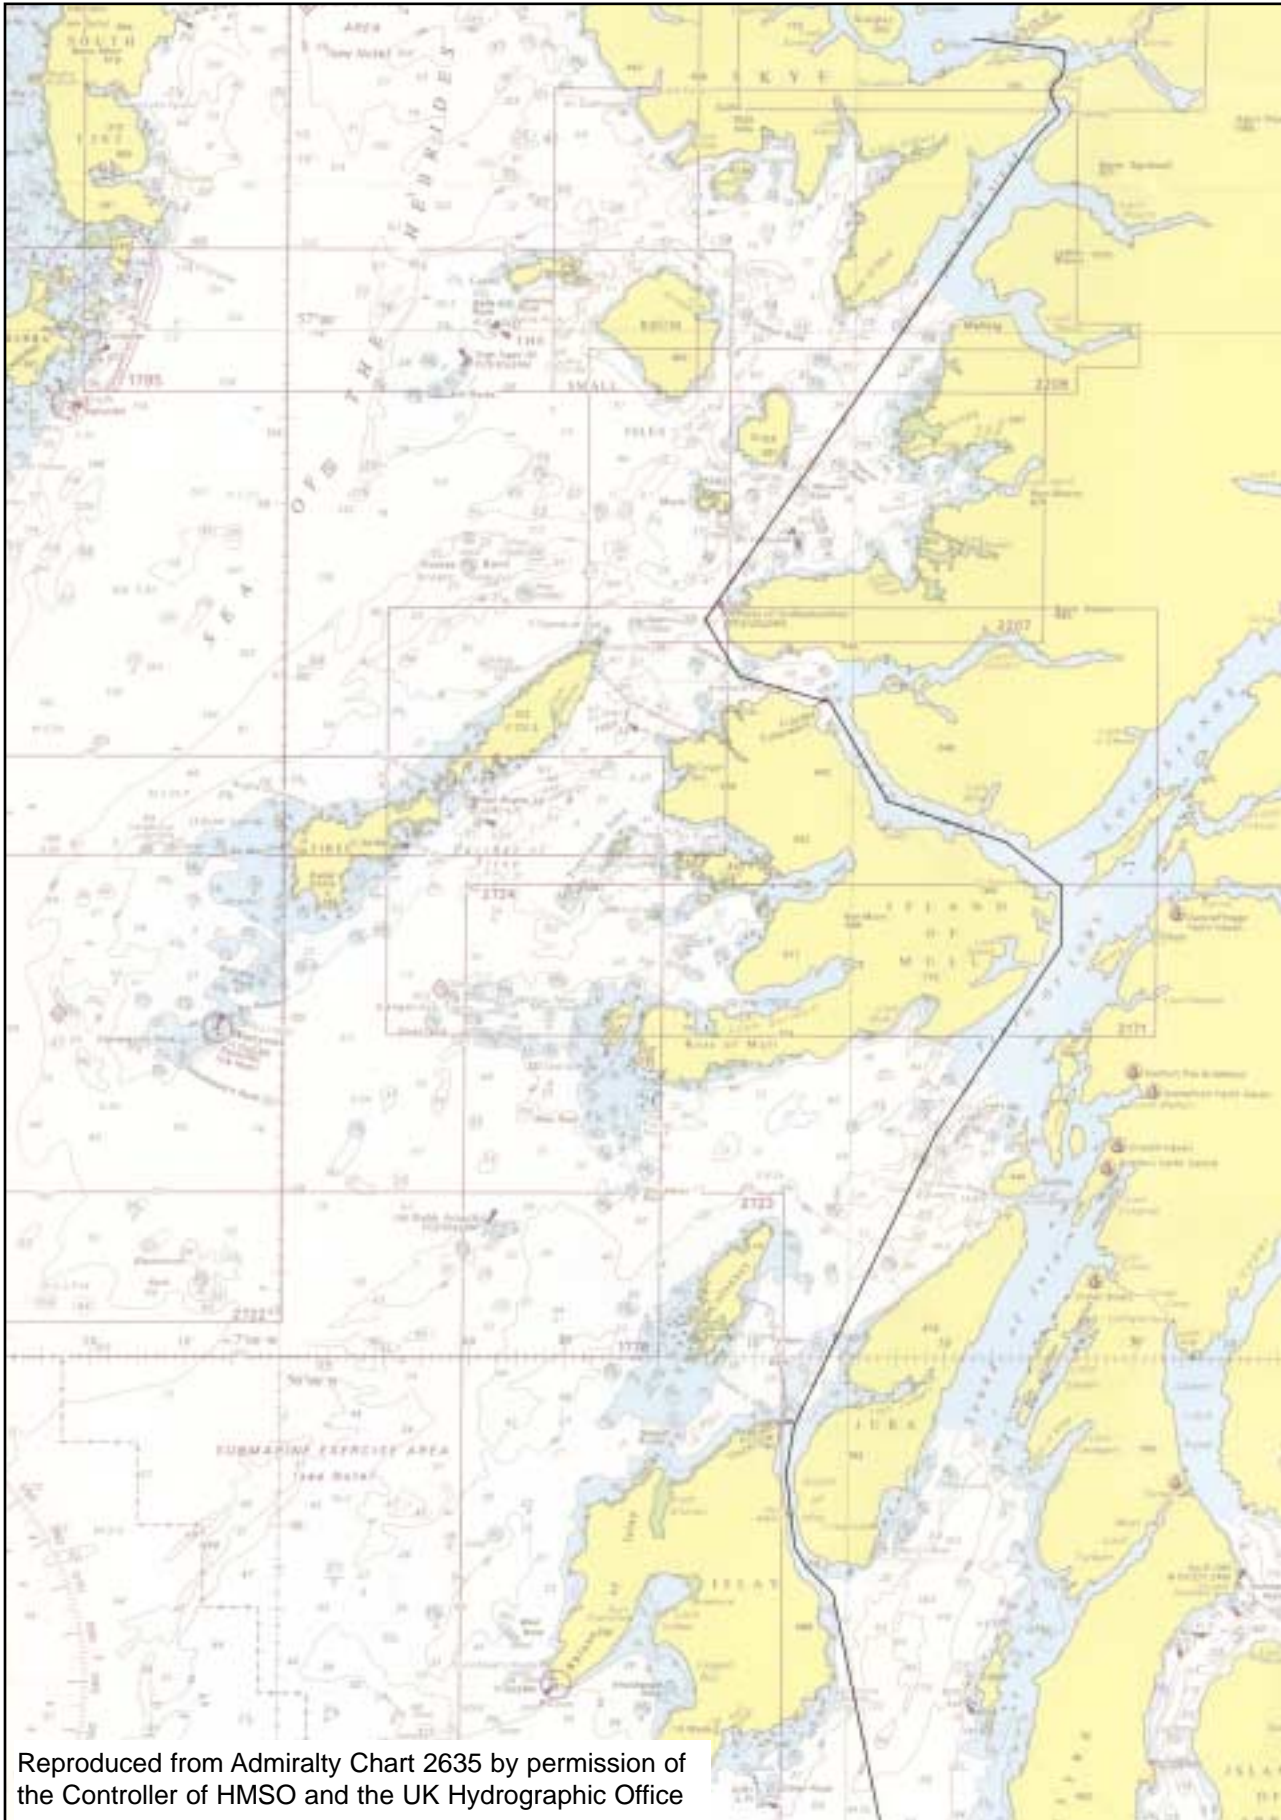
Figure 4

This route is recommended only for small vessels, due to the limiting conditions in Kyle Akin...

Controlling depth. *Kyle Akin has a least depth of 8.8m...in the fairway of the channel passing S of Eileanan Dubha. The least depth in the channel passing N of Eileanan Dubha is 9m.*

Controlling height and width. *Skye Bridge, with a minimum vertical clearance of 30m over a navigable width of 80m, spans the W entrance to Kyle Akin.*

The Inshore Traffic Route
