Report on the investigation of
a fatal accident to a man overboard
from the fishing vessel
Osprey (INS130)
in Lochinver Harbour
20 April 2002

Marine Accident Investigation Branch
First Floor
Carlton House
Carlton Place
Southampton
United Kingdom
SO15 2DZ

**Report No 3/2003
January 2003**

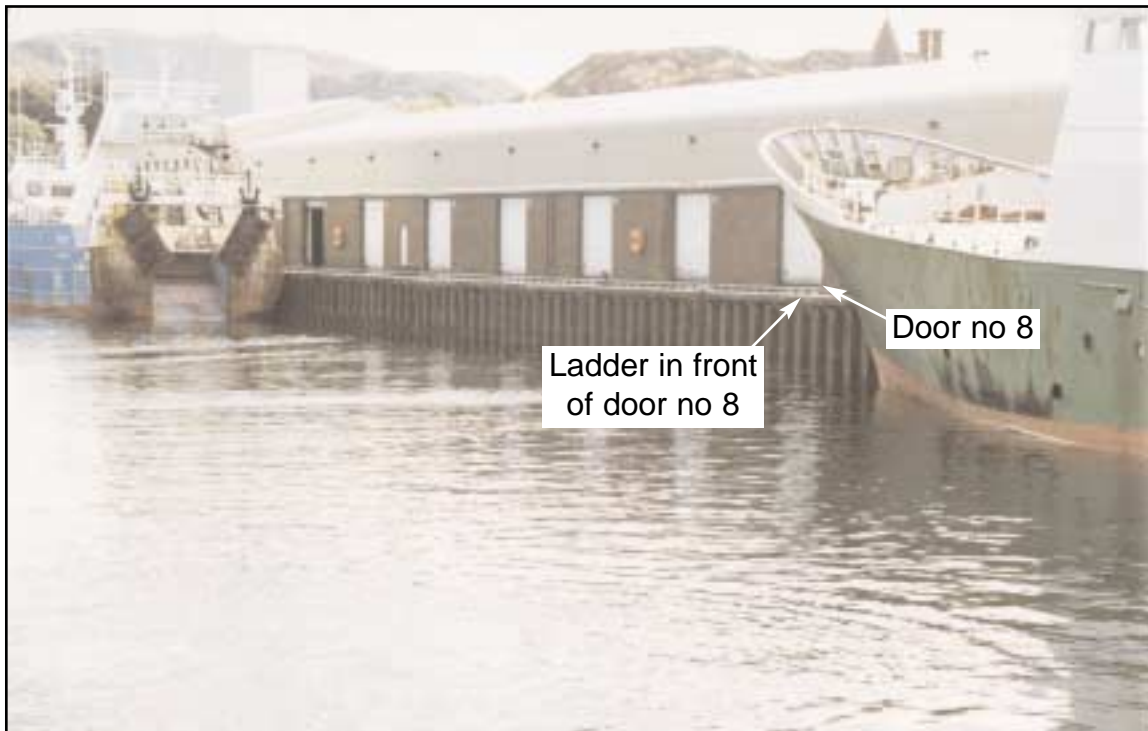
Lochinvar Market Quay (ladder highlighted)

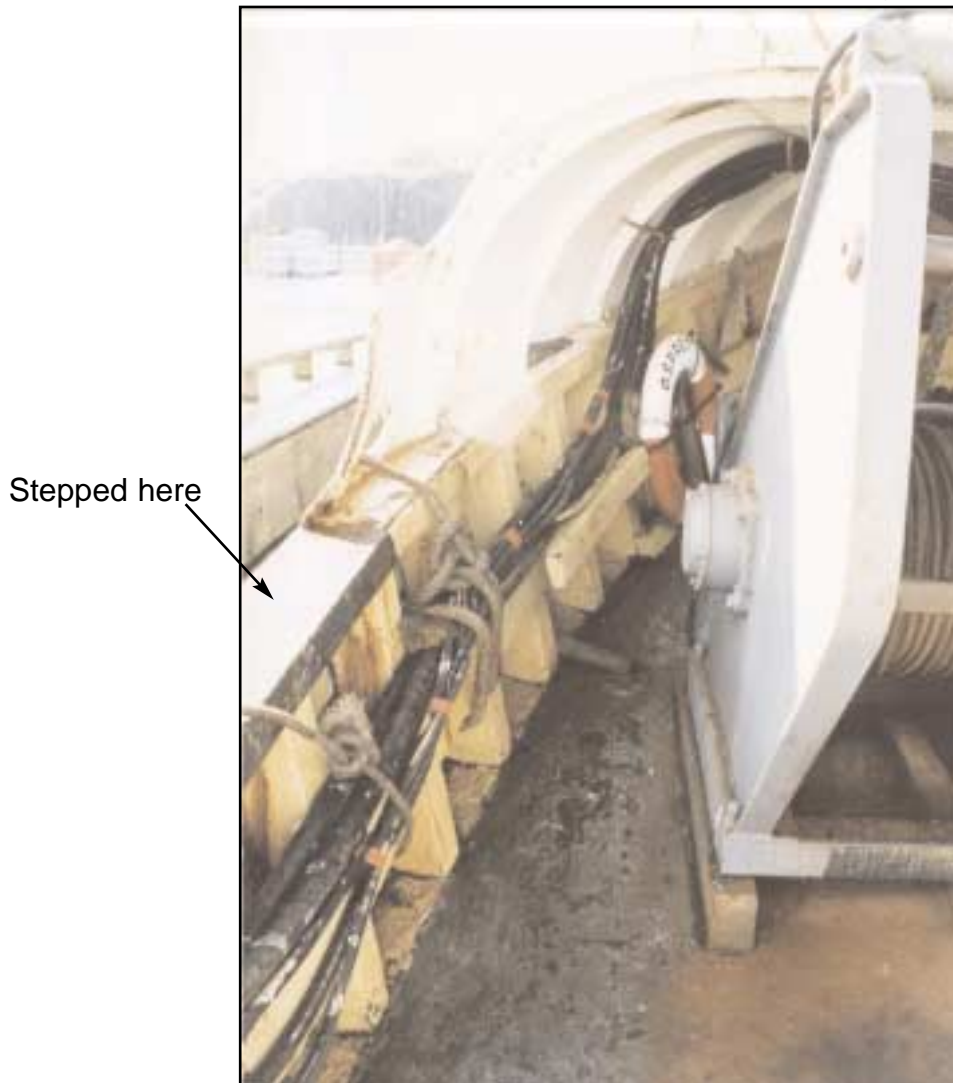
Figure 5

Osprey, foredeck area from where Mike Simpson stepped on to quay ladder

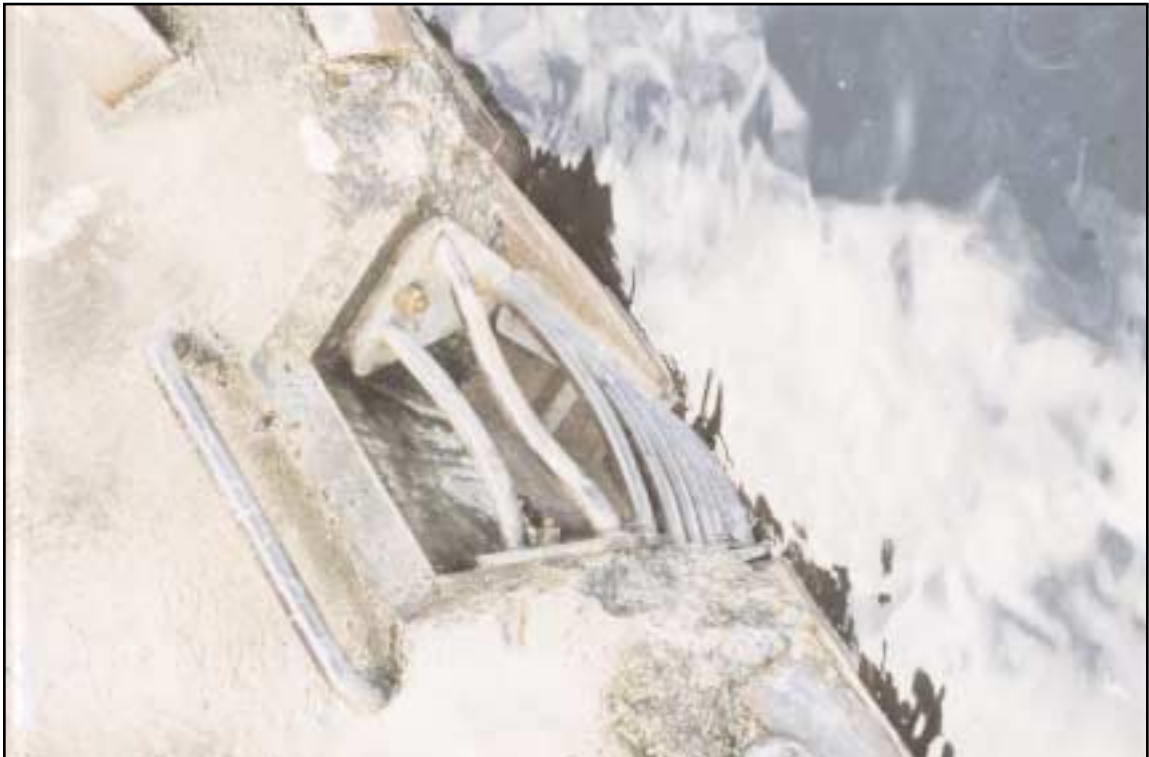
Figure 7

Market quay ladder concerned

An HSE inspector visited Lochinver on 24 April to check for any hardware or operational problems concerning the harbour. None were found that were worthy of comment. The recessed quay ladder (**Figure 7**) was inspected, and appeared to be in good condition with no missing rungs. The HSE then formally handed over the investigation to the MAIB on 25 April, in accordance with the HSE/MCA/MAIB Memorandum Of Understanding.

Negotiating the ladder on the market quay obviously contributed greatly to the difficulty in coming alongside the quay. This process is frequently carried out by fishing vessels all over the British Isles. Mike Simpson had stepped from vessels, to quay ladders, on many occasions during his career as a fisherman. Many times in the past the skipper had used ladders and quays which were in a far worse condition. However, could anything have been done to improve this ladder, and make it safer to use?

In this case, an adequate handhold is provided on the quay some 0.3m from the quay edge (**Figure 7**). However, it would be far more difficult to use than two handrails which extend 1m above the quay. Negotiating the top of this ladder was difficult. From an ergonomic point of view, the ladder is poorly designed; it is used mainly when there is a need to keep a quay clear of vertical obstructions (to allow the operation of cranes and forklifts for example). Unfortunately, this design of ladder is very common throughout the British Isles, and it is not known whether it contributes significantly to the number of dockside accidents nationally. A recommendation is made to the HSE to investigate whether these types of ladder present a significant risk to harbour/dock safety. This work can then feed into the review being conducted by the HSE of the Approved Code of Practice to the Docks Regulations, *Safety in Docks*. Guidance on dock/quayside ladders, and, in particular, their ergonomic design, can be provided to ensure the risk of using these ladders is reduced to as low as is reasonably practical.
