Report on the investigation of
the capsizing and foundering of

Radiant PD298

10 April 2002

**Report No 2/2003
January 2003**

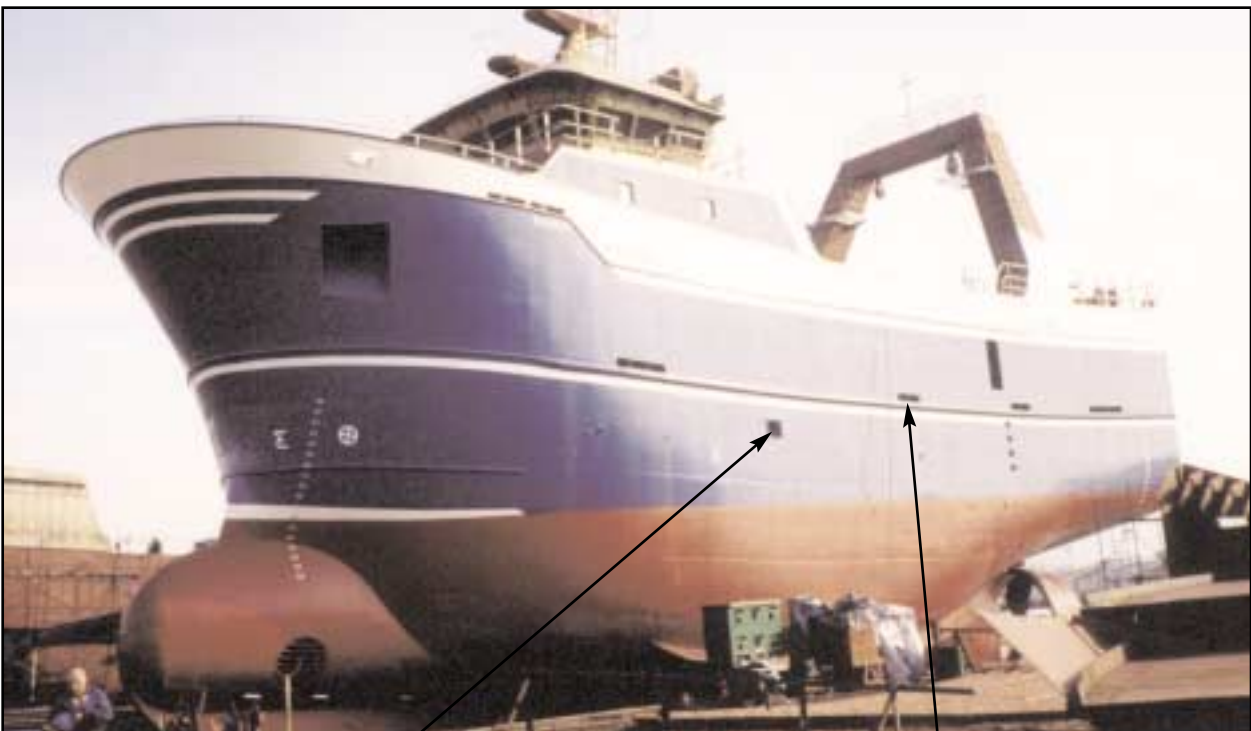
Gutting chute

Scupper adjacent to
port engine air intakes

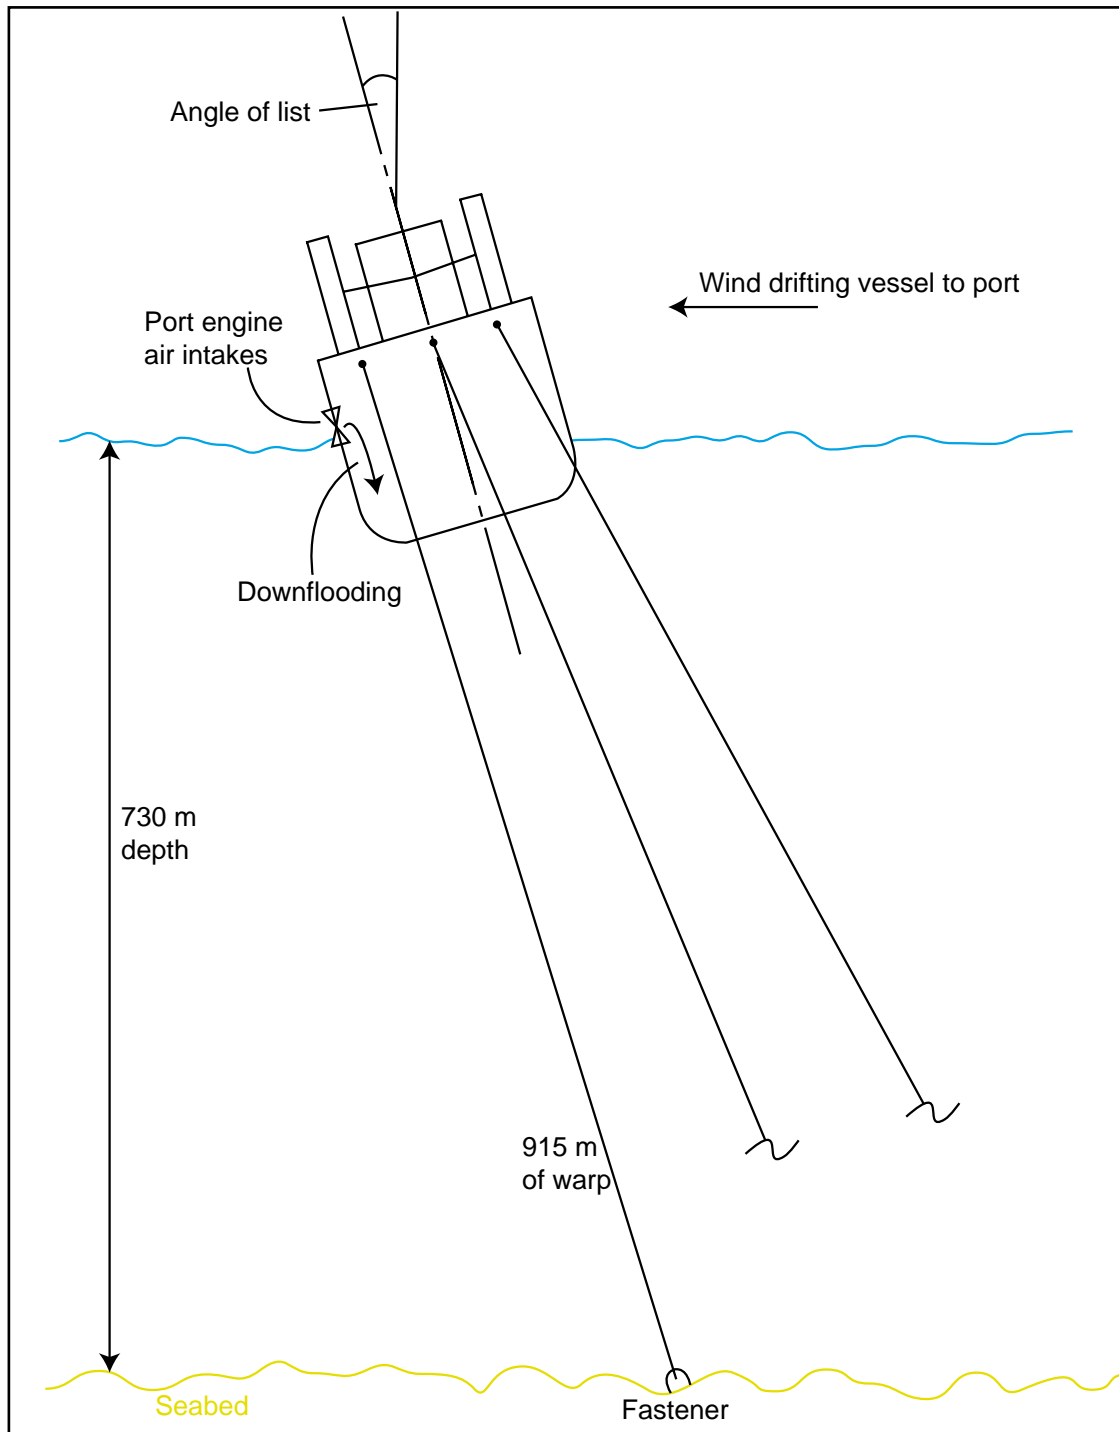
Figure 4

The hauling was performed mainly using auto-heave, but occasionally William Lawson used manual heave to get the wires even ie an equal amount of wire deployed from each winch. The skipper was at the winch control panel facing aft at this time. Hauling back proceeded until there was about 915m (500 fathoms) of warp out. The wind was drifting the vessel to port. Although not directly over the fastener, there was a substantial load on the port warp, which caused a heavy list to that side. The drift prevented the warp coming to the plumb line (**Figure 4**).

The effect of wind

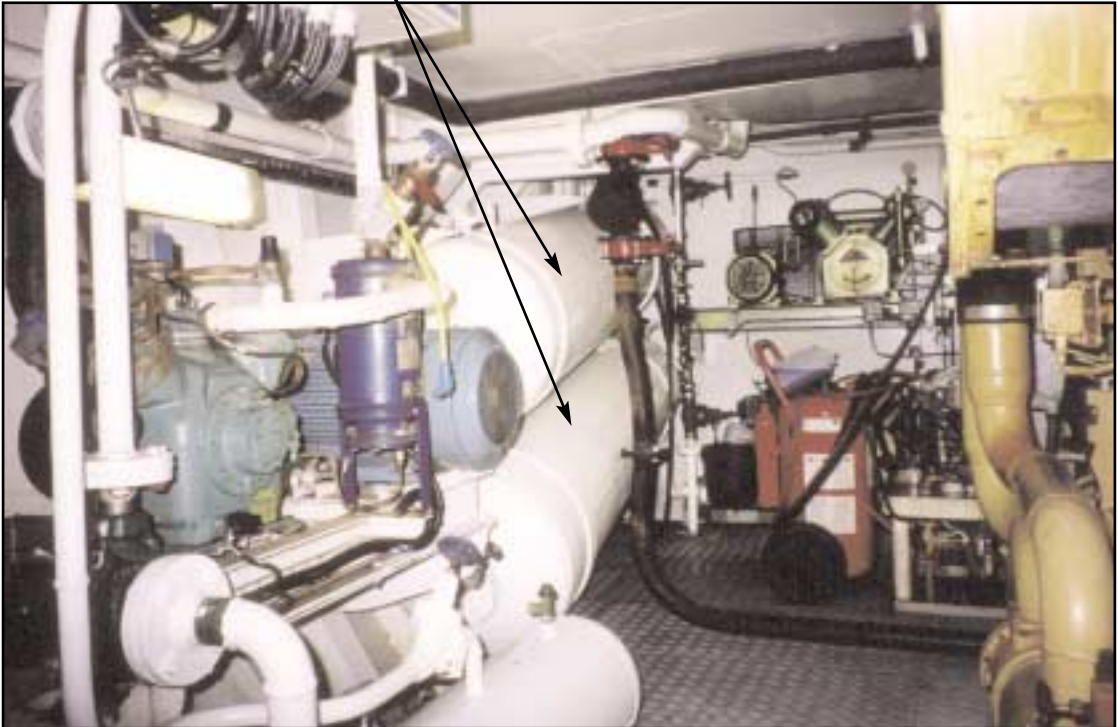
Figure 5

Air bottles

Forward / port corner of engine room

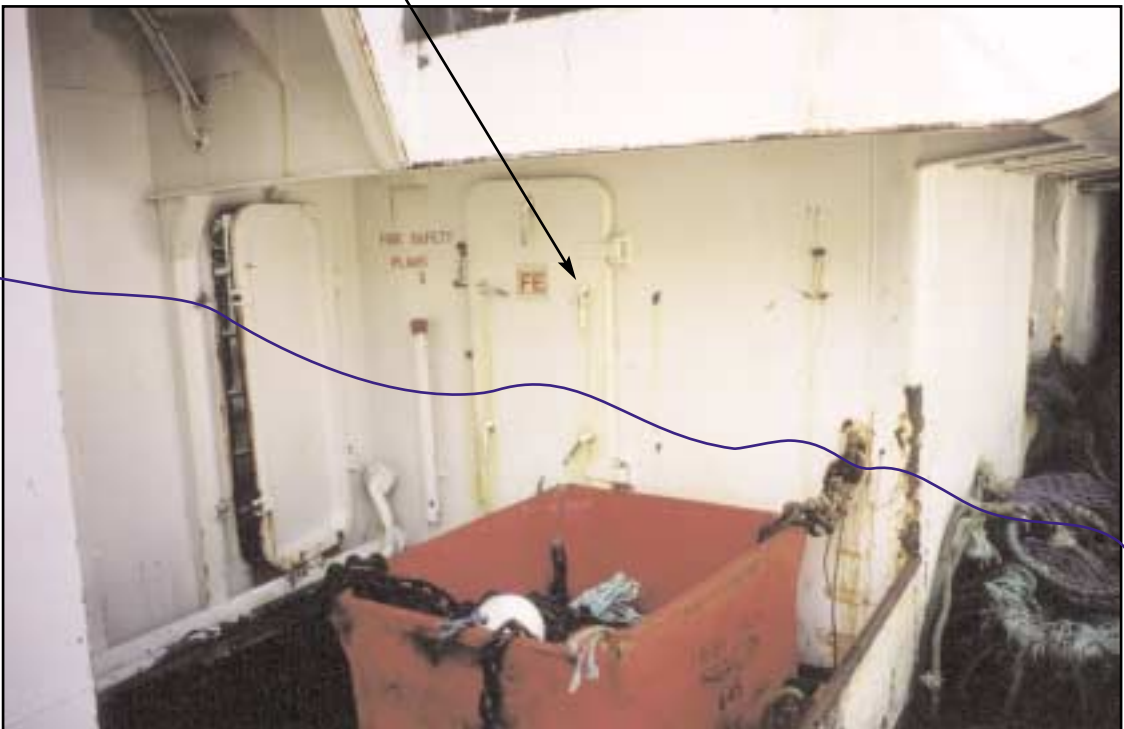
Figure 6

William Ritchie went aft with the intention of cutting the port warp with a grinder or burner. As he made his way along the shelter deck he could see that the waterline was halfway up the door of the store (**Figure 6**) where the grinder and burning equipment were stowed. Realising it would be impossible to cut the warp, he returned to the starboard side of the wheelhouse, followed shortly after by George Maskame.

Door to store room

Approximate
waterline

Port / aft side of working deck

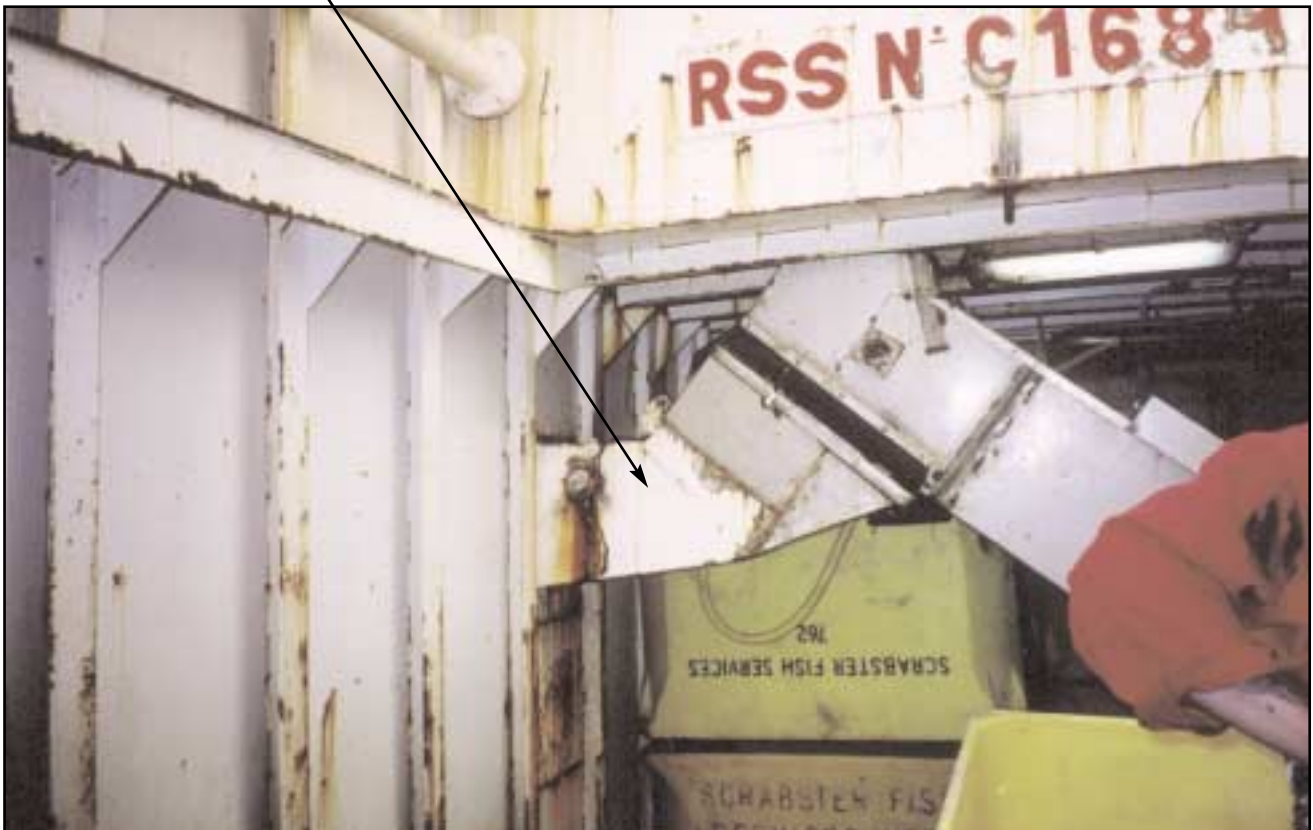
Figure 8

A conveyer took the fish forward to the processing space, where they were cleaned and gutted. Offal was discharged overboard through a gutting chute (**Figure 8**); this opening in the port side of the vessel could be closed watertight. The processed fish were then put into boxes, which were taken down and stowed in the refrigerated fish hold. The gutting chute was normally closed when there was no fish processing, so it should have been closed at the time of the accident.

Closeable gutting chute

Port side of processing space

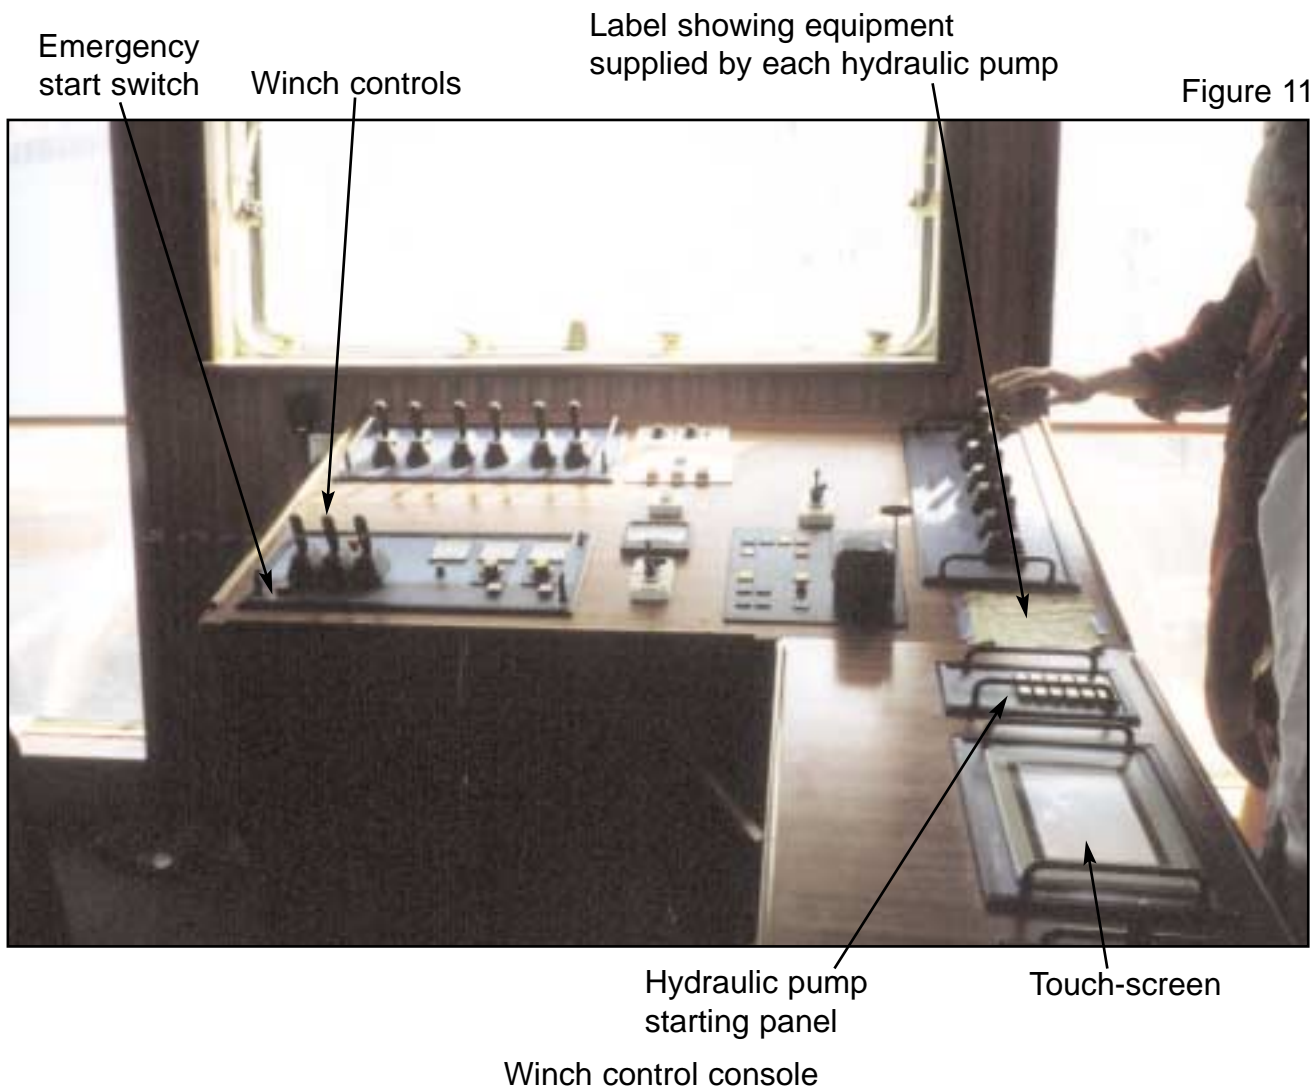
The PTS Pentagon touch-screen (**Figure 11**) was located in a console at the aft end of the wheelhouse. The touch-screen was the main user interface with the system. Different pages could be called up on the screen to control various aspects of the system. The screen displayed any alarms, which were triggered. There was also an audible alarm. Before the loss, *Radiant's* William Lawson is fairly sure that no alarms showed on the touch-screen; he was looking at this screen frequently while he was operating the winches. The audible alarm sounded a warning to the winch operator at the start and end of hauling, so William Lawson was familiar with the noise. If the audible alarm had gone off before the accident he is fairly sure he would have heard it. William Ritchie did not hear it sound either, while he was in the wheelhouse.

2. Put more emphasis on the hydraulic emergency start facility when training fishermen to use the PTS Pentagon system. Winch operators must be aware that they should use the emergency start if the hydraulics fail and this is putting the vessel in danger.
3. Enable the safety brake when configuring PTS Pentagon systems.

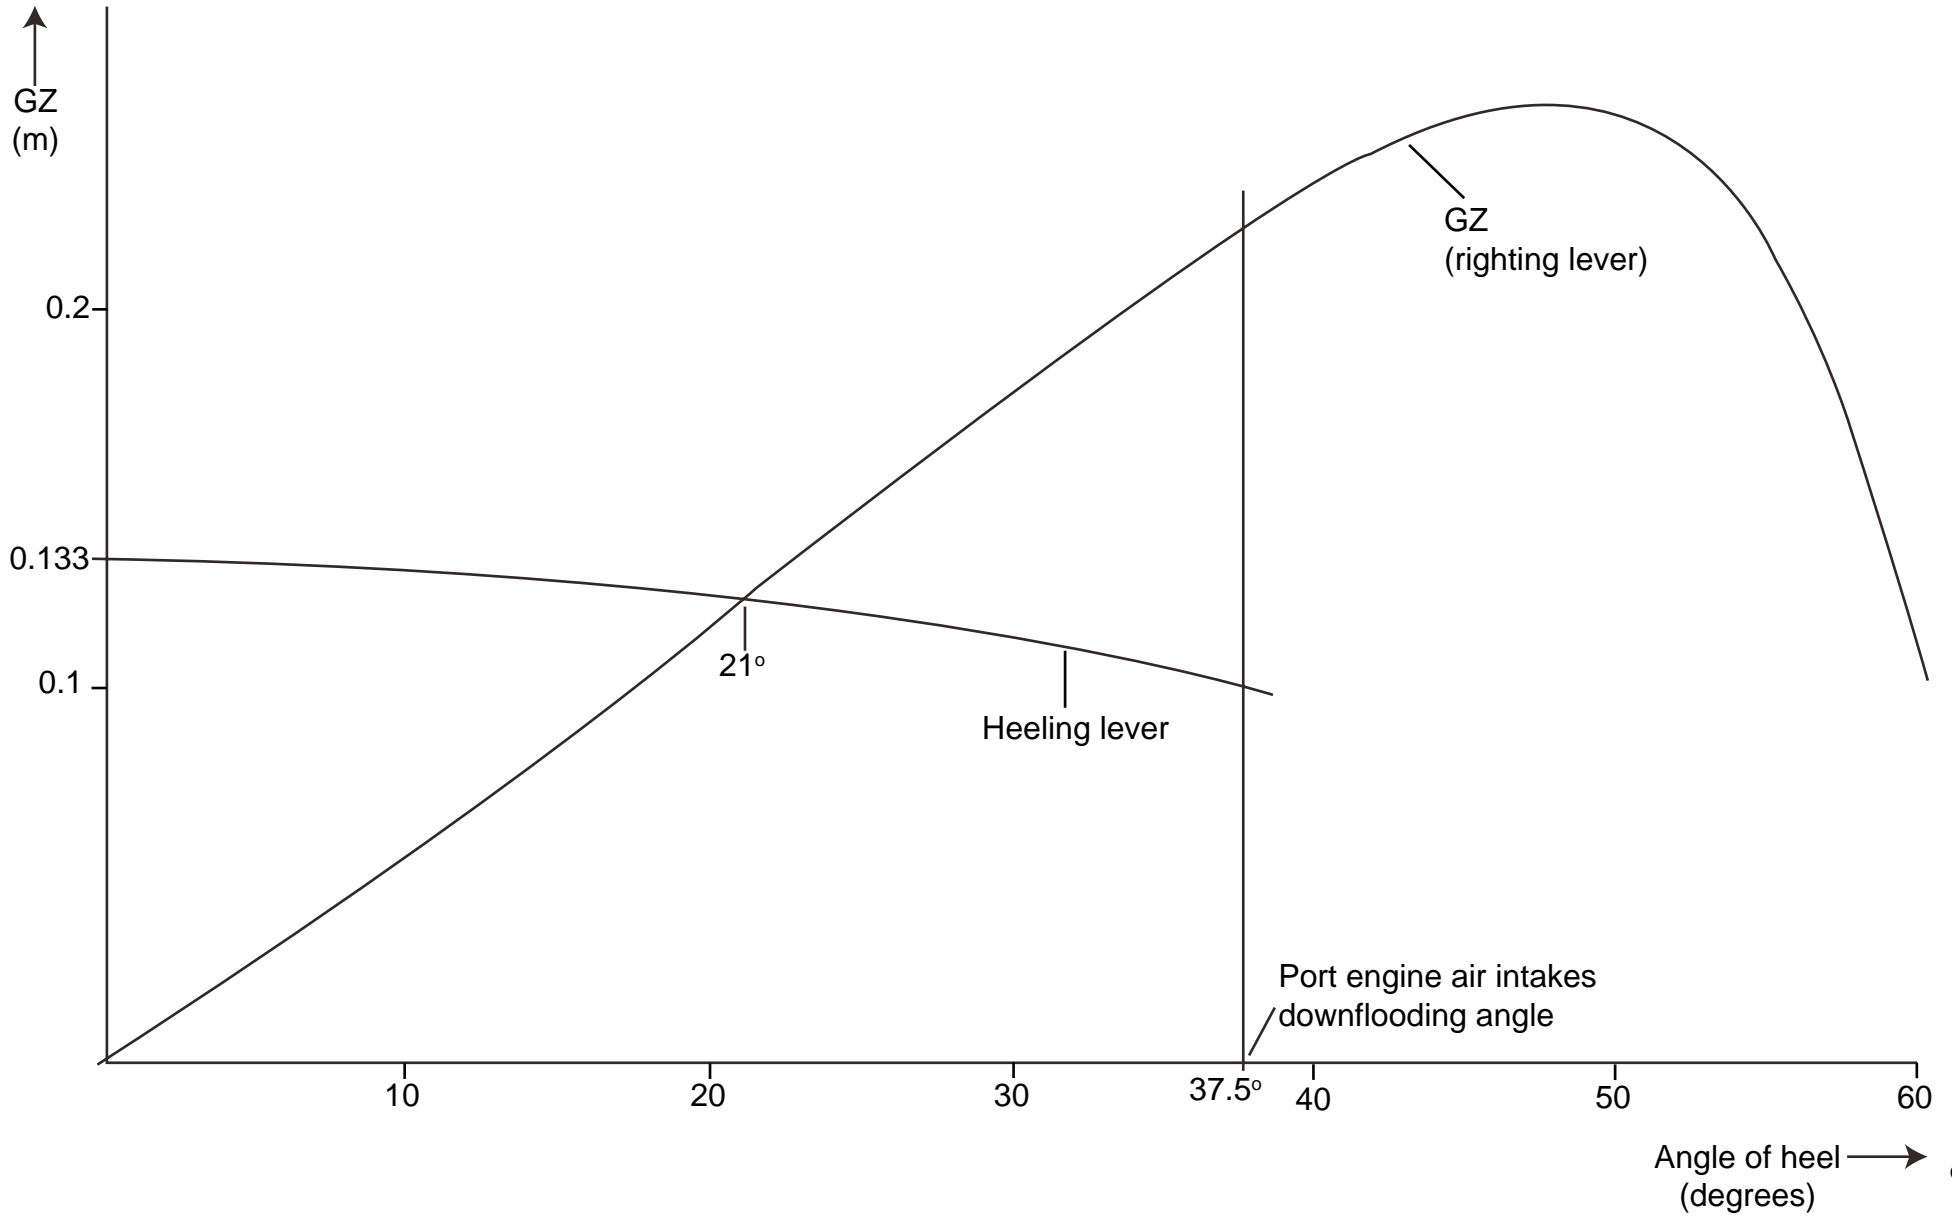
Figure 12

Stability curve (condition 6)

Radiant was fitted with powerful winches, capable of seriously compromising stability. A vessel’s stability can be judged by the area under the righting lever curve (**Figure 12**). At the time of the accident, this area was cut off at an angle of 37.5°. The heeling lever caused by the port winch uses up most of the area under the curve. The small area above the heeling lever curve was not sufficient to keep the vessel stable when she was rolling in the heavy swell. The MAIB has investigated similar cases in the past. The loss of *Heather Bloom* in 1994, and *Westhaven* in 1997 are examples.

For similar vessels, a notice should be shown in bold print near the front of the stability book, warning skippers of this danger. A recommendation has been made to the MCA to require such a warning notice, if the power of the winches is sufficient to seriously degrade stability. When stability books are checked, the MCA should require a suitable warning notice to be included, if the winch power poses a risk of capsize.

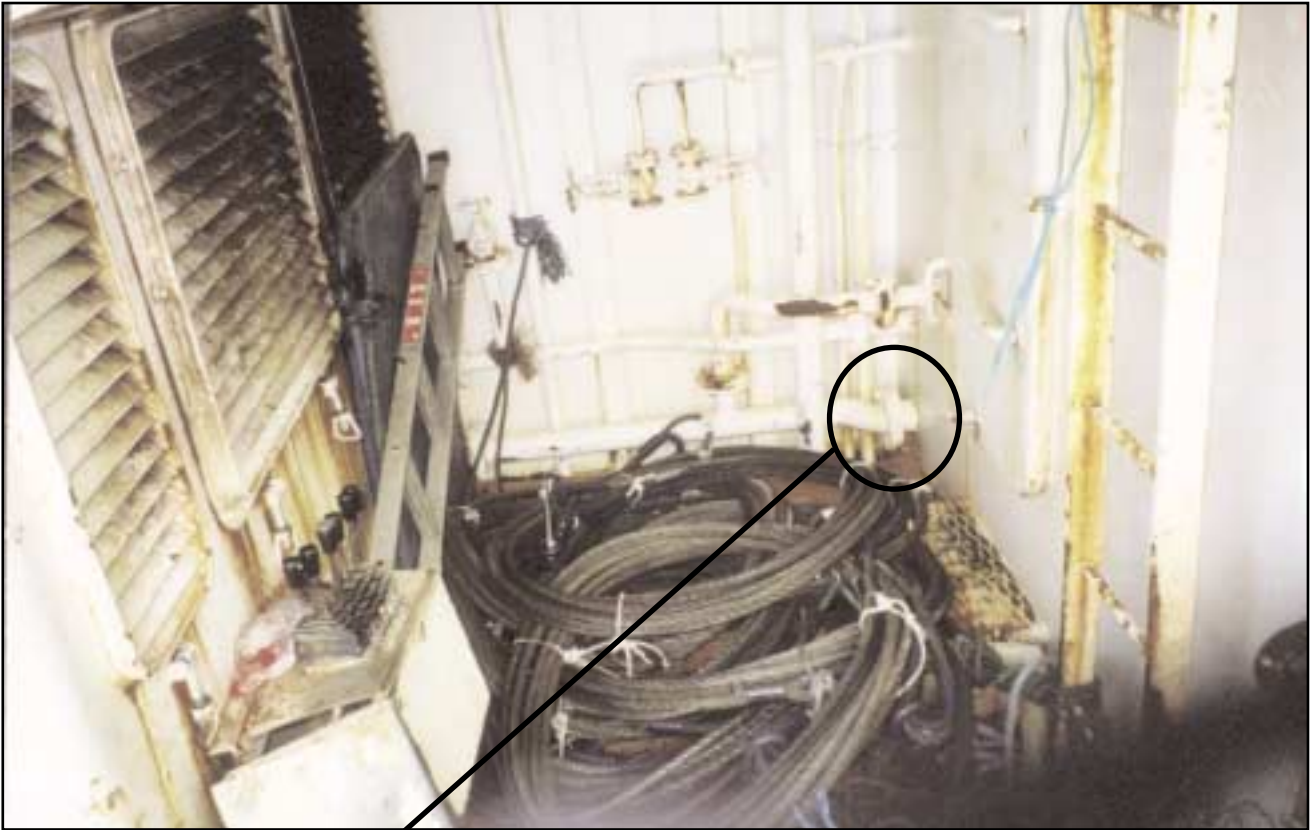
Figure 15

The stability calculations showed that with a heel to port, the engine air intakes on that side, were the first downflooding point. The next downflooding point occurred at an angle of about 44° through the port warp opening (**Figure 16**) into the port trawl winch space. This space would also have flooded during the latter stages of the accident, which would have hastened the capsize. As no bilge alarms were fitted in the trawl winch spaces, no alarm would have sounded in the wheelhouse to warn the crew of the problem. However, the flooding of the port winch space could not have caused the capsize on its own, because all its boundaries to other parts of the ship were watertight, and the space was small.

Port engine air intakes (downflooding point)

Seawater accumulated on the working deck and then downflooded through the port engine air intakes. George Maskame observed the flooding of the engine room during the initial stages. William Ritchie saw and heard steam issuing from the engine air outlets just before the loss. This indicates that floodwater had got on to the hot machinery. The flooding of the engine room was well advanced at this stage.

The positioning of openings, which affect watertight integrity, is an important part of a vessel’s design. Engine air intakes and outlets should be considered as downflooding points, even if closures are fitted. As a minimum, openings should be positioned such that the stability criteria are passed, but preferably they should be fitted higher, so that downflooding does not occur until there is a very large angle of heel or list. A recommendation has been made to the builders of *Radiant* and *Resplendent* to carefully consider this during their construction of fishing vessels.

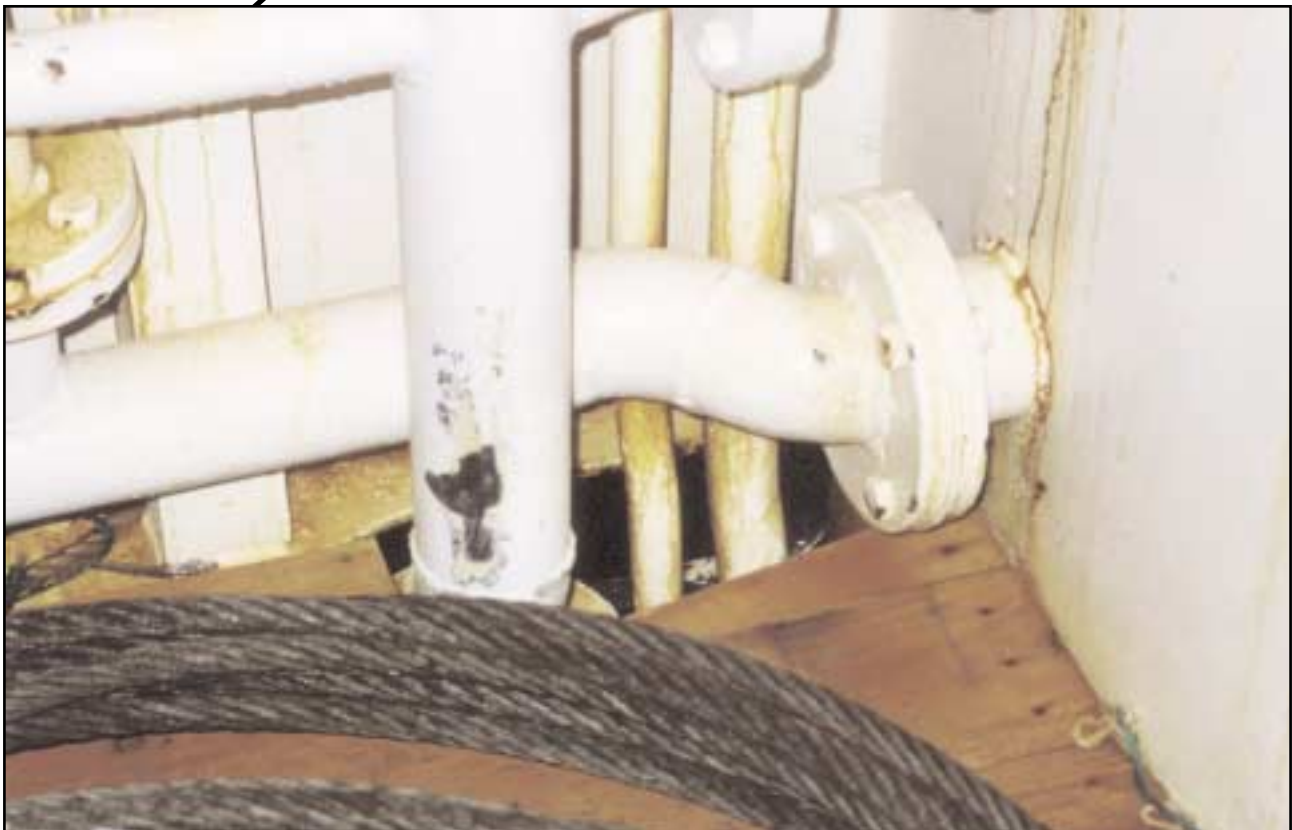
Figure 16

Scupper adjacent to engine air intakes

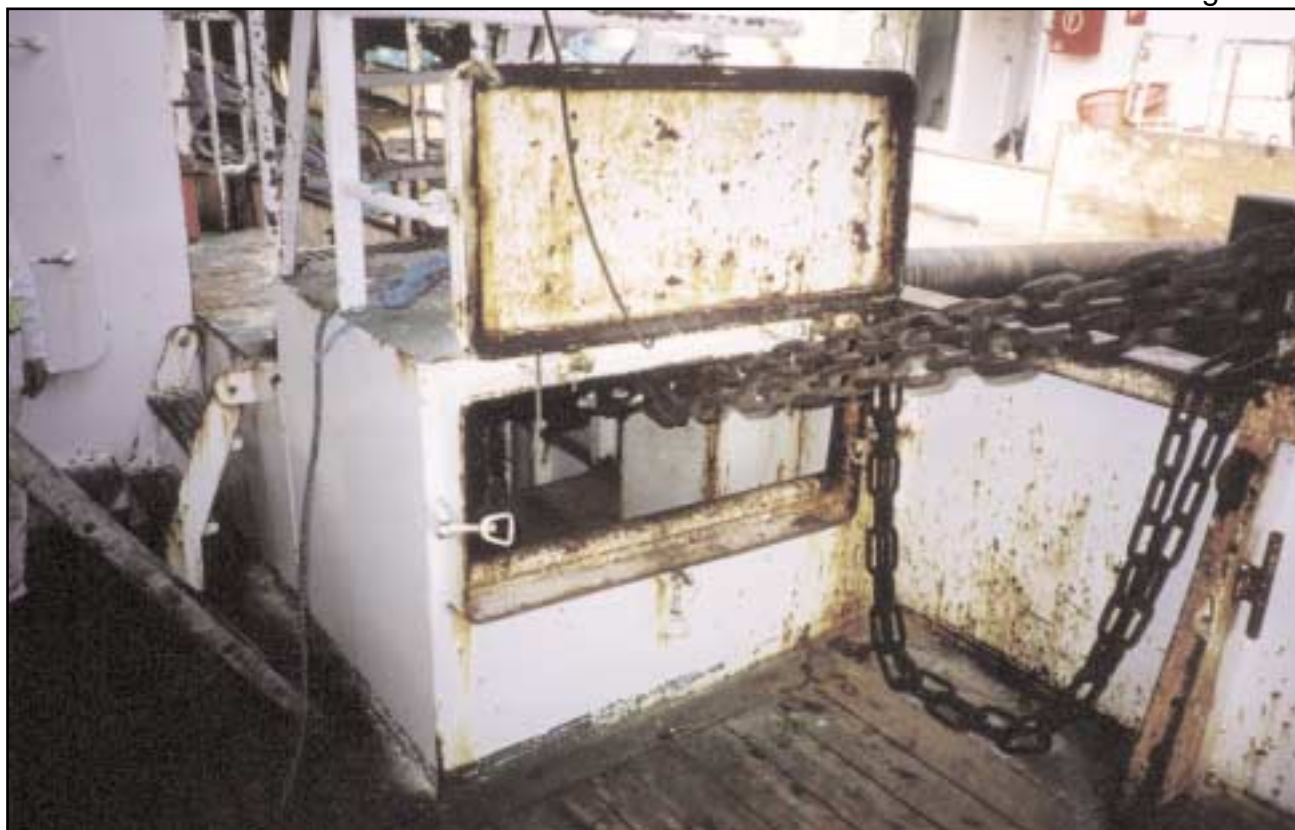
Warp hatch to port winch (downflooding point)
