Report on the investigation of the  
collision between the ro-ro ferry  
***Stena Gothica***  
and the eastern approach jetty at  
Immingham on 2 April 2002

Marine Accident Investigation Branch  
First Floor  
Carlton House  
Carlton Place  
Southampton  
United Kingdom  
SO15 2DZ

**Report No 39/2002  
December 2002**

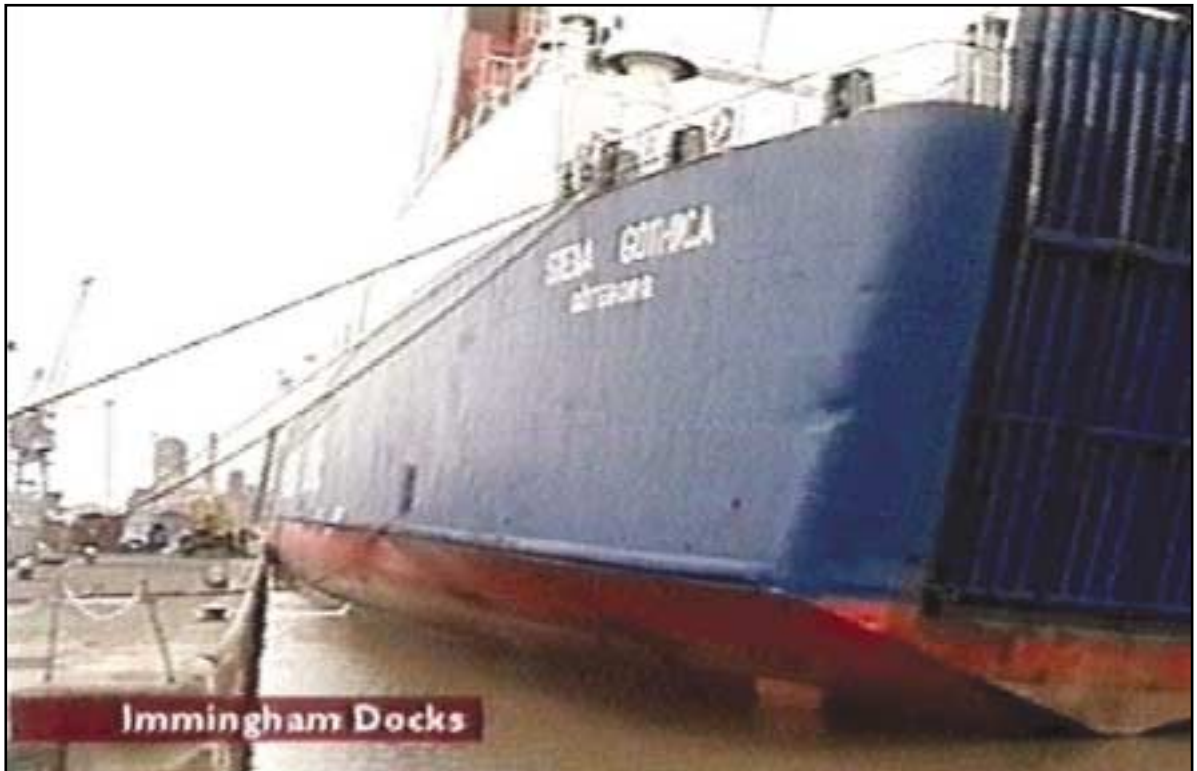
Figure 3

The vessel continued to list and reached a maximum heel of 14.5° at 0333, when there was about 2.5m of water in the starboard aft corner of the lower hold (**see Figures 3 & 4**). The firefighters and salvors were able to both slow the rate of ingress of water and, also, to lower the water level in the hold so that during the course of the morning the list was gradually reduced. *Stena Gothica* remained in the lock throughout this period.

Vessel listing in lock

Lift recess

Water level marks

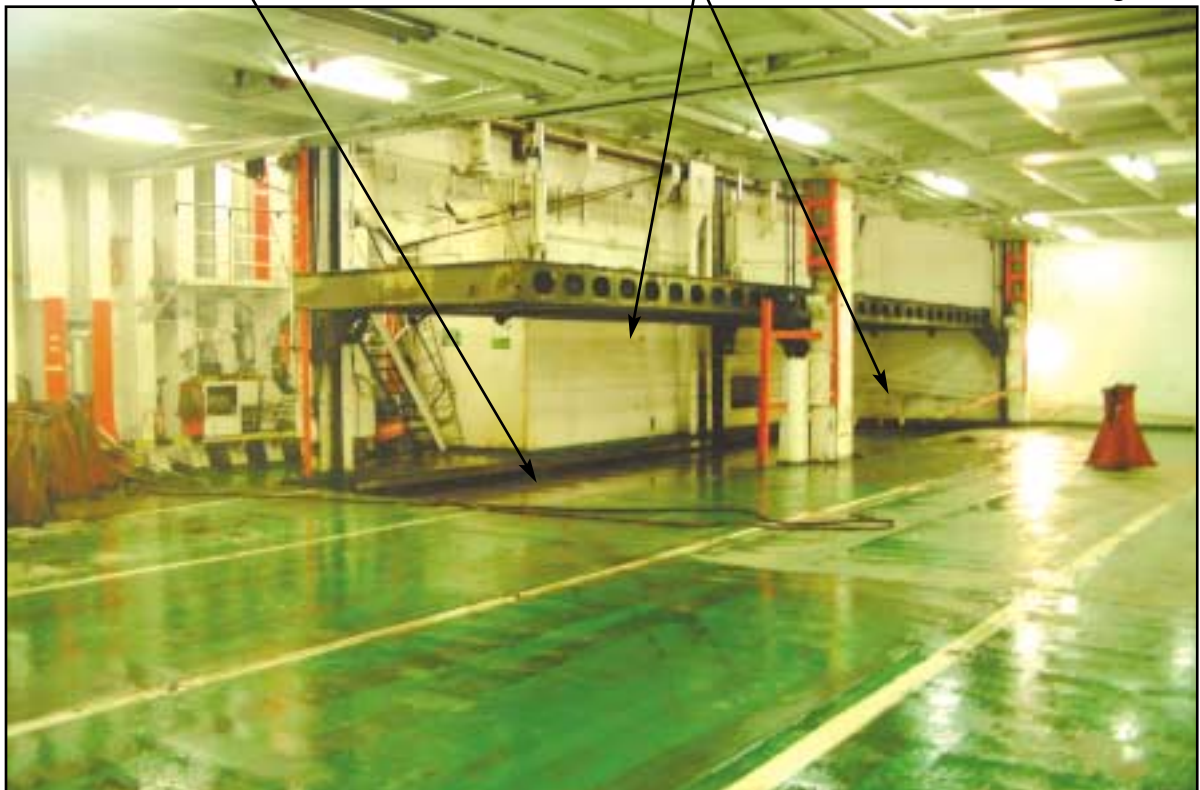
Figure 4

Lower cargo hold looking aft (taken 2/4/02 pm)

11. The lower hold lift housing, located in the aft starboard corner of the hold, filled first, causing the vessel to list to starboard, bringing the damaged area closer to the waterline, and keeping the water already in the lower hold away from the damaged side. [2.5]

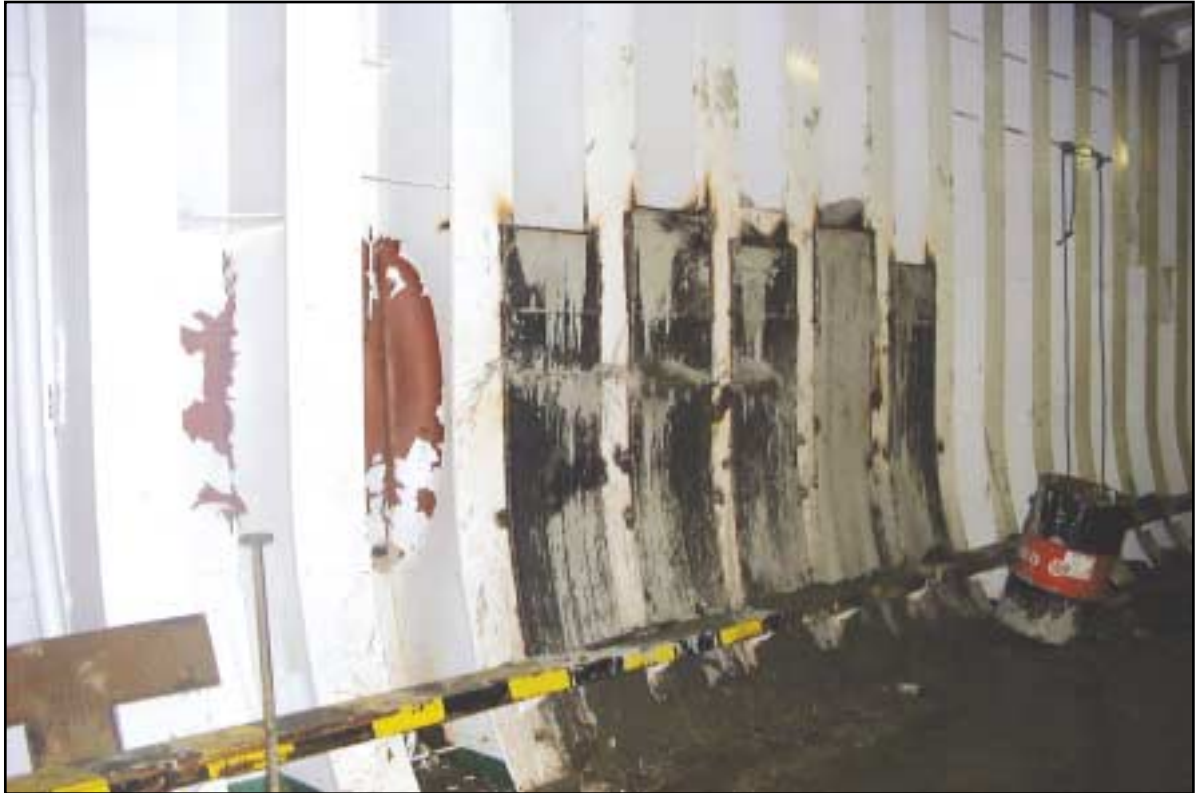
Temporary repair made to damage

In mid-afternoon the vessel was moved to berth No 4 where she was all fast at 1442. The cargo was discharged and further temporary repairs involving welding carried out (**see Figure 5**). An MAIB inspector arrived at the vessel shortly after she berthed to start the investigation.

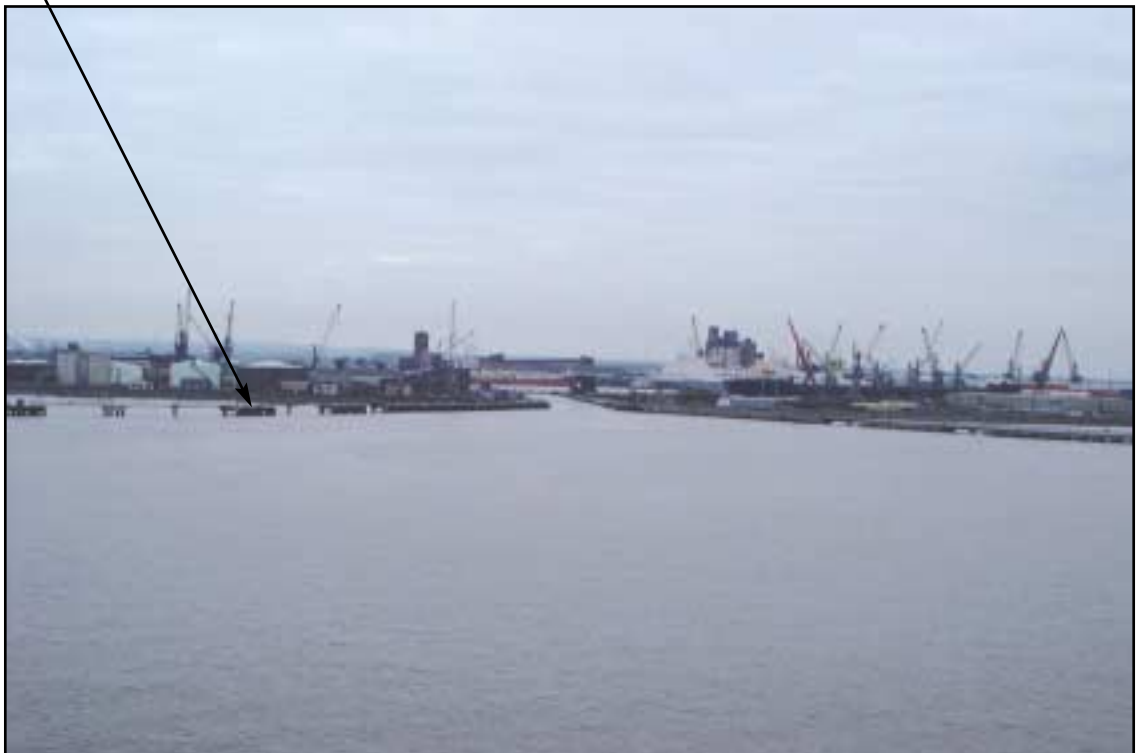
Figure 7

Fender no 24

Immingham lock from the river

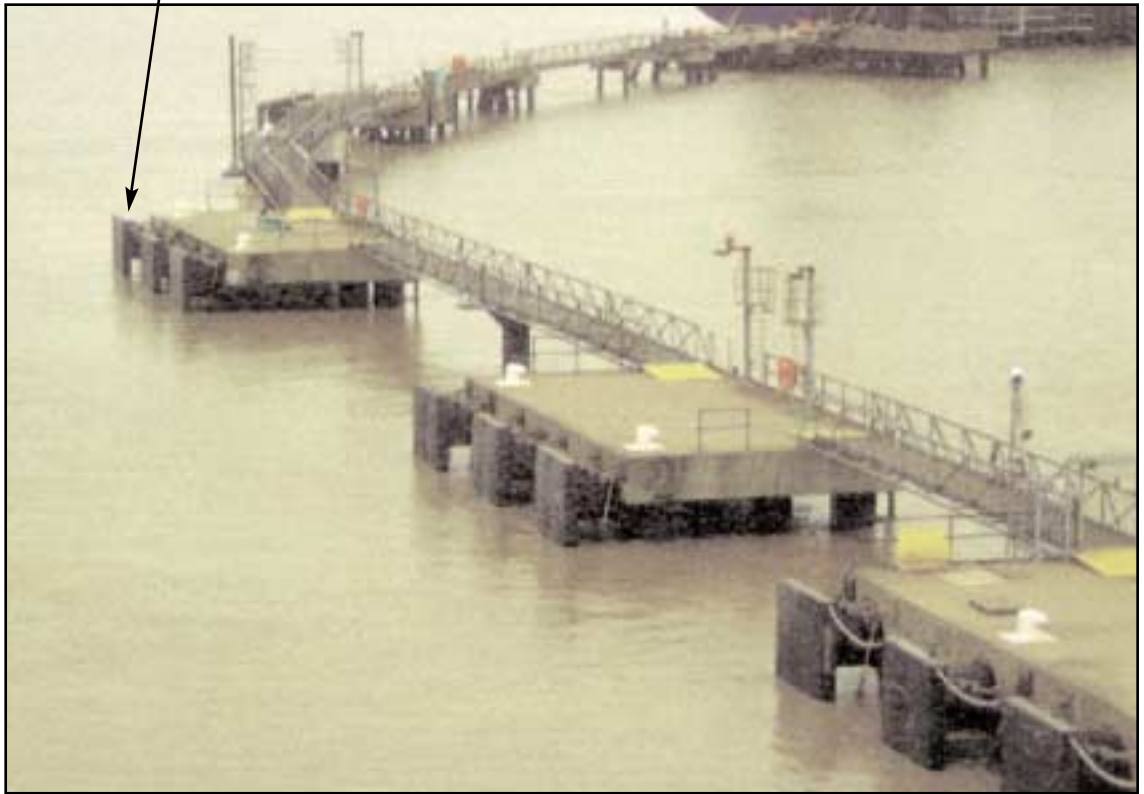
Figure 8

Eastern approach jetty  
(taken June 2002 after fender repaired)

Since the incident, the fendering has been fully repaired (**see Figure 8**).

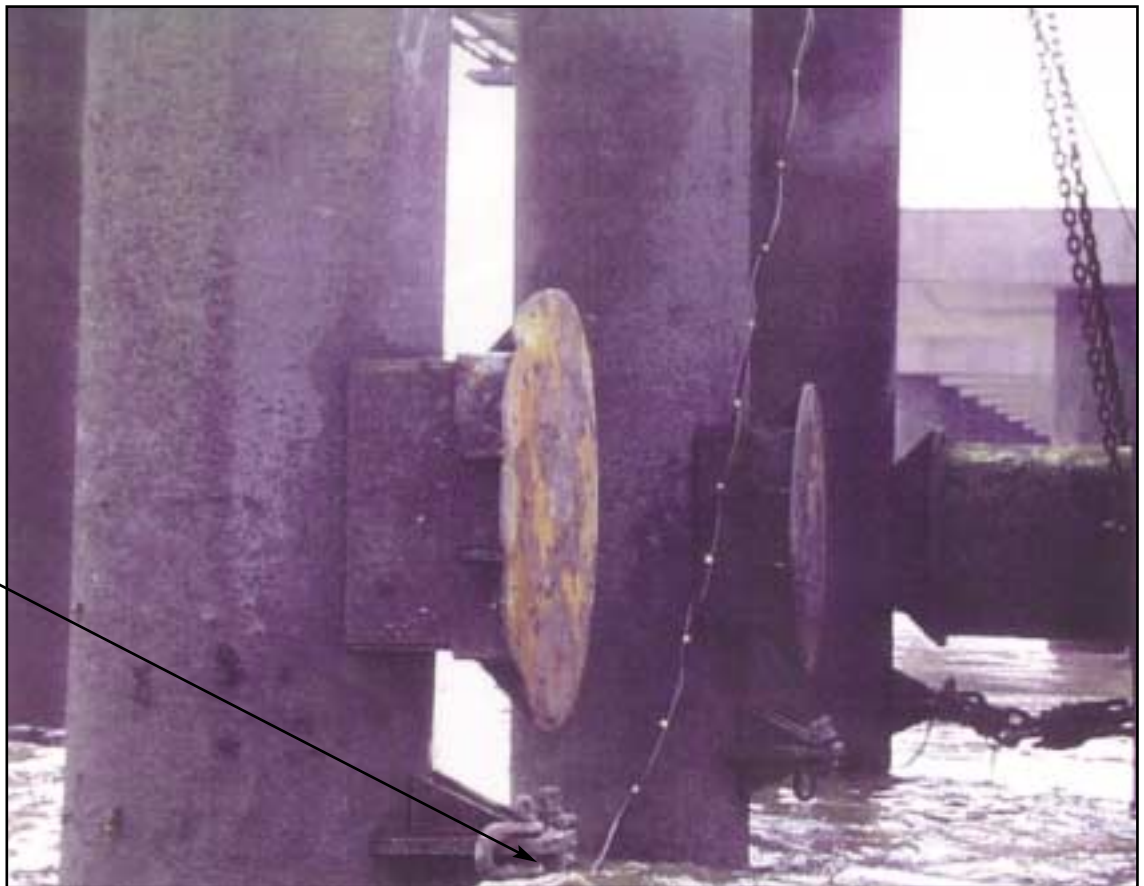
Figure 9

The damage to *Stena Gothica* was caused by the lug underneath the flange. In **Figure 9**, paint marks from the hull can be seen on one of the shackles attached to this lug. The middle fender (No 23) was also damaged as a result of this incident and was taken away for repair.

Lug which  
caused  
damage  
(note paint  
on  
shackle)

*Stena Gothica* had the misfortune to impact the Eastern jetty at the location of the missing fender and sustained most of her damage from the lug under the flange shown in **Figure 9**.

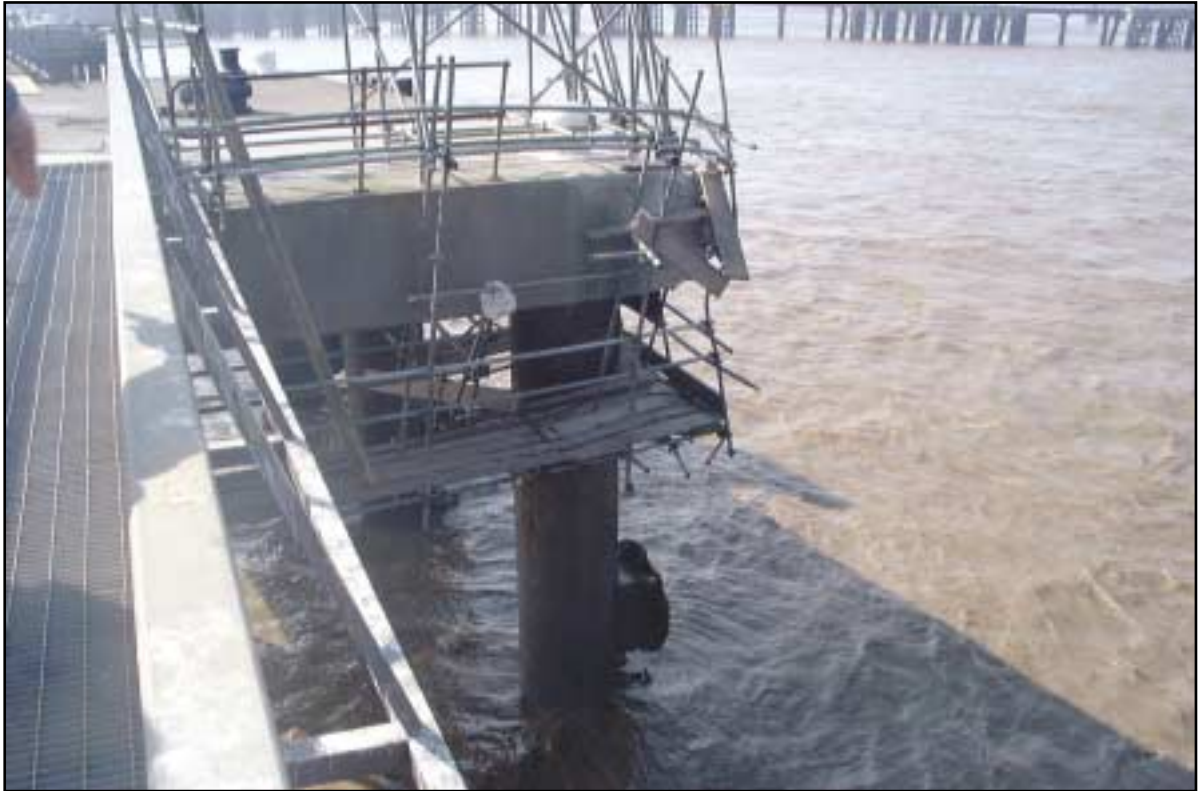
Figure 10

At the time of the incident the outermost fender on the second dolphin (No 24) from the lock was under repair and missing due to an earlier incident. The missing fender had scaffolding around it and was marked by a flag. The pilots had been informed.

Fender 24  
(note damage to scaffolding)

At the time of the incident, the outermost fender on the second dolphin (No 24) from the lock was under repair and missing because of an earlier incident. The missing fender had scaffolding around it and was marked by a flag, but was not marked at night. No temporary fendering had been put in place during the repair period. The pilot was aware that the fender was missing, but masters had not been notified. The pilot did, however, inform the master immediately before the contact, of an area of scaffolding on the jetty around the missing fender and that he could not land alongside this area.

3. Ensure that whenever control measures, such as fenders, are missing, masters are informed before their arrival at the port.
4. Ensure that whenever fendering is removed, for repair or any other reason, that it is replaced by temporary fendering of equivalent strength.
5. Emphasise the advantages of advanced planning among its pilots.

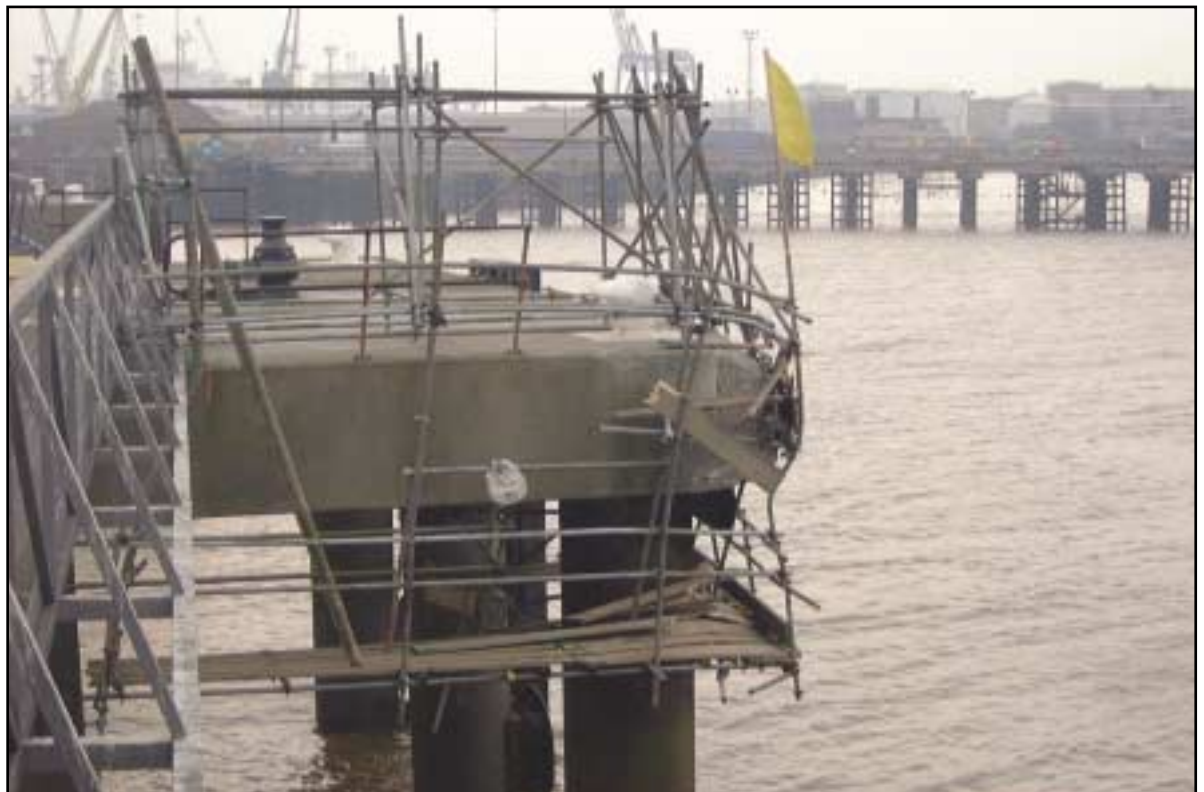
Figure 11

Fender 24
