Report on the investigation of the
collision between the ro-ro ferry
Stena Gothica
and the eastern approach jetty at
Immingham on 2 April 2002

Marine Accident Investigation Branch
First Floor
Carlton House
Carlton Place
Southampton
United Kingdom
SO15 2DZ

**Report No 39/2002
December 2002**

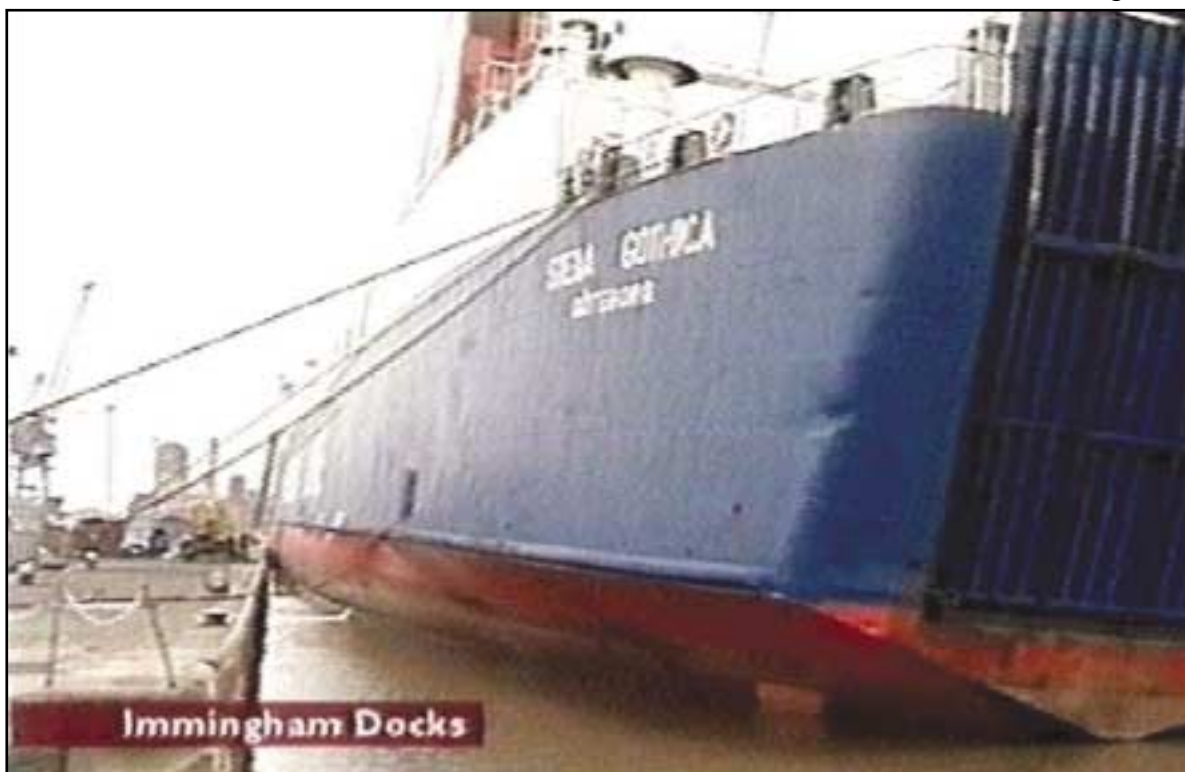
Figure 3

The vessel continued to list and reached a maximum heel of 14.5° at 0333, when there was about 2.5m of water in the starboard aft corner of the lower hold (**see Figures 3 & 4**). The firefighters and salvors were able to both slow the rate of ingress of water and, also, to lower the water level in the hold so that during the course of the morning the list was gradually reduced. *Stena Gothica* remained in the lock throughout this period.

Vessel listing in lock

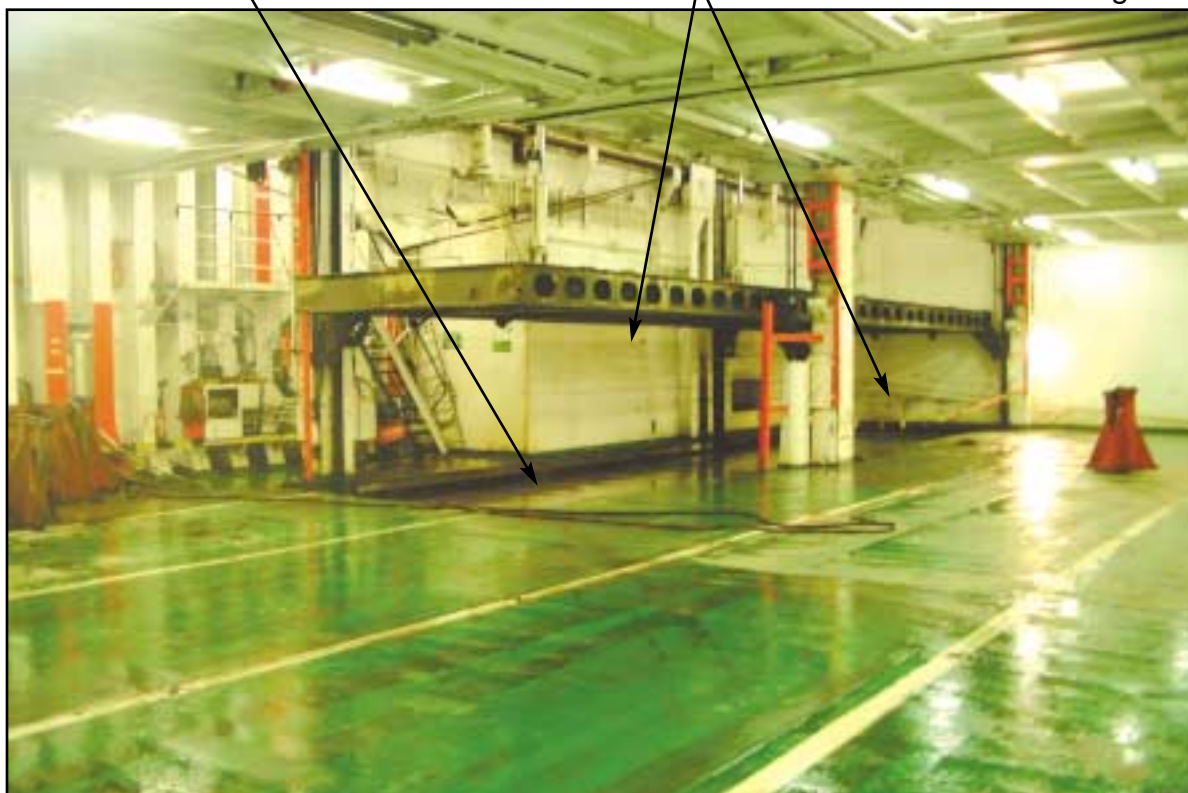
Figure 4

Lower cargo hold looking aft (taken 2/4/02 pm)

11. The lower hold lift housing, located in the aft starboard corner of the hold, filled first, causing the vessel to list to starboard, bringing the damaged area closer to the waterline, and keeping the water already in the lower hold away from the damaged side. [2.5]

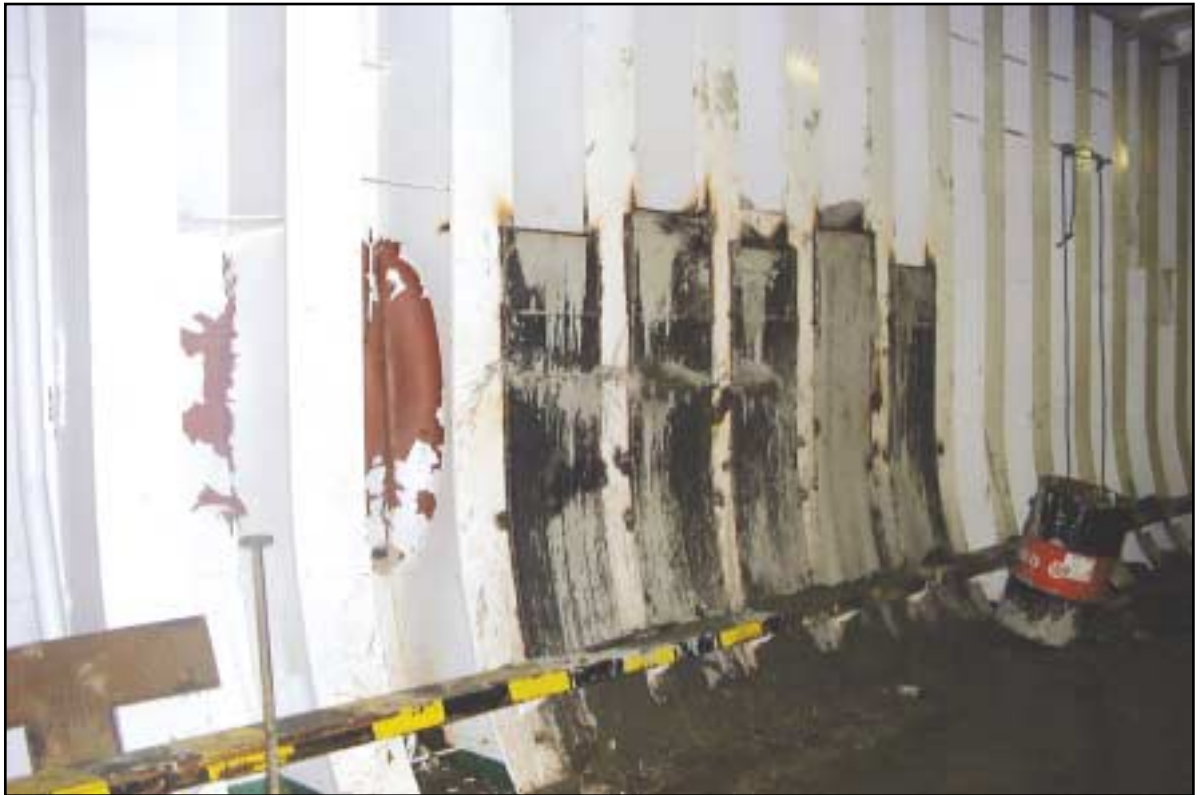
The officers in the engine room contacted the master and informed him that the vessel was taking on water. The vessel was then moved into the lock. The impact had caused a 3 metre gash in the port side shell plating, below the waterline just aft of midships in the vicinity of frame 100. This led to a large ingress of water into the lower cargo hold. The lower hold lift housing, located in the aft starboard corner of the hold, filled first. About 20 minutes after entering the lock the vessel started to list to starboard.

Temporary repair made to damage

In mid-afternoon the vessel was moved to berth No 4 where she was all fast at 1442. The cargo was discharged and further temporary repairs involving welding carried out (**see Figure 5**). An MAIB inspector arrived at the vessel shortly after she berthed to start the investigation.

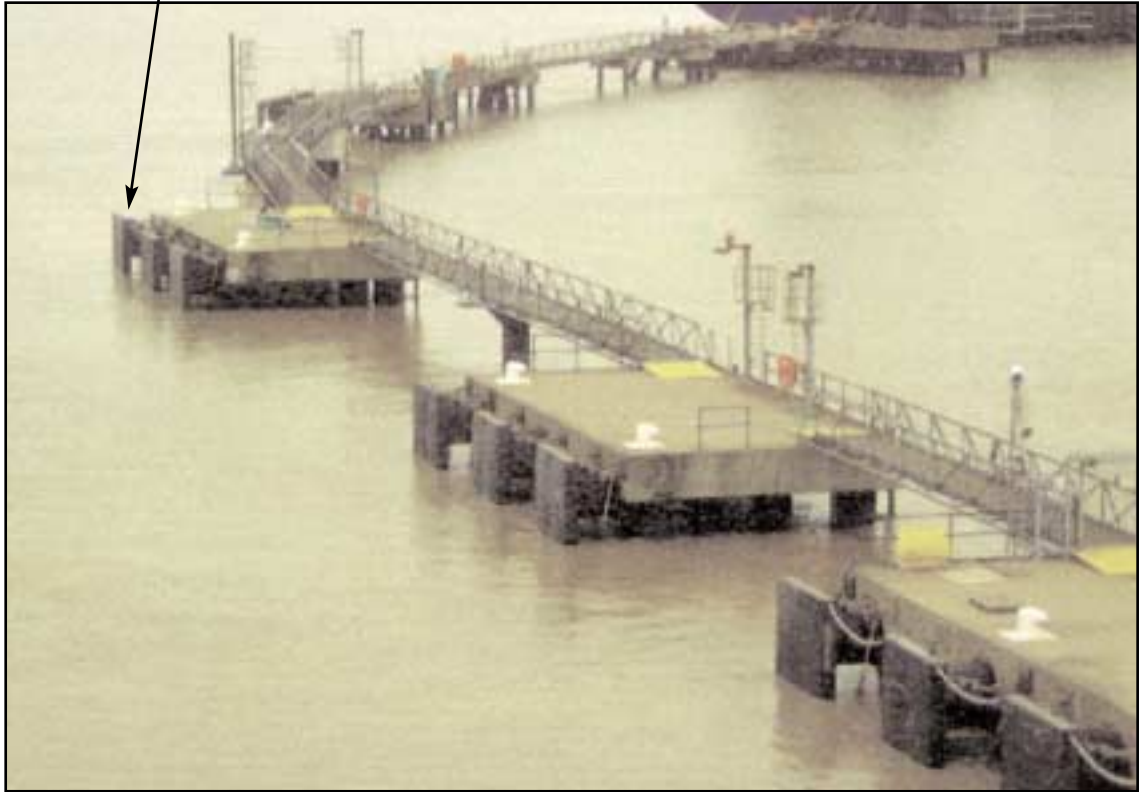
Figure 8

Eastern approach jetty
(taken June 2002 after fender repaired)

Since the incident, the fendering has been fully repaired (**see Figure 8**).

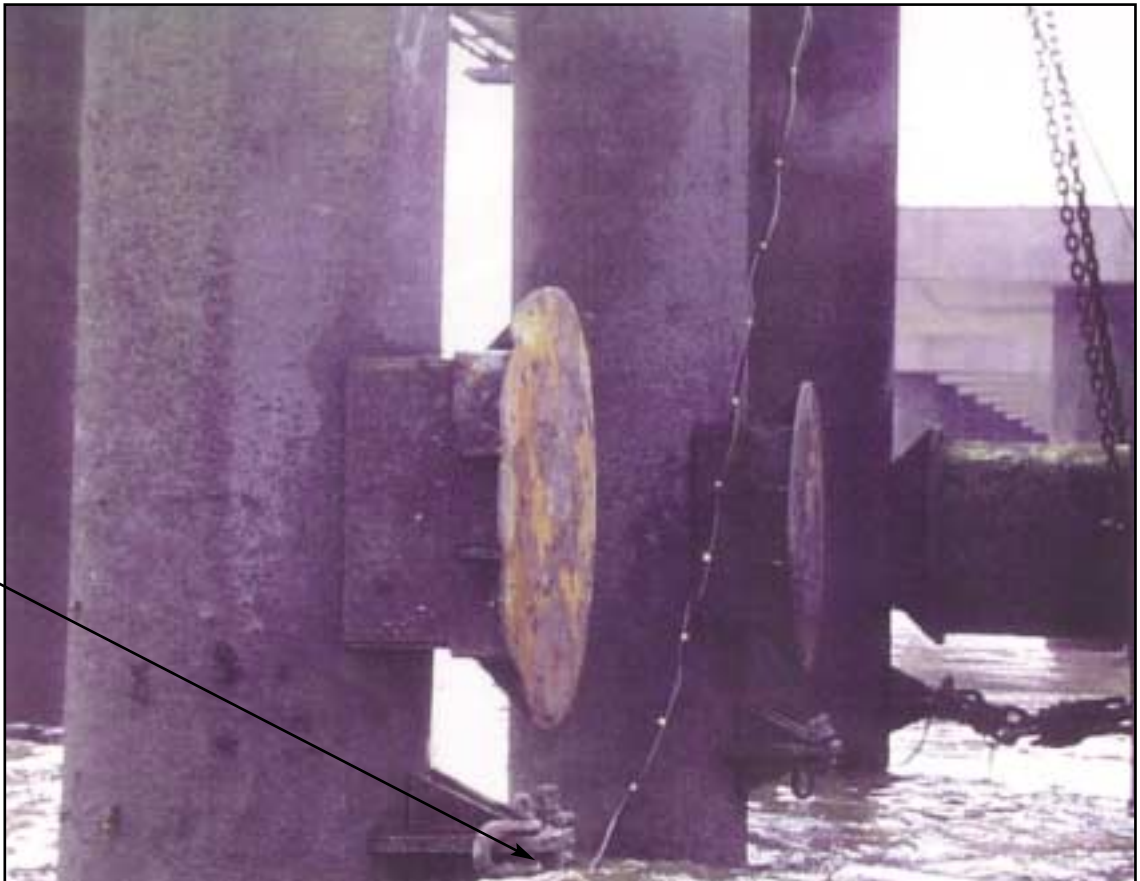
Figure 9

The damage to *Stena Gothica* was caused by the lug underneath the flange. In **Figure 9**, paint marks from the hull can be seen on one of the shackles attached to this lug. The middle fender (No 23) was also damaged as a result of this incident and was taken away for repair.

Lug which
caused
damage
(note paint
on
shackle)

Stena Gothica had the misfortune to impact the Eastern jetty at the location of the missing fender and sustained most of her damage from the lug under the flange shown in **Figure 9**.

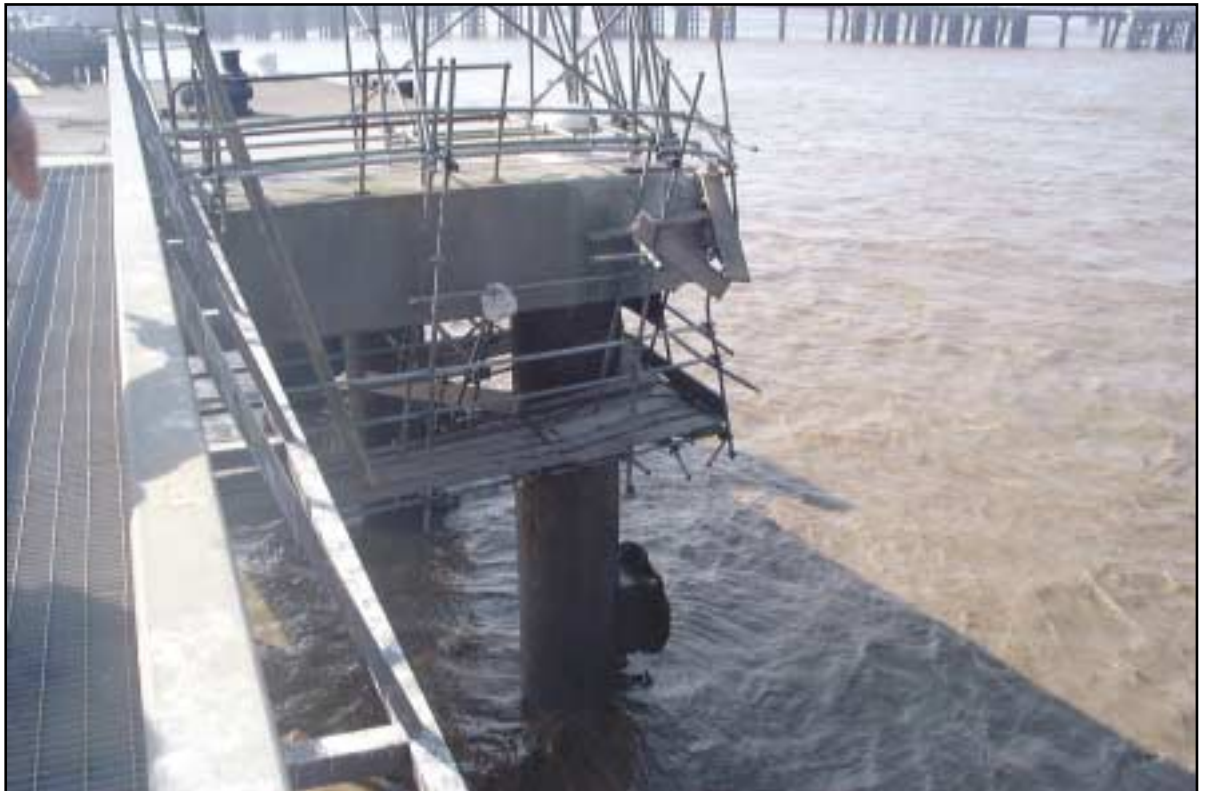
Figure 10

At the time of the incident the outermost fender on the second dolphin (No 24) from the lock was under repair and missing due to an earlier incident. The missing fender had scaffolding around it and was marked by a flag. The pilots had been informed.

Fender 24
(note damage to scaffolding)

At the time of the incident, the outermost fender on the second dolphin (No 24) from the lock was under repair and missing because of an earlier incident. The missing fender had scaffolding around it and was marked by a flag, but was not marked at night. No temporary fendering had been put in place during the repair period. The pilot was aware that the fender was missing, but masters had not been notified. The pilot did, however, inform the master immediately before the contact, of an area of scaffolding on the jetty around the missing fender and that he could not land alongside this area.

3. Ensure that whenever control measures, such as fenders, are missing, masters are informed before their arrival at the port.
4. Ensure that whenever fendering is removed, for repair or any other reason, that it is replaced by temporary fendering of equivalent strength.
5. Emphasise the advantages of advanced planning among its pilots.
