Report on the investigation of the
collision between the ro-ro ferry
Stena Gothica
and the eastern approach jetty at
Immingham on 2 April 2002

Marine Accident Investigation Branch
First Floor
Carlton House
Carlton Place
Southampton
United Kingdom
SO15 2DZ

**Report No 39/2002
December 2002**

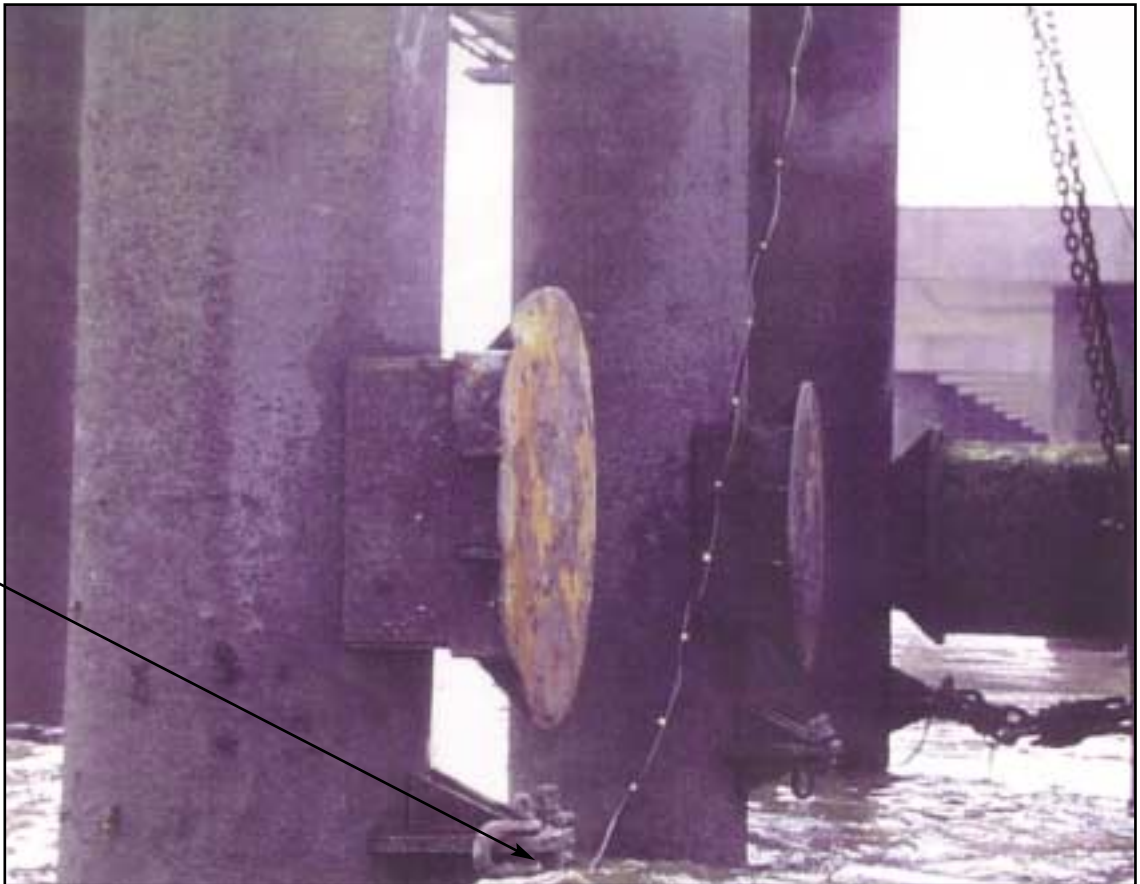
Figure 9

The damage to *Stena Gothica* was caused by the lug underneath the flange. In **Figure 9**, paint marks from the hull can be seen on one of the shackles attached to this lug. The middle fender (No 23) was also damaged as a result of this incident and was taken away for repair.

Lug which
caused
damage
(note paint
on
shackle)

Stena Gothica had the misfortune to impact the Eastern jetty at the location of the missing fender and sustained most of her damage from the lug under the flange shown in **Figure 9**.
