Report on the investigation of
the collision between
the Saint Vincent and the Grenadines registered
general cargo ship
Aroid
and the Antigua and Barbuda registered
general cargo ship
Anjola
in the River Trent
on 25 February 2002

Report No 30/2002
October 2002

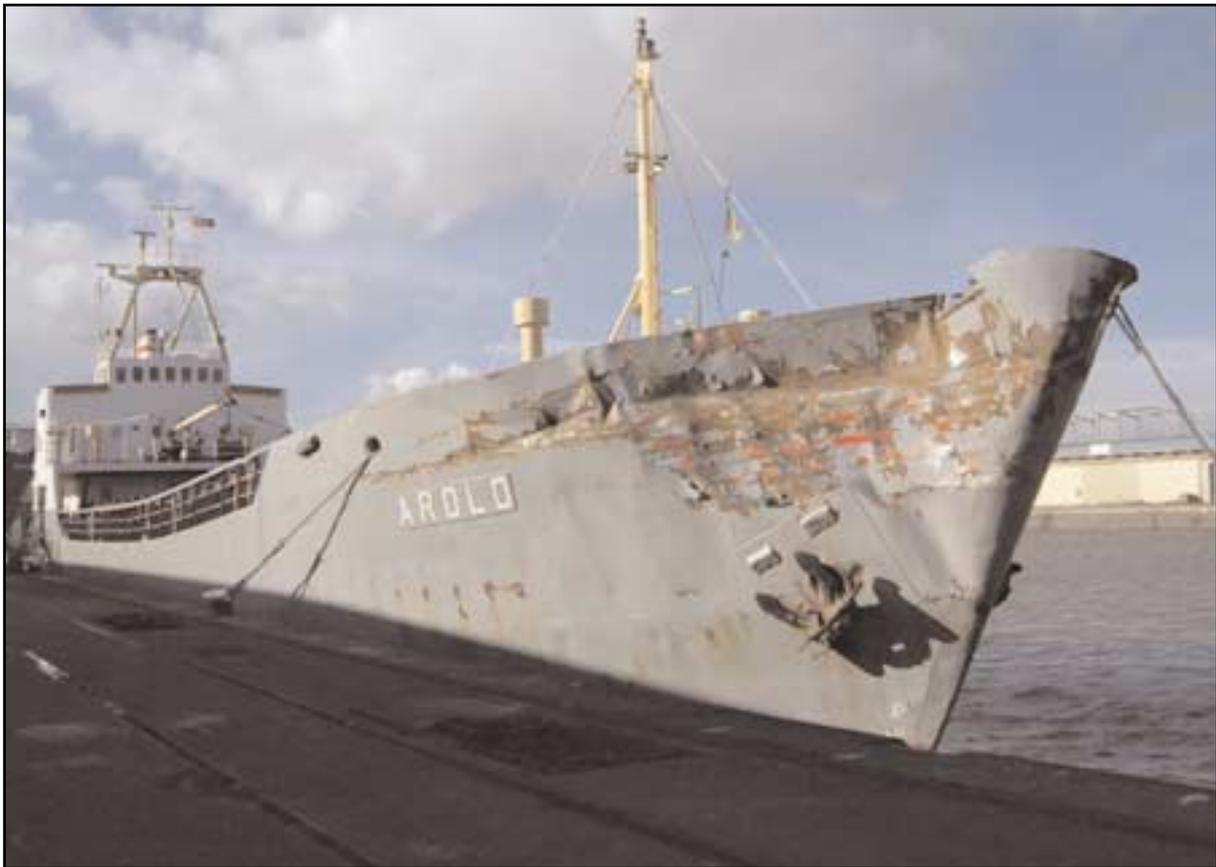
Arold berthed at King George Dock, Hull, showing damage to starboard bow

Time and date	: 1712 UTC, 25 February 2002	
Location of incident	: Latitude 53° 36.5'N, Longitude 000° 43.3W near Grove light in the River Trent	
Persons on board	: 10	6
Injuries/fatalities	: None	None
Damage	: To starboard bow	To stem

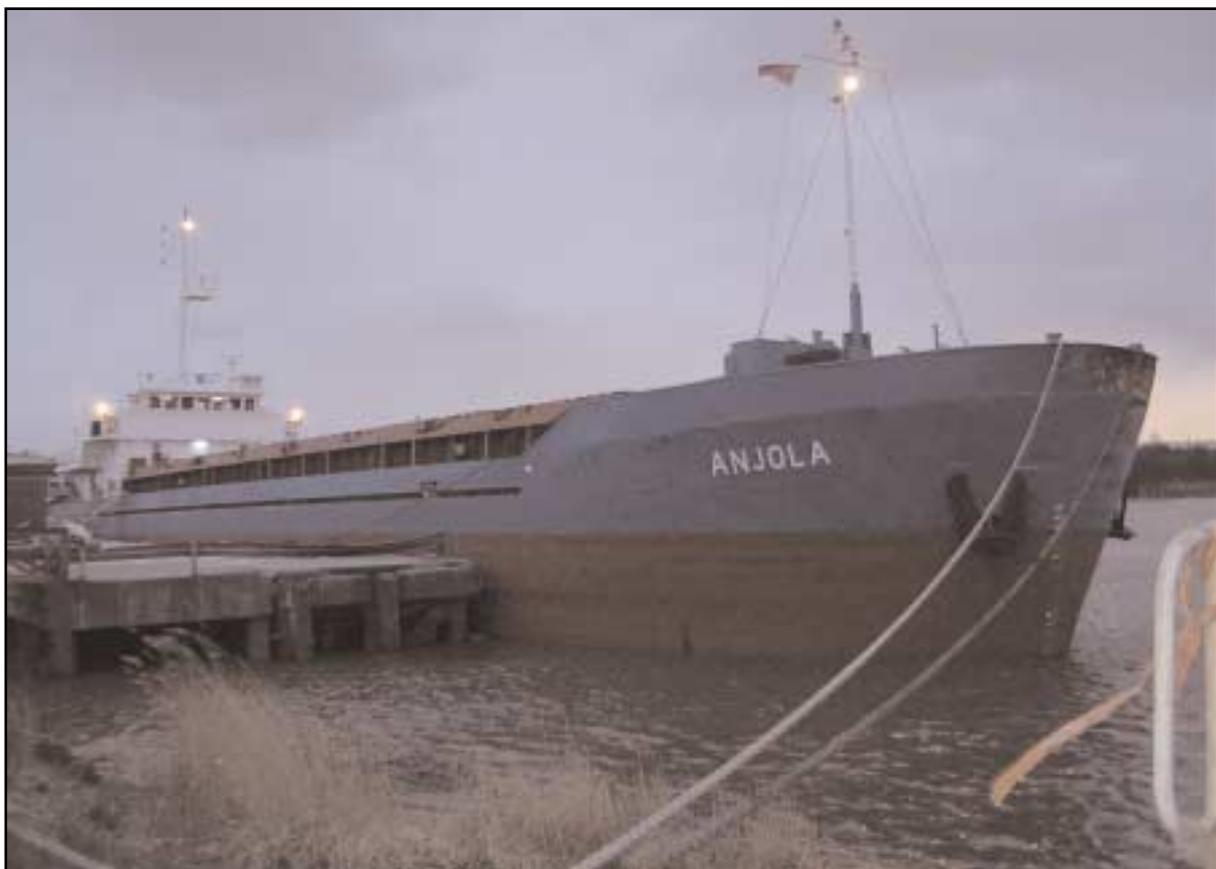
Anjola berthed at Gunness, showing damage to stem
