Report of investigation
into sinking of
fv *Tullaghmurry Lass* N246
with loss of three lives
in the Irish Sea
on 14 February 2002

Marine Accident Investigation Branch
First Floor, Carlton House
Carlton Place
Southampton
SO15 2DZ

**Report No 4/2003
February 2003**

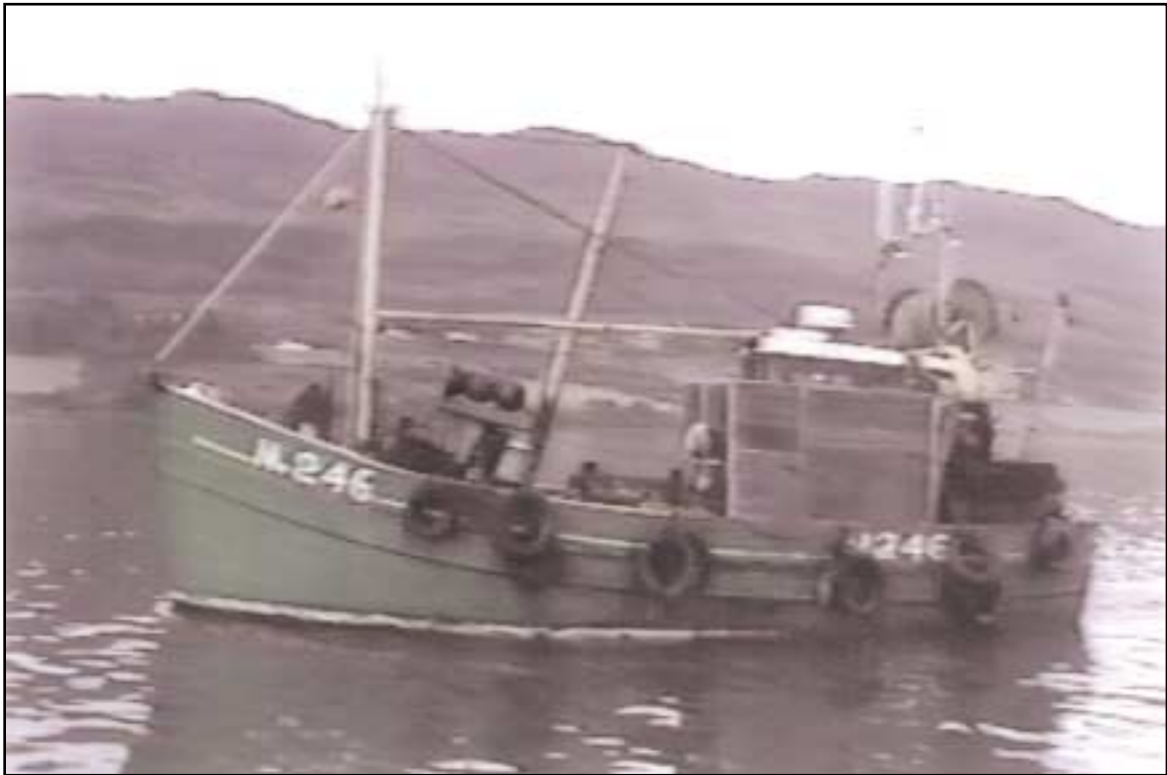
Figure 1

Port side of *Tullaghmurry Lass*

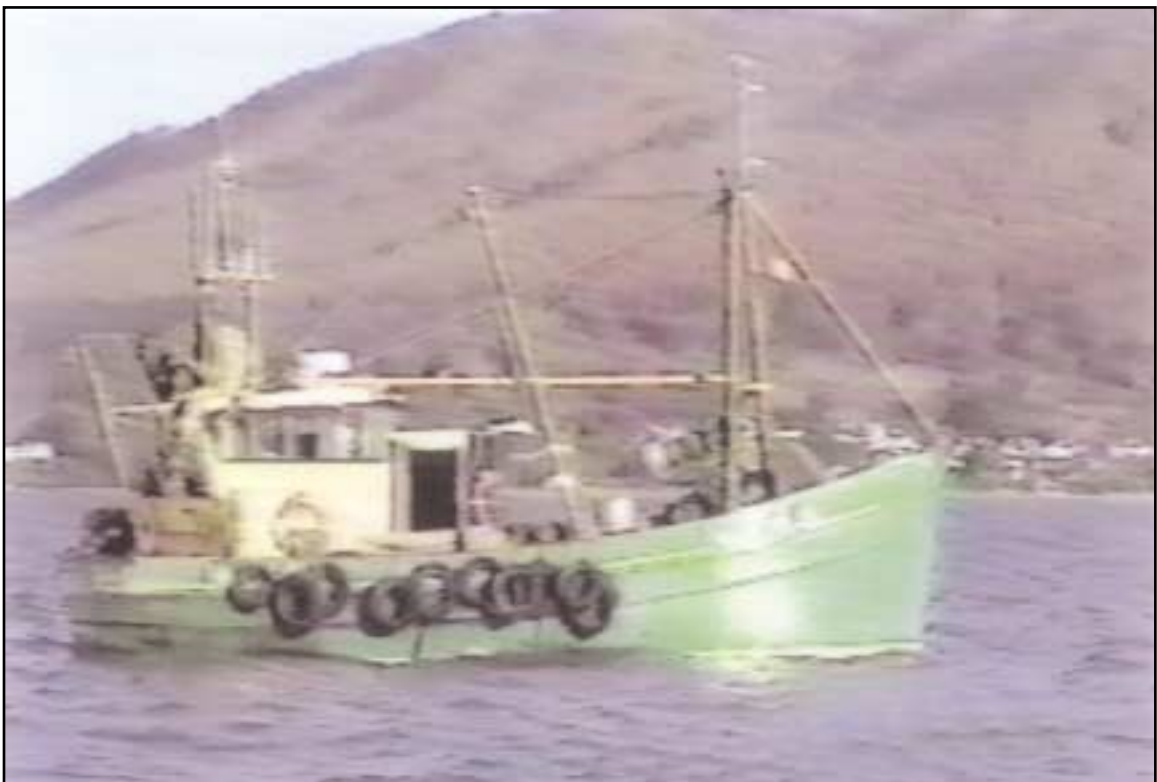
Figure 2

Starboard side of *Tullaghmurry Lass*

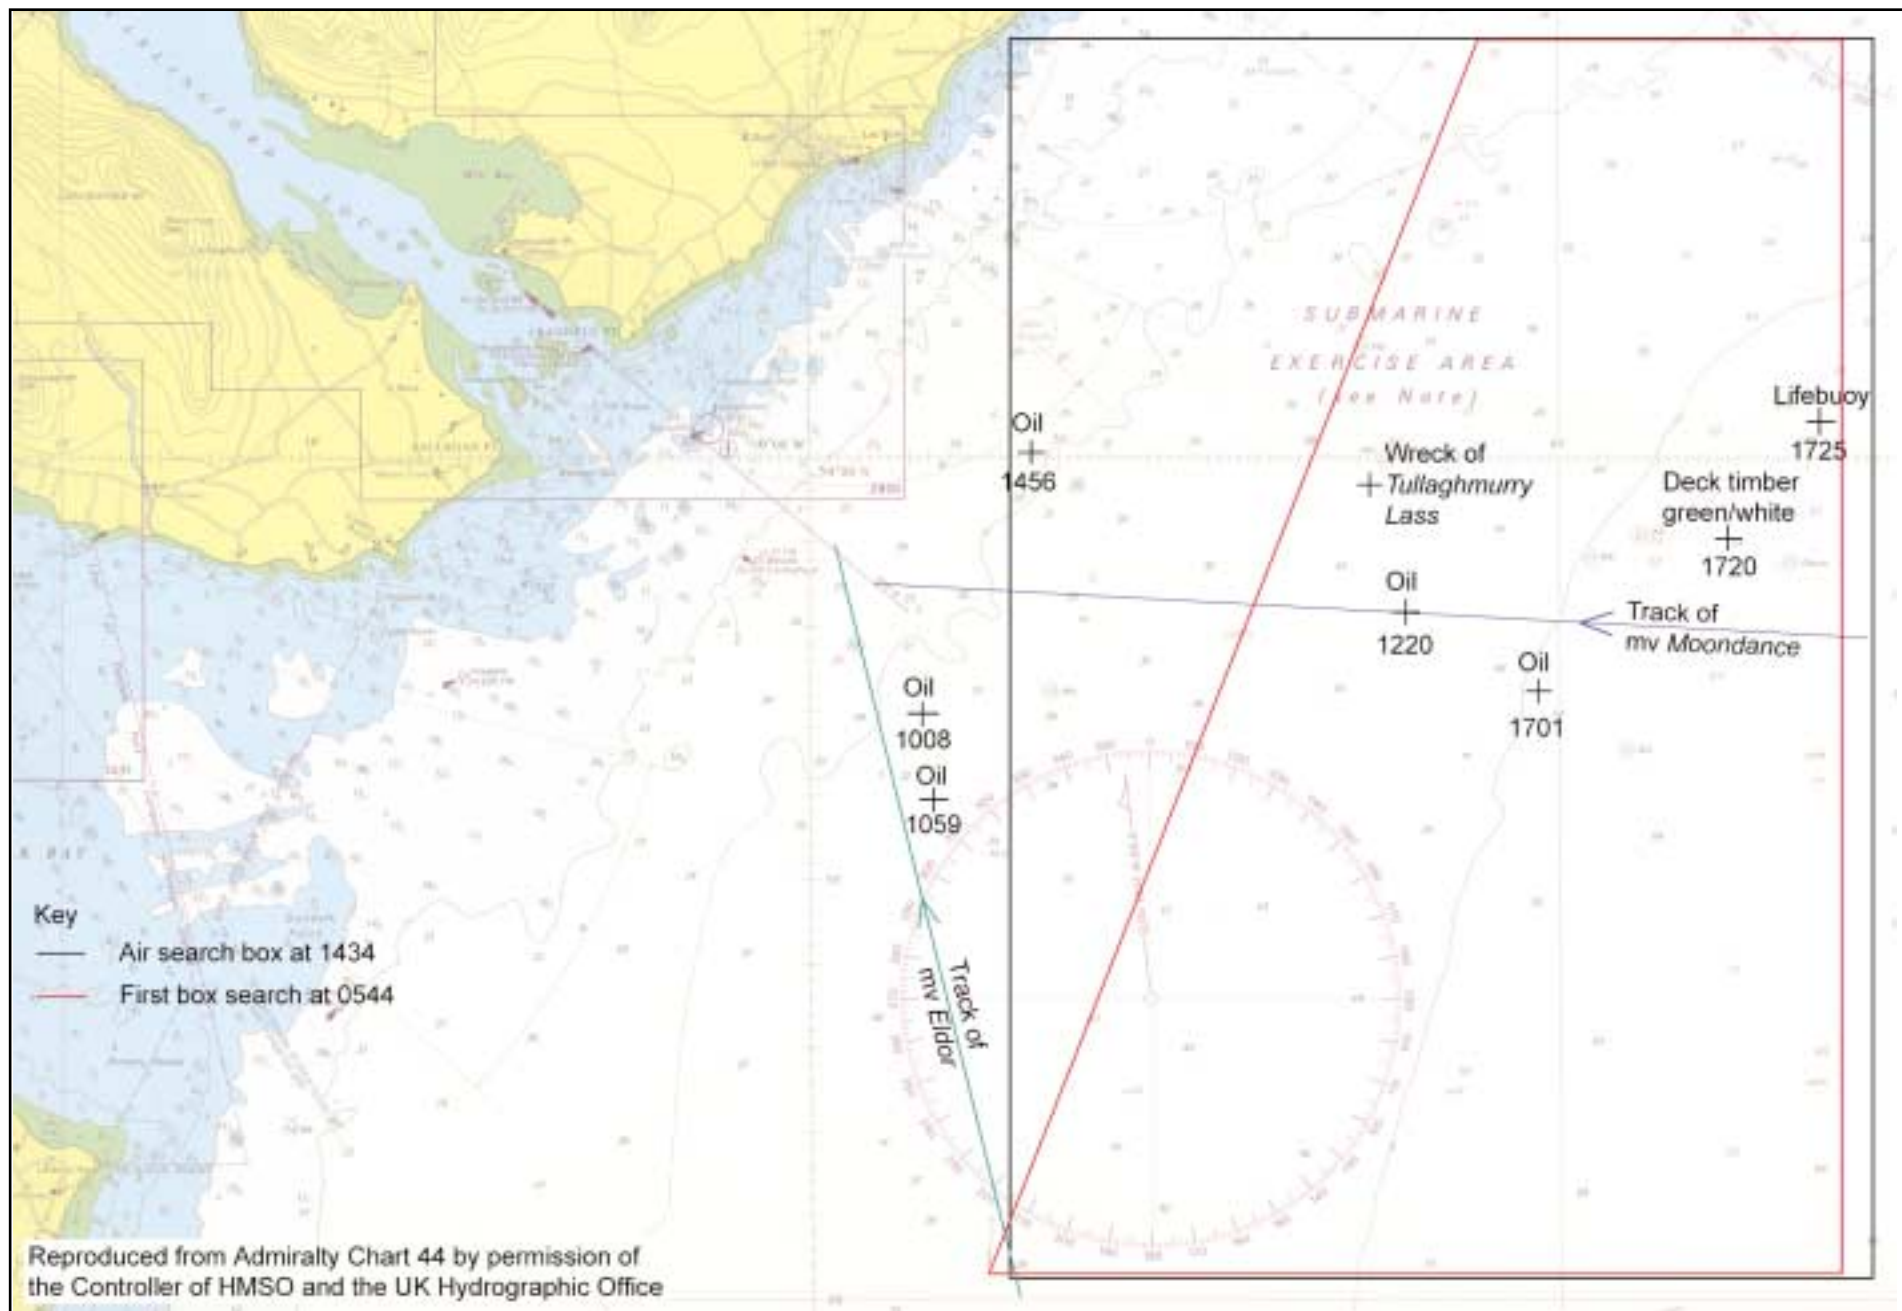
Chart extract showing the searches for *Tullaghmurry Lass* on 15 February 2002

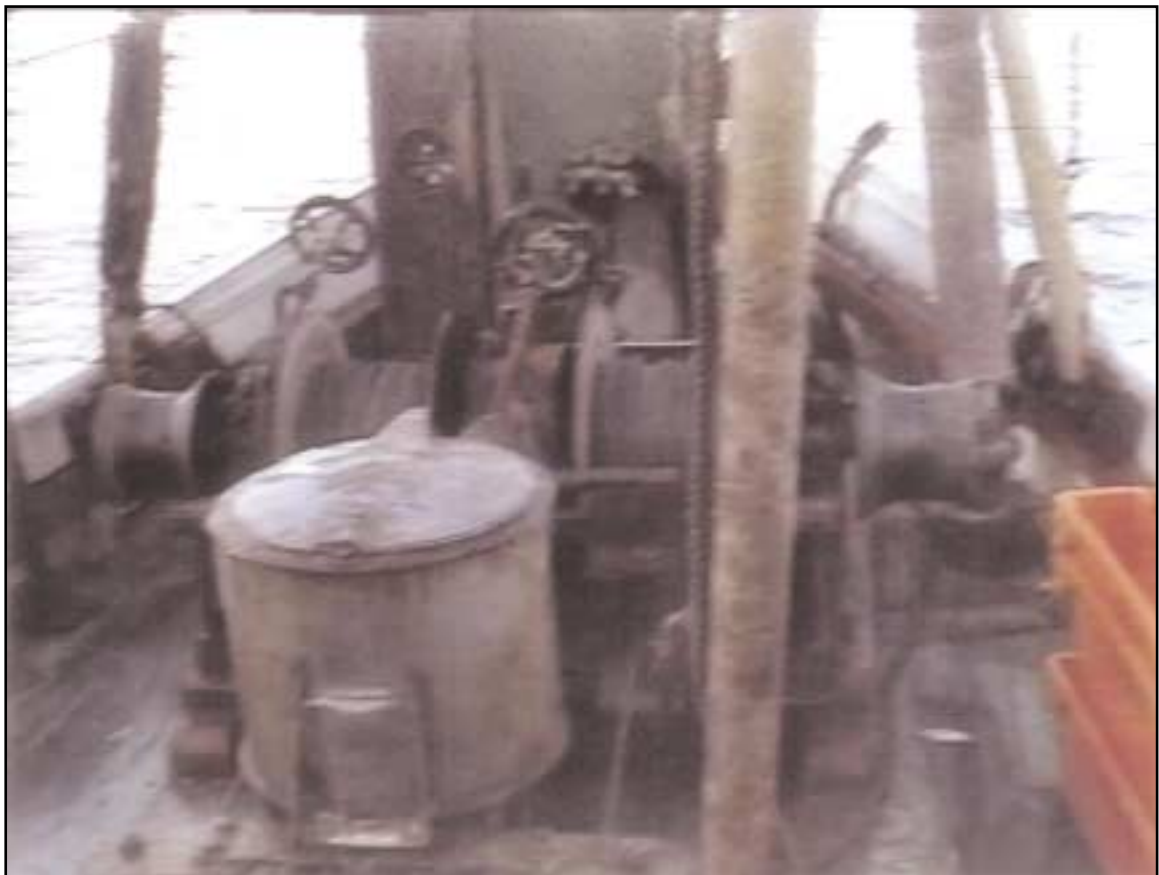
Figure 4

The working deck, forward

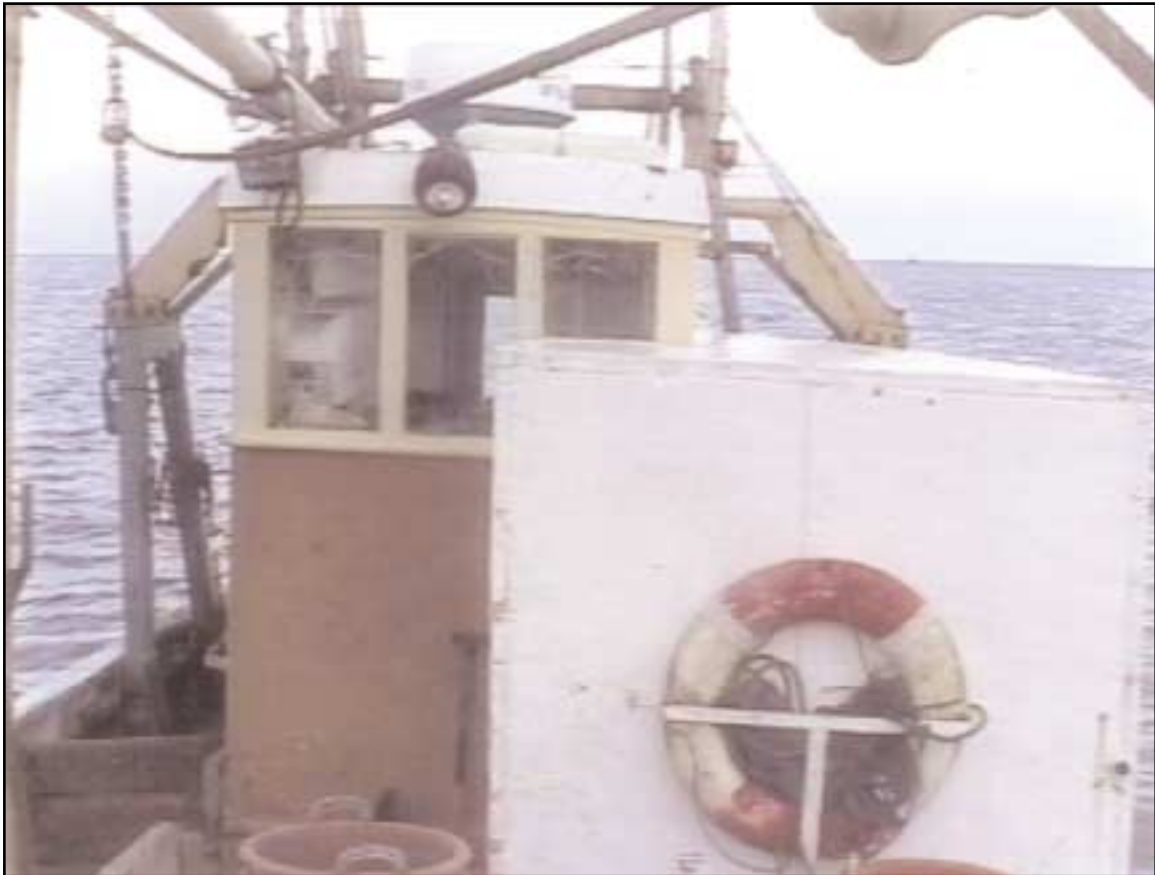
Wheelhouse, gantry and shelter
