Report on the investigation of the
grounding of the passenger ro-ro ferry

Sardinia Vera

off Newhaven on

Report No 32/2002
October 2002

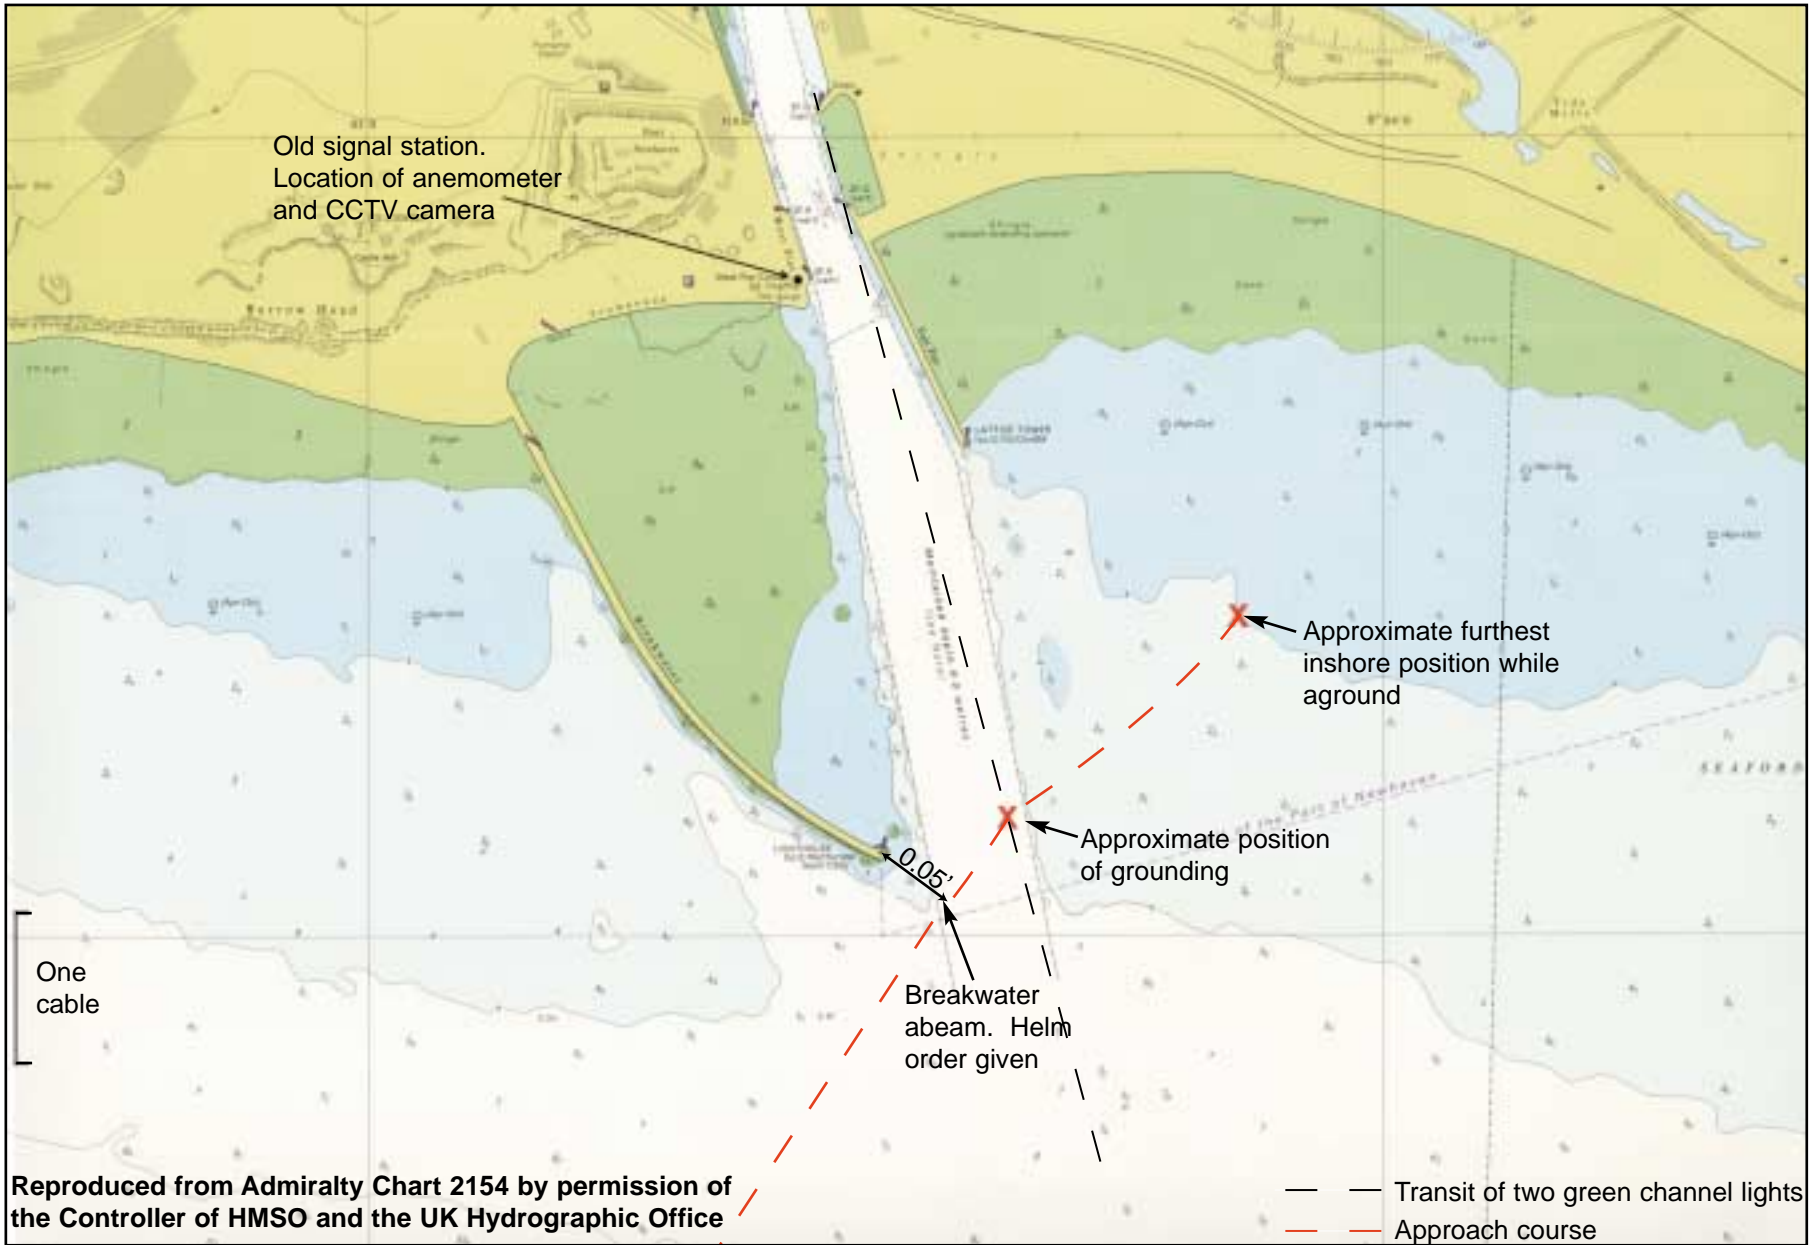
Figure 3

Chart extract showing the Newhaven approach channel

The wheel-over point was on the 5-metre contour line (**see Figure 3**). It was just over an hour after low water with a predicted height of tide of 0.8 metre, observed to be about 0.5m above prediction. This allowed minimal underkeel clearance at a draught of 5.3 metres. The depths marginally closer to the breakwater from this position are further reduced. If the vessel was just a few metres closer to the breakwater than the wheel-over position, it is possible she was at a depth close to touching bottom. This is even more likely when it is considered that there was a 2.5 metre swell running.

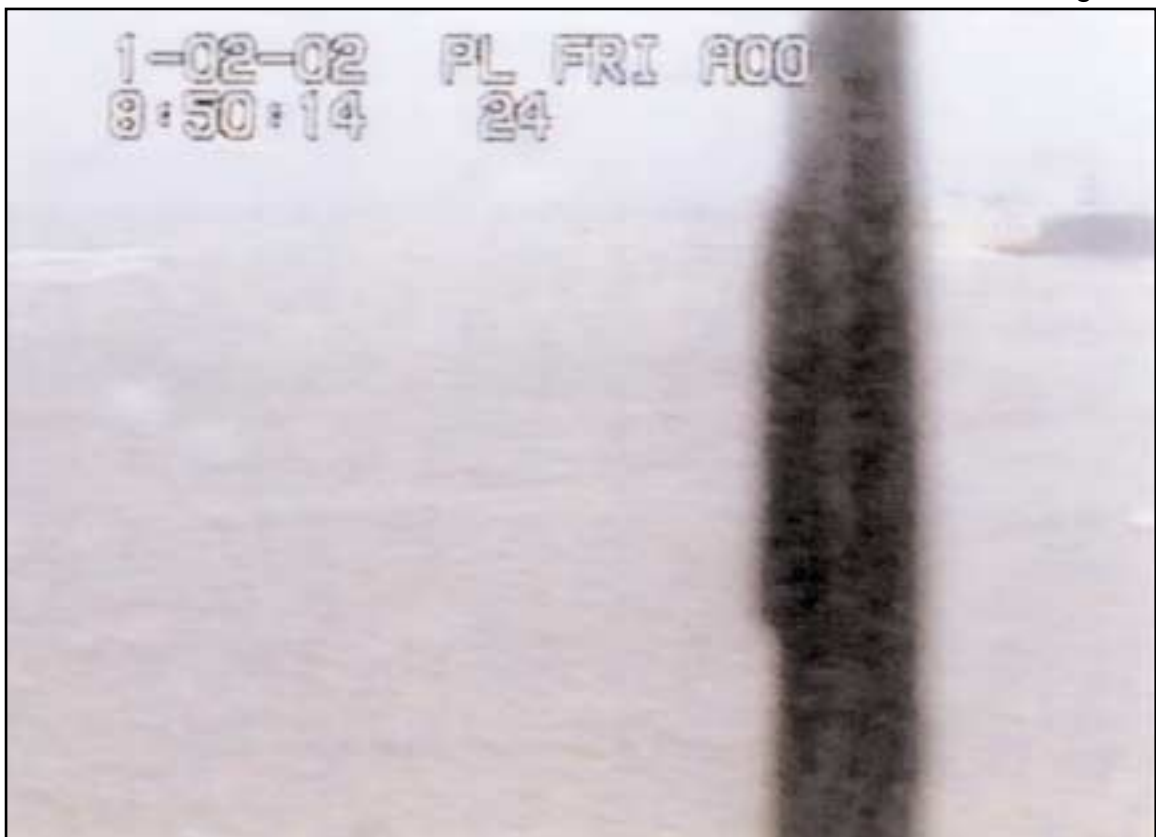
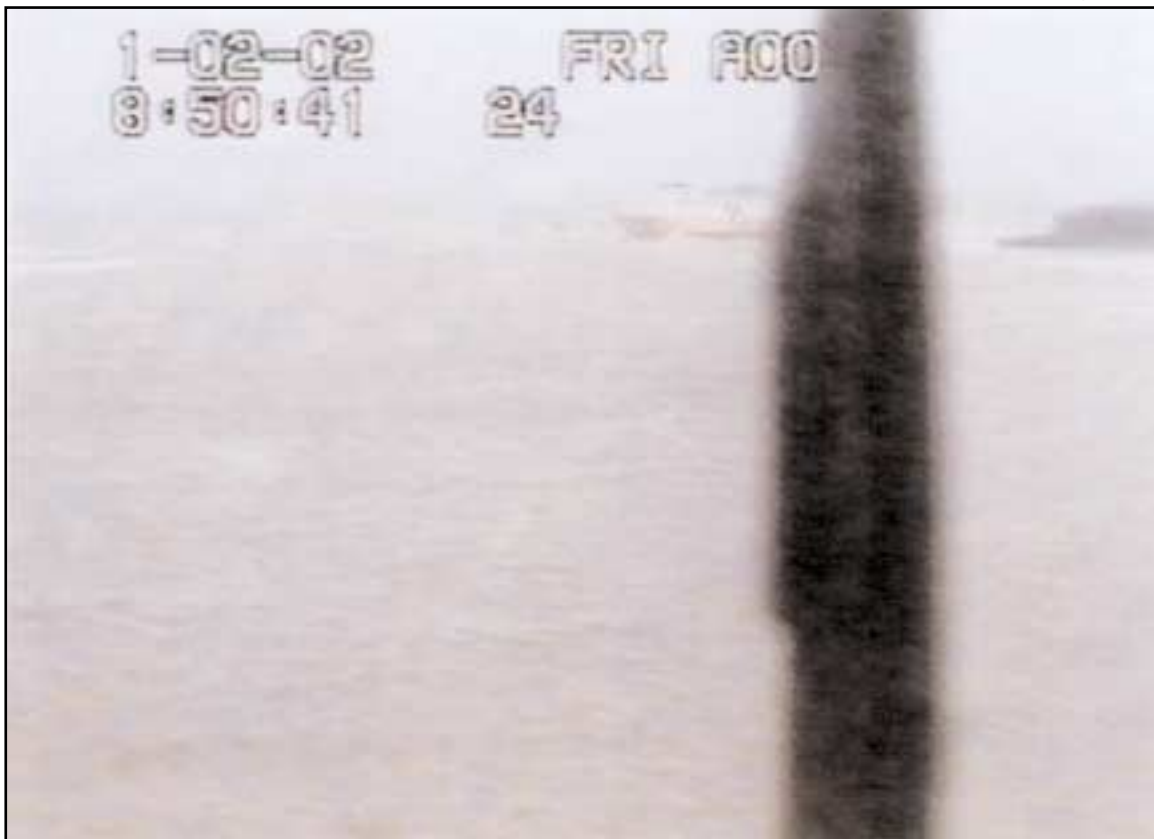
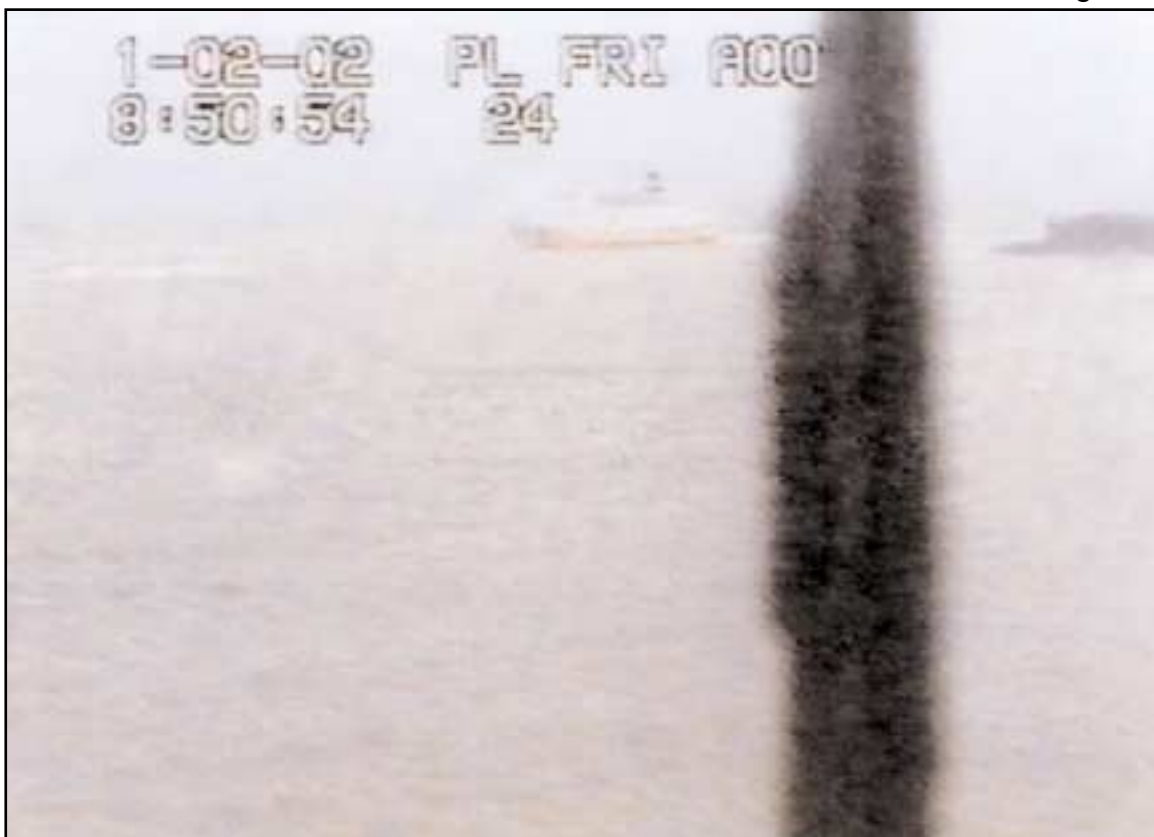
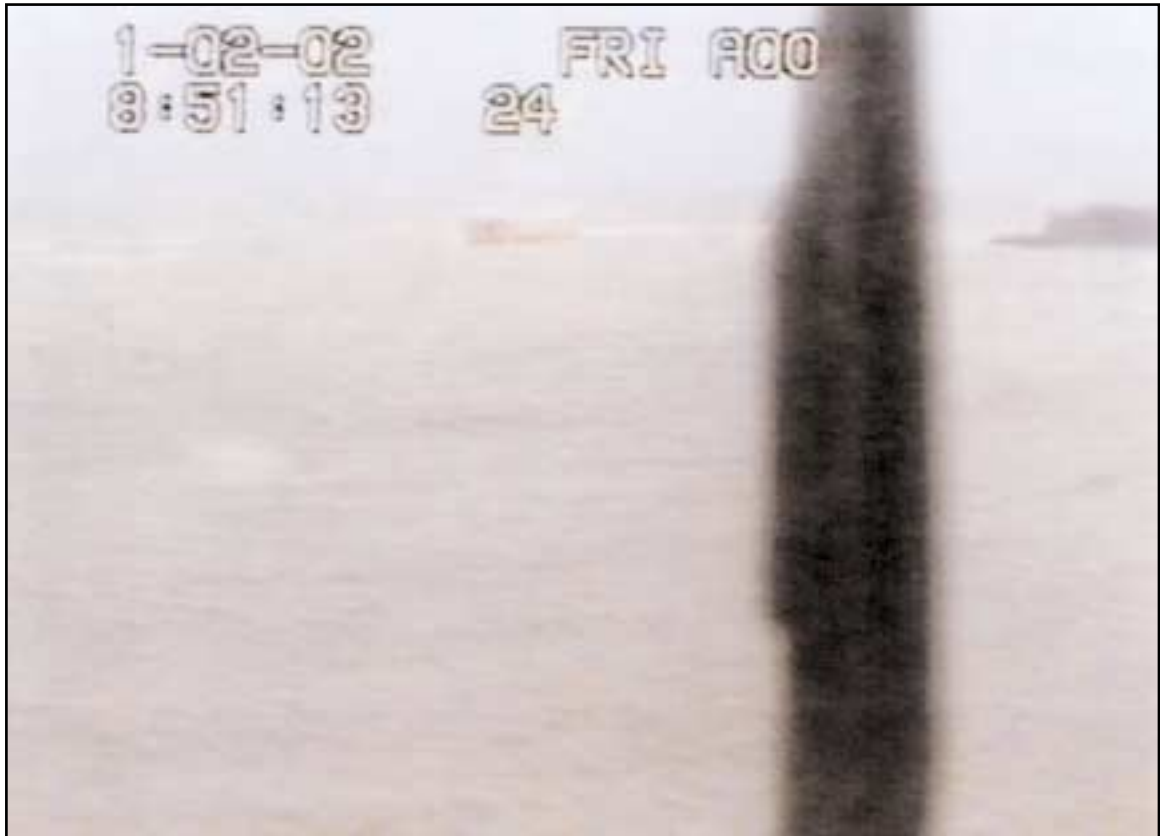
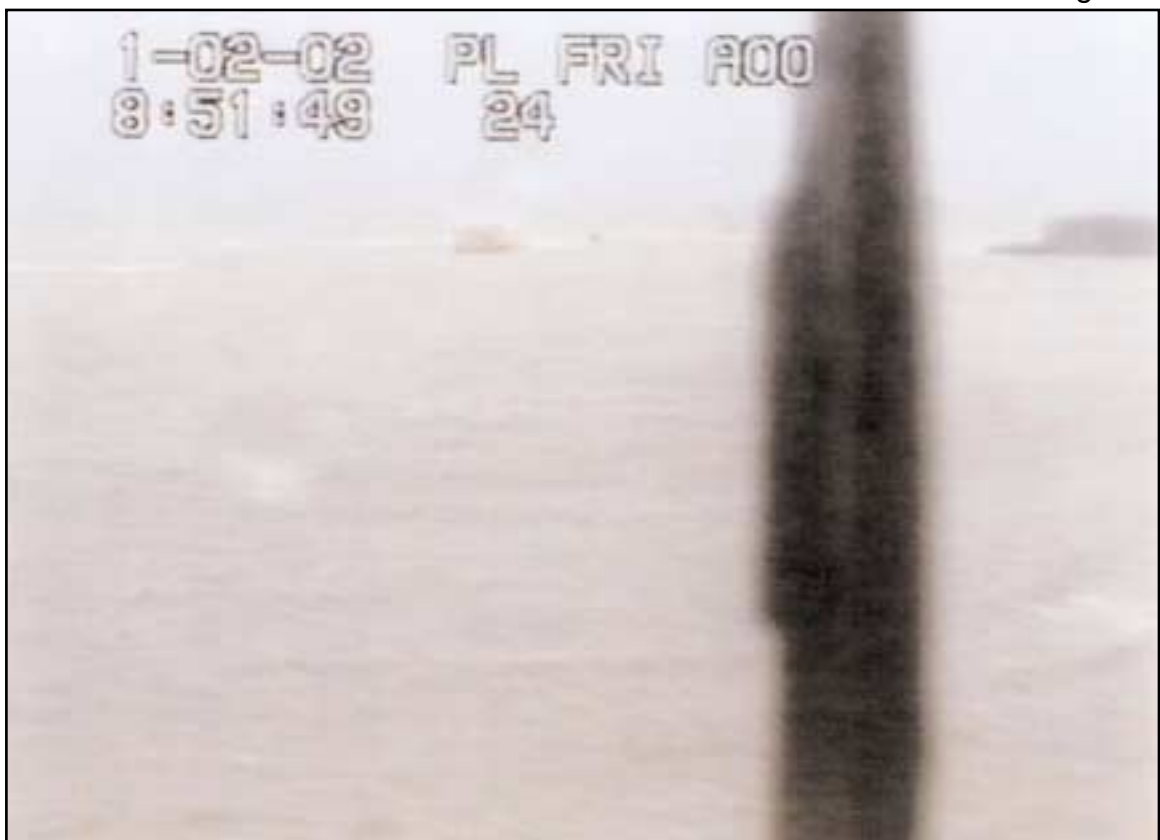
At 0850, while following the parallel index, the first officer ordered “hard to port” as the end of the breakwater came abeam of the bow. Immediately, the wheel was turned hard over to port (**see Figures 4 to 8 for the port control closed circuit television footage**).

However, the vessel continued on the same heading. After a few seconds, the master and the pilot realised that something was wrong. The master ordered the port engine to be stopped and the starboard engine to full ahead to “slew” the vessel’s head around to port. The pilot was about to give the same order but realised that the master had already given it.

Port control CCTV - breakwater abeam of vessel (Photographs 4-8)

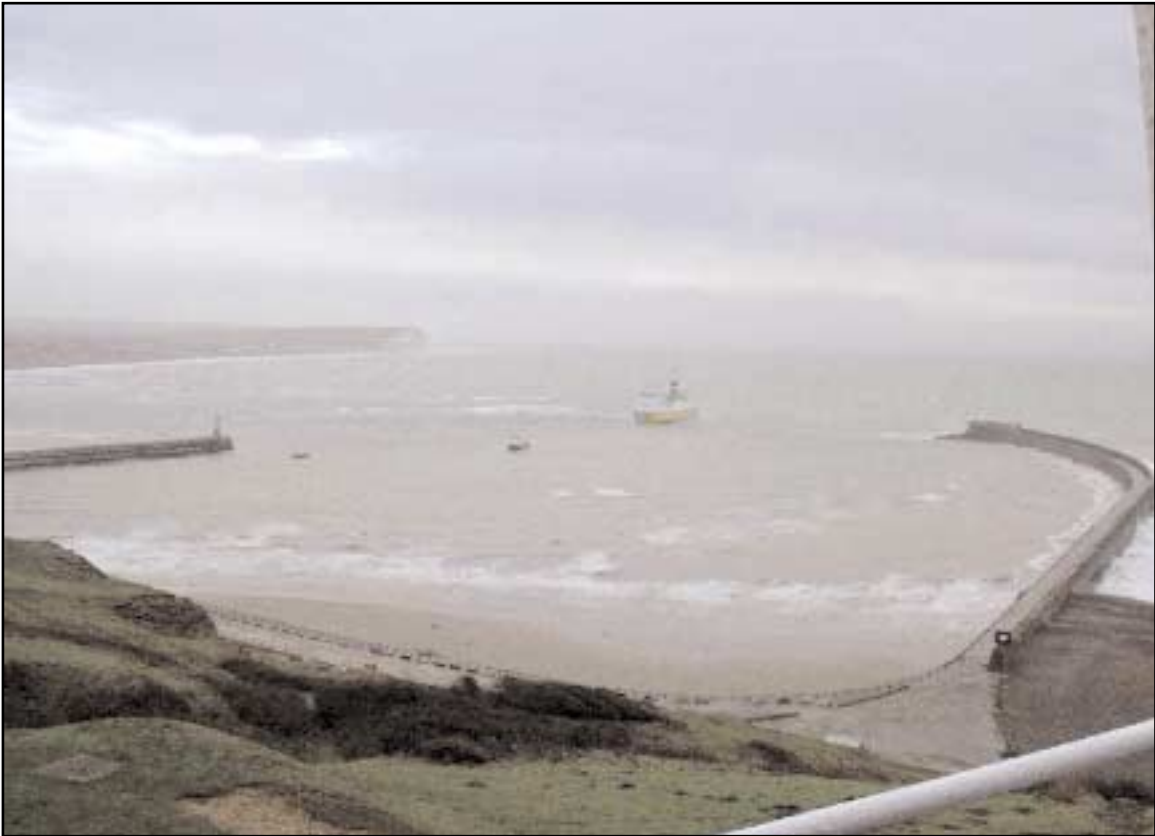
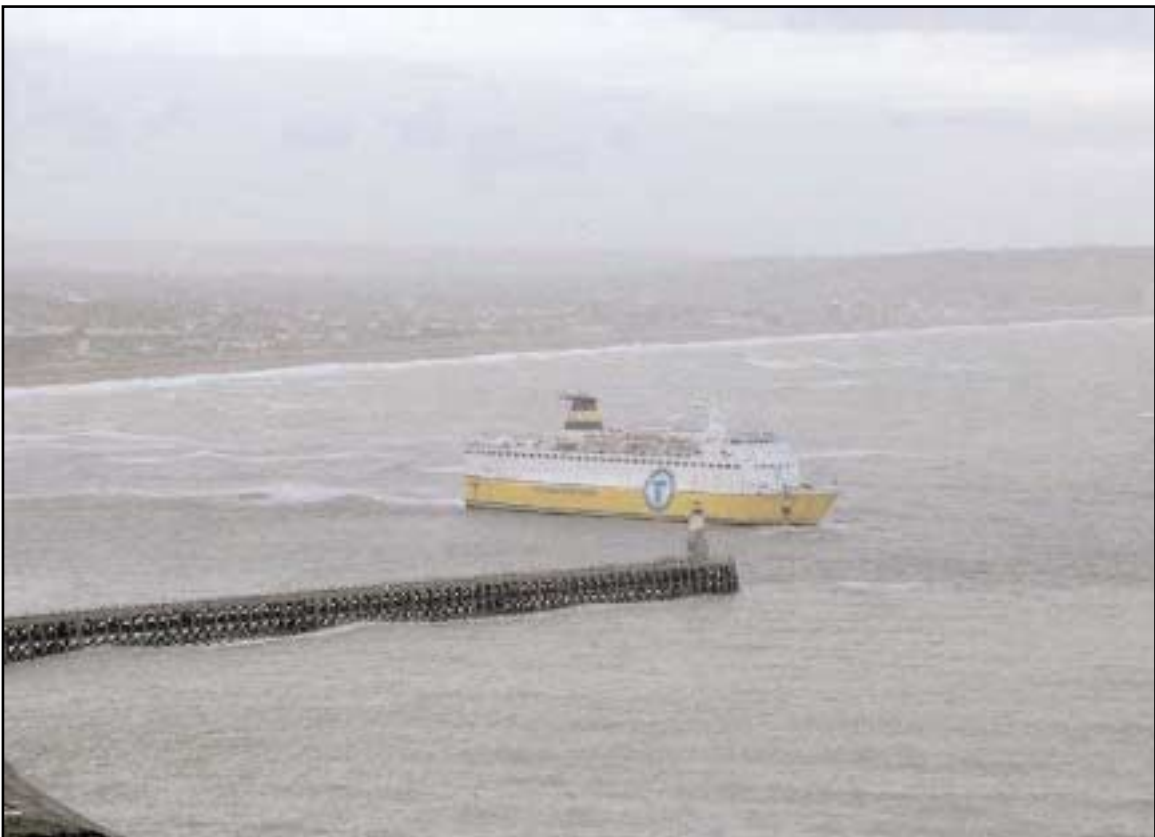
Figures 9 and 10 - *Sardinia Vera* aground

The vessel was then being pushed further inshore by the weather and was, at one stage, on the 2-metre contour line. At that time, there were fears that she might not be refloated at high water and, with the poor forecast, might be blown further aground towards, or even on to, the beach without the possibility of being refloated until the next spring tides (**see Figures 9 and 10**).

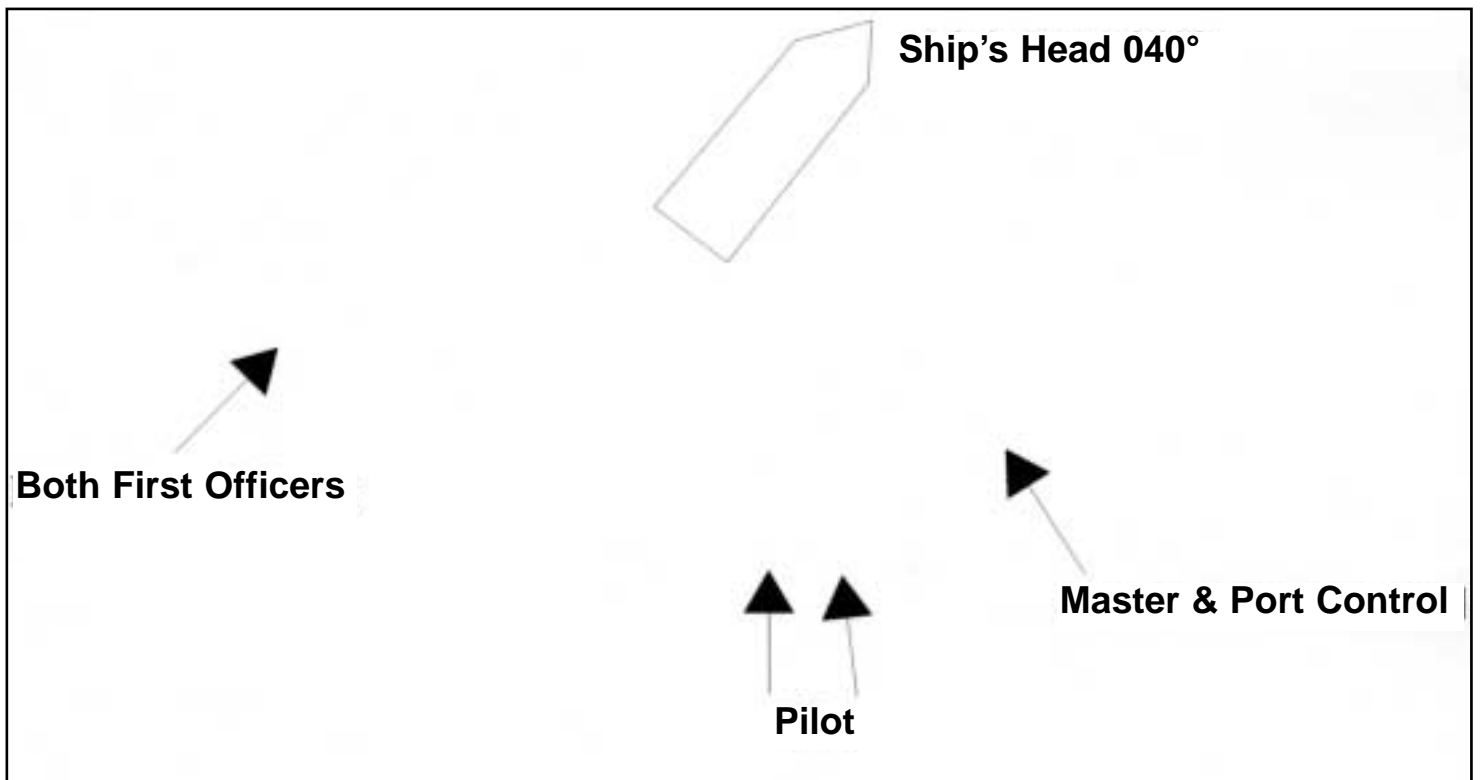
Figure 11

Pilot	S or slightly east of S
Master	SSE
First officer (training)	SW
First officer	SW
Port control	SSE

Estimation of wind direction at the time of the incident

The weather conditions were not good, with the sea and swell approximately astern. There are differing accounts as to the wind direction (**see Section 1.3 and Figure 11**). The reciprocal of the vessel's course was 220°. The two first officers reported the wind direction from the south-west. This would have been very slightly to port of right astern. The master and port control reported the wind as coming from the south-south-east. This would have put the wind about 25° abaft the starboard beam. The port control information came from an anemometer inside the port and, therefore, the conditions might have been different to those outside the port because of eddies etc. The pilot reported the wind as coming from the south or slightly to the east of south. This would have put the wind about 45° on the starboard quarter.

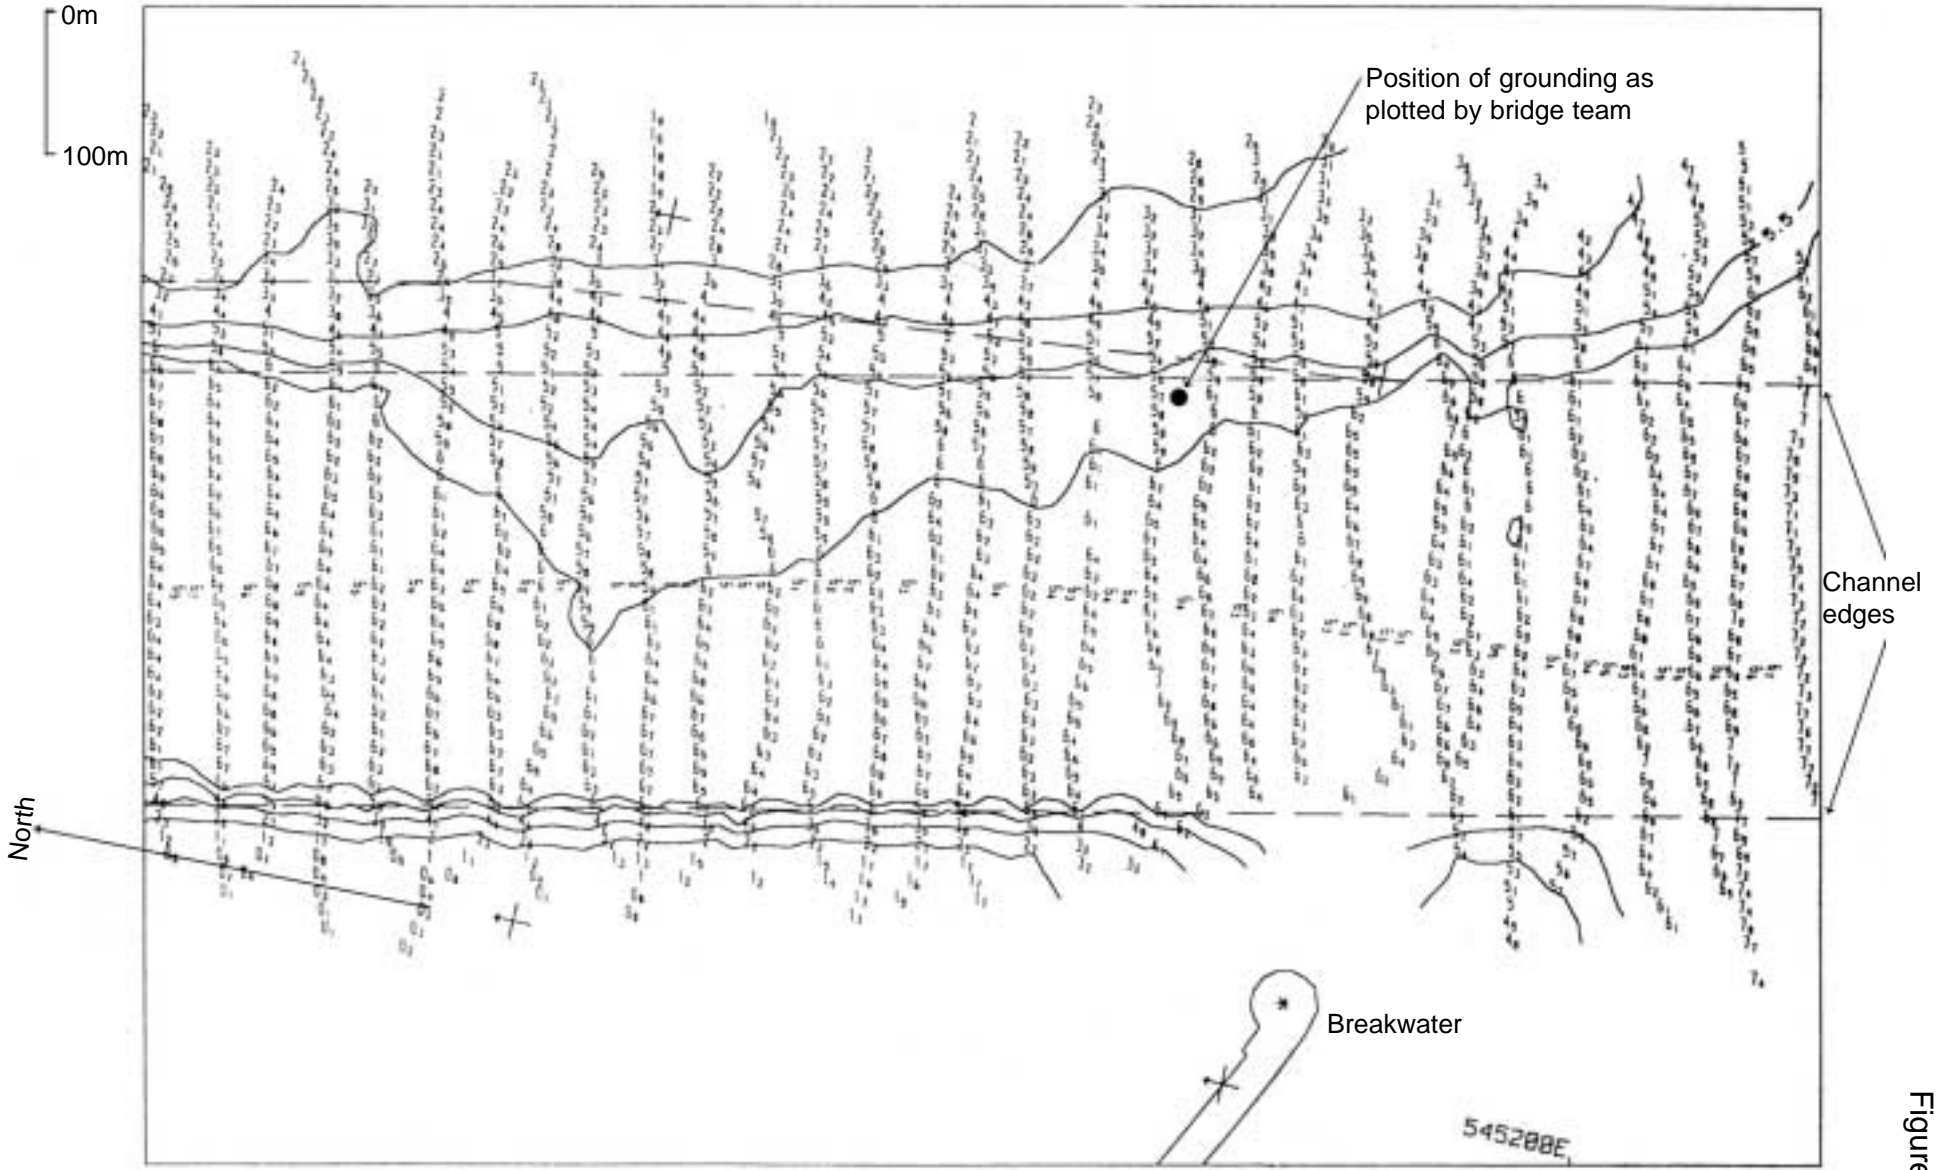
Figure 13

Maintenance dredging normally occurred twice a year and had been completed shortly before the incident. A depth survey was made on completion of the dredging operation. The latest survey, conducted in January 2002, is shown in **Figure 13**. No further survey was intended to be made until the next dredging operation.

Survey made in January 2002

1. With respect to Newhaven approach channel:
 - Take further steps to reduce the silting of the eastern side of the approach channel.
 - Carry out a formal written risk assessment with regard to vessels entering Newhaven approach channel in a variety of wind and tidal conditions.
2. With respect to the port control:
 - Install radars, which have the ability to record data for playback purposes, in the port control.
 - Install an anemometer on the end of the western breakwater with a remote readout to the port control.
