Report on the investigation of the
grounding of the passenger ro-ro ferry

Sardinia Vera

off Newhaven on

Report No 32/2002
October 2002

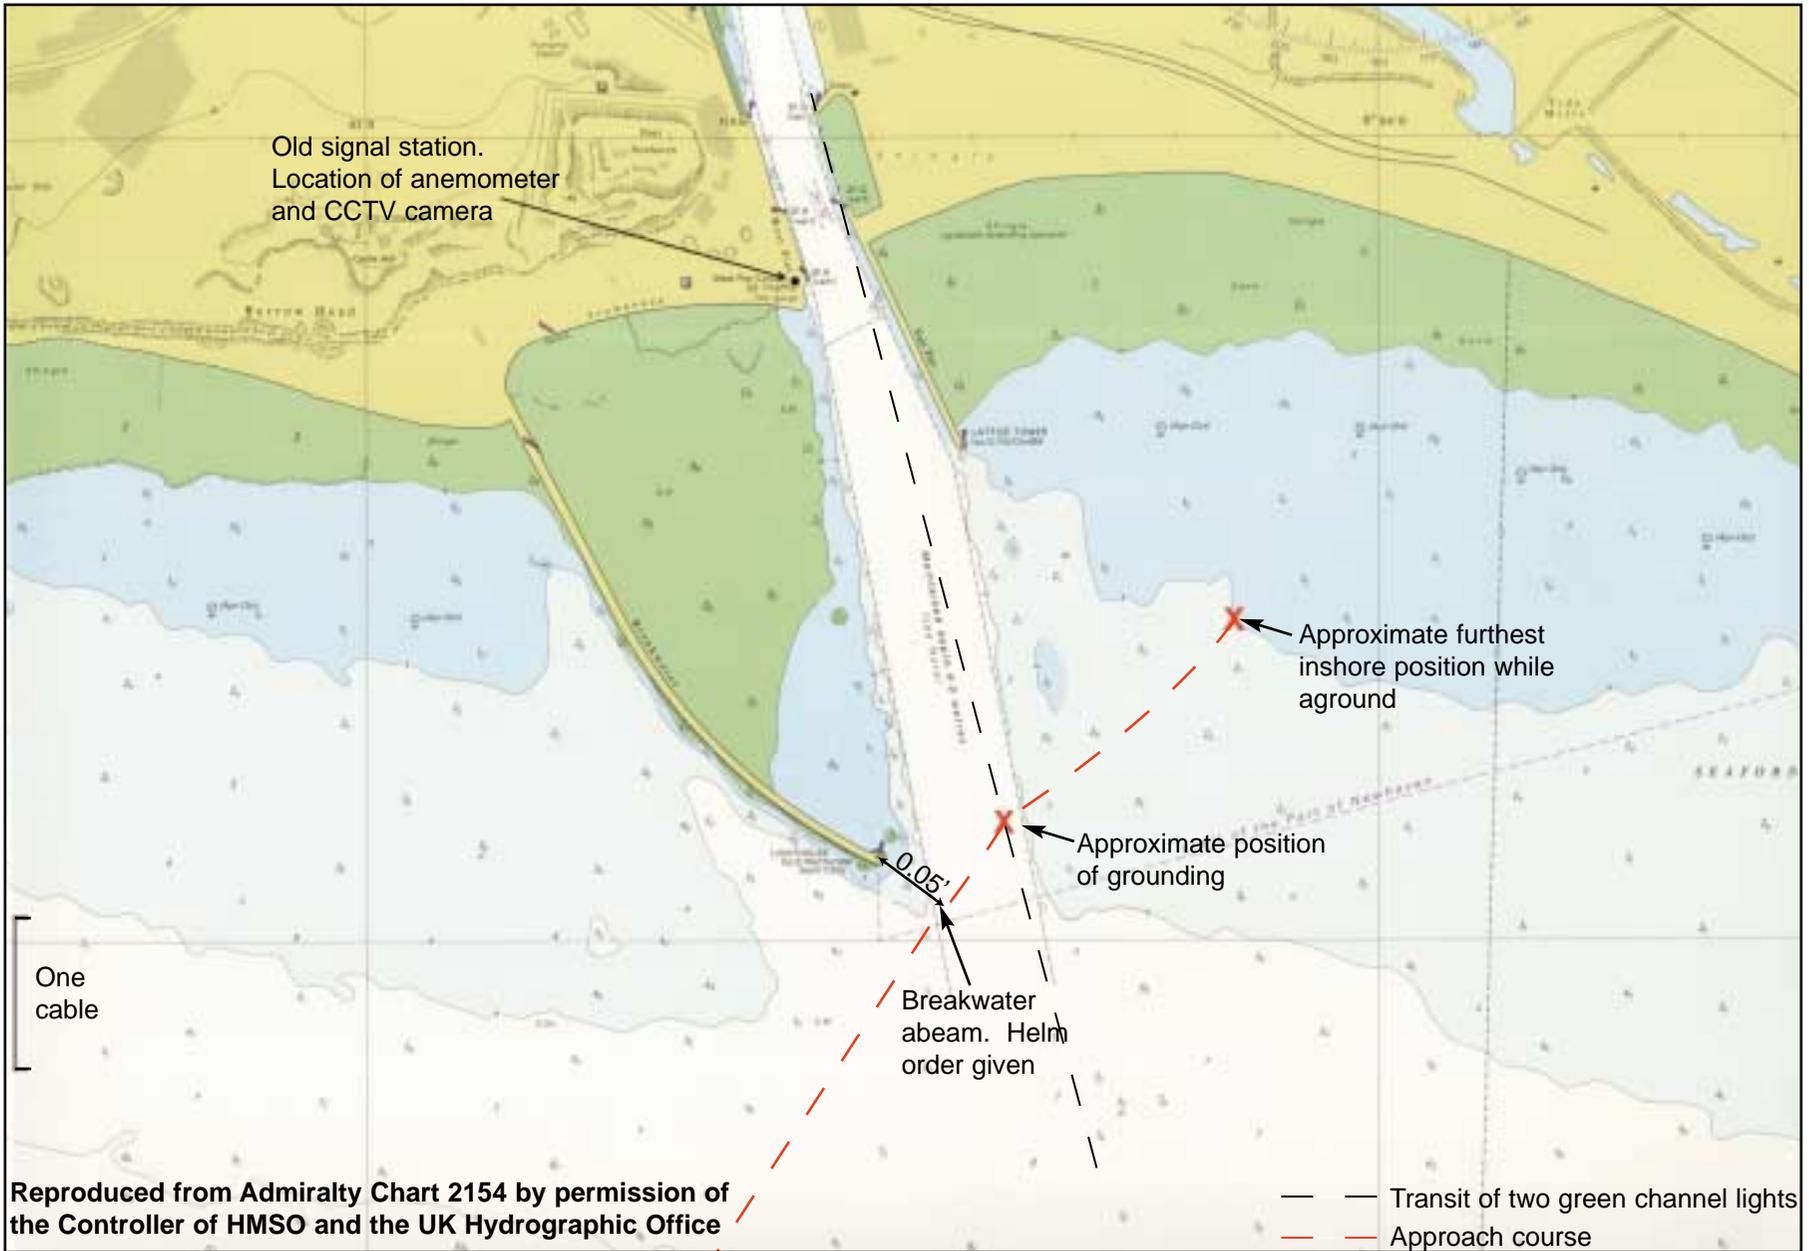
Figure 3

Chart extract showing the Newhaven approach channel

The wheel-over point was on the 5-metre contour line (**see Figure 3**). It was just over an hour after low water with a predicted height of tide of 0.8 metre, observed to be about 0.5m above prediction. This allowed minimal underkeel clearance at a draught of 5.3 metres. The depths marginally closer to the breakwater from this position are further reduced. If the vessel was just a few metres closer to the breakwater than the wheel-over position, it is possible she was at a depth close to touching bottom. This is even more likely when it is considered that there was a 2.5 metre swell running.

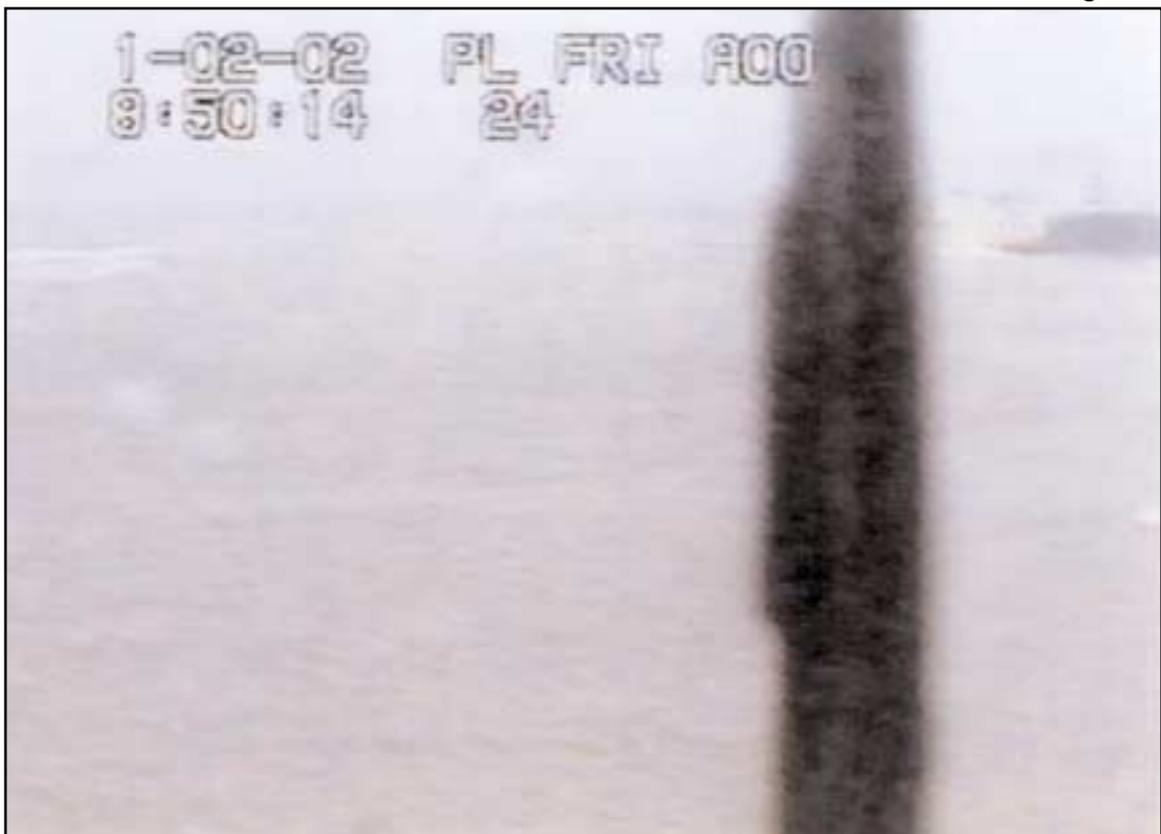
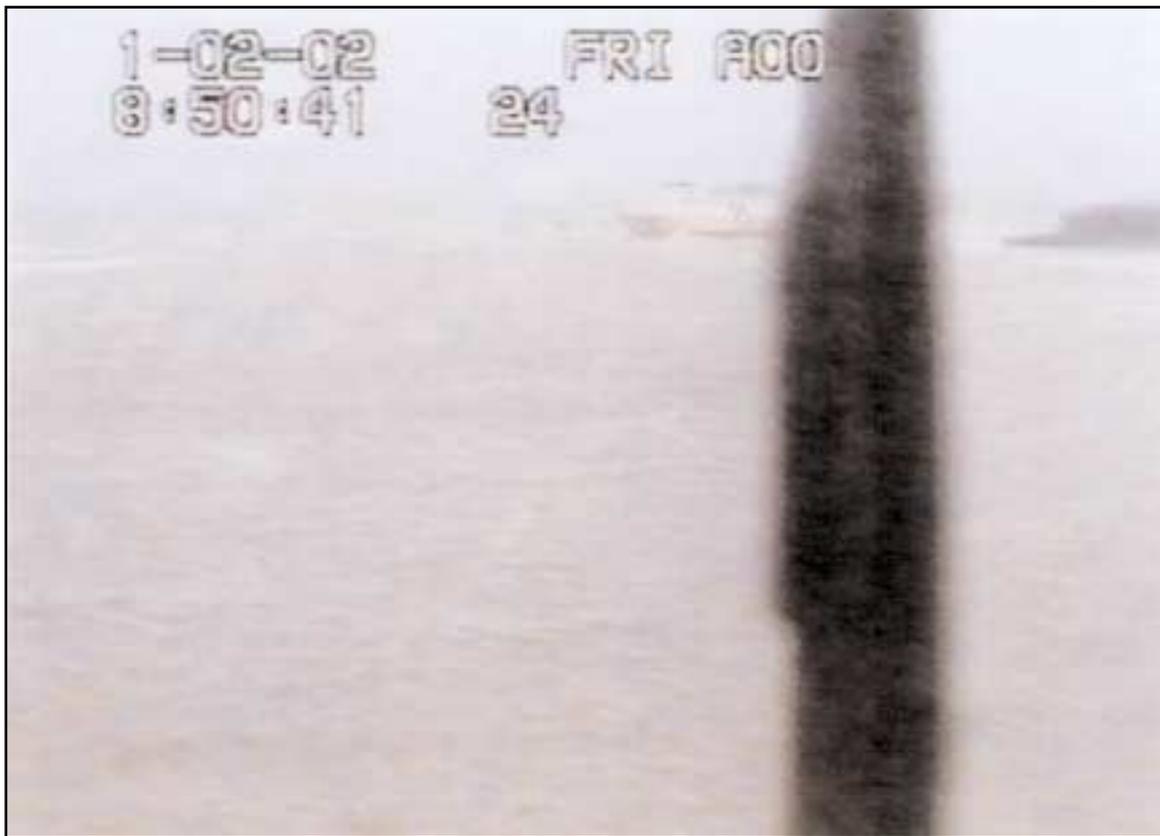
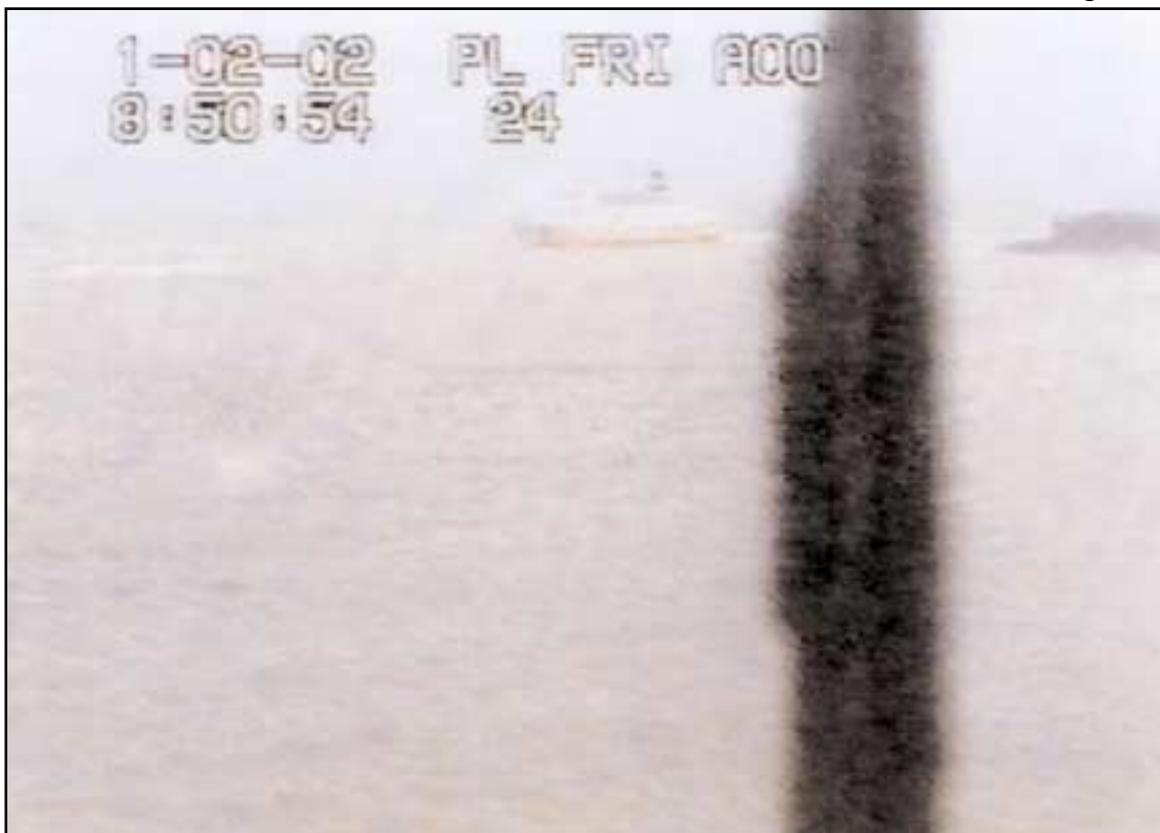
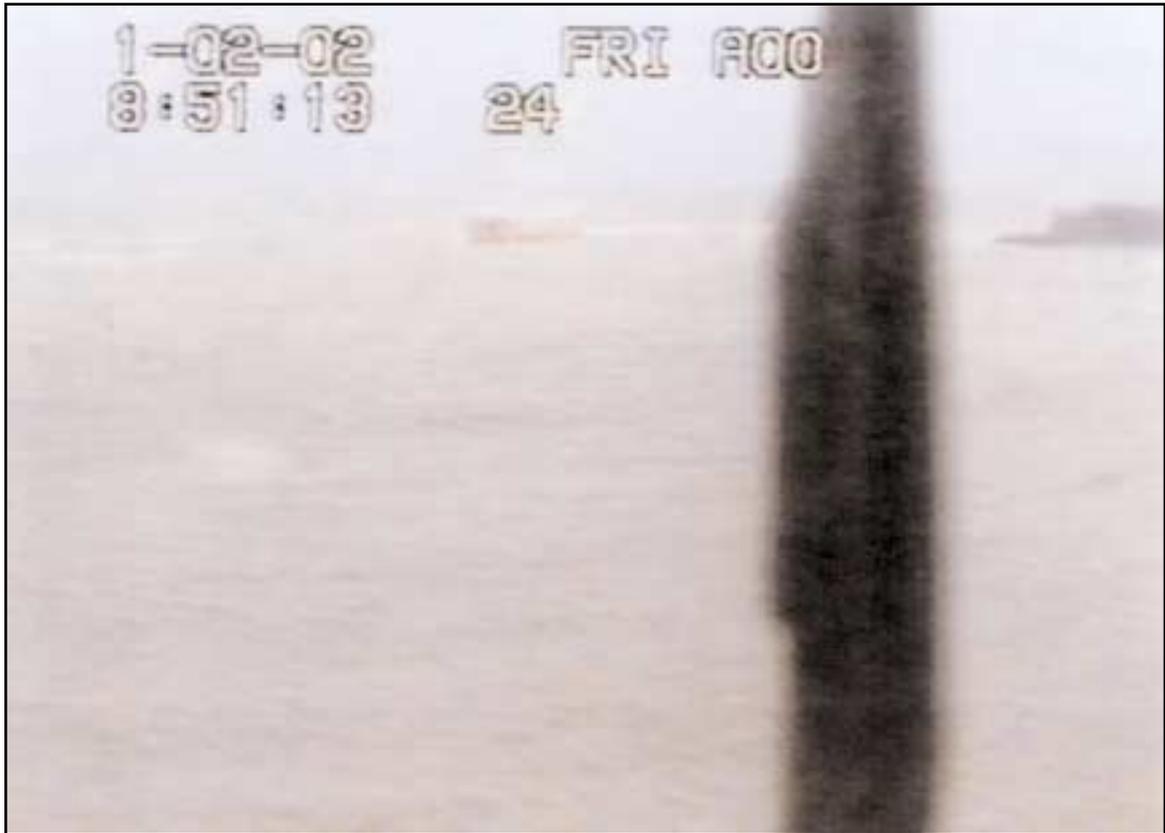
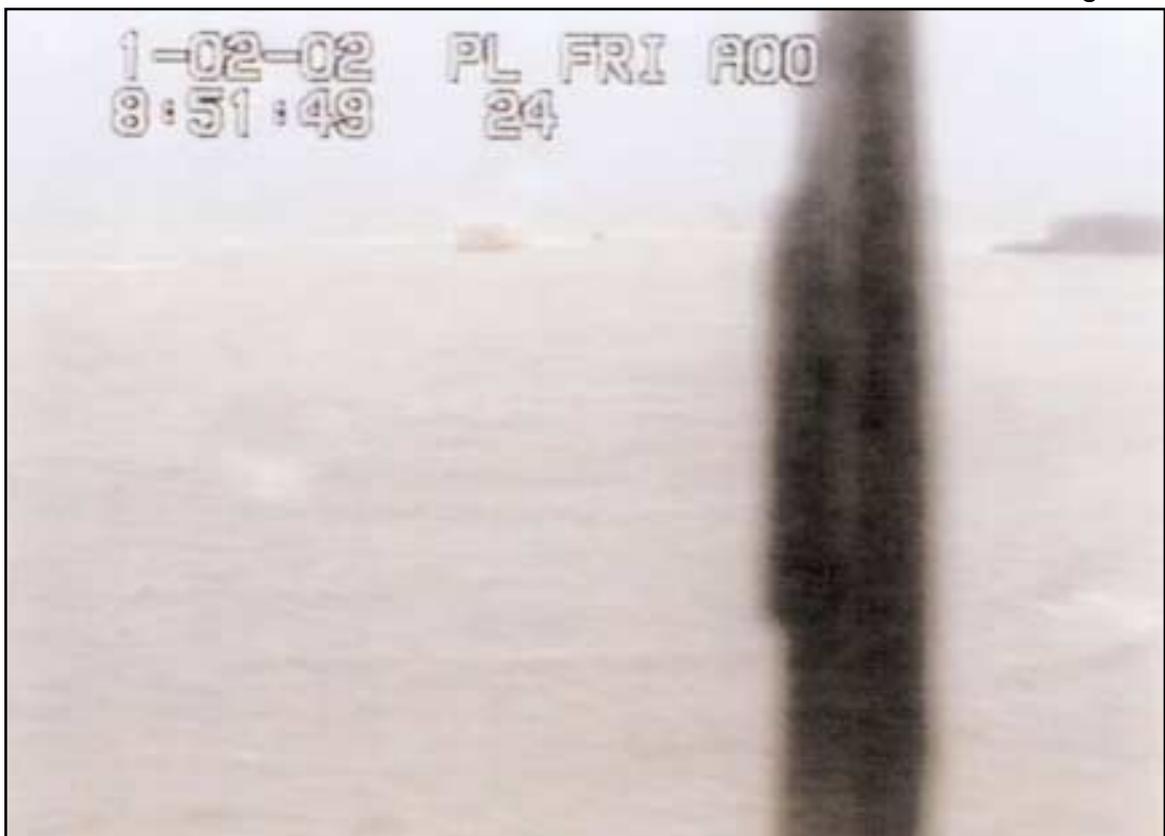
At 0850, while following the parallel index, the first officer ordered “hard to port” as the end of the breakwater came abeam of the bow. Immediately, the wheel was turned hard over to port (**see Figures 4 to 8 for the port control closed circuit television footage**).

Port control CCTV - breakwater abeam of vessel (Photographs 4-8)

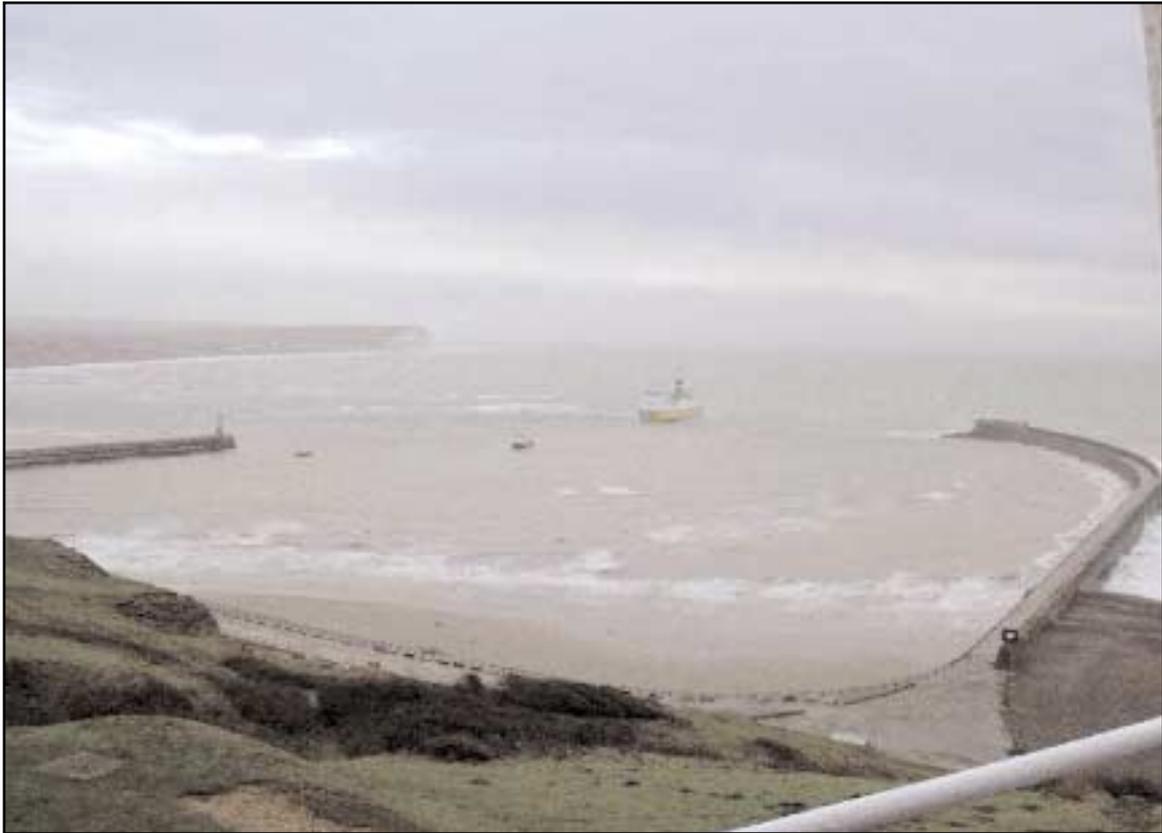
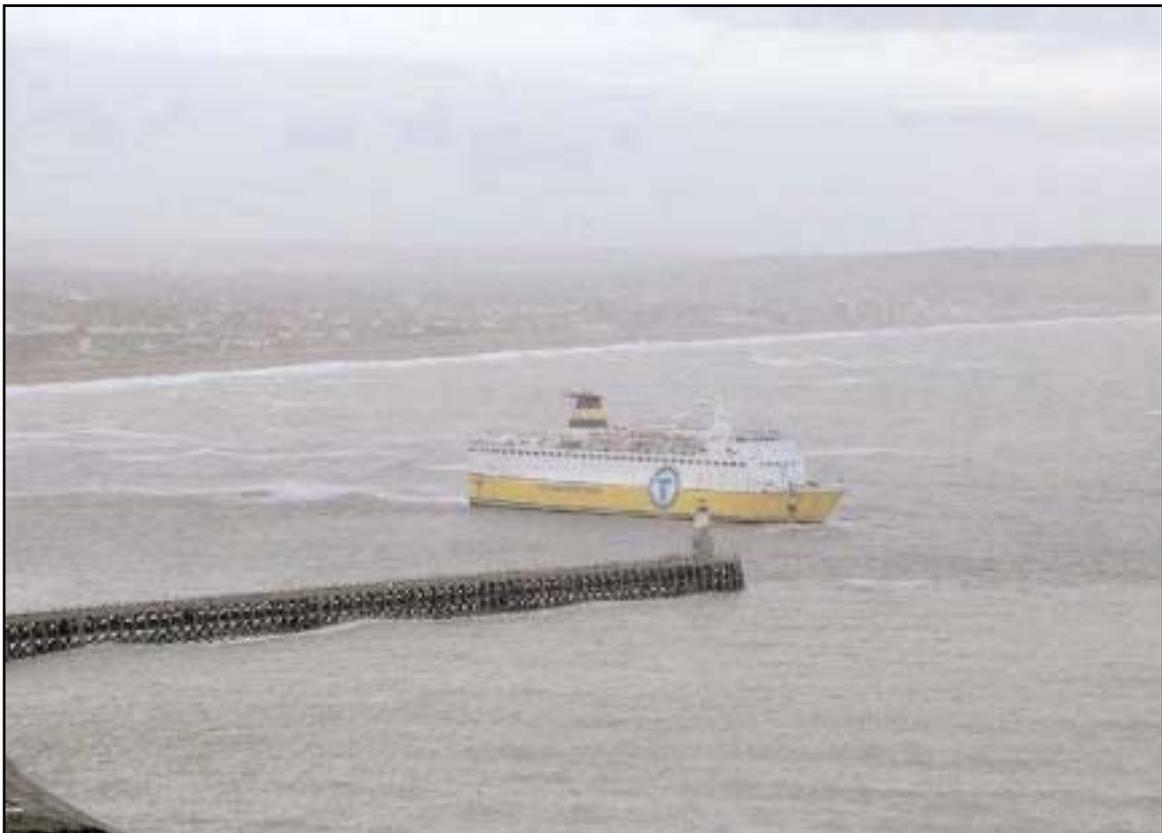
Figures 9 and 10 - *Sardinia Vera* aground

The vessel was then being pushed further inshore by the weather and was, at one stage, on the 2-metre contour line. At that time, there were fears that she might not be refloated at high water and, with the poor forecast, might be blown further aground towards, or even on to, the beach without the possibility of being refloated until the next spring tides (**see Figures 9 and 10**).

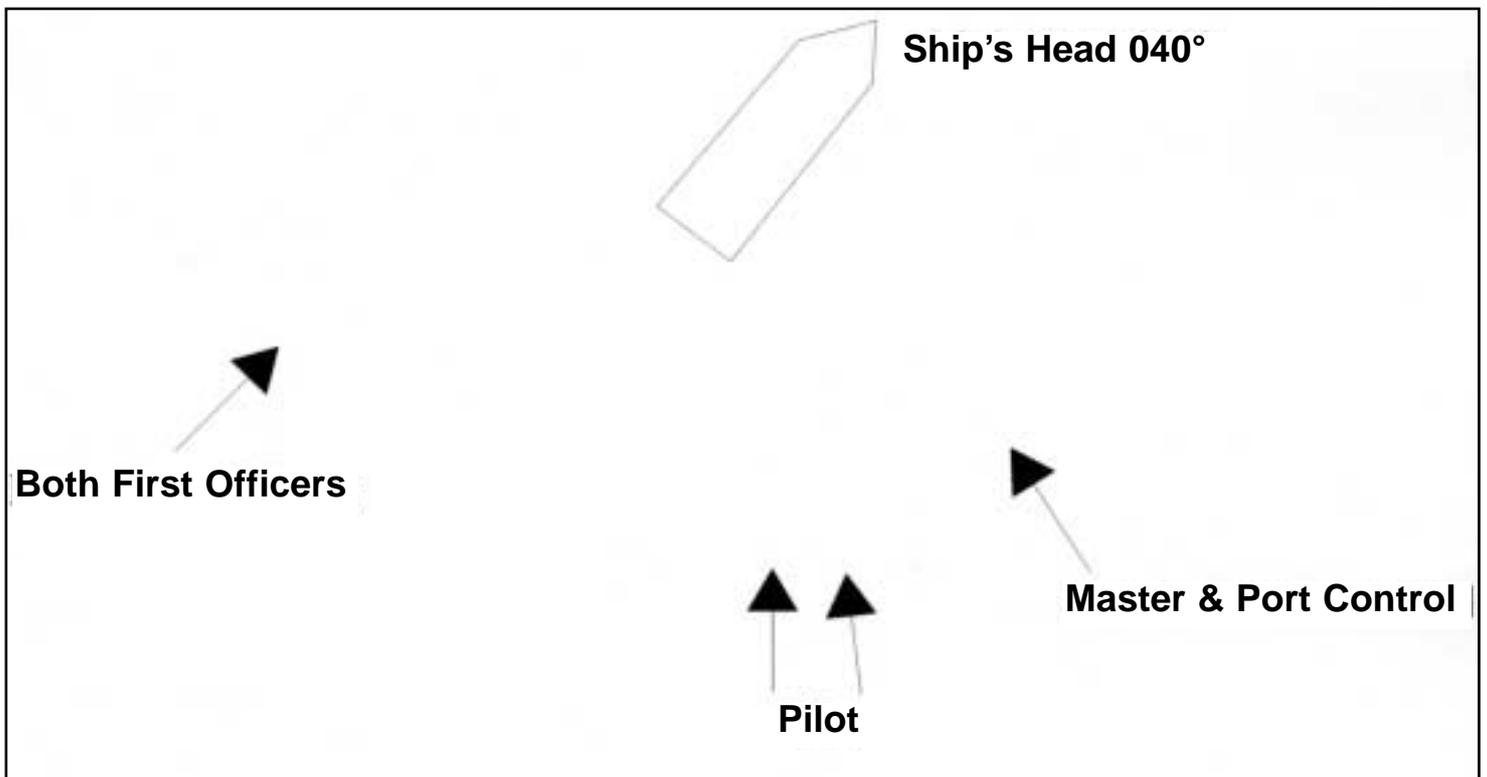
Figure 11

Pilot	S or slightly east of S
Master	SSE
First officer (training)	SW
First officer	SW
Port control	SSE

Estimation of wind direction at the time of the incident

The weather conditions were not good, with the sea and swell approximately astern. There are differing accounts as to the wind direction (**see Section 1.3 and Figure 11**). The reciprocal of the vessel's course was 220°. The two first officers reported the wind direction from the south-west. This would have been very slightly to port of right astern. The master and port control reported the wind as coming from the south-south-east. This would have put the wind about 25° abaft the starboard beam. The port control information came from an anemometer inside the port and, therefore, the conditions might have been different to those outside the port because of eddies etc. The pilot reported the wind as coming from the south or slightly to the east of south. This would have put the wind about 45° on the starboard quarter.

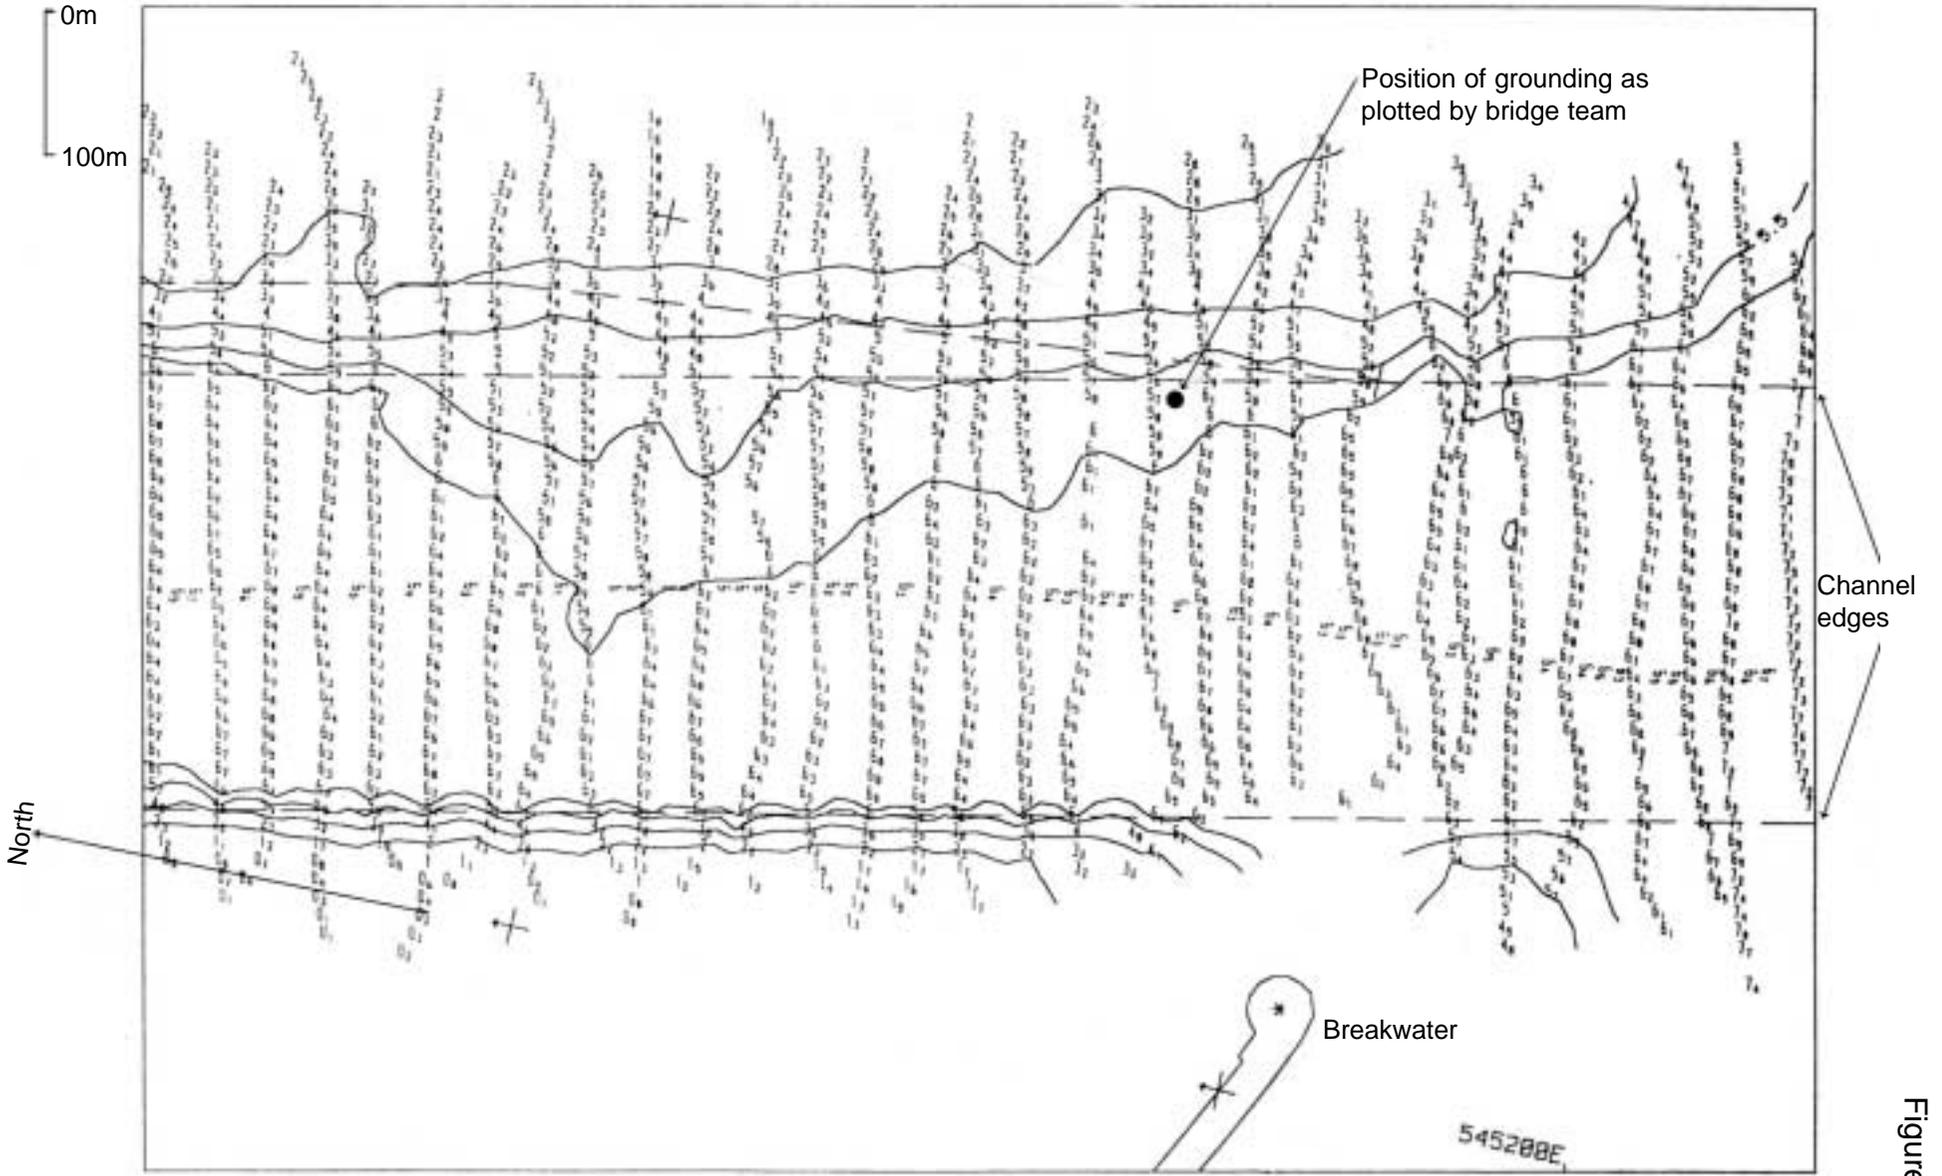
Figure 13

Maintenance dredging normally occurred twice a year and had been completed shortly before the incident. A depth survey was made on completion of the dredging operation. The latest survey, conducted in January 2002, is shown in **Figure 13**. No further survey was intended to be made until the next dredging operation.

Survey made in January 2002

1. With respect to Newhaven approach channel:
 - Take further steps to reduce the silting of the eastern side of the approach channel.
 - Carry out a formal written risk assessment with regard to vessels entering Newhaven approach channel in a variety of wind and tidal conditions.
2. With respect to the port control:
 - Install radars, which have the ability to record data for playback purposes, in the port control.
 - Install an anemometer on the end of the western breakwater with a remote readout to the port control.
