Report on the investigation of
the capsizing of the fishing vessel

Charisma (OB588)

30 January 2002

**Report No 38/2002
November 2002**

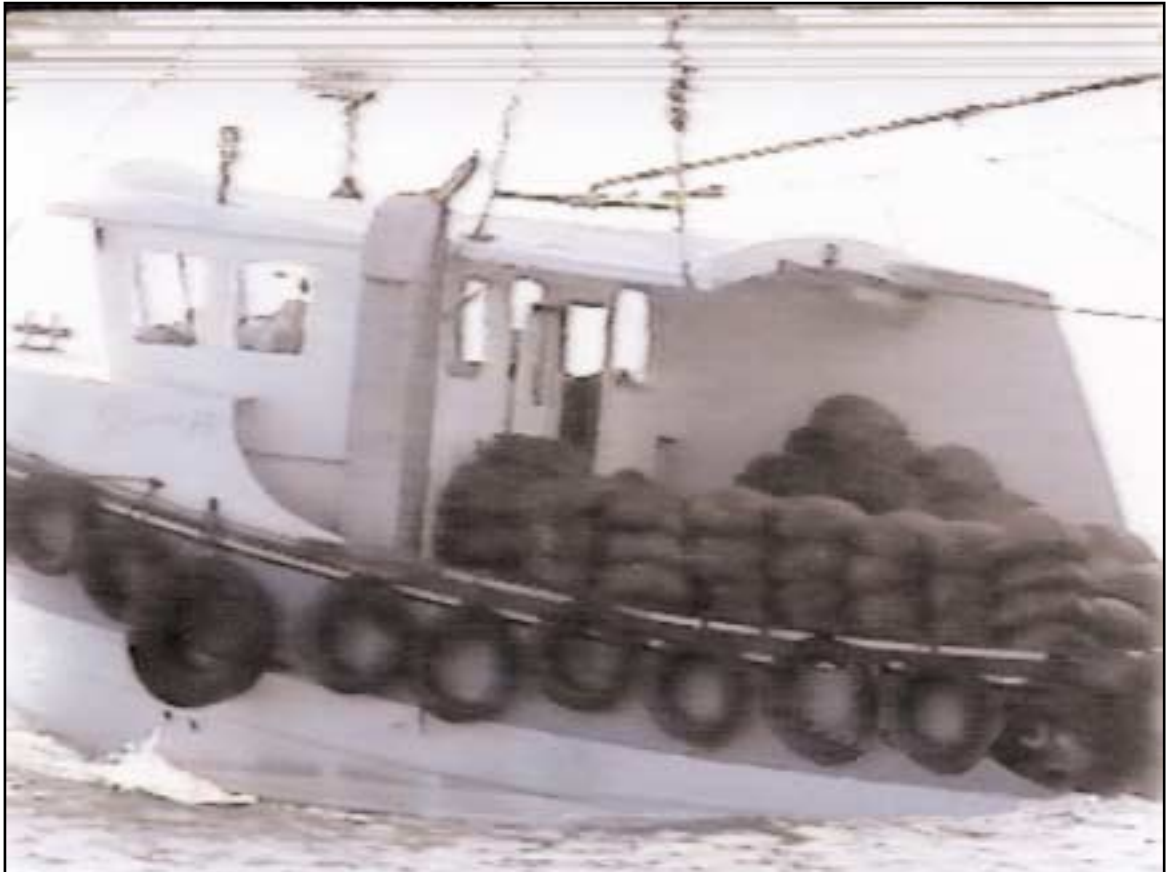
Figure 3

An example of mussel bag loading on *Charisma*

When a bag of mussels was full, it was tied off and then stacked on the deck. None were put in the fish hold, as it was too strenuous to get the full bags in and out of the hold. On weighing a selection of mussel bags retrieved from the seabed after the accident, it was found the average mass of a bag of cleaned mussels was 27kg. When the catch was good, it was not unusual to stack bags six or seven high on *Charisma's* deck.

Although the load of mussels on its own did not capsize *Charisma*, she was overloaded. Even without the flood water, the vessel had virtually no stability margin to cater for snagged lines, heeling while turning, or wind/wave action. Stability margins are applied to ensure that vessels are safe to operate. When these margins are eroded by permanent heavy additions to the vessel, or by overloading, the risk of capsize is considerable. Even the simple action of placing the catch in the hold would have dramatically improved *Charisma's* stability. Condition 2a superimposed on Condition 2 in Annex 3 clearly demonstrates the improvement, which is solely due to lowering the catch's VCG by 1.5m. Furthermore, a design GZ curve taken from the Cygnus Marine Ltd *Preliminary Stability Book* is also included for comparison. This curve meets the stability criteria that are applied to fishing vessels greater than 15m LOA, which was the recommended standard when the book was produced.

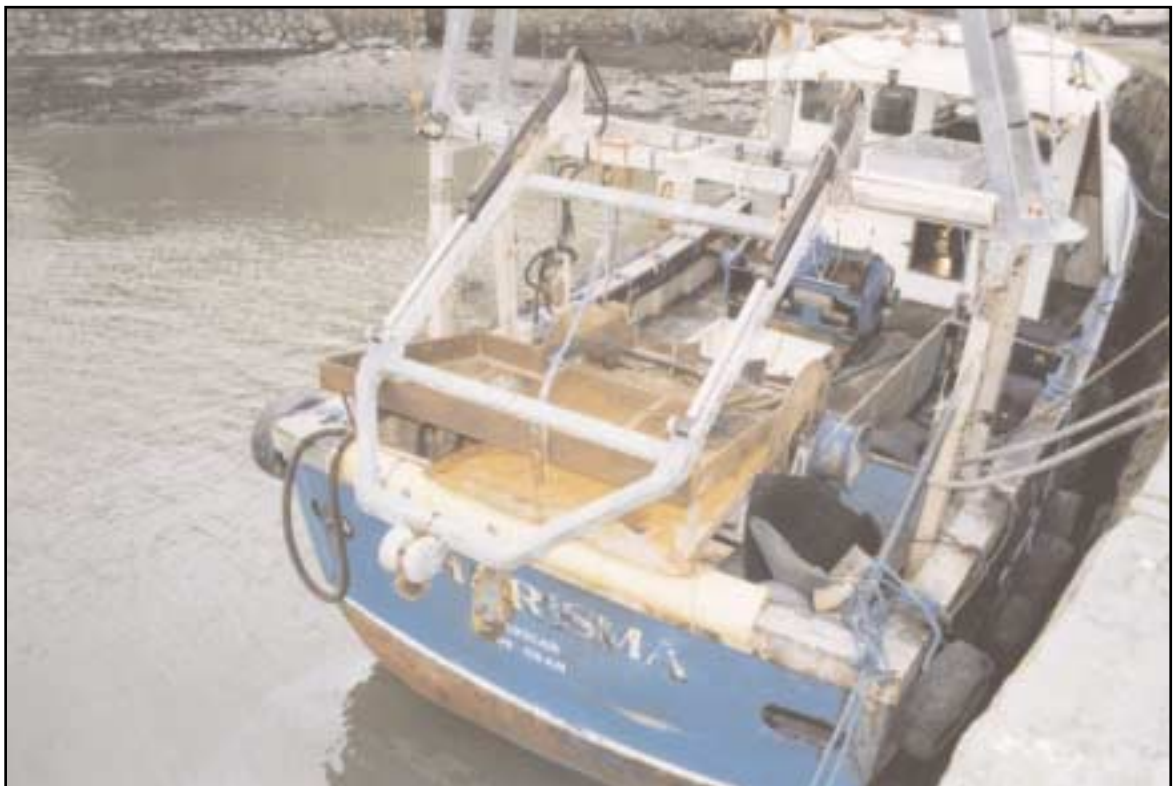
Figure 4

Charisma's stern showing mussel bench and hydraulic gear

Two years before the accident, the owner fitted the gallows, mussel bench and hydraulic rams (**Figure 4**). The previous gallows had rusted through. The owner was not aware of any official weight capacity for the vessel and, therefore, no particular allowance or calculations were carried out for the addition of this structure on the stern.

The replacement of the gallows by the owner, and the subsequent fitting of the mussel bench and hydraulic lifting gear, were significant additions to the vessel. The gallows fitted to *Charisma* were large for the size of vessel. In addition, the mussel bench fitted was of very heavy duty construction and, although probably able to last longer in service, its effect on stability and freeboard was significant. As guidance, the seven page pamphlet '*Safety on the Sea - Capsize Safety for Fishing Vessels*', produced by the RNLI's Sea Safety Liaison Working Group, is an excellent publication, providing useful guidance on fishing vessel stability, and should be essential reading for all fishermen. Some extracts are included at **Annex 4**.

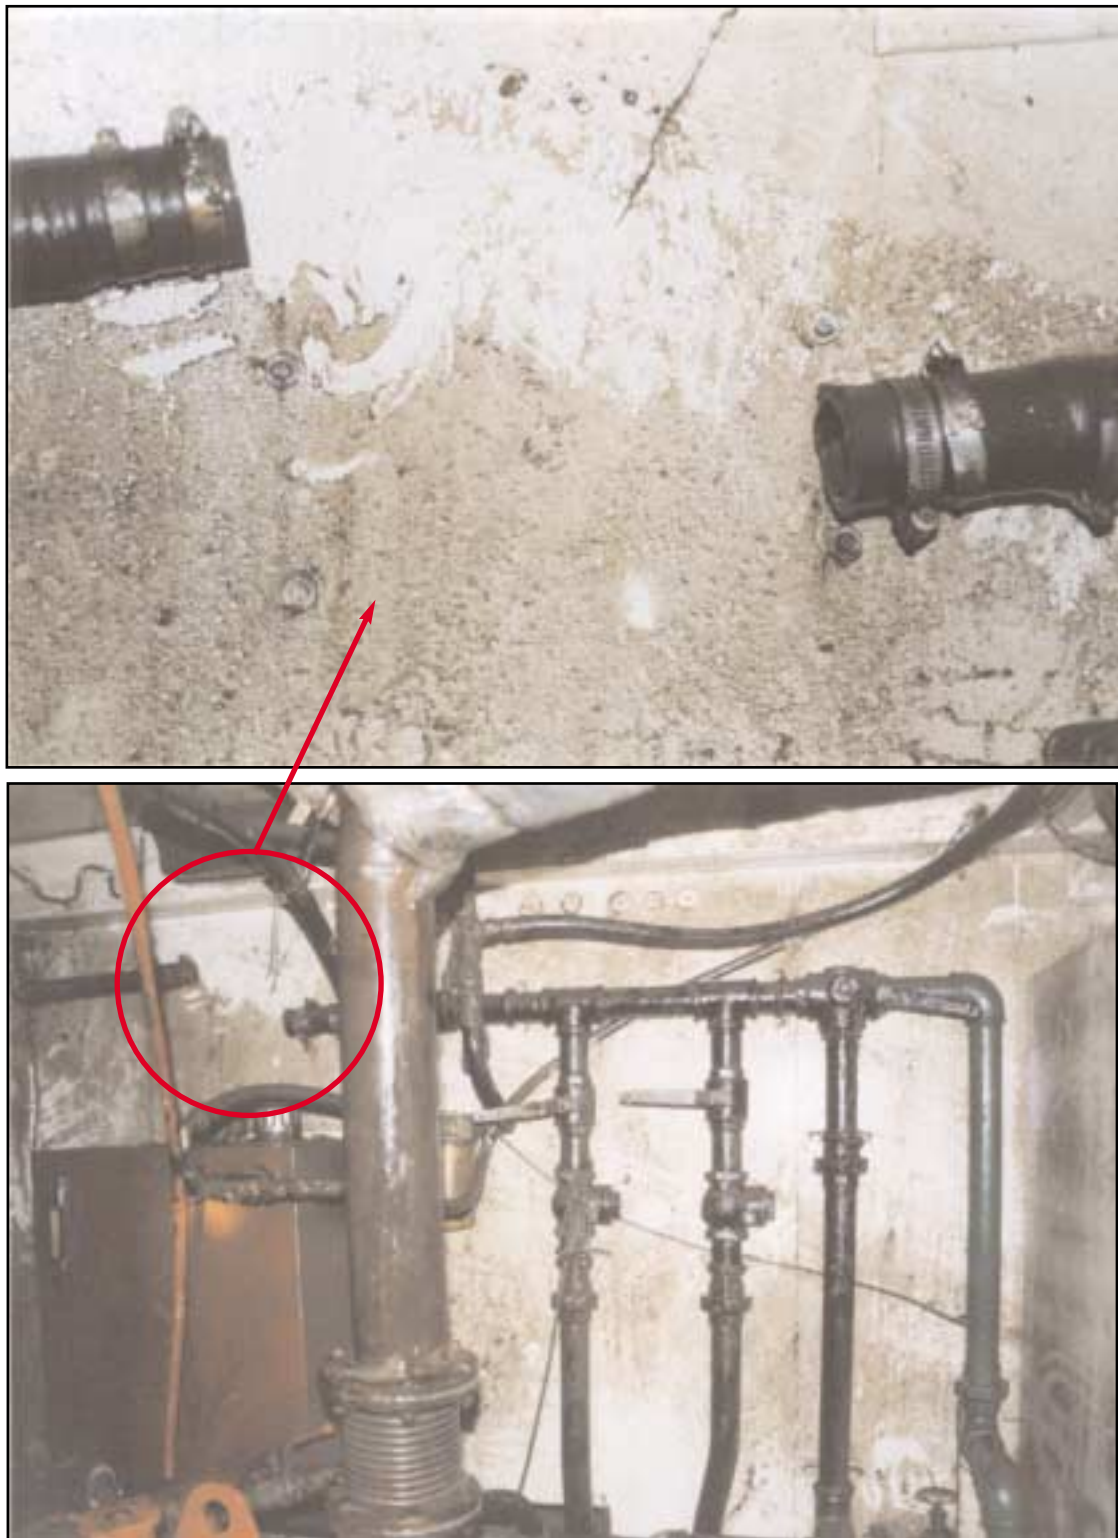
Figure 5

A manually operated bilge pump was fitted on the aft bulkhead of the engine room. However, two days before the accident, the skipper had removed it. He replaced the seals in the pump in an attempt to get it working again, but with no success. A bung wrapped in rag was jammed into the inboard end of the discharge overboard pipe on *Charisma*. The discharge overboard was 0.36m below the deck, 0.8m aft of the wheelhouse.

On closer inspection of the engine room, no trace was found of a bung, although the skipper had stated that a bung and rag had been used to plug the open bilge discharge pipe (**Figure 5**).

View of aft engine room bulkhead showing location of missing manual bilge pump

The last option is the most likely cause of flooding. It is highly likely that the bilge discharge was submerged below the waterline on numerous occasions during the latter part of 29 January and on the morning of 30 January (as a result of the large catch on deck). The bilge might have also had some water present at the start of the 2 days, as no checks of the fish hold or engine room were made during this time. Wedging a bung into a 30 to 40mm rubber pipe is a highly unsatisfactory method of maintaining watertight integrity. It is unlikely the bung would have stayed in the pipe. When the vessel was not heavily loaded, the bilge discharge was well clear of the waterline and might not have been considered a great risk to flooding.

The last line of defence fitted in *Charisma* was the manually operated bilge pump attached to the aft engine room bulkhead. Again, this did not have a high pumping capacity but, in the event of a complete power failure, it provided the only means of pumping out floodwater. Maintenance of this system is required from time to time, and that is precisely what the skipper was doing a few days before the accident. Unfortunately, he was unable to repair the old manual bilge pump and, not considering the lack of manual bilge pumping capability and possible back flooding, did not fit a new one.

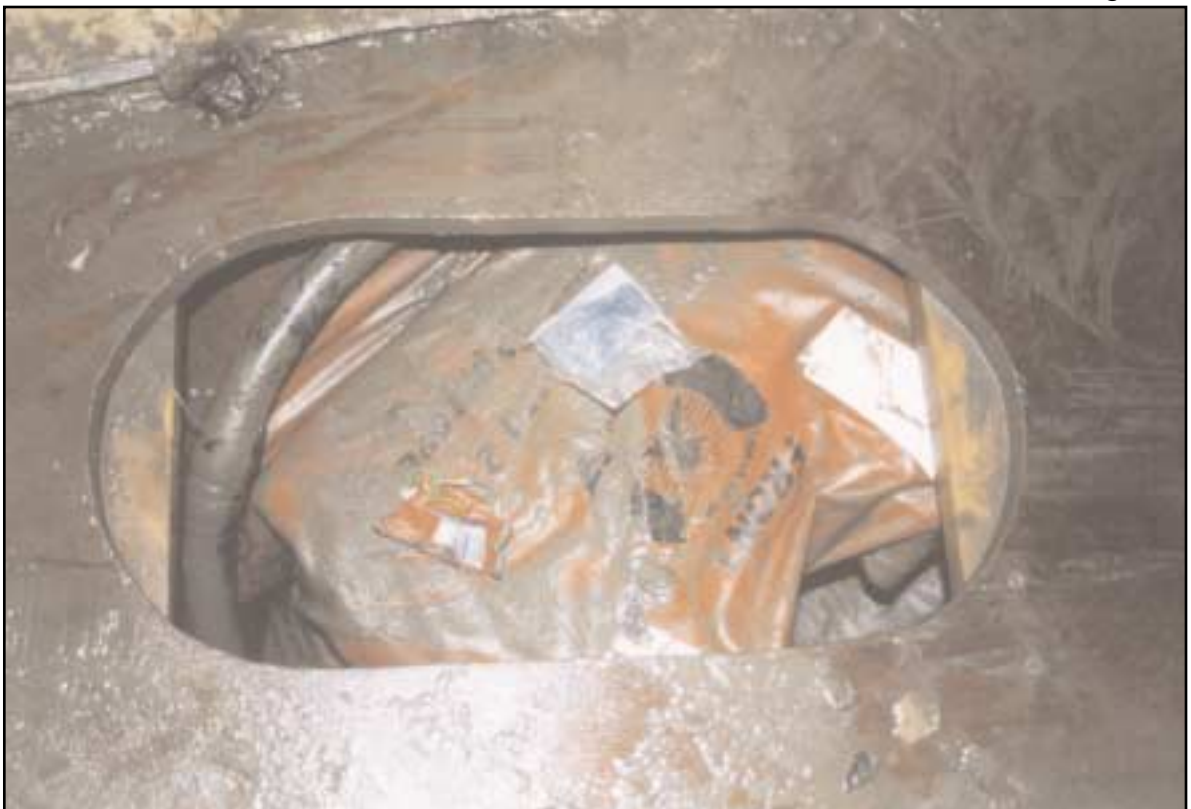
Figure 6

Three lifejackets were found stowed in a starboard under-bunk locker in the cabin. The lifejackets were effectively jammed in tight. The small locker opening made retrieval of the lifejackets very difficult (**Figure 6**). After the inspection by the coastguard on 7 January 2000, they had instructed that lights be fitted to the lifejackets to comply with fishing vessel regulations. This had not been done.

Stowage of lifejackets as found under cabin bunk

Had lifejackets been worn at the time of the accident, it is highly probable that no lives would have been lost. For some time, the MAIB, MCA and RNLI have campaigned for fishermen to wear lifejackets as a matter of course; when they are really needed, the time required to don them is restricted. Additionally, in the case of *Charisma*, several minutes warning were required to extract the lifejackets from the under-bunk locker.

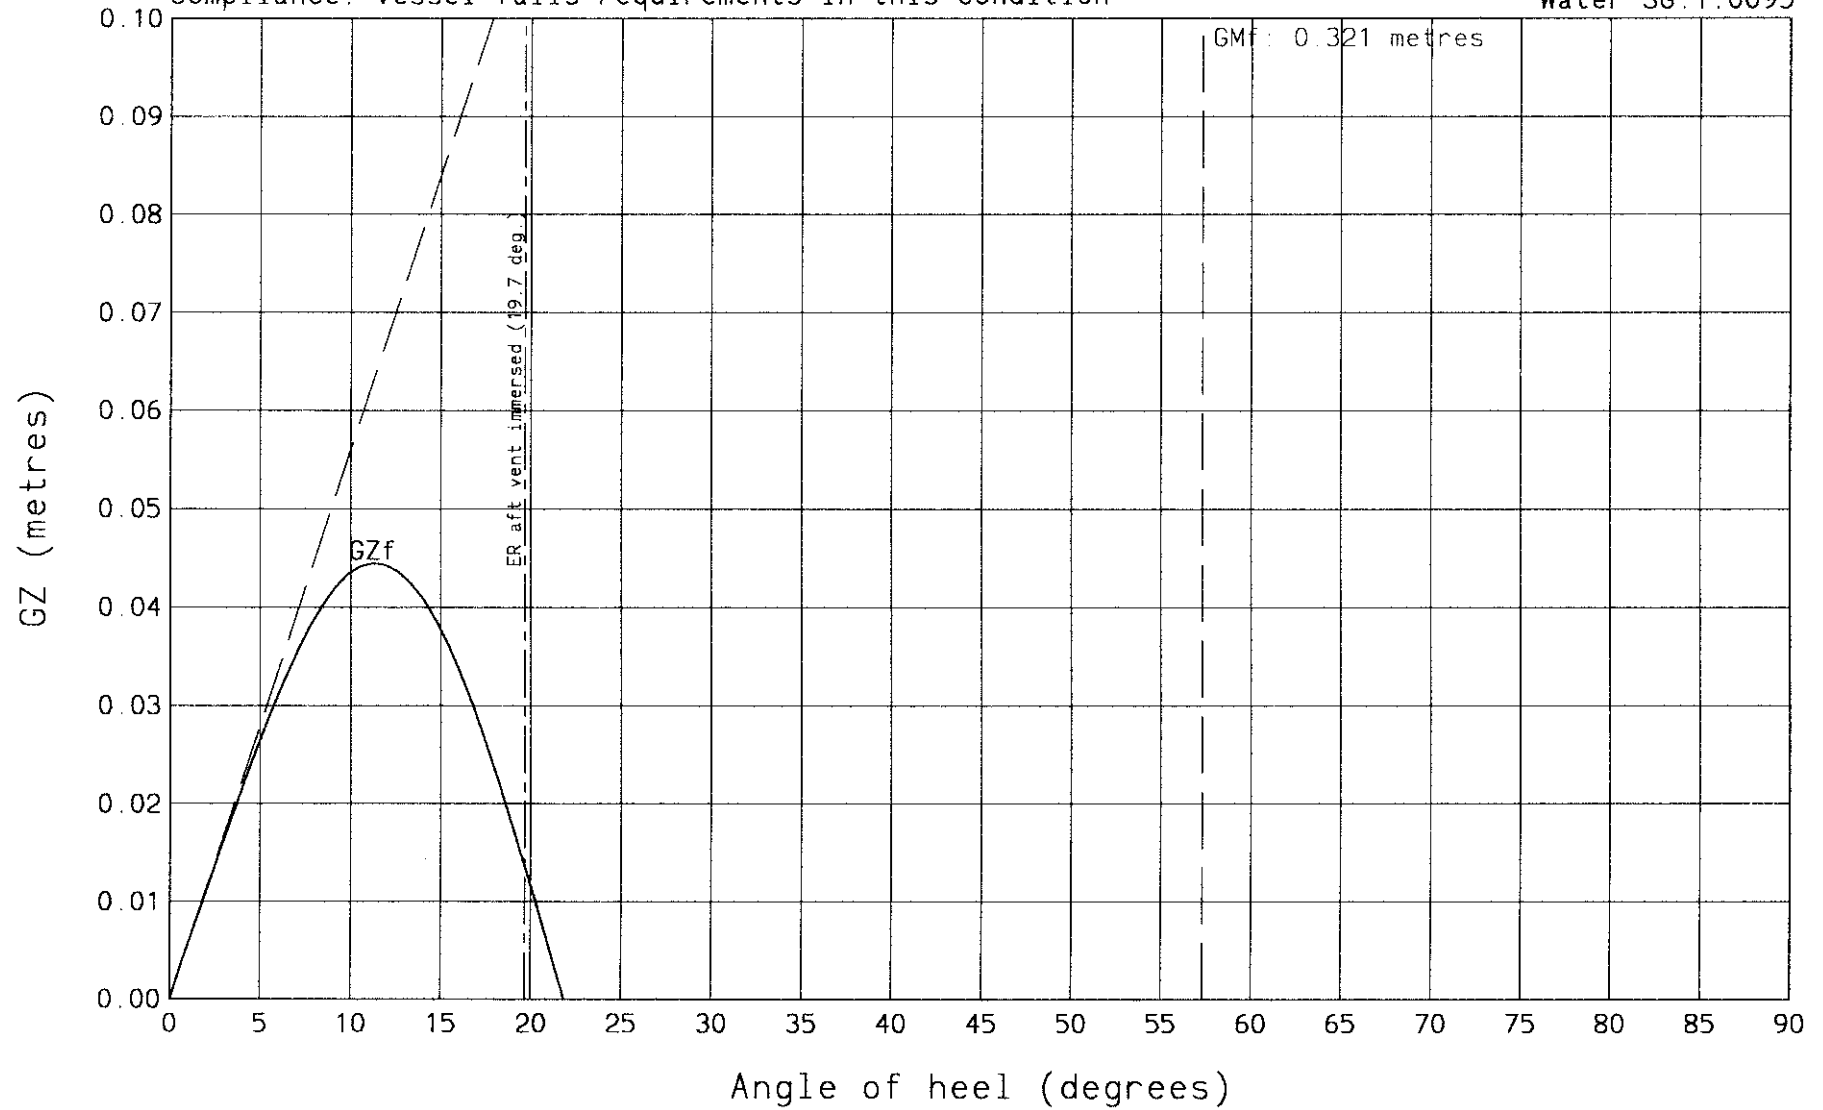
It is readily apparent that the load carried on *Charisma* was not sufficient to cause capsizing on its own. Although the GZ curve is not healthy and only has 0.045-0.05m maximum righting lever, in calm conditions the vessel should remain upright. It is roughly estimated that 6.5-7.0 tonnes of floodwater would be required to cause capsizing.

Compliance: Vessel fails requirements in this condition

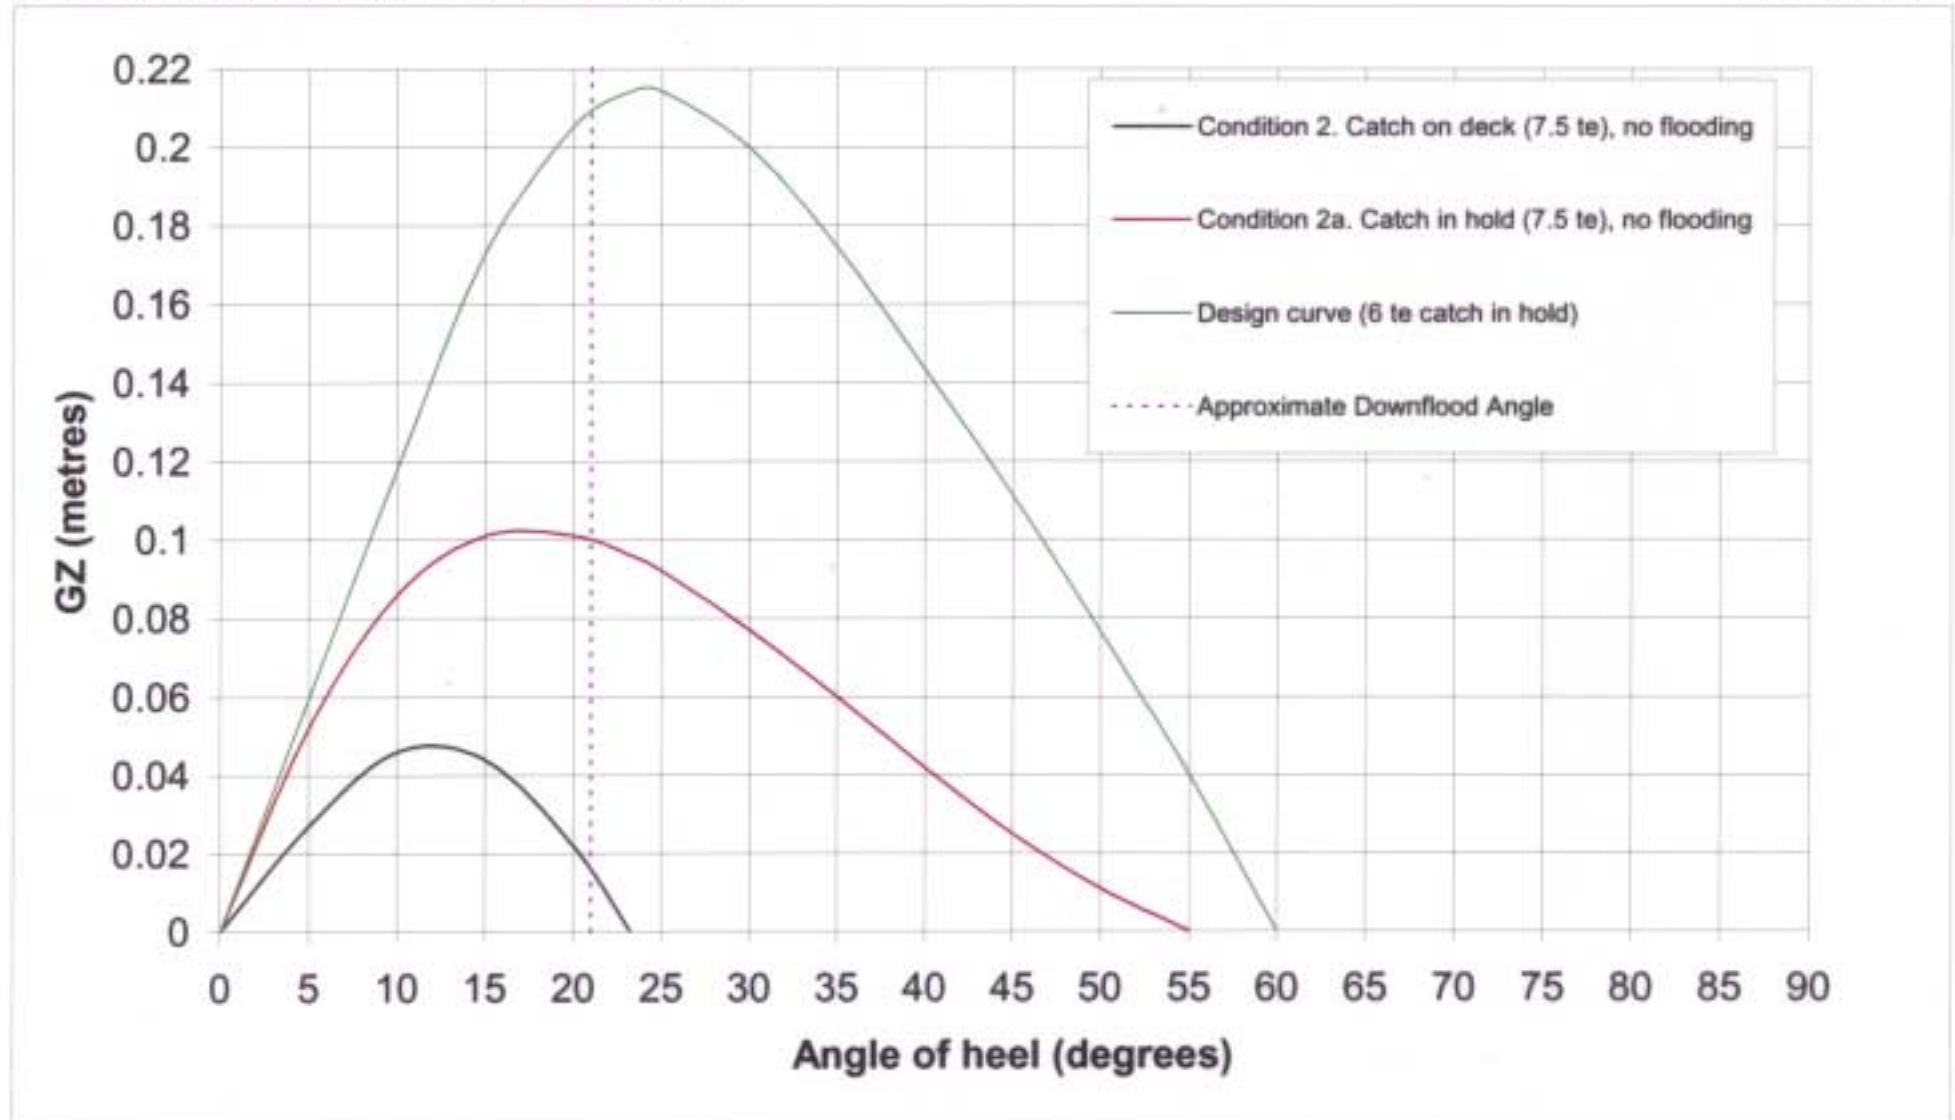
Compliance: Only design curve meets requirements
