Report on the investigation of
the collision between
Diamant/Northern Merchant
3 miles SE of Dover
on
6 January 2002

Marine Accident Investigation Branch
First Floor
Carlton House
Carlton Place
Southampton
United Kingdom
SO15 2DZ

Report No 10/2003
April 2003

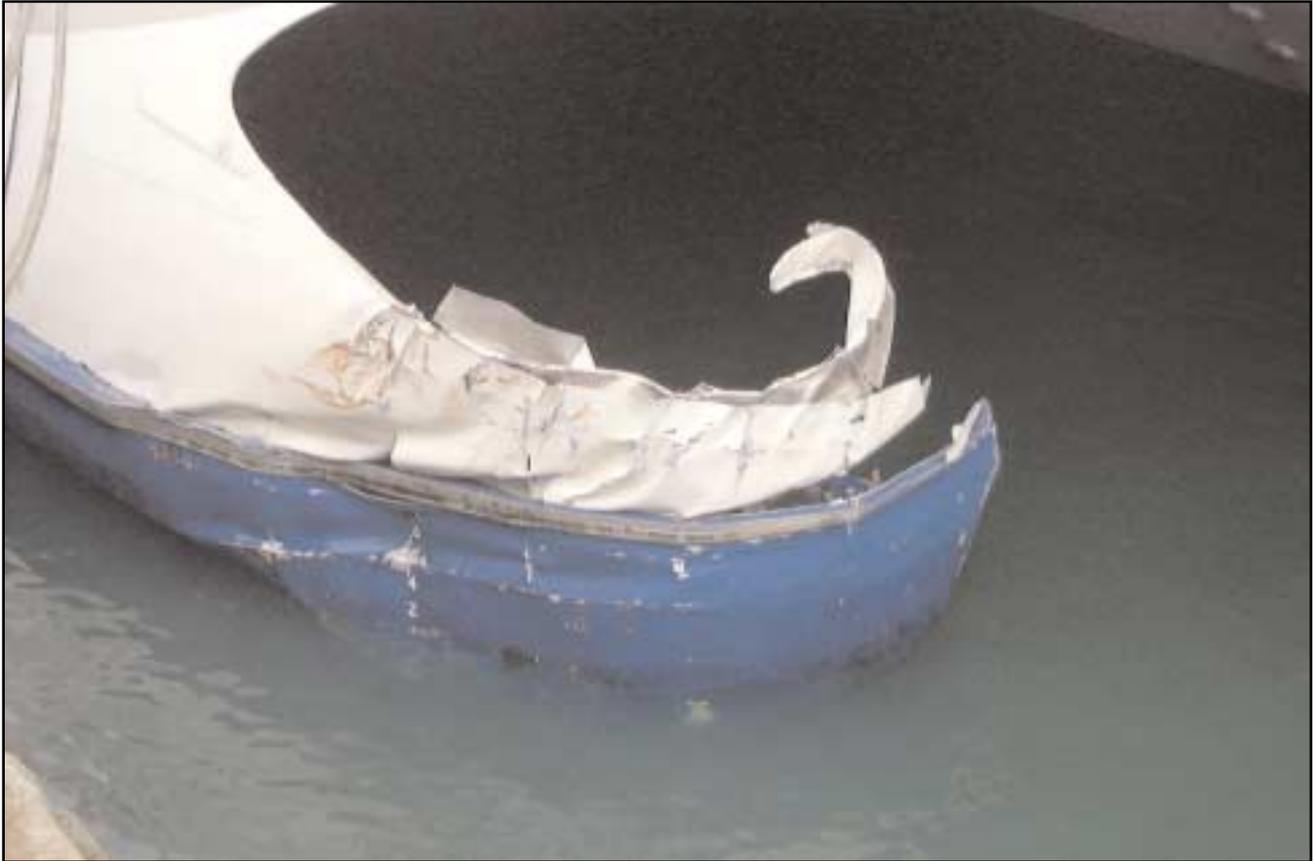
Figure 6 - damage to *Diamant*

As a result of the collision, *Diamant* suffered substantial prow and starboard side wave piercer damage. *Northern Merchant* suffered slight damage to her port side shell plating. There were no injuries.

After soundings and checks were made, it was reported that there was substantial damage to No.1 void space in the starboard hull (**Figure 6**) with ingress of water, but the bilge pumps were coping. Damage to some cars was also reported. Ten minutes after the collision, the master made a further announcement to the passengers to inform them the vessel would be continuing to Dover at slow speed.

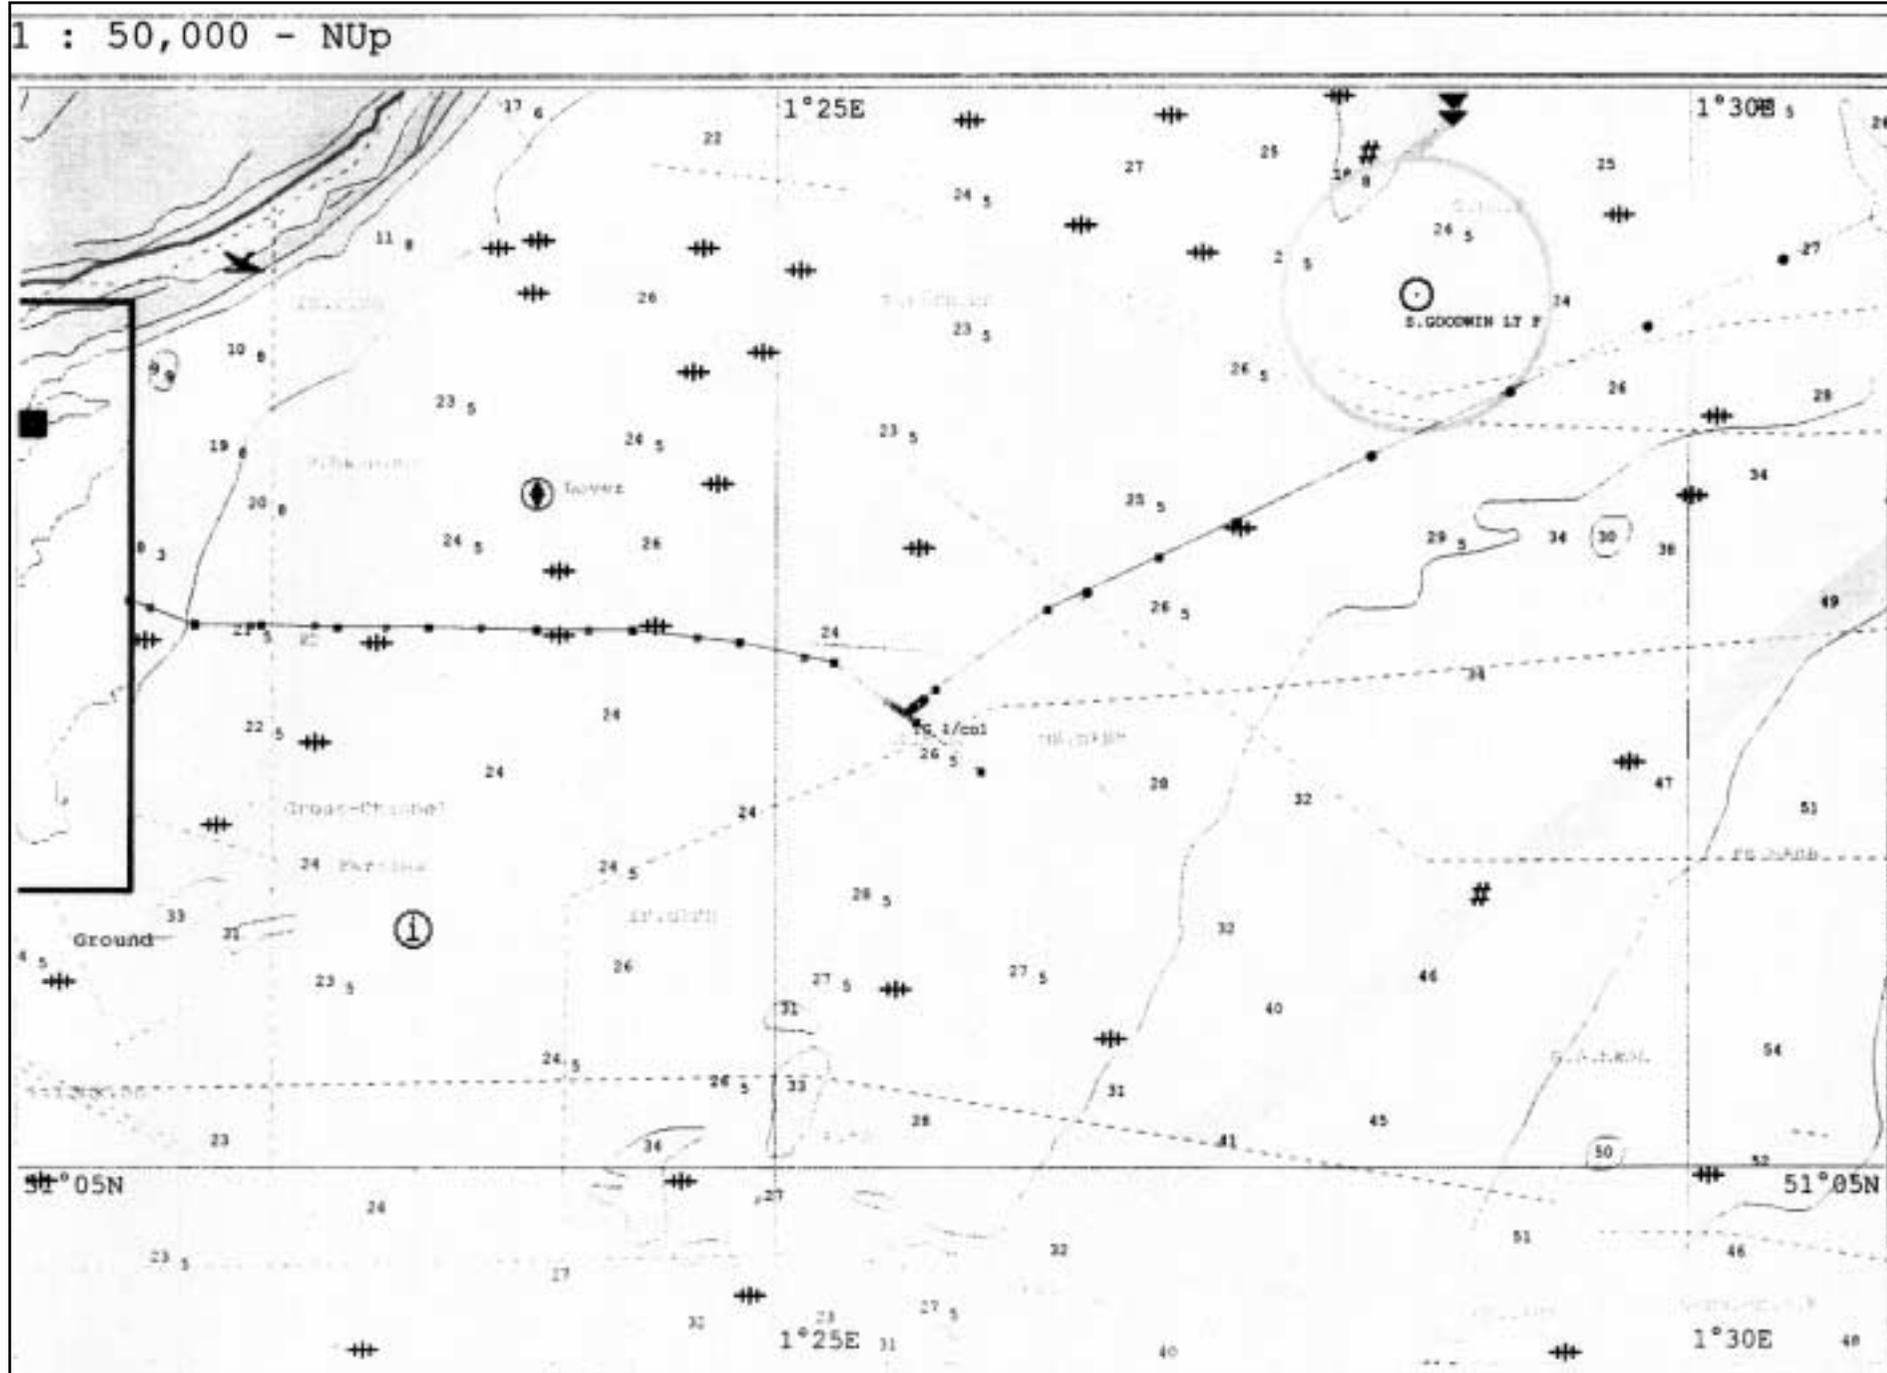
Figure 7

The bridge team's assumption that it was a green-green situation was incorrect, as *Northern Merchant* continued to show her port side throughout the accident (**Figure 7**). Their assumption was based on their anticipation of *Northern Merchant's* likely passage. In not monitoring the ARPA course and speed display following their initial appraisal, contrary to Rule 7(b), they failed to maintain a full appraisal of the situation, contrary to Rule 5 of the Collision Regulations. Instead, reliance was placed solely on her CPA; the master neither requested, nor was offered, the ARPA's course and speed reading.
